**TOMB OF MENNA (TT69)
CONSERVATION AND
DOCUMENTATION PROJECT**

Fall Season Report

September 9-November 13, 2008

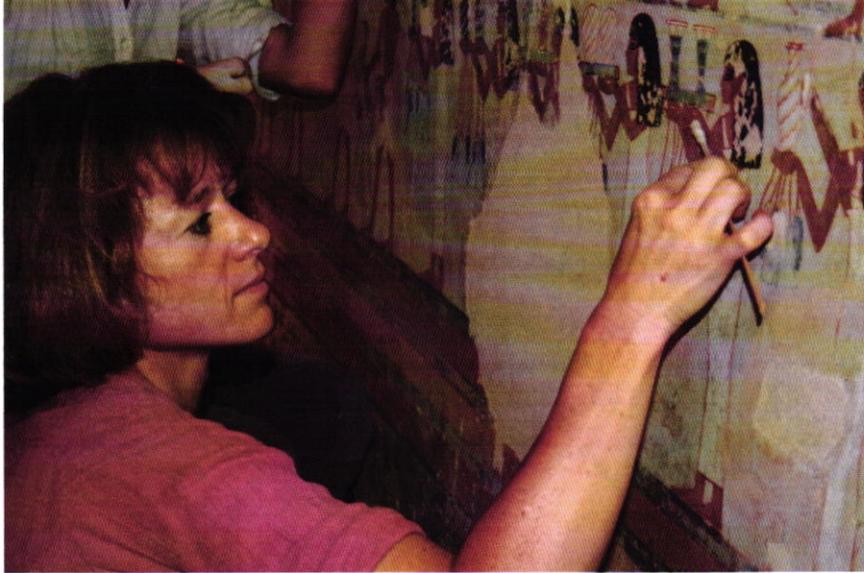
Picture 1: *Paraloid B72 removal in progress, right (Sarah Livermore)*

Fall 2008 saw the completion of the removal of the Paraloid B72 in which a great deal of dirt was embedded (**Picture 1**). The advantage is immediately visible in the colors that have returned to their original brightness (see p. 6 below). An acetone surface cleaning was also undertaken on the inner and entrance door thicknesses which were coated with century of oil from hands and arms touching its surface (**Picture 2**). In addition, graffiti in the form of pencil and chalk marks left by earlier copyists were removed, but only in cases where the decoration would not be damaged.

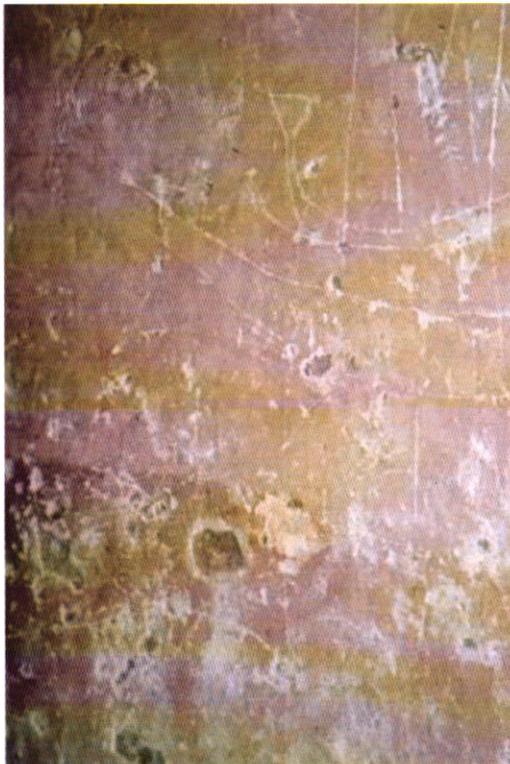
Picture 2: *Inner Door right, showing cleaning line with upper part cleaned.*

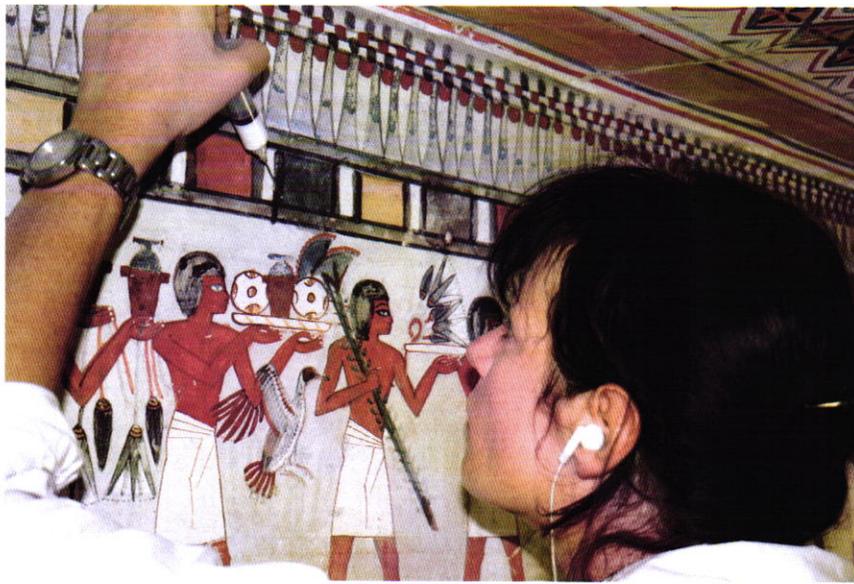
Picture 3: *Flake fixing Long Hall Left (LHL) (Bianca Madden)*

Areas of powdering or flaking paint were fixed and consolidated with a 1:1 solution of Plexol B500 (an acrylic dispersion) and water (**Picture 3**). To stabilize the flaking edges, a gypsum-based filler was used that later received a toned wash (aqua sporca) to reduce its visual impact (**Pictures 4 and 5**). The ancient loss of blues and greens in the tomb was also investigated. The best explanation is that the ancient binding medium was too strong and contracted, pulling off the frit-based pigment with it.

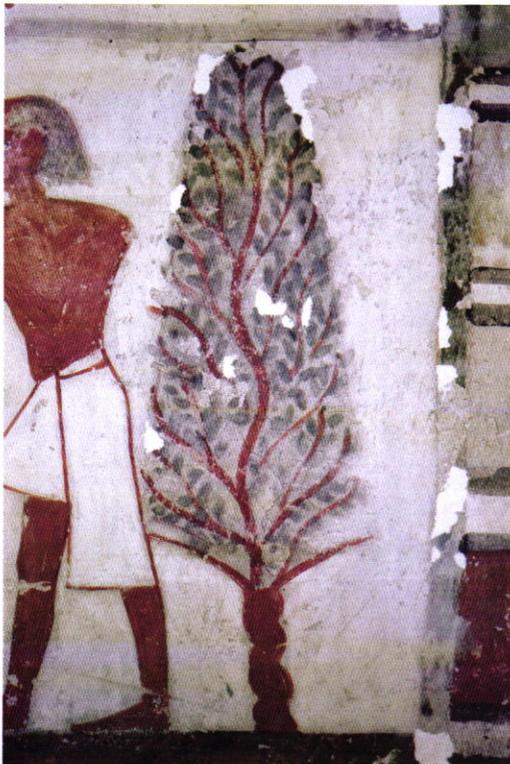
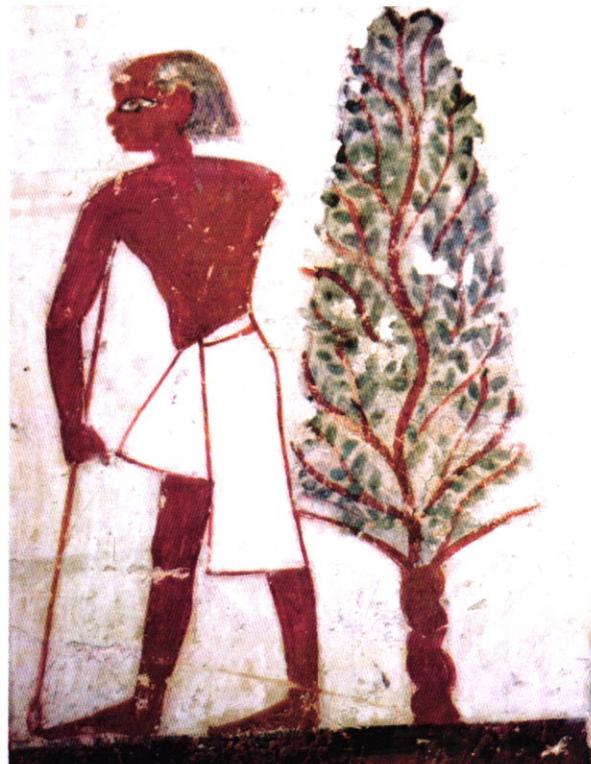
Pictures 4 & 5: Fine surface edge repairs on the greens, before toning with aqua sporca (left) and after (right).

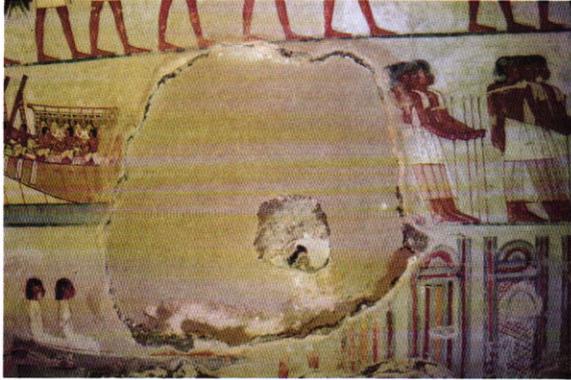
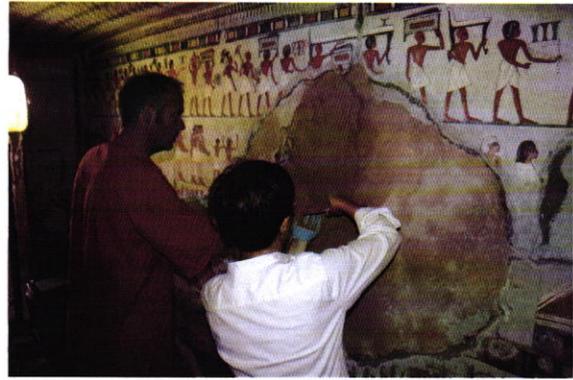
Pictures 5 & 6: First layer of repair mortar, with adhesive repairs to the edges (right), applying the top layer of mortar (left) (Mark Perry and Cristina Berretta).

We decided to remove the majority of the older PVA/sand repairs because they were dislodged, cracked or didn't connect with the edges of the original plaster. The old fills were removed from the center out and repairs were made to the edges to stabilize them. Several layers of lime mortar were spread on the exposed *muna* and then cut back to be flush with the surface for visual cohesion on the wall (**Pictures 5-8**)

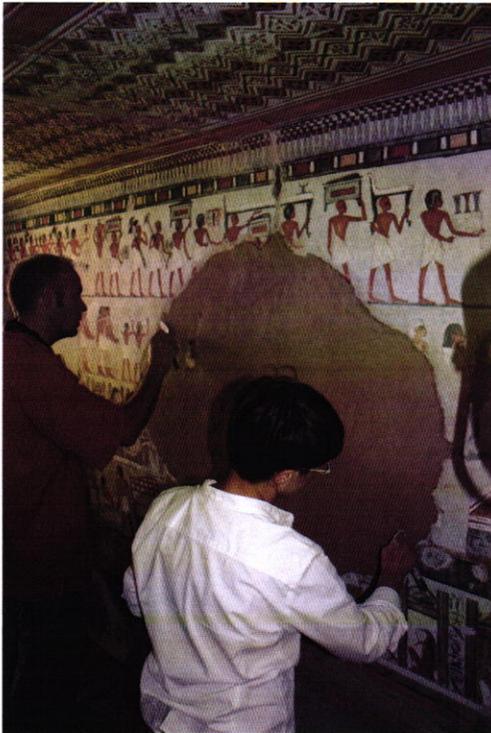
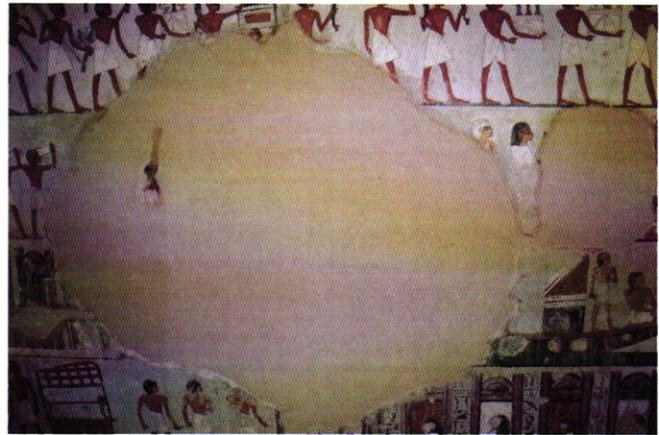
Pictures 7 & 8: Left, cutting back the final layer (Mark Perry and Cristina Berretta). Right, the finished repair

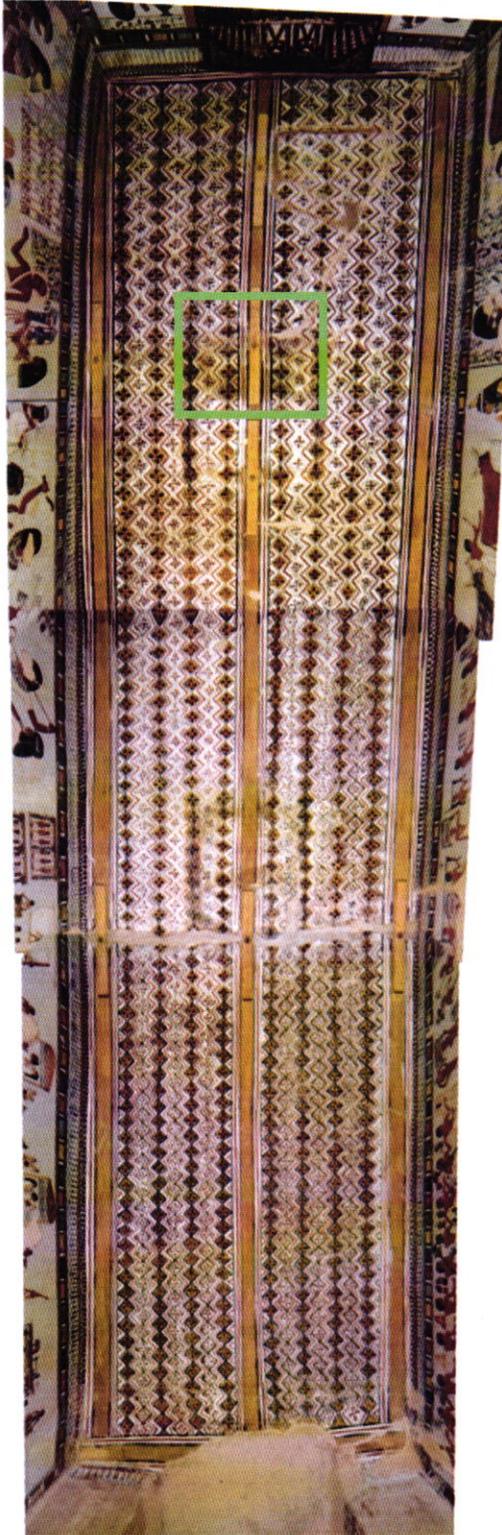
Picture 9

Picture 9: Long hall ceiling with seven (7) steel plates fixed to it. The areas investigated are indicated in the red squares. The bend in the ceiling is due to the stitching of the photographs and does not exist.

The ceilings were lightly dusted. Chalk graffiti as well as wasps' nests were eliminated. Staining and mortar smears along the edges were removed and stabilized. In the long hall, we investigated a 60 cm x 60 cm square that was cut out of the ceiling. At some point in the early-mid 20th century, this square was cut as part of a stabilization plan constructed around long steel plates that are still anchored into the ceiling (**Picture 9**). By carefully excavating around the edges of the square, we found several threaded pins anchored to the stone above the ceiling and a large amount of plaster of Paris that was introduced as an adhesive to hold the square section of ceiling in place. Two steel plates were placed on the ceiling face, held in place by nuts at the end of the threaded pins. These plates were padded with paper and thick yellow felt between the plate and the ceiling face. Once this modern ceiling anchoring system was revealed, we discovered an arrangement of palm wood beams that crossed the width of the ceiling every ca. 40 cm. This technique was intended as a structural base for the *muna* and plaster ceiling. In the long hall behind the ceiling, some voids as deep as 25cm remain above the plaster fill. However, the ceiling squares are well attached and structurally sound (**Picture 10**). Since the corners of the original square were hidden by poorly done modern repainting,

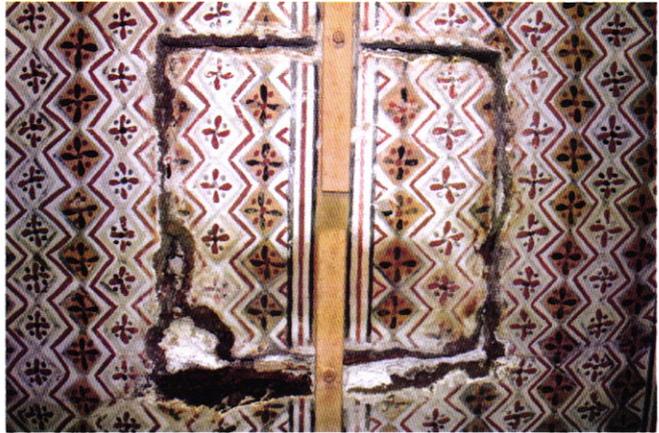
Picture 10 (below right): The square with repainting removed showing the plaster of Paris (lower left and right) and the remains of the wooden beam (lower left).

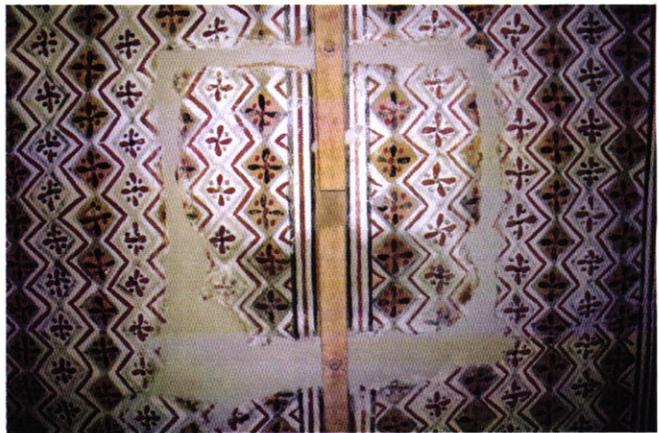
Picture 11 (lower right): The square stabilized with a lime mortar fill with no repainting.

we decided to remove the modern paint and stabilize the square with the same lime putty and sandstone mixture that was used for the other fills on the walls (**Picture 11**).

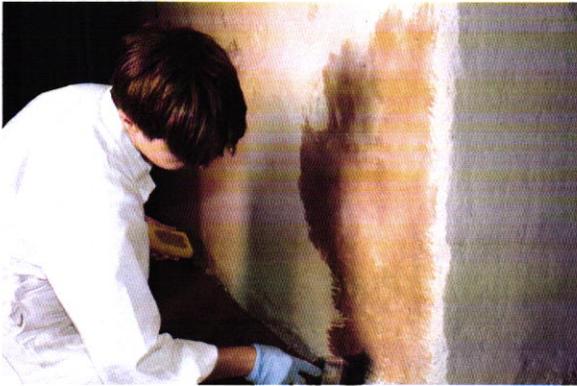
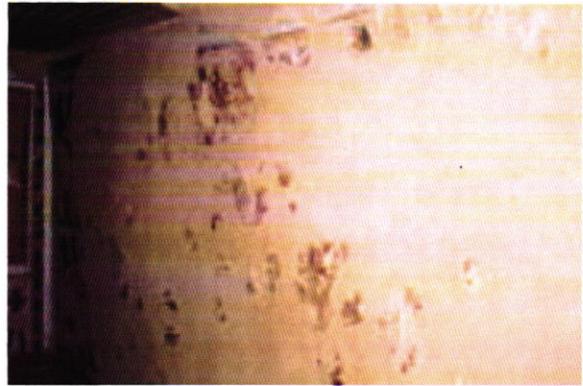
Picture 12: Left, applying lime wash to the broad hall far left wall (Cristina Berretta)
Picture 13: Right, the lime washed wall

The broad hall far left (BHFL) wall contains fragments of decoration except for the far left corner scenes of Menna and his wife that are complete. The last conservation intervention, before that of the Tomb of Menna Project, worked with two tones of repair plaster: a dark pink mortar applied around the fragments, and a lighter sand-toned plaster. We decided to treat the wall with a lime wash composed of lime putty and earth pigments (aqua sporca) that acted to unify the wall visually (**Pictures 12-13**). The same treatment was used on the two phases of repair plaster on the entrance hall. Aqua sporca was also used to tone out the fine surface repairs made with the white gypsum based filler to make these repairs ‘disappear’.

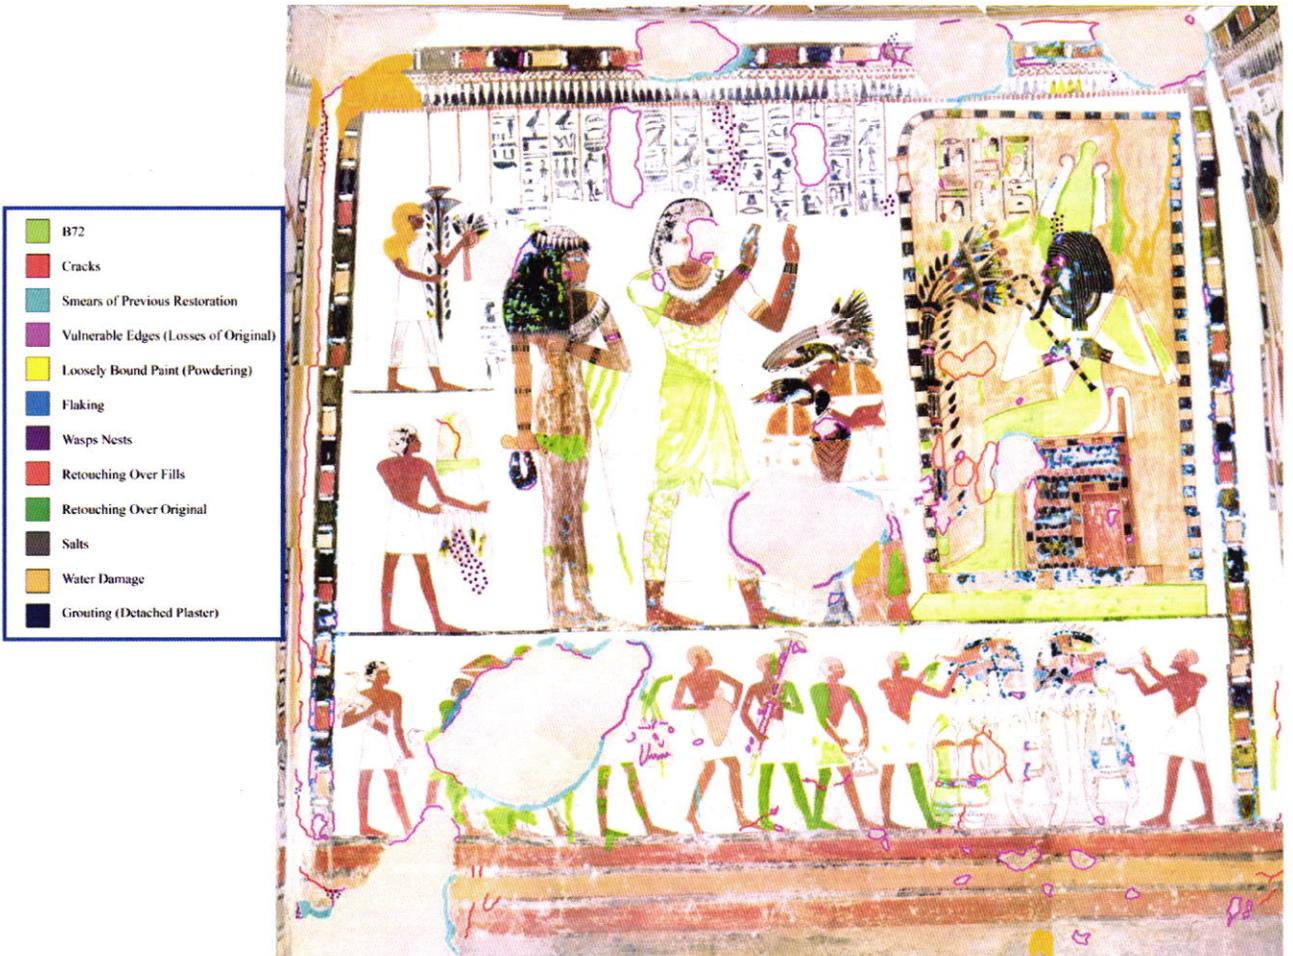
Picture 14: Digital condition survey of broad hall small left wall with color key (Doug Thorp)

A complete condition survey of the tomb was carried out on A-3 photographs taken of the tomb chapel before starting work in 2007. This survey was then transferred onto the computer as a digital record during the 2007 season and completed in the 2008 season. This digital documentation gives a complete visual record of the condition of the tomb before work started, in both high and low resolution format (**Picture 14**).

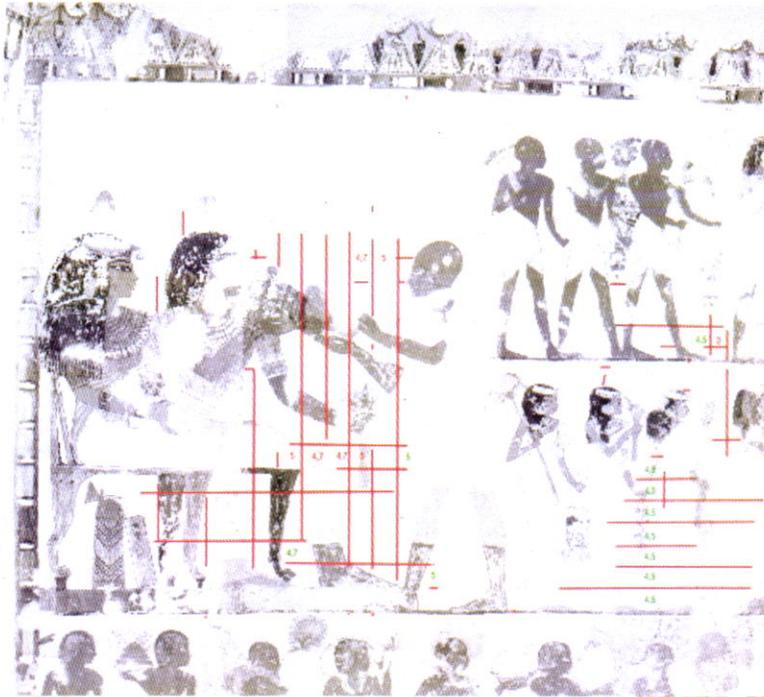
Picture 15:
Documentation of grid lines remaining on Broad Hall Near Right wall (BHNR) (Kerstin Leterme)

Visual analysis of the painting stratigraphy was undertaken by Kerstin Leterme (University of Ghent) from September 21st to November 10th, 2008. The steps followed this season were: the plaster layering (muna-gypsum plaster-intonaco); guideline systems (squared grids, proportional systems) (**Picture 15**); preliminary drawings; the relationship between the background wash and the figures and objects; the sequence of colors applied on the walls; the transparency effects; and final outlines and corrections. All of these steps and their documentation are currently being analyzed and interpreted with the help of the data obtained from the archaeometric data and the conservator's observations to be able to obtain a complete synthesis and overview of the painting process and the pictorial practices used in the tomb chapel of Menna.

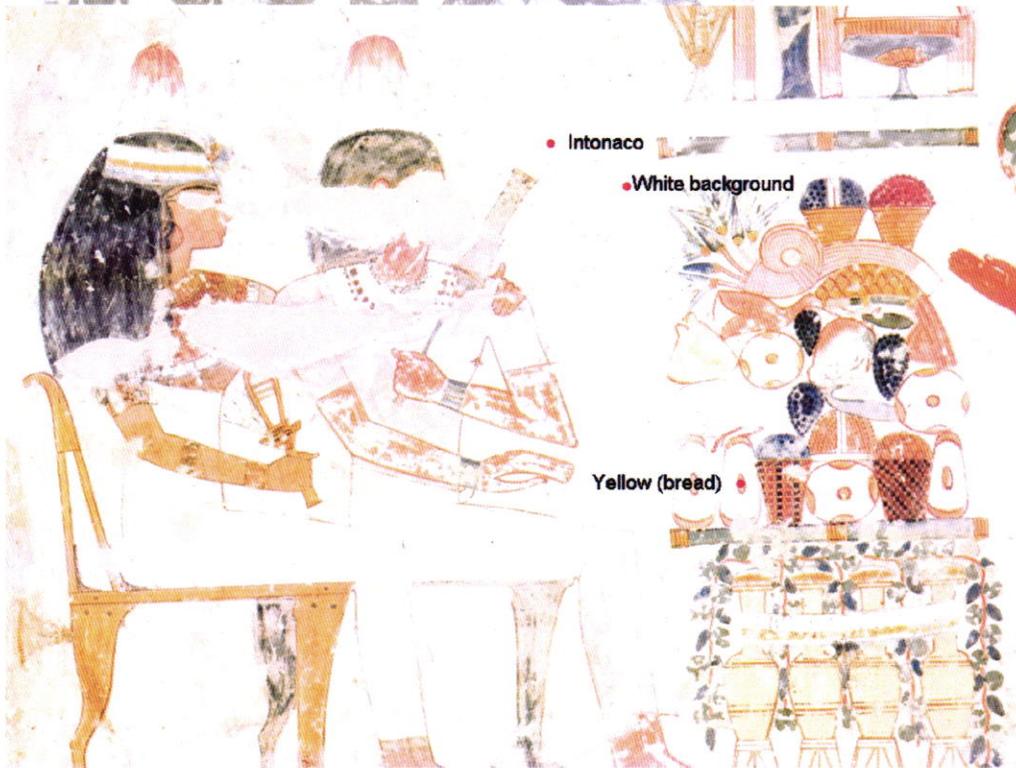
Picture 16:
Points used for visual (VIS) color spectroscopy

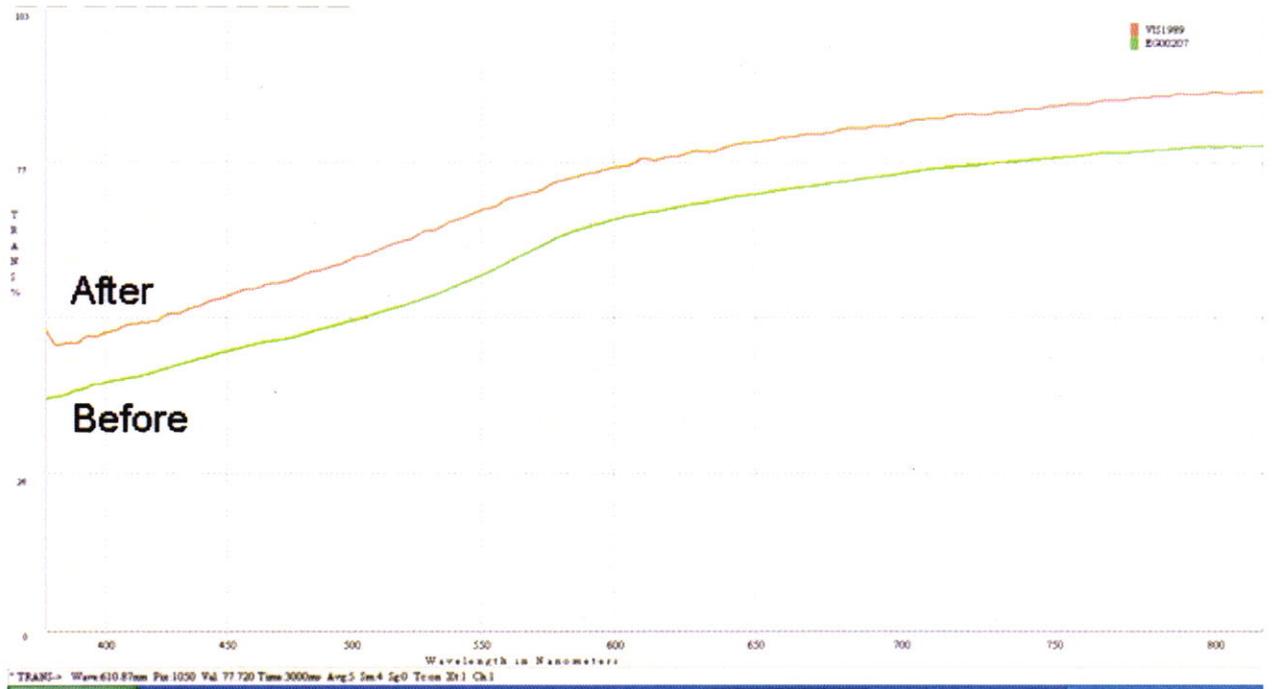
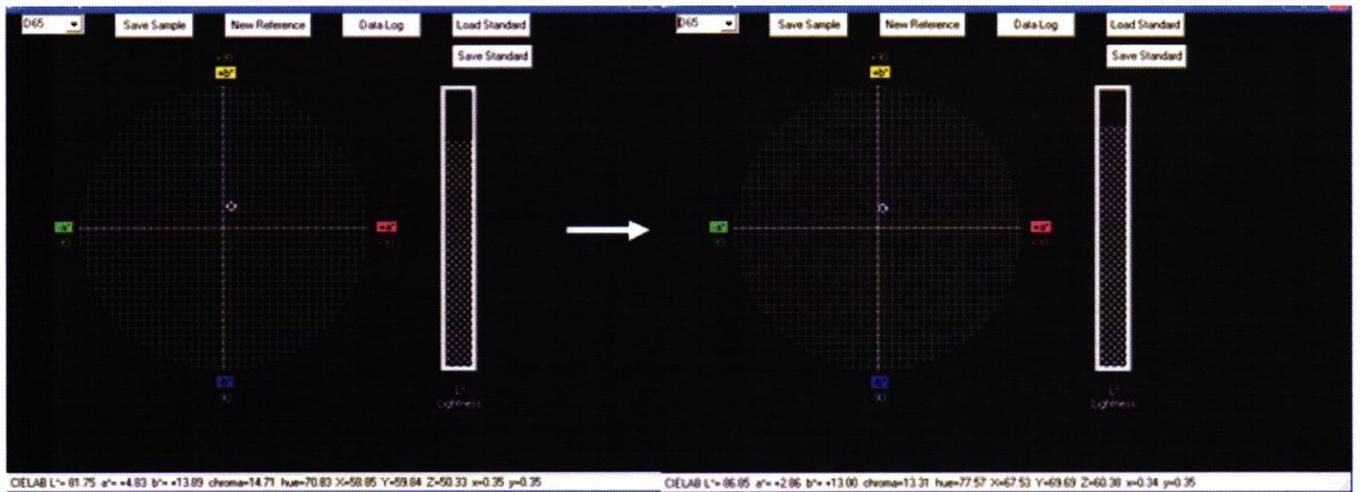
Intonaco: before and after cleaning

Same colour spectra, slight differences, mainly in lightness L^* .

Picture 17: Intonaco color before and after cleaning

The results of the color measurements by VIS spectroscopy from October 2007 were compared to those acquired in November 2008 to see if conservation of the pigments, binders, and plaster had altered the original colors in any way. We found that the spectra remained the same, indicating that the pigment had not been altered or changed. To the contrary, the brightness varied seen by the graph lines that are closer to the bottom of the graph, thus indicating lightness. These lighter readings of the colors are certainly the result of removing the B72 embedded with dust and dirt particles from the walls. As an example, **Picture 16** shows the points taken on the BHFR of offering of bouquet to Menna and Henuttawy, which includes the intonaco (**Picture 17**), white background (**Picture 18**), and yellow (**Picture 19**)

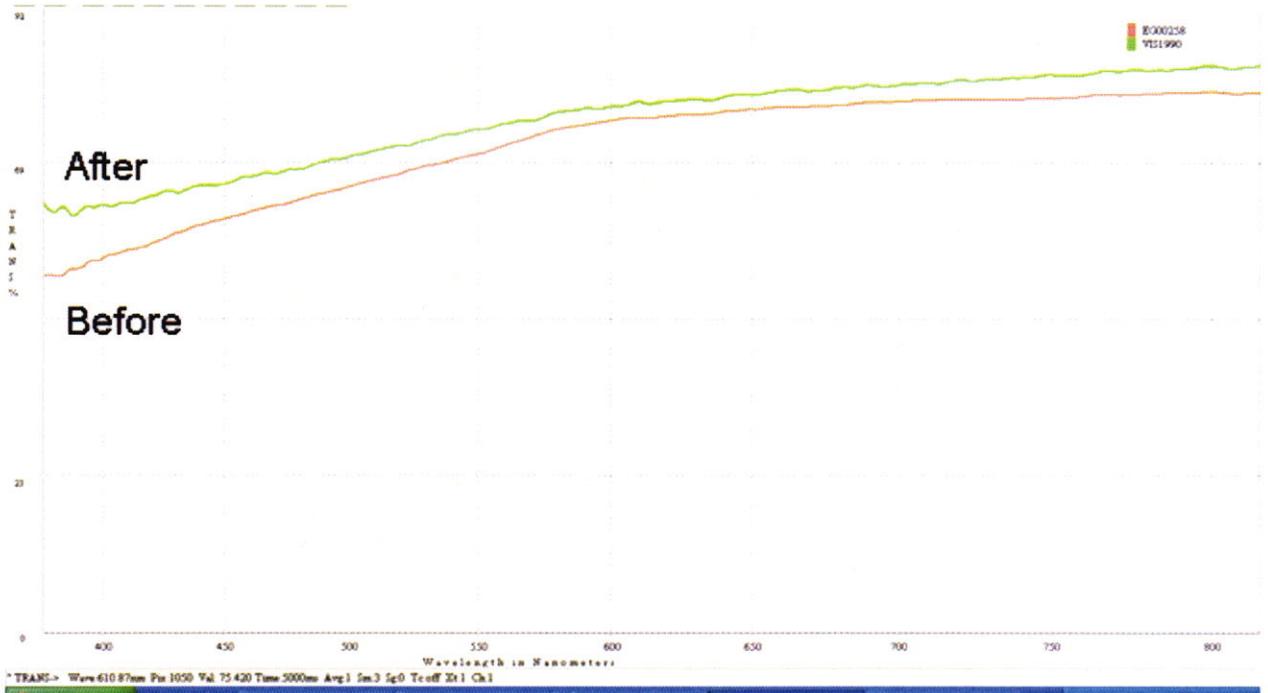
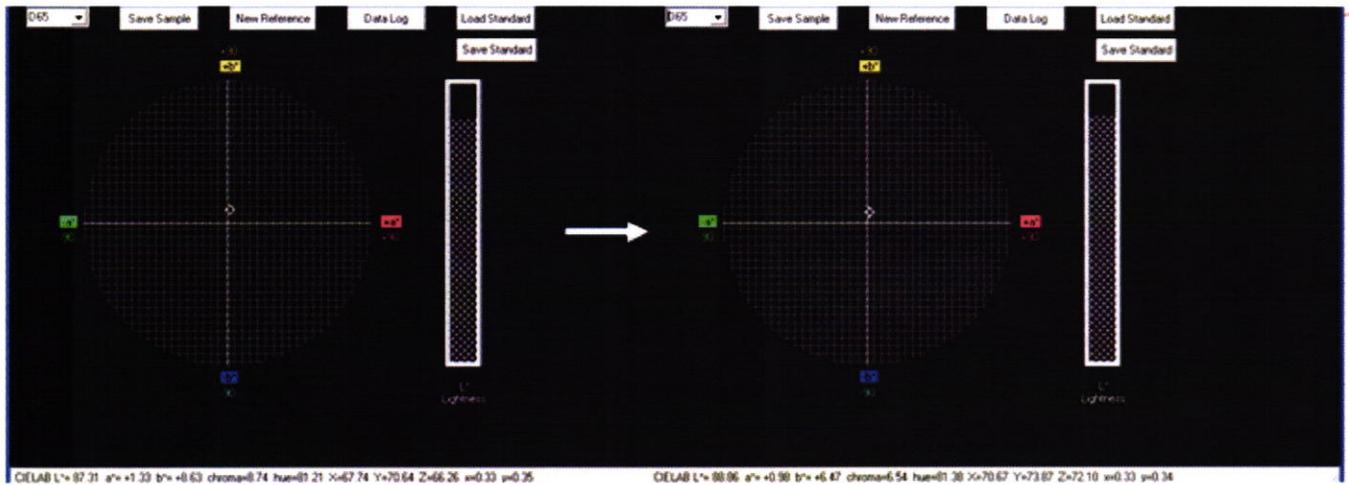
White background : before and after cleaning

Same colour spectra, slight differences, mainly in lightness L^* .

Picture 18: White background before and after cleaning

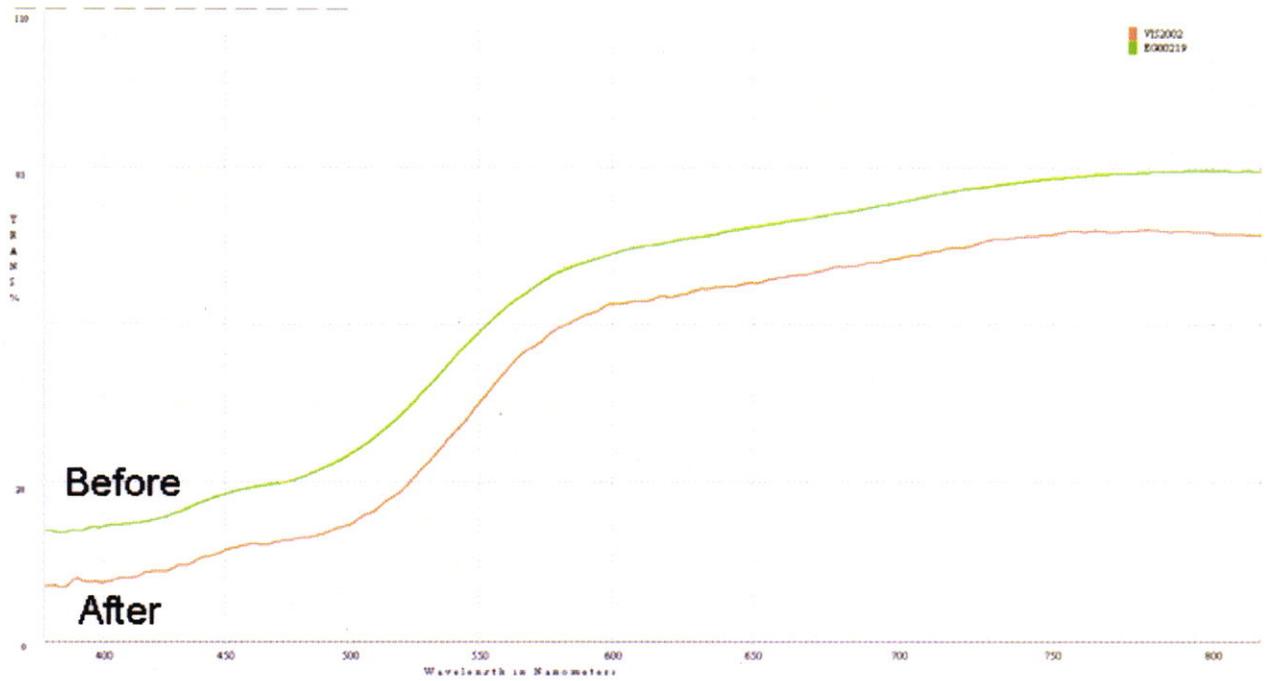
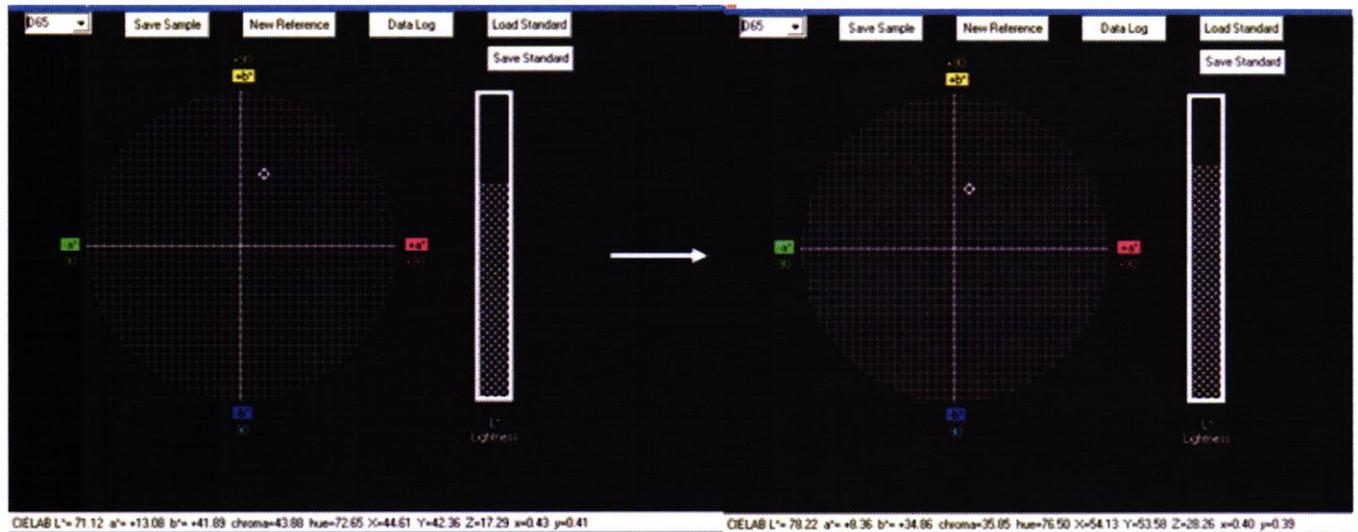
Yellow: before and after cleaning

Same colour spectra, slight differences, mainly in lightness L*.

Picture 19: Yellow before and after cleaning

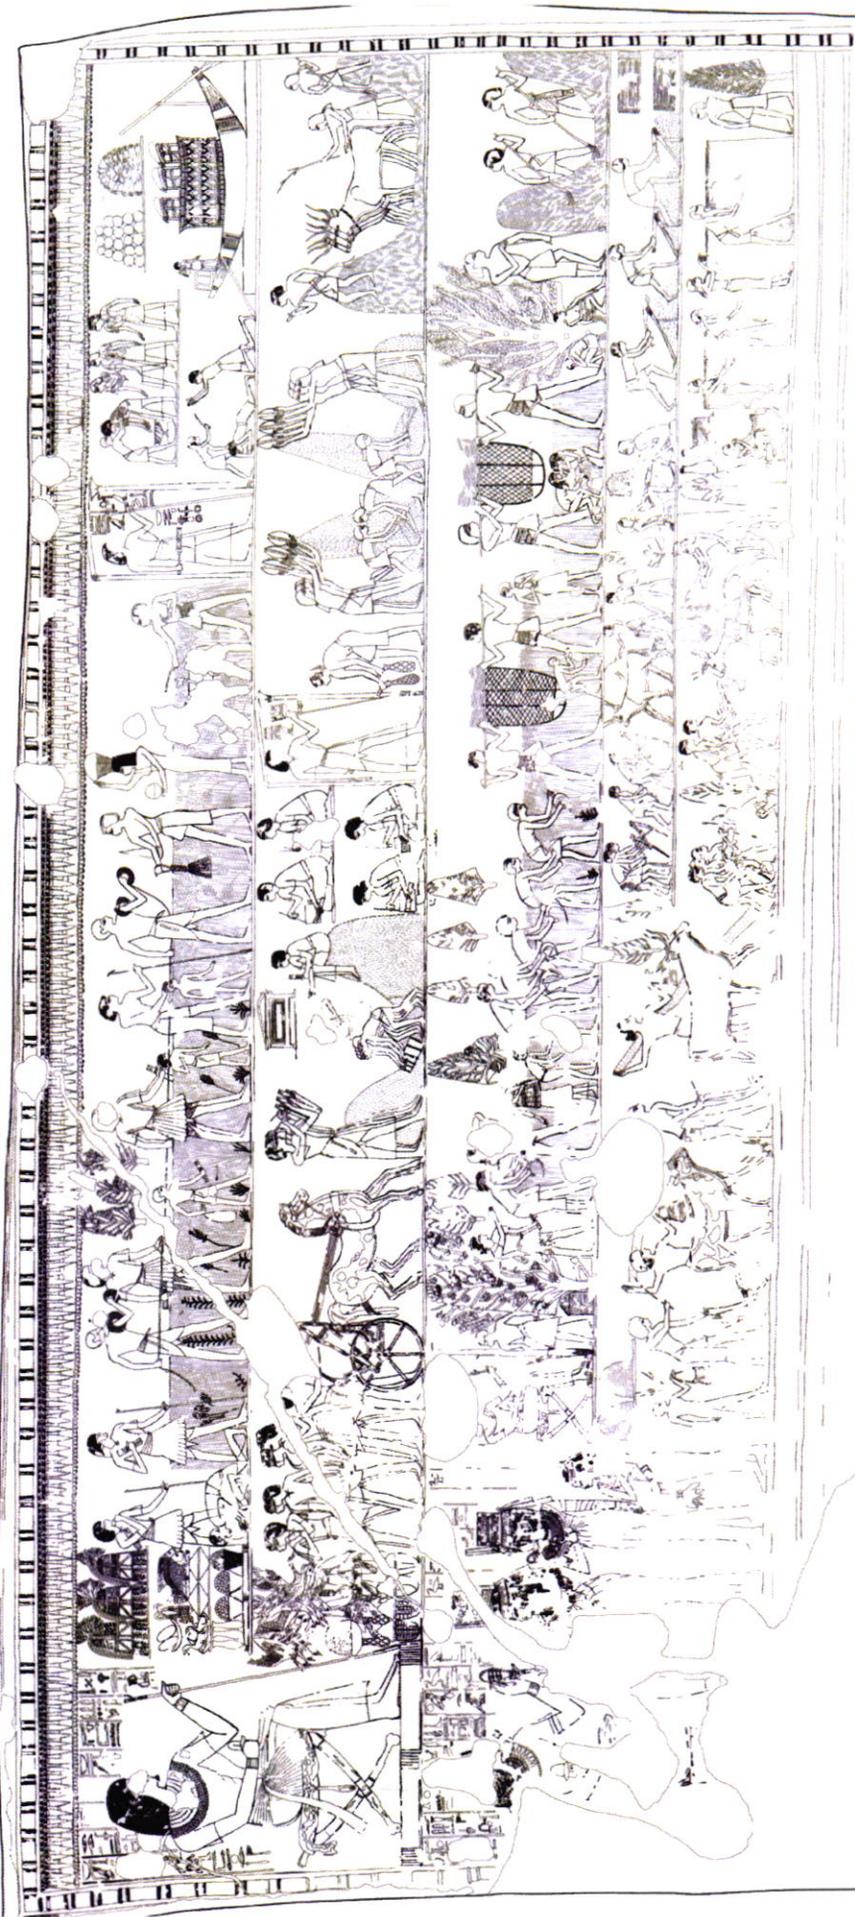
Picture 20:
Digital vector drawing
of Broad Hall Near
Left (BHNL)
(Pieter Collet)

During most of the 2008 season, Dr. Melinda Hartwig collated the texts and corrected the digital vector drawings. In 2007, draftsman Pieter Collet completed the vector drawings by tracing the rectified and stitched photographs in Photoshop Illustrator (**Picture 20**). The drawings were printed out on A3 paper and checked against the wall; the resulting corrections will be entered and printed for the final publication. This proved to be an exact and non-invasive method of producing drawings to record the outlines of the texts and wall decoration.
