**"Conservation and Display of Roman Mosaics  
Kom el-Dikka, Alexandria"**

**2nd Progress Report  
for Preparatory Work and  
Documentation**

submitted by Dr Wojciech Kołataj, the Project Director  
July 20, 1998

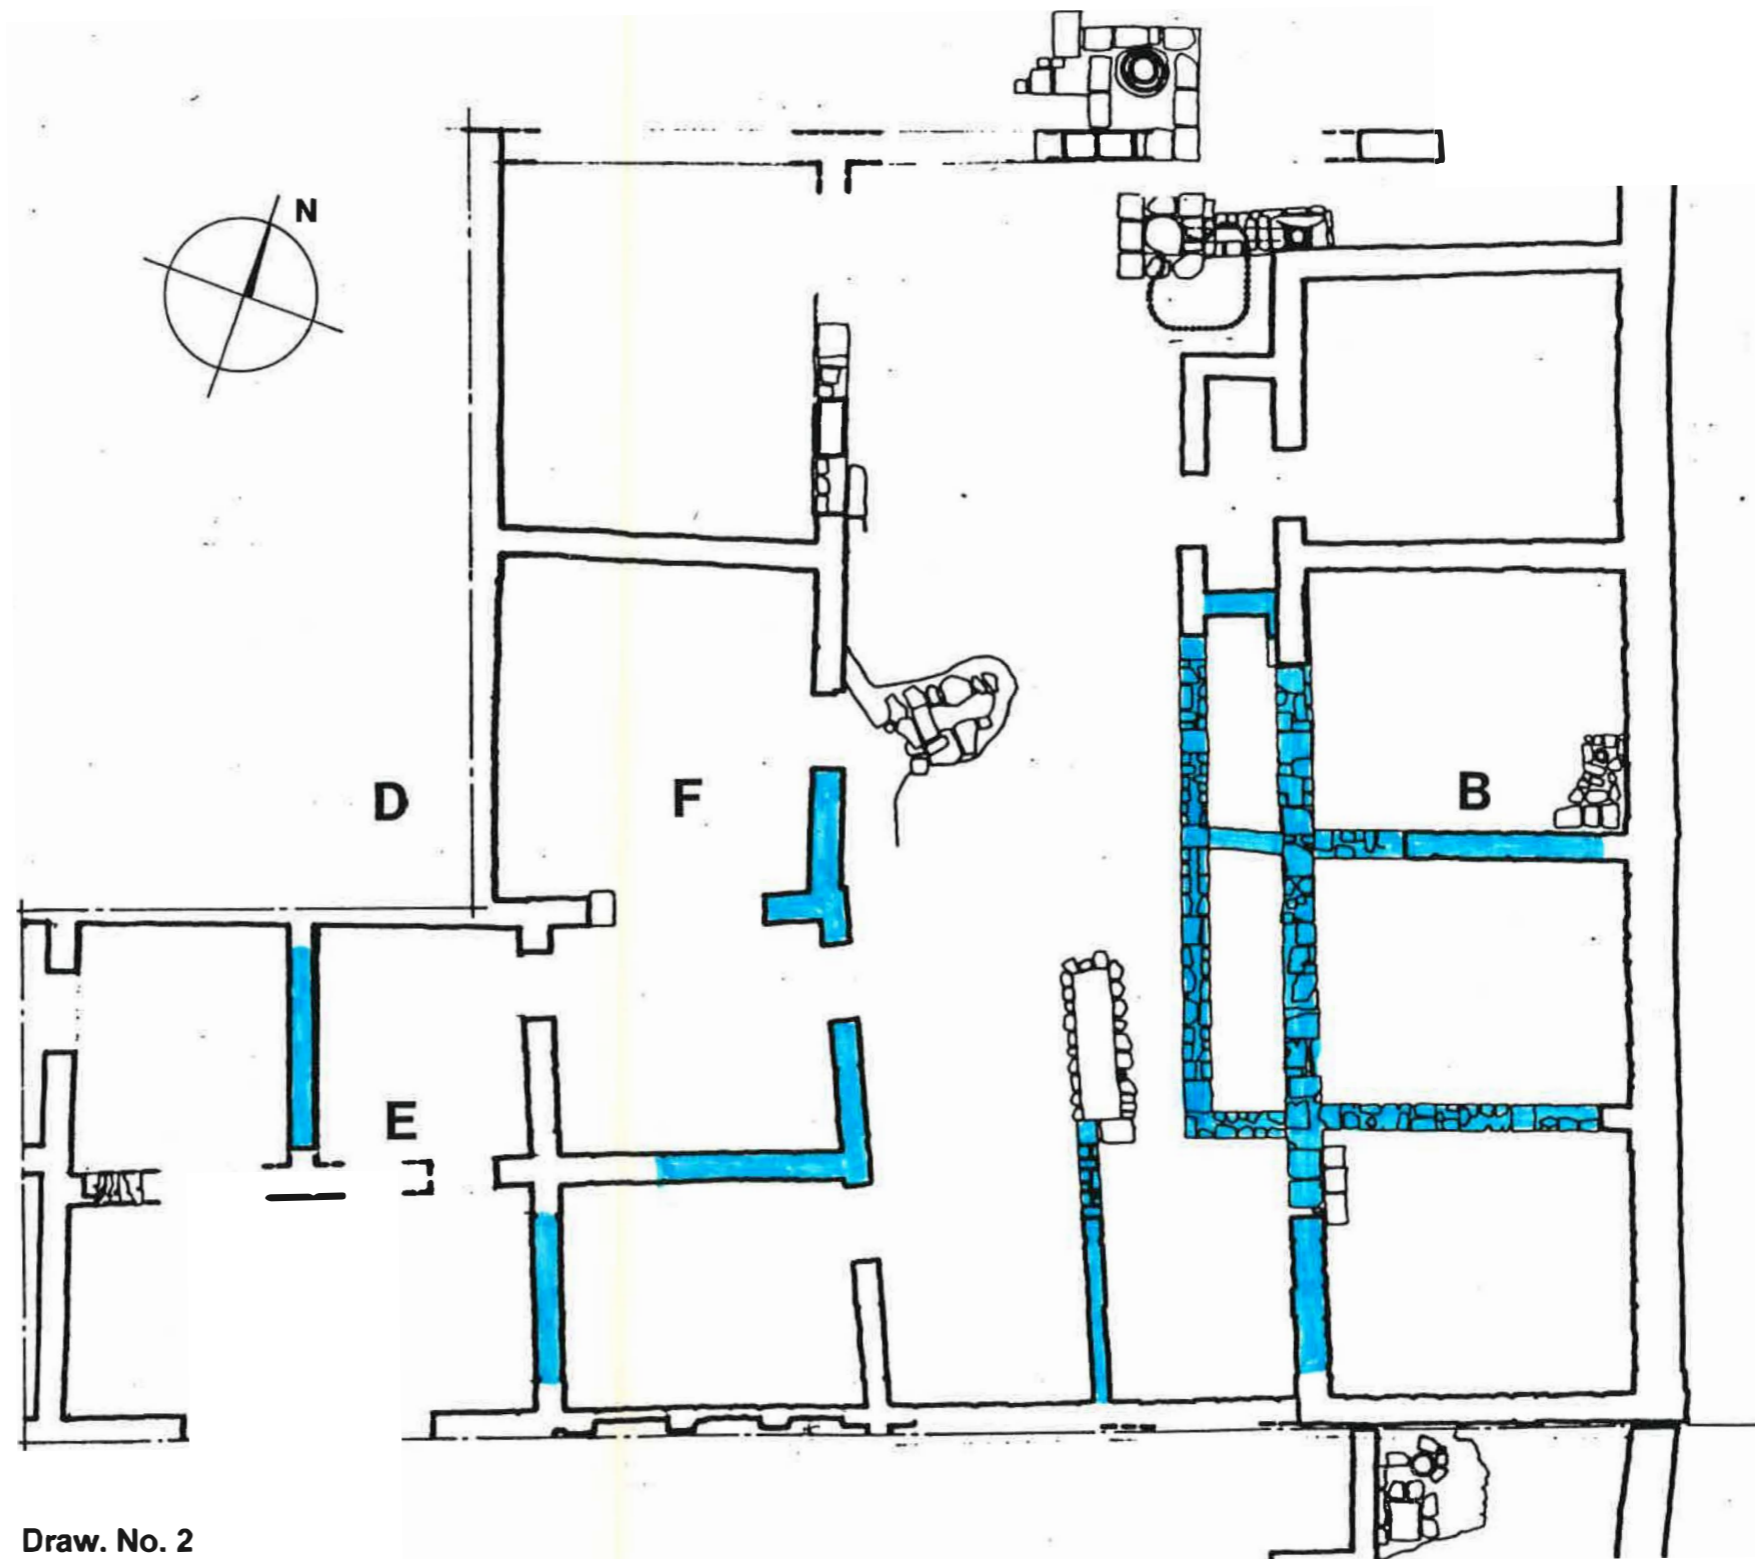
Draw. No. 2

KOM EL-DIKKA,  
BYZANTINE BUILDINGS B and F

removed segments of walls

- Mosaic  $\alpha$ -3 extends well to the west for some 2,50 m more. The centrepiece of this mosaic was made in an *opus sectile* technique, featuring highly elaborate multicoloured geometric design. Preserved fragments make the theoretical reconstruction possible. (Phot.nos. 11, 12; draw.no 3)
- Mosaic  $\alpha$ -6, featuring black-and-white geometric design was re-buried under restored walls of the Byzantine building B, and therefore could not be displayed. (Draw. no. 2).

Both these facts had an essential impact on overall design of the planned shelter. The shelter initially designed to cover a square measuring 12 x 12 m (or 14 x 14 m) as suggested in the submitted Proposal, would not cover all the newly discovered mosaics. It had been decided therefore, to extend the shelter to the west to some 15 m, retaining the 12 m span of girders, although placed along the N-S axis. This new solution called for appropriate modification in the roof inclination. Moreover, eastern wall of the adjacent Byzantine building F, built over the western portion of mosaic  $\alpha$ -3, had to be dismantled. (Phot. Nos. 5, 6; Draw. No. 2).

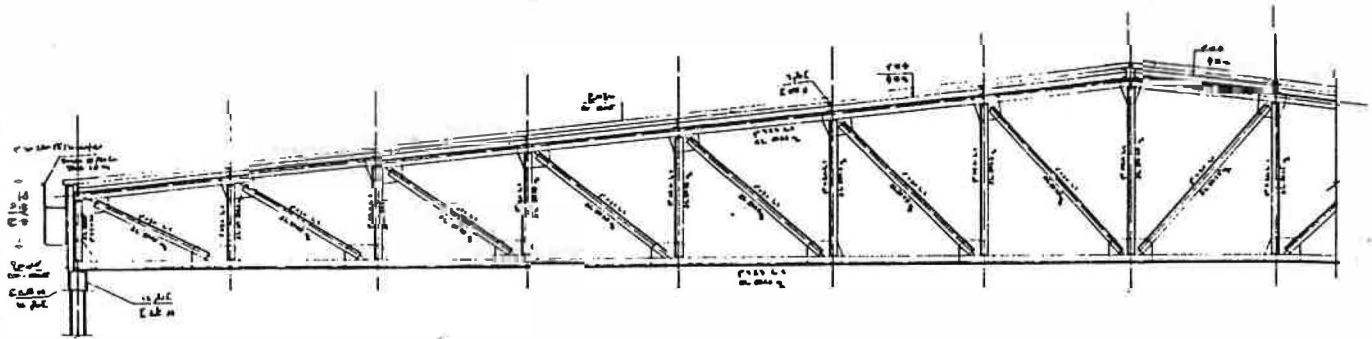
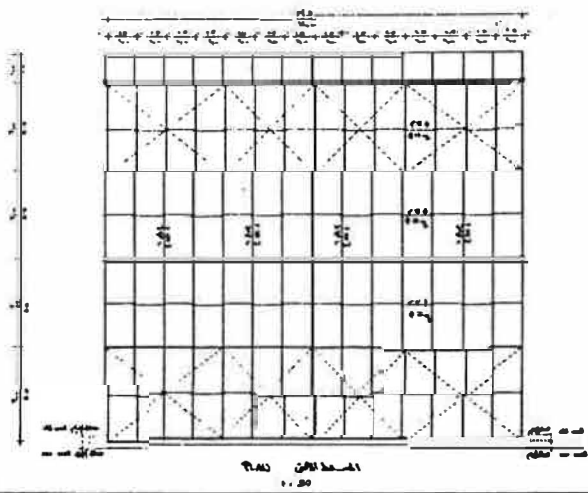
Draw. No. 6

# MOSAICS SHELTER ROOFING CONSTRUCTION

Use Rivets with  
a plate by riveting

As a result of this adjustment, structure of the roof is designed to rest from the south on modern revetment wall, and from the north on transverse steel beam supported by four steel pillars. The said alteration, albeit advantageous to the overall concept of the shelter, appeared to be rather difficult in execution. Firstly, the relation of supporting pillars to the existing walls of the Byzantine building is rather clumsy, and secondly, the necessity to construct panel-glass walls of the surface twice as large as initially planned will certainly cause substantial costs increase. Taking those two factors into account, we decided to apply more suitable variant of roofing: to reduce the number of girders but at the same time to retain more stabilising system of their setting in a 3 x 3 m grid. (Draw. no. 6).

- Roofing structure will be made of 6 girders, each one 12 m long. Girders will be made of L50 steel bars, doubled in upper and lower beam. Steel bars will be welded to sheet iron joints. Vertical and diagonal members will be made also of L50 steel bars. Girders' forefronts from the east and west will be cased with corrugated sheet iron. Gabled walls will be structured as panels-glass walls: lower sections made of clear transparent glass and upper parts (the gable itself) made of shaded opaque glass. Iron gutters will be shaped along the northern and southern eaves. (Draw. No. 6)

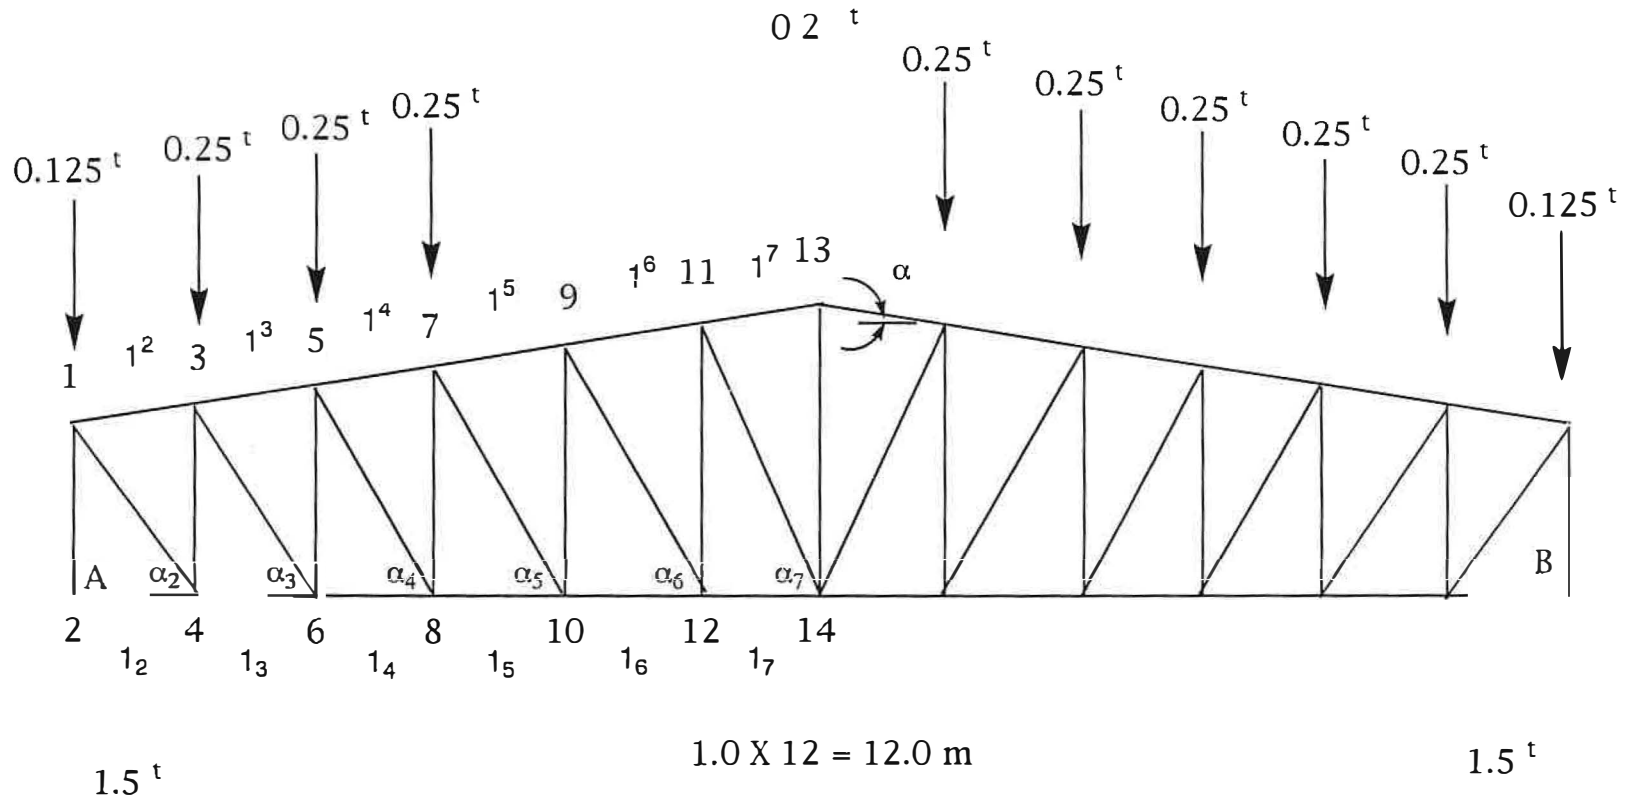
Max. height = 1.20 m

Min. height = 0.6 m

Heights

1-2	0.6 m	7-8	0.9 m	$\alpha_2 = 30.96$	$\alpha_5 = 41.99$	$\alpha = 5.71$
3-4	0.7 m	9-10	1.0 m	$\alpha_3 = 34.99$	$\alpha_6 = 45$	
5-6	0.8 m	11-12	1.1 m	$\alpha_4 = 38.66$	$\alpha_7 = 47.73$	
		13-14	1.2 m
