**"Conservation and Display of Roman Mosaics
Kom el-Dikka, Alexandria"**

**4th Progress Report
Completion Report for the Expanded
Shelter Construction**

COMPLETION REPORT FOR THE EXPANDED SHELTER CONSTRUCTION

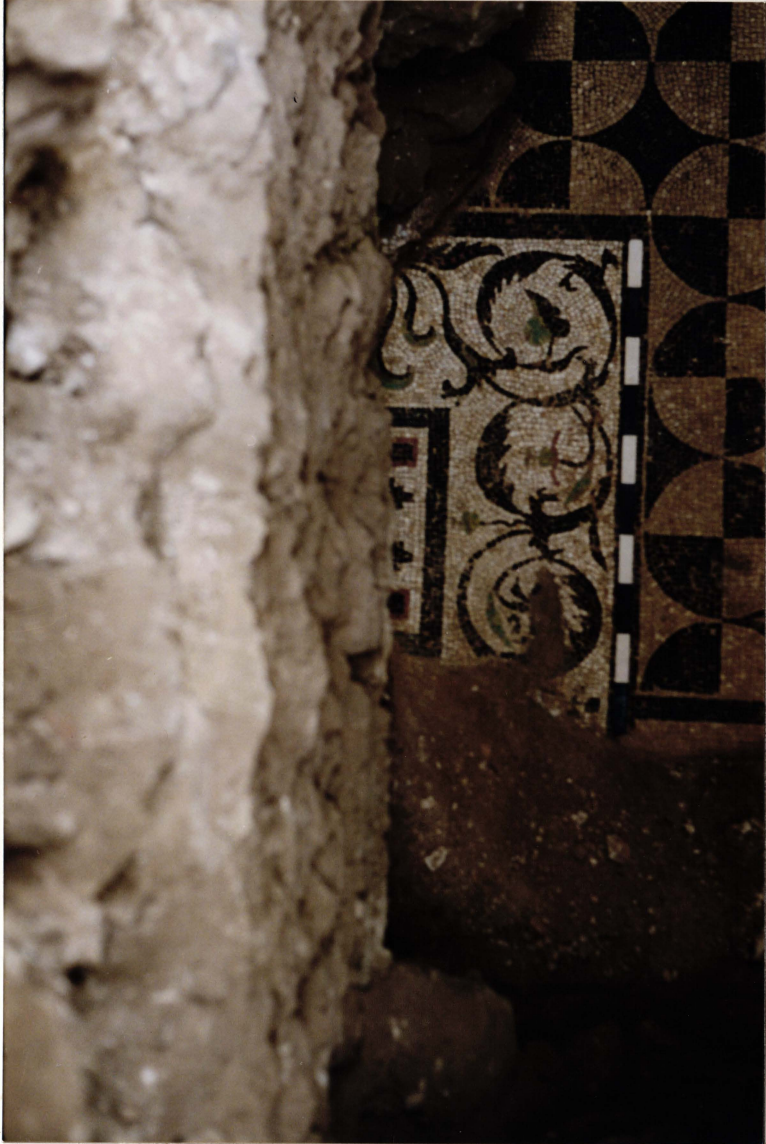
Phot. 2. Fragment of the mosaic found below walls of the Byzantine building "B".

The *opus tessellatum* mosaic (measuring 2,3 x 3 m) is composed of a central element surrounded by a wide fringe featuring a geometric design made of overlapping black and white squares and circles. The central element (1,3 m x 1,3 m) is decorated with an elaborate multicoloured floral design framing a small panel (0,5 x 0,5 m) with an animal represented. The panel is finely made of extremely small-sized tesserae. The mosaic is generally well preserved except for a large diagonal lacuna in its northern section and a small fragment of its western edge is considerably damaged with some of its tesserae dislodged, cracked or missing.

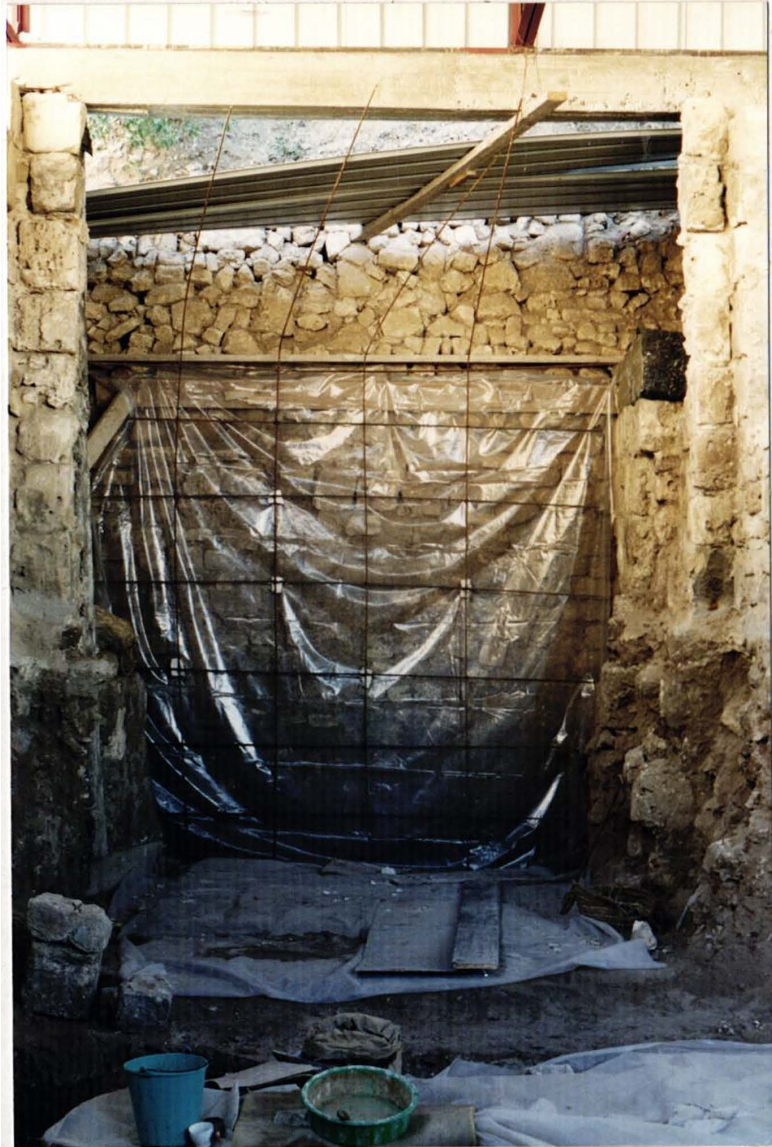
Phot. 4. Southern revetment wall; insulation and reinforcement structure.

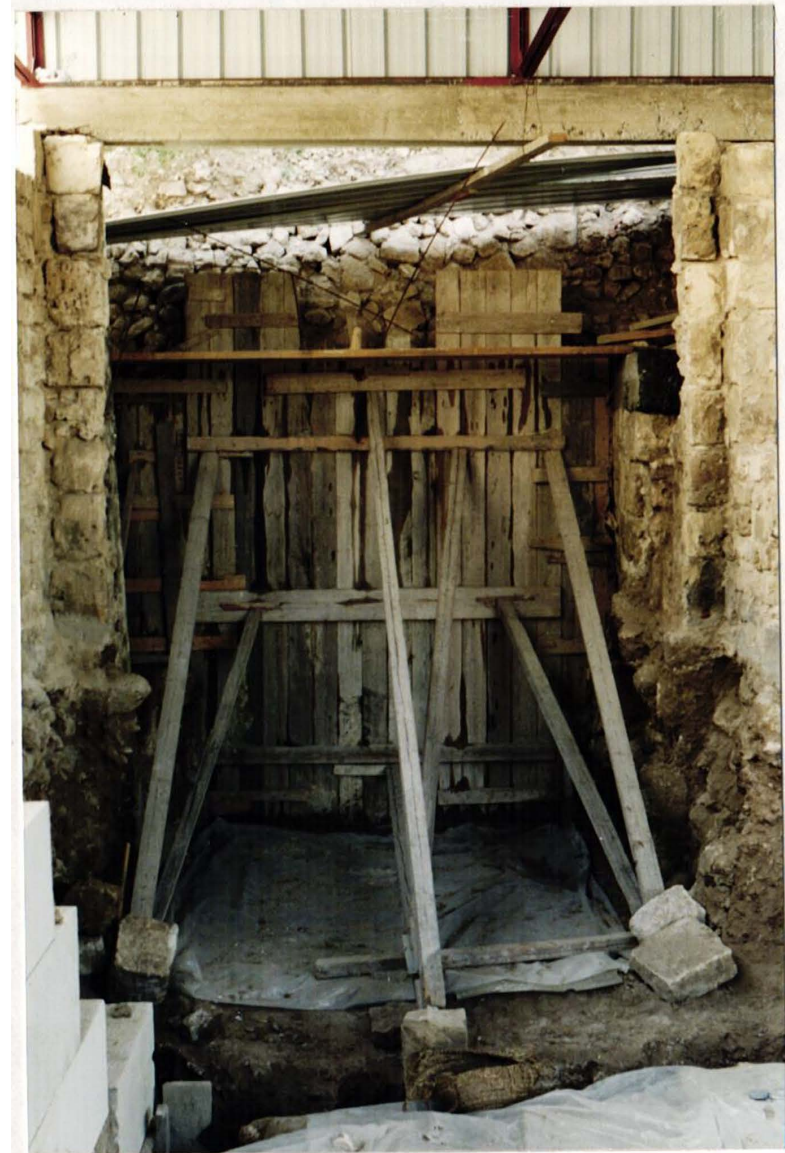
Phot. 5. Southern revetment wall; boarding.

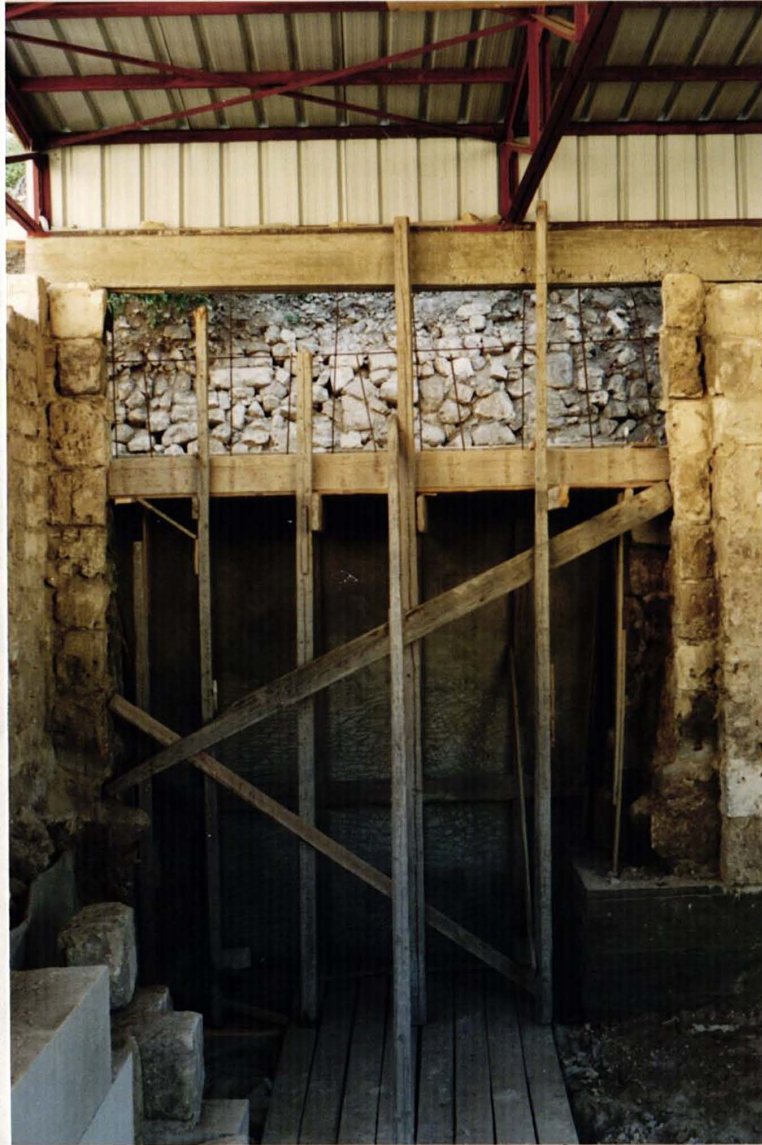
Phot. 6. Ceiling of the niche; boarding.

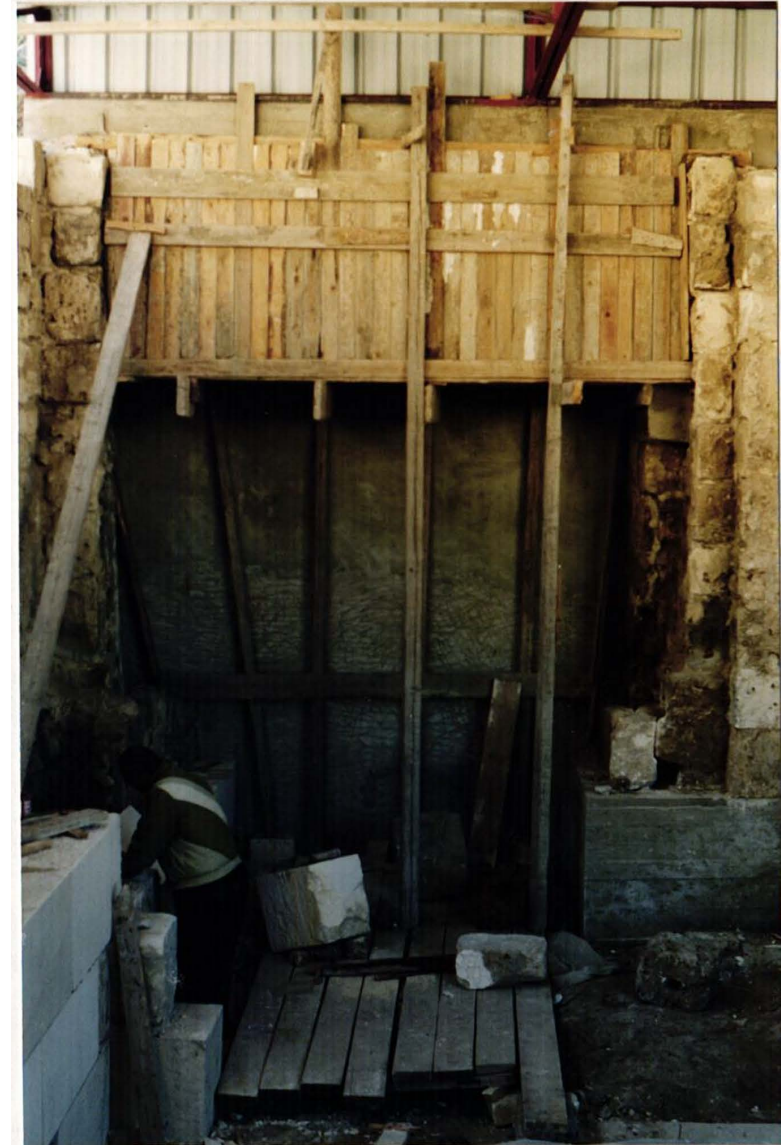
Phot. 7. Front wall above the ceiling; boarding.

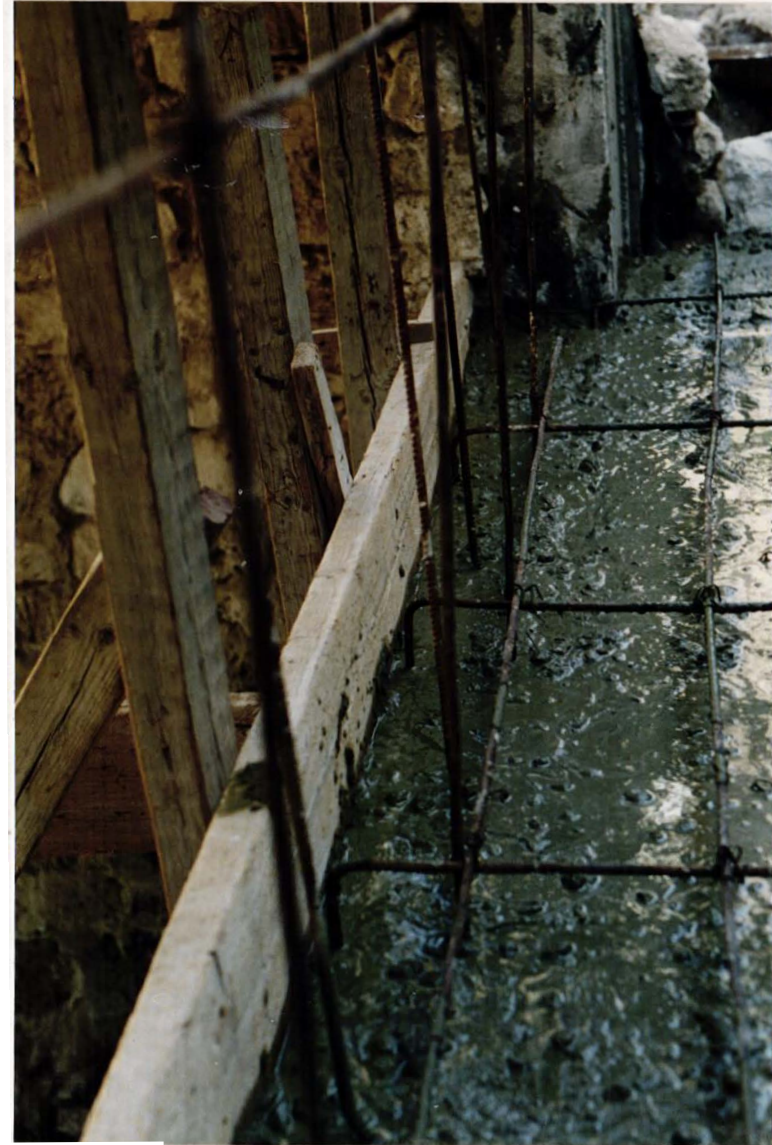
Phot. 9. Ceiling of the niche; placing concrete.

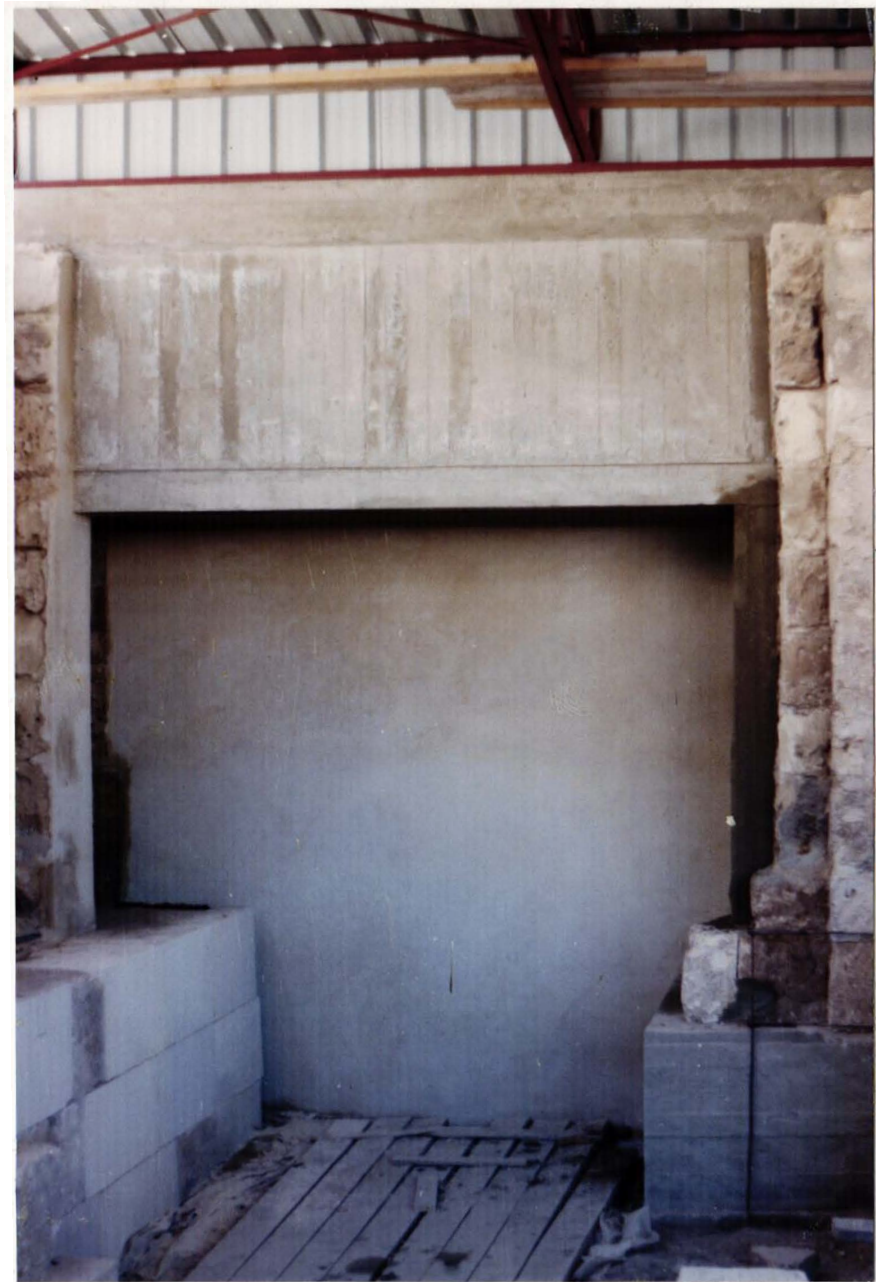
Phot. 11. The niche after completion of construction work.

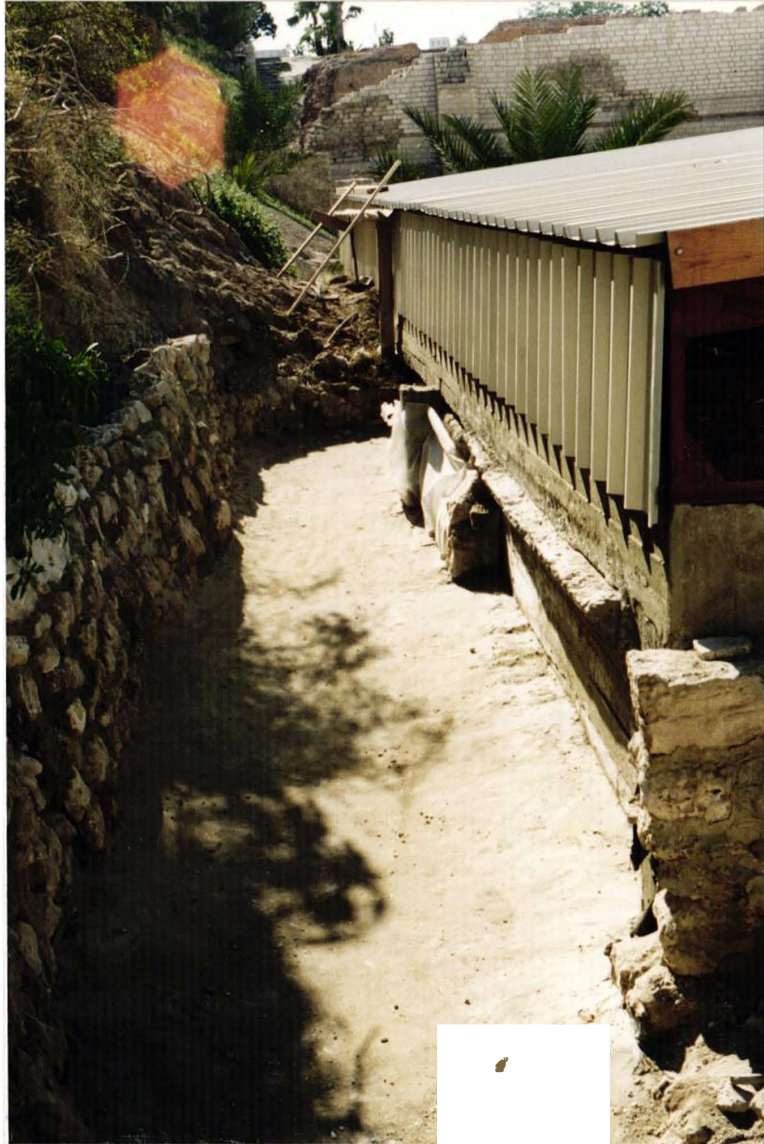
Phot. 12. Draining structure built above the ceiling.

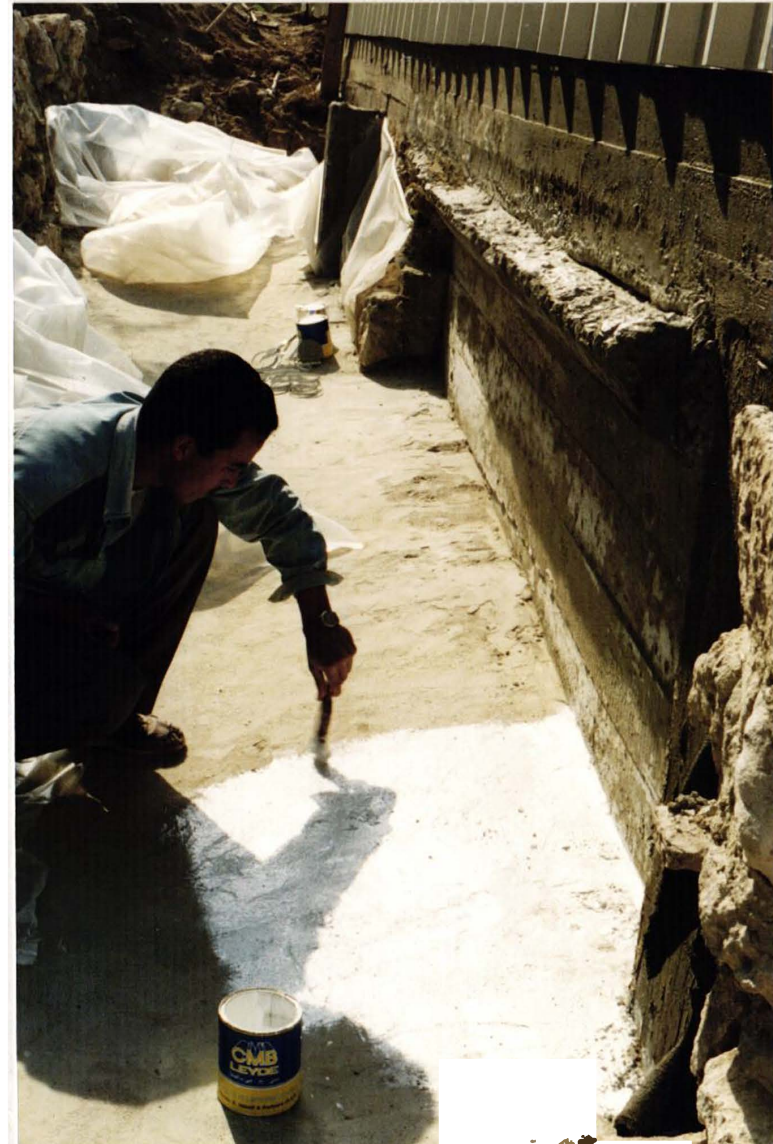
Phot. 13. Draining structure during insulation work.

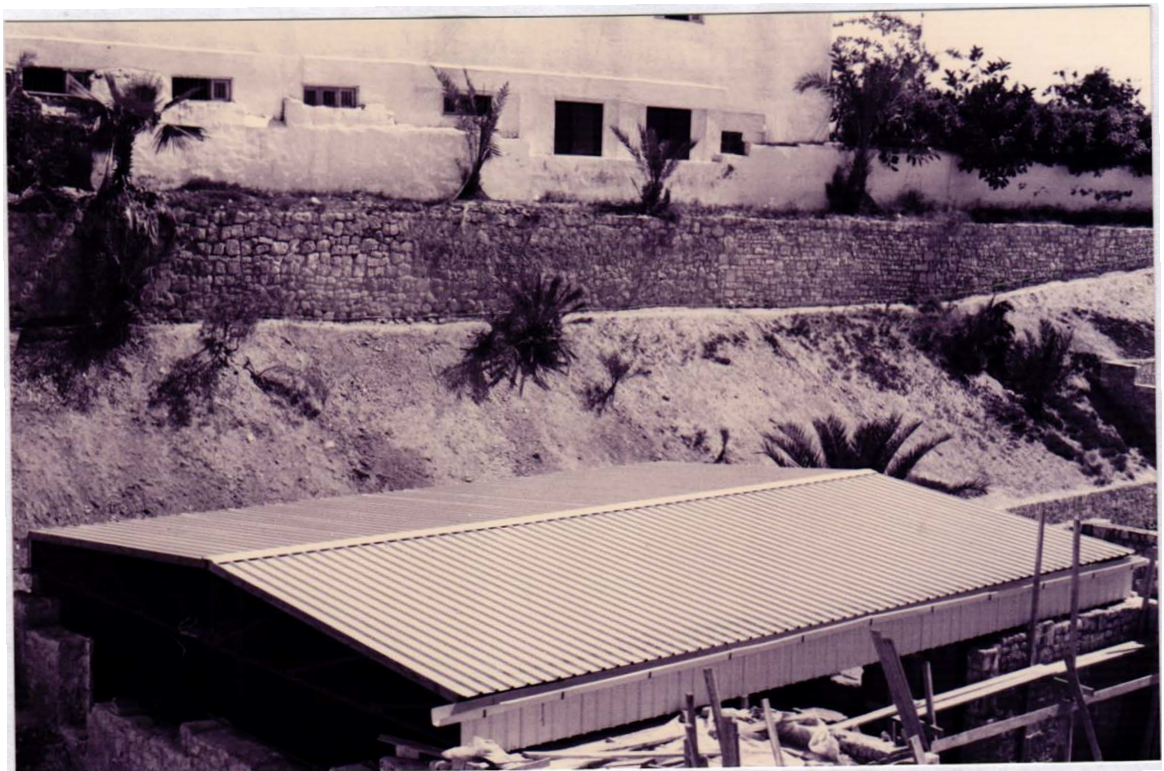
Phot. 15. Gutters along the northern edge of the roof.

1.3. Mounts for gutters were welded along the northern and southern edge of the roof. Mounts were made in accordance with adopted gradient of drainage, (length of each mount varied from 17 to 27 cm). Gutters were then fixed on mounts. (Phot. nos. 14-15).

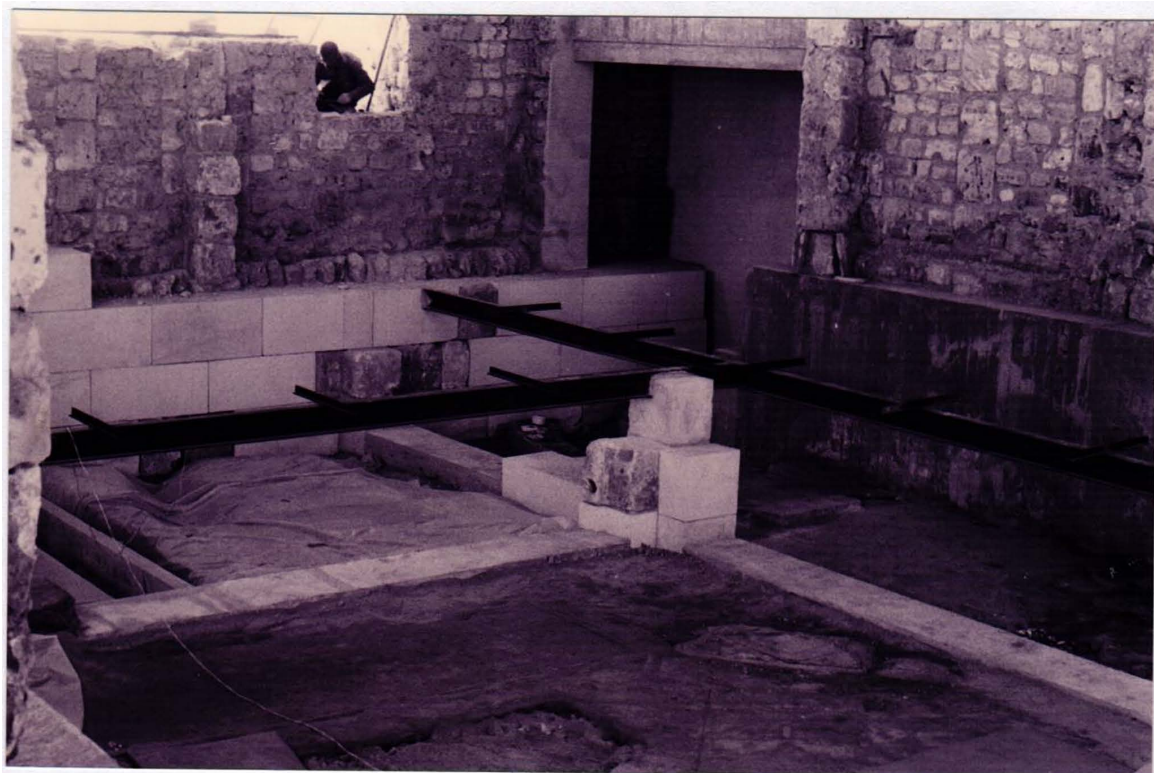
Phot. 16. Foot-bridge. General view.

The foot-bridge was constructed as a frame made of steel eyebars (180 mm) welded together to form a T-shape structure in plan. The frame composed of 2 perpendicular sections (12 m and 6,80 m respectively) rests on partially restored ancient walls of the villa. Walkway, 0,80 m wide is built of wooden planks in sections 1,5 m long (5 cm thick), supported by T-irons (50 x 50 mm) welded perpendicularly to the frame. (Phot. Nos. 16-17; Draw. No. 6)

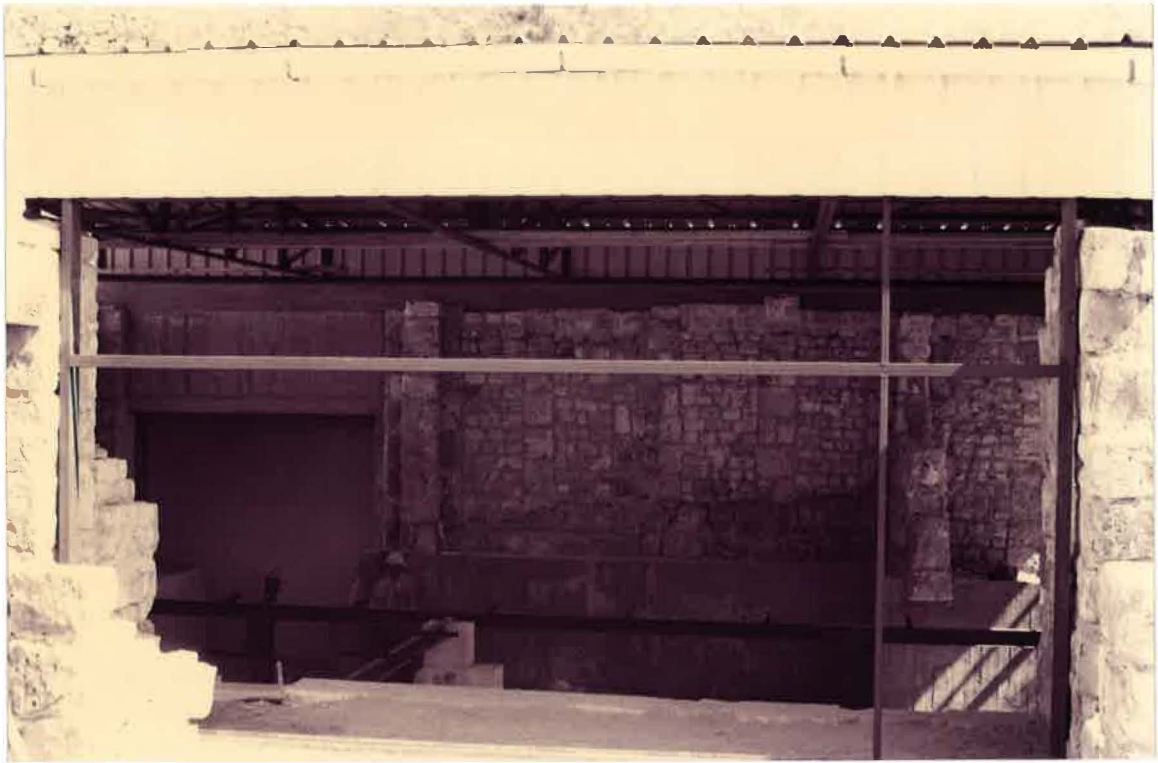
Phot. 18. Panel glass frames. Northern side of the shelter.

Steel structure of panel glass walls was completed in all three sections: from north, west and east. The construction was made of steel box-sections (80x40 /2mm). Tops of the vertical elements were welded to the steel beam from the north side, and to the girders from the west and east respectively. Bottom partes of the sections were sunk into concrete socle topped with sills. (Phot. Nos. 18-19)

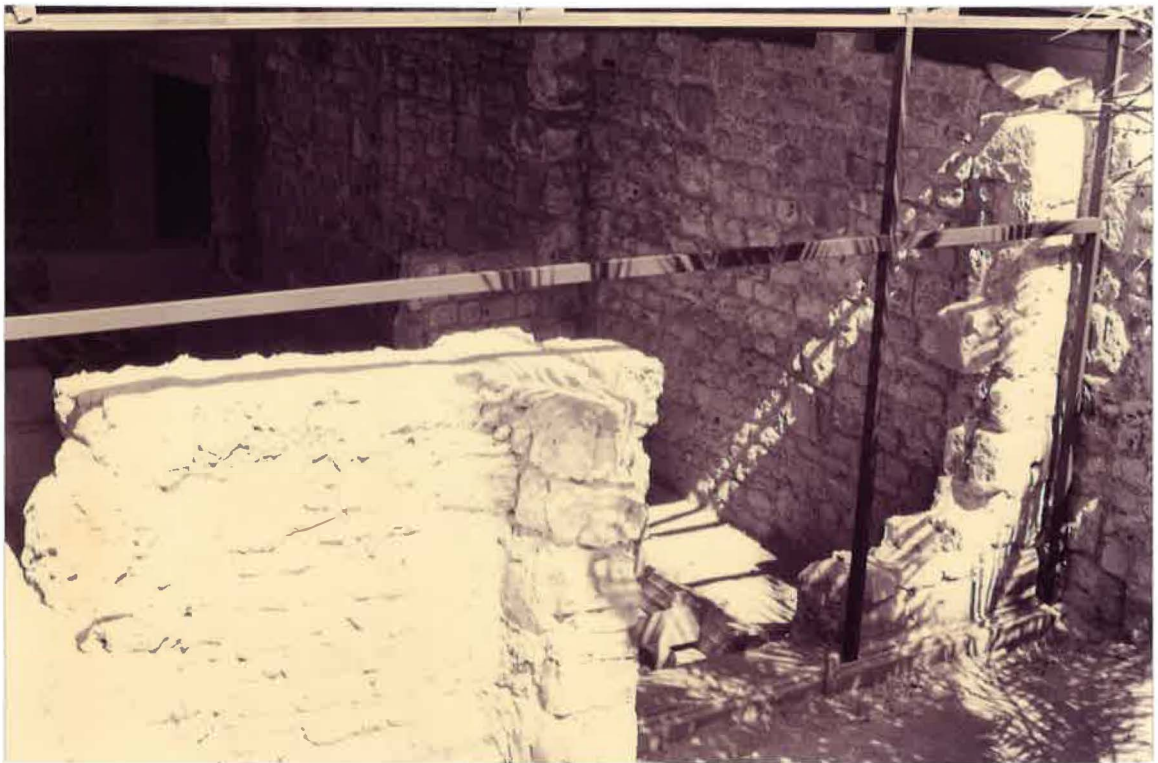
Phot. 19. Panel glass frames. Western side of the shelter.
