American Research Center in Egypt  
Egyptian Antiquities Project

**"Conservation and Display of Roman Mosaics  
Kom el-Dikka, Alexandria"**

**5th Progress Report  
Completion Report  
for Mosaic Conservation Work**

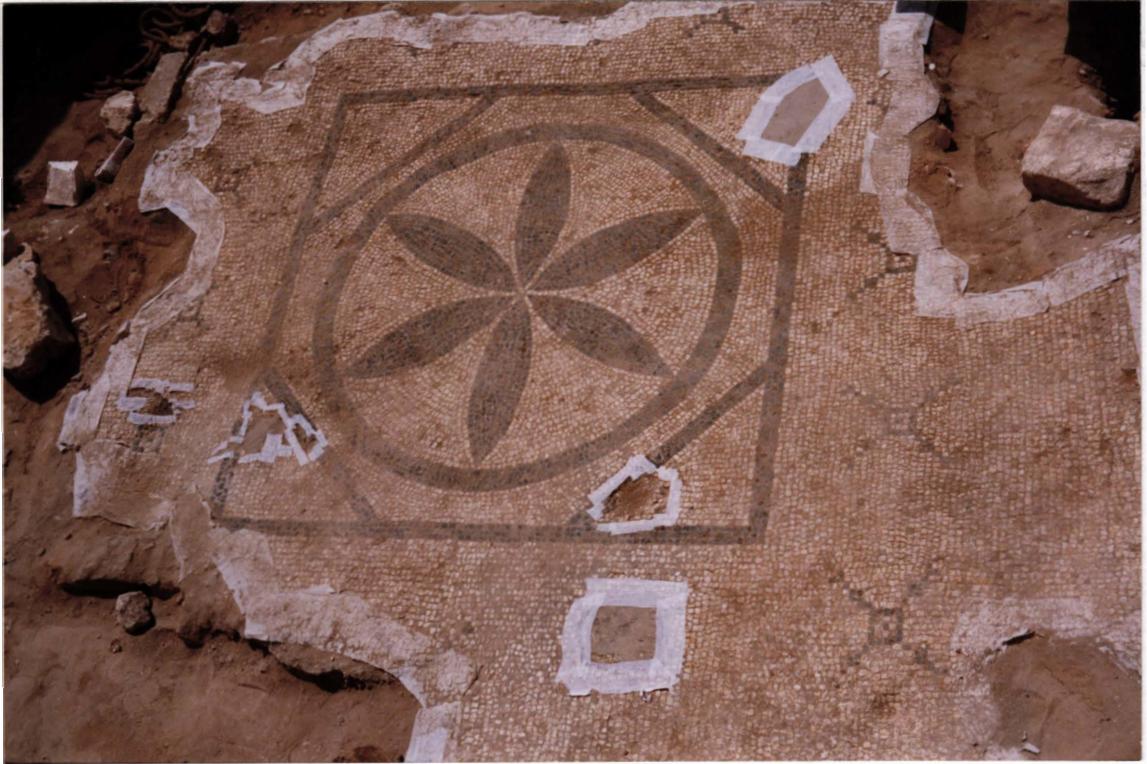
- Loss of tesserae along borders of the mosaic, ca. 15% of the original surface is missing. (Phot. 1)
- Small lacunae in geometric design were filled with cement in 1970's.
- Surface is distorted and sagged
- Bedding mortar is weakened and disintegrated.

1. Mosaic  $\alpha$ -2, after cleaning and during temporary protection of edges and lacunae.

- the surface was mechanically and chemically cleaned (rinsed and dried)
- cement fillings of lacunae were removed mechanically
- lacunae were reintegrated and some parts of the mosaics edges were reconstructed with original tesserae found in the debris (Phot. 2, 4).
- Some crumbled areas, edges and cracks were stabilized with a soft mixture of mortar (lime, marble powder, Plextol).

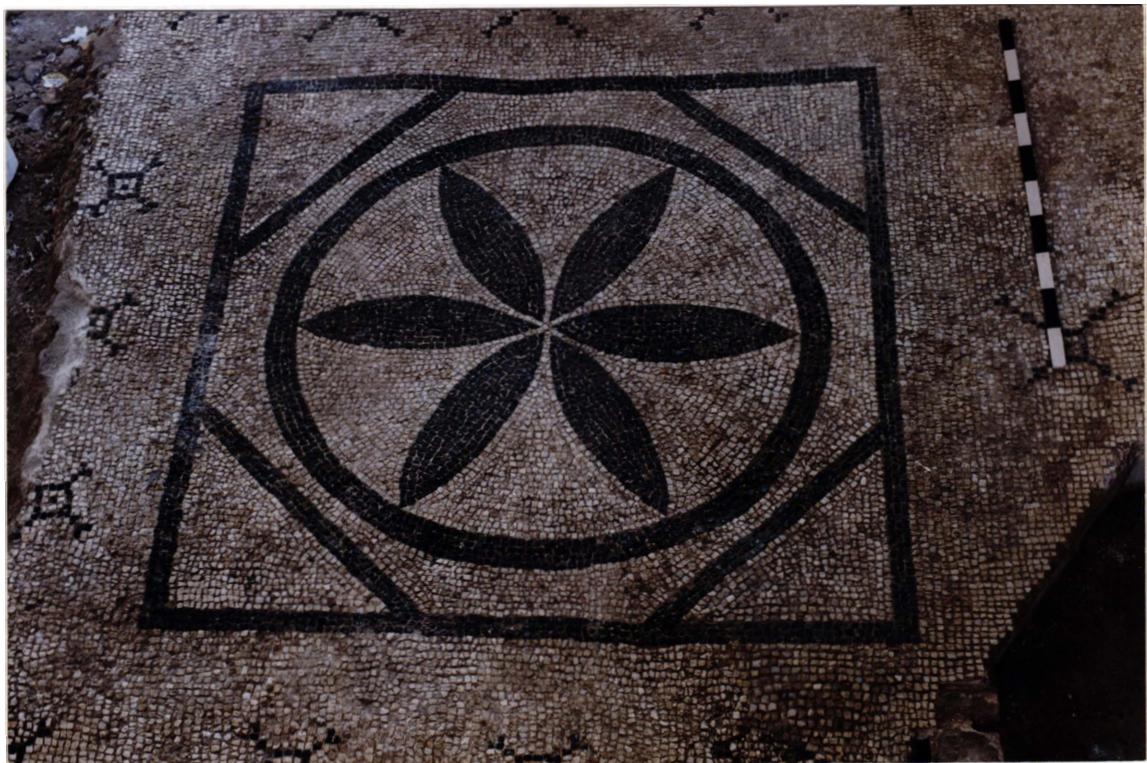
2. Mosaic  $\alpha$ -2 after partial reconstruction of damaged edges and reconstruction of the lacunae.

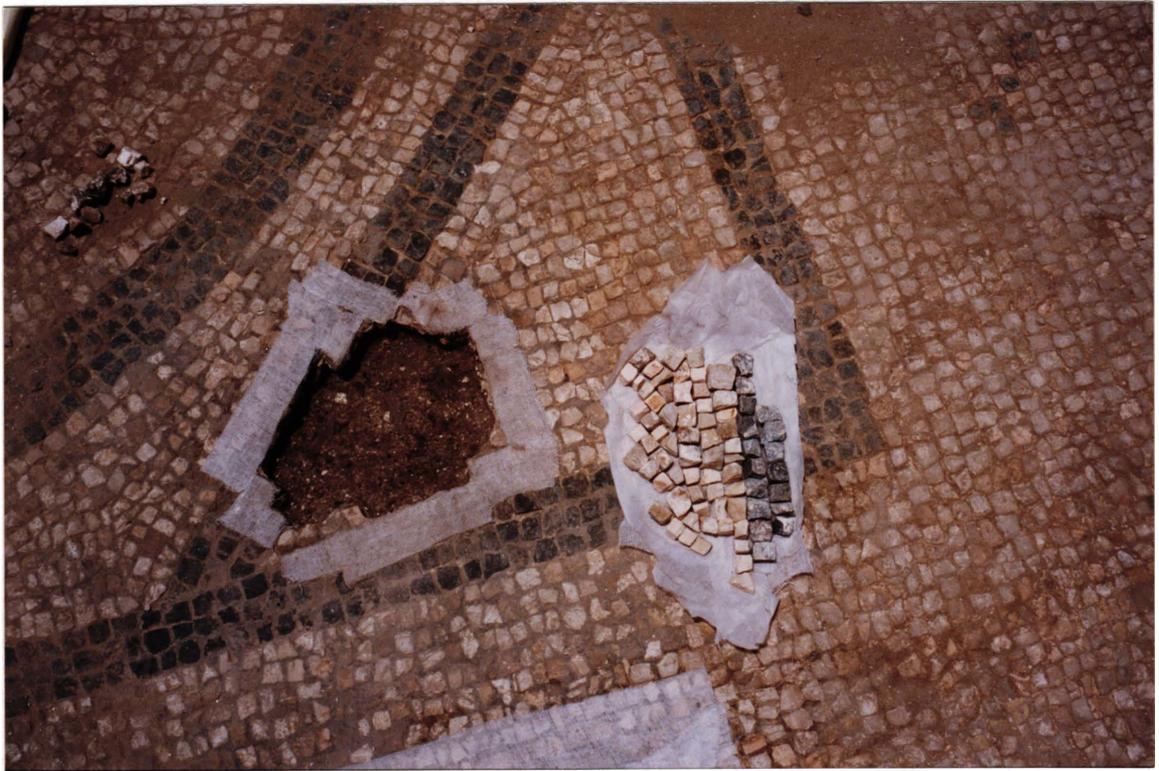
3. Fragment of the mosaic lacuna prepared for reconstruction.

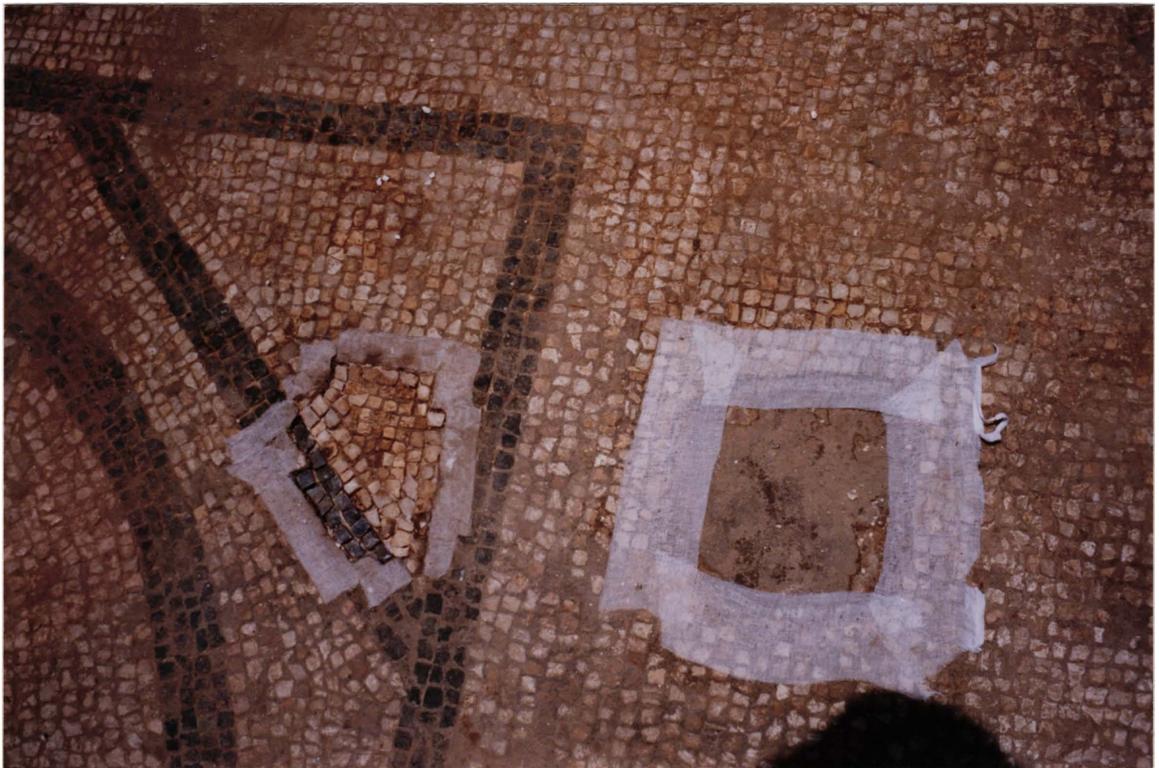
4. The same fragment after reconstruction. To the right an old repair, cement filling prepared for removal.

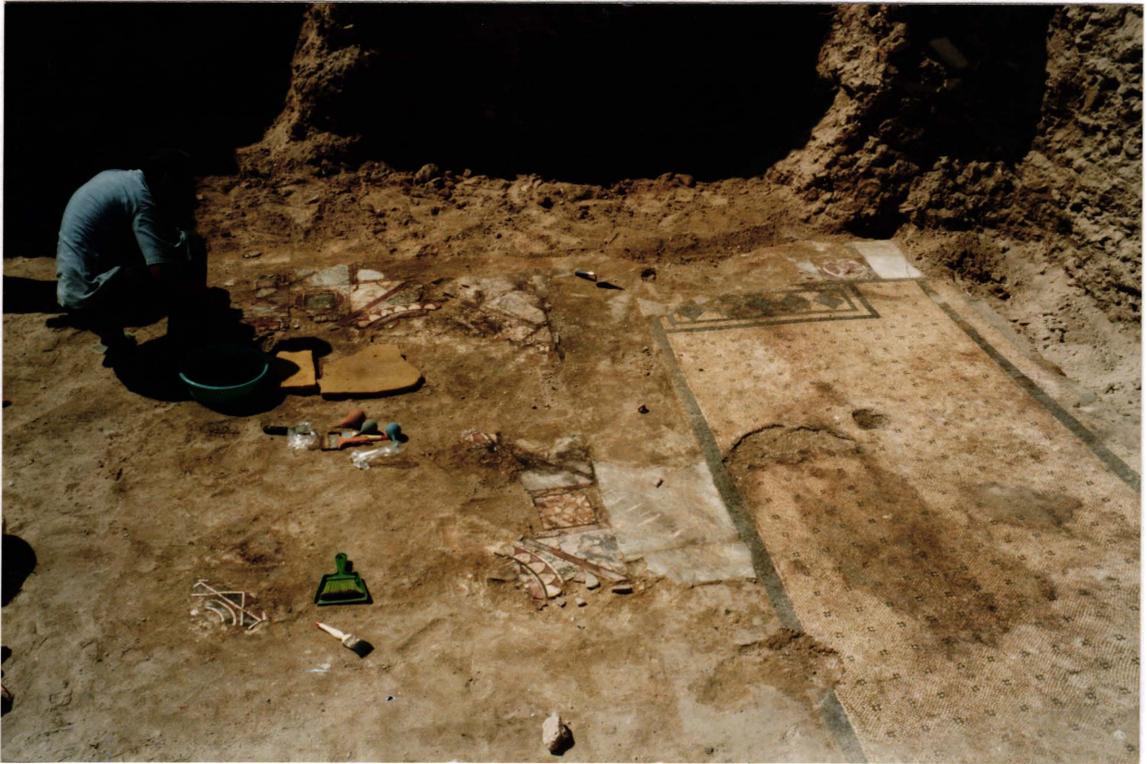
5. Mosaic  $\alpha$ -3. Western part of the U-shaped mosaic with *opus sectile* decoration during the cleaning of the surface.

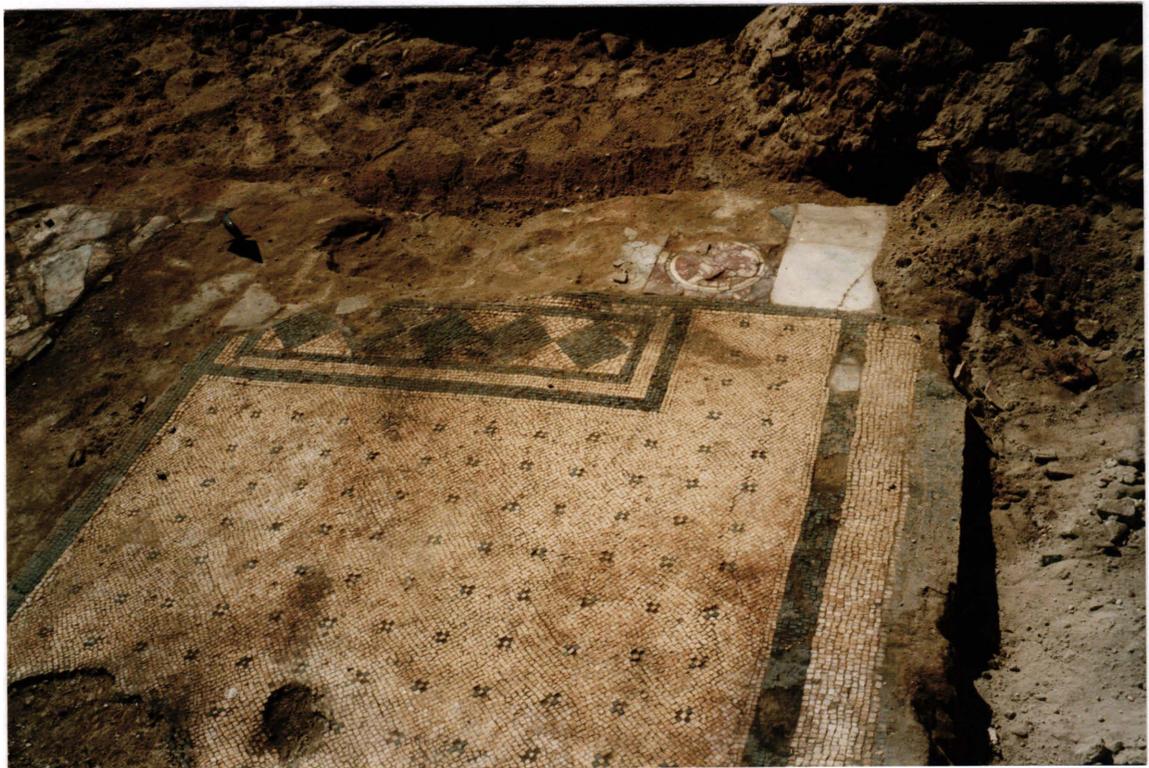
- big damages and loss of tesserae along borders of the mosaic where the stone walls were plundered.
- Loss of many black tesserae from black strips which emphasized the mosaic edges (Phot. 6).
- In several sections a fire caused breaking of tesserae and darkening of the white background. There, the underlying mortar has lost its coherence and tesserae are loose (Phot. 6).
- Ancient repairs of the big lacunae filled with marble slabs at random (Phot. 7)
- Modern repairs from 1970's using big tesserae and cement mortar (Phot. 8).
- Severe cracking of bedding - the mosaic was distorted in its western part due to ground subsiding. Consequently a wide crack was formed and the tesserae on the edge of the pavement were dislodged (Phot. 9, 10).

6. South-west corner of the mosaic after cleaning.

- consolidation of original bedding in the weakened parts with injections of Plextol emulsion diluted in water 1:2.
- Re-establishment of loose tesserae; two methods were chosen for this purpose. The direct method applied to the small lacunae where lost tesserae were pressed into the soft lime mortar to fill the voids. In the other, indirect method, the tesserae were first reconstructed face down on canvas with drawn contour of the missing sections. The reconstructed section of *tessellatum* mosaic was turned face up and put back in place in the bonding layer (lime, marble powder, acrylic resin). After checking and adjusting for adhesion, the cloth from the tessellatum surface was removed. Crack repair and lacunae were filled using original tesserae or local materials similar to the original.

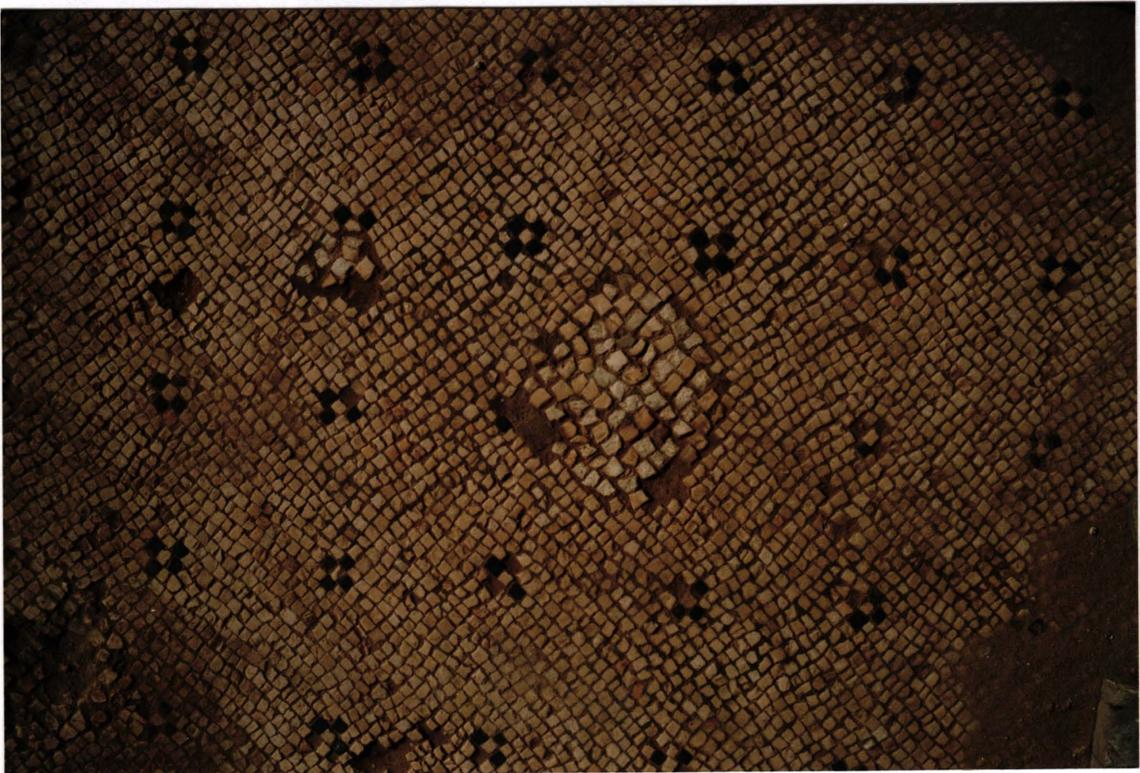
8. Modern repair of lacuna with cement filling used as a bedding for big tesserae, to be removed.

One of the aims of the conservation of this mosaic was to preserve all historical evidence, hence the decision was made to leave ancient repairs executed with big marble slabs chosen at random as well as all deformation and distortion of the surface. Modern repairs with the use of cement mortar had to be removed.

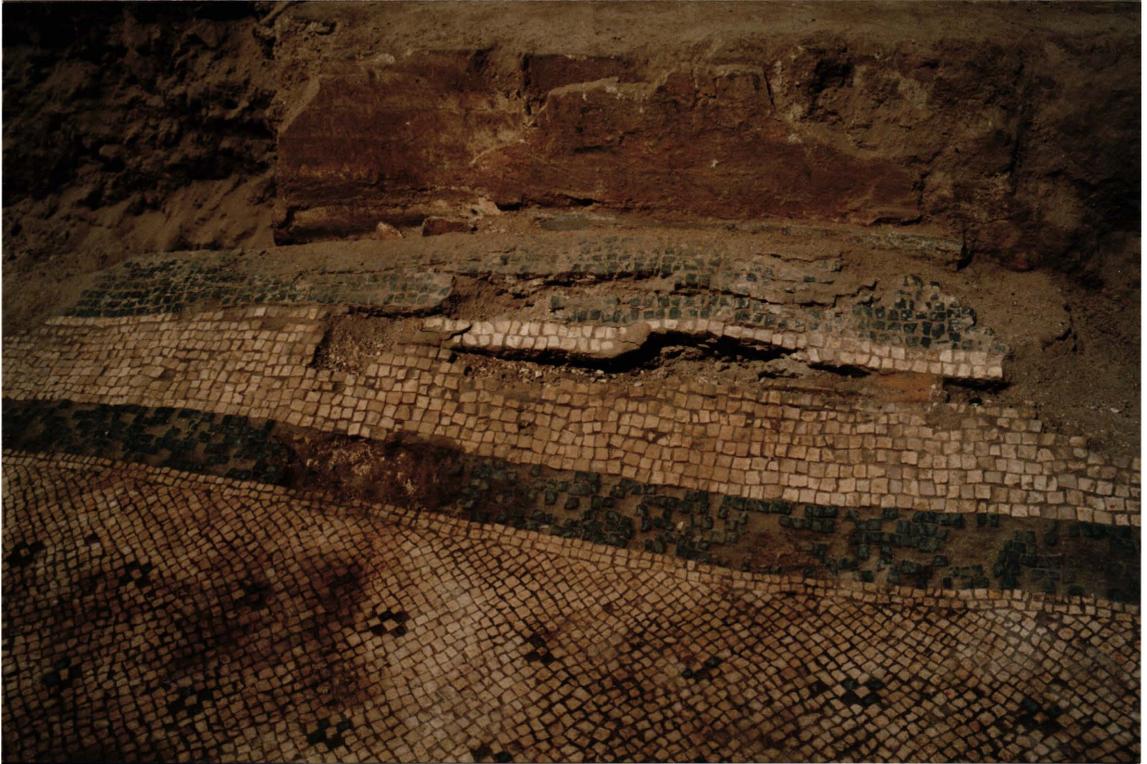
9. Bedding cracking due to the subsiding of the ground.

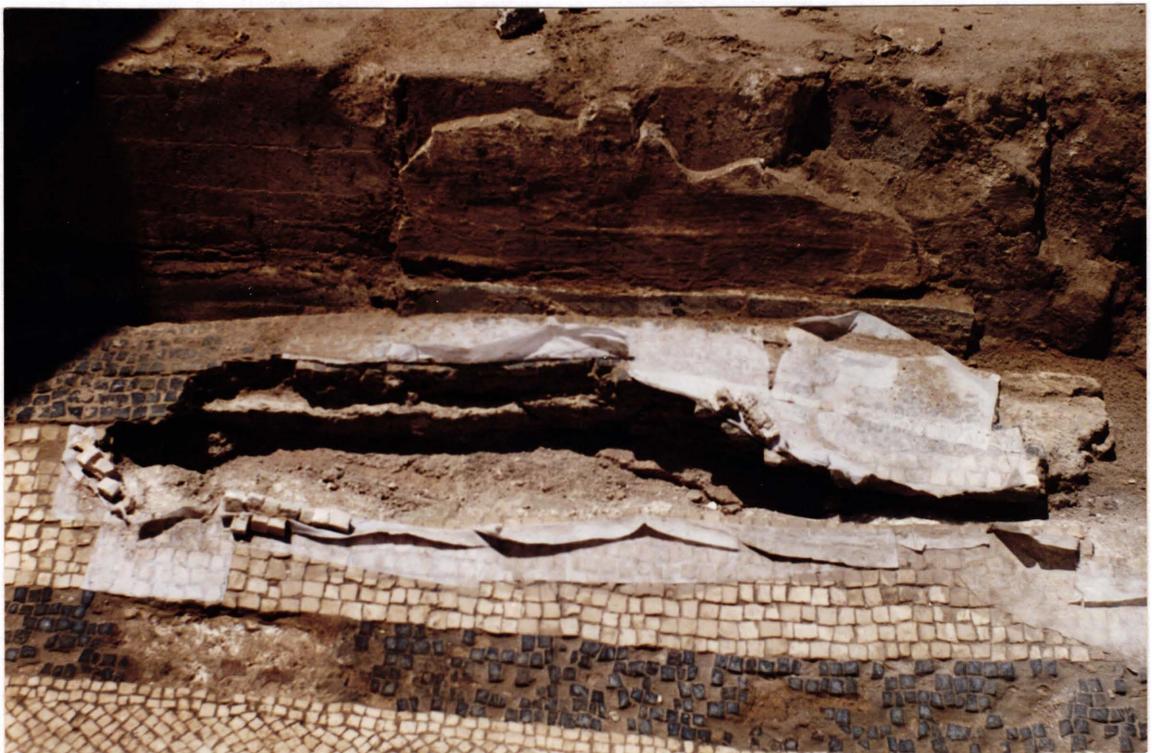
10. The same fragment of mosaic during restoration.

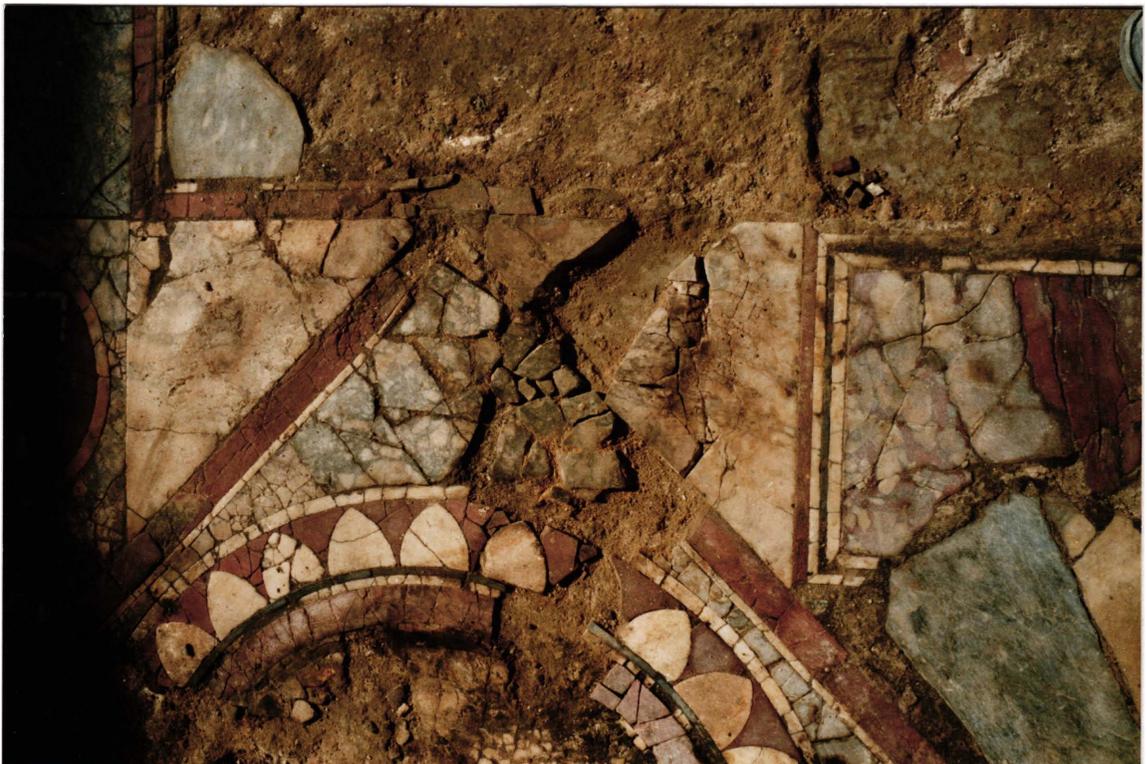
12. Recorded fragment, after cleaning.

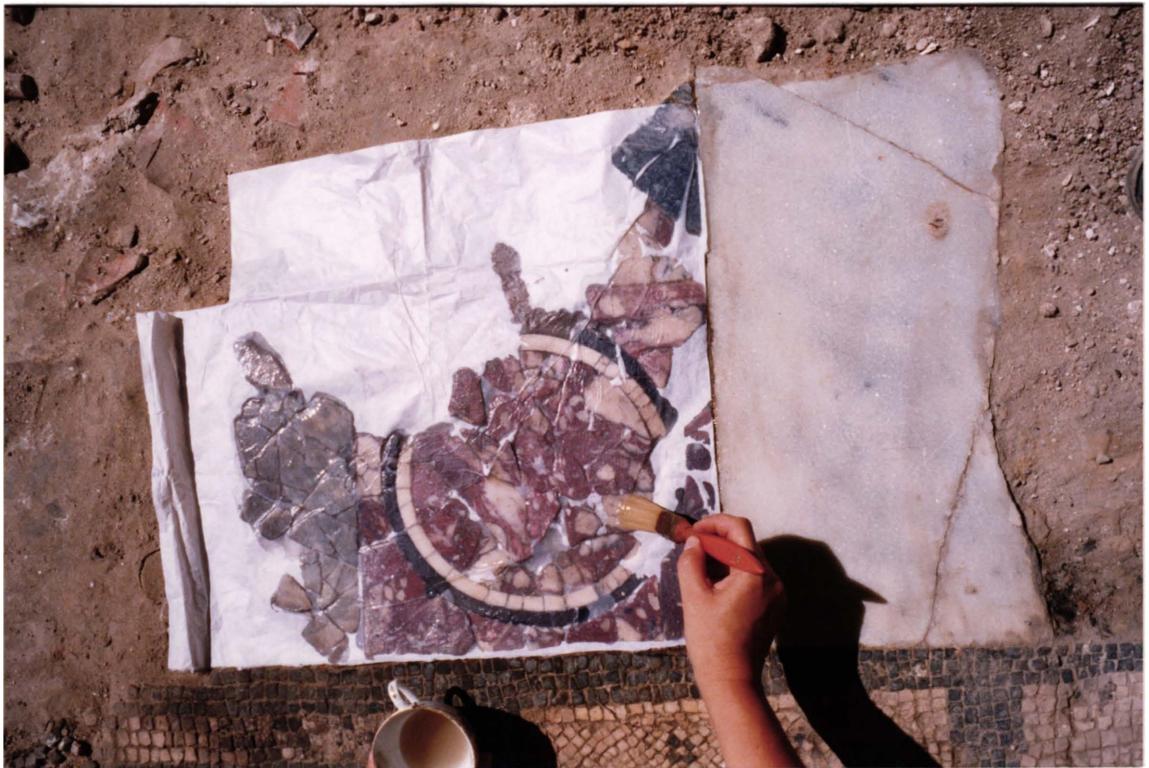
14. Preparation for lifting of this fragment: facing with Japanese paper and carboxymethylcellulose as adhesive.

- Four fragments of decoration in *opus sectile* were traced (1:1) and detached from the bedding mortar. Remaining parts of decoration were lifted, then carefully cleaned and partially reconstructed. A bedding of two layers of different mortars was applied to the reverse side of these fragments. 1st- thin layer of lime, marble powder and Plextol. 2nd - lime, sand, white cement mixture(1:4:0,3) reinforced with stainless wire netting. Fragments were fixed onto their original position. (Phot. 15, 16).
- Other fragments of *opus sectile* decoration have been provisionally protected with Japanese tissue paper facing, in order to prevent the fragile parts from further damage, then gradually reinforced with rich fluid mortar of lime and Plextol and left *in situ*.

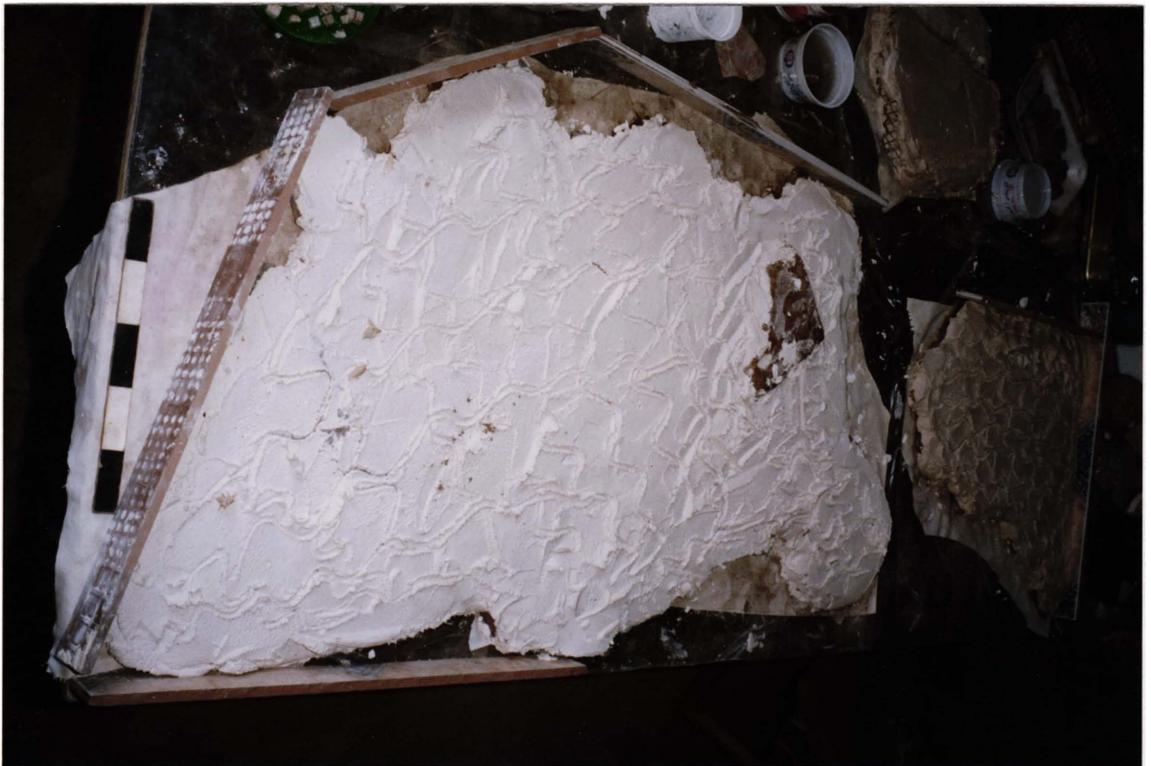
16. Application of the bonding layer to the reverse side of the *opus sectile* decoration.

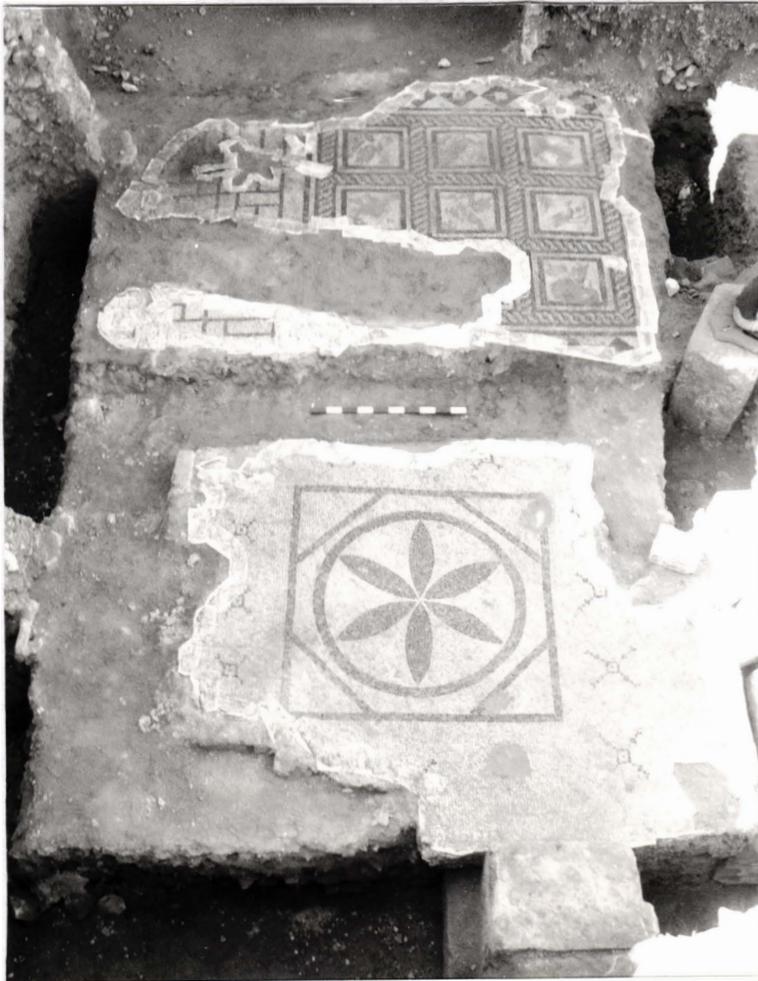
- about 30% of the surface of this mosaic has been lost completely (Phot. 18).
- Two of the panels with birds, big fragment of the geometric design and decoration along the edges of the mosaic are missing.

18. Mosaic  $\alpha$ -2 with rosette and mosaic  $\alpha$ -5 with bird panel.

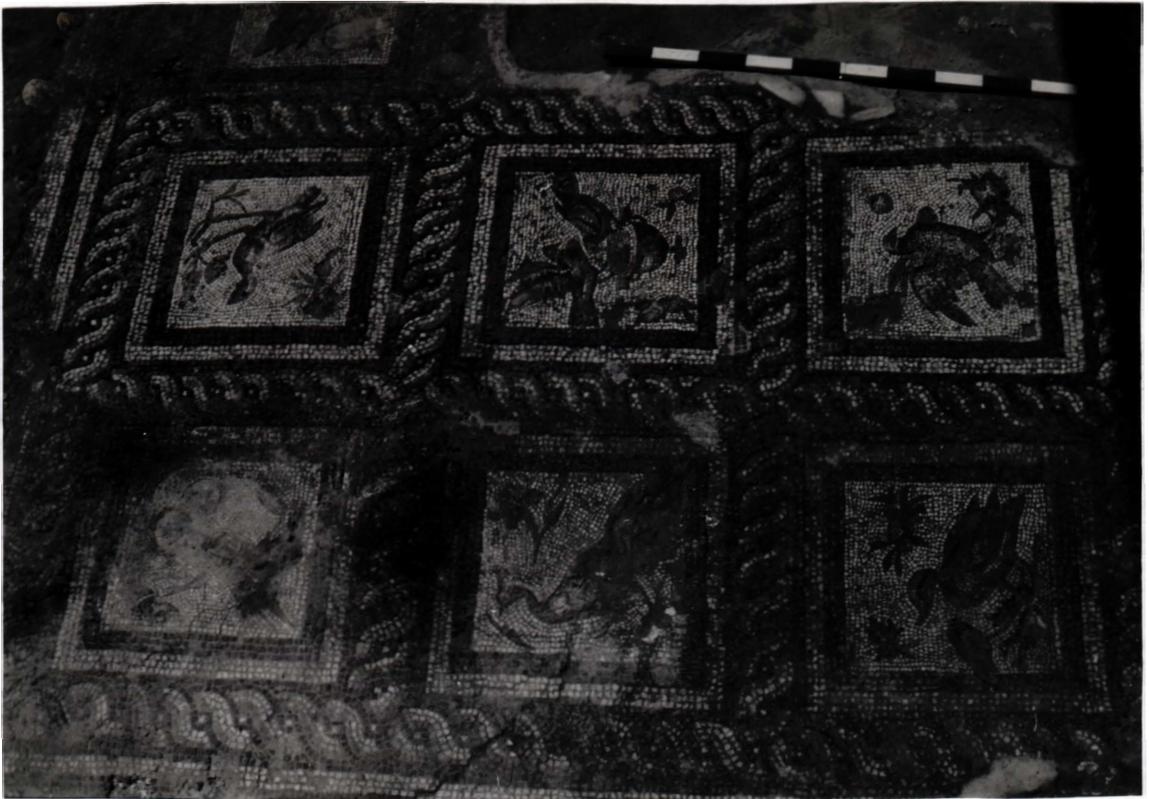
19. Panels with birds, before conservation.

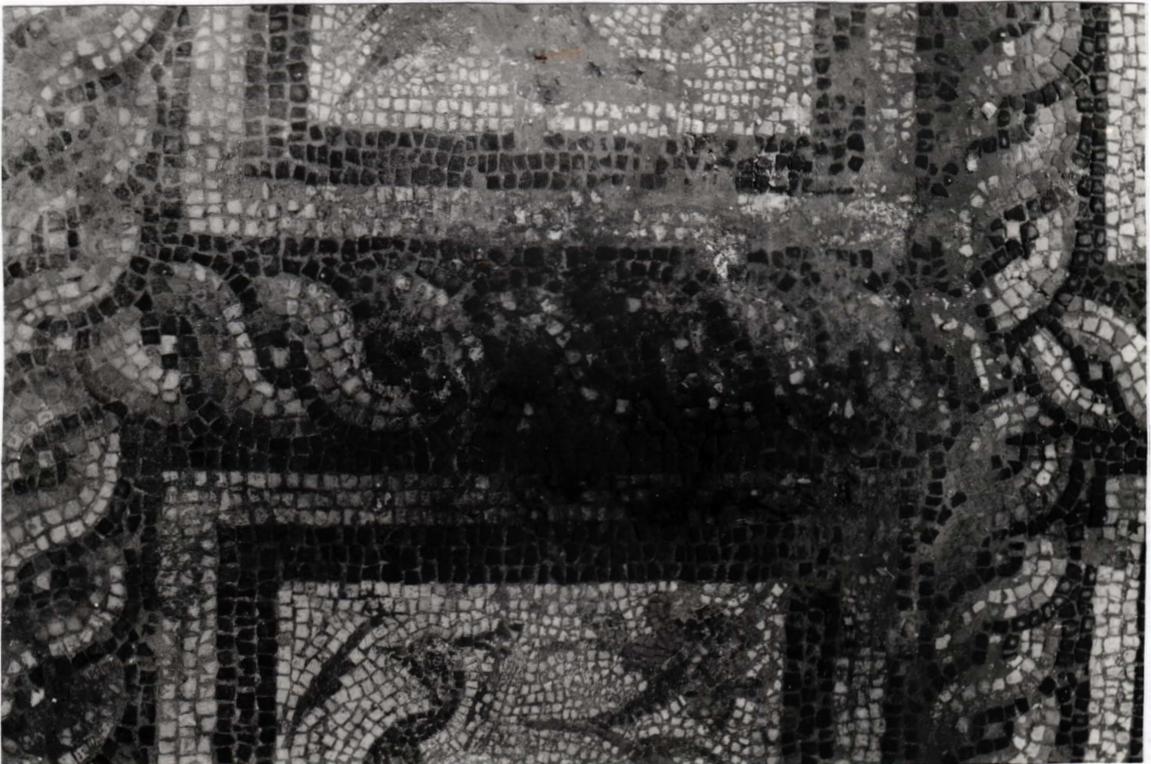
20. Burned fragment of the mosaic. Surface protected with cement mortar in the 1970's.

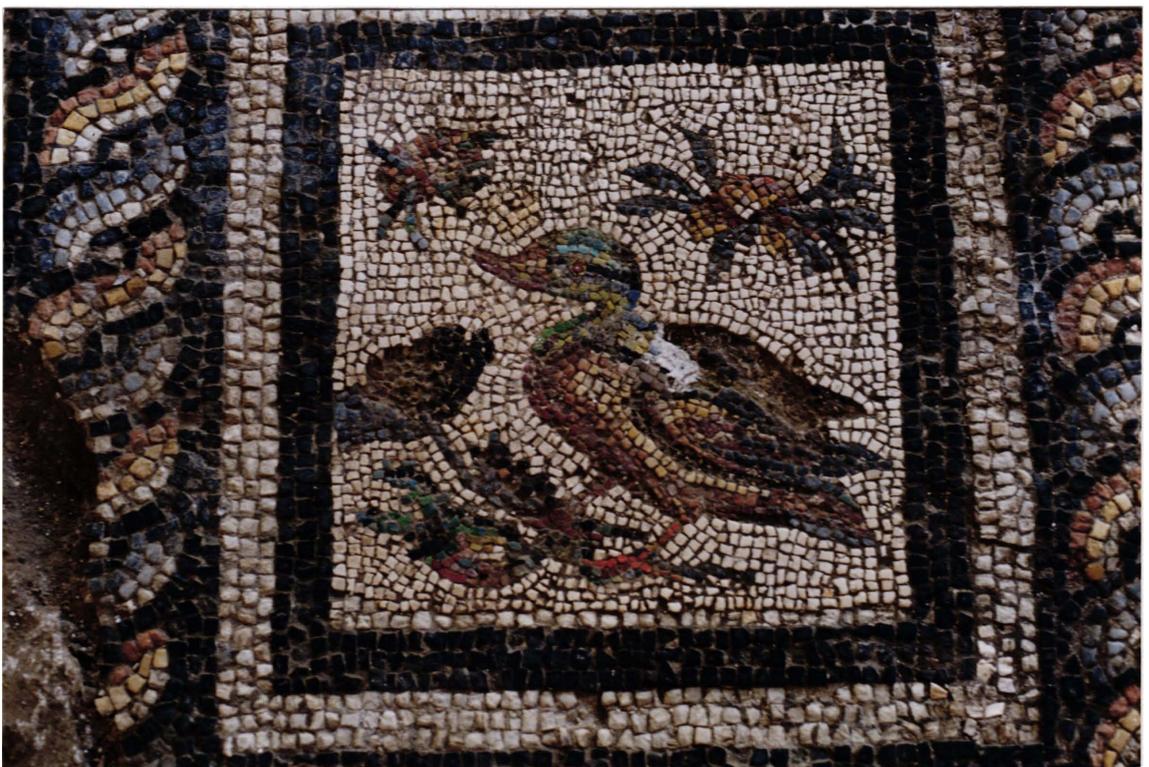
22. The same panel during restoration.

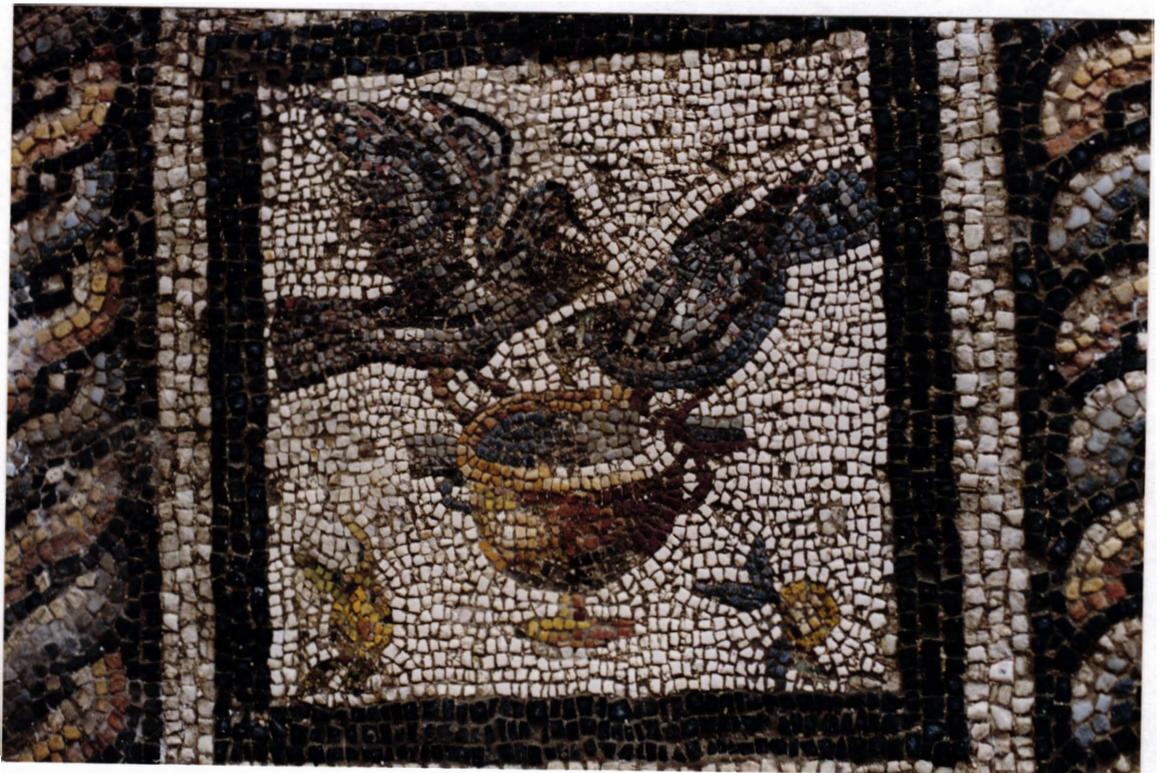
24. The same panel after restoration.

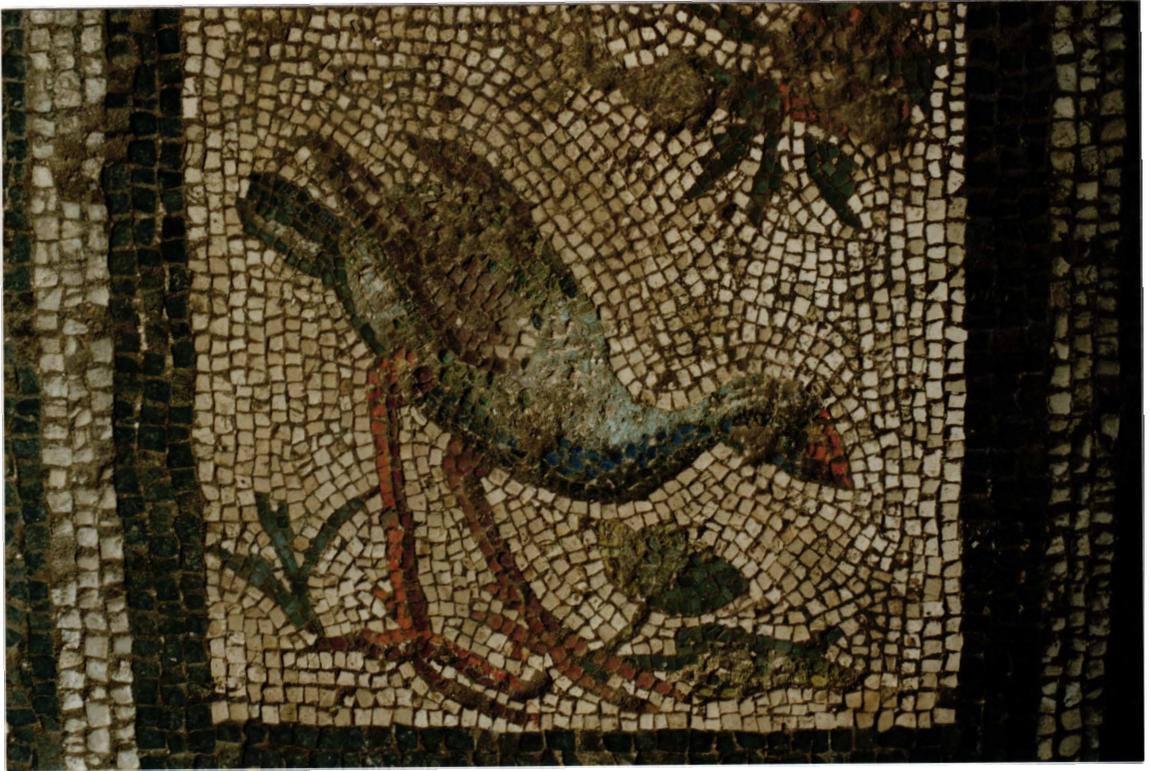
25. Panel with heron, after cleaning.

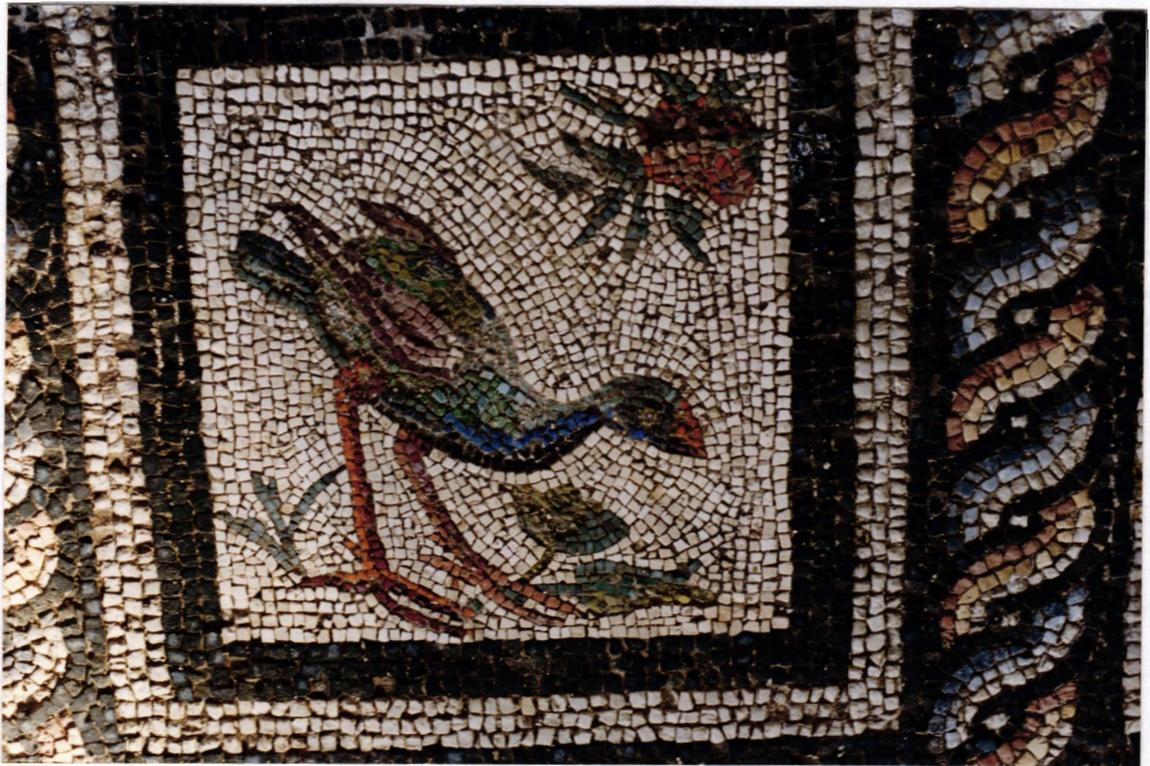
26. The same panel after restoration.

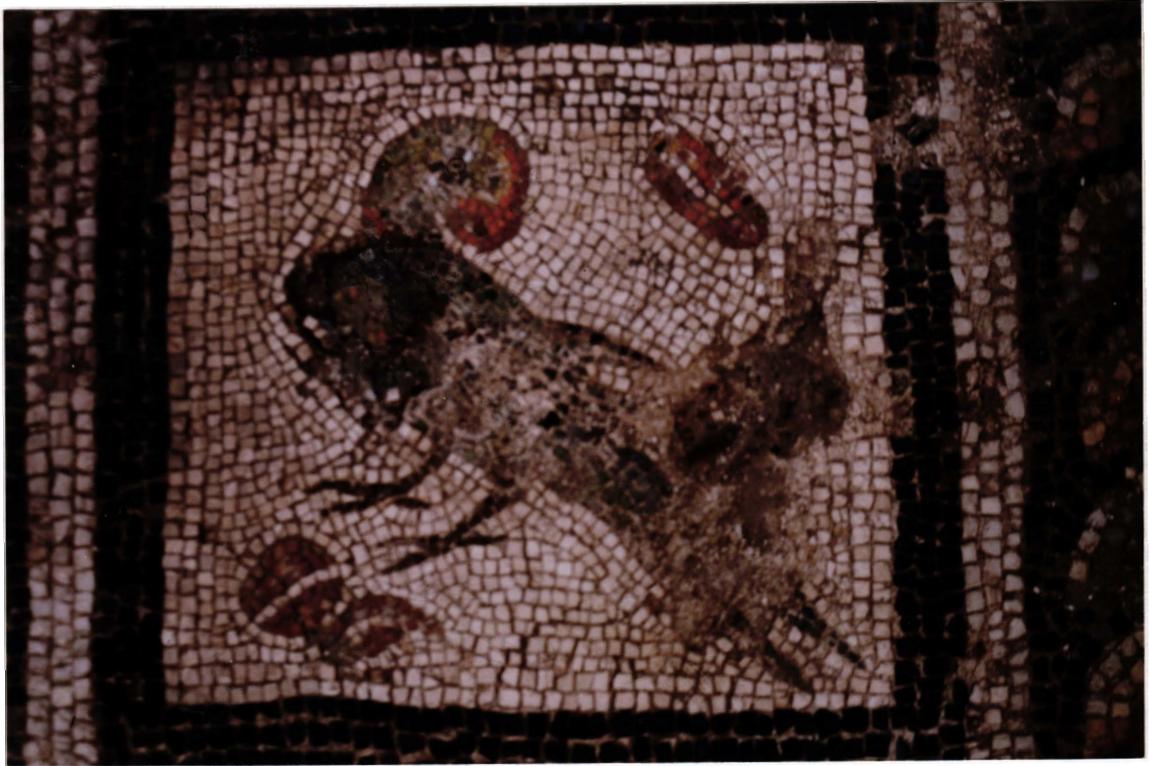
27. Panel with parrot, before restoration.

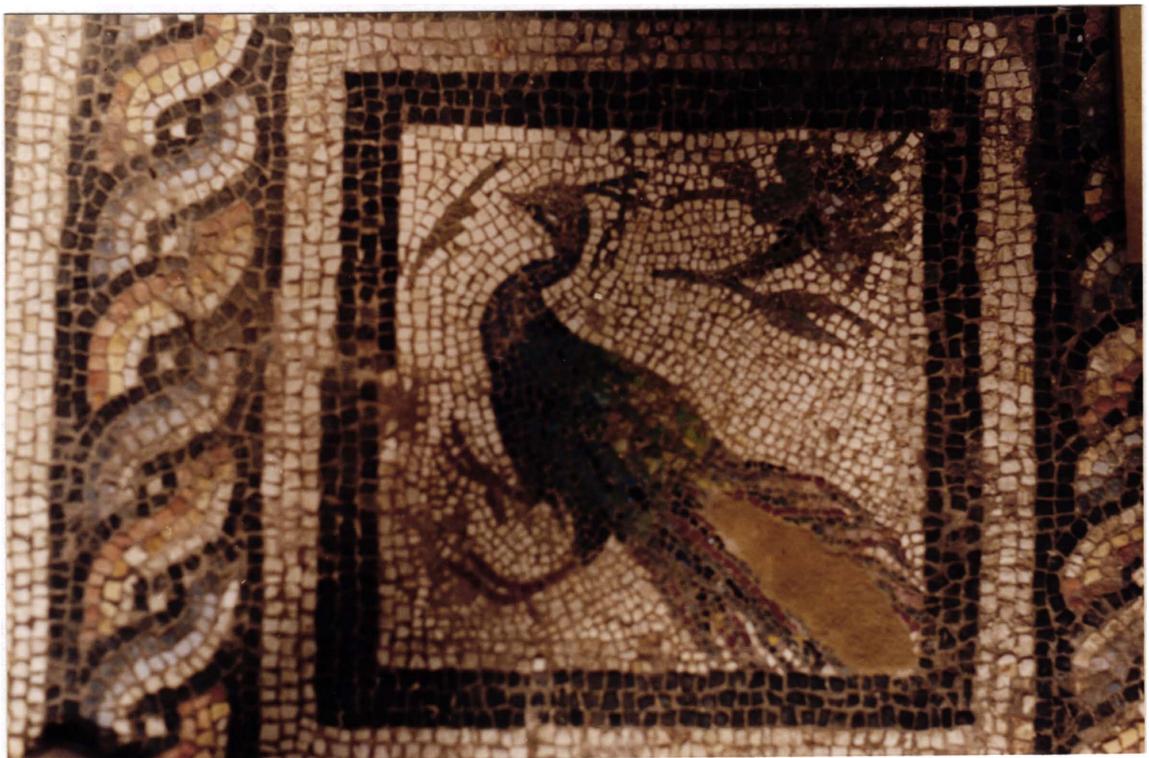
30. The same panel after reconstruction.

- The weak tesserae, small in size, eroded, mainly those made in glass or very soft stones, were treated individually with Paraloid B-60 diluted in ethanol.  
Some fragments of decoration were reconstructed. The reconstruction was done in the small lacunae, on the mosaic edges and in parts of the panels where there is no doubt as to the shape and color of the design. The reconstruction was possible thanks to the preserved colored ground and retrieval of original material (glass paste and tesserae found during excavations in the debris). Resetting of tesserae and reconstruction of disintegrated fragments was executed using magnifying glass (x 2,5). (phot. 28, 30, 35)

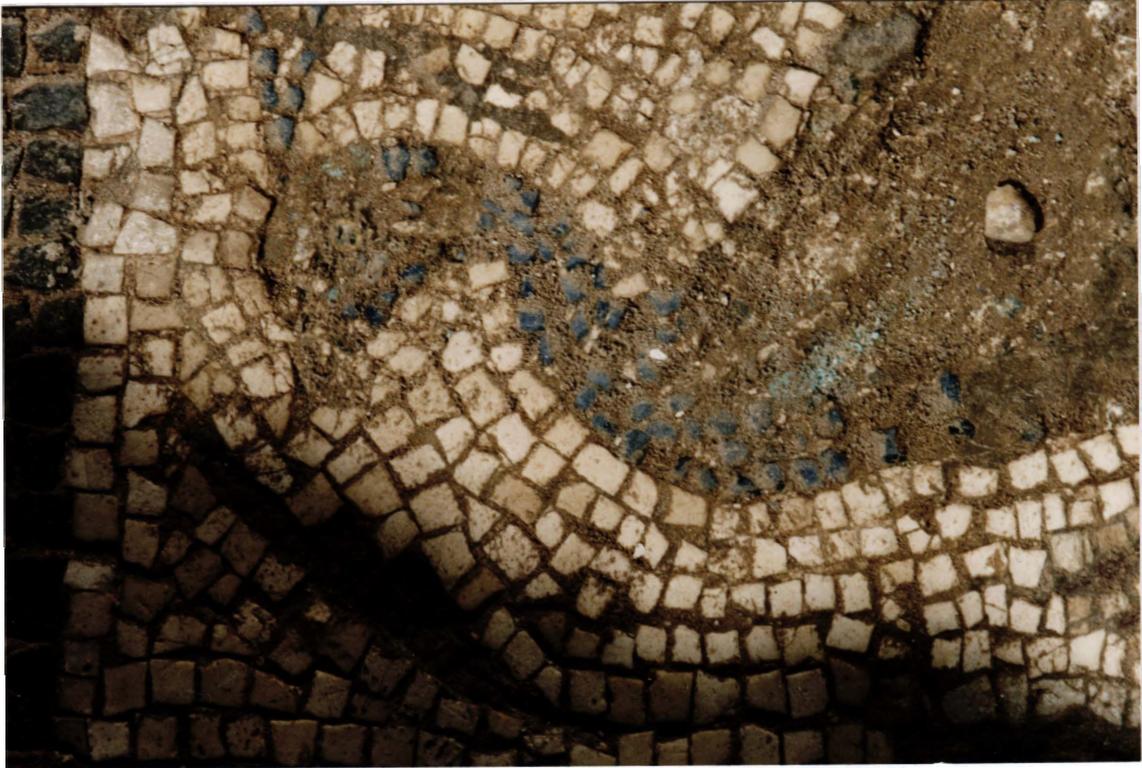
- The underlying soil has sagged and shifted.
- The surface is distorted due to mechanical damages (collapsed roof and walls)
- The glass tesserae are very soft and have been disintegrated and seriously eroded by soluble salts activity due to the high alkaline content of the glass paste. In many parts, where the glass paste was used for decoration, only remnants of colors and shape of tesserae can be seen (phot. 23, 25, 27, 29).
- In ancient times, a fire caused darkening of the mosaic surface and disintegration of the bedding mortar in several places (Phot. 19, 20). In antiquity small lacunae had been filled with white marble pieces (Phot. 31-33).

31. Fragments of the panel with peacock showing deterioration of glass tesserae.

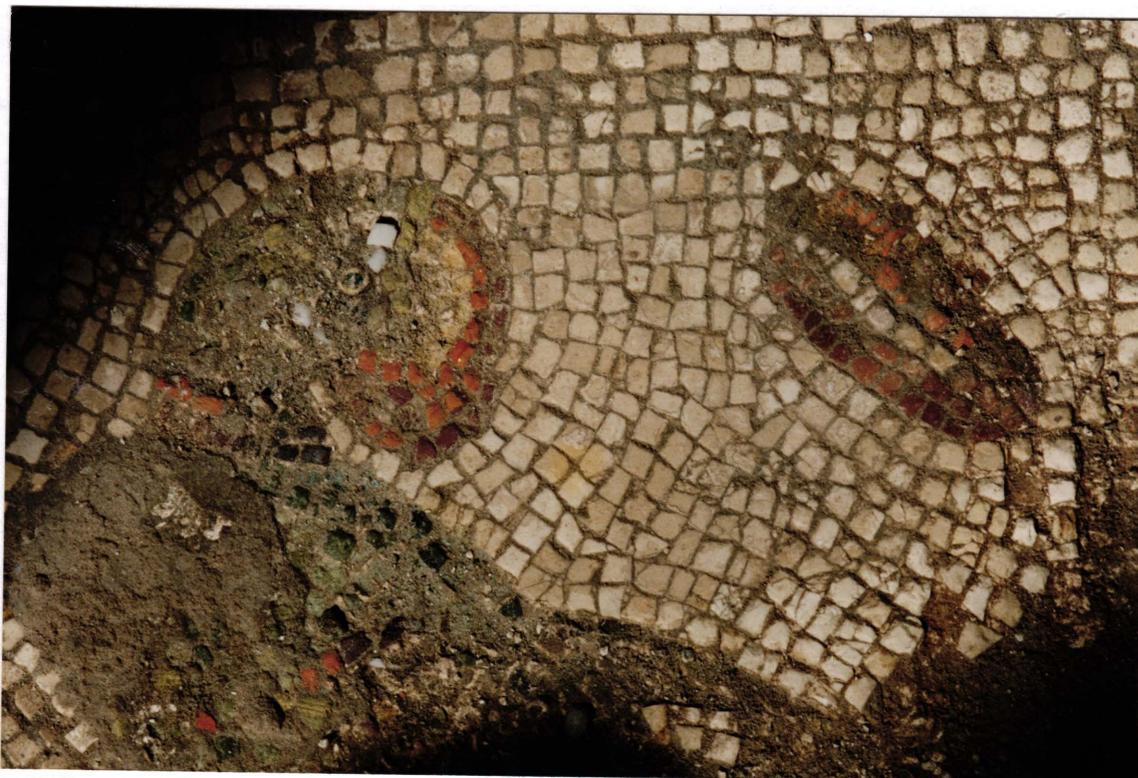
33. Fragment of parrot repaired with cement mortar, before conservation.

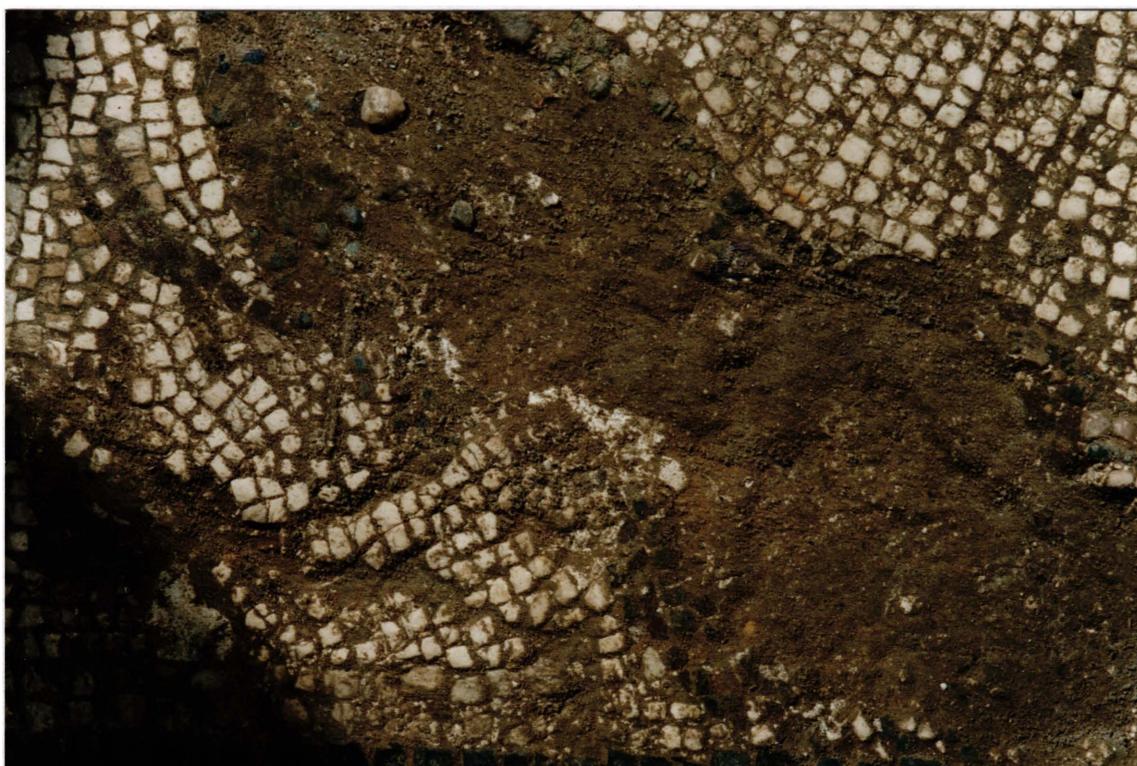
34. Fragment of peacock, before conservation.

- Edges were provisionally protected with Japanese tissue paper (Phot. 35).
- Modern repairs with cement were removed mechanically using chisels and dentist tools (phot. 34). Protective band of cement applied on mosaic edges was replaced with lime mortar.
