American Research Center in Egypt  
Egyptian Antiquities Project

**"Conservation and Display of Roman Mosaics  
Kom el-Dikka, Alexandria"**

**5th Progress Report  
Completion Report  
for Mosaic Conservation Work**

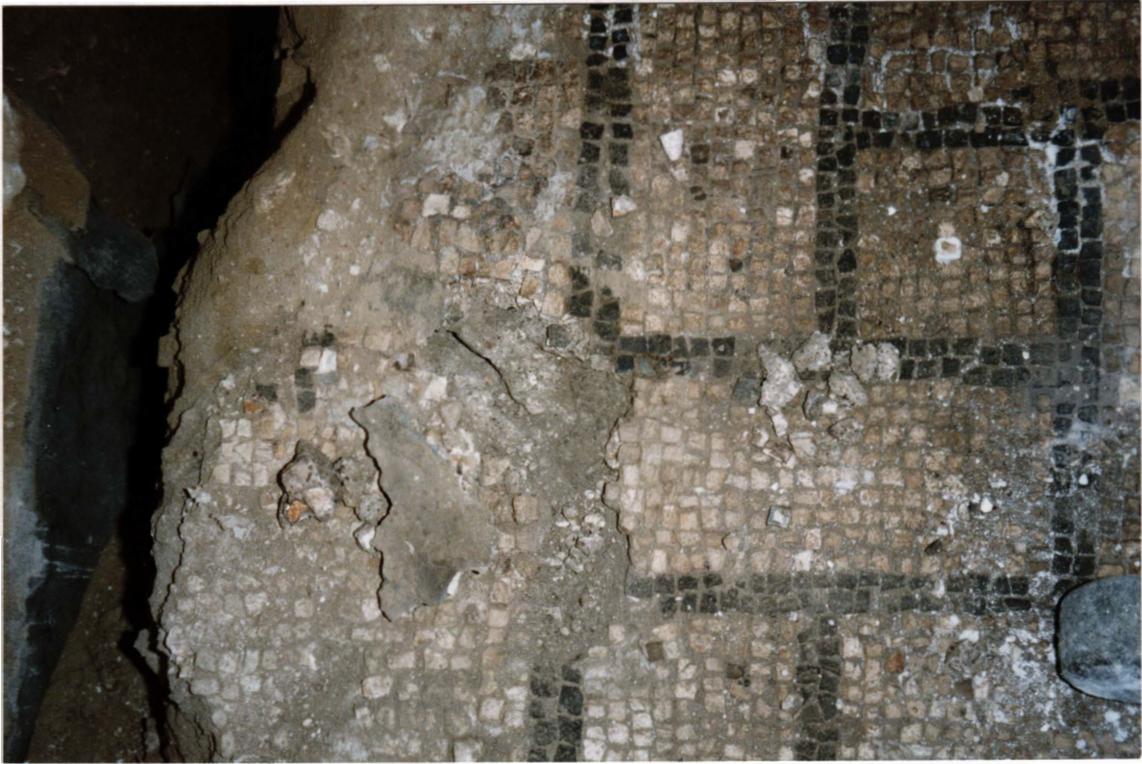
35. East corner of mosaic  $\alpha$ -5 - geometric pattern, before conservation.

- Edges were provisionally protected with Japanese tissue paper (Phot. 35).
- Modern repairs with cement were removed mechanically using chisels and dentist tools (phot. 34). Protective band of cement applied on mosaic edges was replaced with lime mortar.

- The weak tesserae, small in size, eroded, mainly those made in glass or very soft stones, were treated individually with Paraloid B-60 diluted in ethanol.  
Some fragments of decoration were reconstructed. The reconstruction was done in the small lacunae, on the mosaic edges and in parts of the panels where there is no doubt as to the shape and color of the design. The reconstruction was possible thanks to the preserved colored ground and retrieval of original material (glass paste and tesserae found during excavations in the debris). Resetting of tesserae and reconstruction of disintegrated fragments was executed using magnifying glass (x 2,5). (phot. 28, 30, 35)

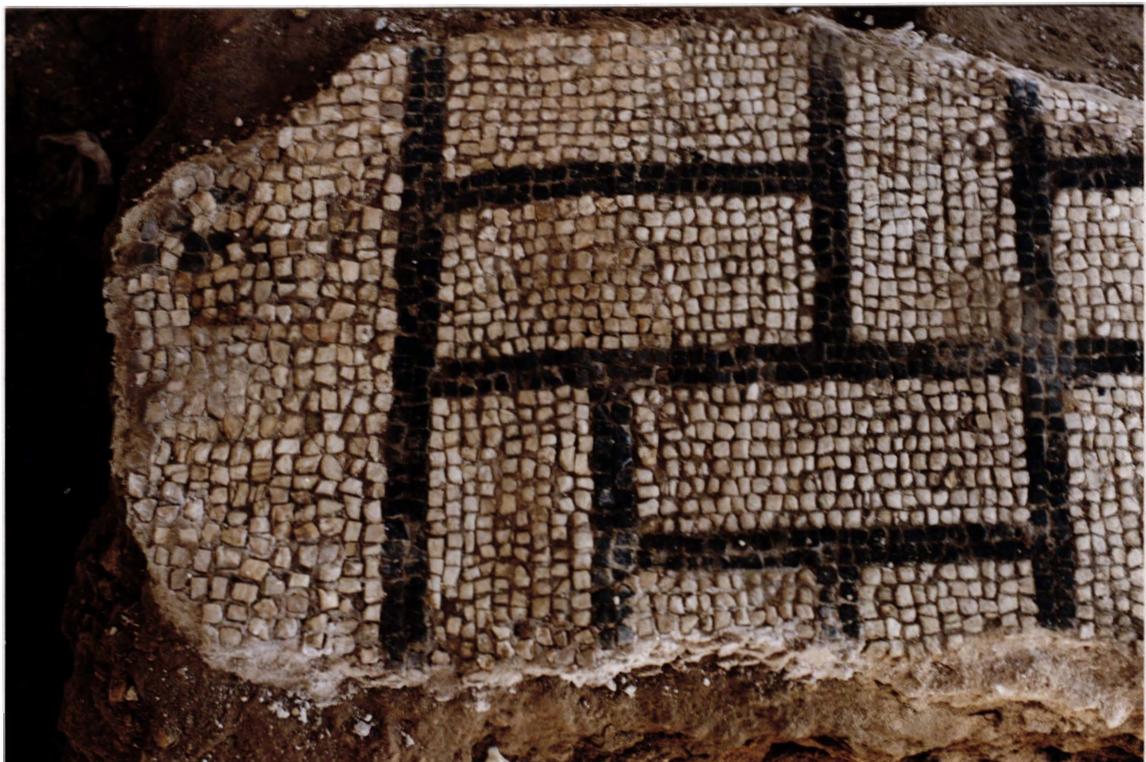
36. The same fragment after removal of cement and filling of lacunae

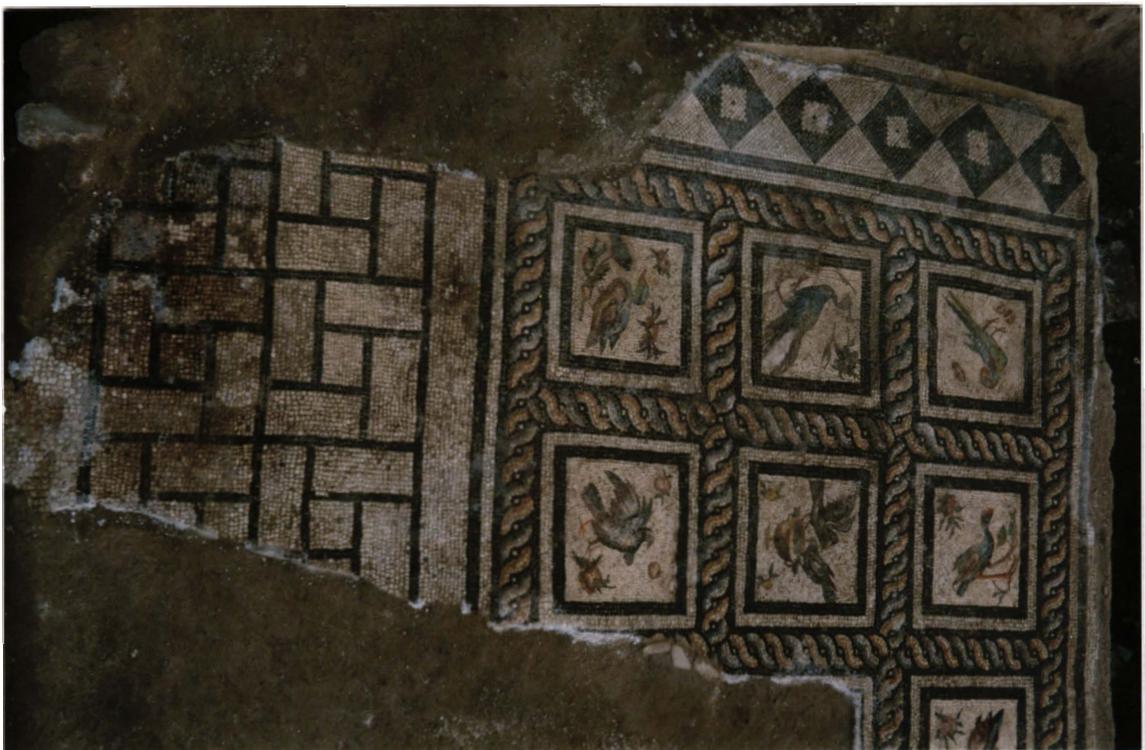
38. The mosaic after reconstruction of lacunae, edges reinforced with lime mortar.

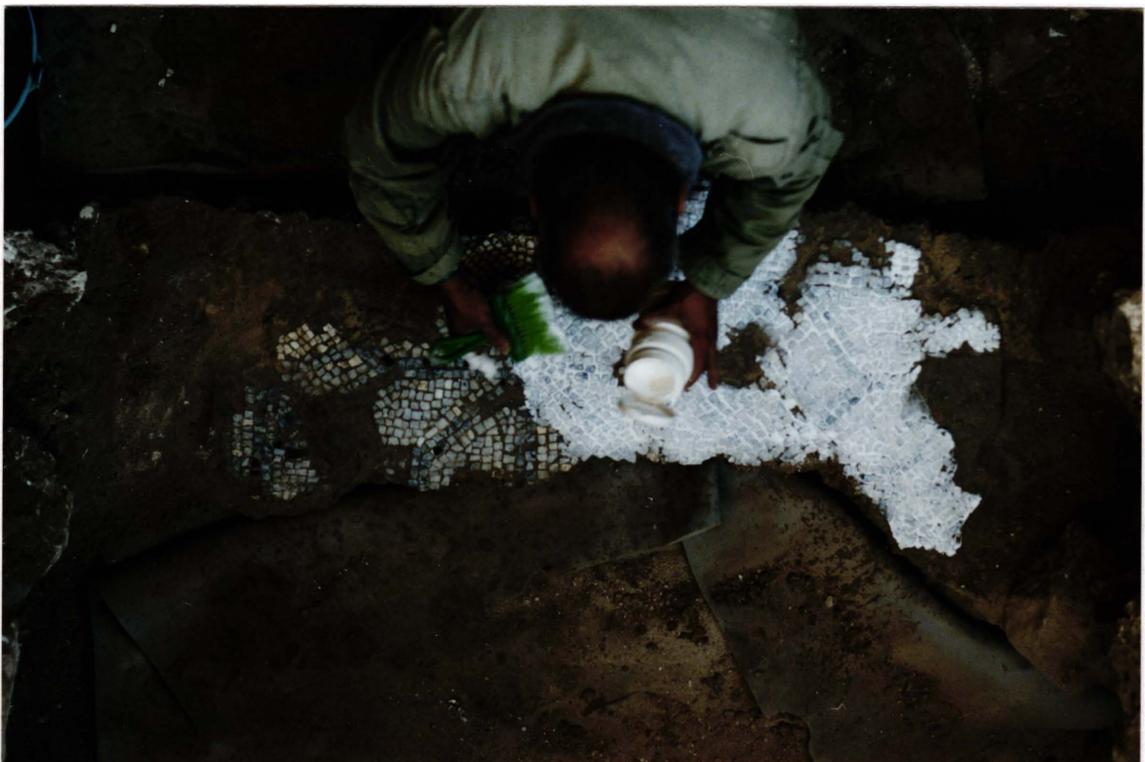
40. Facing of this fragment with canvas and PVA emulsion.

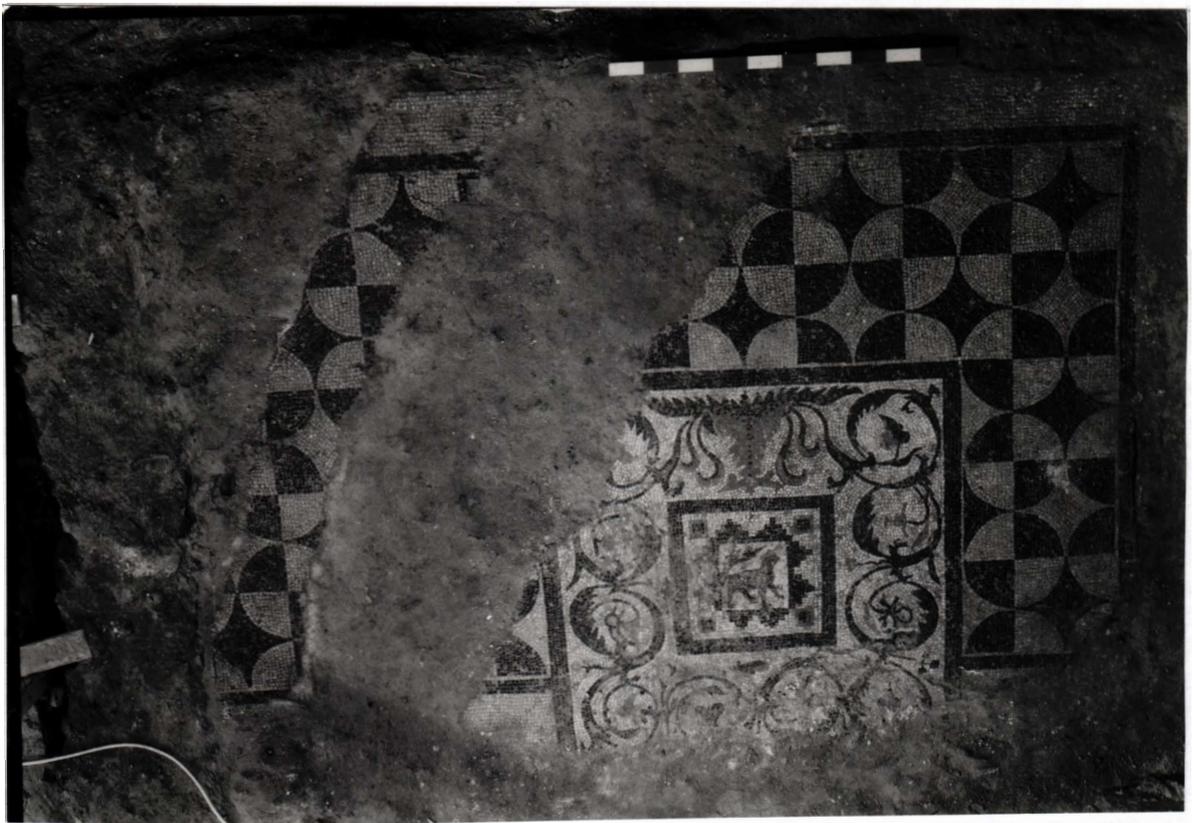
- about 20% of the original surface is missing.
- The mosaic is preserved in two separated fragments. A long diagonal gap, about 50 cm wide separates northern part of geometric decoration from the rest of the pavement.
- Loss of tesserae along the edges of the mosaic.
- The central part of pavement has been covered with a fragment of superimposed geometric mosaic  $\alpha$ -7. Remnants of this mosaic were lifted and transferred to the store.
- The remains of pink bedding mortar of the lifted fragment cover the surface of the central part of the mosaic. In this part the bedding is disintegrated and tesserae are crumbling.
- Blue faience tesserae eroded, their surface is very dark and deteriorated.

41. Mosaic  $\alpha$ -6, before conservation.

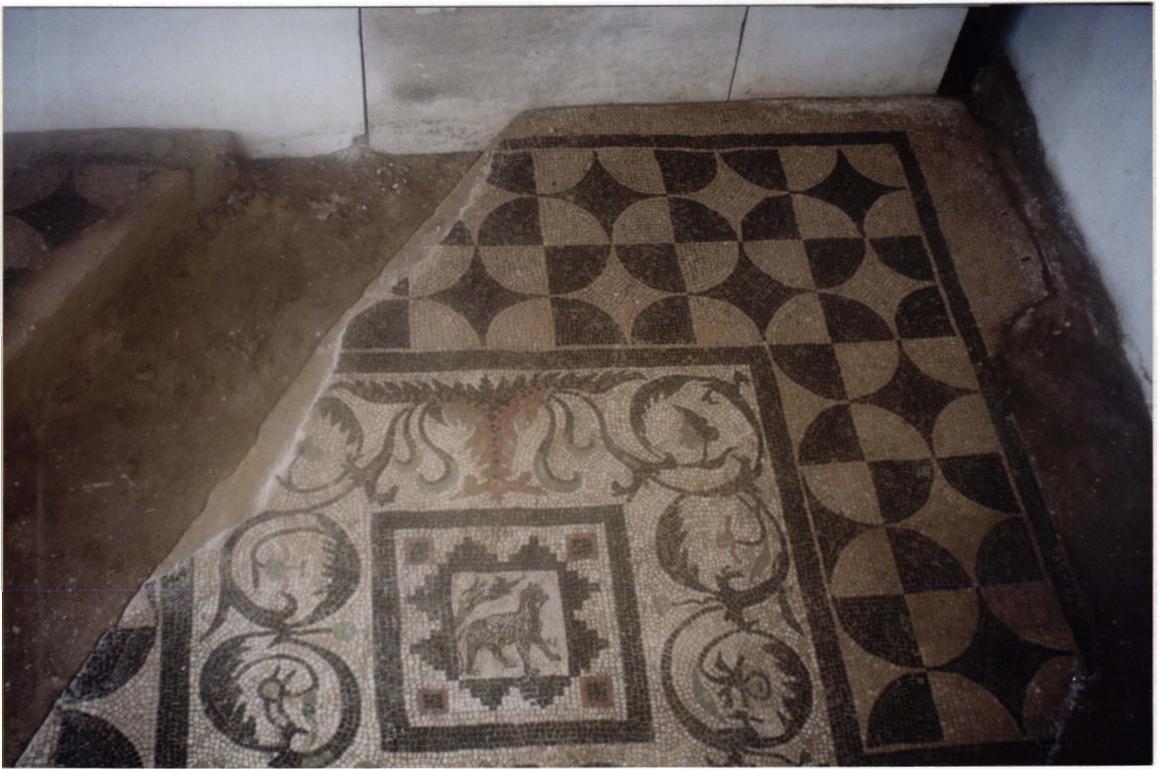
43. Mosaic α-6, after conservation.

- Lifting of the disintegrated fragment. Due to the sunken bedding, deformation of the surface and disintegration of the cubes, the fragment measuring ca. 50 cm<sup>2</sup> had to be lifted and replaced in situ on a new fixed bedding. The fragment was carefully cleaned, the soil from the edges has cleared away. Loose tesserae were collected, bagged and their location marked on a 1:1 tracing. The cut lines were traced on a 1:1 drawing. The edges of cut lines on the mosaic were protected with Japanese tissue facing. The fragment was faced with gauze tissue and a second layer of canvas using carboxymethylcellulose as a glue. The faced fragment had to be dried with hot air (with the help of hair-dryer). The fragment was removed and reverse cleaned mechanically. The new bedding was prepared to reset lifted fragment made of lime and sand mortar with 0.5 % of white cement, while lime, marble powder and Plexol was used to make a bonding layer.
