**CONSERVATION PROJECT OF THE  
ASLAM AL-SILAH DAR MOSQUE**

**QUARTERLY PROGRESS REPORT**

**MARCH 2007-MAY 2007**

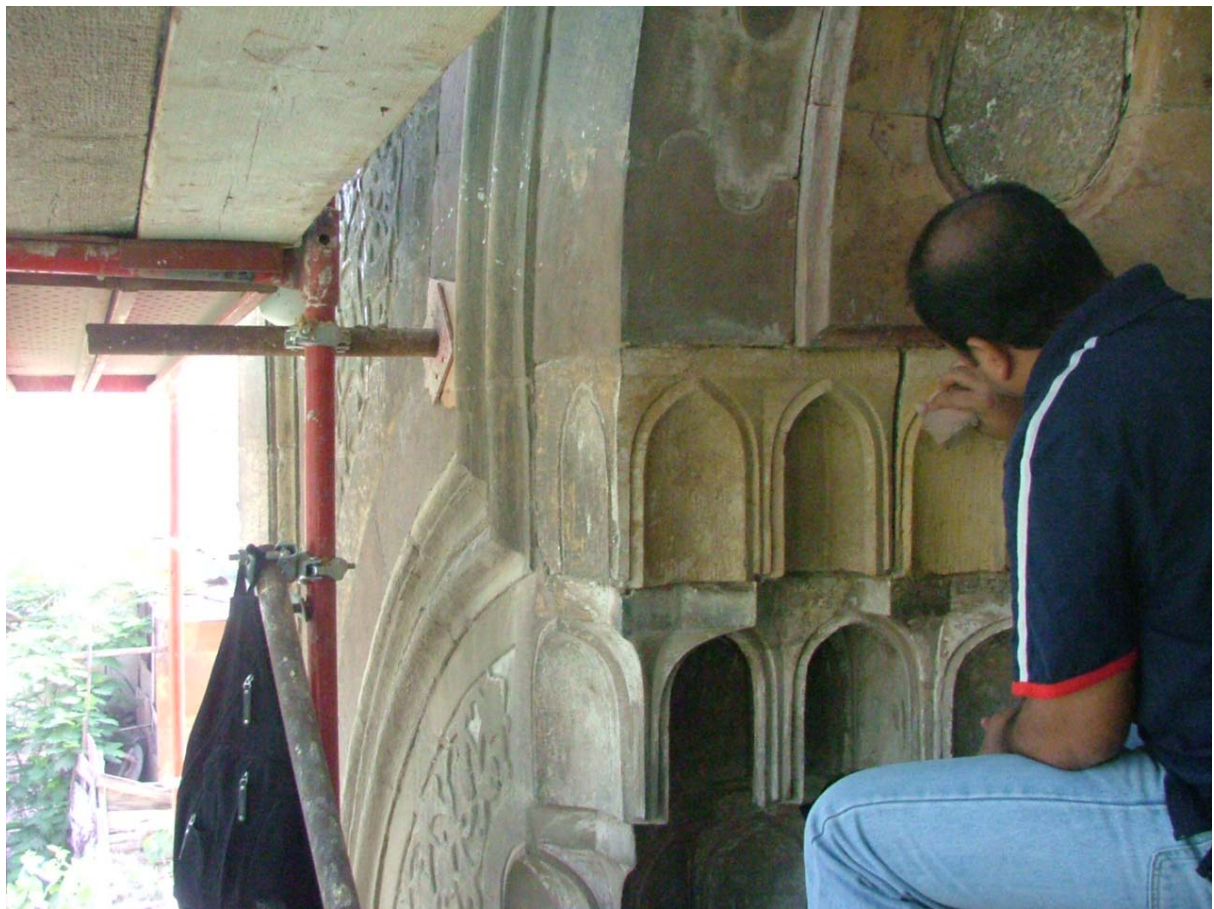
*Stone cleaning activities through mechanical and poulticing techniques.*

Mechanical cleaning test were started on the western façade in order to determine the state of the lime stones. Following, the fine restoration activities were initiated using poultice made of bentonite and paper pulp with a low concentration (3-5%) of Ammonium Bicarbonate. The same polychromy pattern of the lime stone found on both the southern and eastern façade was revealed.

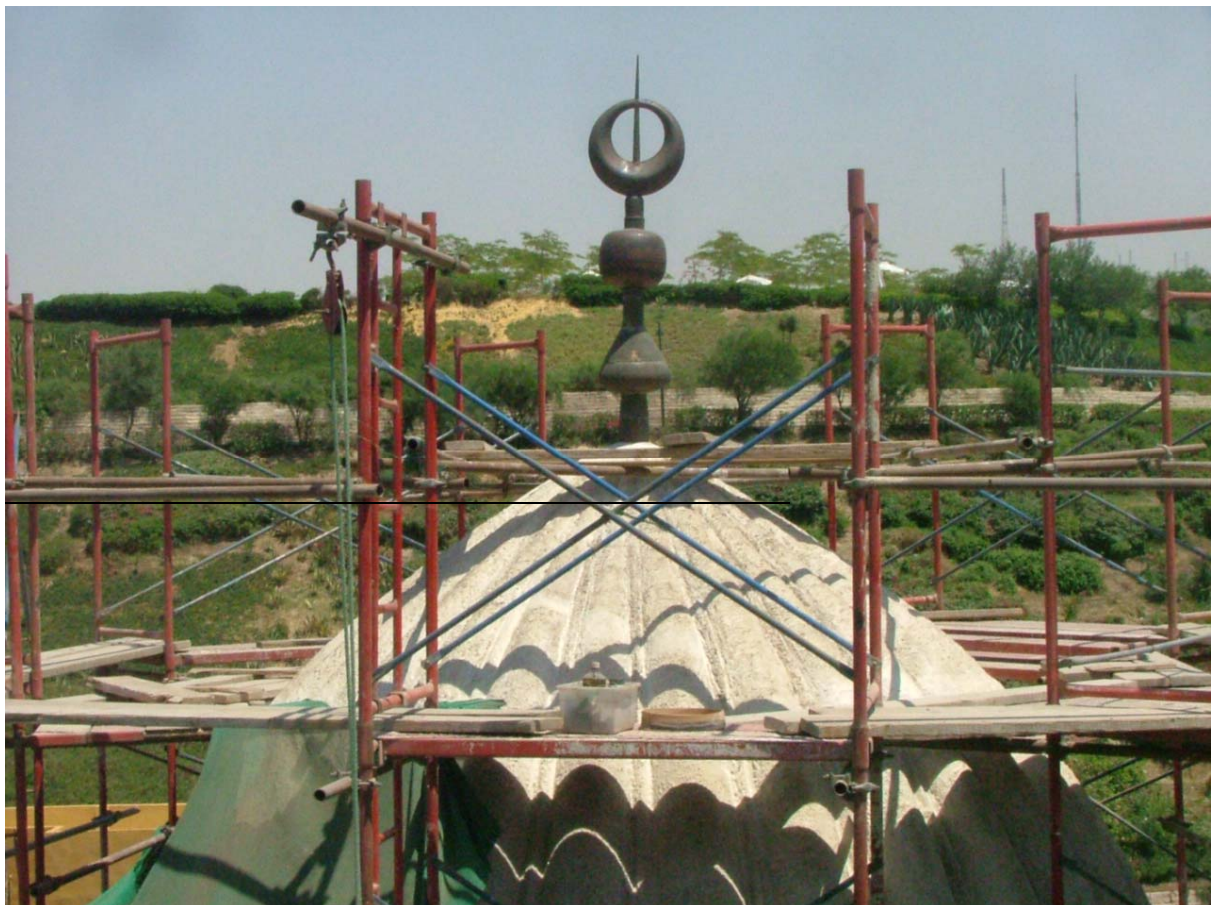
*View of the dome exterior after the cleaning and installation of the copper crescent*

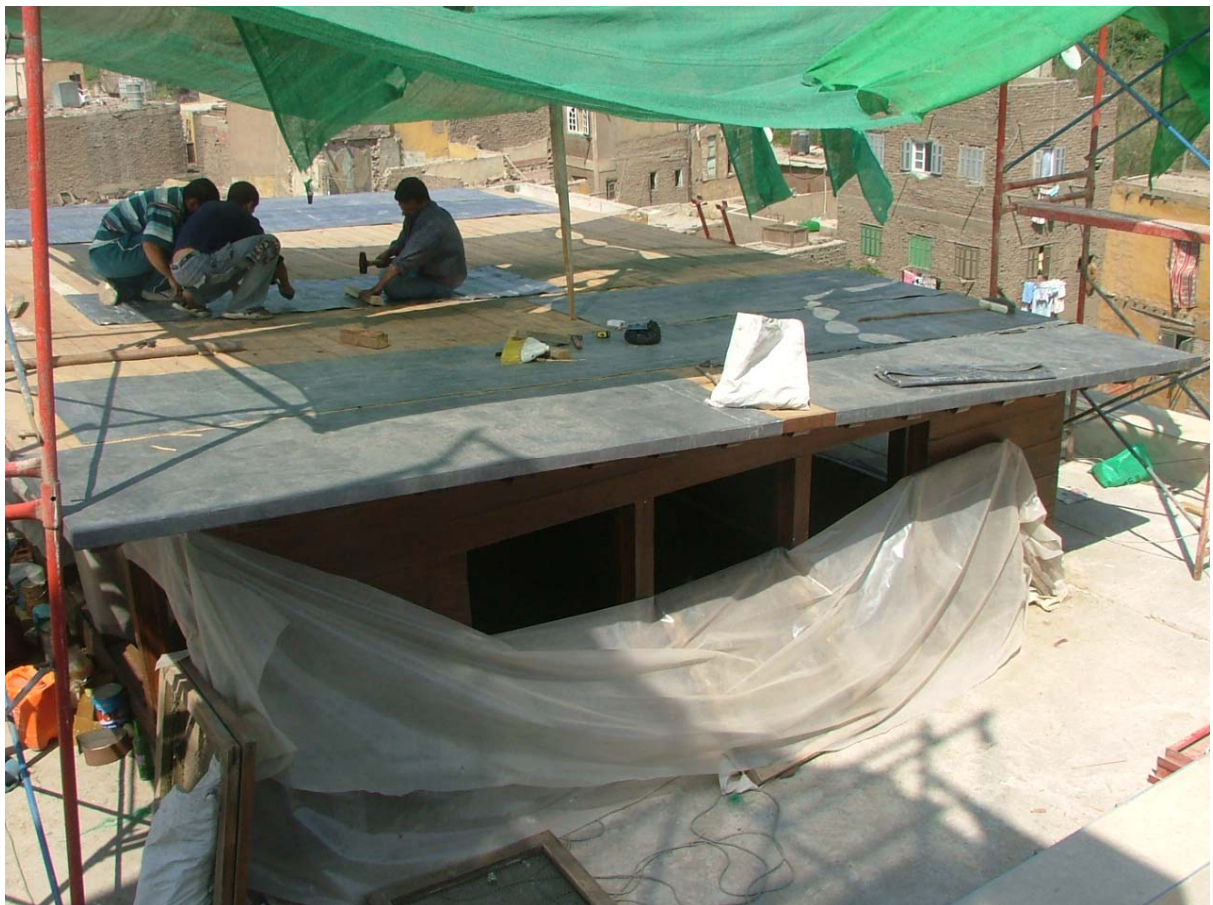
*Central shokhsbekba during the insulation using lead sheets*

The replacement of broken and damaged beams of all the roofs of the mosque was completed. The insulation of roofs was also finalised using bitumen sheets covered with mortar screed. The southern and qibla roofs will be insulated after the dismantling of the dome and minaret scaffoldings.
