CONSERVATION PROJECT OF THE  
ASLAM AL-SILAH DAR MOSQUE

QUARTERLY PROGRESS REPORT

September - December 2007

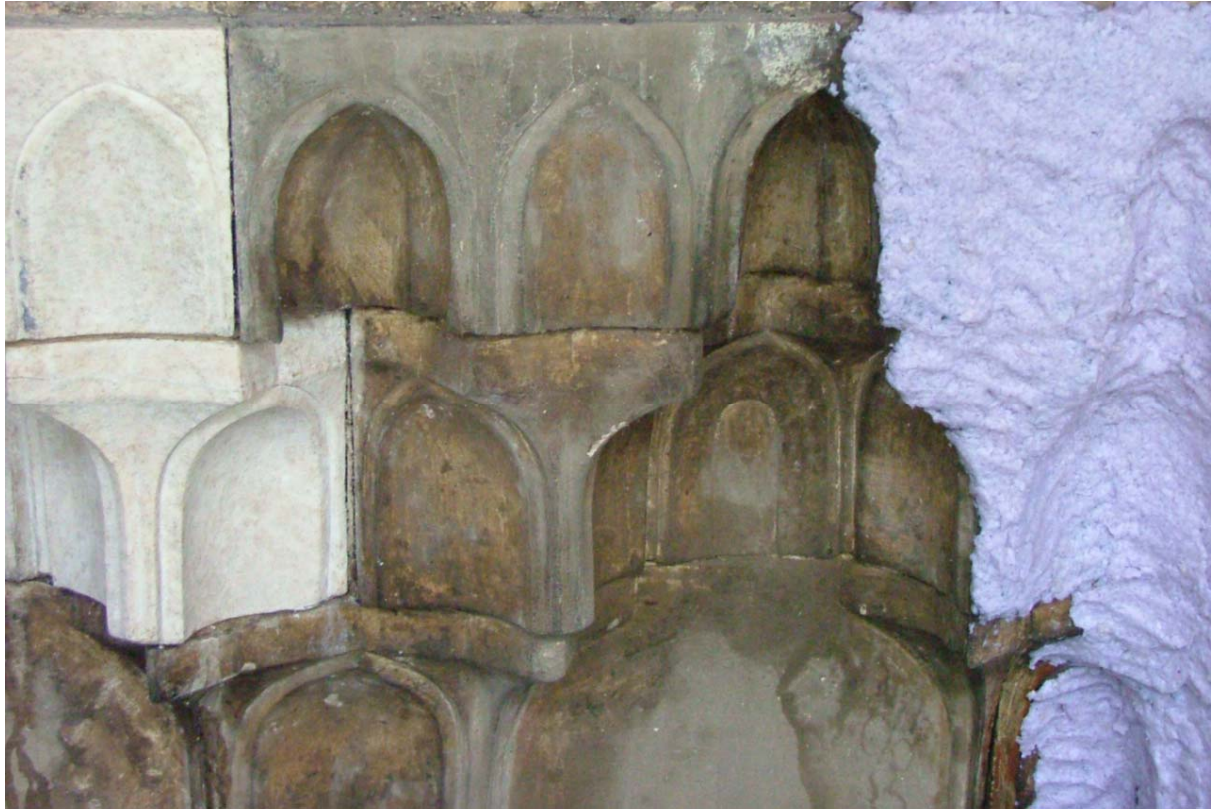
The fine restoration and cleaning activities were completed on the limestone part of the façade. As for the entrance portal adorned with *muqarnas* and decorated with carved limestone and carved marble, the work is proceeding very well showing nice details and colors of the stones. The cleaning was carried out using different techniques (such as the micro-sand-blaster or poulticing with ammonium carbonate) depending on the type of the stone and the crust on it. The lower part of the entrance portal was in quite a bad condition with a very thick layer of crust; it was cleaned with sand-blasting technique. The remaining activities on the portal will be finalized by mid of January 2008. The wooden elements, repaired and painted, were placed and the scaffolding on the right side of the façade was removed.

*Detail showing the muqarnas on the side entrance portal*

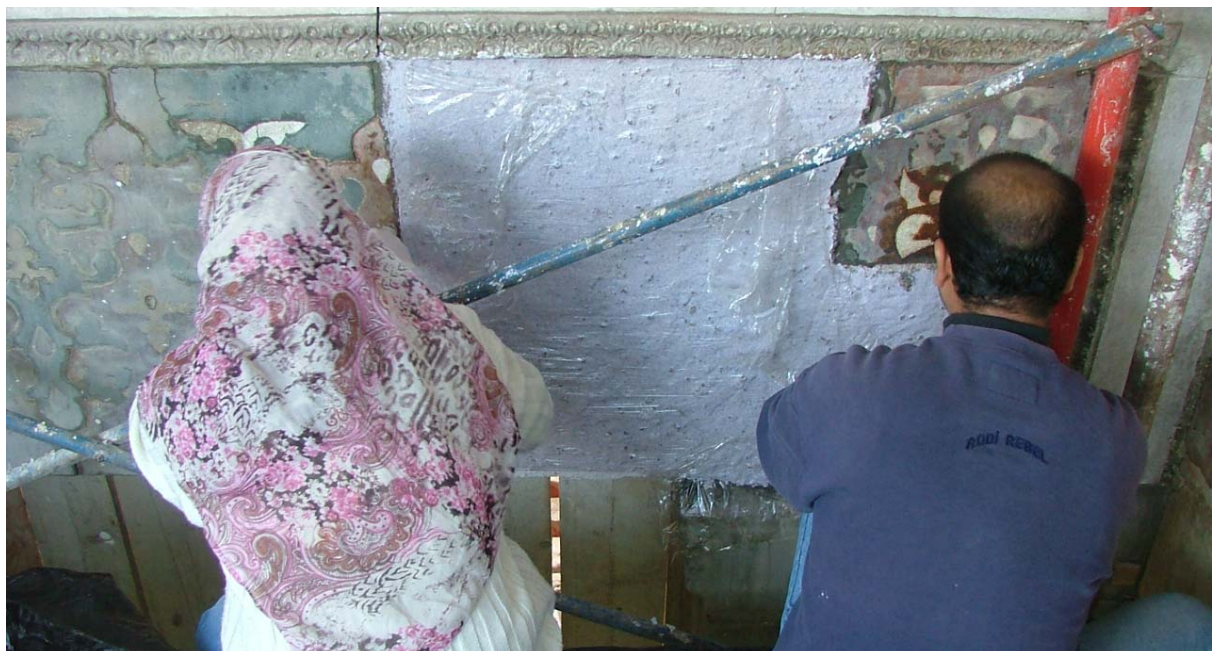
*Activities of marble cleaning on the west façade*

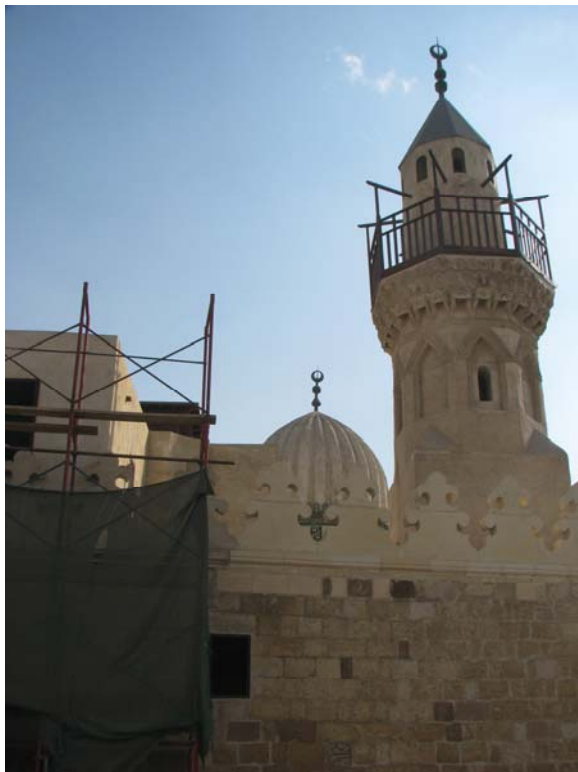
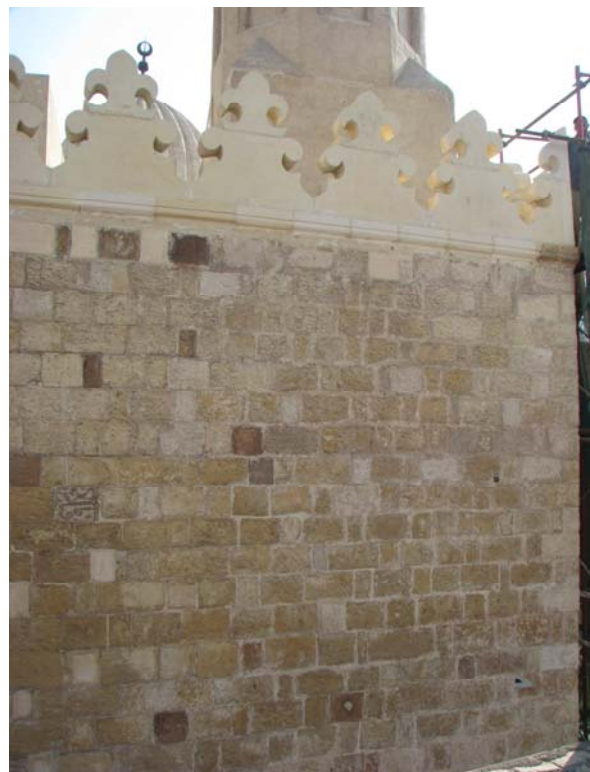
*Views of the west façade after cleaning and inserting the restored wooden elements*

Few stones need to be replaced on the western façade entrance after the removal of the scaffolding.

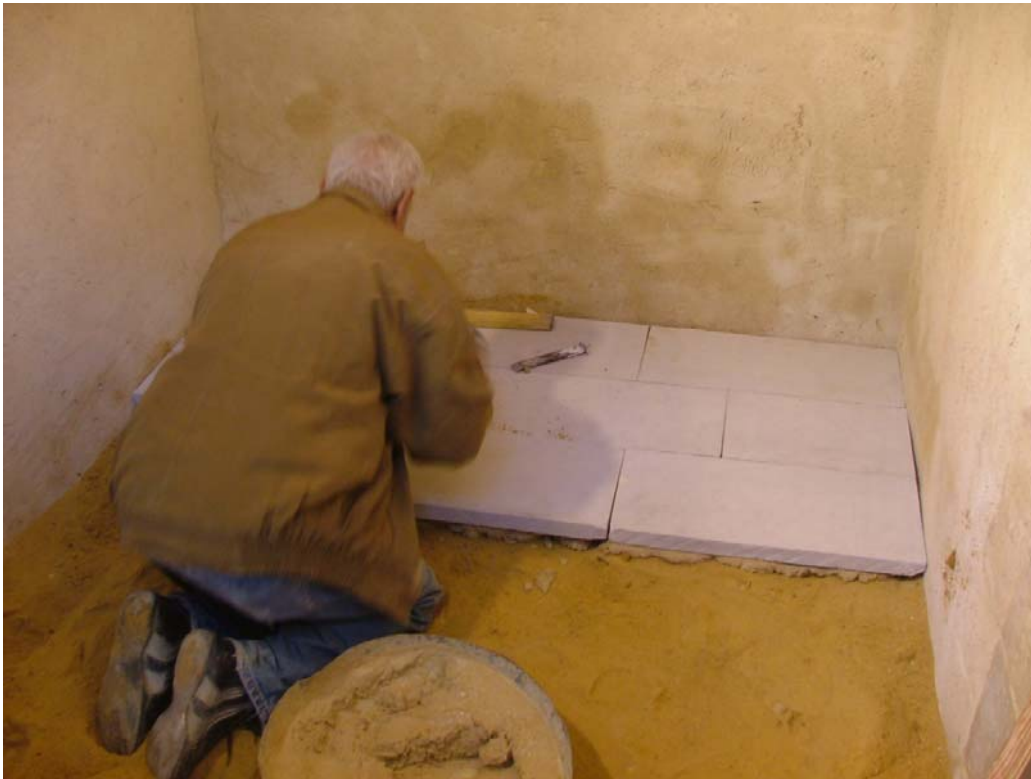
All remaining activities in the five shops were finalized; the walls were plastered and the floors were tiled. Some remaining activities of stone replacement and stone cleaning were also finalized.

*Tiling activities of one of the shops on the west façade*

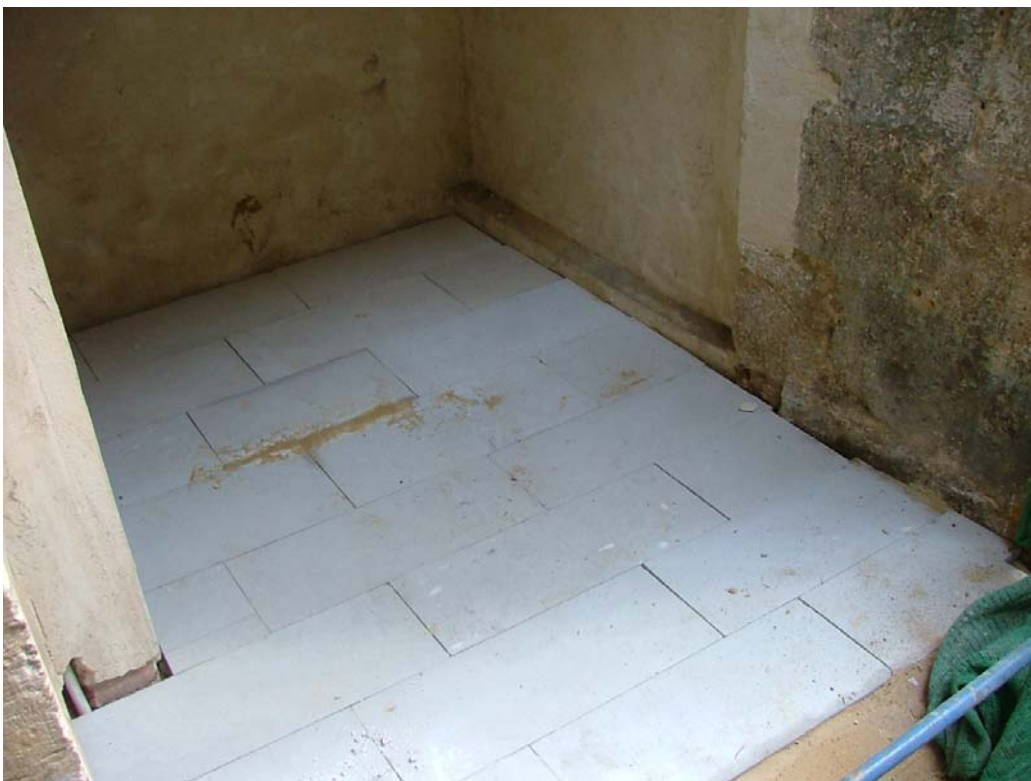
*One of the shops after tiling*

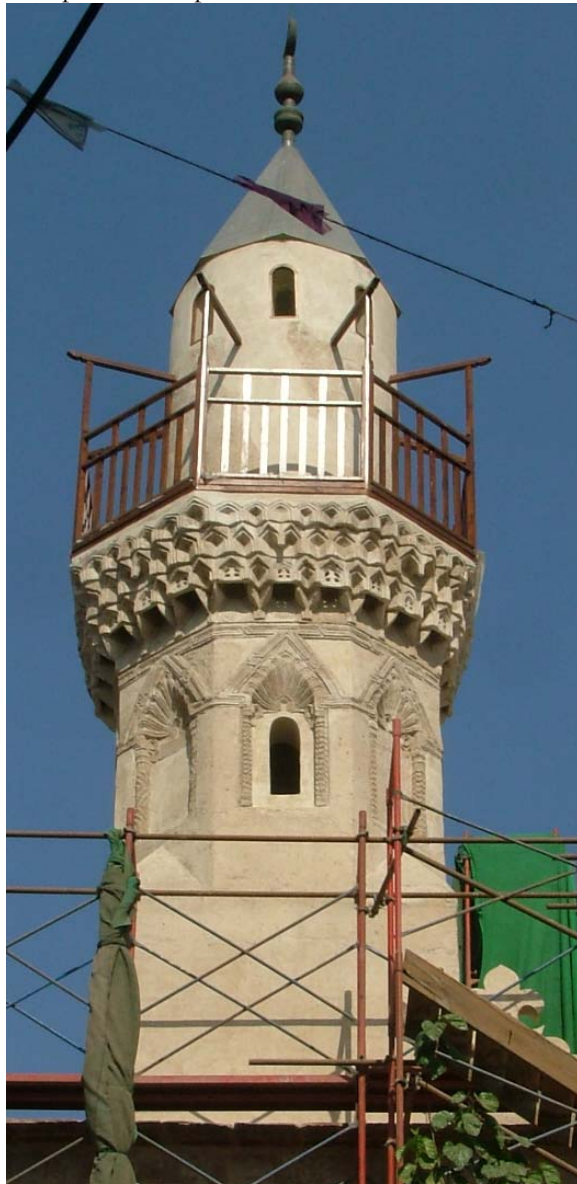
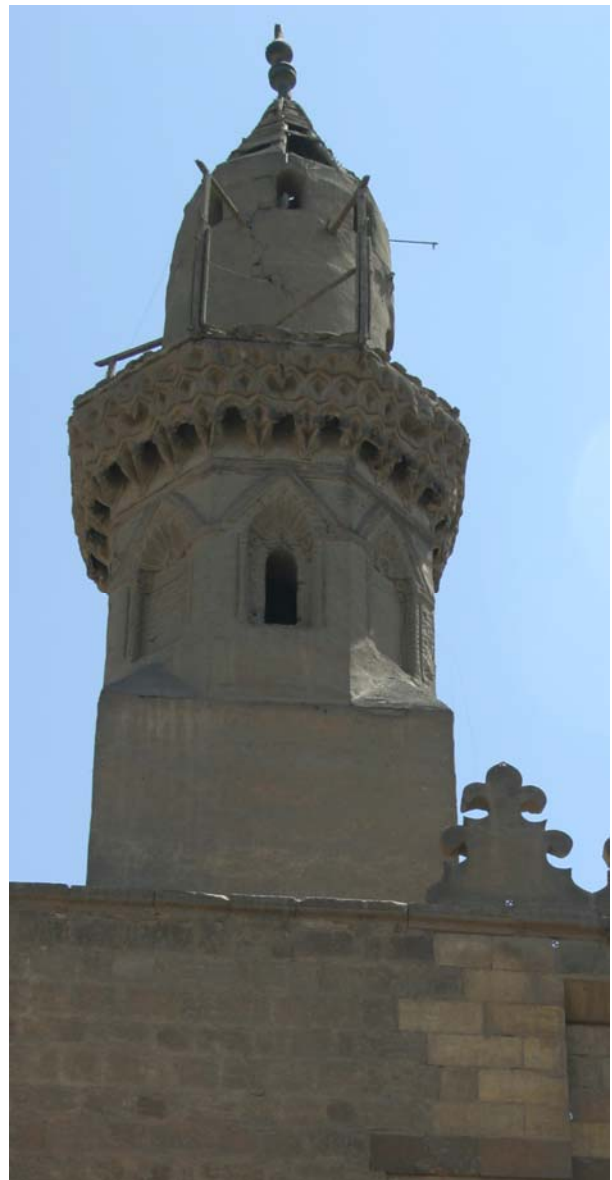
Completed in September 2007.

*Views of the minaret after restoration and before restoration*

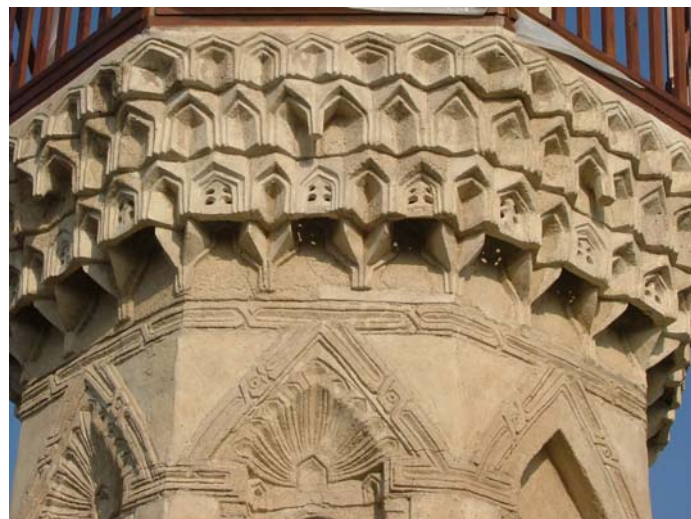
*Detail of the minaret's muqarnas after restoration*

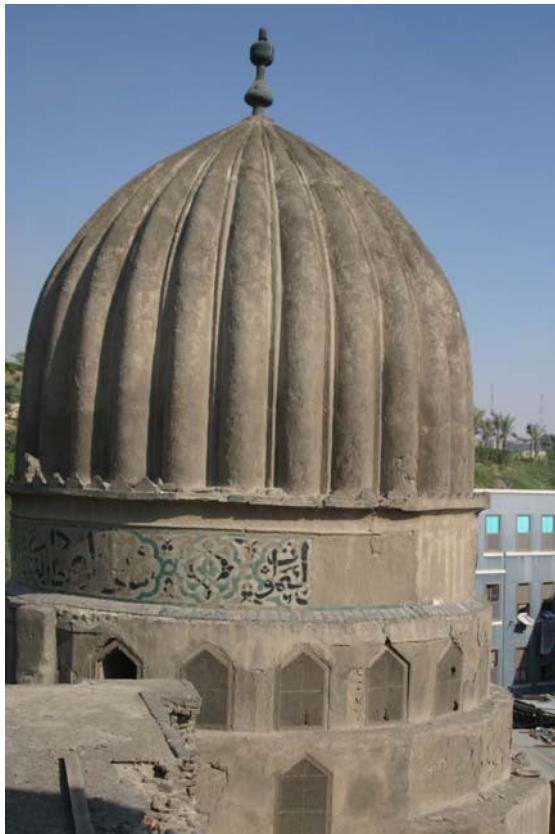
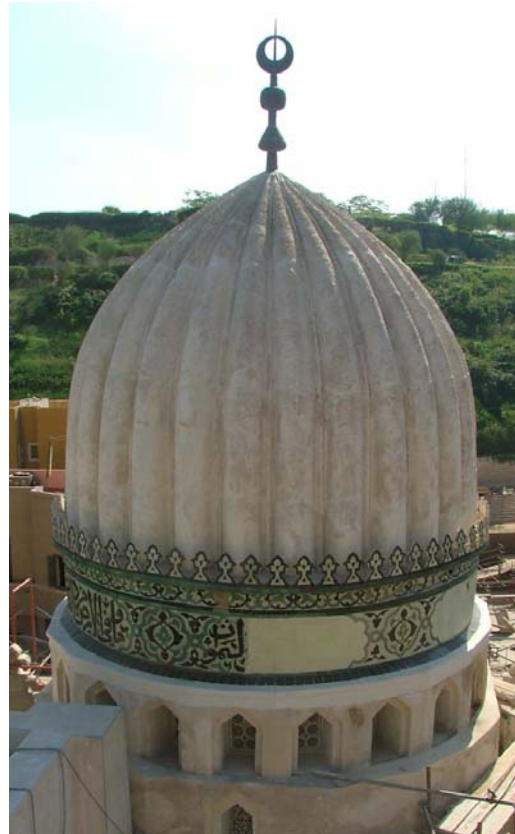
The retouching of the crenellations (made in plaster), the inscription band and its floral decoration was completed. A decision is being studied concerning the completion of the inscription band in the areas where no ceramic tiles are found. The existing gypsum grills with glass on the interior of the mausoleum were cleaned from the outside. As for the exterior gypsum windows (which are missing) designs were proposed to the SCA and discussions are taking place concerning the matter. The scaffolding was dismantled.

*Views of the exterior of the dome before and after intervention*

All activities are completed. Study the possibility of completing the missing part of the inscription.

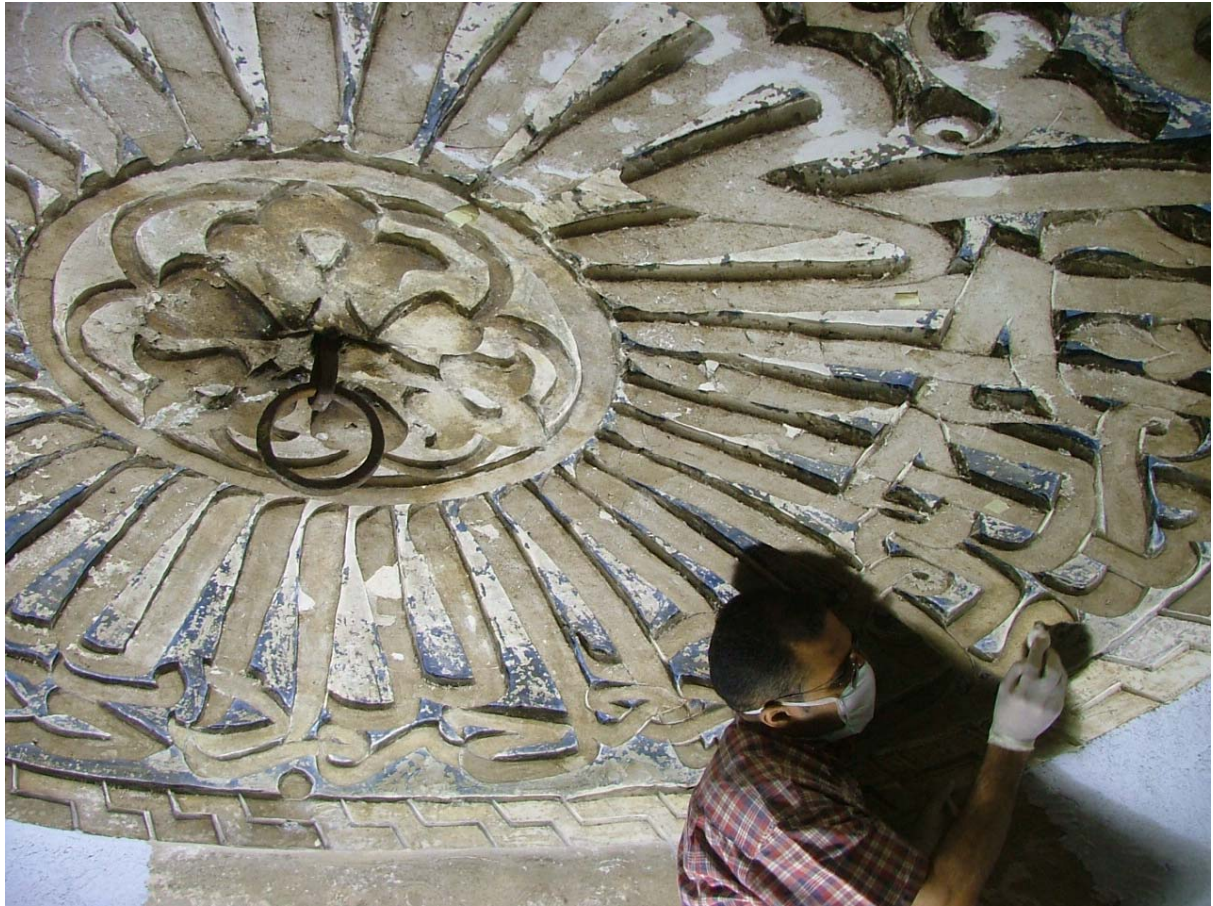
The erection of the scaffolding in the interior of the dome was completed and the fine restoration activities started from the top of the dome. The inscription on the roundel was cleaned and the blue background was fixed where it was flaking and retouched where it was lost. The gypsum plaster was cleaned mechanically removing a recent limewash layer; this was followed by further cleaning of the plaster. The highest level gypsum grills were cleaned from the interior.

*View of the roundel during cleaning*

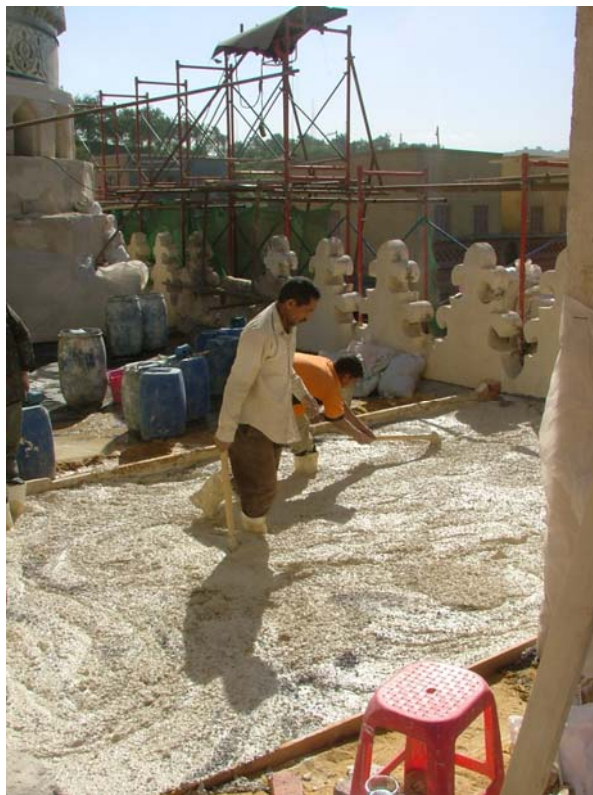
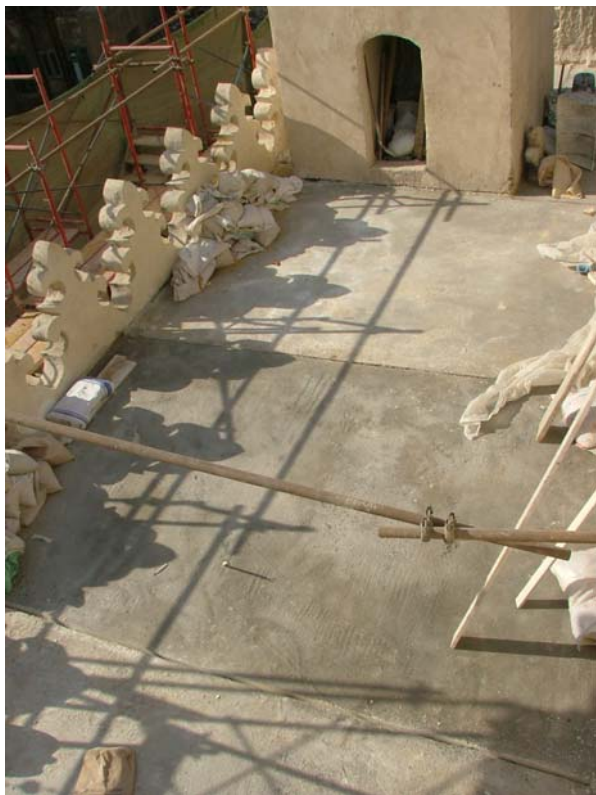
The southern and eastern ceilings were insulated; this completes all roofing and insulation activities.

*The upper insulation layer during application and after hardening*

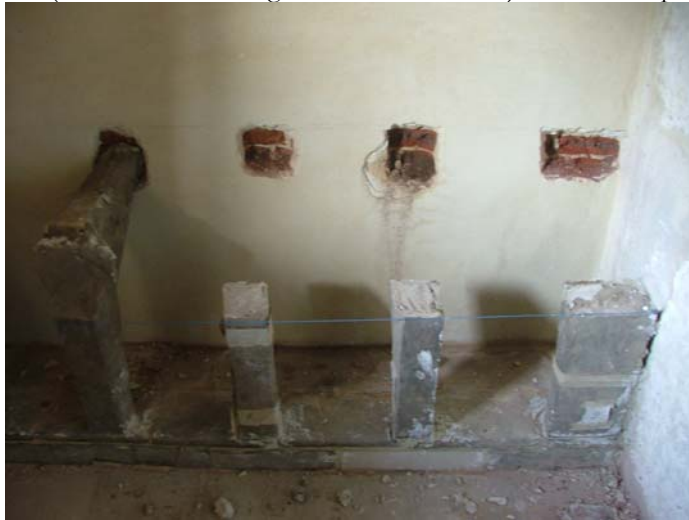
The stone niches in the rooms, (the one in room 1.2 was dismantled earlier to repair the ceilings and the walls), were repaired restored, replacing the damaged or lost ones and cleaning the existing ones.

*During erection of the niche in room 1.2*

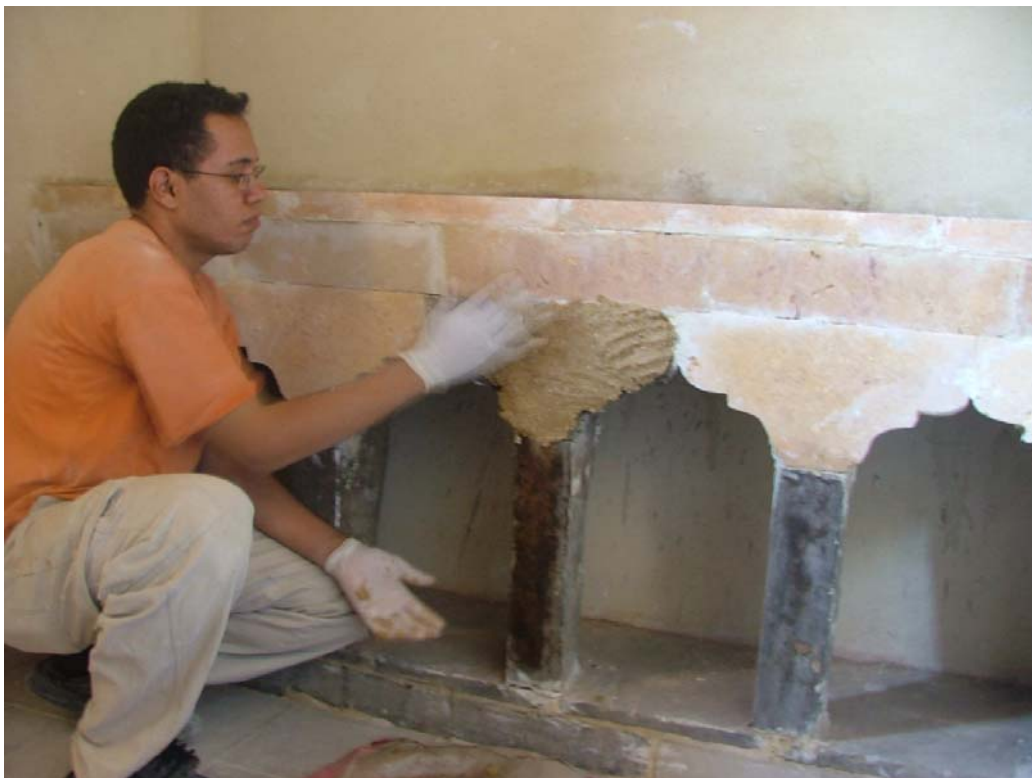
Rooms 1.2 and M1: The rooms around the staircase (rooms 1.2 and M1) were completely restored; after the brick repair activities were finalized and the ceilings restored and repaired, plastering and tiling activities started and were completed, as well as the stone cleaning and plaster cleaning.

*Room 1.2 after the niche was installed and during cleaning*

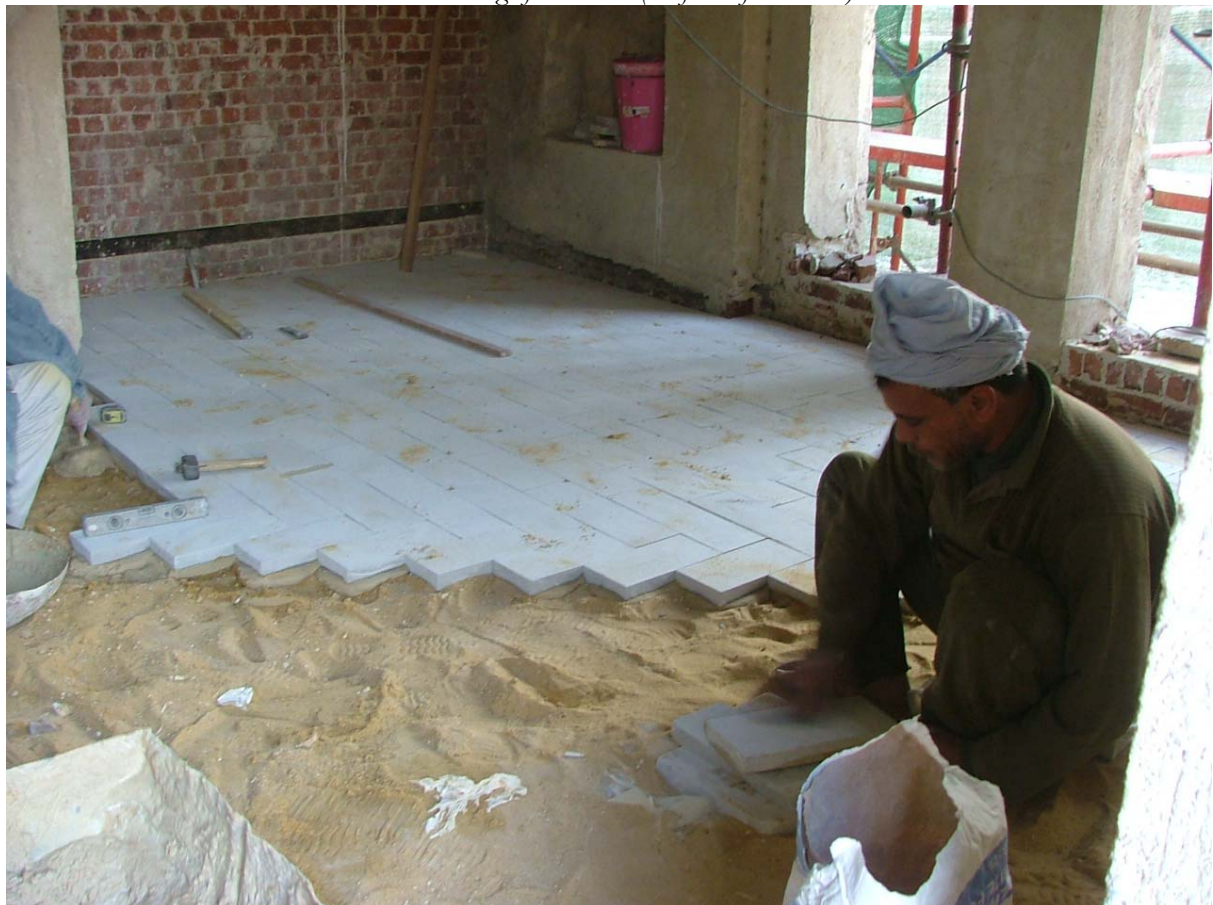
Room 1.3: the brick repair in the room was completed as there was a serious crack between the room and the west iwan. The floor of the room (the ceiling of room M2) was also completed.

*Tiling of room 1.3*

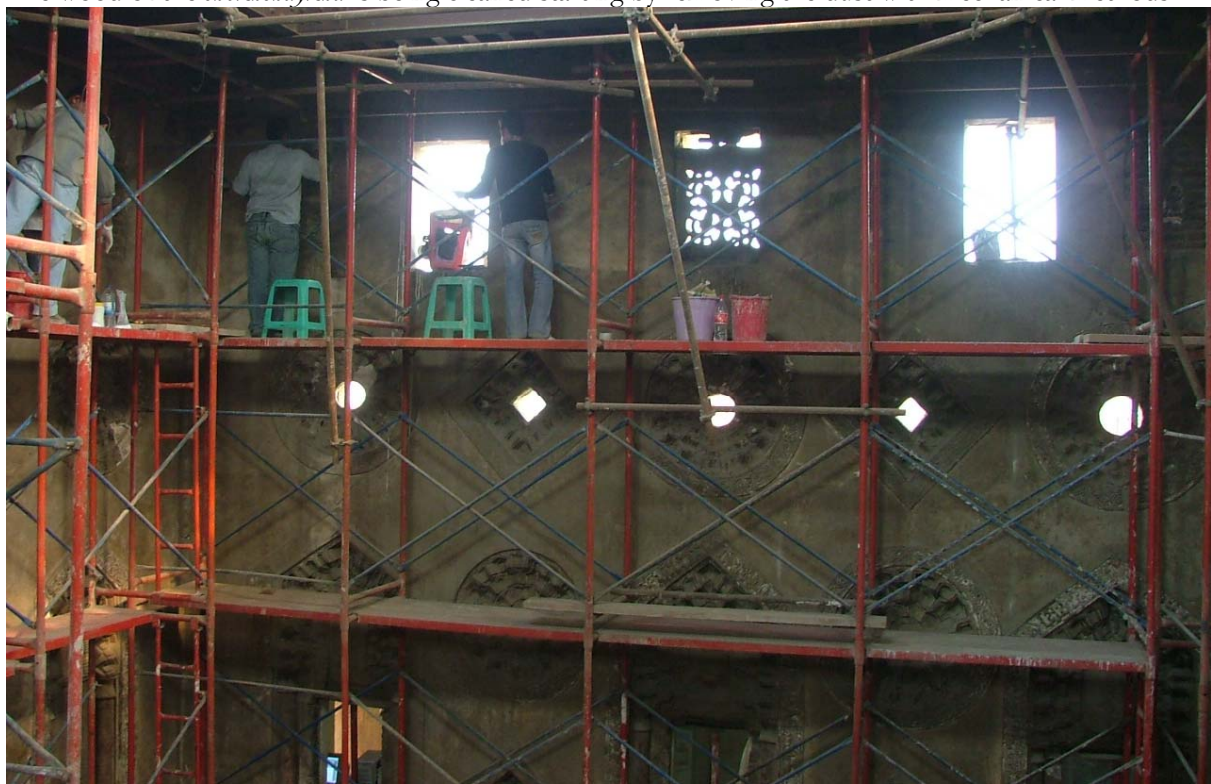
The gypsum plaster was carefully studied and the problems identified. In several areas the plaster is detached from the background brick wall and this needs injection. Also, serious cracks existed and had to be filled. Before the injection activities started, the fine dust covering all the walls was removed with fine brushes. Cleaning tests were also applied to see what kind of method to be applied for cleaning the gypsum. It was decided to use a 2 % ammonium carbonate poultice.

*The mosque courtyard during the testing phase*

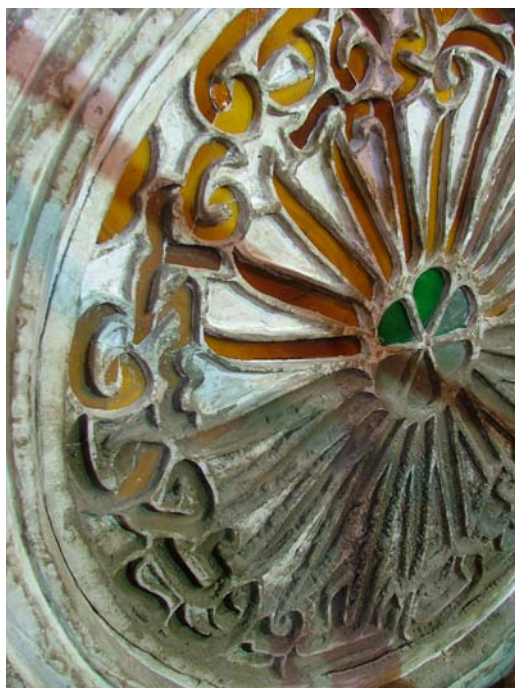
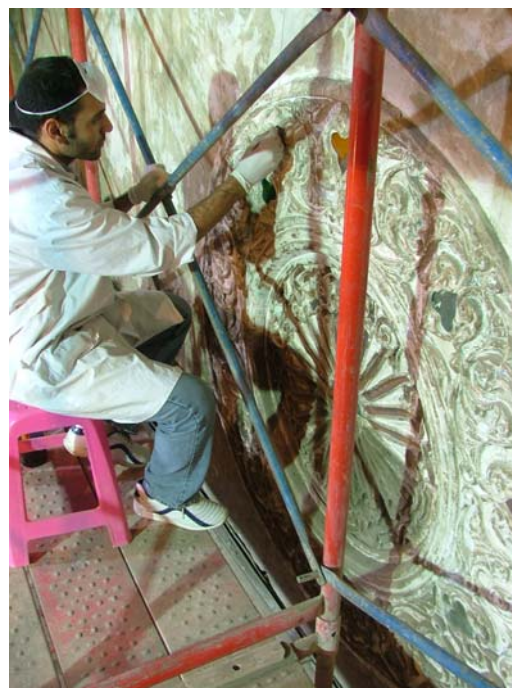
Restoration and conservation activities started also in the East (qibla) iwan. The activities started also with the gypsum plaster cleaning similar to that of the courtyard.

*Activities of removing the fine dust from the decorated gypsum roundel in the qibla iwan*

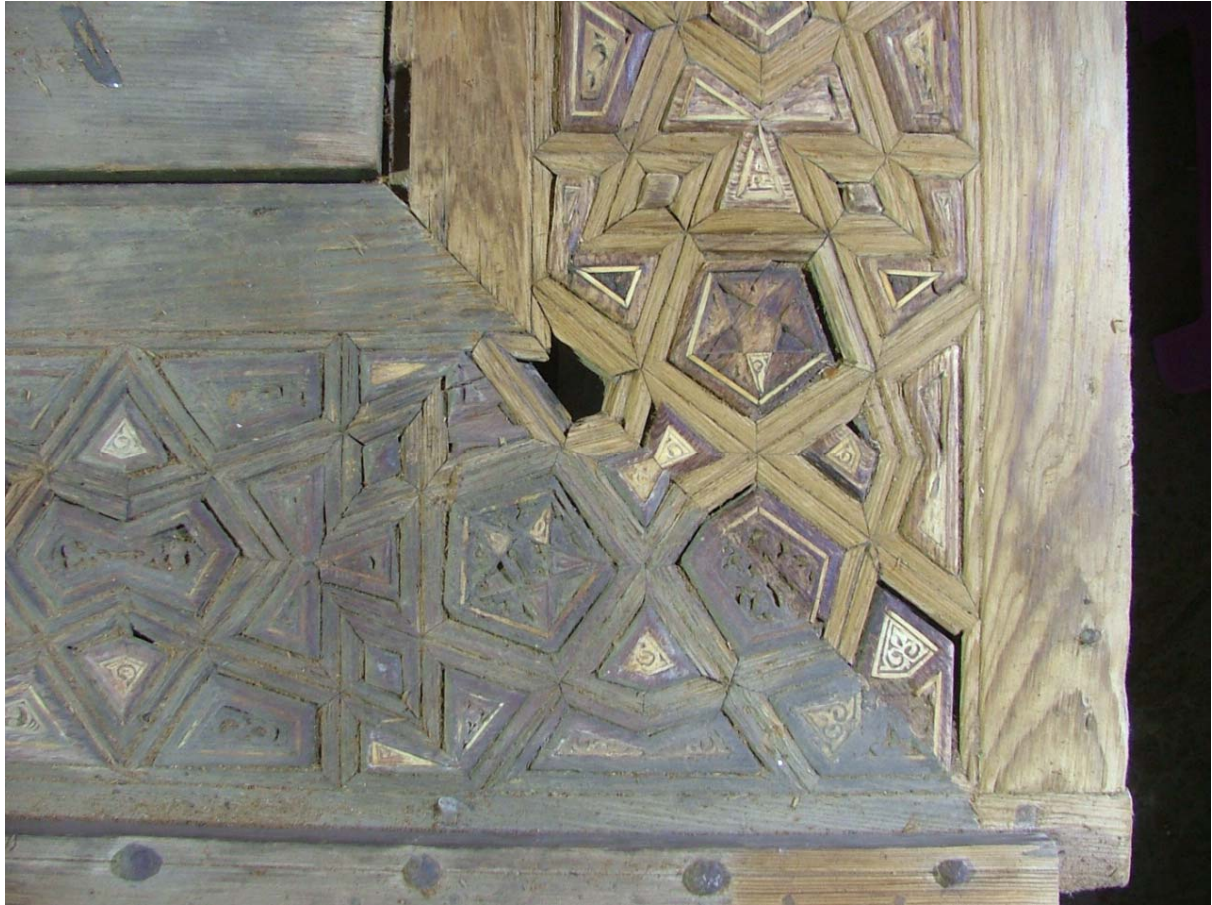
As mentioned in the previous report, the woodwork restoration of doors, windows and shutters is currently in progress and will be proceeding during the following months. In general, depending on the state of conservation of the item, carpentry restoration takes place followed by fine cleaning and conservation of the wooden elements.

*Sample of cleaning the wooden shutters of the niches of the qibla ivan*
