CONSERVATION PROJECT OF THE ASLAM AL-SILAHDAR MOSQUE

**QUARTERLY PROGRESS REPORT**

July - September 2008

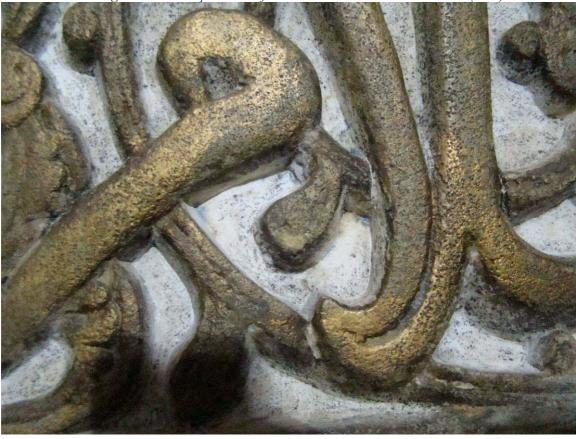
Cleaning the marble inscription band of the entrance to the mausoleum and detail (below)
