CONSERVATION PROJECT OF THE
ASLAM AL-SILAH DAR MOSQUE

QUARTERLY PROGRESS REPORT

October – December 2008

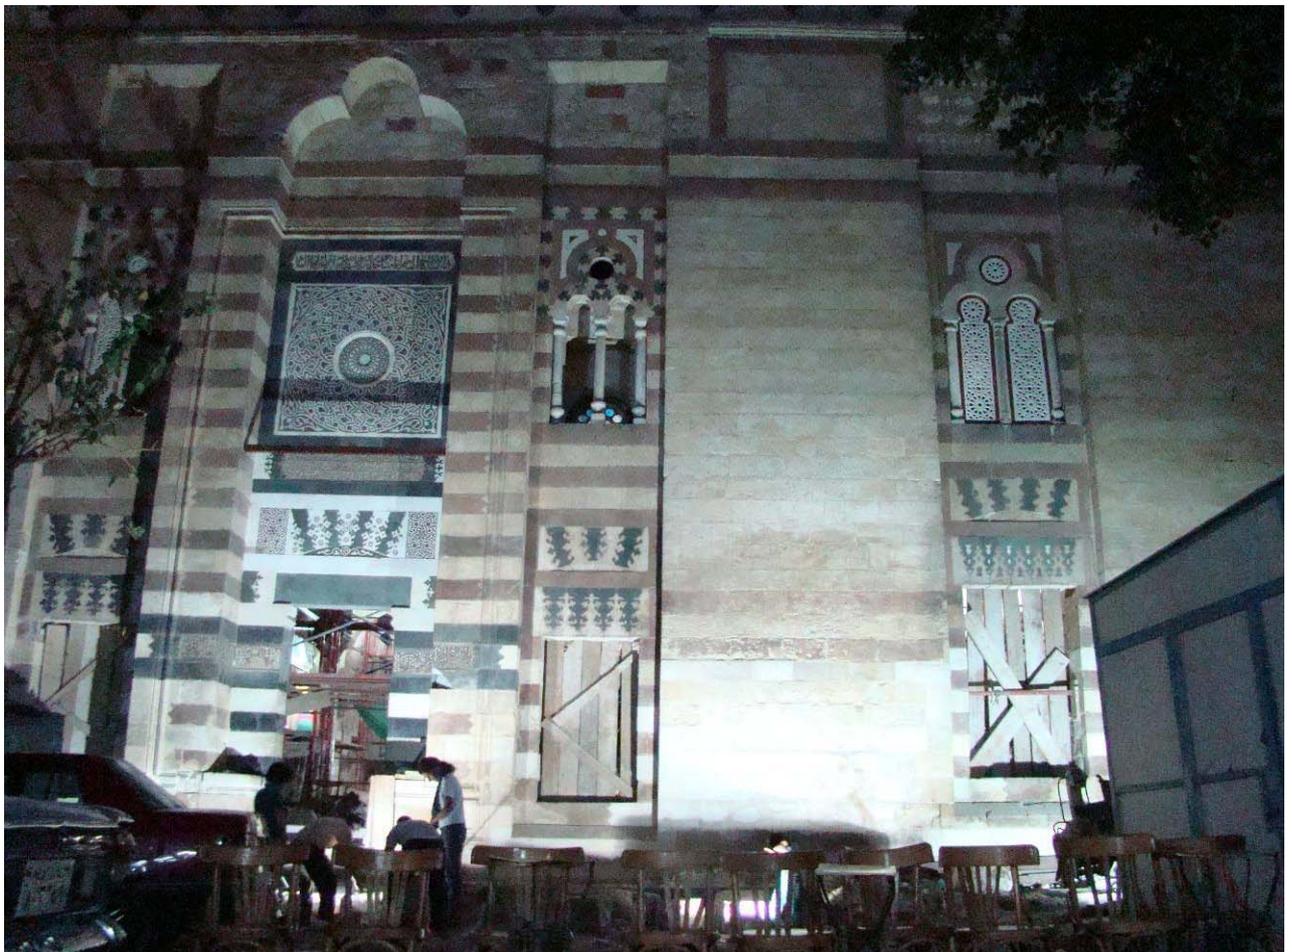
Lighting tests of the facades have also been done in order to begin installation of the exterior lighting units.

View of the main façade during the lighting tests trials

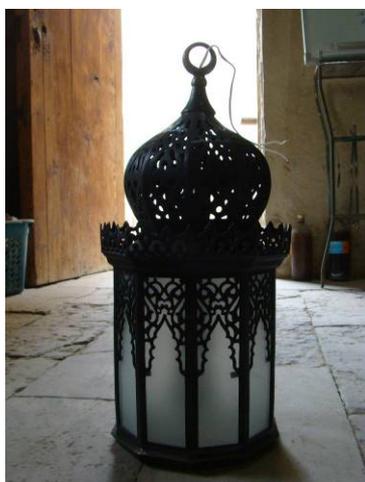
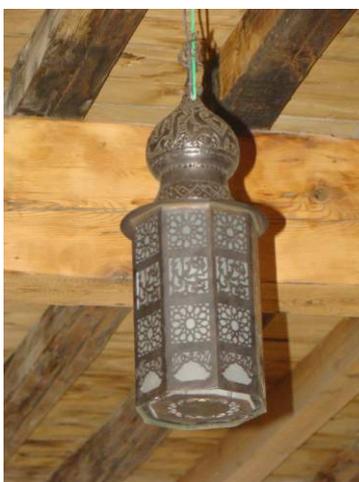
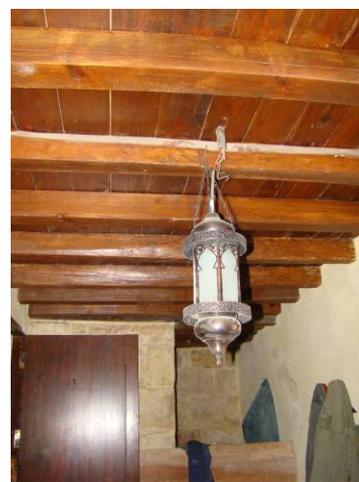
Samples of lighting units

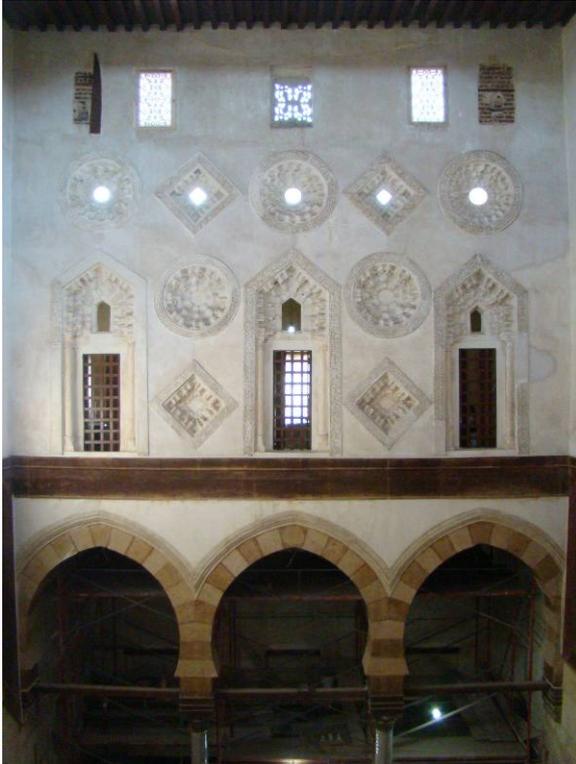
- The scaffoldings were dismantled from all four façades of the mosque courtyard following the finalization of all necessary electric and sound wiring installations. The missing part of the wooden inscription band on the west façade was manufactured and installed. All electric wiring is placed in ducts above the inscription band.
- The cleaning of the four column capitals was finalized.

Northern courtyard façade

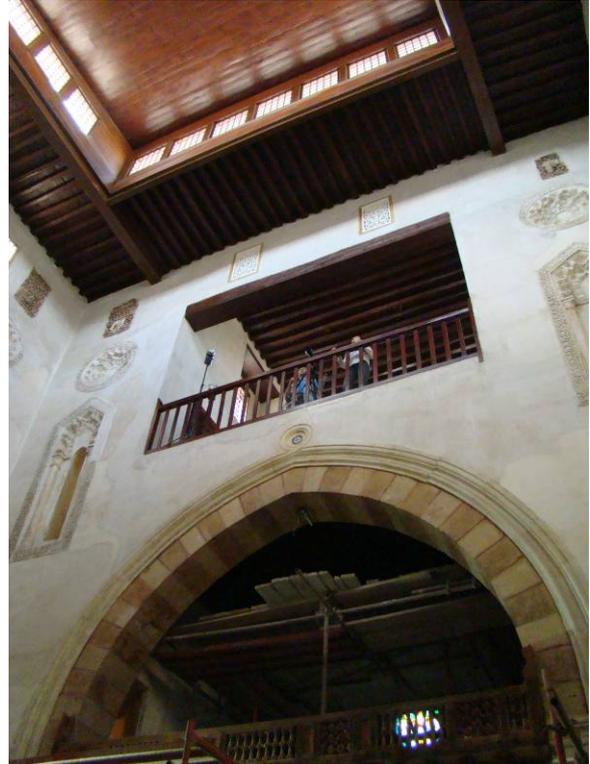
Southern courtyard façade

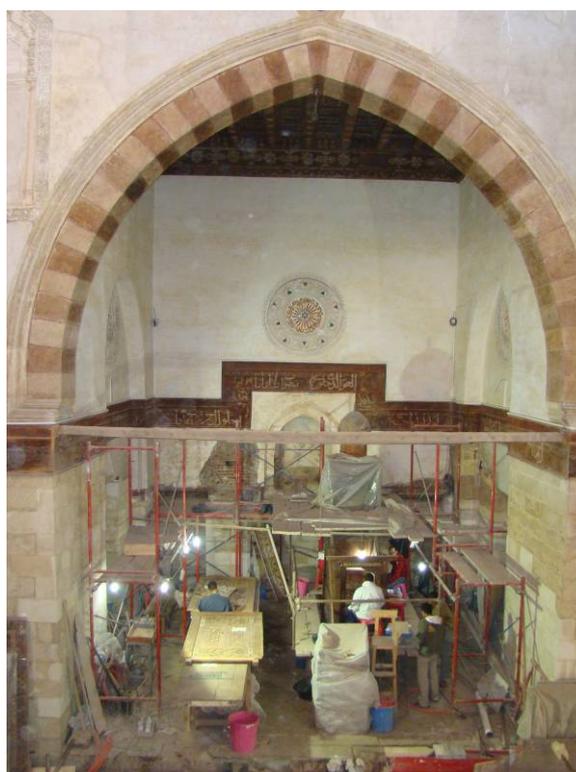
Scaffoldings were dismantled in the Qibla iwan upon the finalization of the restoration of the painted wooden ceiling. The same case of blue traces that were found on the gypsum roundel decorations were found on the three facades of the iwan. After identifying the pattern of the color, the retouch took place and the scaffoldings were dismantled.

Qibla Iwan after partial scaffolding dismantling

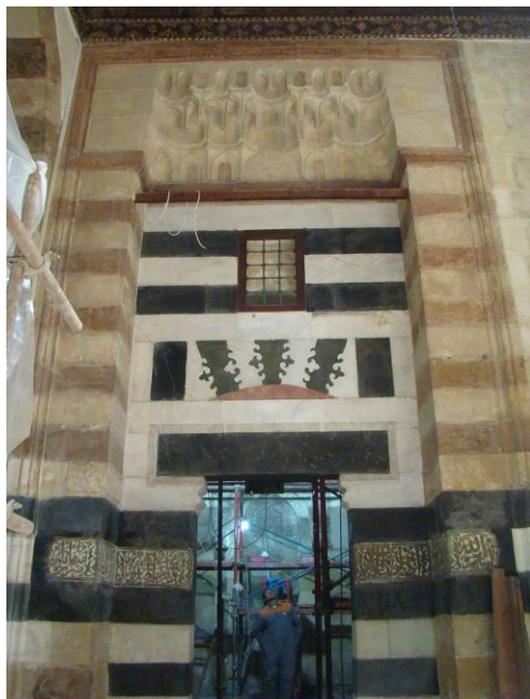
Mausoleum façade after cleaning & restoration

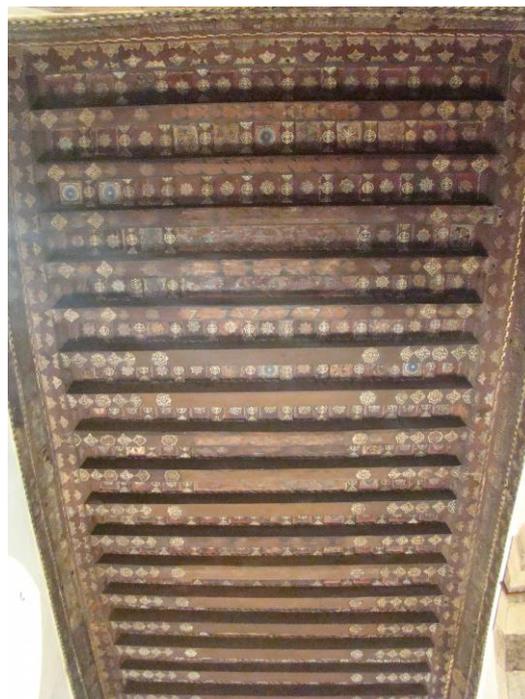
Cleaning of the south ceiling was finalized. The new wooden beams installed during the period of the *Comité* which did not have any decorations were painted in order to unify the colors of the whole ceiling. The facades were also finalized and the scaffoldings were dismantled. The two side windows of the iwan contained small painted ceilings. The few traces of color that remained were consolidated and conserved. Stone replacement of the damaged tiles took place.

View of the South iwan ceiling after restoration

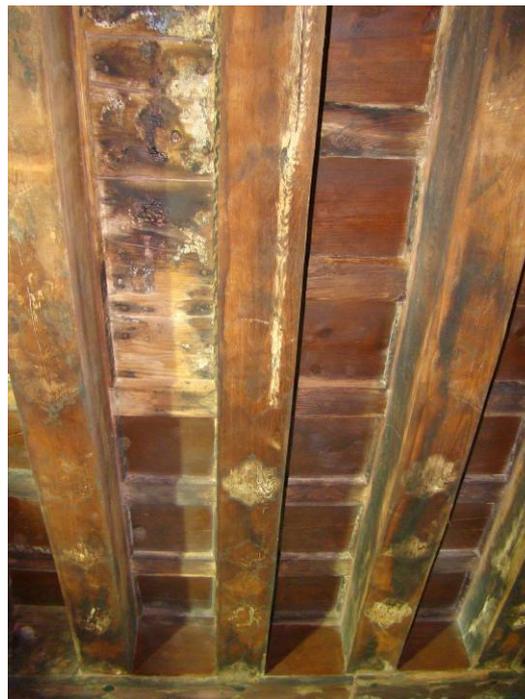
South iwan Ceiling during cleaning

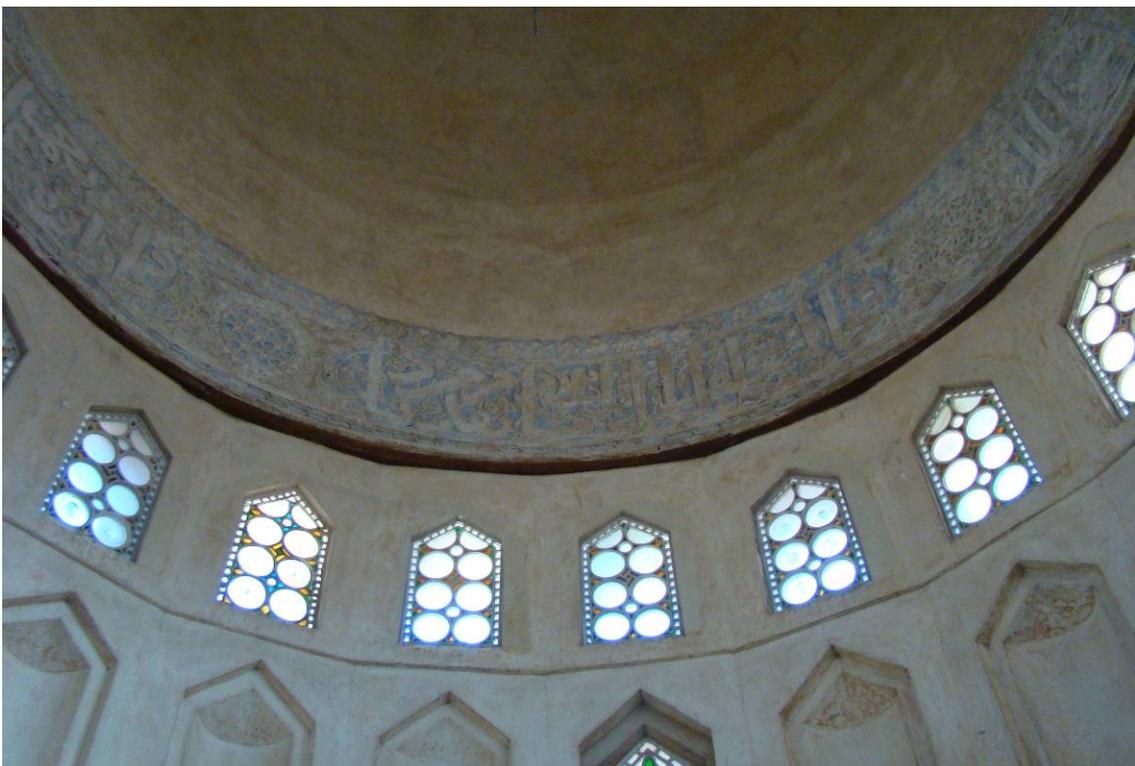
Consolidation and fixation of the detached parts of the plaster is finished and re-touch of the blue color around the four gypsum roundels was also finalized, as similar traces to those in the mosque were found on the four facades of the mausoleum. The missing inner gypsum window on the southern façade was manufactured in place.

The dome inscription band after cleaning

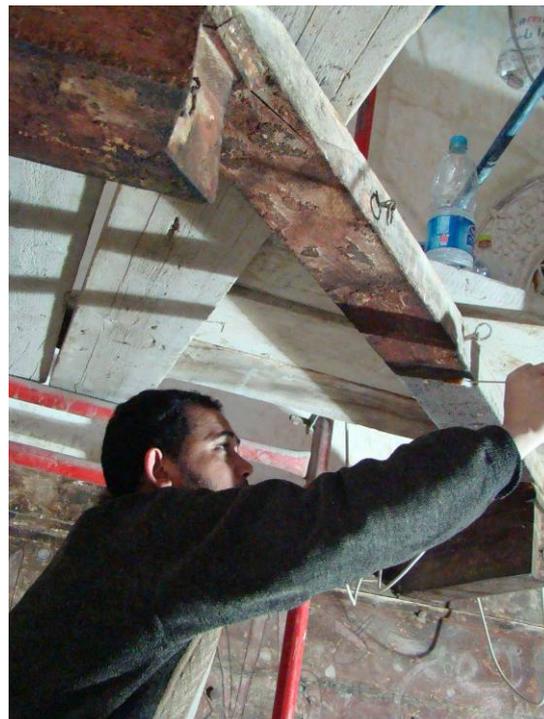
red paint was finalized and allowed us to identify the Qur'anic verse. Also the carpentry work was finalized. Some re-touch activities are currently in progress as well as the cleaning and consolidation of the wooden octagon on which traces of colored decoration were found. The mausoleum scaffoldings were dismantled till the level of the inscription band.

Cleaning and of the wooden octagon

Complete the cleaning and consolidation of the wooden inscription band and octagon. Finalize the cleaning of the stucco on the mihrab. Manufacture of the new bases for the marble columns and install them. Plastering of the lower area and finalizing tile replacement.

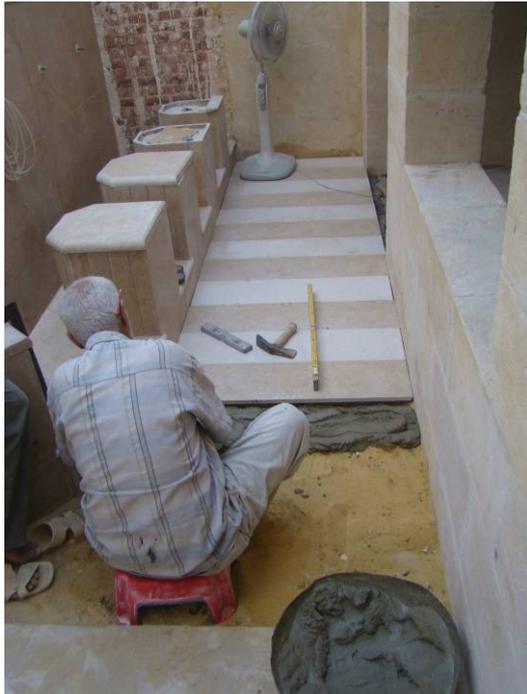
Marble tiling of the ablution area

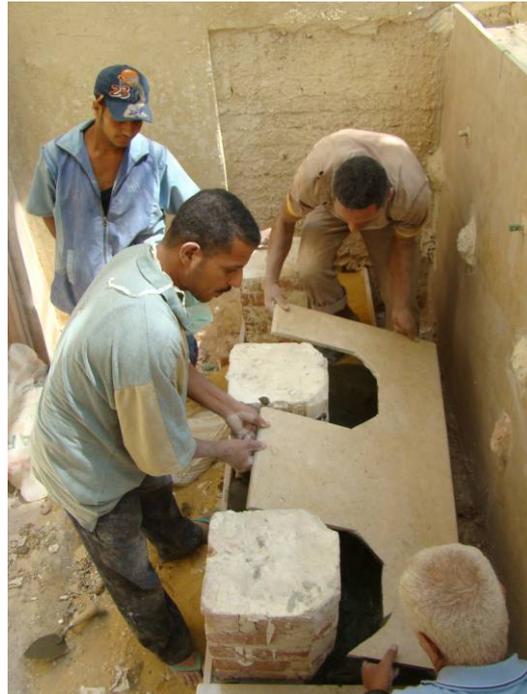
Installation of marble seats

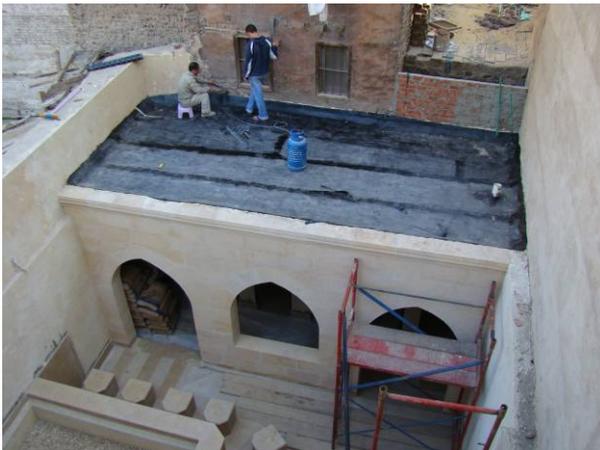
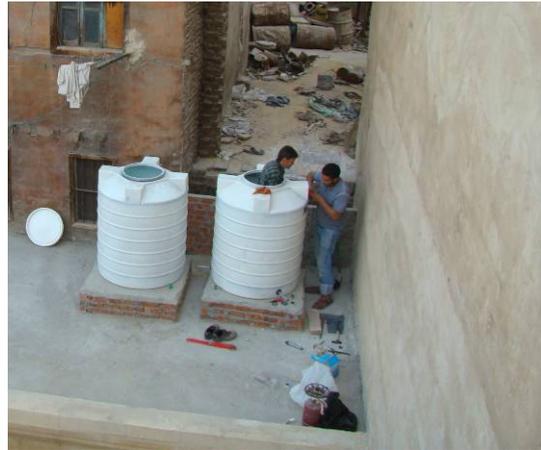
All major construction electric and sanitary works in the ablution area were completed. Two water tanks were installed on the toilettes roofs after their insulation. A wooden structure was built around them as a protection matter as well as an esthetic aspect. The plaster of vestibule leading to the ablution area was cleaned. Missing wooden parts of the inscription band were completed. The wooden roofing of the vestibule was cleaned and painted. The entrance and vestibule are currently being tiled.

*Insulation of the ablution roof and view of the water tanks during installation
Cleaning of the old plaster at the western entrance portal and painting of the wooden ceiling*

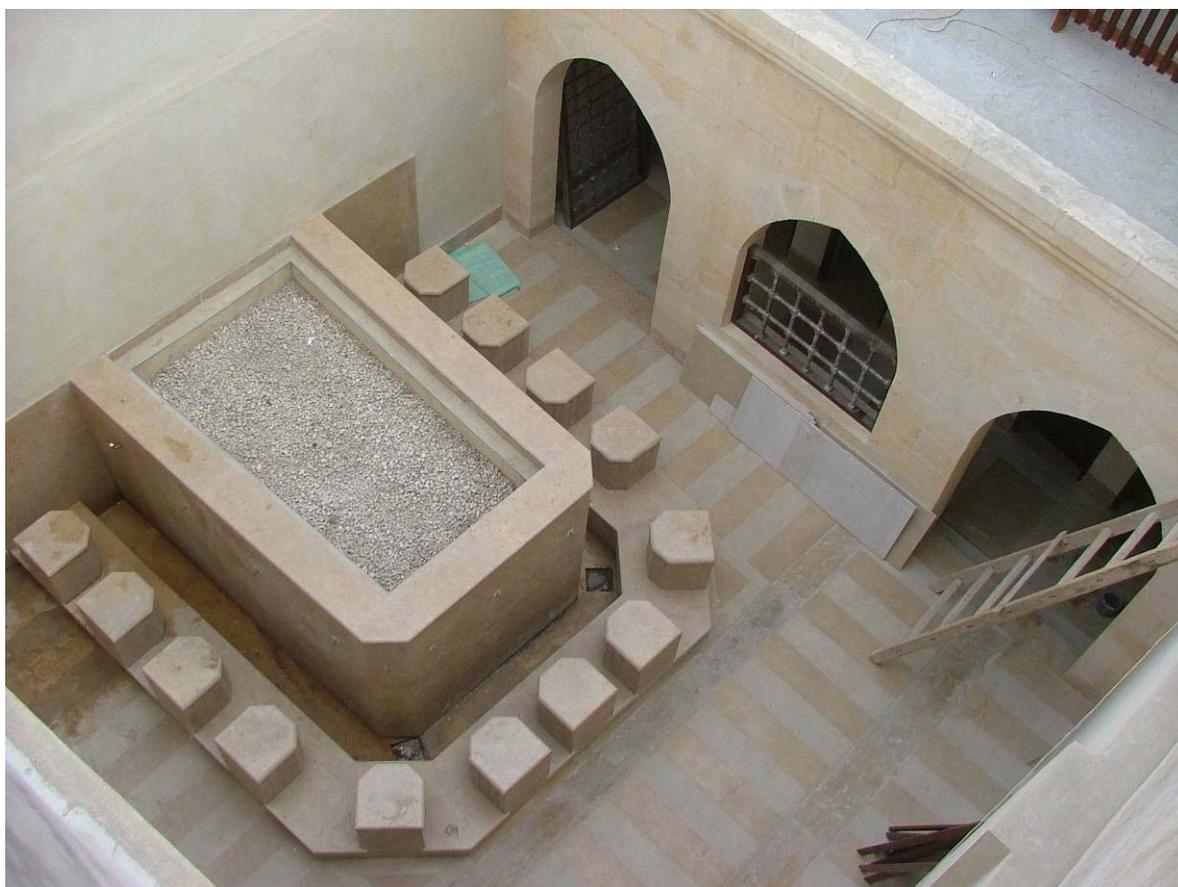
View of the ablution area
