# **ARCHITECTURAL CONSERVATION RED MONASTERY FALL 2016**

## **THE TOWER**

**TECHNICAL REPORT**

**14 December, 2016**

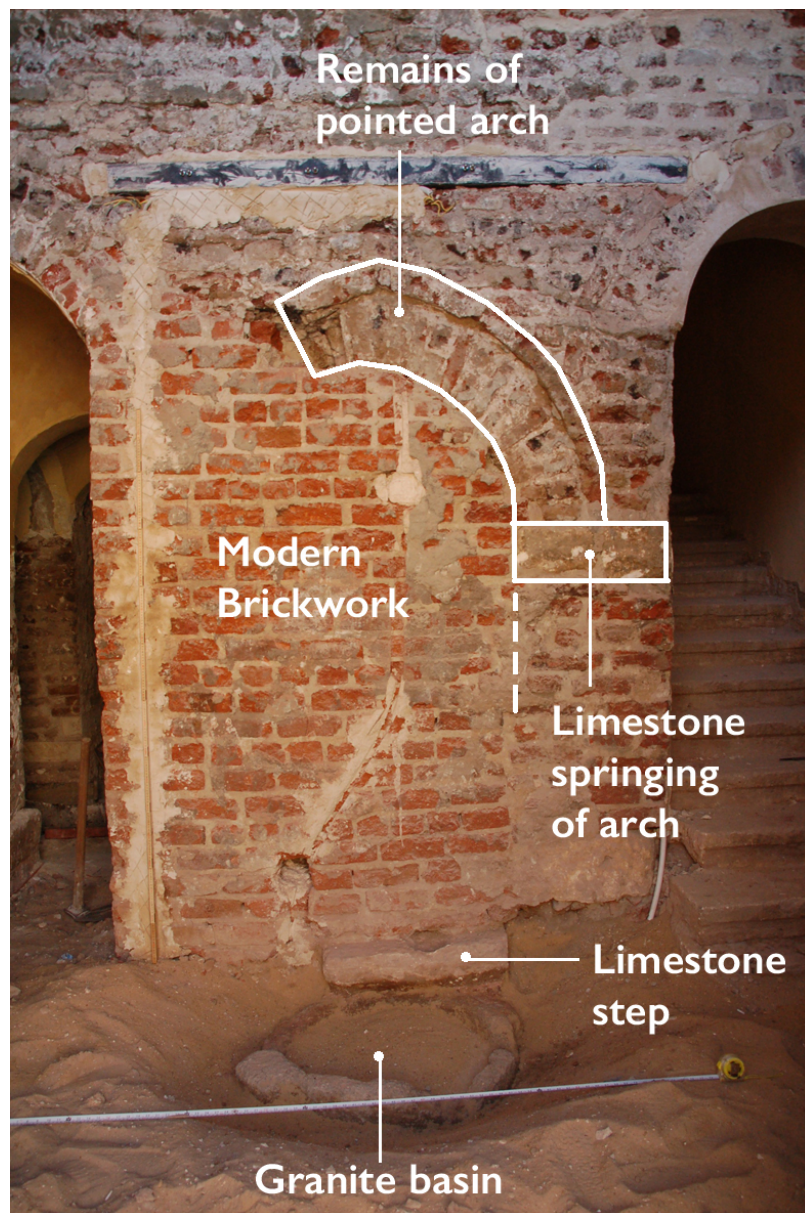
After removing cement render in the entrance area of the tower, the original opening for access to the well at ground floor level was discovered. This had a pointed arch, half of which had survived the rebuilding of the masonry of the well when it was converted into a toilet in the 1980s. By measurement, the width of the opening size was ascertained to be 88 cm. Remains of a white plaster survived on the underside of the arch. As noted in the report of the last campaign, a circular granite basin was uncovered in front of this opening set into the floor of the entrance area of the tower, with a limestone step up into the arched opening (see below for treatment). It is likely that this opening was not a door, but a deep window giving direct access to the well from the entrance area. An enigmatic circular ceramic pipe (20 cm in diameter) was also found embedded vertically on the central axis of the well within the remaining section of the elliptical vault over the entrance area.

View showing the relationship between the granite basin, limestone step and remains of arch above blocked opening into well

The pointed arch of the opening into the well inside the entrance area was restored with re-used old bricks springing from a new limestone impost block. The existing modern brickwork beneath the arch was only cut back in the area immediately below the arch to a depth of 25 cm to avoid further structural problems in this area while still expressing the form of the original opening. The brickwork of the arch itself (both original and restored) was left exposed.

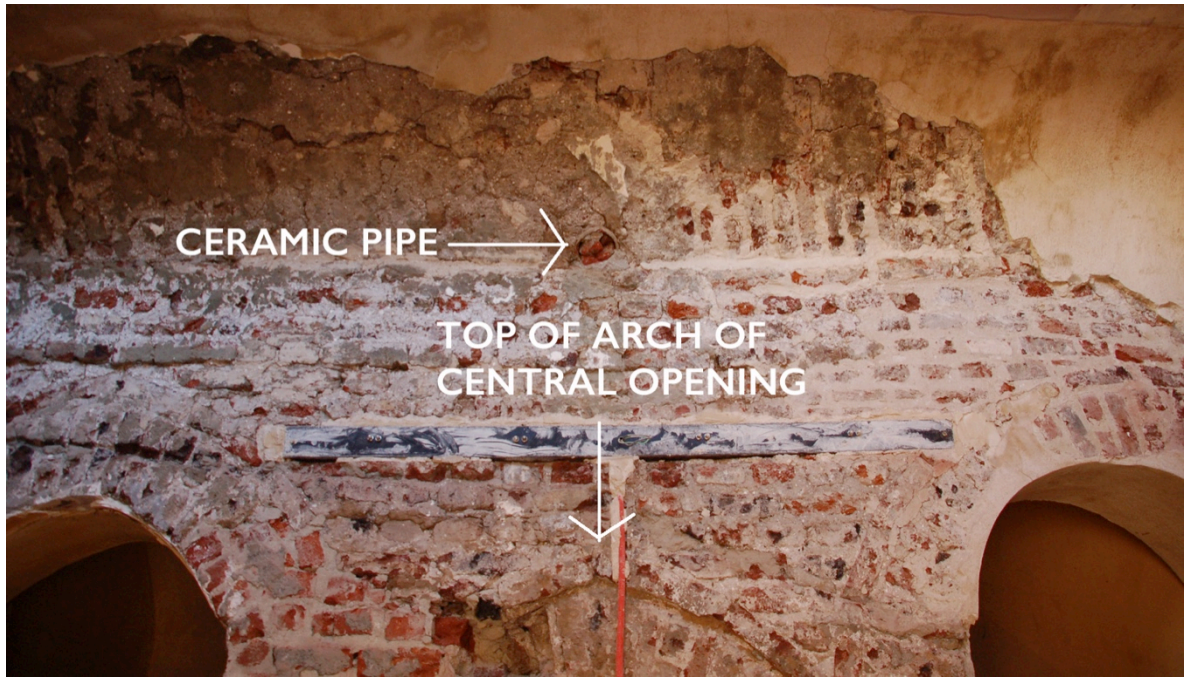
View of location of embedded ceramic pipe in elliptical arch over entrance area

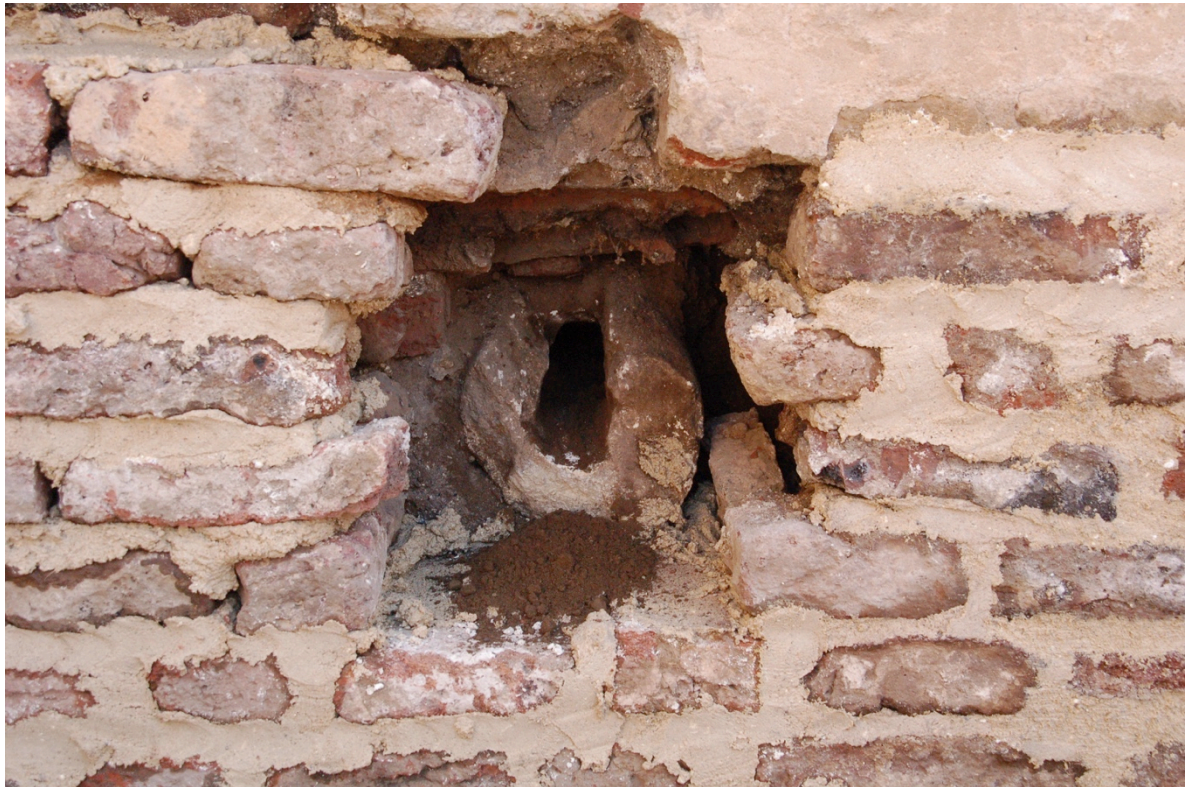
Limestone drainage channel in west face of tower

A new limestone drainage channel was installed to the right of the door indicating the line of the original limestone drainage channel set within the west wall. The new channel was inserted in such a way as to allow for natural ventilation to aerate the undercroft of the stair from the exterior.

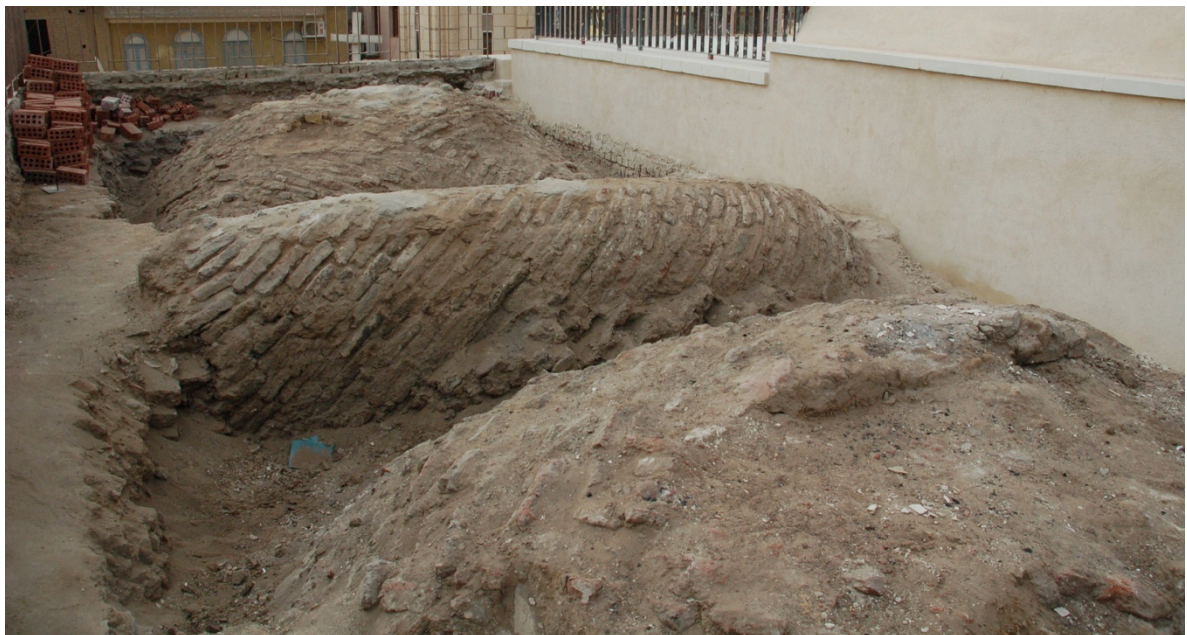
Following clearance, the two domes with ‘sailor’ vaults, located to either side of an inclined elliptical vault, were fully revealed. All were built from a mixture of fired bricks and mud bricks laid with a silt mortar that had been badly attacked by termites. The domes and vault were all in a fragile condition. It was also noted that some sections of wall supporting the south side of the northern dome were also built with mud brick, possibly indicative of earlier repairs carried out when the building was converted to domestic use. The dome to the north is slightly smaller than that to the south, and was severely damaged by later structures that cut into its structure. The elliptical vault was laid with an inclination towards the west, and had rounded ends. The character of the brickwork would suggest that these structures were all part of a single build on the roof, possibly in the late 17<sup>th</sup> century or early 18<sup>th</sup> century (by correlation with the now demolished dome over the *khurus* of the main church which has a *terminus ante quem* of 1737, the date of the visit by Richard Pococke to the Monastery).

View of domes and barrel vault from northeast after clearance

The corners of the domes were built up over new brick arches designed to take the stress off these important but weakened parts of the original structure. Then a series of brick courses were laid cantilevering in towards the domes' perimeter from the surrounding walls. This brickwork was constructed with a fall to external rainwater spouts on the east side of the terrace. Facing walls to the damaged interior edge of the parapet were built with new openings for four galvanised steel rainwater spouts projecting 40 cm from the outer face of the building. Three different levels were introduced onto the terrace to minimise the amount of new brickwork required to achieve the required falls across the width of the roof. The uppermost level included the south dome and elliptical vault, with a step down to a lower level around the south, east and west sides of the north dome. Two further steps down on the north side of the north dome bring the level down to a final floor finish equivalent to the viewing deck on the north side of the stair enclosure. The steps were emphasized with re-used limestone stair treads to indicate the best route to avoid treading on the domes and barrel vault.

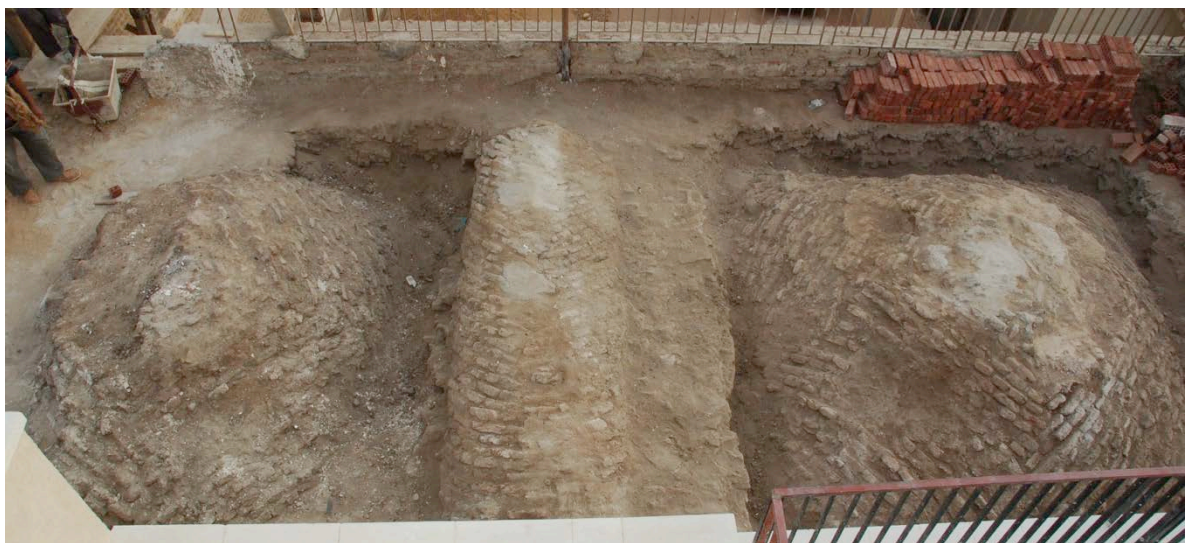
View of domes and barrel vault from above after clearance

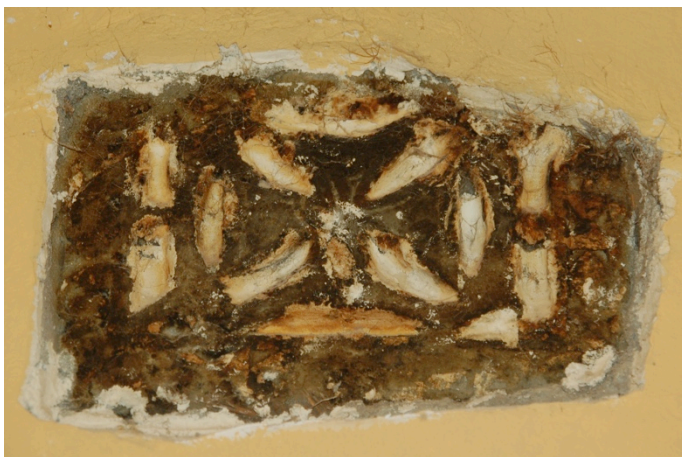
At the eastern end of the corridor at first floor level one limestone block, carved with a Maltese cross was set into the wall at high level and was partially covered by the apex of the elliptical barrel vault over this space. The piece is clearly in a secondary context, but it closely resembles other examples that were used in the decoration of the trilobe portal within the nave. The block has been damaged by an attempt to make the form of the cross more legible by scratching.

Carved limestone block in first floor corridor (left) and parallel from the trilobe portal in the nave

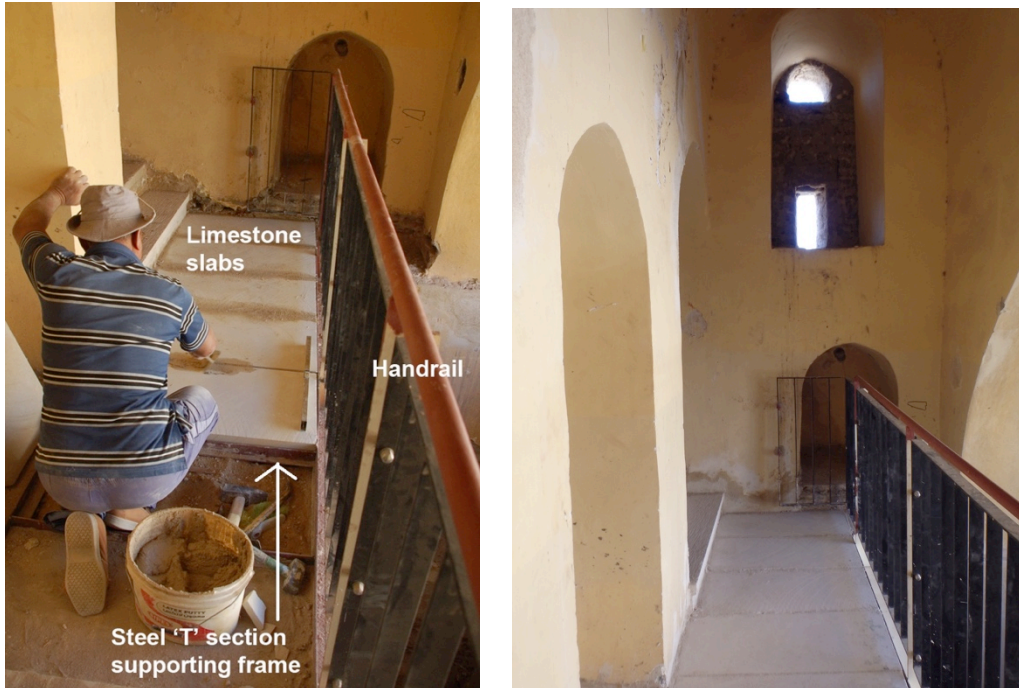
The balcony overlooking the entrance area to the tower was created in 1912 when the original elliptical east-west vault over this space was cut in half. The remaining half vault was inadequately supported, and structural protection was provided to the edge of the balcony last season by capping the remaining masonry of the vault horizontally with a steel channel 30 cm deep supported by steel plates inserted into the walls at either end of the

vault. During the autumn campaign, the balcony was levelled with a secondary steel chassis that provided support not only for a new steel balustrade along the edge of the balcony but also a new stone pavement above the balcony. The stones (90 cm x 45 cm x 10 cm on average) were set within a subsidiary frame made of steel 'T' sections that prevented direct loading being imposed on the already weakened vault below.

The mezzanine balcony during (left) and after (right) works

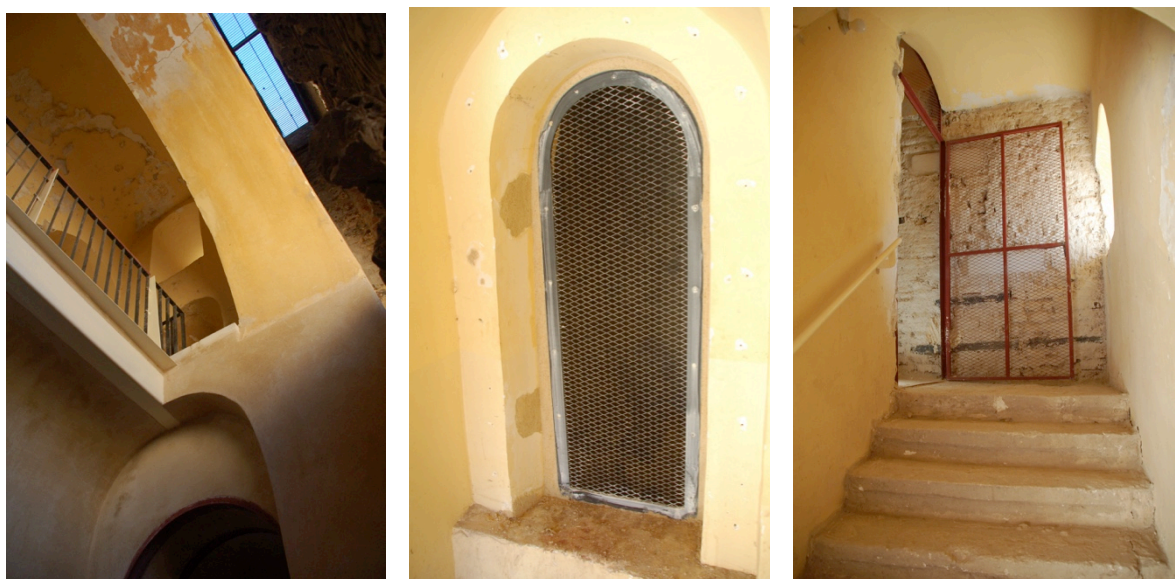
General view of balcony looking up (left); typical steel frame window with bird mesh deterrent (center) and steel gate on staircase with bird mesh (right)

Windows into the east end of the balcony and into the well were protected by an anti-bird mesh, set in steel frames. A new lightweight steel door frame with mesh was placed on the landing above the balcony to prevent the access of birds to the upper level of the tower.

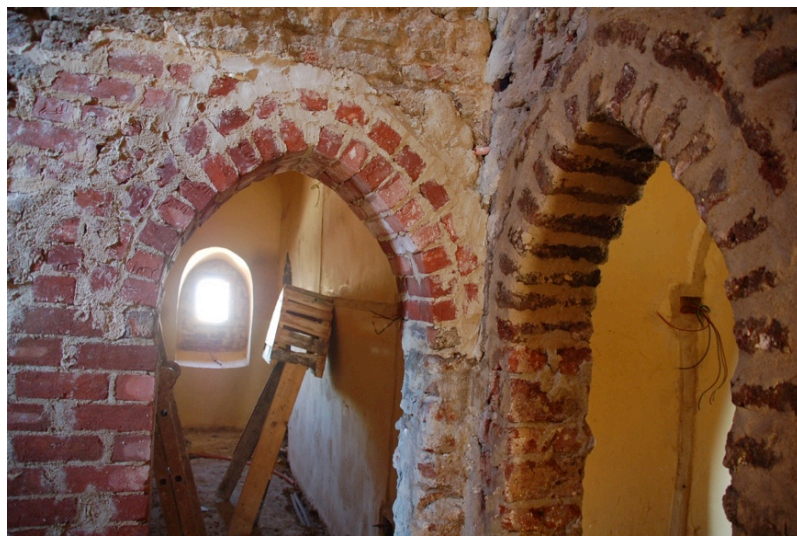
The doors to the first floor after masonry consolidation following traces of the original arches

The two door openings into the rooms at first floor level were returned to their original size and shape following traces discovered after the removal of the thick cement render that surrounded them. They had at some point been widened, incurring damage to their jambs and tops that originally took the form of pointed arches. Limestone thresholds were also fitted on these two doors. Treated pitch pine doors were installed here and at two other locations on the first floor, following a traditional design with top and bottom pivots.

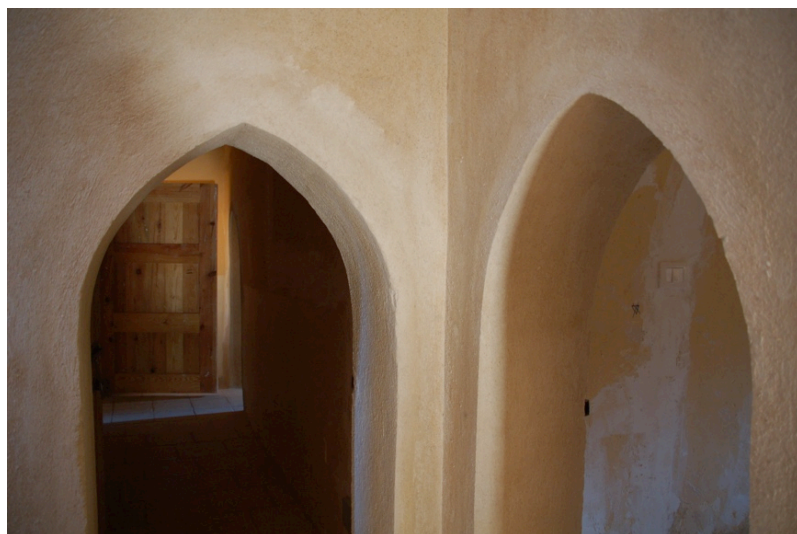
The doors to the first floor after finishing works

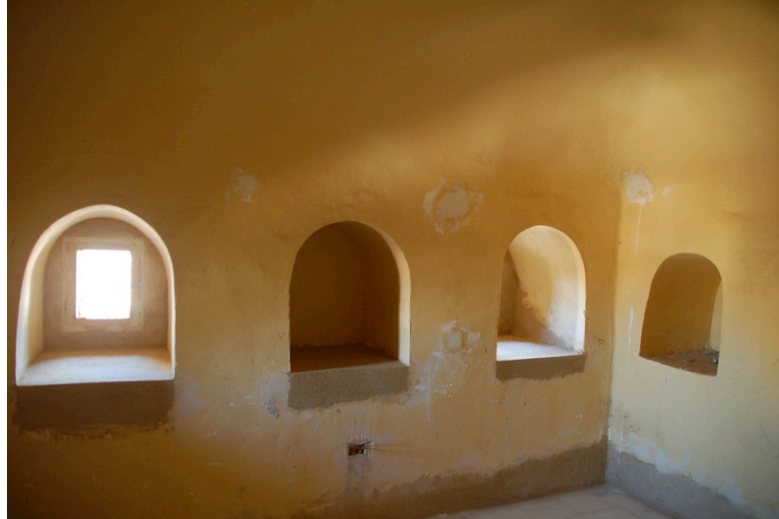
Treatment of windows and niches on first floor

Eleven window openings were fitted with new treated pitch pine opening windows set within painted steel angle frames. The windows were fitted externally with a bird deterrent mesh and have been left without glazing while the building continues to dry out. The gypsum sills to the windows and niches of the rooms on the first floor were levelled with lime plaster to increase their durability.

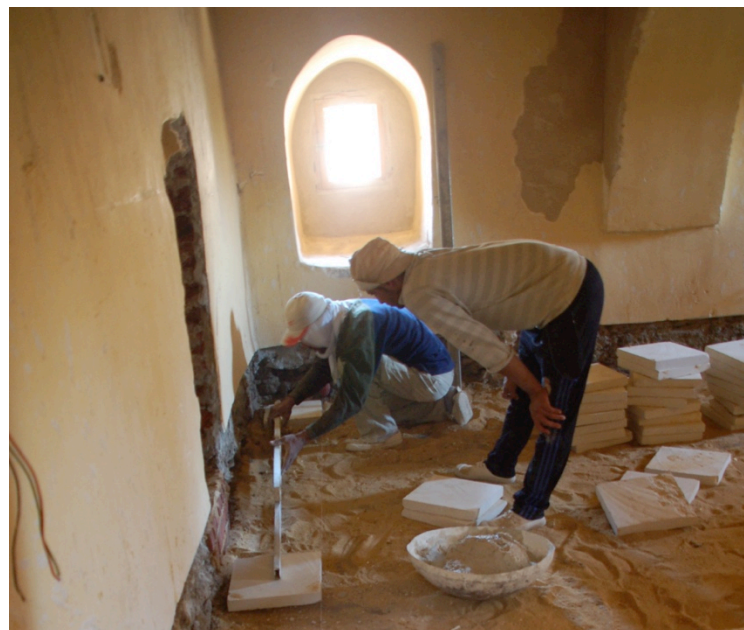
Tiling in progress on first floor

Certain areas of cement and gypsum plaster on the walls were removed and the exposed brickwork re-plastered with a lime plaster. Owing to the strength of the cement render applied, however, it was not removed from all locations to avoid extreme damage to the underlying brick masonry. All the floors were re-tiled using a 4 cm thick x 30 cm square limestone floor tile. Electrical supply to new lighting and power fixtures was provided in subsurface conduit with 35mm thermoplastic cables from a new sub-distribution board on the east wall of the well beside the staircase.

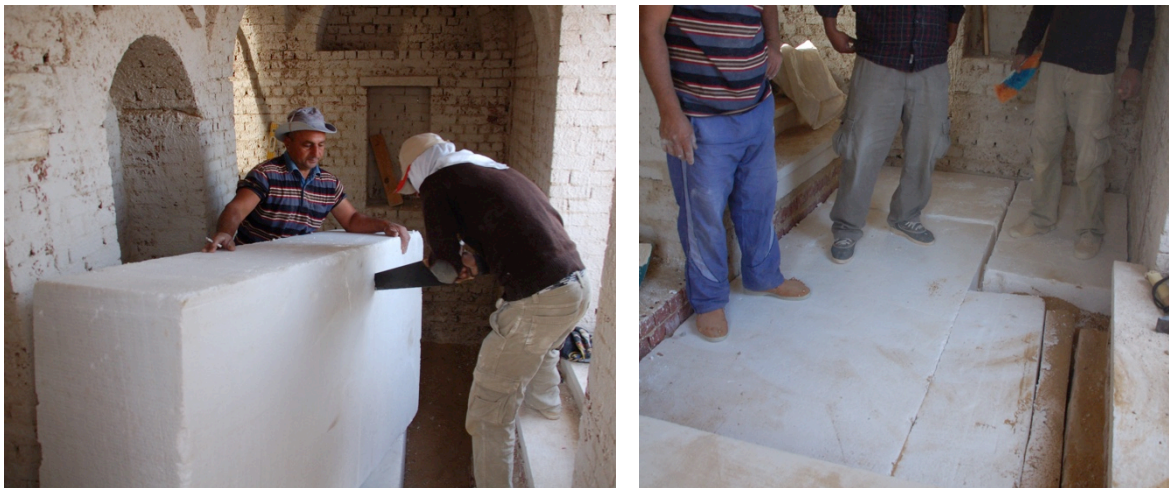
Installation of white foam block on stair landing to reduce loading

The bricks used for the staircase enclosure were 20 x 10 x 7 cm with holes to reduce the weight of the structure. Relieving arches and niches were used in a number of locations, also to reduce the imposed loadings, and the build up of the lower landing was made over a white foam block infill for the same reasons. One original limestone corner impost block, found in the tower, was re-used in the structure. A timber pulley emplacement, also found in the tower, was built into the well to indicate its original use.

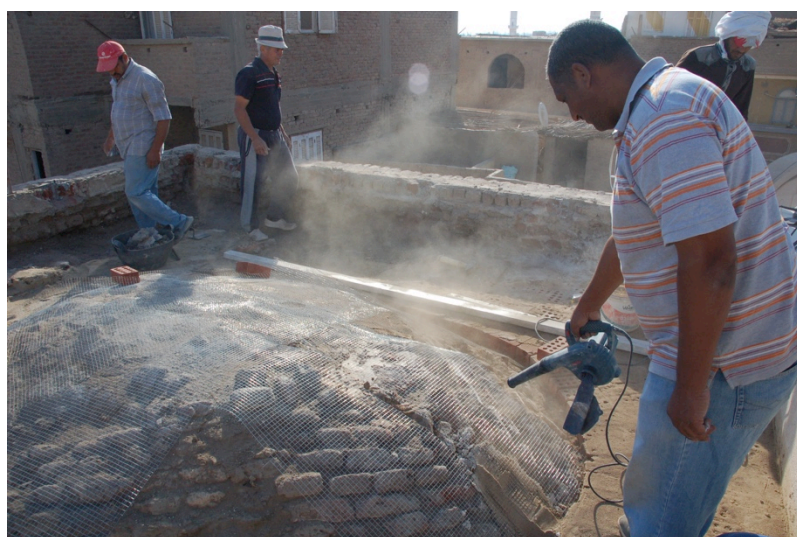
Cleaning surfaces of the vaults

The surfaces of the domes were first cleaned off and a treated with a dilute solution of 'Addibond 65' – a liquid Poly Vinyl Acetate [PVA] coating suitable for use as a general purpose building adhesive, tack coat for plastering / renders and for the priming of porous surfaces. Following this, the exposed upper surfaces of the vaults were covered with a 1 cm x 1 cm square galvanised steel mesh reinforcement. Then lime plaster was applied in two coats – a tack coat followed by a finishing coat.

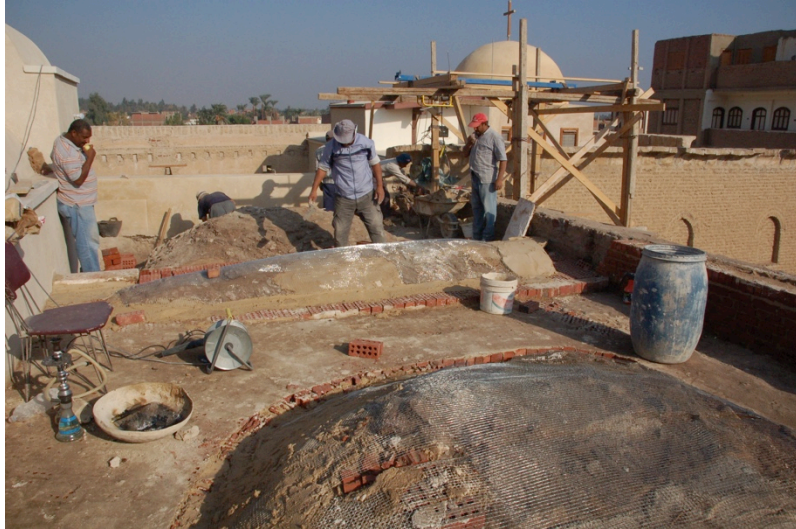
Covering the exposed areas with galvanised mesh

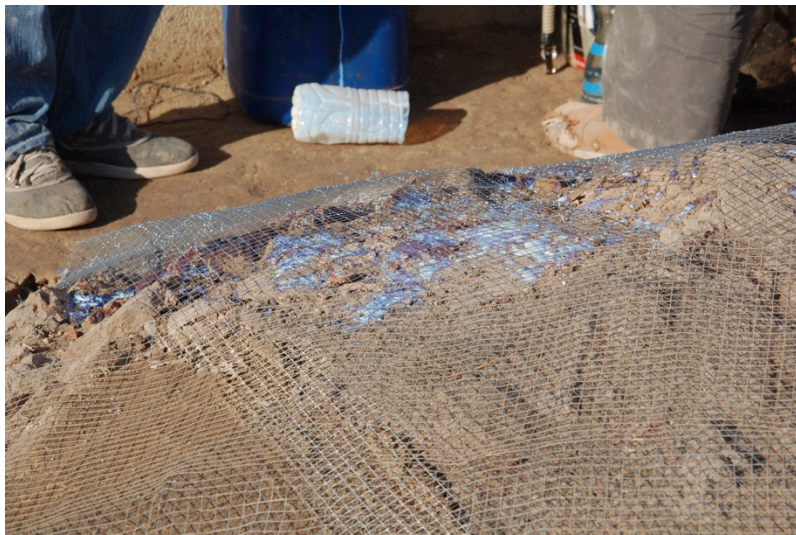
Application of dilute 'Addibond' consolidant

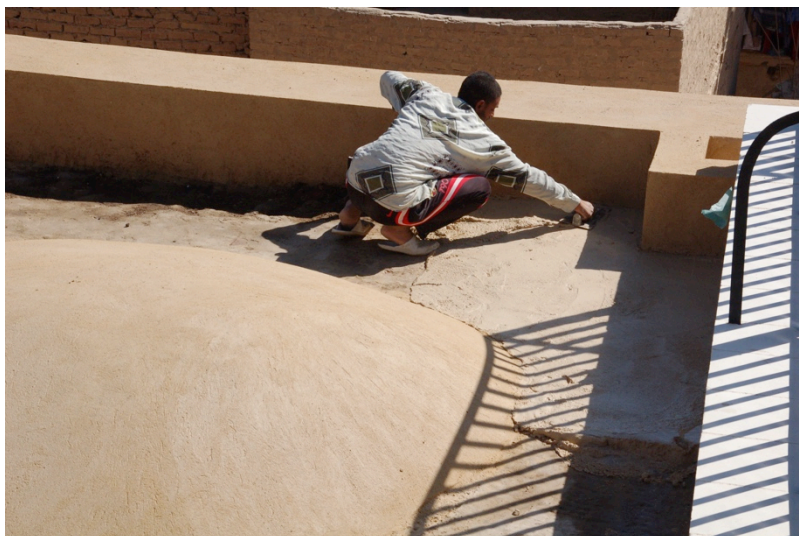
Plastering the domes and roof surface

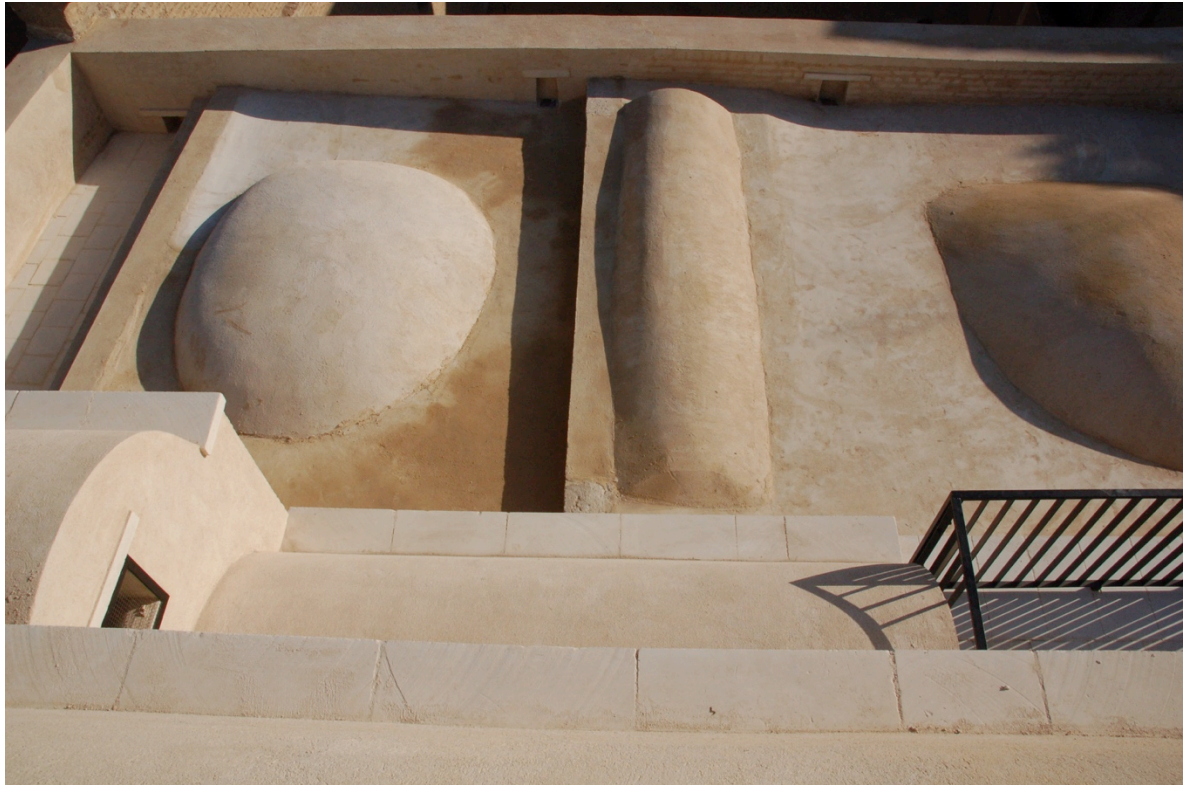
View of completed intervention on lower area of roof showing vaults plastered to fall to new external rainwater spouts

The two domes and elliptical barrel vault on the lower terrace were seriously deteriorated, partly as a result of human activity and partly due to a high concentration of termites due to the use of a silt mortar and the presence of quantities of organic fill. The underside of the domes and vaults was covered with a very thick and dense cement render, cracked in places, which could not be removed without risking the collapse of the structures. The in situ conservation of these features was a serious challenge. A further key objective was to provide adequate falls across the roof to ensure the successful disposal of rainwater on the eastern side of the roof.

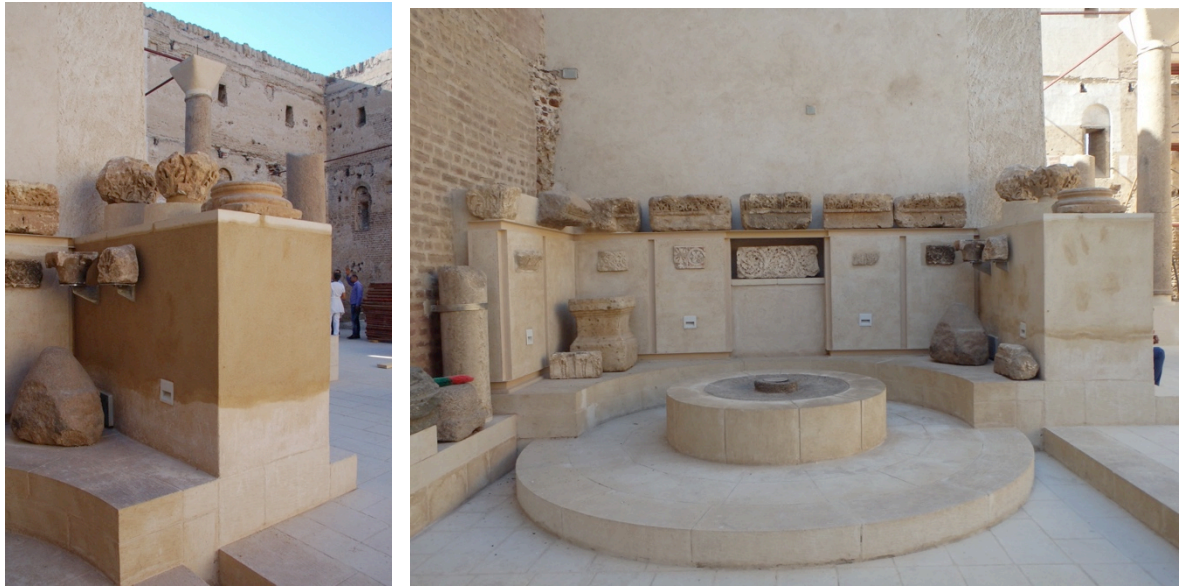
New section of lapidarium under construction (left) and completed additions to lapidarium (right)

The existing modern wall on the north side of the lapidarium in the south hall of the church was built up to a height matching the horizon level of the stands for the limestone cornice blocks. Three newly discovered carved limestone fragments were then incorporated into the display supported on stainless steel mounting brackets. The wall was then plastered, and column fragments re-installed at a height where it would be more difficult for them to be damaged. Stone fragments on the south wall of the display were also secured in a more permanent manner using stainless steel fixings to prevent them becoming dislodged from their positions and falling.
