RED MONASTERY CONSERVATION PROJECT 2015

TECHNICAL REPORT 3: 26th November 2015

1 TECHNICAL REPORT ON SITE ACTIVITIES: SEPT 28 – NOV 26

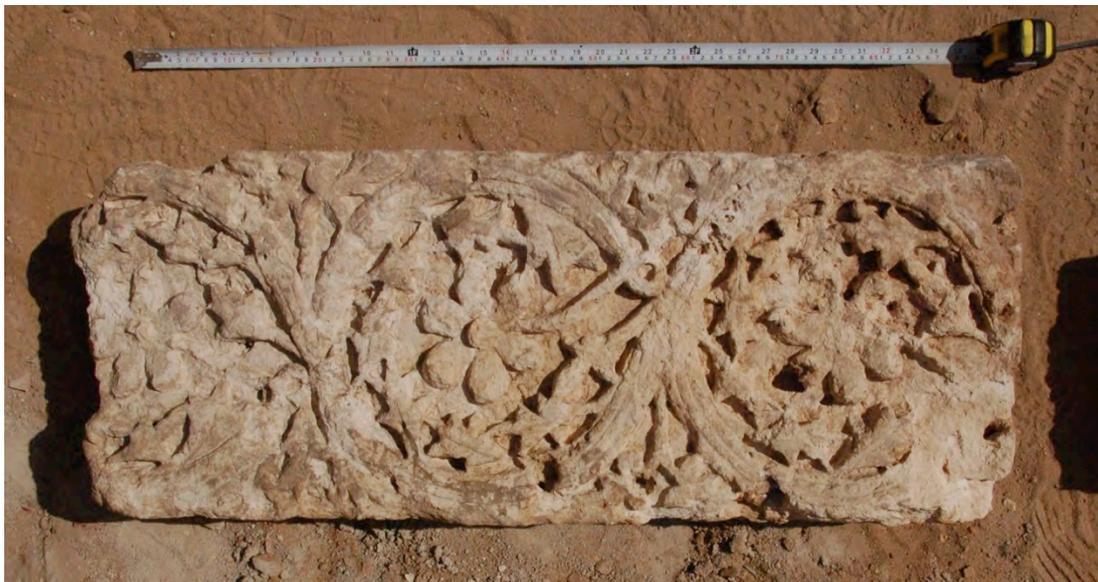
Frieze block with acanthus scroll and central rosettes [92cm long x 37cm high x 16cm deep]

The blocks were cleaned and included in the new display of fragments near the well. [see below, page 5]

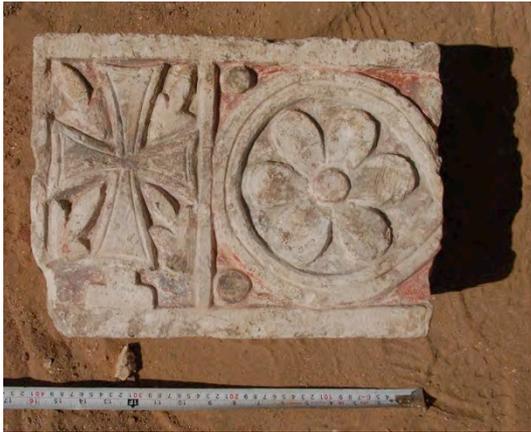
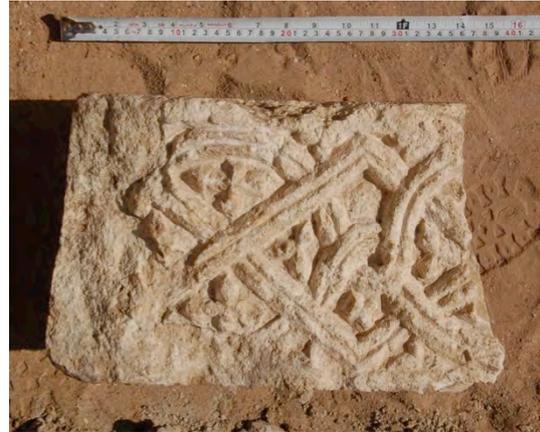
Left: block with carved cross and rosette, with traces of blue and red paint [34cm long x 25cm high x 20cm deep]. Right: block with entrelac and lozenge motif [34cm long x 21cm high x 20cm deep]

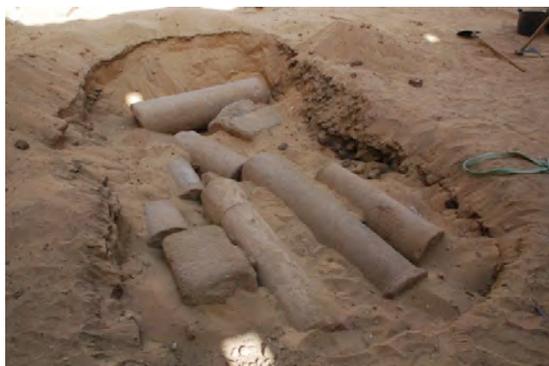
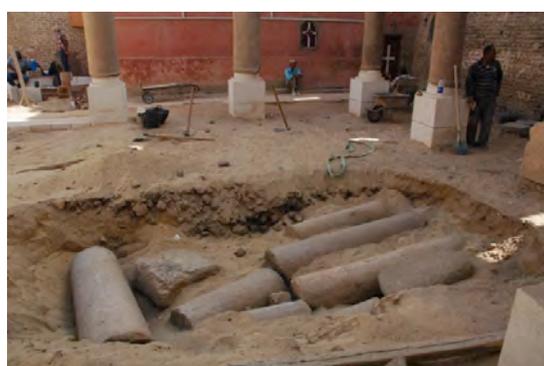
Photos showing site of reburial

[B] A further element of work related to the establishment of final levels prior to paving was the reburial of unwanted worked stones. On 29.09.15, a total of ten worked stones were reburied inside the nave under the supervision of Inspector Hassan. The location for reburial was at the west end of the nave in the backfilled area of the excavation carried out in 2010. The pieces were buried at a depth of one meter below the finished floor level of the nave. These stones were mostly fragments of column shafts that could not be re-assembled or other pieces that could not be put on display or used in the anastylosis of the colonnade at the west end of the church. They are listed as follows:

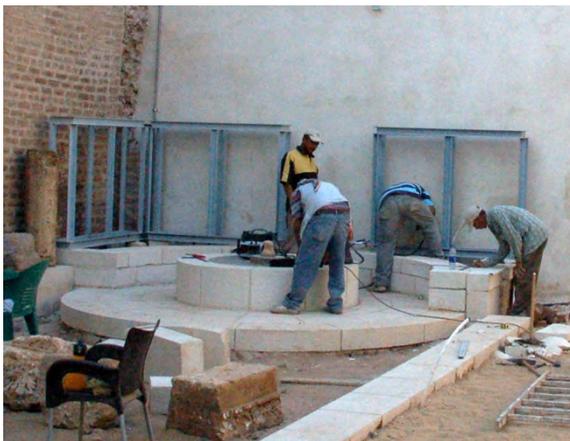
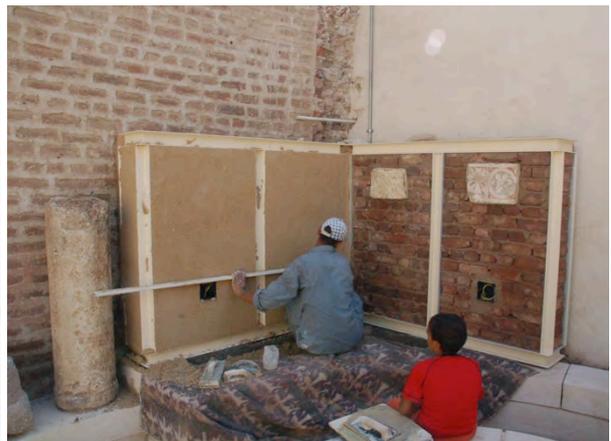
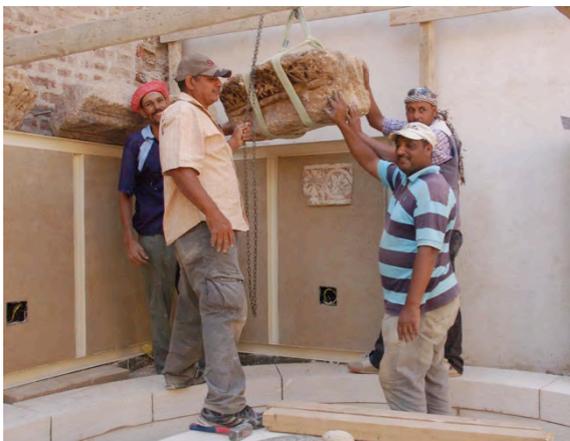
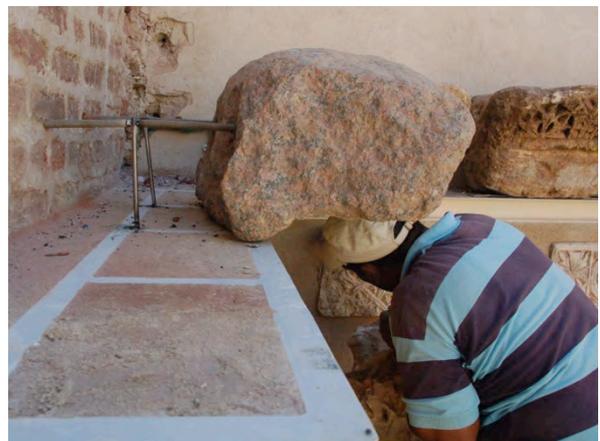
Photos showing sequence of construction of display stands for carved limestone fragments

[C] The final part of the preparatory work related to the nave was the creation of a new lapidarium for the display of worked stones. This was located south of the nave, adjacent to the well. Three new painted steel frames 1.4 metres high and 30 cm deep were designed to carry the large cornice blocks deriving from the nave. These frames were filled with brick and plastered, with three smaller blocks being inset into the masonry. The stones include:

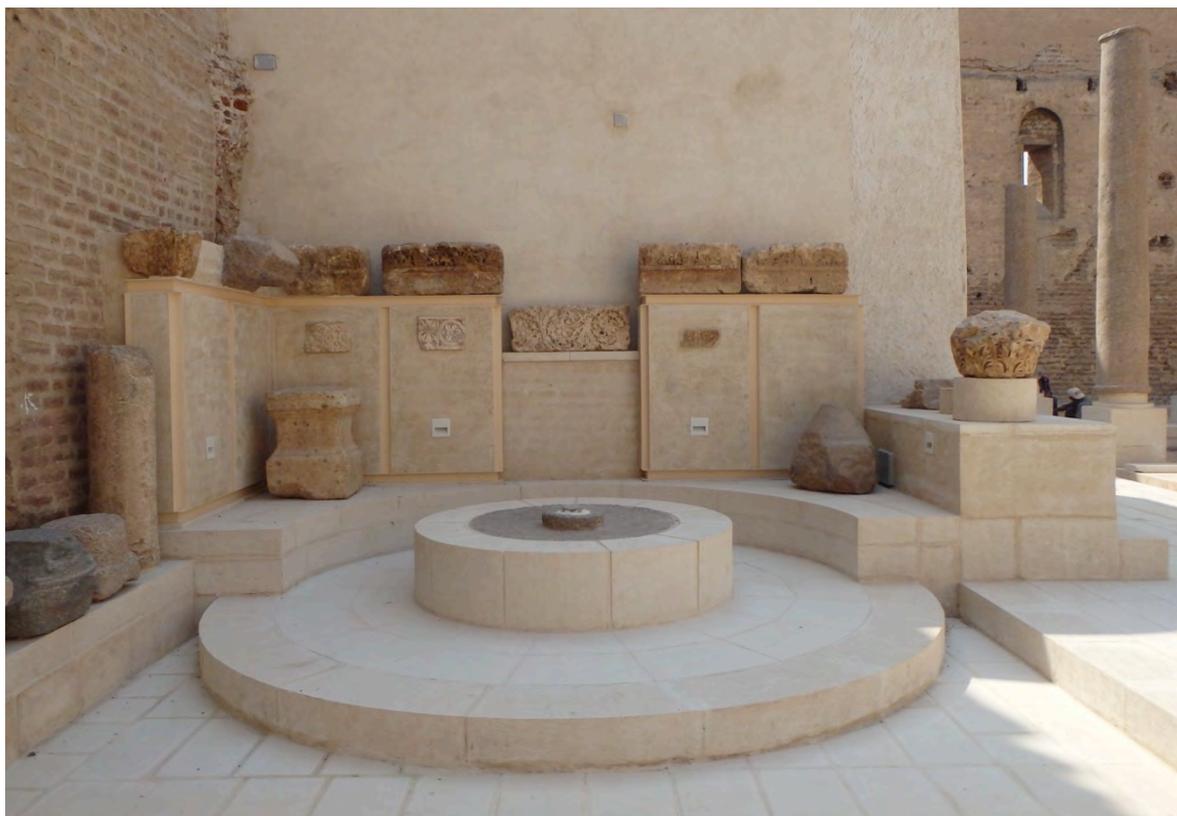
Frontal view of the completed display of stone fragments
