Bianca Madden
Conservator of Wall Painting and Polychrome Sculpture
The Garden Flat 5 Rawlinson Road Oxford OX2 6UE
07789067364/01865 513144 bianca@biancamadden.com
www.biancamadden.com

CONSERVATION OF WALL PLASTERS AND TEXTS
WEST WALL, RED MONASTERY
OCTOBER – NOVEMBER 2019

Report No: BMRM1219 Date: 1 December 2019 Author: Bianca Madden, Conservator of Wall Painting and Sculpture, The Garden Flat 5 Rawlinson Road Oxford OX2 6UE; T: 07789067364/01865 513144; E-mail: bianca@biancamadden.com

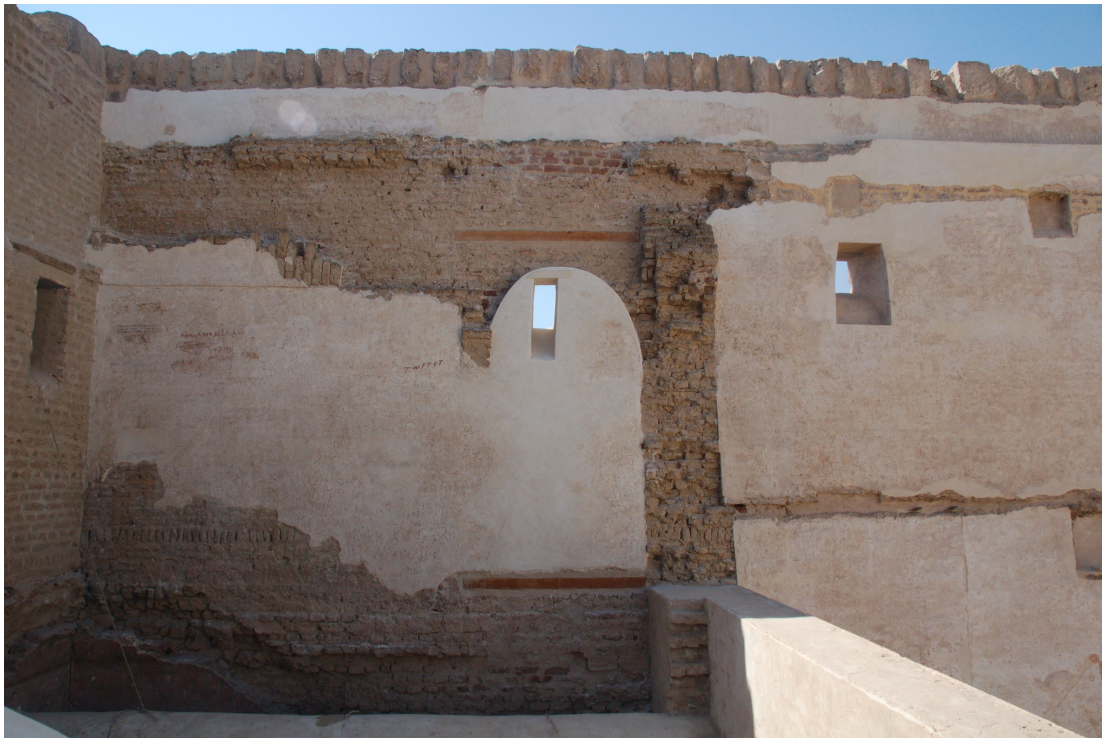
The area of the west wall after the 2019 conservation project. Photo credit N. Warner

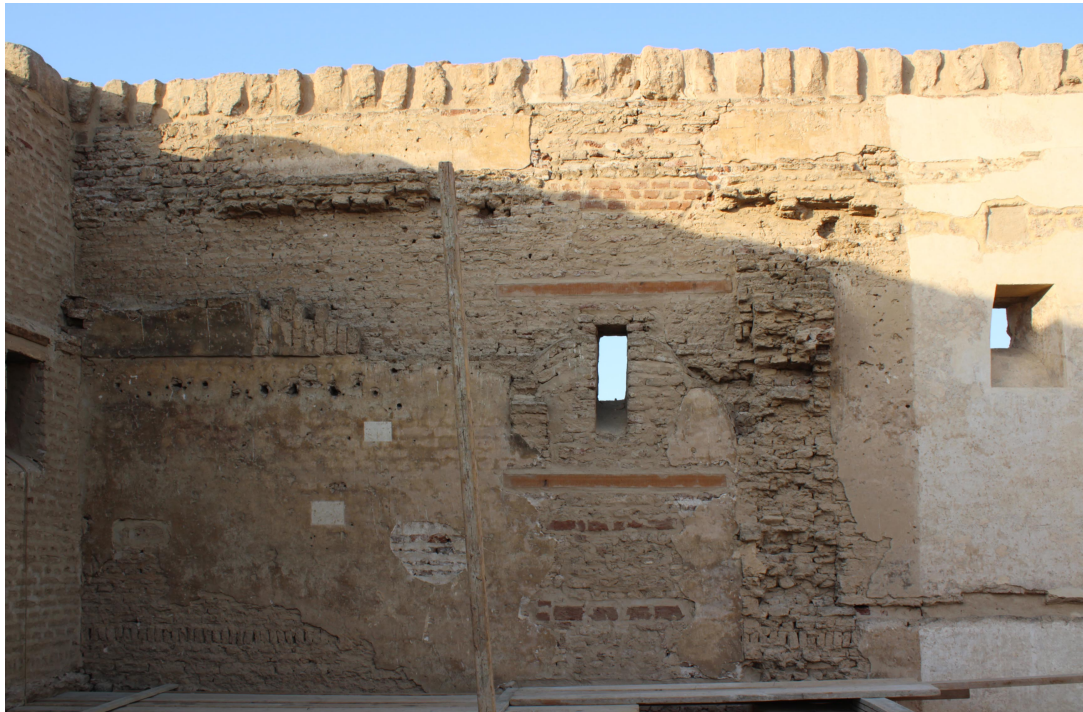
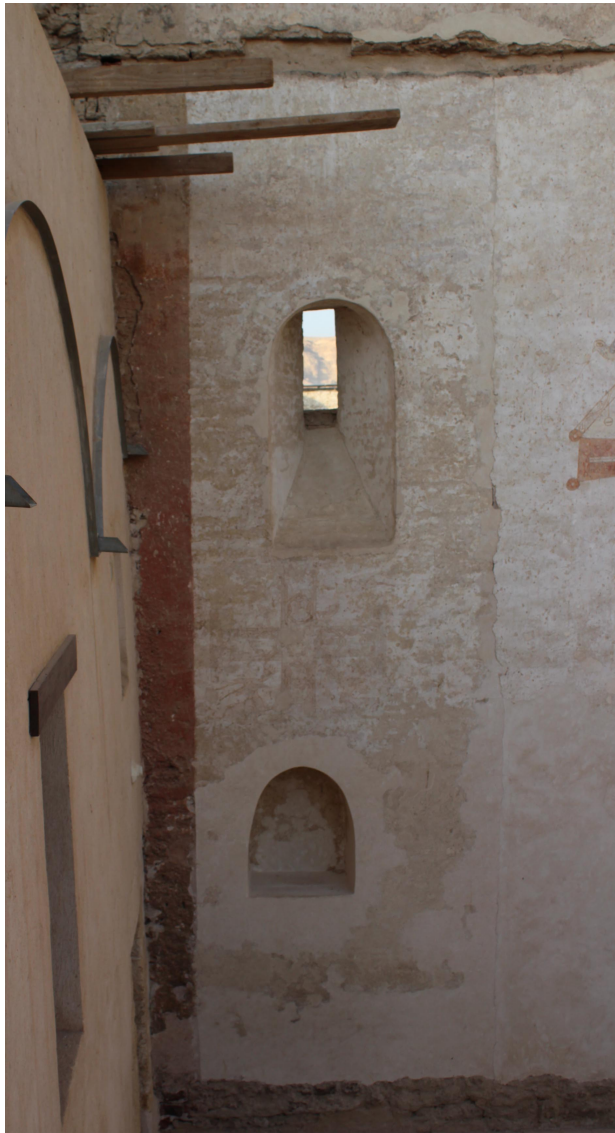
The remaining unconserved area was all located on the west wall of the nave, and consisted of a final strip of plaster measuring approx. 45 cms running the height of the wall between the new chapel at the south west (sw) corner of the wall and the plaster conserved in the previous campaigns, and a larger area of plaster, approximately five metres wide in the sw corner of the wall above the chapel, this area included five clear graffiti texts as well as some splash marks, and fragments of letters.

Above and next page, the areas at the start of the conservation project

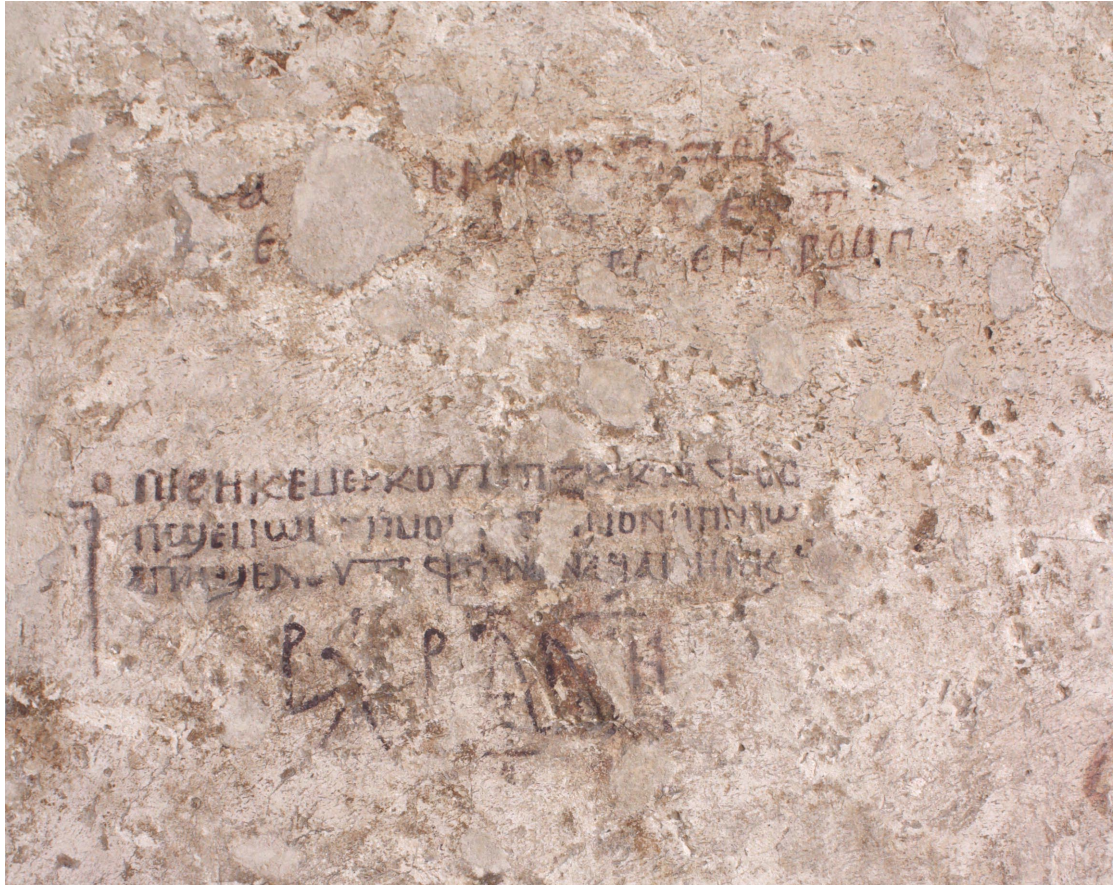
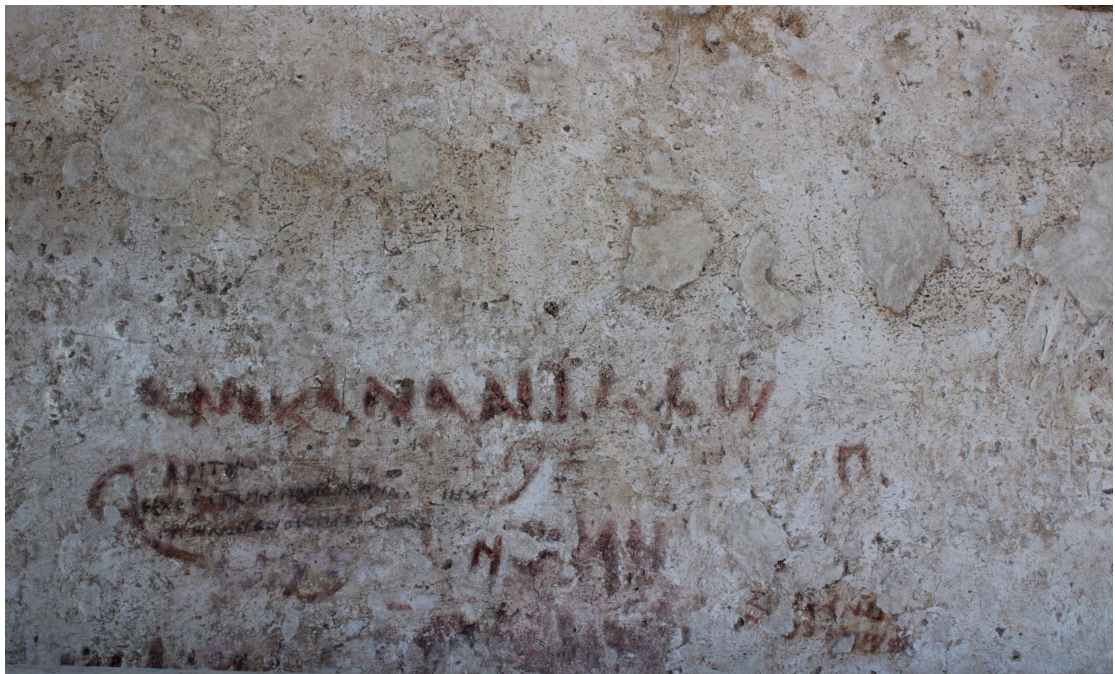
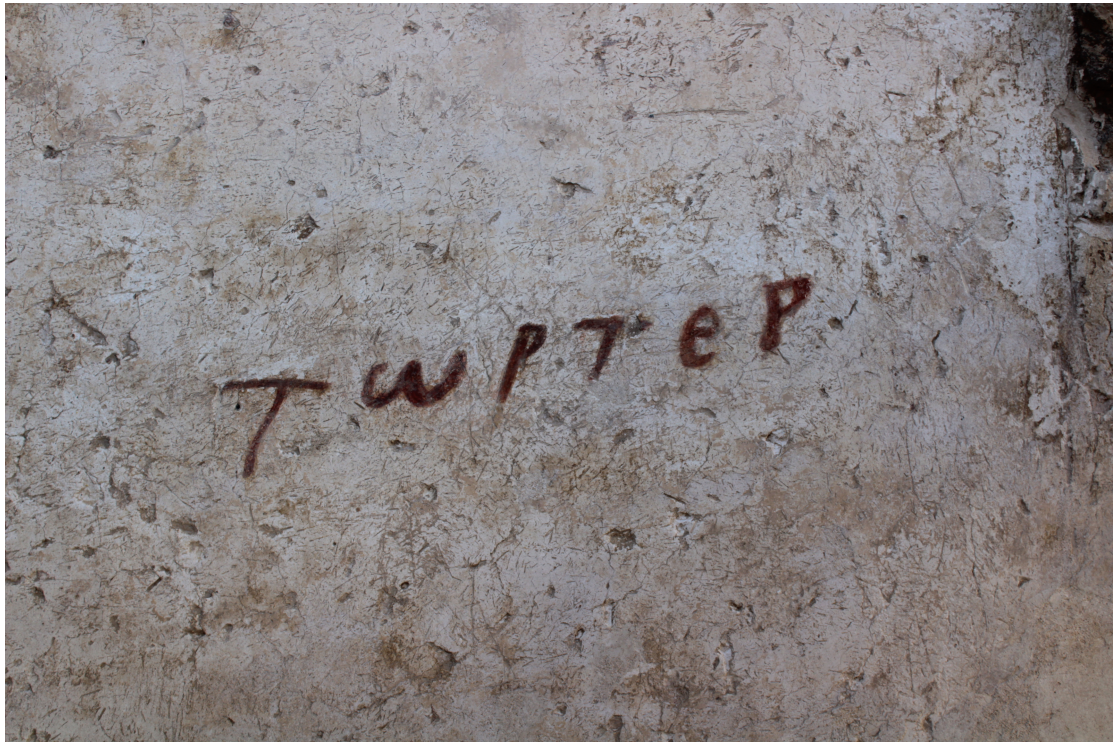
Above, the three text areas after conservation

These final areas of plaster are now secured, the texts consolidated and much more visible following the removal of the covering and surrounding dirt layers. Repairs not only secure the original plaster but make these areas read coherently with the rest of the walls of the nave. While the filling of the various holes within the plaster has reduced the nesting and perching opportunities for birds within the plaster, the area the top of the wall still affords perching points.⁵

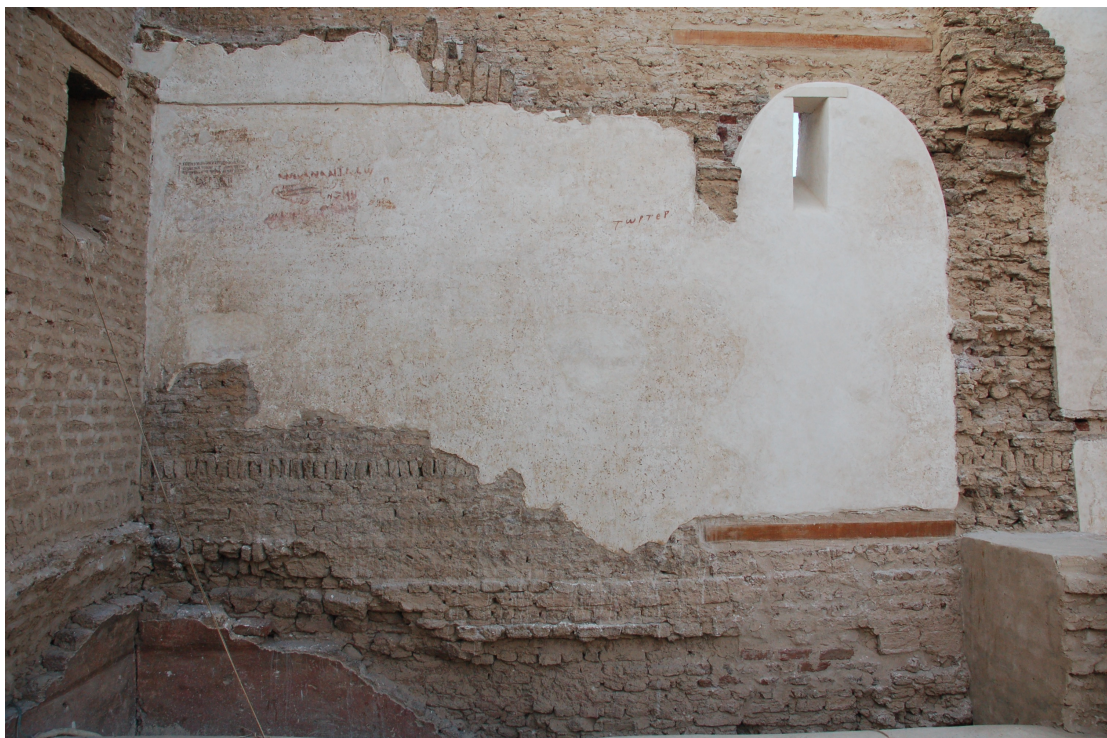
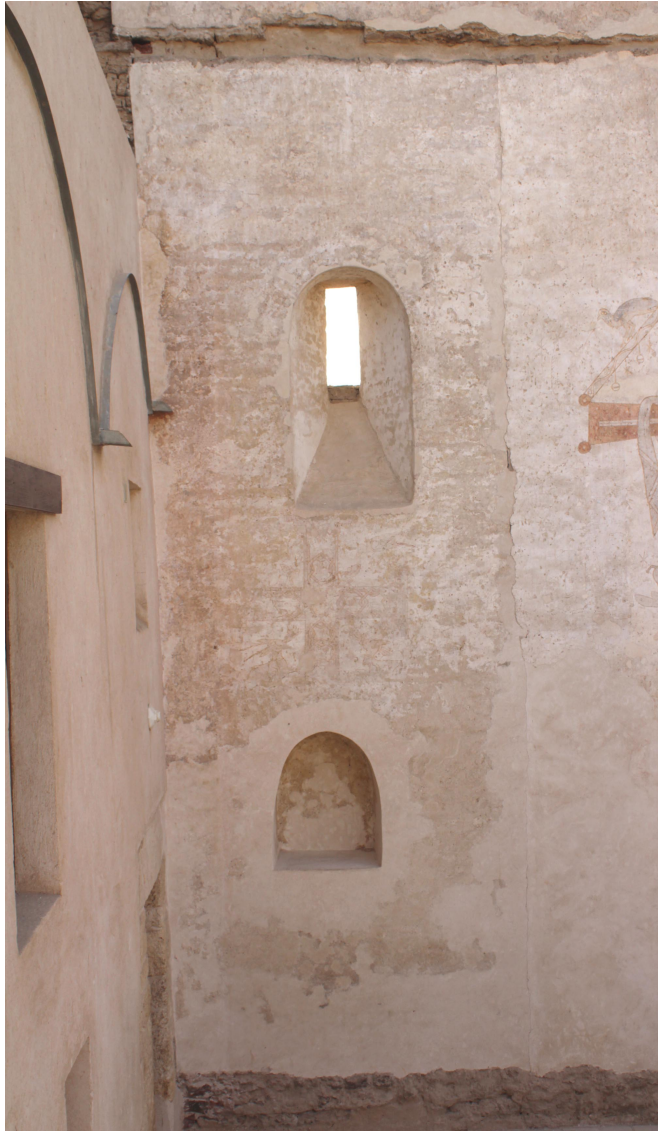
Above, and previous page, the two plaster areas after conservation
