SPECIALIST REPORT

“Red Monastery Architectural Conservation Project”

Cultural Heritage Tourism Project (APS)

October 2013 – June 2014

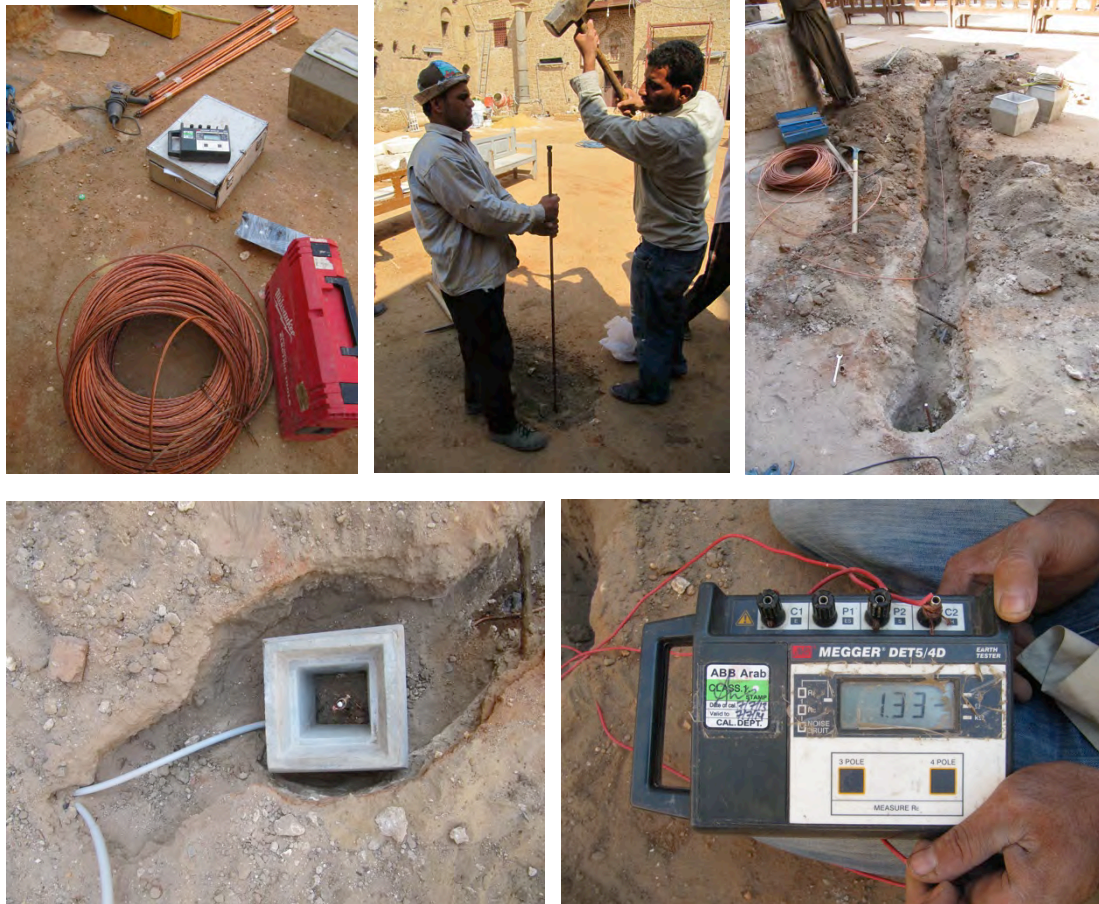
Photographs showing installation of new earthing system

1.5 An electrical earthing system in the nave of the church. The new earth has a 1.33 Ohm rating, within the maximum 2 Ohm rating. The system uses two solid copper rods, driven vertically into the ground to a depth of six metres, in the positions shown on the attached plan. These are linked to each other by a twisted copper cable sunk 40cm underground, and connected with a bolt connector to the earth deriving from the internal electrical distribution board inside the church. The earth is also directly connected to a new lightning conductor mounted on the roof of the church.

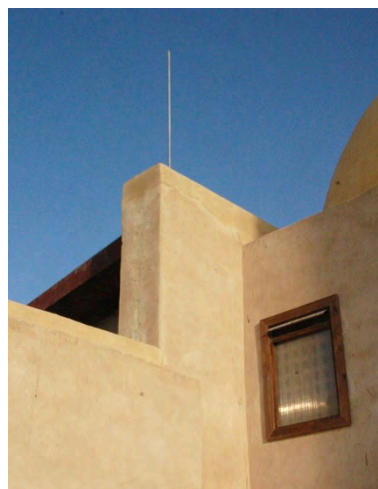
New lightning conductor on roof of church

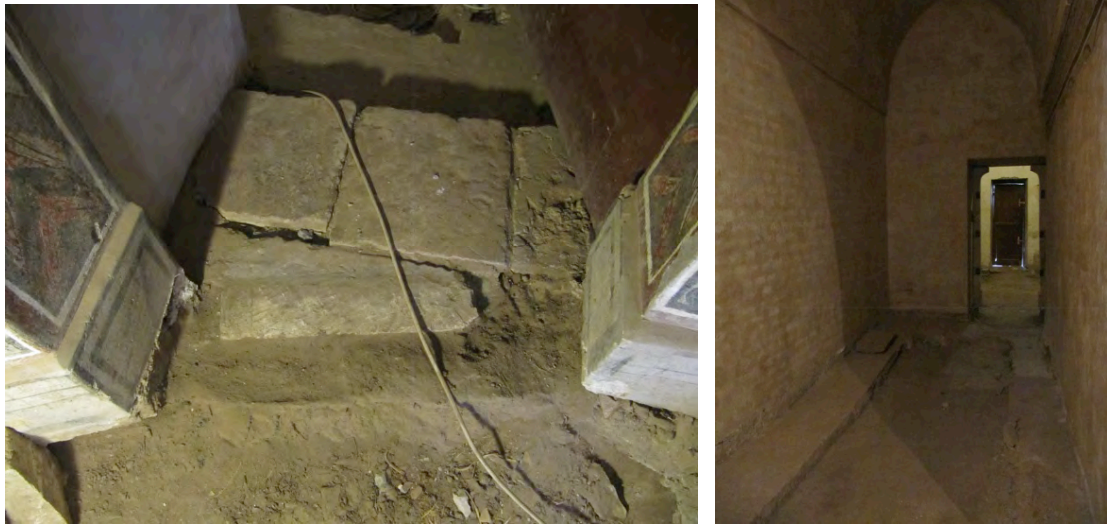
The entrance to the north side chamber showing original slabs that were used as the level for the new flooring (left) and concrete beam in south side chamber projecting above the new floor level (right).

3 Wherever reinforced concrete beams projected above the level of the new floor.

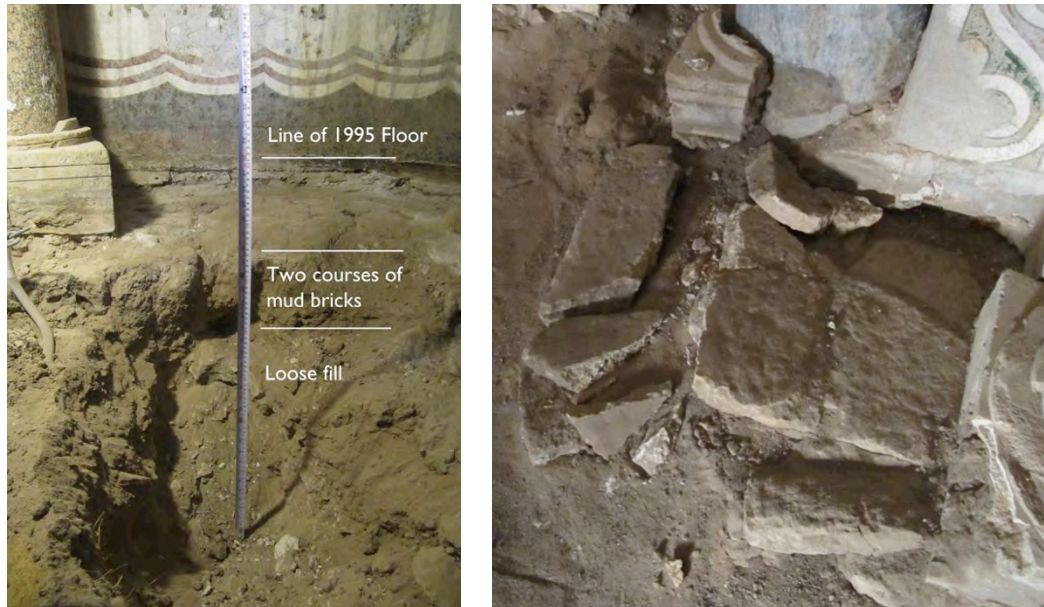
The archaeological remains of the mud brick blocking walls in the east lobe were found to consist of two layers of mud bricks laid over fill. These courses were removed in the north and central section of the lobe, but were left in the south section where they were below the level of the new floor. The badly damaged section of original flooring in the southwest corner of the east lobe was impossible to preserve in situ and was removed.

Remains of mudbrick blocking walls in east lobe (left) and fragmented section of original floor in southwest corner of east lobe (right).

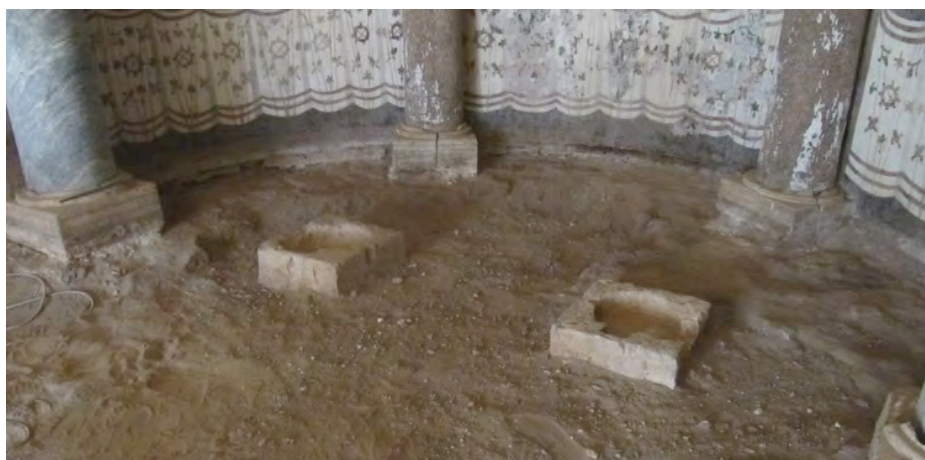
Existing blocks with circular depressions either side of 1912 altar, before incorporation into new floor.

Also in the east lobe, two blocks with circular depressions serving as column emplacements, part of the altar that was installed here in 1912 and demolished in 2008, were reset close to their original positions at the level of the new floor, and the depressions filled with new limestone plugs. These blocks provide a physical reminder of the altar that once stood here. Another limestone block that was reused in the altar, carved with a cross, was put on display in the church in the north side room.

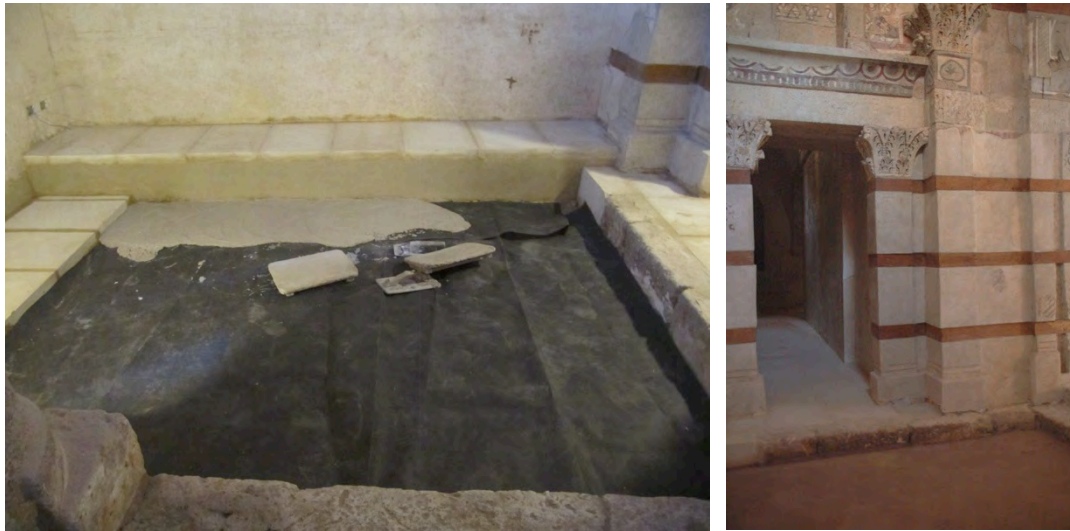
Geotextile membrane laid over surviving original floor in north area of khurus (left) and completed lime screed (right).

In the north area of the khurus, where a large section of the original stone paving of the nave is preserved, special conservation measures were undertaken. The original blocks were first covered with a geotextile membrane, and a lime screed was then laid over this in two layers. The composition of the screed was as follows:

Layer 1 (below): 5cm deep and consisting of 1 lime, 1 sand, 1/2 gravel and 1/2 coarse ground brick, 1 fine ground brick with a small additive of fly ash.

Layer 2 (above): 2cm deep consisting of 1 lime, 2 sand, 1 fine ground brick with a small additive of fly ash. A wooden float was used for finishing.

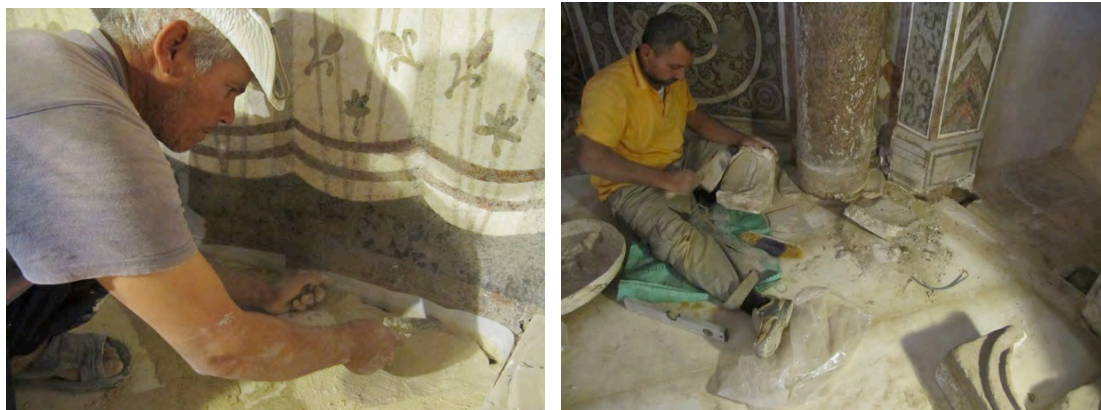
Finishing the junction of the floor with the painted plaster surface (left), and re-setting detached limestone collars at the bases of the granite columns (right).

The finishing of the edges of the floor at junctions with painted plaster surfaces was done with a non-permeable plastic barrier that was later trimmed off. Column bases were fixed in position where they had been detached. Final finishing of all cracks and joins was carried out by the fine conservation team in Season 3 [see section 4, below].

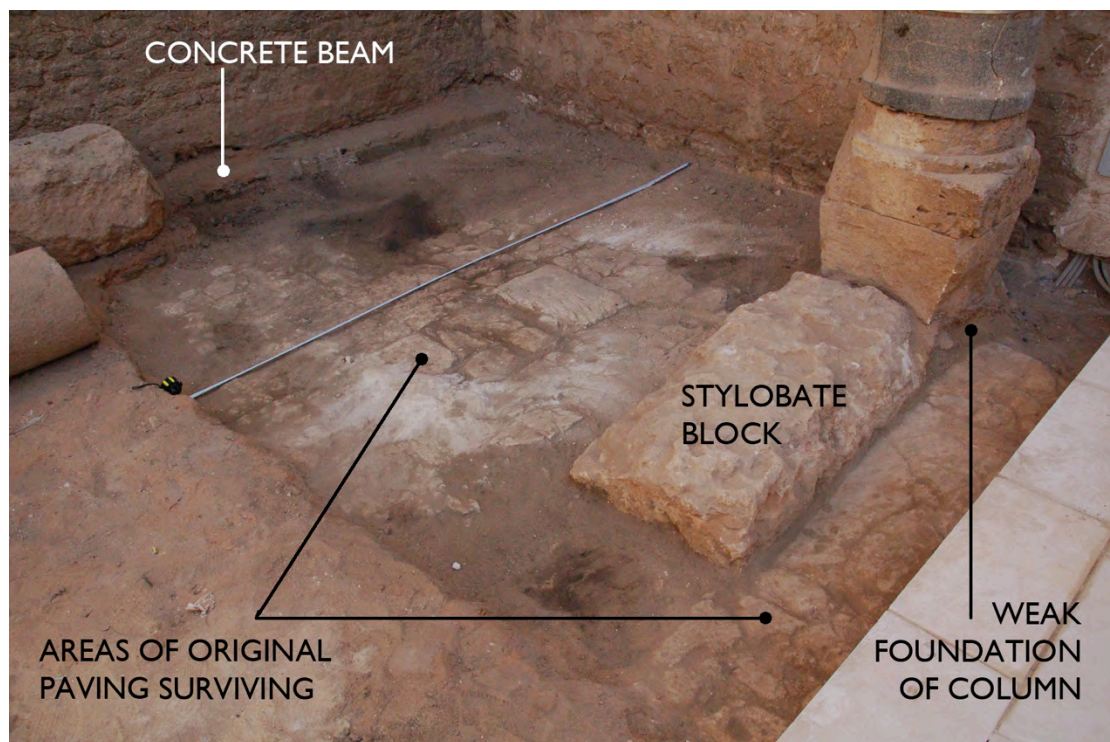
View of original paving discovered in northeast corner of nave

On the north side of the platform, an area of approximately four square metres of the original limestone floor belonging to the nave was discovered, close to the existing stylobate block on this side. To protect this floor, it was covered with a geotextile and lime screed matching the specification of the screed that was used over the floor discovered in the area immediately to the east within the Comité enclosure wall. In order to consolidate the base of the existing column on this side of the nave, which has no proper foundation, the level of the platform was continued around the column base extending in front of the façade of the wall by 90cm. A new plastered brick and limestone mastaba was constructed at the same height over the existing concrete raft dating to 1995. This was done for aesthetic reasons. An opening was left in the step to provide access to the future new door in the Comité wall [see 3, below].

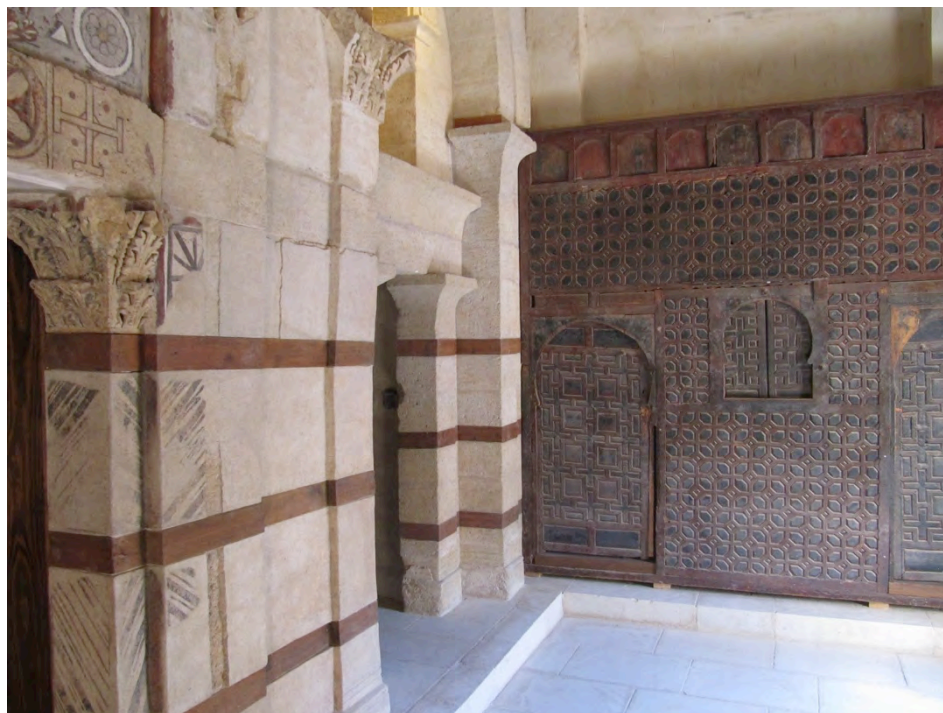
View of repaired screen fixed against south wall of khurus.

The Heikal screen was moved to a position on the south wall of the khurus. It was then repaired with a new secondary subframe and fixed to the wall prior to cleaning. The gap between the top of the screen and the south wall of the khurus was filled with an overlapping timber roof. The central window of the screen has a built in cupboard to prevent rubbish from being thrown behind the screen. This cupboard can also serve as a receptacle for the written prayers that are frequently left by visitors to the church.

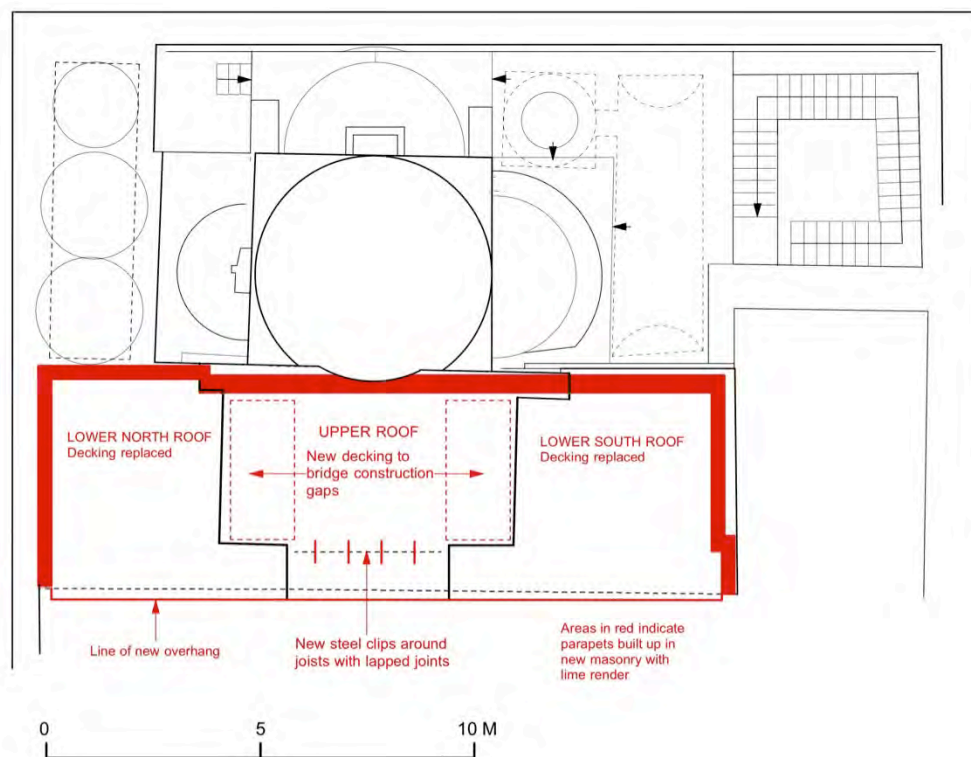
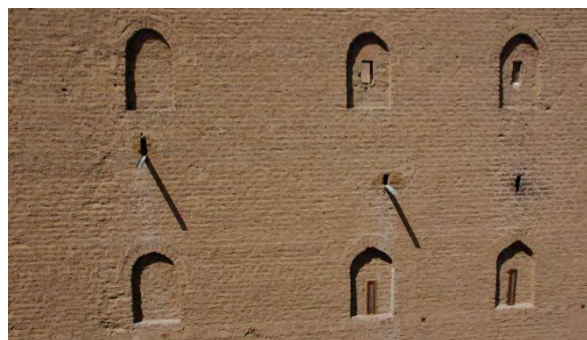
- 1 The timber decking, dating to 1995, was not continuous between the roof over the central part of the khurus and the overhangs to either side. There was a gap of 20cm between these two sections of roof that was only bridged by the existing bitumen sheet.
- 2 The roof beams above the platform over the trilobe portal were not continuous but had lapped joints, forming an extremely weak connection liable to failure [Drawing 1 and 2].
- 3 There was a severe infestation of termites in the lower roofs affecting the timber boarding.
- 4 Additionally, it was noted that holes made to allow rainwater to drain off lower sections of the roof were not fitted with rainwater spouts.

New rainwater spouts on east façade from lower areas of roof

- 1 The gap in the decking of the upper roof was bridged with new timber decking.
- 2 The roof beams of the upper roof were strengthened with steel clips
- 3 The timber decking of the lower roofs was replaced with new 1" decking, treated with chemicals against insects and painted with red oxide to match the surface finish of the existing roof.

Following this, the roof was lined with a new bitumen roll isolation and covered with a 75mm white cement screed reinforced internally with a galvanized metal mesh. Galvanized metal flashings were used around the perimeter of the roof, and a new overhang [*rafrafa*] was installed to shed water away from the face of the Comité wall. In order to provide a good construction detail, the back [east] and side [north and south] edges were built up with new brick masonry and lime mortar, covered with new lime plaster. Two new galvanized metal rainwater spouts were fitted to the lower roofs on the east side of the building extending beyond the line of the east façade.

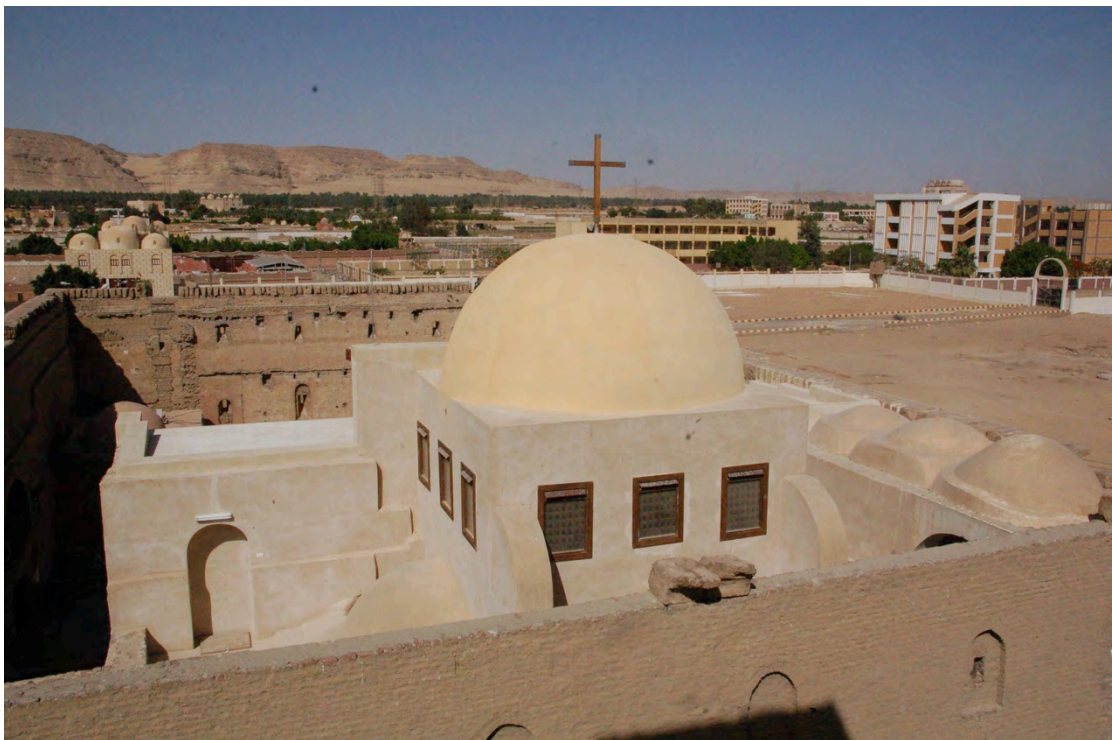
View of completed roof seen from east

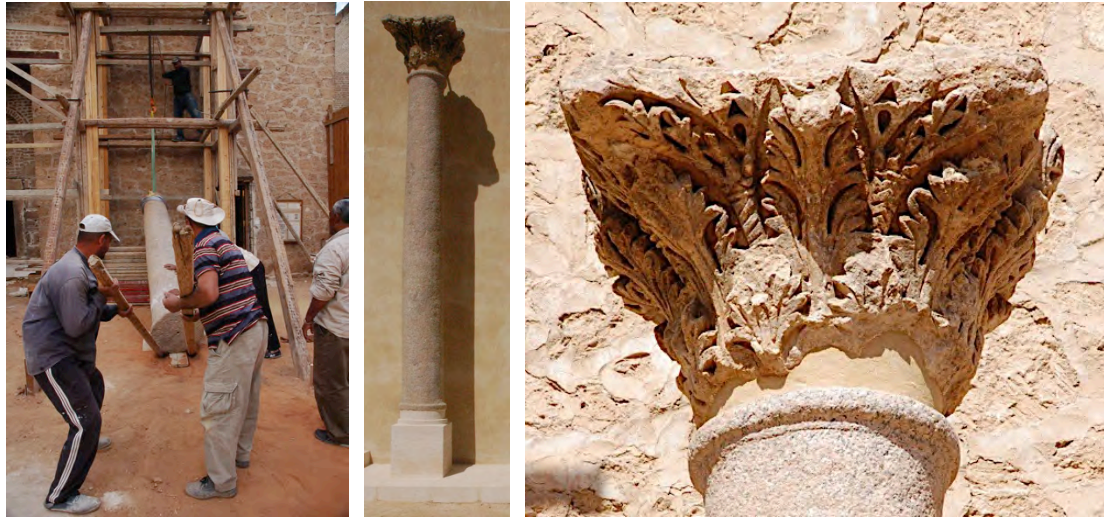
The Aswan granite column being raised and after installation [left and center] and detail of restored Corinthian capital.

10.2 One of the existing fallen Aswan granite column shafts lying in the nave was cleaned and set up on a new limestone base in the south side of the nave. Above the shaft, an existing limestone Corinthian style capital was installed after cleaning with poultices of dilute ammonia. The base, shaft and capital were pinned together with stainless steel rods set in epoxy, and lead sheet was used to separate each feature. The assembled column and capital were fixed securely back to the Comité façade wall with a stainless steel bar in a sleeve set within the top of the capital.

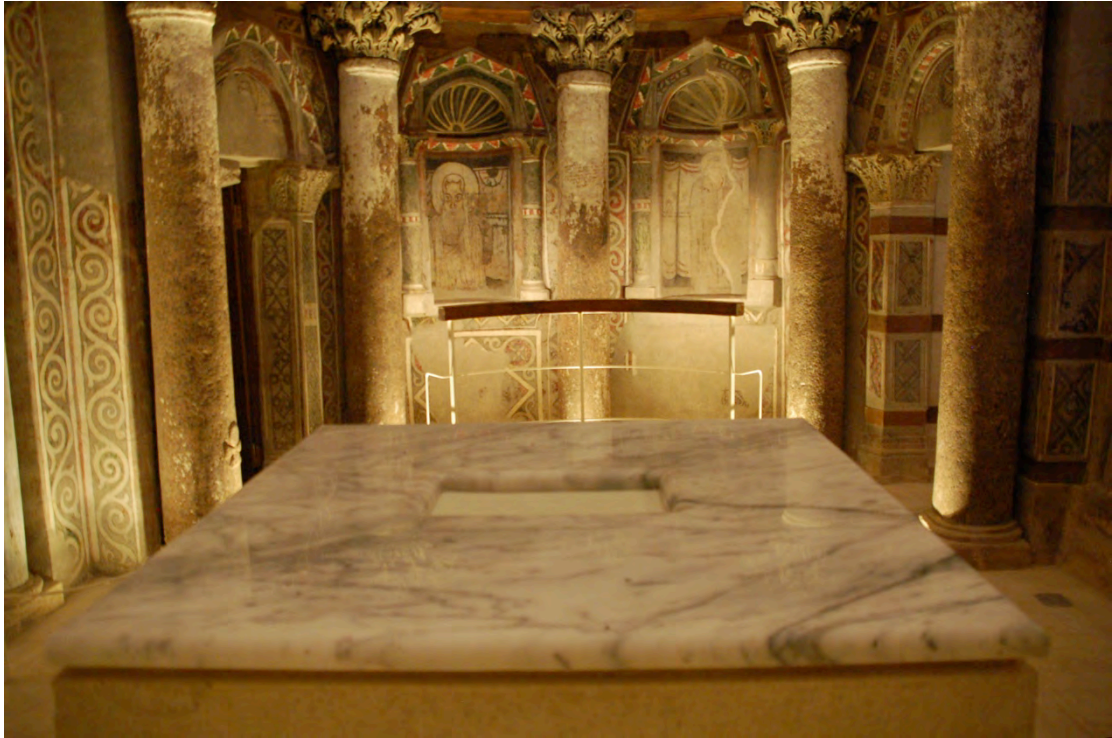
A new altar measuring 1.2 x 1.2 x 1.1 high [seen in photo in section 7, above] was constructed of plastered fired brick masonry in the center of the sanctuary. A 4cm Carrara marble top, with central cut-out, was installed on top of this structure.

Detail view of new Carrara marble altar top

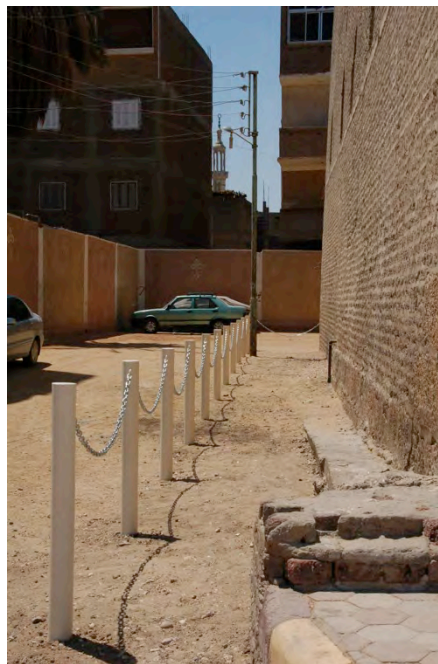
In order to protect the east wall of the church from potential damage caused by vehicles parked in close proximity, a line of circular steel posts were set at a distance of 1.8m from the wall, linked by a continuous galvanized steel chain.

View of new steel post fence behind east wall of church
