**ARCHITECTURAL CONSERVATION
RED MONASTERY SPRING 2016**

Part II: The Tower

PRELIMINARY REPORT

Dr. Nicholas Warner, April 28, 2016

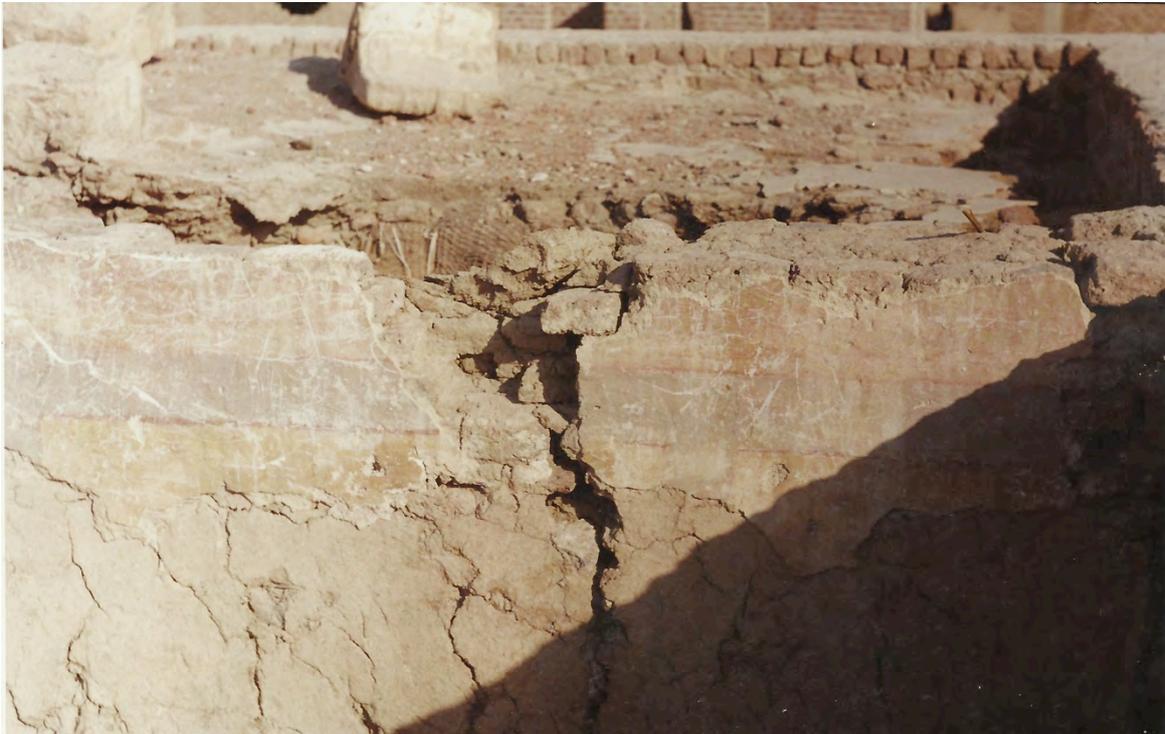
The interior of the tower was undoubtedly plastered originally with a lime plaster. Some of this plaster was also decorated with plain color treatments but none of it appears to have survived the intervention of 1995-96, discussed below.

Fig. 5.7 Polychrome painted plaster bands on a first floor wall in the tower, circa 1995, now destroyed

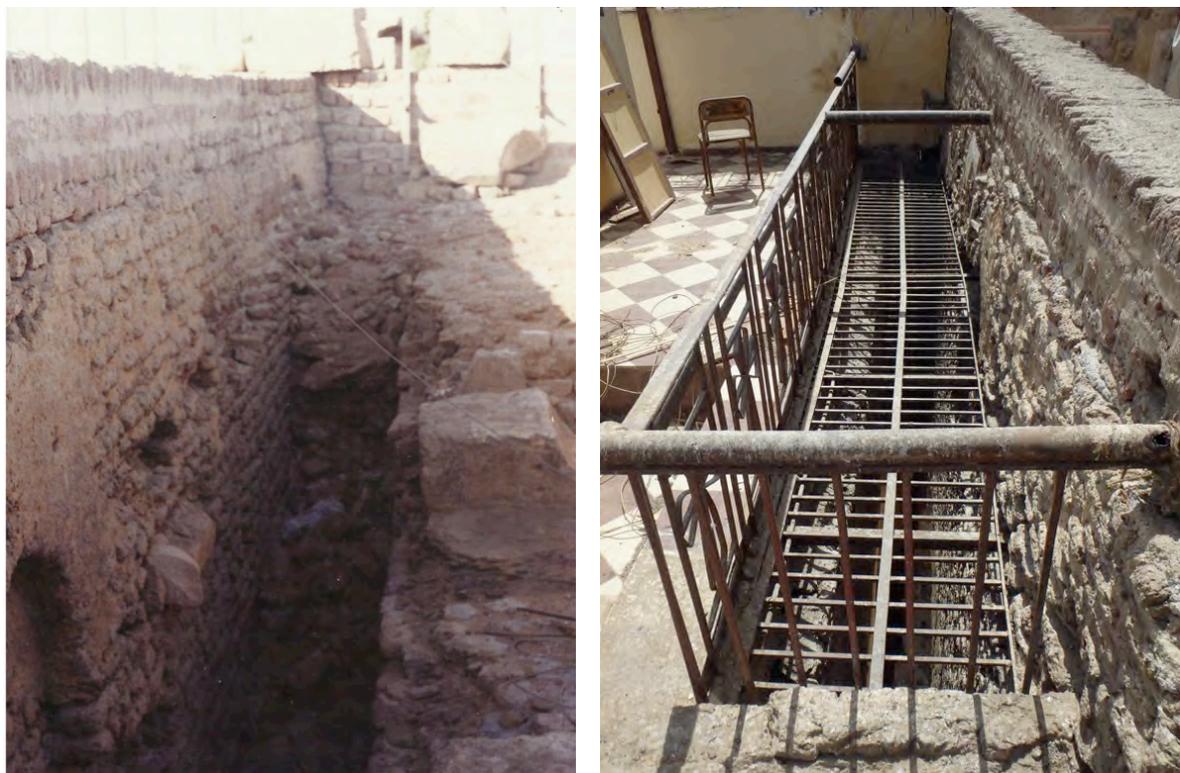
The extent to which the SCA project of 1995-96 intervened on the first and second floors of the tower is not completely clear. An open metal grille was certainly installed to cover the top of the gap between the tower's north wall and the south wall of the church above the south portal. This grille cut through a blank window arch of the south façade of the church. The sides of the gap between the two walls was not completely filled to full height and thus provided ideal roosting locations for birds. The crude repairs to the two domes of the first floor date to this period, as do various other masonry reconstructions, such as arches. The domes over the southeast and northeast rooms are made of fired brick. Both these domes were constructed using silt mortar, so the cement treatment was particularly inappropriate and difficult to rectify without causing considerable damage to the original structure. A number of timber stitches were also employed in the outer walls of the staircase. At the same time, numerous areas of the tower were re-plastered using a thick, dense, cement render, including the large arch in the north wall. It is likely that the renewal of the treads on the staircase can also be ascribed to this period of work.

Fig. 6.5 The gap between the north wall of the tower before (left) and after (right) the installation of the metal grille and handrail in 1995-96

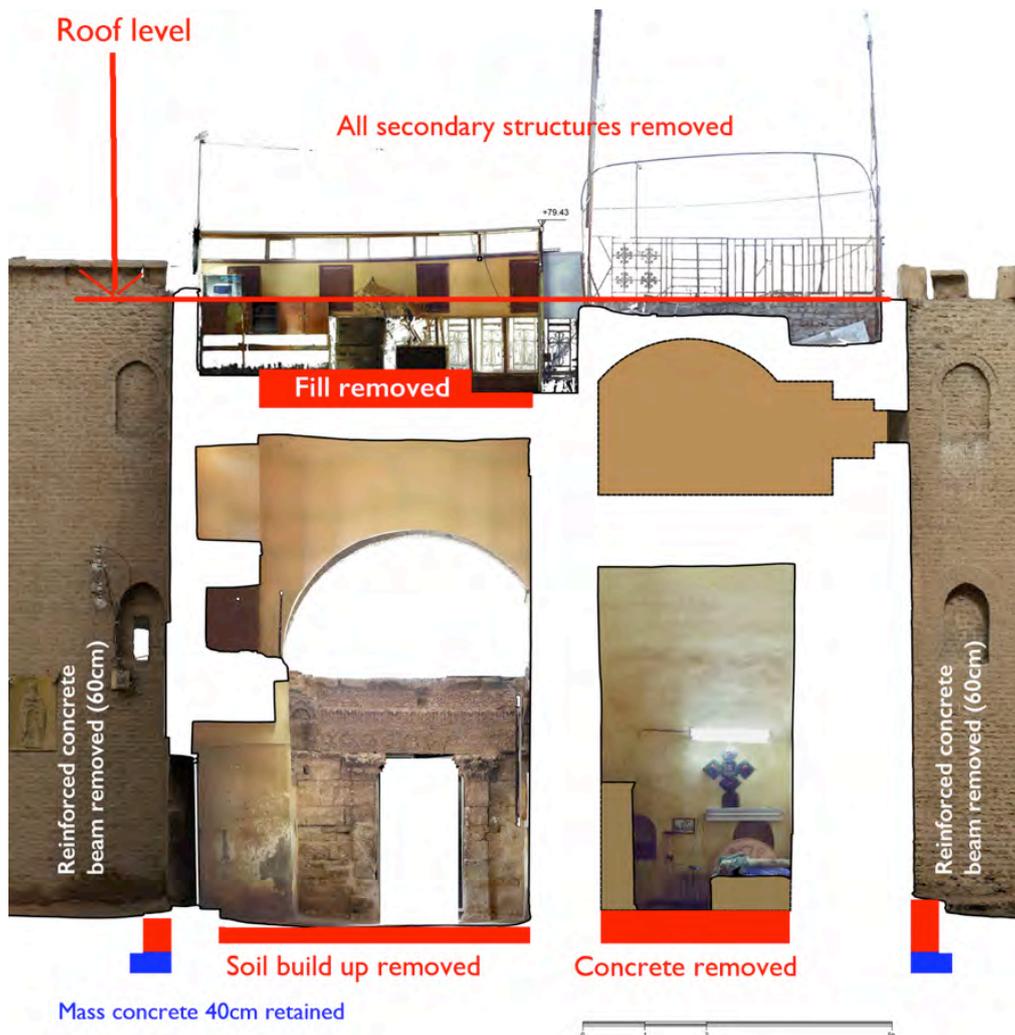
Fig. 7.1 East-west section through tower entrance area looking north showing elements removed

The first intervention in the tower was the stripping of the tower of all accretions, including reinforced concrete beams at ground level on the exterior, and concrete slabs, ceramic tiling, toilets, water pipes, electrical cables throughout the structure. Also removed was a significant amount of organic material at roof level that dated to the period of when the roof of the tower was re-inhabited after c.1905. The remains of the houses at second floor level, which seem to have been constructed with mud or fired brick laid in silt mortar, were demolished at some point after 1976. The levelling of the houses was covered by a layer of cement, possibly introduced in 1996 when the tower was re-occupied by Abuna Antonius. The levelling of the houses was covered by a layer of cement, possibly introduced in 1996 when the tower was re-occupied by Abuna Antonius.

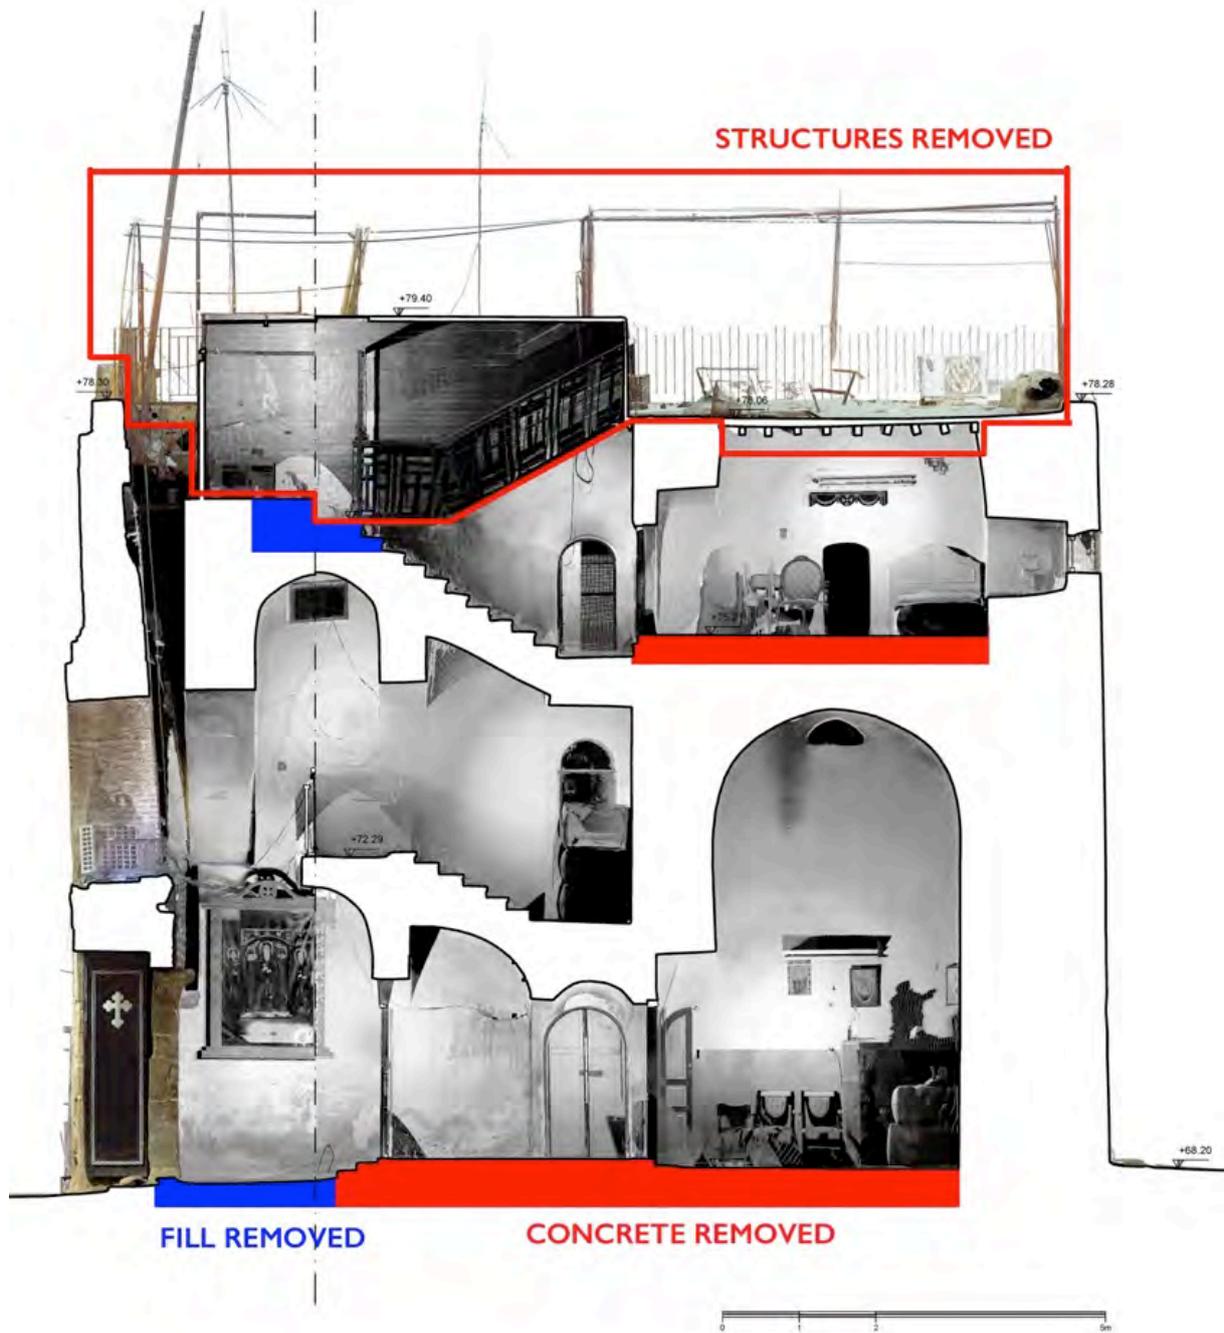
Fig. 7.2 North-south section through tower and south portal looking east showing elements removed

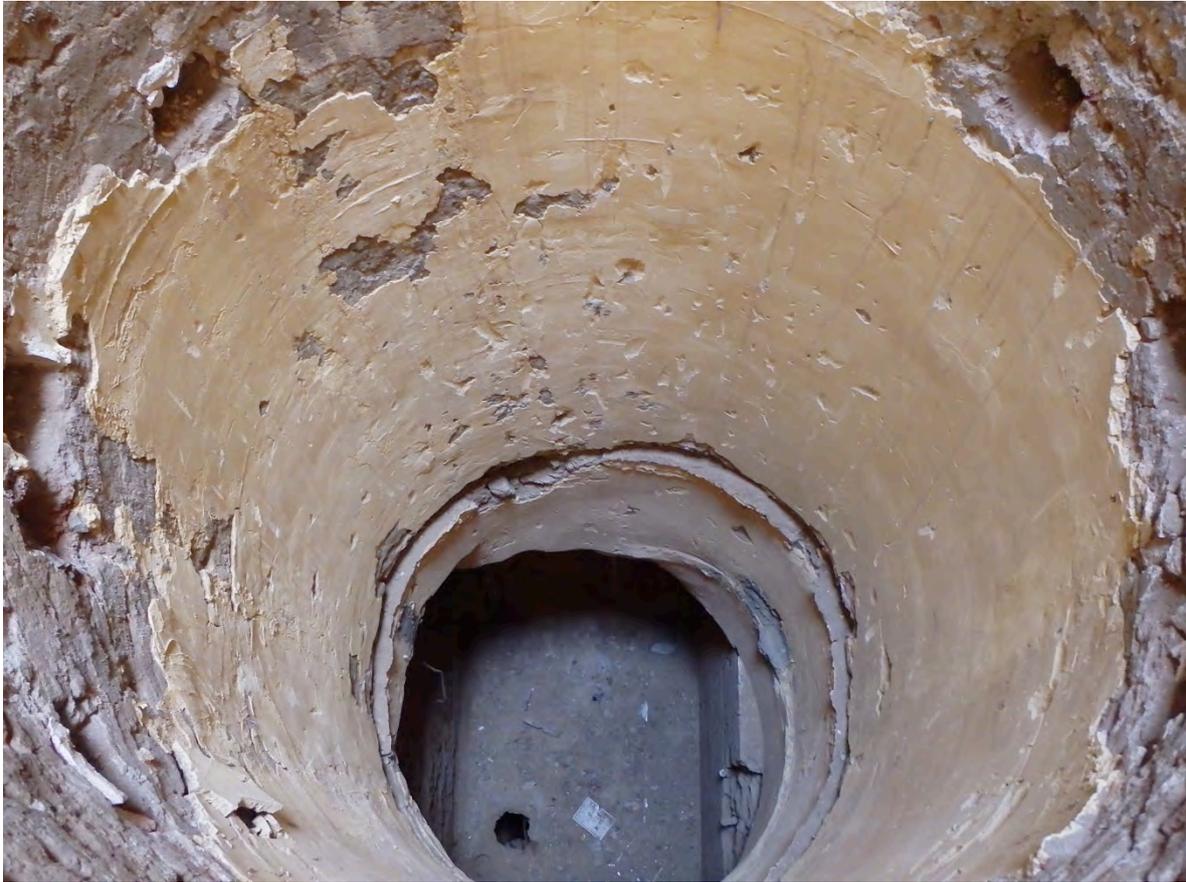
After the removal of a number of concrete slabs and the toilet at ground level, the brick well in the center of the tower was shown to be 1.1 m in diameter and approximately 6.5 m deep. It extended to the full height of the structure and had one surviving opening into it at mezzanine level. The emplacement for a least one beam to support a pulley was visible, together with a number of evenly distributed holes vertically that indicate footholds.

Fig. 7.4 The well seen from the mezzanine window opening looking down

After its reconstruction at ground floor level, the well provides a feature of interest in the building. It is recommended that there should be two points for seeing into the well: one on the balcony level of the staircase through an existing arched opening, and one at a higher level. The missing upper section of masonry surrounding the well would be rebuilt in association with the staircase leading to the roof, with an arched opening into it that mirrors the arched opening at the lower level. The timber beam and pulley block discovered during the work would be mounted inside the well facing this opening.

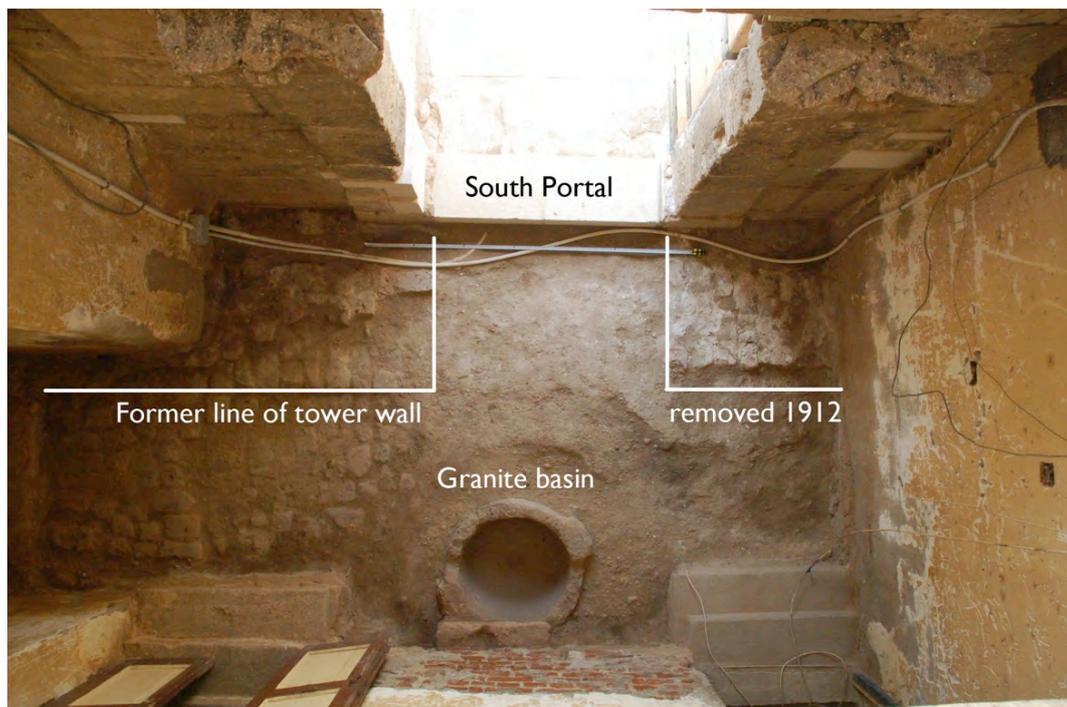
In 1912 the Comité removed a major part of the north wall of the tower in order to expose the carved stone frame of the south portal. A new arch was constructed at that time, made from hollow bricks, to support the remaining section of this wall at high level. The remains of the original fired brick foundation for the wall were discovered during clearance.

Fig. 7.6 View of tower entrance area from above showing location of wall removed in 1912 and granite basin

It is recommended that the final treatment of the entrance area of the tower should contain some visual clues as to the former presence of the north wall of the tower that was substantially removed by the Comité in 1912. In plan the position of the wall can be marked in the paving by a different material, such as basalt, to differentiate it from the limestone paving proposed in the remainder of the entrance area. In section the position of the wall can be indicated by a difference in the color of the plaster, making a distinction between what was once solid masonry (eg. grey plaster), and what was interior space (eg. white plaster).

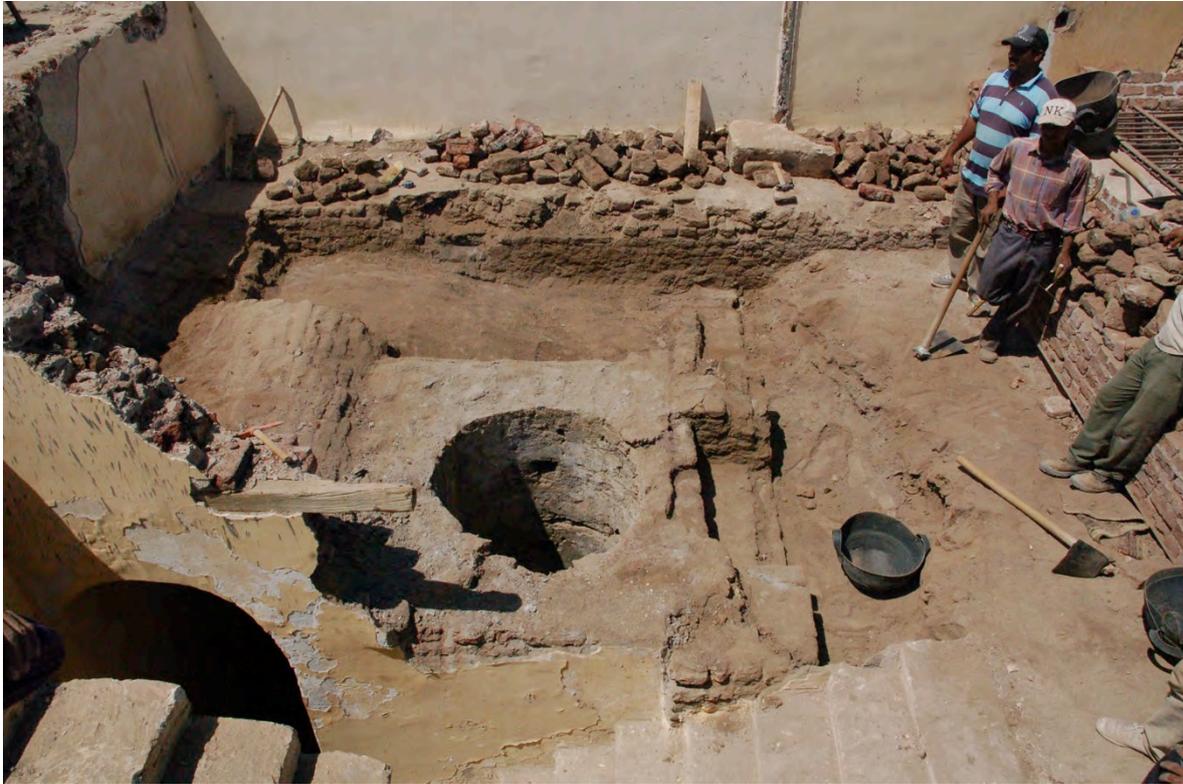
Excavations showed that the well shaft was accessible from the first floor of the tower on its north side, via a niched opening that replicated the opening now located on the staircase landing at mezzanine level. This opening into the well was possibly related functionally to a

50 x 50 cm hole, 1.6 m deep, located directly above the apex of the brick arch over the north wall of the tower. There was no surviving evidence for the continuation of the staircase around the core masonry surrounding the well, but it can be assumed that the stair continued up to the roof, or a second floor, supported on vaults as below.

Fig. 7.11 First floor: view from east showing top of well and exposed vaulting of staircase

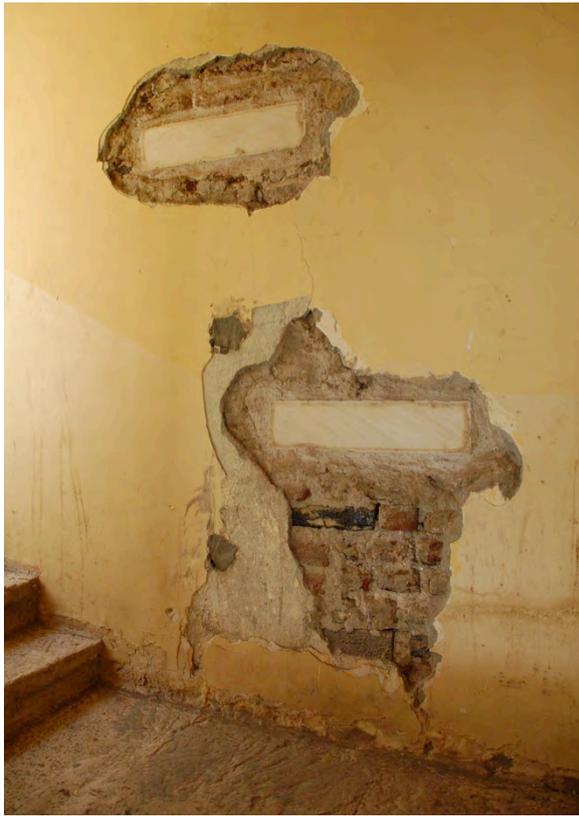
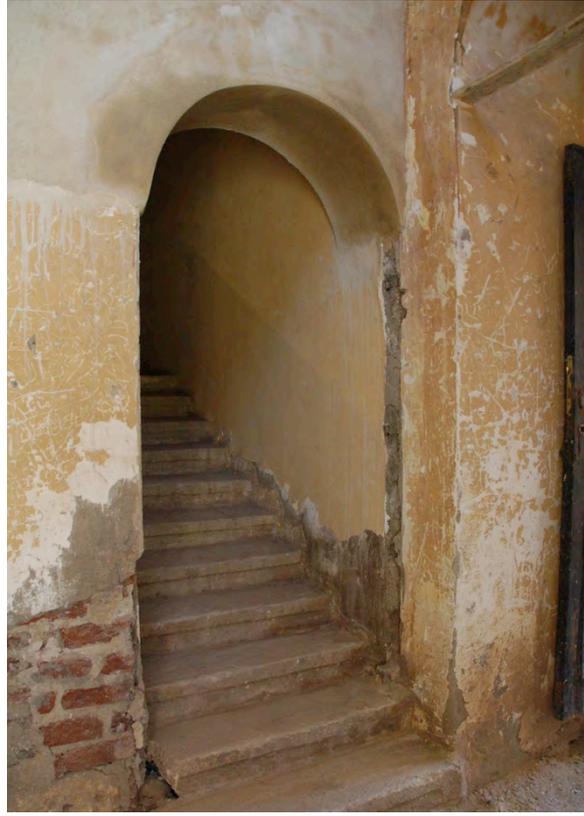
Fig. 7.28 New limestone stitches in the walls of the staircase (left), and restored arch over stair entrance (right)

To strengthen the walls in areas around the staircase where cracking was apparent, stone stiches measuring 15 x 15 x 60 cm were introduced into the masonry. The arch over the doorway at ground level over the staircase, above which serious cracking was evident, was rebuilt following the original profile and the poor quality timber lintels below it removed. Two other significant interventions were also made in the ground floor entrance area:

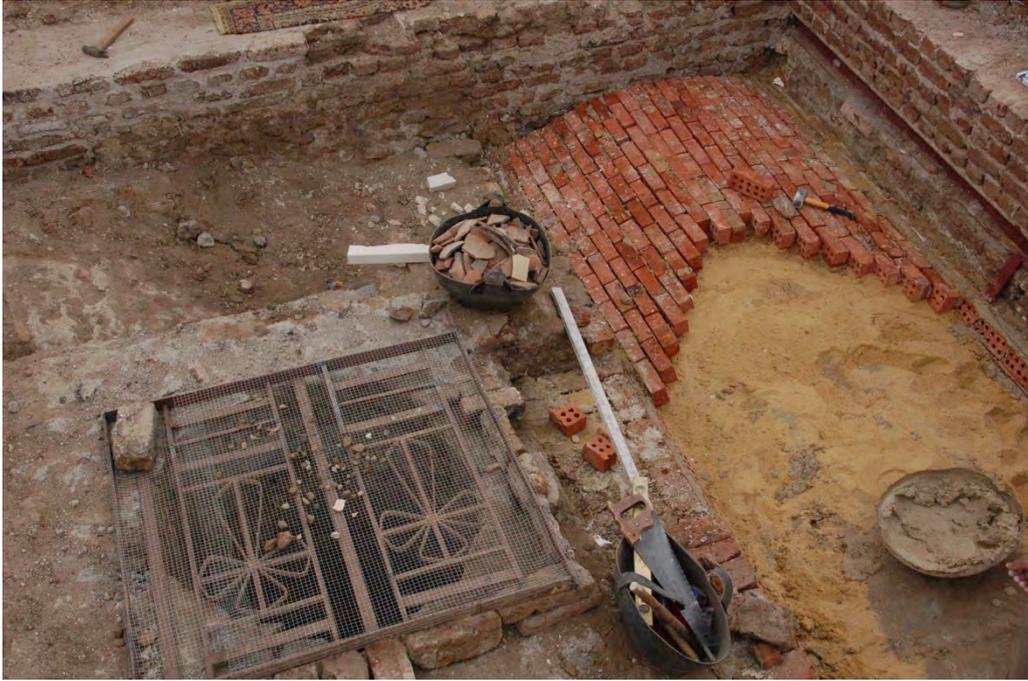
Fig. 7.36 View of new protective vault 1 from the east during construction

This shallow vault was built above the north vault over the mezzanine balcony in order to avoid undue loading of this original piece of the structure of the tower whose future strength could not be guaranteed. The new vault was supported on horizontal steel channels 4.6 m long spanning between the east and west ends of the original vault. This vault will provide the base for the future intermediate landing of the staircase.

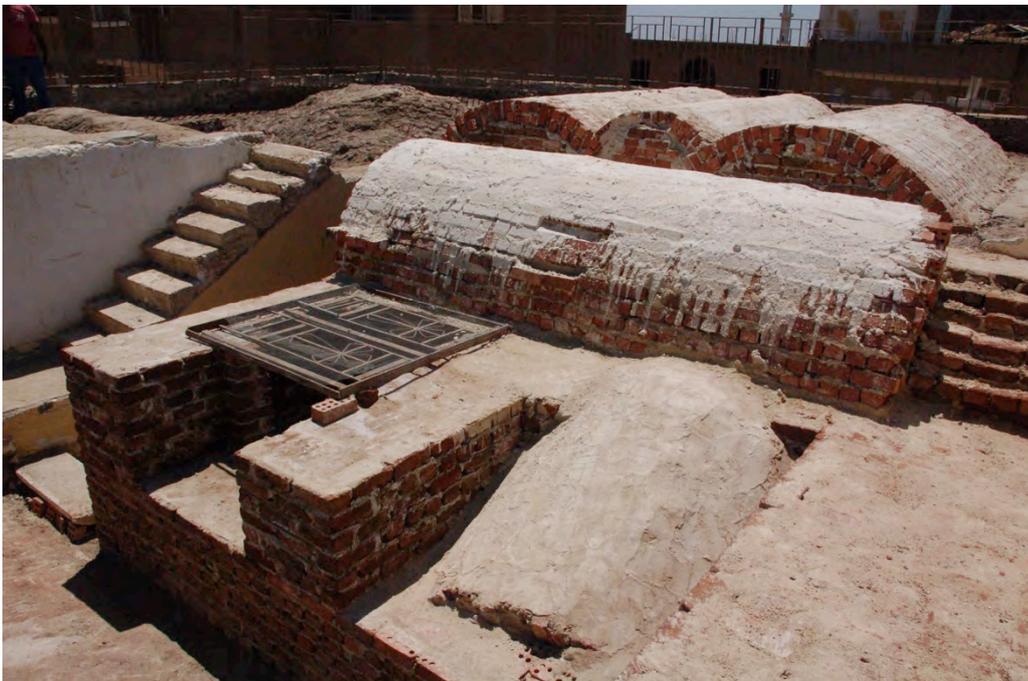
Fig. 7.37 View of new protective vault 2 from the northwest (in foreground) and vault 3 in background

This semi-circular sloping vault, radius 65cm, was built above the west vault of the stair in order to avoid undue loading of this original piece of the structure of the tower whose future strength could not be guaranteed. A short wall was constructed at the base of the vault over the staircase arch below to provide lateral stability. This wall was supported on horizontal steel channels 1.55 m long spanning between the east and west ends of the original vault.

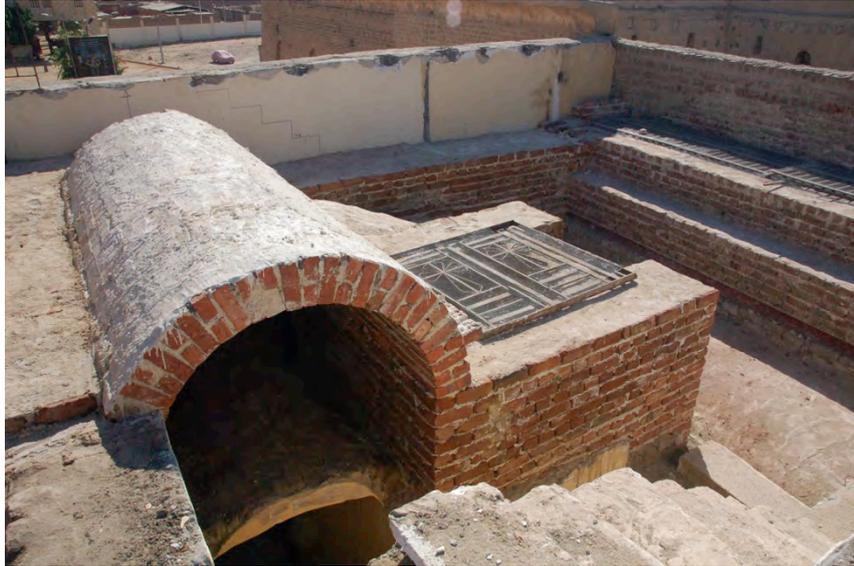
Fig. 7.38 View of new protective vault 3 from the east

This semi-circular vault, radius 65cm, was built above the south vault of the stair in order to avoid any loading of this original piece of the structure of the tower that was extremely weak. It will provide the base for the future upper landing of the staircase leading to the roof of the tower, and the space between the old and new vaults will be filled with a brick blocking wall.

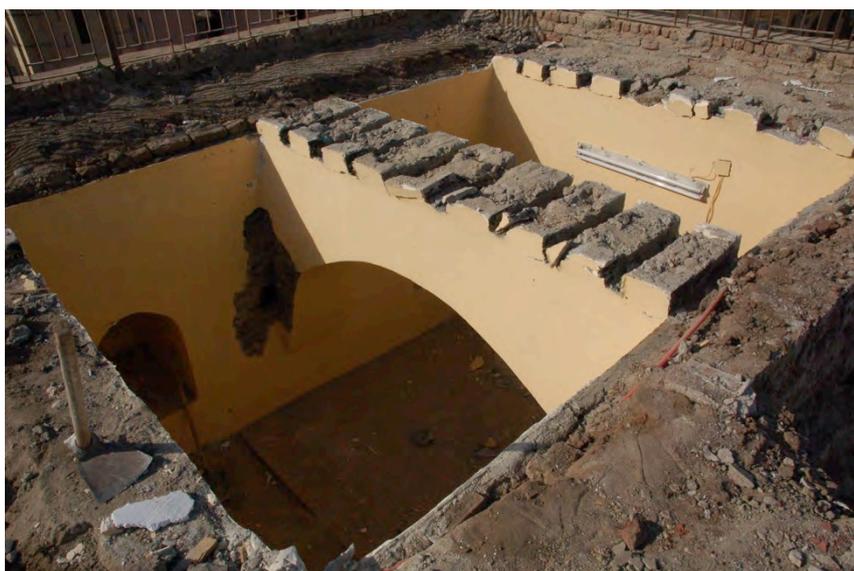
Fig. 7.39 View of southwest room from the northeast after removal of timber roof construction

This arch was part of a secondary phase of construction and was extremely weak. To strengthen it, and at the same time to allow for the construction of new vaulting over the southwest room, replacing the wooden roof installed here in 2001, three steel beams were introduced above the arch as shown on the attached photographs. Two shallow vaults (50 cm from springing to internal apex) were then built over the two halves of the room running north to south, with a third small relieving vault above and between them.
