**PRELIMINARY FIELD REPORT No1: Vol 2-Final Structural Report**

**DOCUMENTATION and CONSERVATION  
of the SHUNET el ZEBIB MONUMENT  
(c. 2,700 BC) Abydos, Egypt**

**VOLUME 2 - FINAL STRUCTURAL REPORT**

produced by Conor Power, PE, Structural Technology, Inc. for

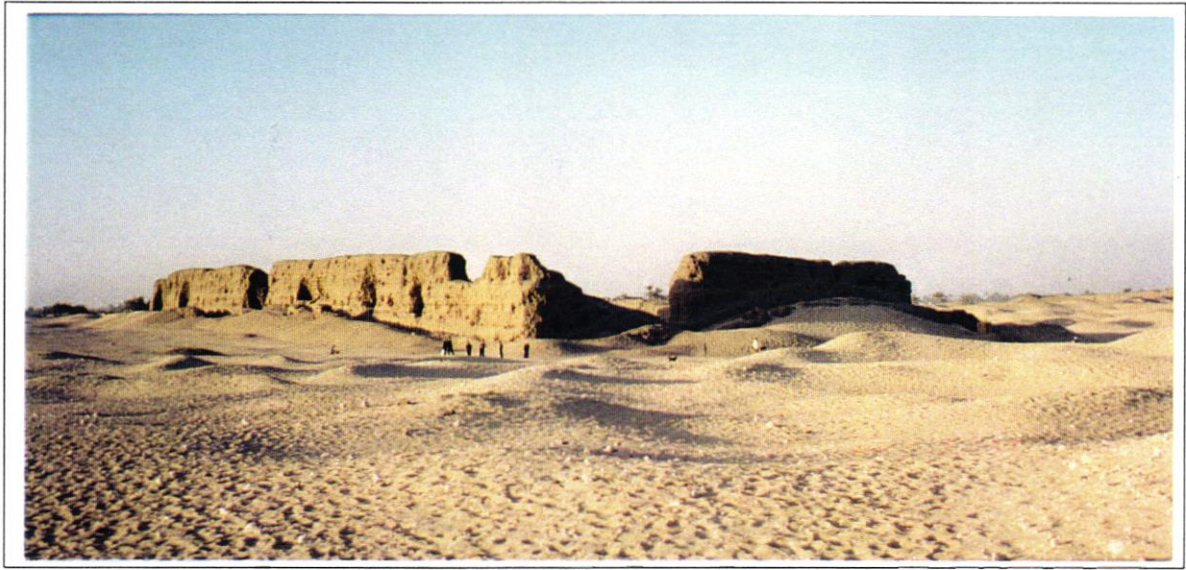
Photograph No. 1 Shunet El Zebib South View

Depicted in Photograph Nos. 1 and 2 as well as shown on Drawing S1 Shunet El Zebib occupies an extensive area and contains walls of massive proportions. The monument, which is rectangular in plan consists of an enclosure surrounded by two sets of mud brick walls. The longitudinal axis runs approximately in a northwesterly direction but for purposes of this report all walls will be referenced to the "job north" direction shown on Drawing S1 and as indicated on Photograph No. 2.

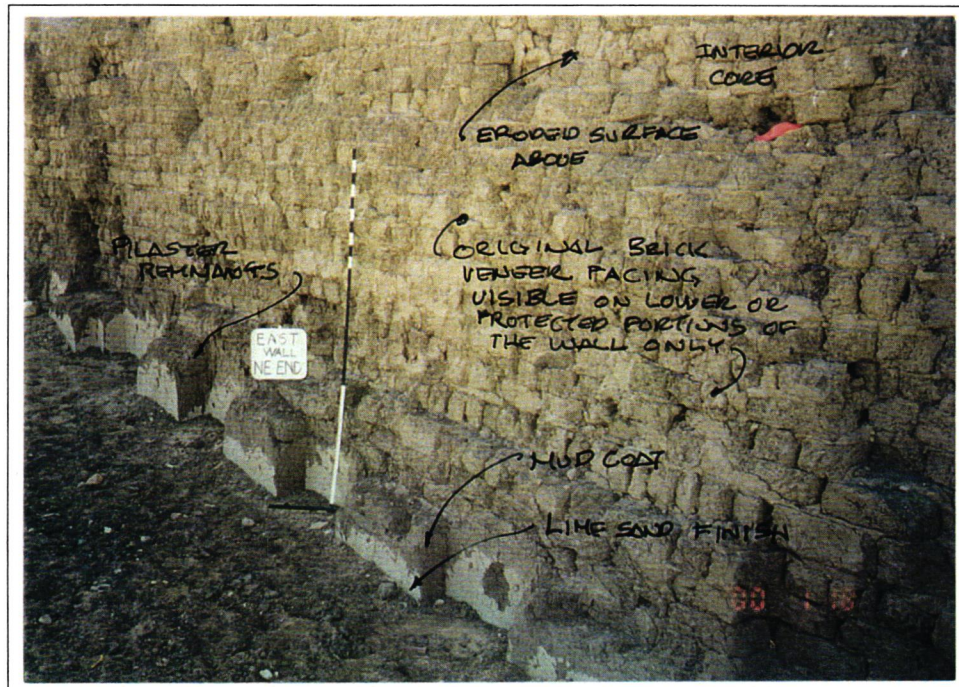
Photograph No. 4 Original Surfaces at Grade

Surprisingly, at certain locations such as that indicated by Photograph No. 4, the original surface on the walls is present and consists of a coating of mud over which has been placed a weak plaster of lime and very fine sand. Structurally, given their age and the materials used for construction, these walls are in remarkable condition, represent, to a degree, the limit of engineering with mud brick, and are worthy of whatever conservation and protection can be afforded them.

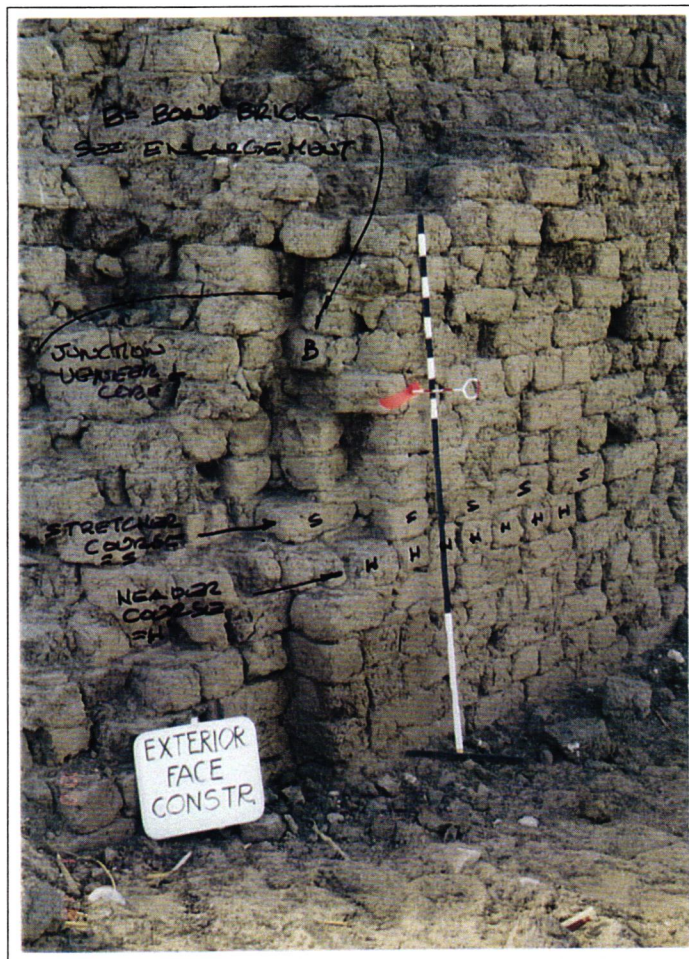
Photograph No. 5 Veneer and Core Wall Coursing

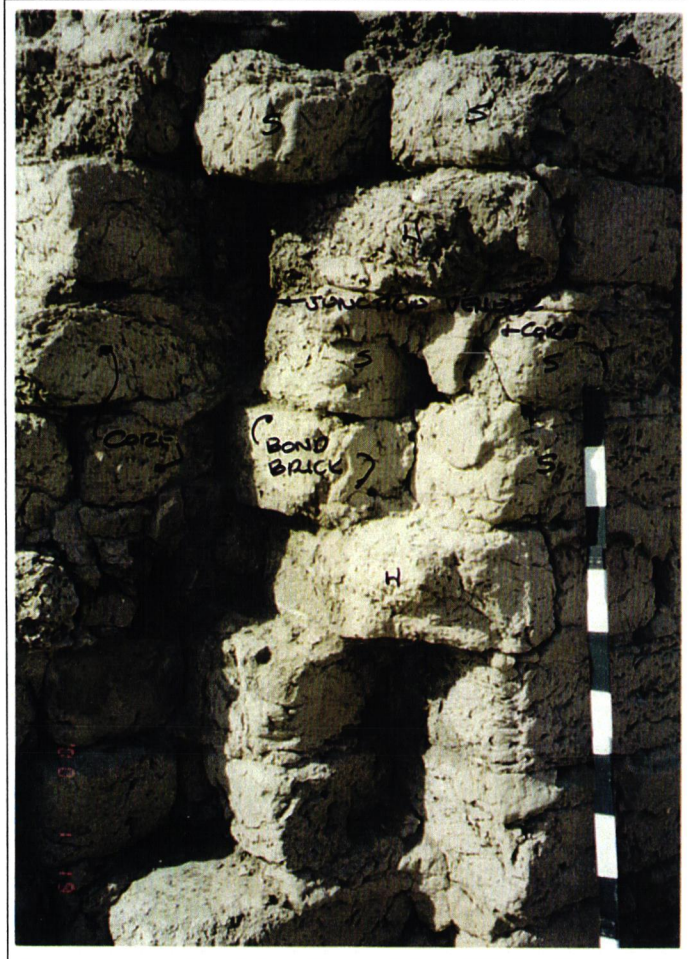
At those limited number of locations where bonding could be observed by the author, the exterior veneer appeared to be, by today's standards, poorly bonded to the interior core. The bond bricks appear to be irregularly placed and relatively few in number. The mud mortar used within the construction is quite adhesive and does contribute to the bond between the veneer and core; however, gaps in its use can be observed Photograph No. 7. As will be discussed below, the bonding method of the core is significantly stronger in the transverse direction (perpendicular to the face of the wall) than that of the veneer. The result of these findings and one proved by observation is that the veneer has and will, if exposed, degrade at a far more rapid rate than that of the core.

Photograph No. 7 Bond Bricks

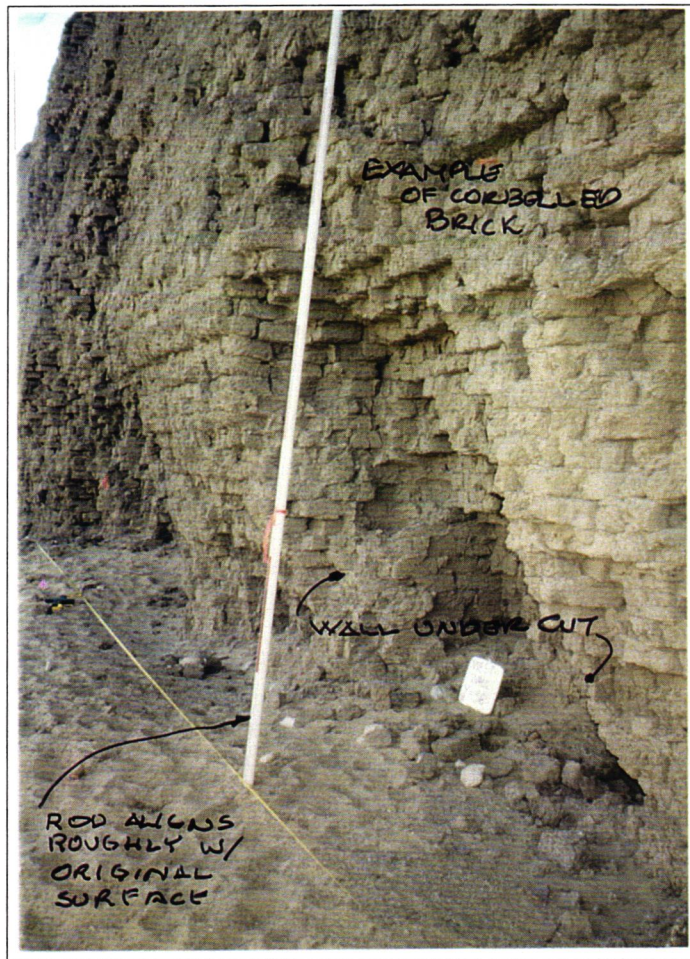
Photograph No. 15 Wall Undercutting

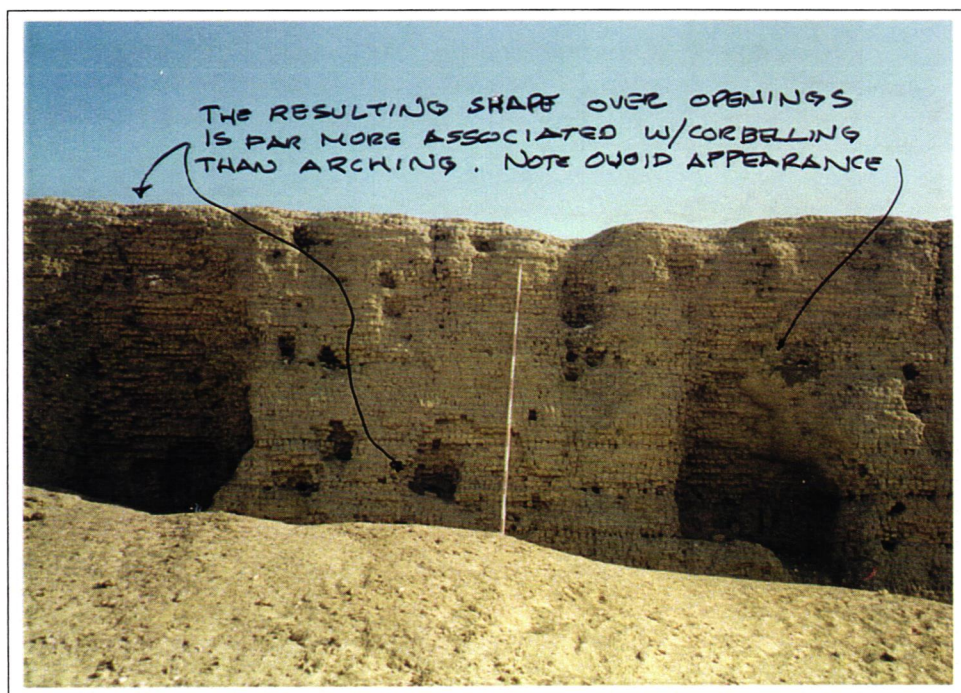
Photograph No. 16 Ovoid Cavitation

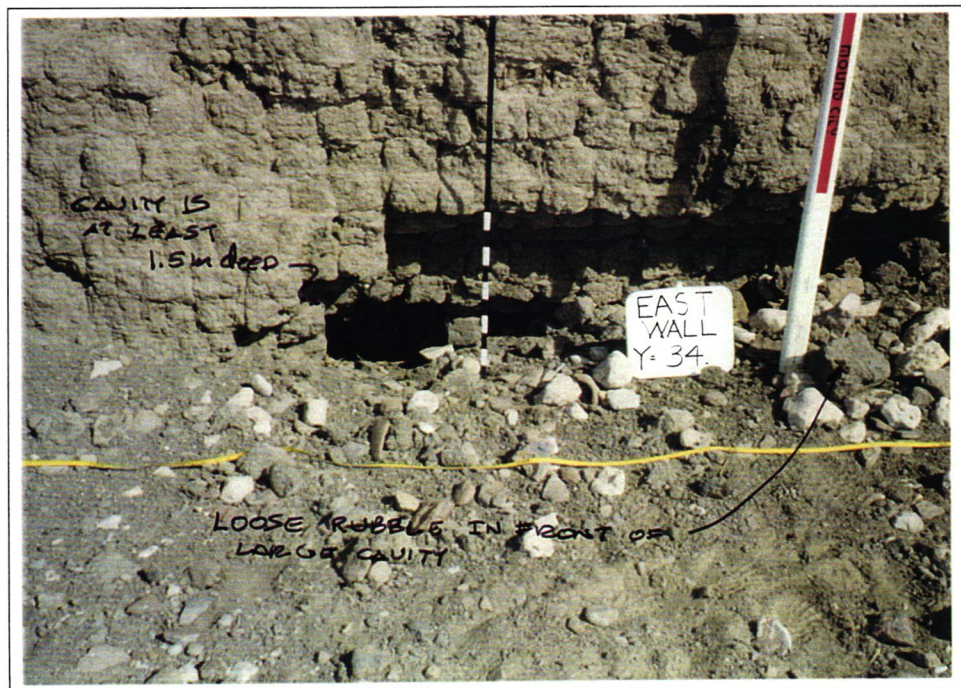
Photograph No. 20 Base Undermining

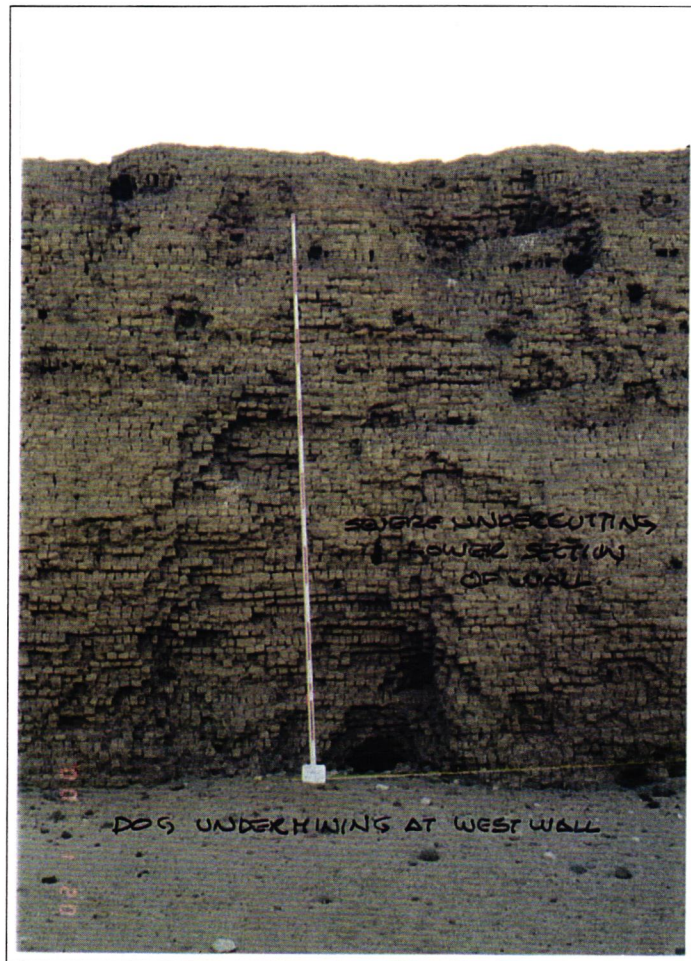
Photograph No. 21 Base Undermining

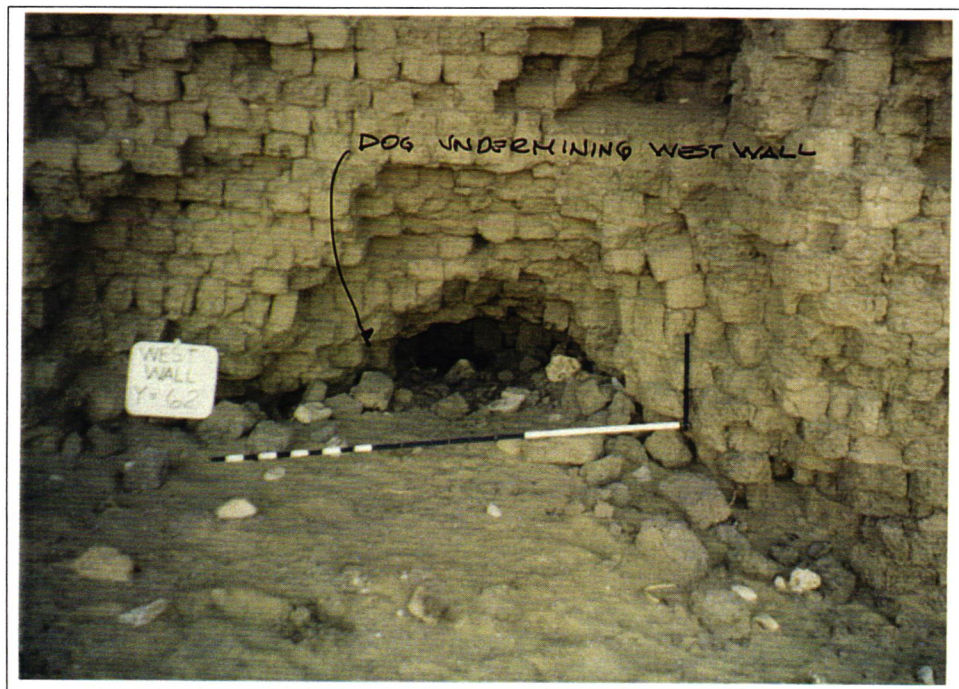
Photograph No. 22 Base Undermining

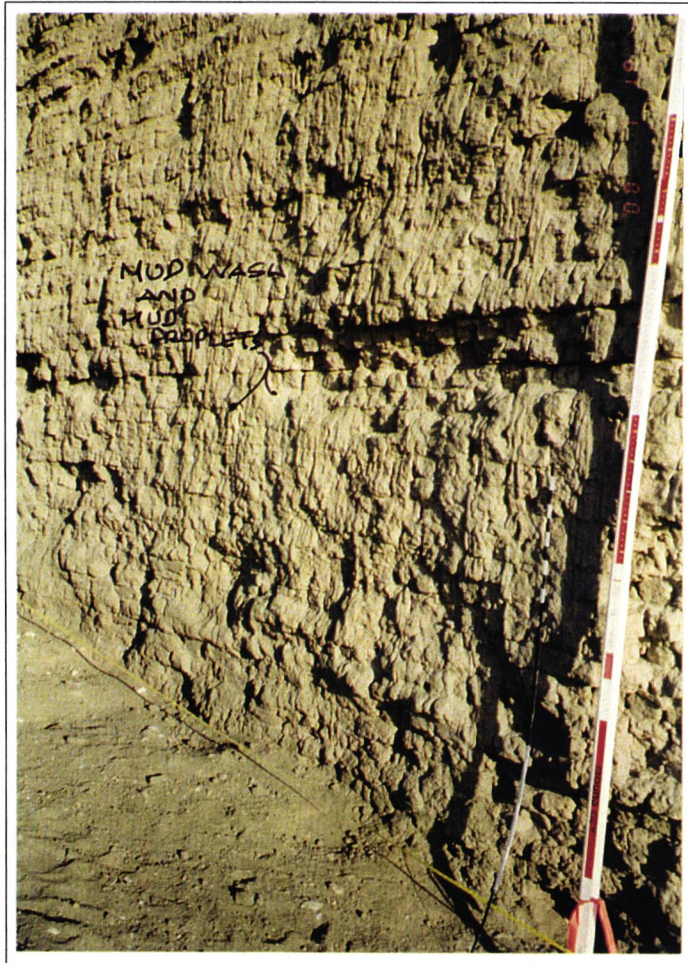
Photograph No. 23 Mud Wash and Droplets

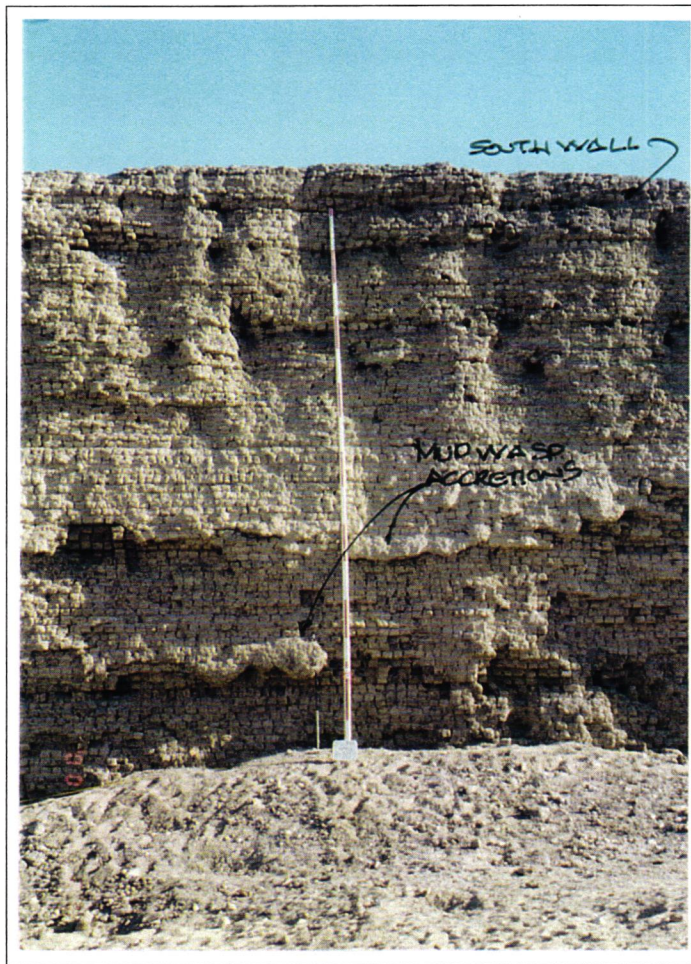
Photograph No. 25 Mud Wasp Accretions

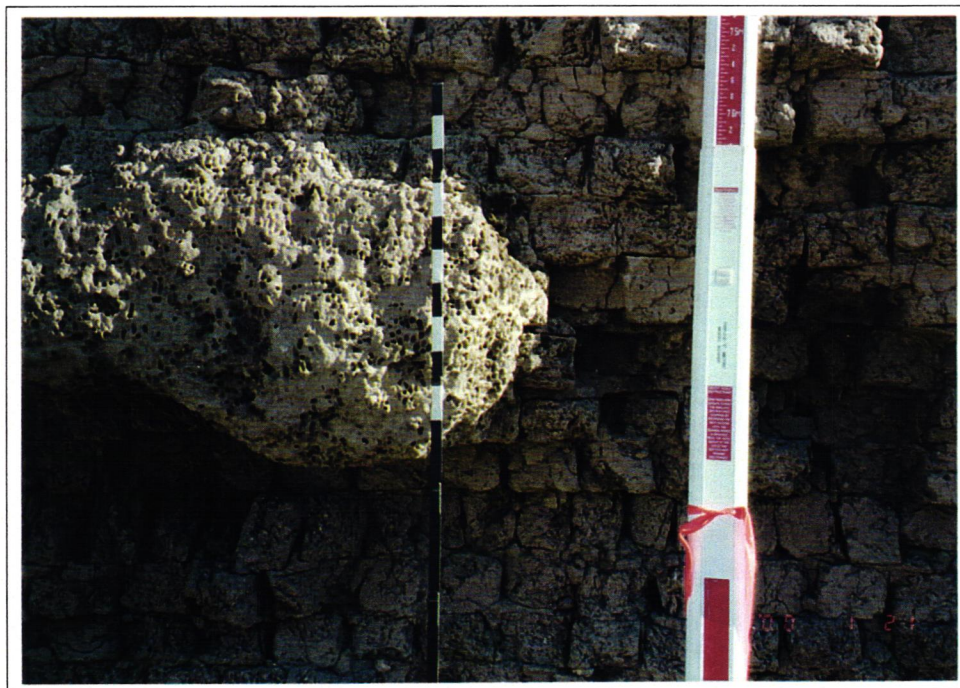
Photograph No. 26 Mud Wasp Accretion

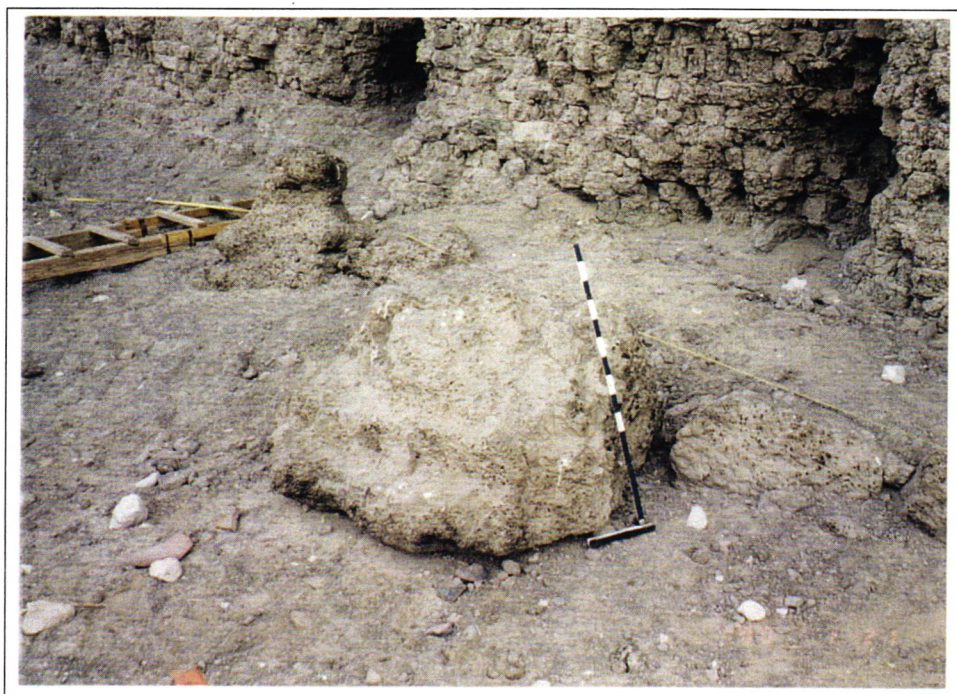
Photograph No. 27 Mud Wasp Accretion

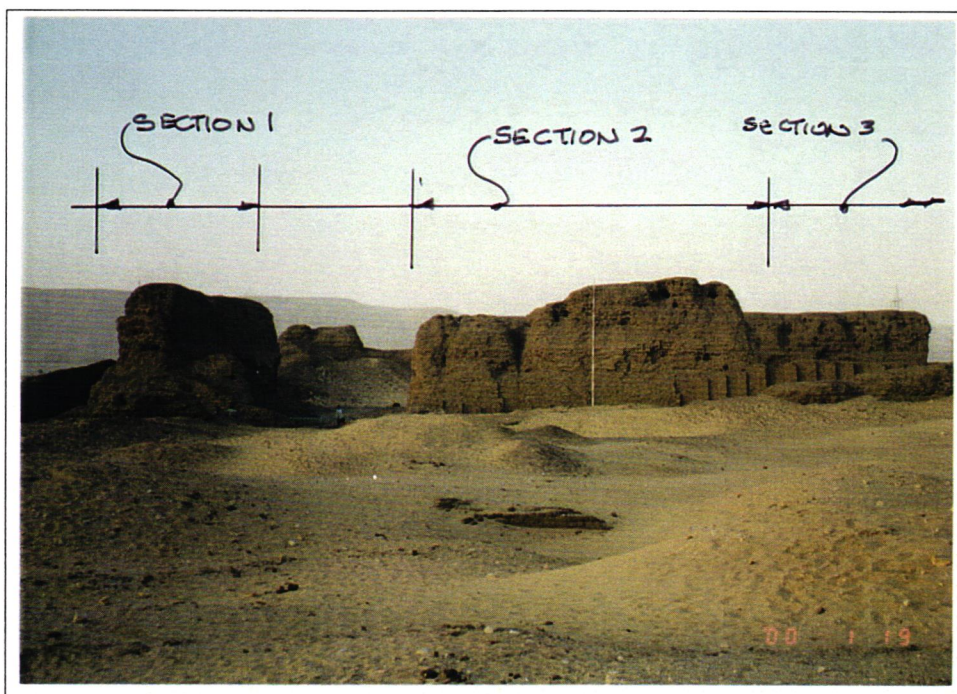
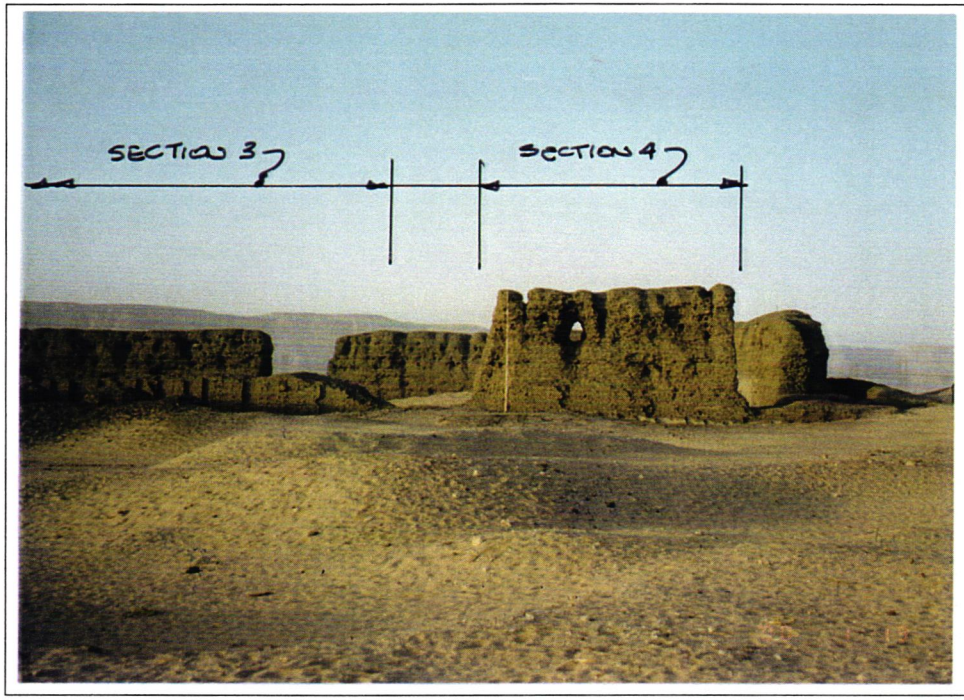
12. The low height interior portion of the wall designated as "Section 3" on Photograph Nos. 28 and 29 contains some of the most dangerous conditions existing at the site; however, the exterior face shown by Photograph Nos. 45 and 46 is in remarkable condition despite the low priority local failure of several existing pilasters. The interior of this wall described by Photograph No. 47 is characterized by numerous undermining conditions, active movement of brick masses, extensive cracking and the presence of inclined brick surfaces. A potential for immediate failure exists at virtually any point along the entire length; all repairs indicated below should be assigned an urgent priority.

Photograph No. 28 East Main Enclosure Wall Divisions

Photograph No. 29 East Main Enclosure Wall Divisions

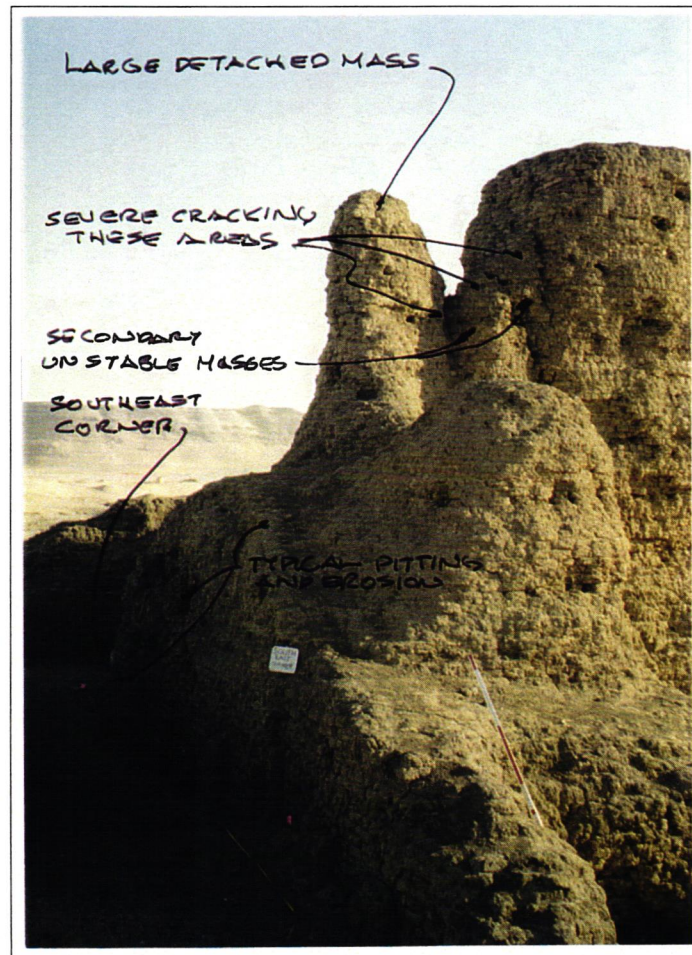
Photograph No. 30 Detached Mass Southeast Corner

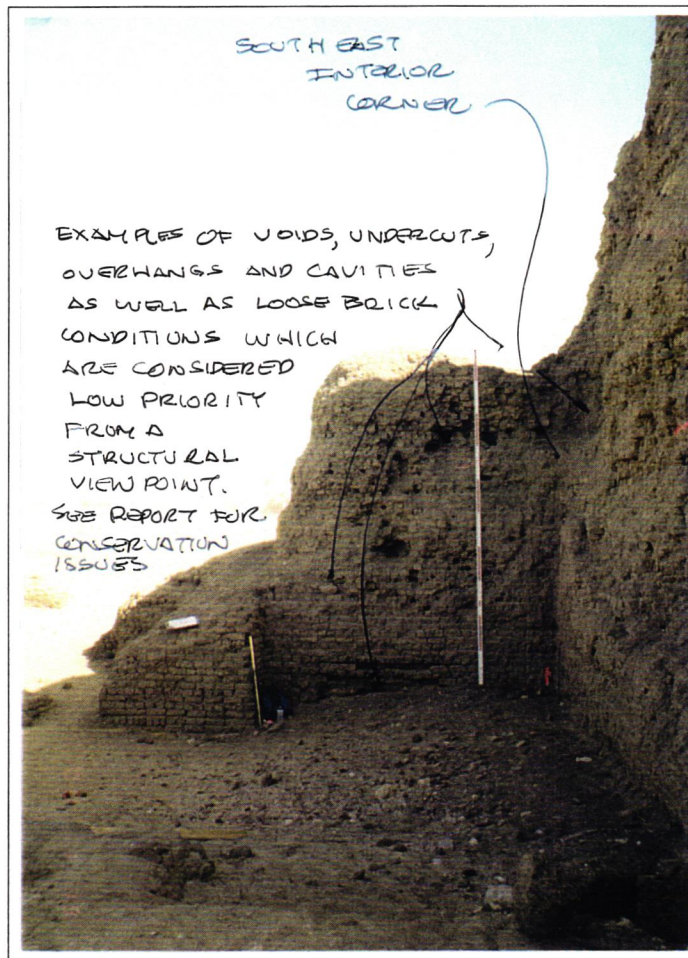
Correction of every wall defect such as those indicated in Photograph No. 33 is not totally necessary from a structural viewpoint. However, such items, designated as low priority within this section only, present conservation issues and are discussed in the other portions of the main report.

Photograph No. 33 Low Priority Structural Examples

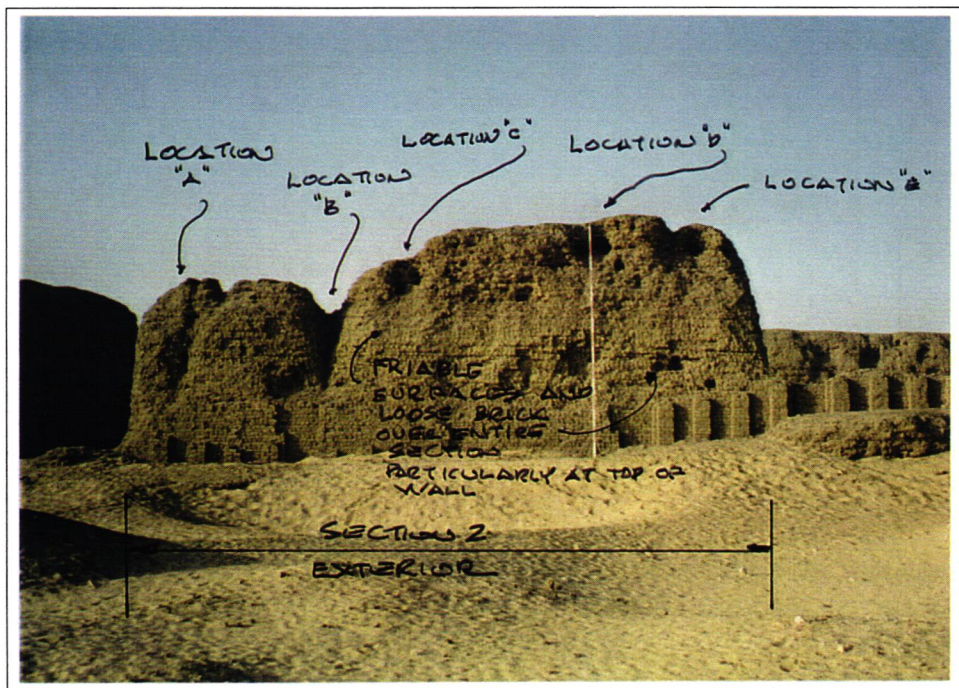
Photograph No. 34 "Section 2" East Main Enclosure Wall

4. At Location "C" depicted by Photograph No. 34 loose brickwork and moderate cavitation were observed. Local high priority rebuilding is recommended in order to reduce the potential for accelerated deterioration.

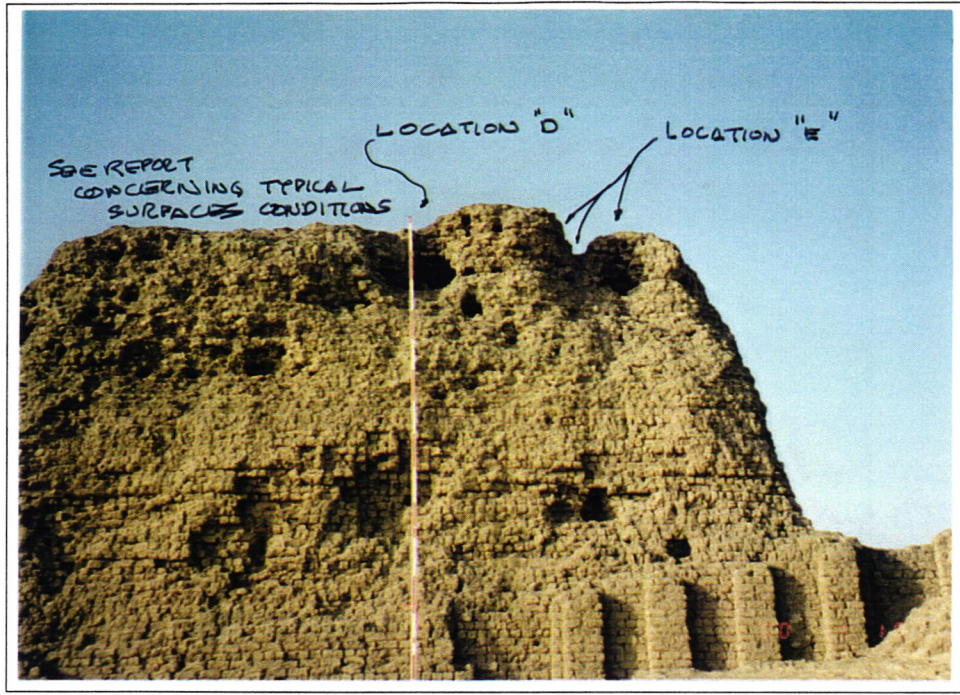
6. At Location "E" delineated by Photograph Nos. 34 and 39, cavitation and erosion at the top of the wall have produced an area of loose overhanging brick which, because of the height and position, should be assigned an urgent priority for local rebuilding. During this work the sharp erosion pattern visible in Photograph No. 39 should be eliminated.

Photograph No. 39 Location "D" and "E" East Main Enclosure Wall Exterior View

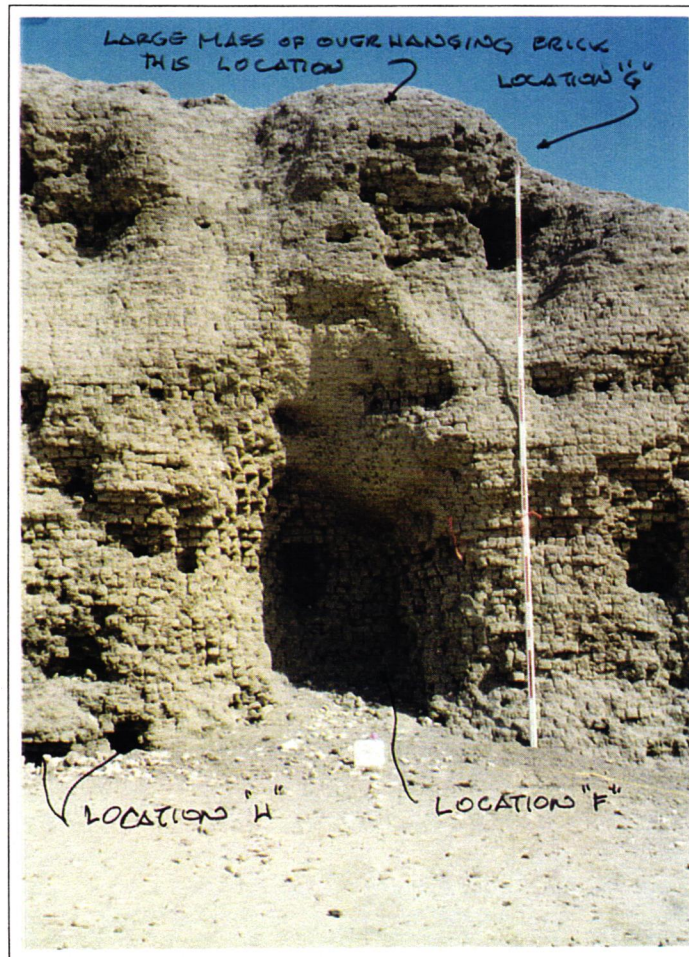
8. A large mass of corbelled overhanging brick occurs at location "G" shown in Photograph No. 40; a moderately sized cavity also exists on the south side of this overhang. Since the

Photograph No. 40 Location "F" and "G" East Main Enclosure Wall Interior View

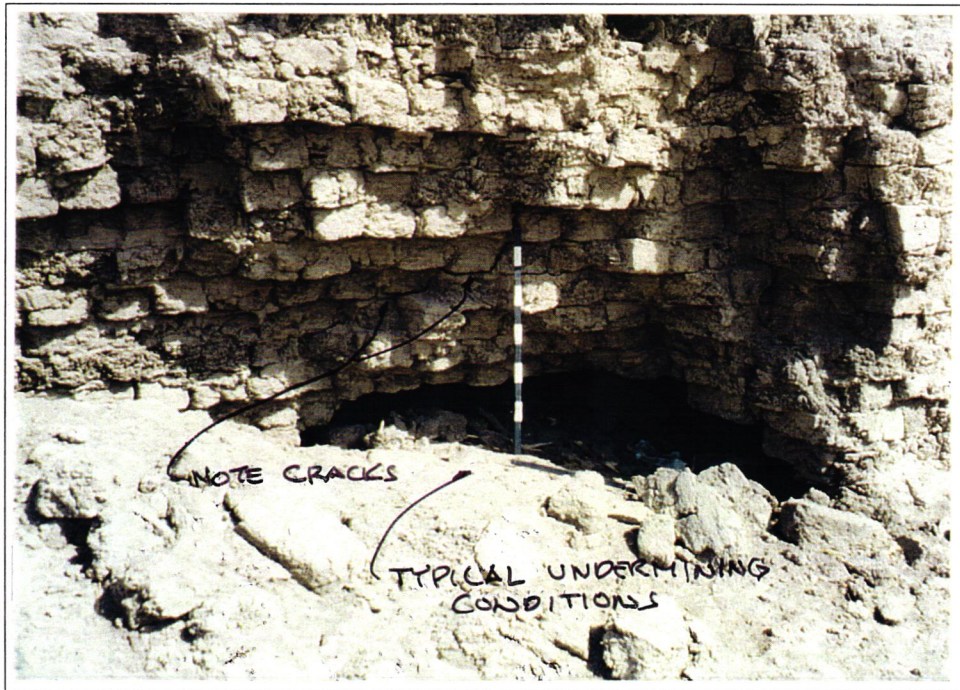
Photograph No. 50 Undermining at East Main Enclosure Wall

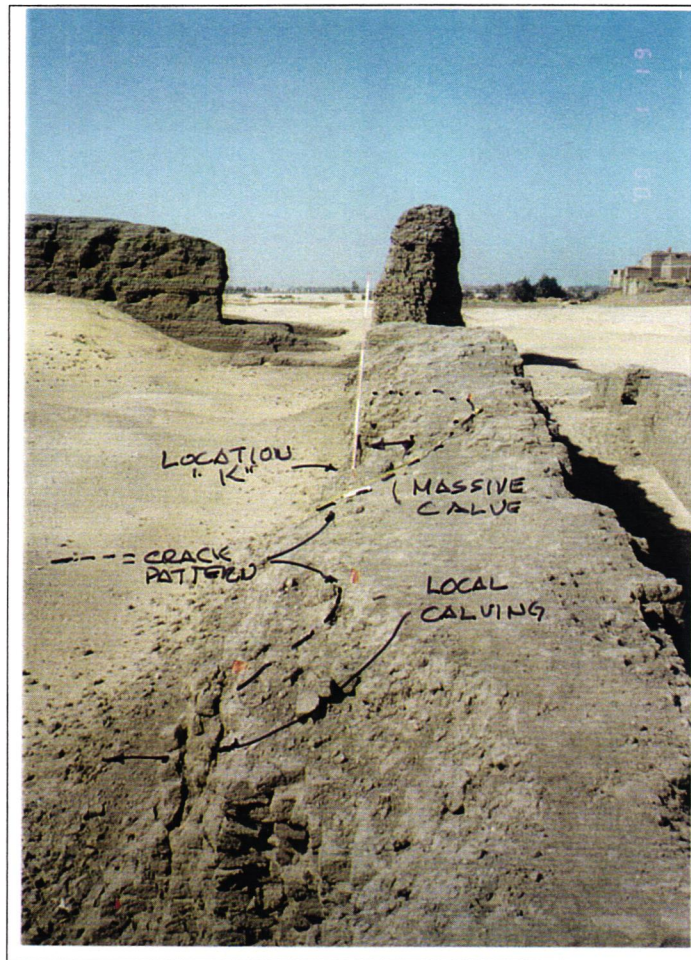
Photograph No. 51 Massive Calving at "Section 3" East Main Enclosure Wall

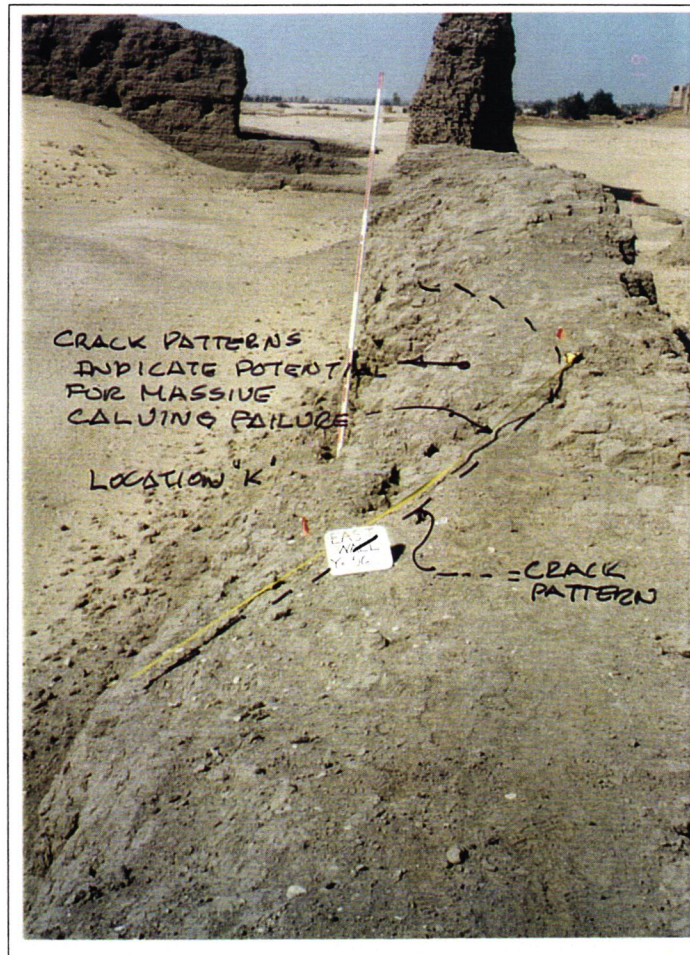
Photograph No. 54 Massive Calving at "Section 3" East Main Enclosure Wall

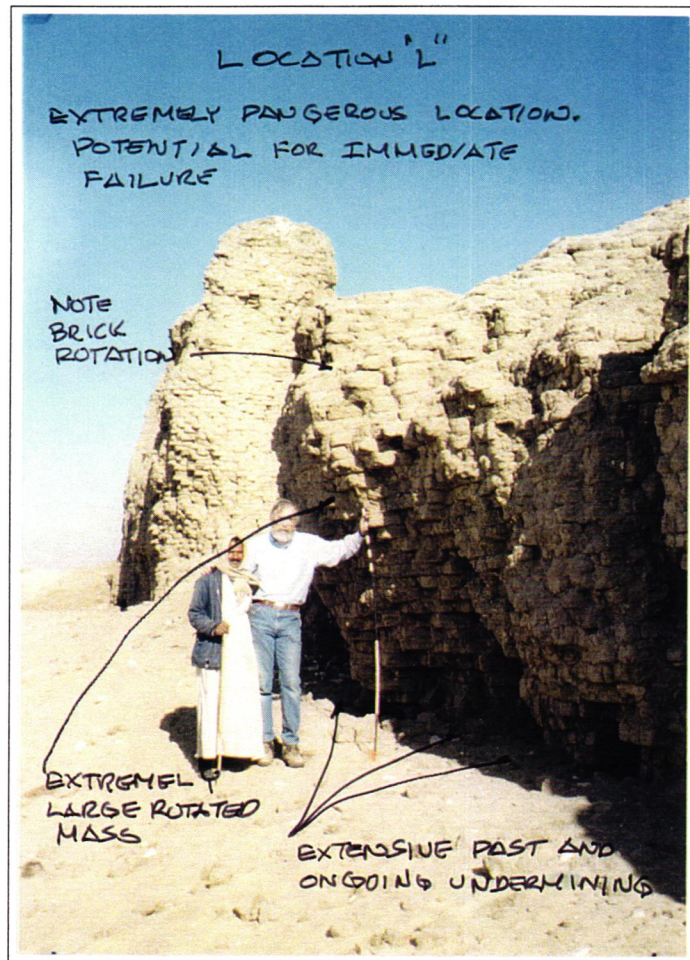
14. A particularly dangerous condition occurs at Location "L" depicted by Photograph No. 55 where an extremely large rotated mass of wall exists. Extensive past and continuing undermining activity is evident.

Photograph No. 55 Extremely Rotated Massive

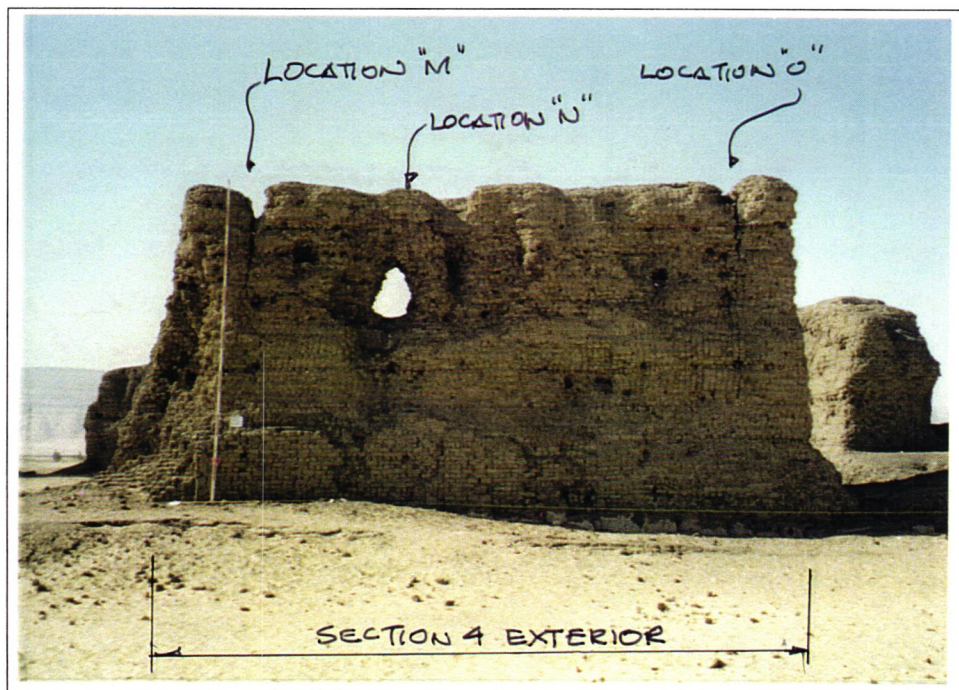
Photograph No. 56 "Section 4" East Main Enclosure Wall Exterior View

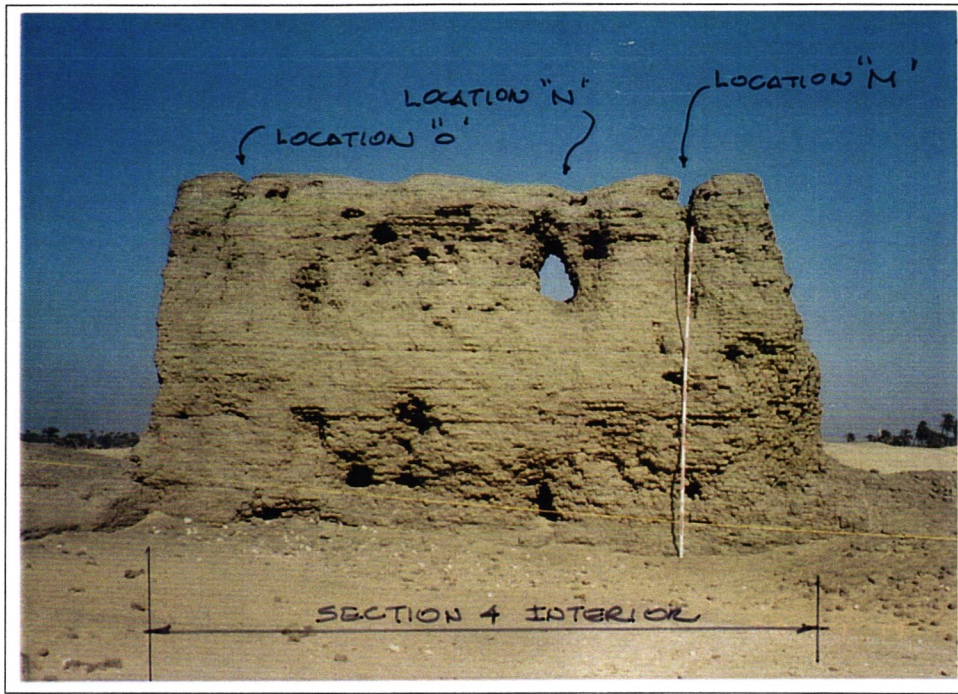
Photograph No. 57 "Section 4" East Main Enclosure Wall Interior View

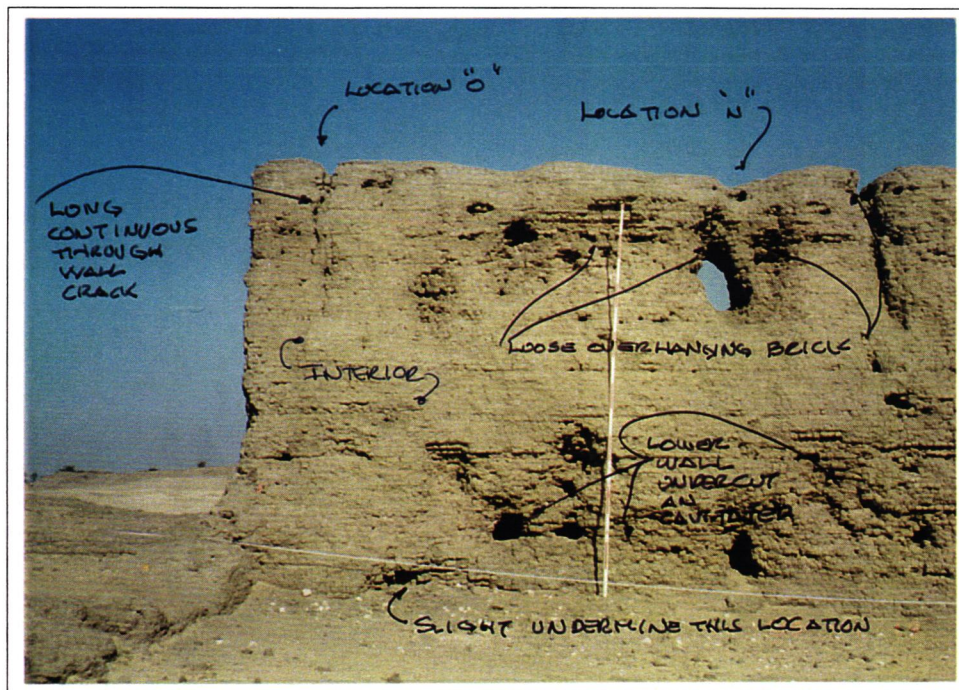
Photograph No. 62 "Section 4" East Main Enclosure Wall North End

18. Undercutting, cavitation and slight undermining conditions are somewhat concentrated on the lower portion of the west face as shown by Photograph No. 62. These are normal priority repairs.

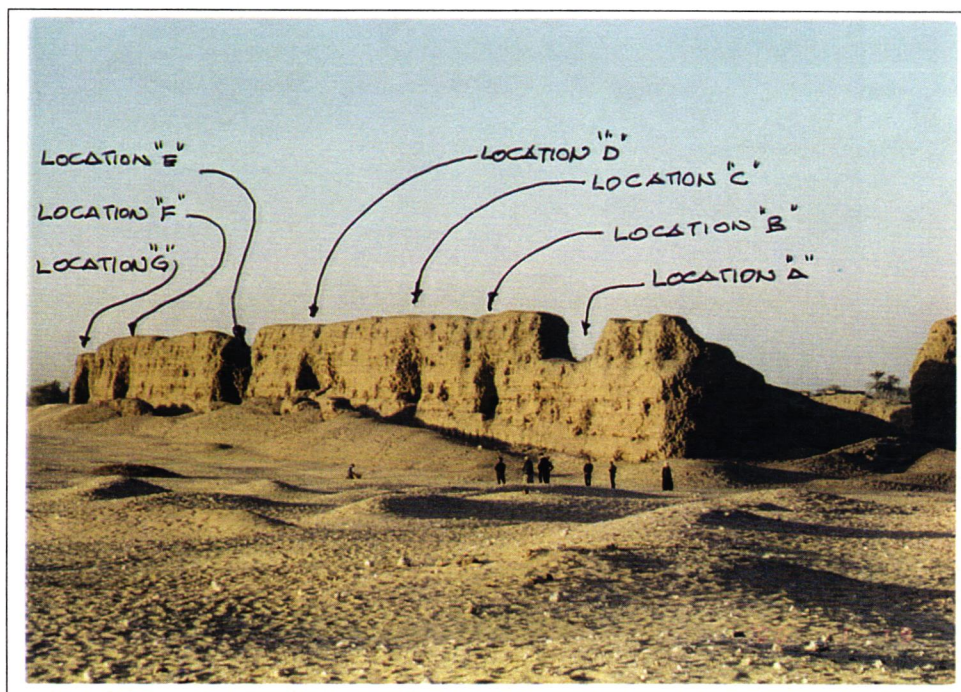
Photograph No. 64 West Main Enclosure Wall Reference Locations

Specific locations on the West Main Enclosure Wall are delineated on Photograph No. 64. These will be used to identify areas of interest in the discussion which follows. The following discrepancies were observed:

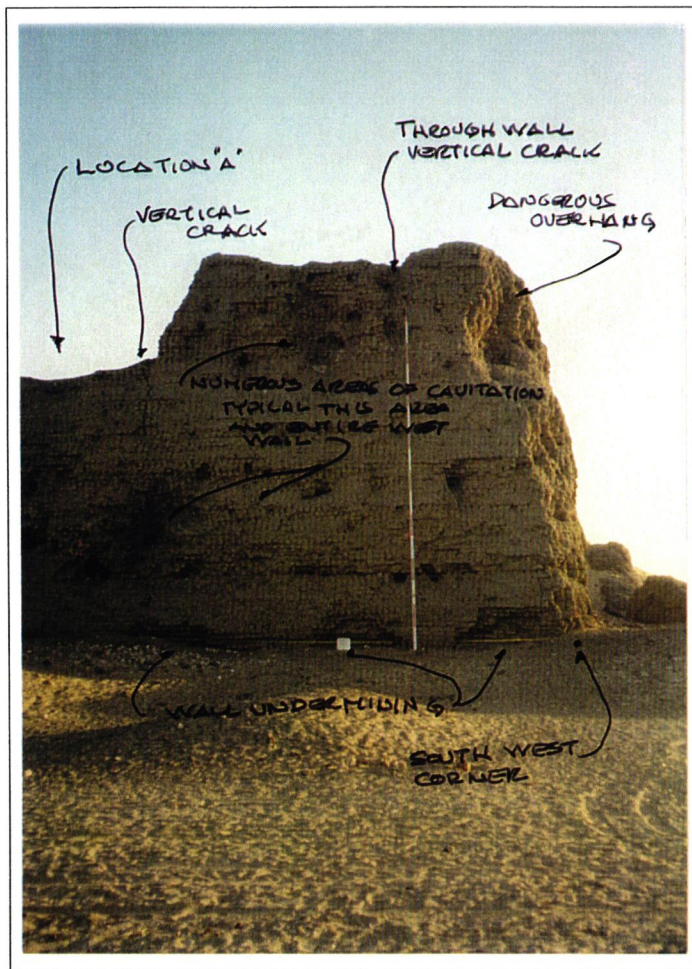
Photograph No. 65 West Main Enclosure Wall South End

1. A somewhat dangerous overhang occurs at the southeast corner as shown by Photograph No. 65 through 67. Since the brick below this condition extends beyond the defect, this high priority repair should be relatively easy to correct. The apparent small calve also indicated would be removed or rebuilt.

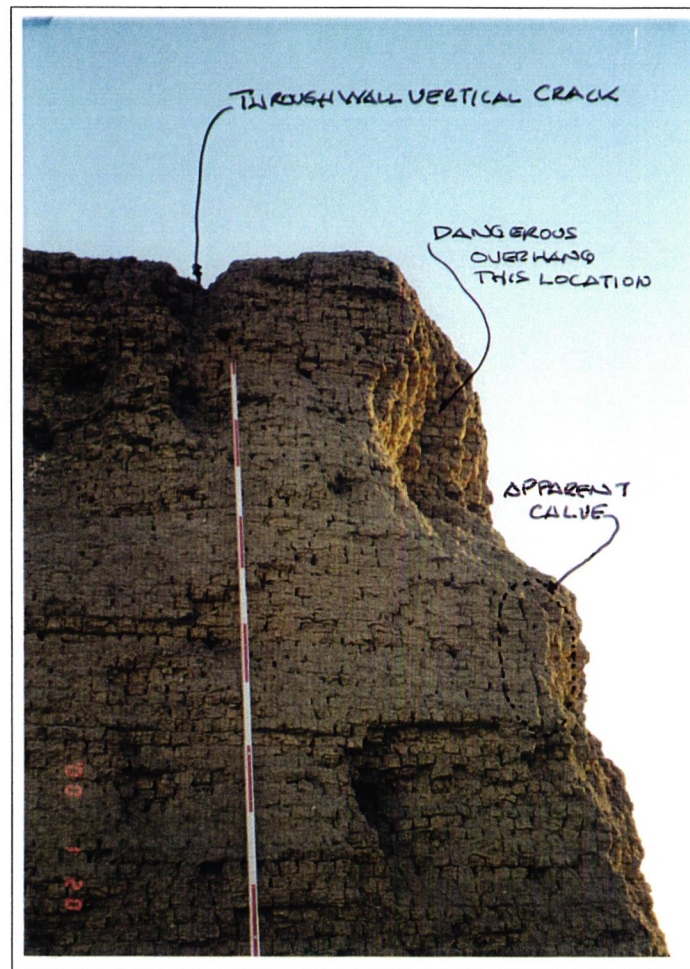
Photograph No. 66 West Main Enclosure Wall South End

Near this same location at the position designated on Photograph No. 66 another overhang containing loose brick exists. Since the surface below this area has deeply eroded, this is another example of a situation that cannot be rectified without extensive modification of the present appearance. At this position we therefore recommend as a high priority repair that all small cavities and open joints be filled, that all loose brick be reset, and, if possible, the surface be rebuilt slightly outward beyond the existing contour using methods previously described.

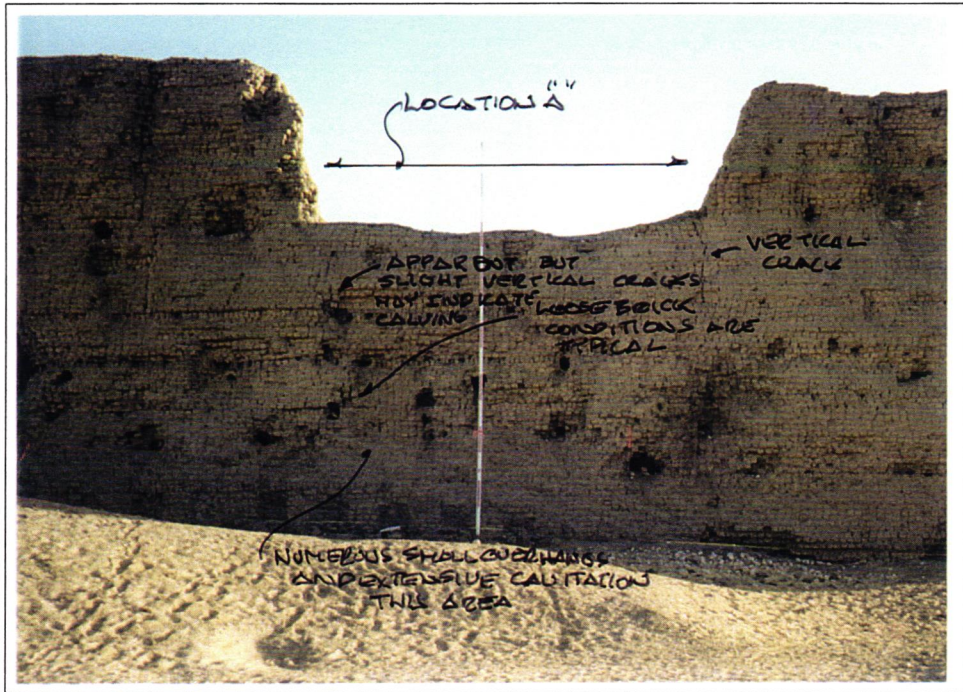
Photograph No. 69 Location "A" West Main Enclosure Wall

4. At the south end of the Location "A" a vertical crack occurs at the position indicated by Photograph No. 69. This low priority condition appears to be one of the few cases that may have resulted from differential settlement. As shown by Photograph Nos. 70 and 71 a large sand dune exists at the interior southwest corner; producing increased bearing strata loads at that location.
