**PRELIMINARY FIELD REPORT No1: Vol 2-Final Structural Report**

**DOCUMENTATION and CONSERVATION  
of the SHUNET el ZEBIB MONUMENT  
(c. 2,700 BC) Abydos, Egypt**

**VOLUME 2 - FINAL STRUCTURAL REPORT**

produced by Conor Power, PE, Structural Technology, Inc. for

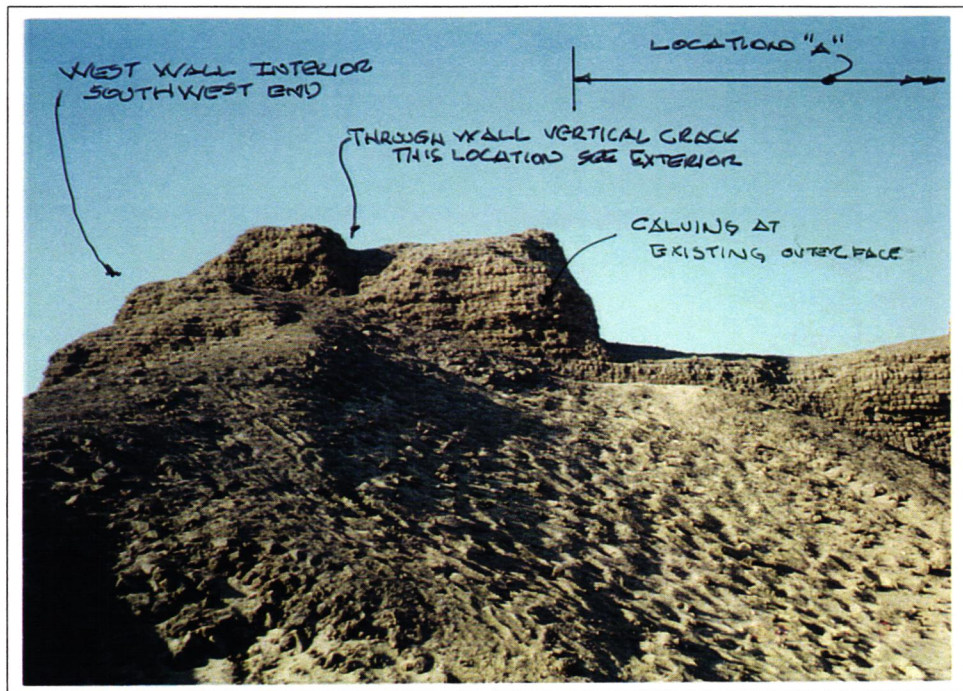
Photograph No. 70 Interior Southwest Corner West Main Enclosure Wall

4. At the south end of the Location "A" a vertical crack occurs at the position indicated by Photograph No. 69. This low priority condition appears to be one of the few cases that may have resulted from differential settlement. As shown by Photograph Nos. 70 and 71 a large sand dune exists at the interior southwest corner; producing increased bearing strata loads at that location.

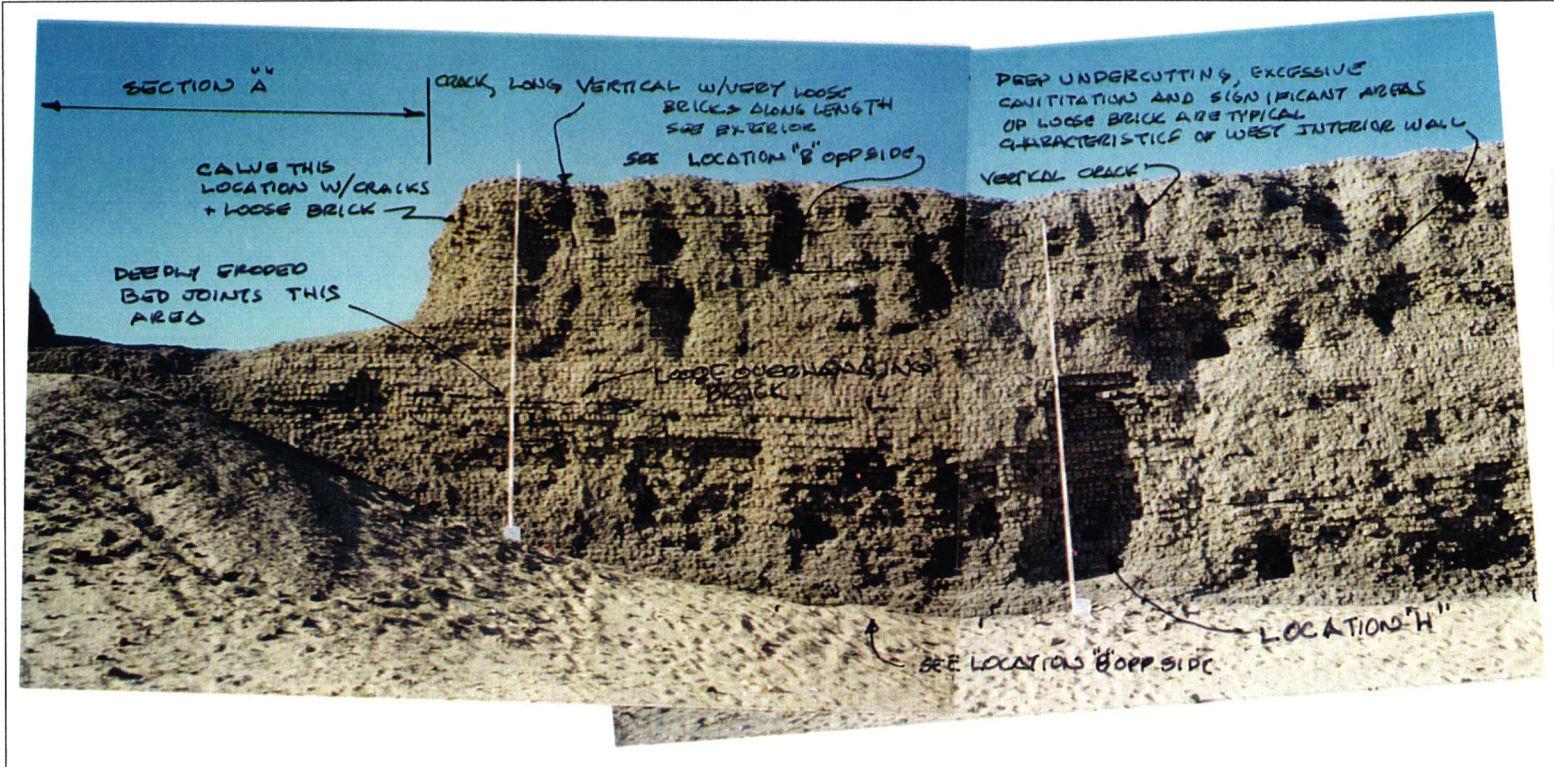
On the interior side of the wall, shown by Photograph No. 71, the surface is typically characterized by deep base undercutting and excessive cavitation with significant areas of loose brick. A cross-section through the wall at this location is delineated by Detail 2 on Drawing S1.

Composite Photograph No. 71 West Main Enclosure Wall, Interior View Adjacent to Location "A"

8. In accordance with the above recommendations an area of loose overhanging brick with deeply eroded bed joints identified in Photograph No. 71 should be locally reconstructed.

10. Between Location “B” and “C”, on the interior side of the wall, an area containing particularly loose brick and a moderately sized cavity exists and is identified as Location “H” on Photograph Nos. 71 and 80. This cavity should be filled and the areas of loose brick should be reset as previously described. Moderate wall undercutting and slight local undermining are also present at the position identified as Location “I” on Photograph No. 81. As a high priority repair we recommend that this undercut portion of wall be reconstructed.

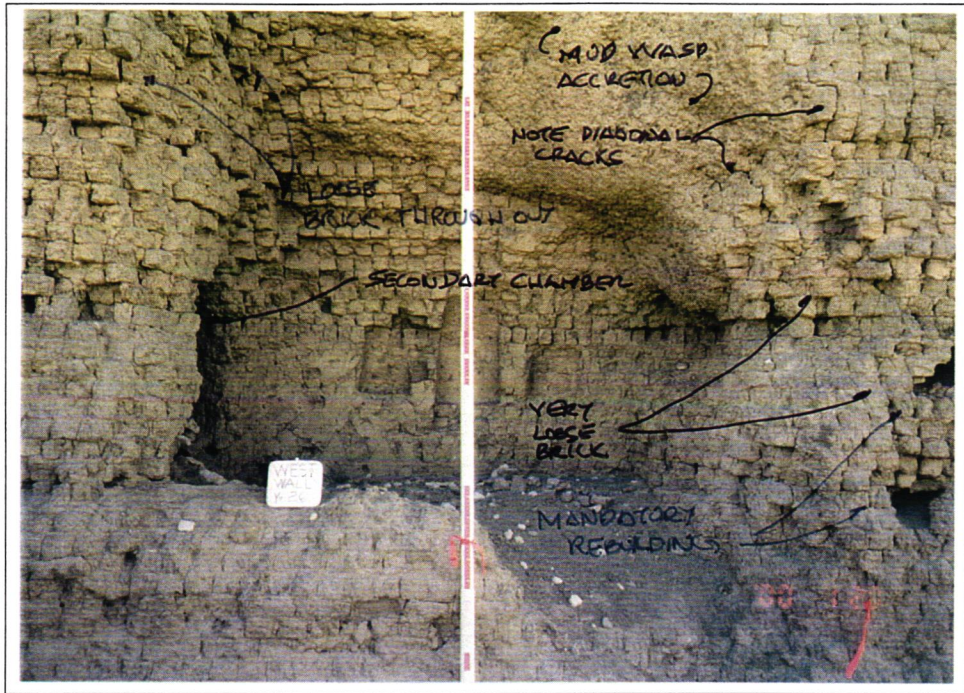
Photograph No. 74 Location "B" Monastic Cell

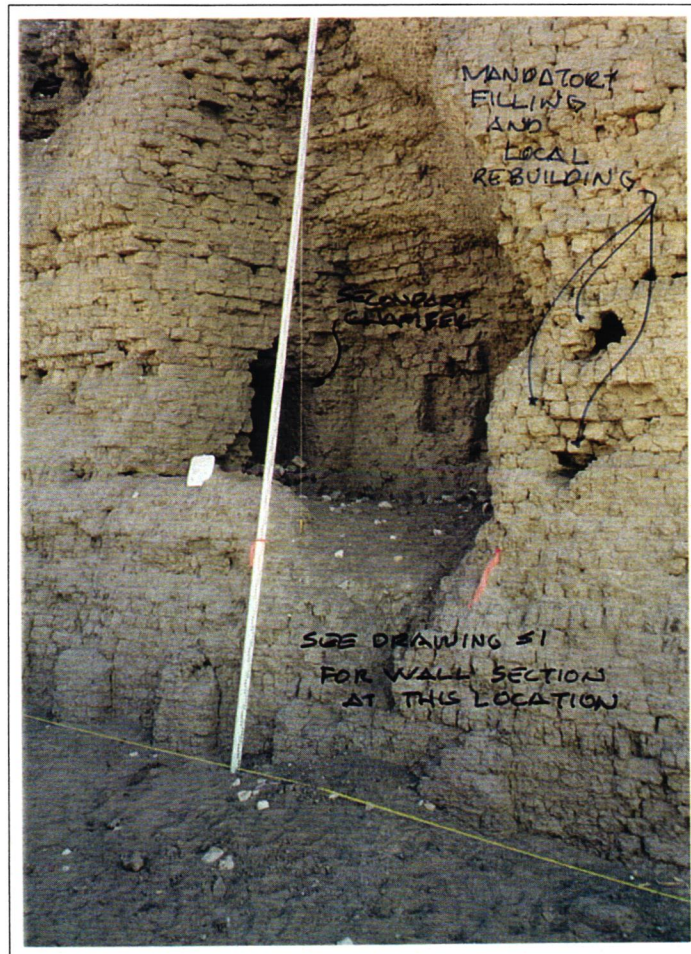
Photograph No. 75 Location "B" Monastic Cell Brick Instability

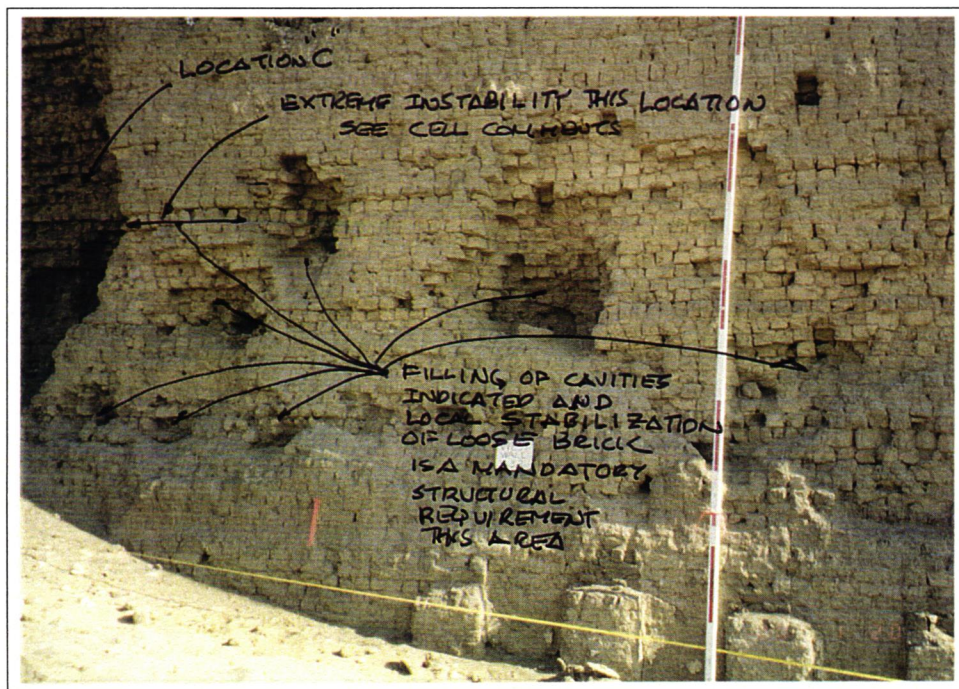
Photograph No. 79 Wall Instability Adjacent to Location "C"

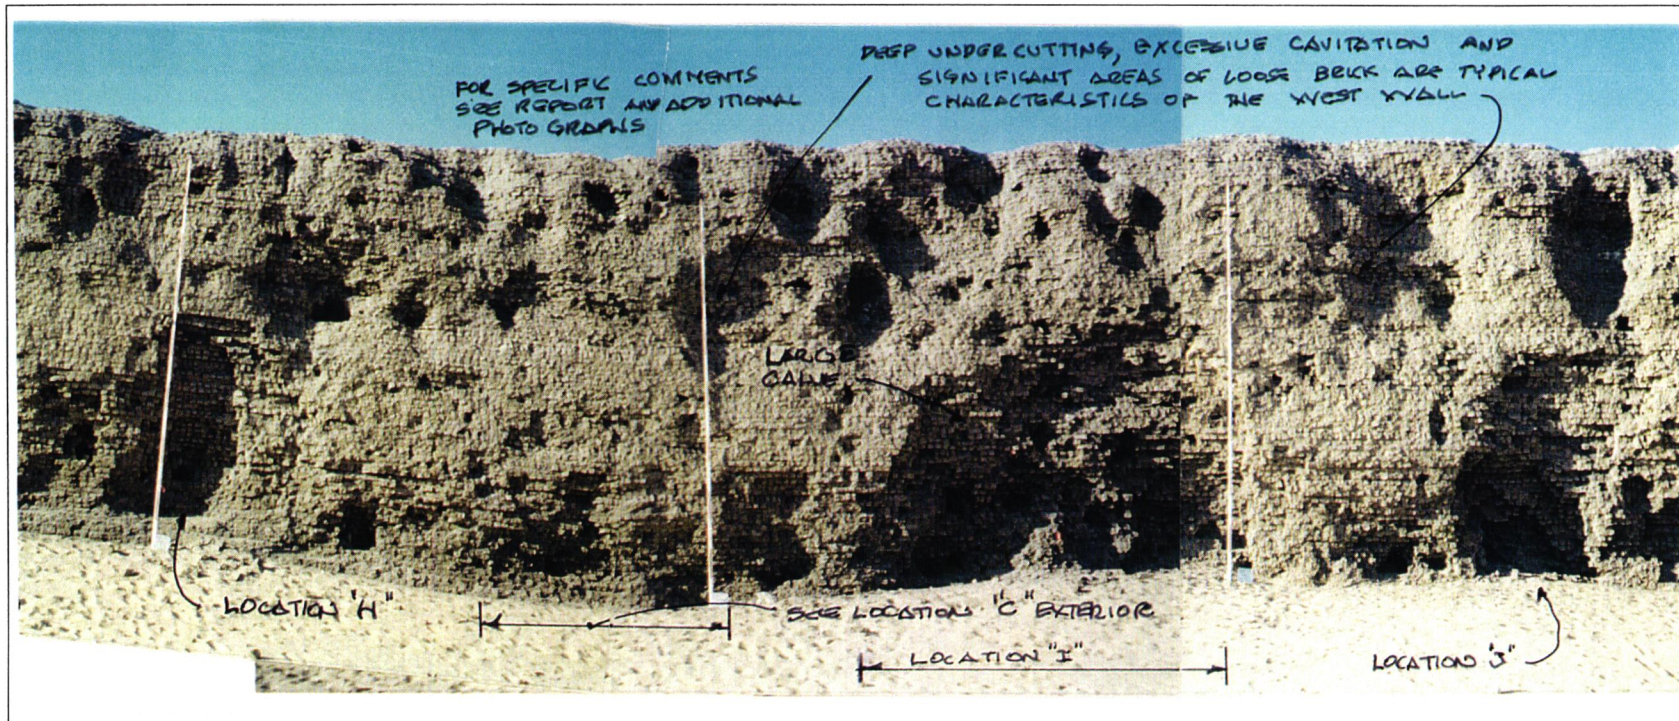
Composite Photograph No. 81 Locations "H", "I" and "J" Interior West Main Enclosure Wall

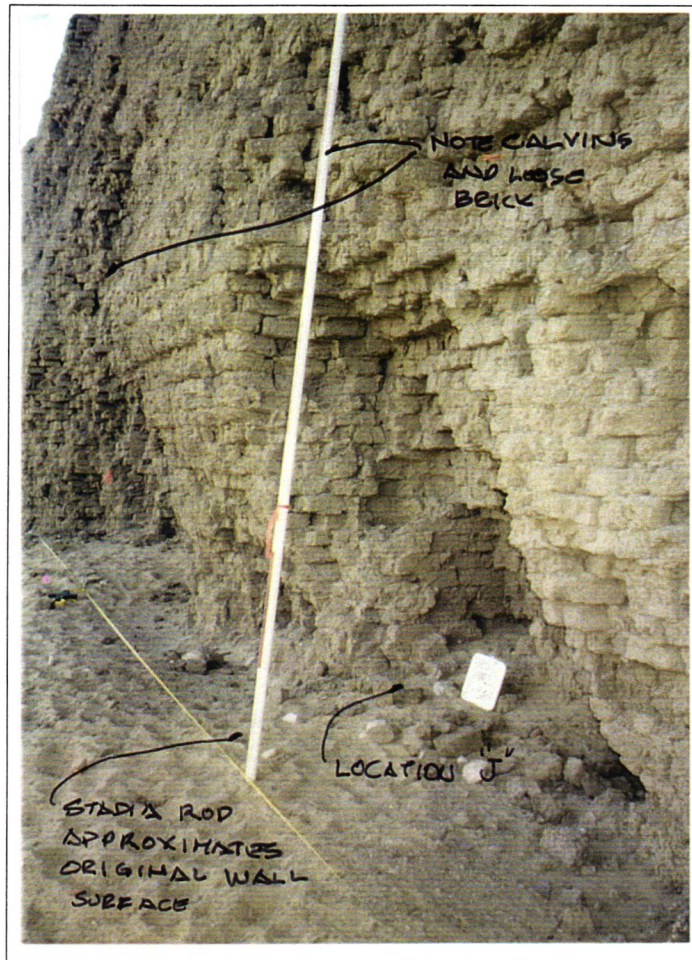
Photograph No. 85 Wall Undercutting West Main Enclosure Wall

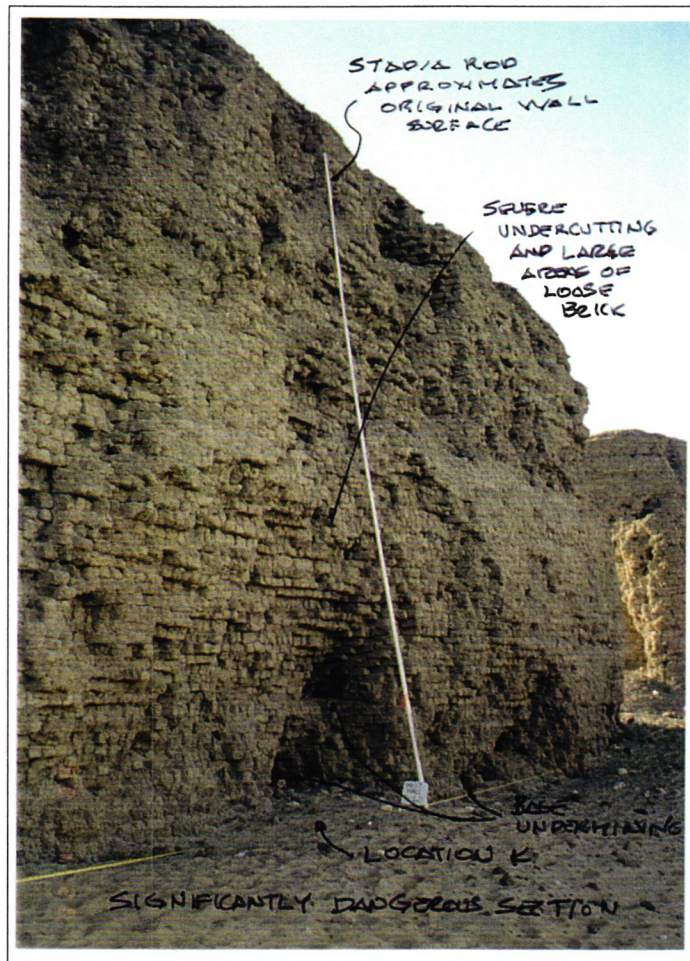
Photograph No. 87 Wall Undercutting West Main Enclosure Wall

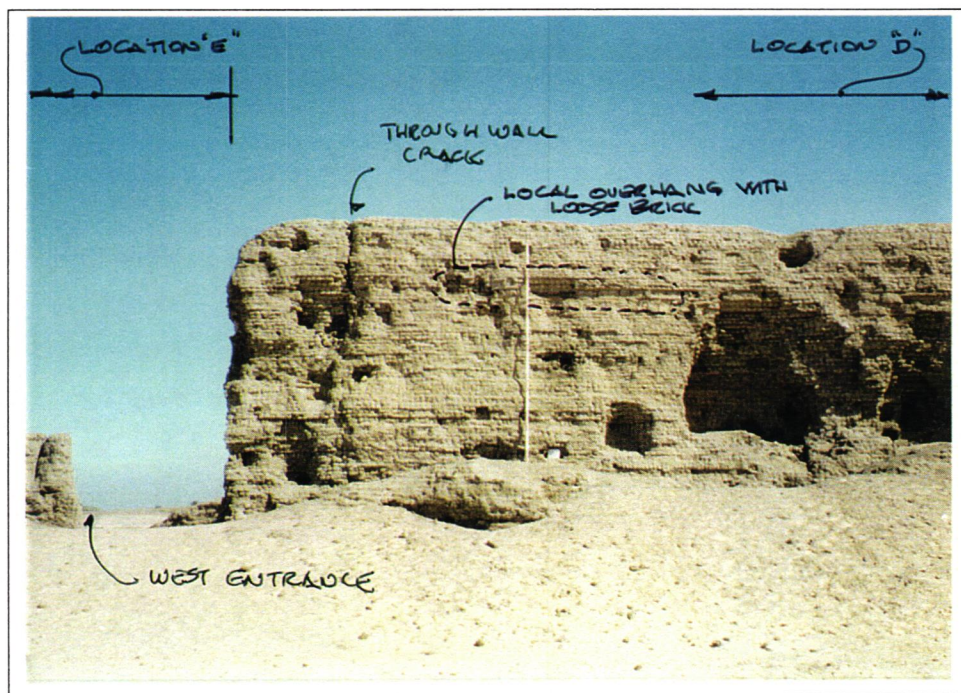
Photograph No. 88 West Main Enclosure Wall Near West Entrance

13. An area of loose overhanging brick occurs immediately adjacent to Location "D" at the position indicated on Photograph No. 88. Repair of this normal priority item simply involves local rebuilding and resetting of individual bricks.

14. The wall gap designated as Location "E" by Photograph No. 64 corresponds approximately to the position of the original west entrance. Very significant vertical cracks occur at each of the end walls that frame this area. The first is described in Photograph Nos. 88 and 89 while the second is indicated by Photograph Nos. 90 and 91. The conditions at the latter position are further complicated by the presence of an extremely unstable mass of brick identified in Photograph Nos. 92 and 93.

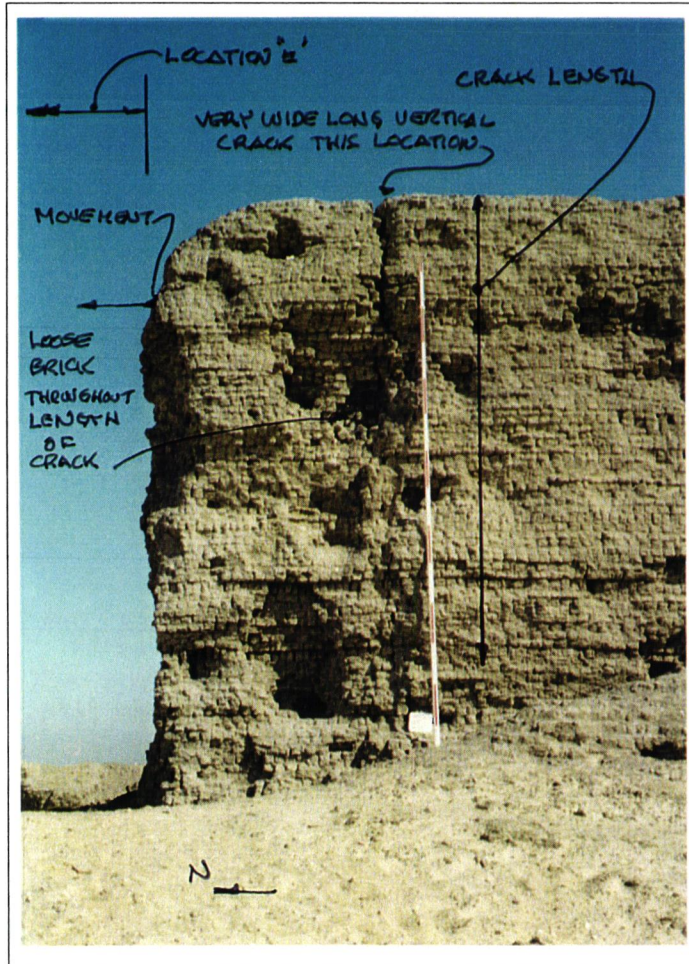
Photograph No. 89 Main Enclosure Wall at West Entrance

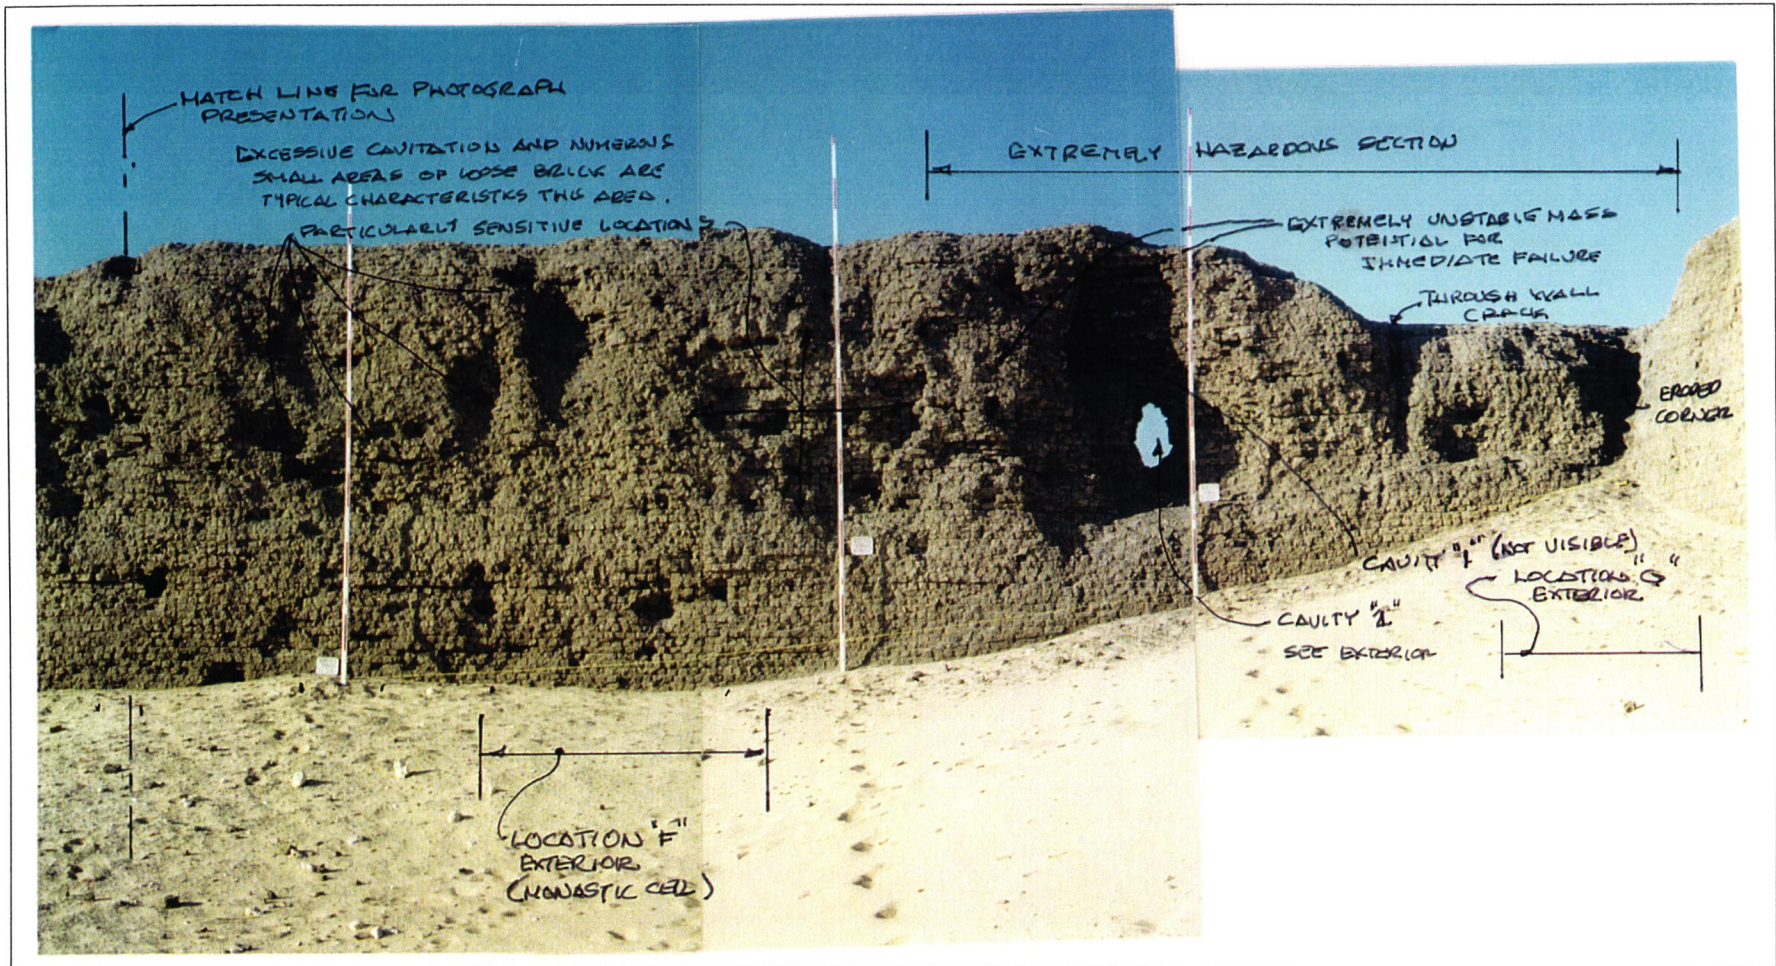
Composite Photograph No. 96 North Interior End West Main Enclosure Wall (2 of 2 Photographs)

18. In order to increase the general stability of the north portion of this wall, the eroded north west interior corner delineated in Photograph No. 96 should be rebuilt.

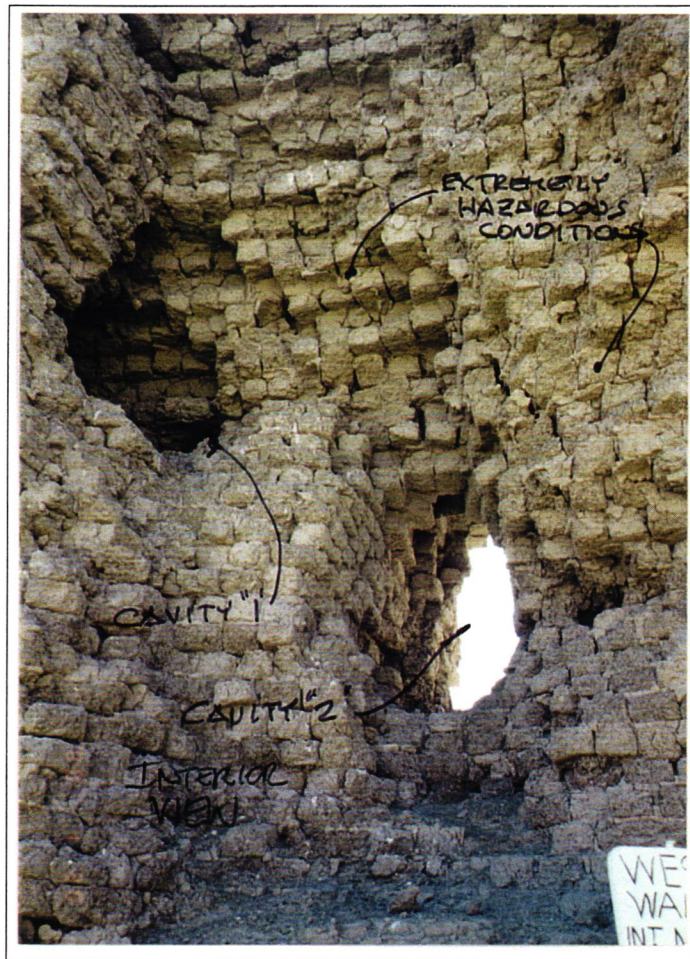
Photograph No. 103 Cavity 1 and Cavity 2 Interconnection, Interior View

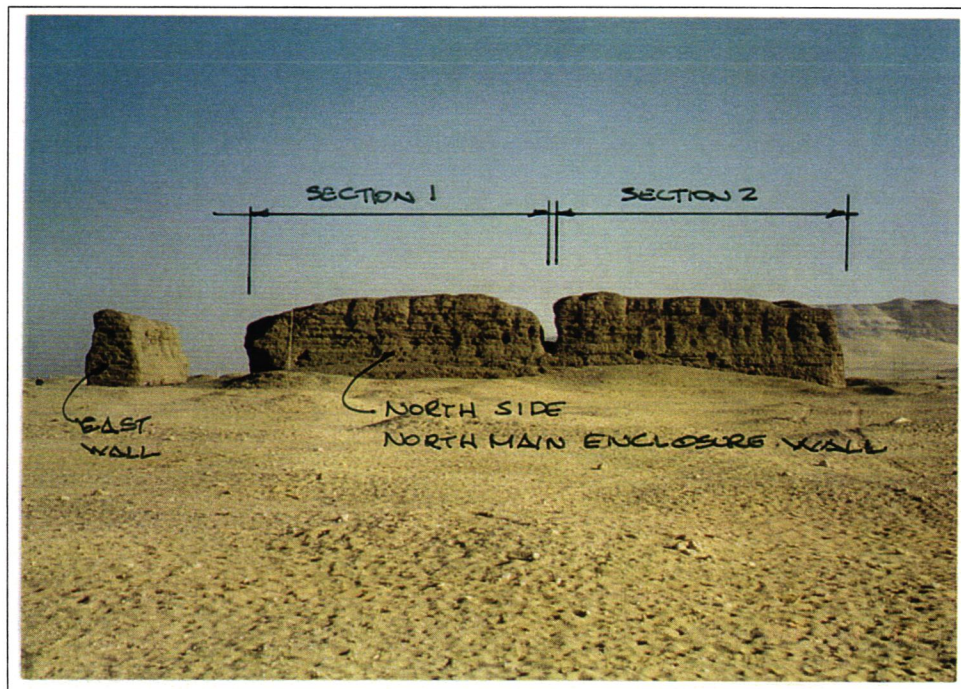
Photograph No. 104 North Main Enclosure Wall

The north Main Enclosure Wall shown in Photograph No. 104 has been arbitrarily divided into two sections to aid in locating prominent structural characteristics indicated below. The following deficiencies were observed:

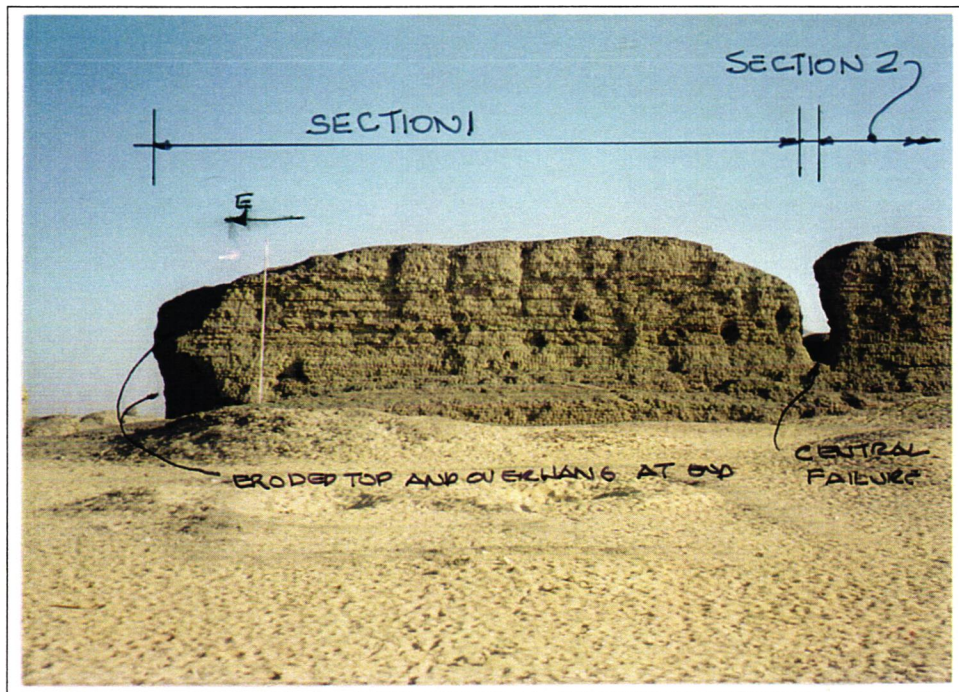
Photograph No. 105 Section 1 North Main Enclosure Wall

2. A large failure separates "Sections 1 and 2" as depicted by Photograph Nos. 105, 107 and 108. The presence of loose and fallen bricks indicate a continuing process of degradation. A mud wasp accretion occurs below a significant area of moderately unstable, overhanging brick on the north side of the failure while excessive cavitation, calving and areas of loose brick were noted mainly on the south side of the opening created by the wall loss. Deep and widespread erosion was observed at the position noted as Location "C" in Photograph No. 108.

Given the relatively good condition of the north interior wall, the ease with which the work could be undertaken from the top of an existing dune, and the potential for massive loss of historic fabric after excavation, the repair of this missing section should be assigned an urgent priority. All cavities shown in Photograph No. 107 should be filled, calved brick should be removed and rebuilt, loose brick conditions should be reset, Location "C" should be filled and the failed portion of wall should be reconstructed.

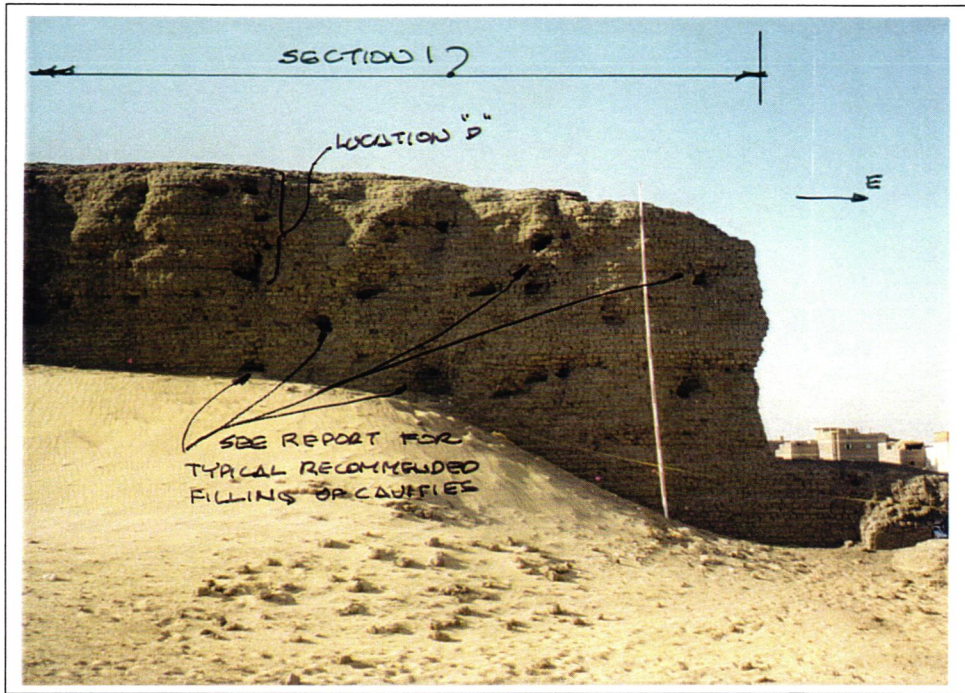
Photograph No. 109 North Main Enclosure Wall East End Interior View

3. A large crack was noted at Location "D" described by Photograph No. 109. A number of small cavities are also indicated. For reasons discussed above we highly recommend that these normal priority items be corrected during any preservation process.

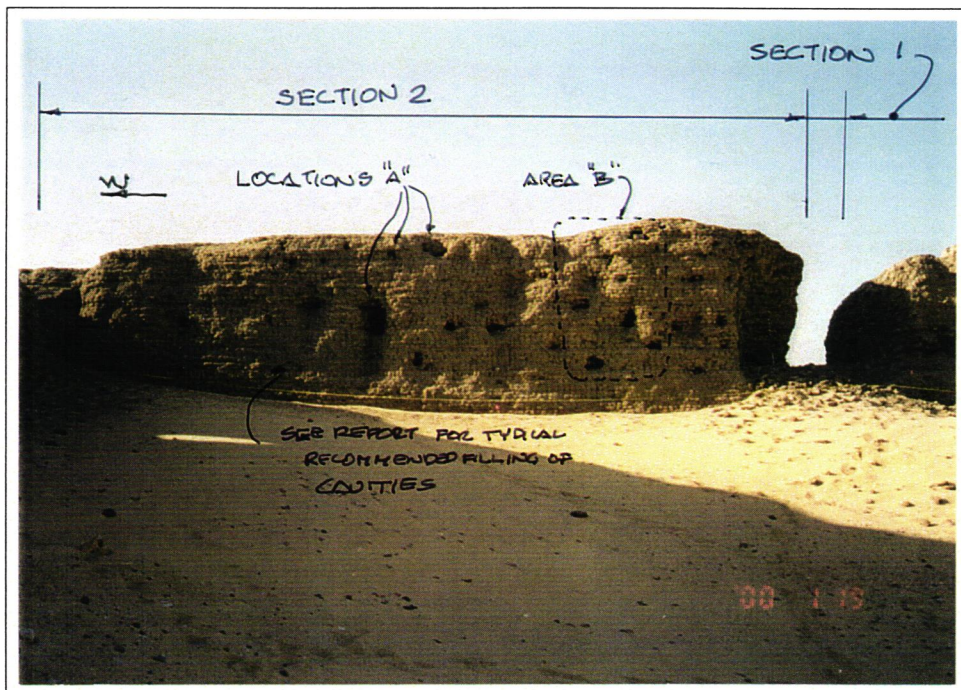
Photograph No. 112 Section 2 North Main Enclosure Wall, Interior View

5. The interior view of "Section 2" is described by Photograph No. 112. At three cavities designated as Location "A" very loose conditions and local calving were observed. Similar deficiencies were observed at the area designated as Location "B". These situations should be corrected as previously described on an urgent priority basis. Given the ease with which work can be undertaken, we recommend that other low priority repairs be completed during the stabilization process.

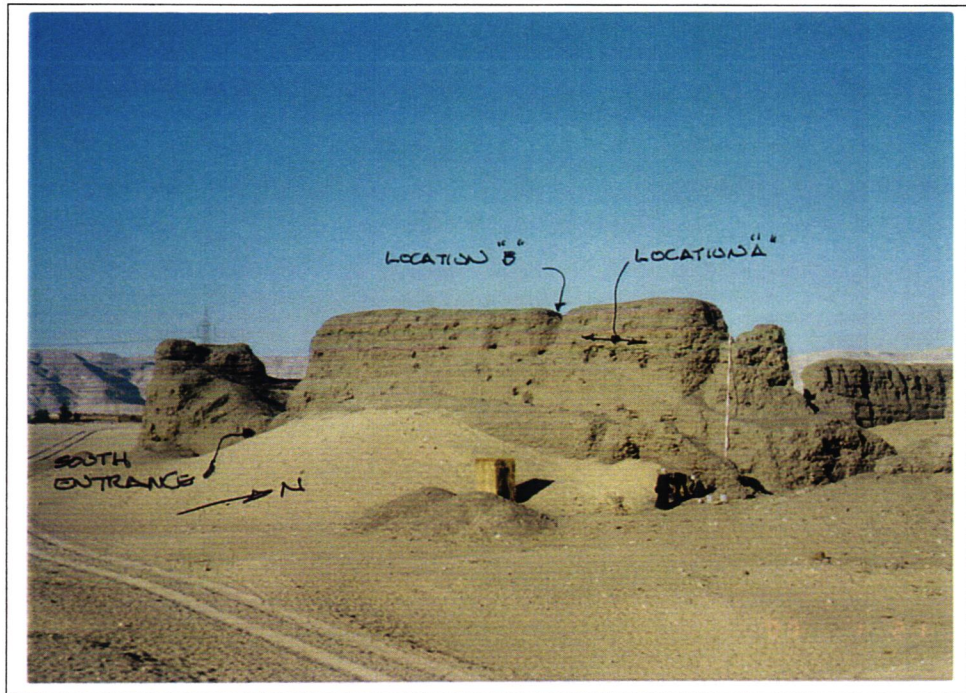
Photograph No. 113 South Main Enclosure Wall

The South Main Enclosure Wall is described by Photograph No. 113. The following deficiencies were noted.

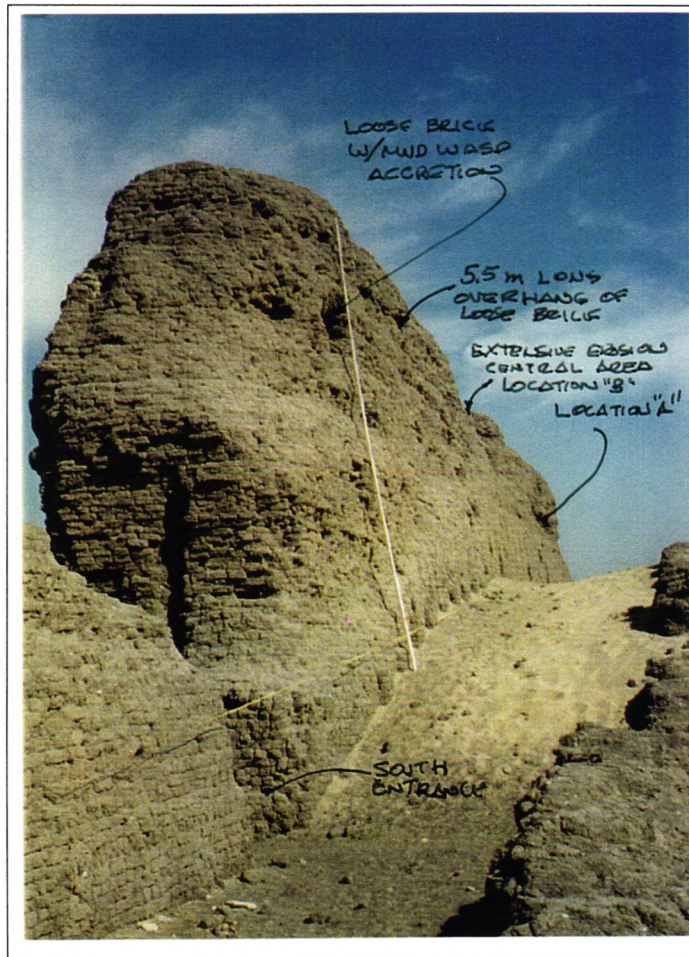
Photograph No. 116 South Main Enclosure Wall

2. The remainder of the exterior surface delineated by Photograph No. 116 is characterized by moderate cavitation, the presence of a very friable surface, local cracking, erosion, and local areas of unstable masonry. Three normal priority areas of concern are indicated on the photograph; Location "A" represents an 4.5 meter projection of loose brick.

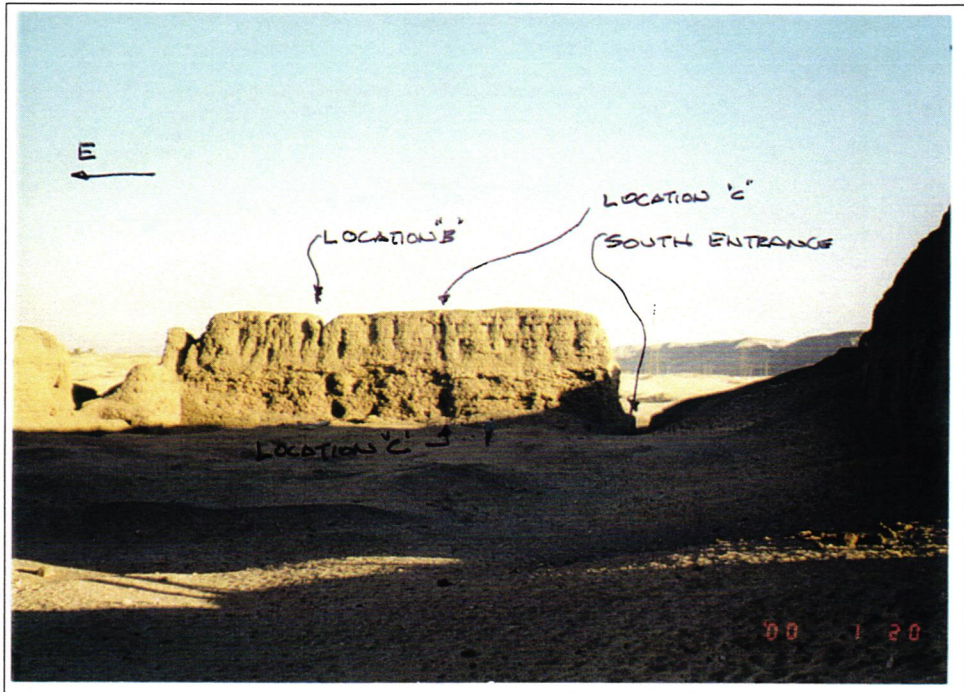
Photograph No. 117 South Main Enclosure Wall, Interior View

The interior of the wall is shown by Photograph Nos. 117 through 120. The amount of brick and their distribution within the sand dune shown in Photograph No. 118 appears to indicate that a failure of massive proportions may have occurred at the southwest corner.

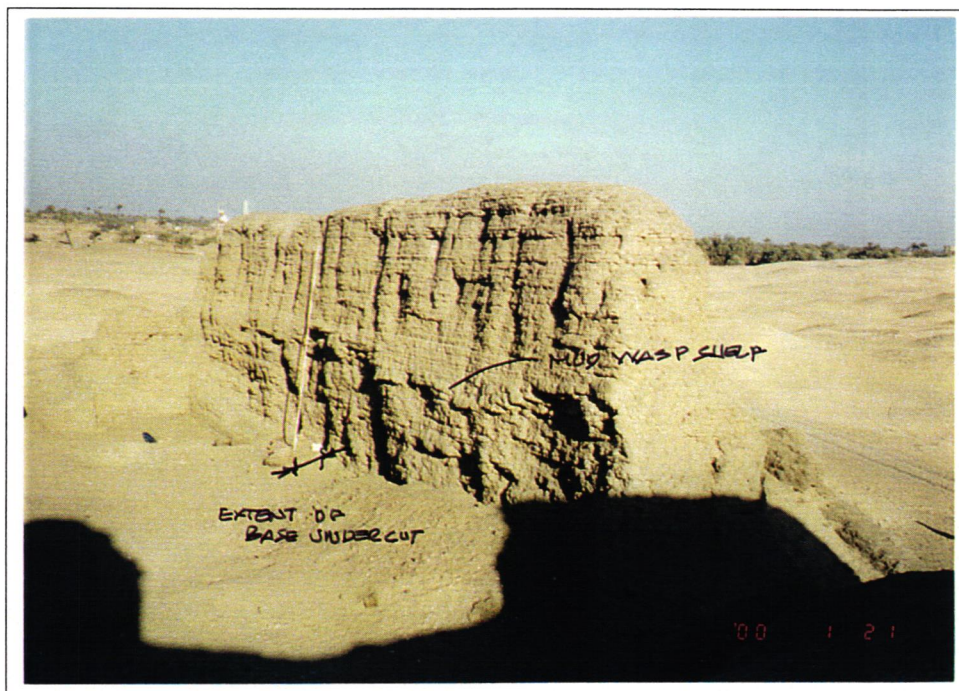
Photograph No. 120 Undercutting of South Main Enclosure Wall

3. The remainder of the south wall depicted by Photograph Nos. 120 and 121 has been severely undercut on the interior face for nearly all of its length. Additionally, the base is moderately cavitated as shown by Photograph No. 122 and extensive local areas of loose brick occur. As an urgent priority repair we recommend that all such unstable masonry be reset and that all cavities greater than 0.3 meters in length or width be filled using procedures indicated at other locations. Somewhat continuous mud wasp accretions, which are visible in the photographs, should be removed.

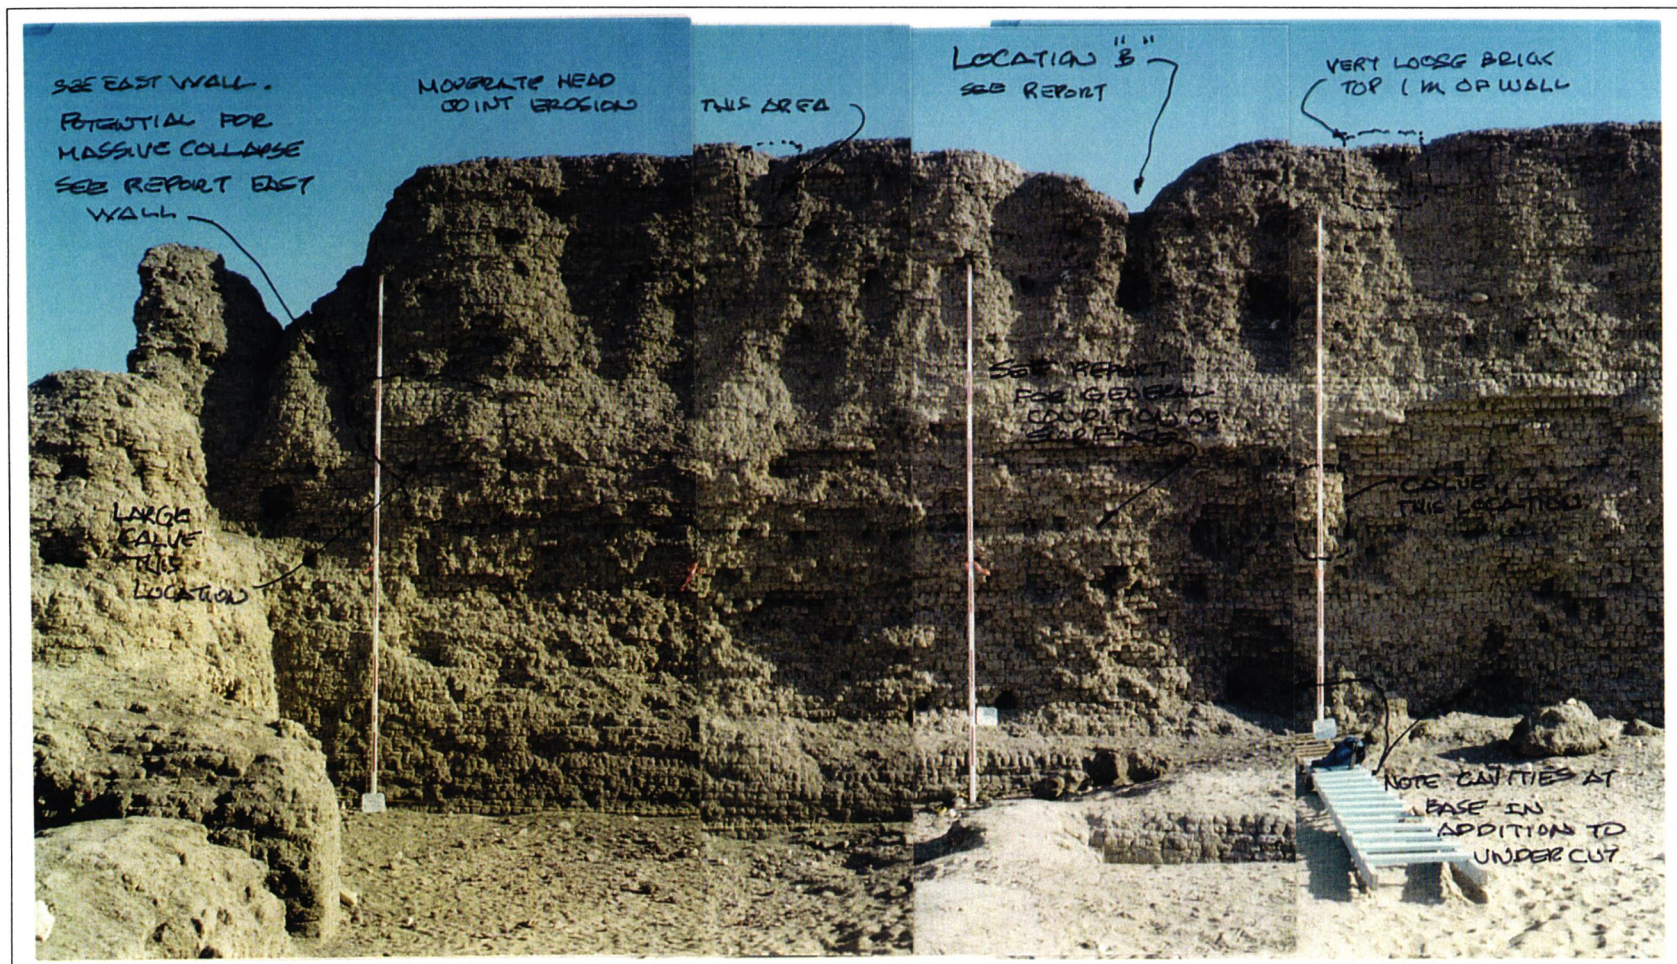
Composite Photograph No. 122 South Main Enclosure Wall

4. As delineated by Photograph Nos. 122 and 123 moderate head joint erosion occurs at a number of locations along the top surface of the wall but is especially severe at and near the position indicated as Location "C" in Photograph No. 123.

5. Two calving locations are indicated on Photograph No. 122; that occurring near the east corner is very dangerous because of its massive size. A side view is depicted in Photograph No. 124.
