PRELIMINARY FIELD REPORT No1: Vol 3-Mud Brick Conservation

**DOCUMENTATION and CONSERVATION
of the SHUNET el ZEBIB MONUMENT
(c. 2,700 BC) Abydos, Egypt**

**PRELIMINARY FIELD REPORT NO. 1
(IN THREE VOLUMES)**

**VOLUME 3 - MUD BRICK CONSERVATION
FIELD REPORT No. 1**

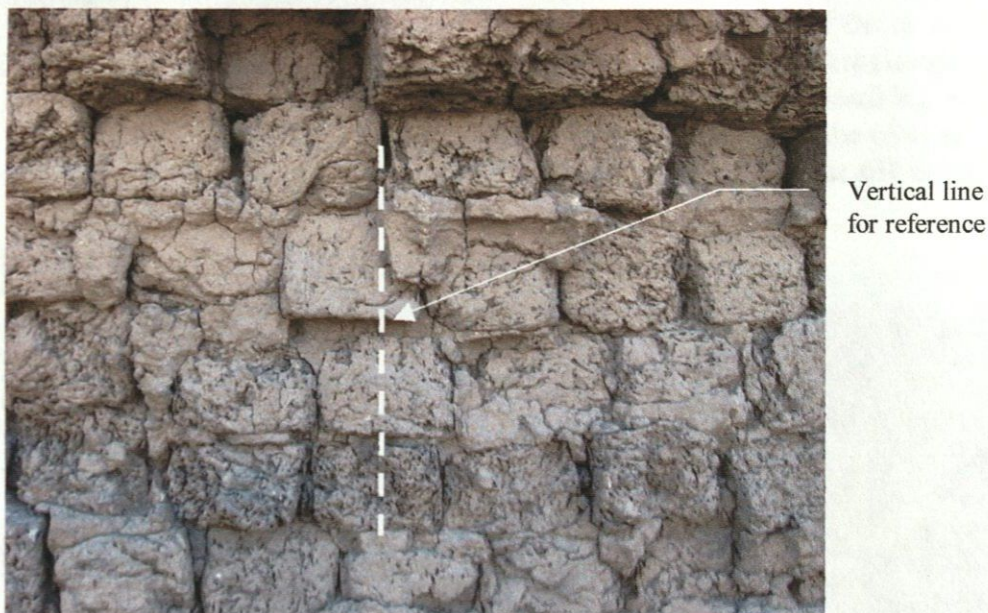
The coursing pattern in the interior wall mass is through-wall headers. There are some minor variations, probably for the purposes previously mentioned. Because of the relative small size of the adobes and the scale of the structure, the overlapping of the vertical joints of the through-wall headers is often minimal or even stacked on top of one another (Figure 15). The consistency of the mortar tends to compensate for what is considered a basic flaw as it contributed to the mud brick mass acting as a monolithic mass rather than as individual building units. However, under a wide range of structural loading over its 4700-year life, crack patterns have developed that often follow the naturally weaker points of those stacked joints.

Figure 15: Detail of a typical wall showing through-wall headers and occurrence of stacked joints.

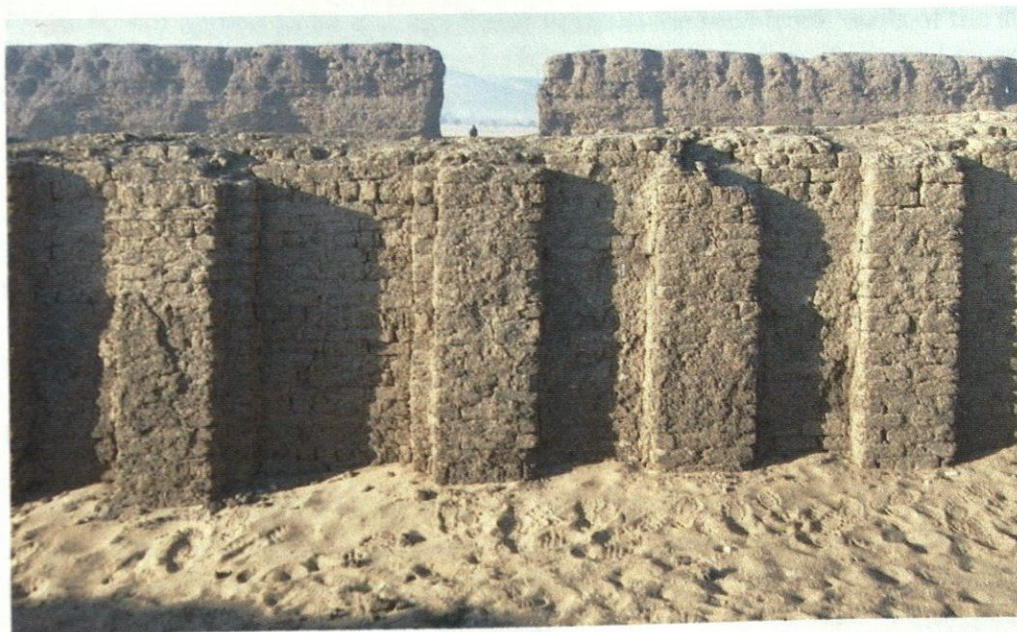
Pilasters exist on all of the exterior walls, or did exist originally. It is not known whether or not these pilasters extended the full height of the structure, as they do not exist on the upper portions of the walls; the ones that do remain are on the wall surfaces that were covered and protected by fill. Some of the better-preserved pilasters are along the center portion of the east wall (Figure 16). The pilasters were constructed integrally with the mud brick coursing. Every fifth course a header extends into the main wall providing a structural tie between the wall and the pilaster. The existence of the tie indicates that the pilasters were planned from the beginning and not added as a later change. However, the mud brick ties were not adequate and many have sheared off. Resulting in the collapse of an entire exposed pilaster, the displacement of smaller parts of the pilaster, or the structural vulnerability of other pilasters that are inadequately attached, but still in place.

Figure 16: Pilasters on the east side of the east wall.

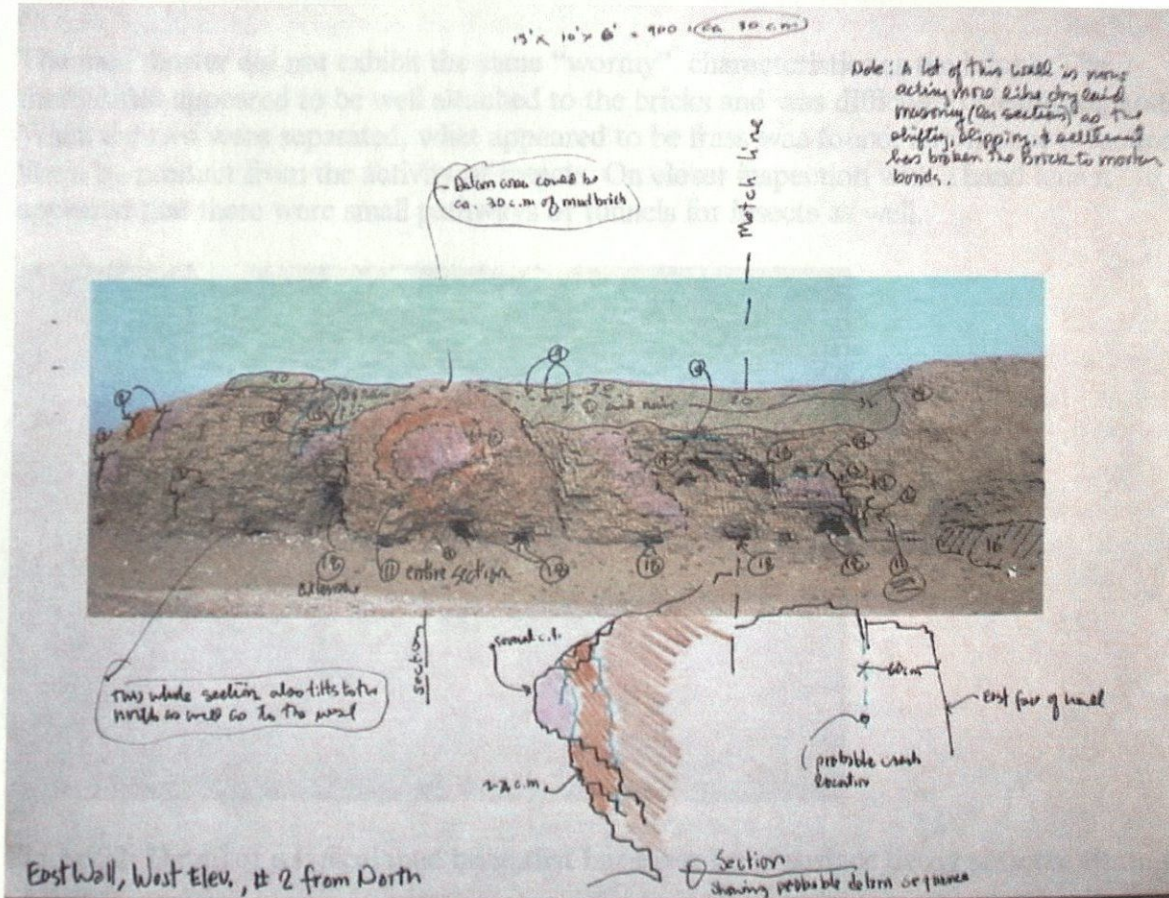
Figure 21: Sample of survey sheet; this one is of a section of the west side of the east wall.

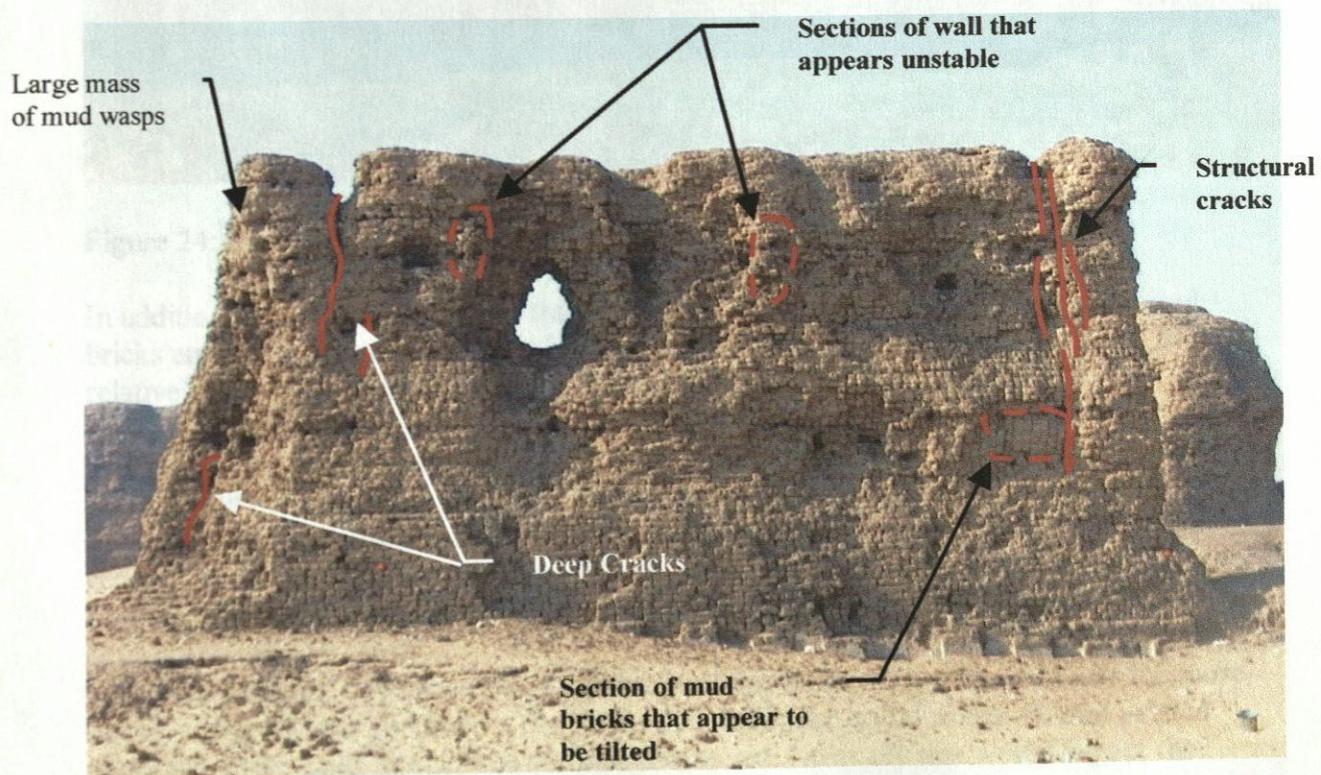
Figure 23: North end of the east elevation of the east wall.

The section of unstable wall right of the opening appears to be approximately 1.5 cubic meters; the section to the left appears to be less than .5 cubic meters. There are also voids behind and to the sides of these two sections. The "tilted" mud bricks near the east end

appear to be associated with the structural cracks that extend down from the top of the wall. Structural cracks, which are represented by dotted red lines, also reflect the separation process of the west end of the wall from the main portion. The area of the wall within several meters of the hole should be further evaluated more thoroughly from ladders or scaffolding. There are also loose adobes on the mid to upper portions of the wall and minor evidence of birds on this wall.

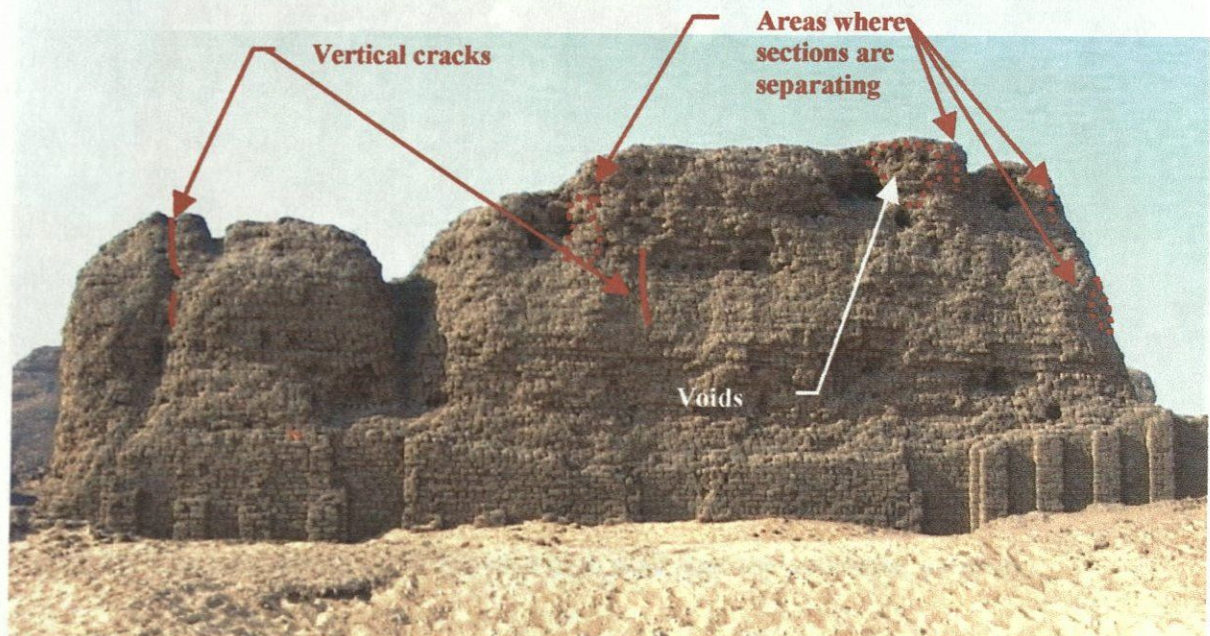
Figure 24: South high section of the east wall, the east elevation.

In addition to the several sections that appear to be delaminating, there are loose mud bricks and voids near the two large holes. There is some mud wasp activity, but it is relatively minor, as is the evidence of birds.

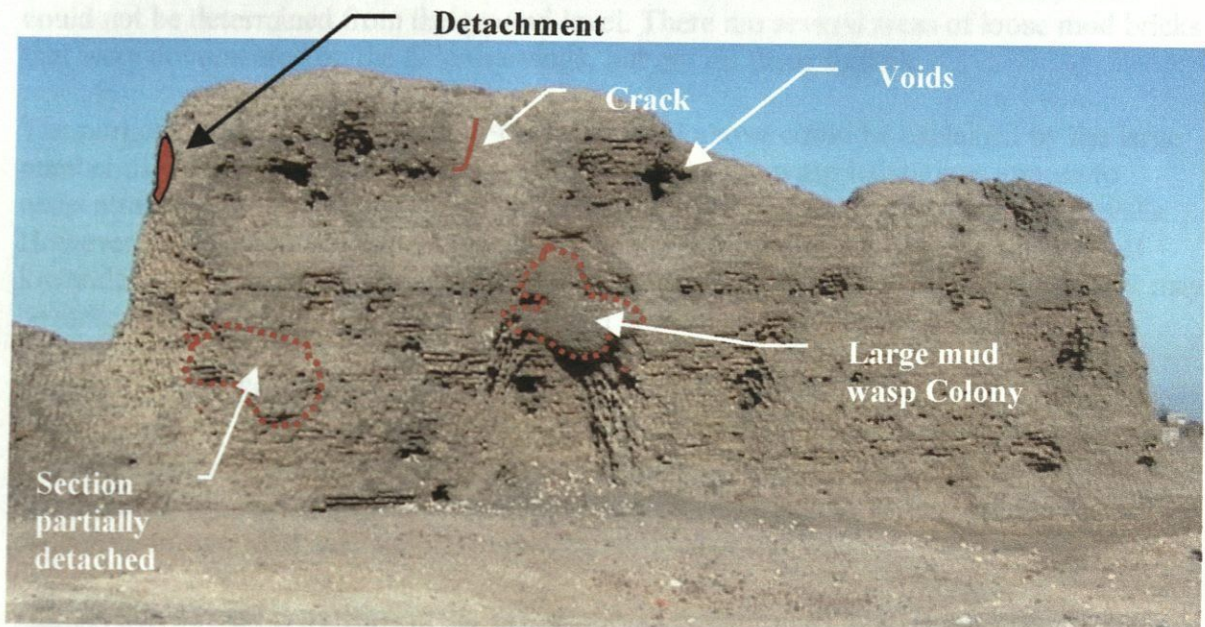
Figure 25: The west elevation of the east high wall near the southeast gateway.

Another significant difference in the condition of the walls on the west side was the more heavily eroded lower portions of the walls. The difference could reflect fill that existed along the lower walls at one time and since removed. Normally one would expect the lower areas would have been protected by the fill and have eroded less. The wind scouring on the upper portions of the walls implies that the surfaces that are currently exposed on the lower portions of the walls have had less exposure to the winds. Of course the specific wind patterns and the micro-turbulence that would occur could explain some of the difference, but it could hardly explain the level of differences that now exist (Figures 25 and 26).

There is very little mud wasp activity on the north high wall in contrast to a very large colony that is active on the south high wall. Wind has scoured these surfaces more than on the east side of the west walls. There is more bird activity on this side than on the east side of this same wall. The birds have created several holes, but the extend of the bird nests could not be determined from the ground level. There are several areas of loose mud bricks that were documented on the field drawings, but not on these figures.

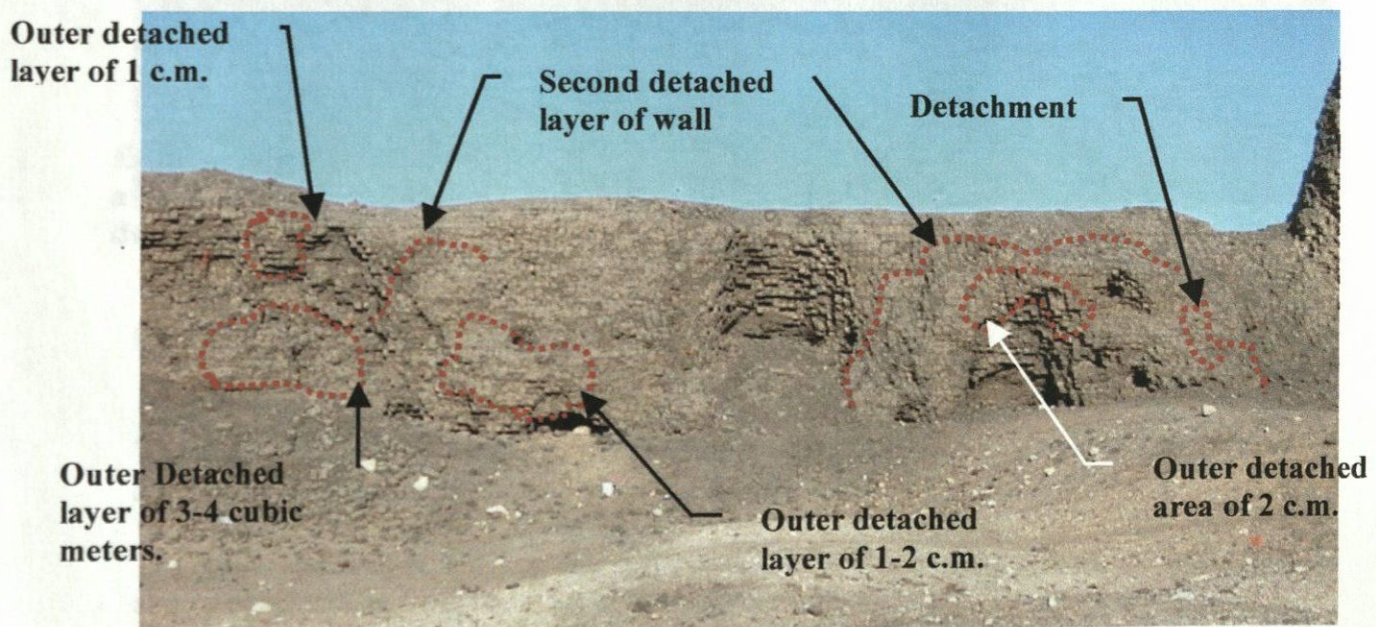
Figure 27: South part of the center section of the east wall.

This section of wall is perhaps in the worse overall condition of any. It has been severely undercut by animal burrowing and perhaps by the adaptive reuse of some of the walls by human interventions in historic times. Large sections of wall are essentially free standing and could collapse anytime with minimal additional changes. Any seismic event will result in significant loss.

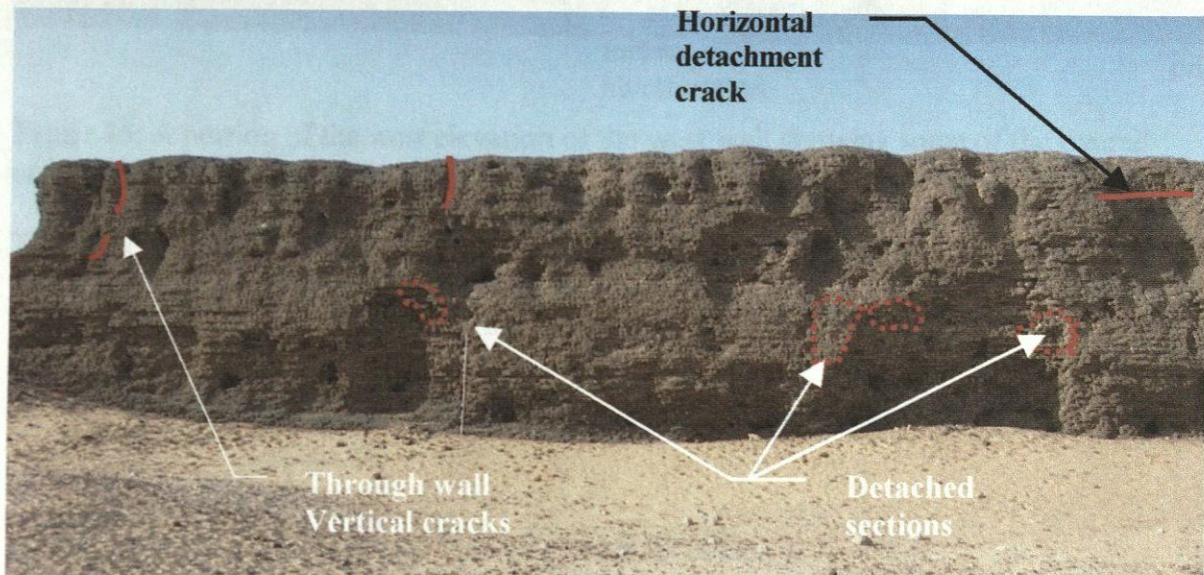
- p. 5 The final sentence should read "... the important site character that ..."
- p. 18. In the third paragraph from the bottom, the second sentence should read "...if the amount of water is decreased, the ..."
- p. 33 Figure 34 caption should read "Partial east elevation of the west wall."

The south section of the east side of this wall exhibits some of the same conditions that do the central portion of the east wall. The undercutting of the wall at its base by animal burrows and possibly excavations into the wall by humans has also resulted in the detachment and delamination of sections of the wall. The extent of the delaminations is not as severe as those of the east wall, but they are extensive and in a similar process will lead to the loss of a considerable part of the wall if not corrected. The conditions on the east side of the wall are exacerbated by the very large voids on the west side that are up to 3 meters deep in this 5-meter thick wall.

Figure 34: Partial west elevation of the west wall.

The conditions indicated on the above image are a summary of the most significant issues. In addition to the two issues pointed out above the wall has numerous mud wasp nests, bird nests, loose mud bricks and other smaller detachments. Similar condition exist on other wall sections but the most critical areas are the ends of the walls on either side of the west gateway and the north end of the wall near the intersection with the north wall.

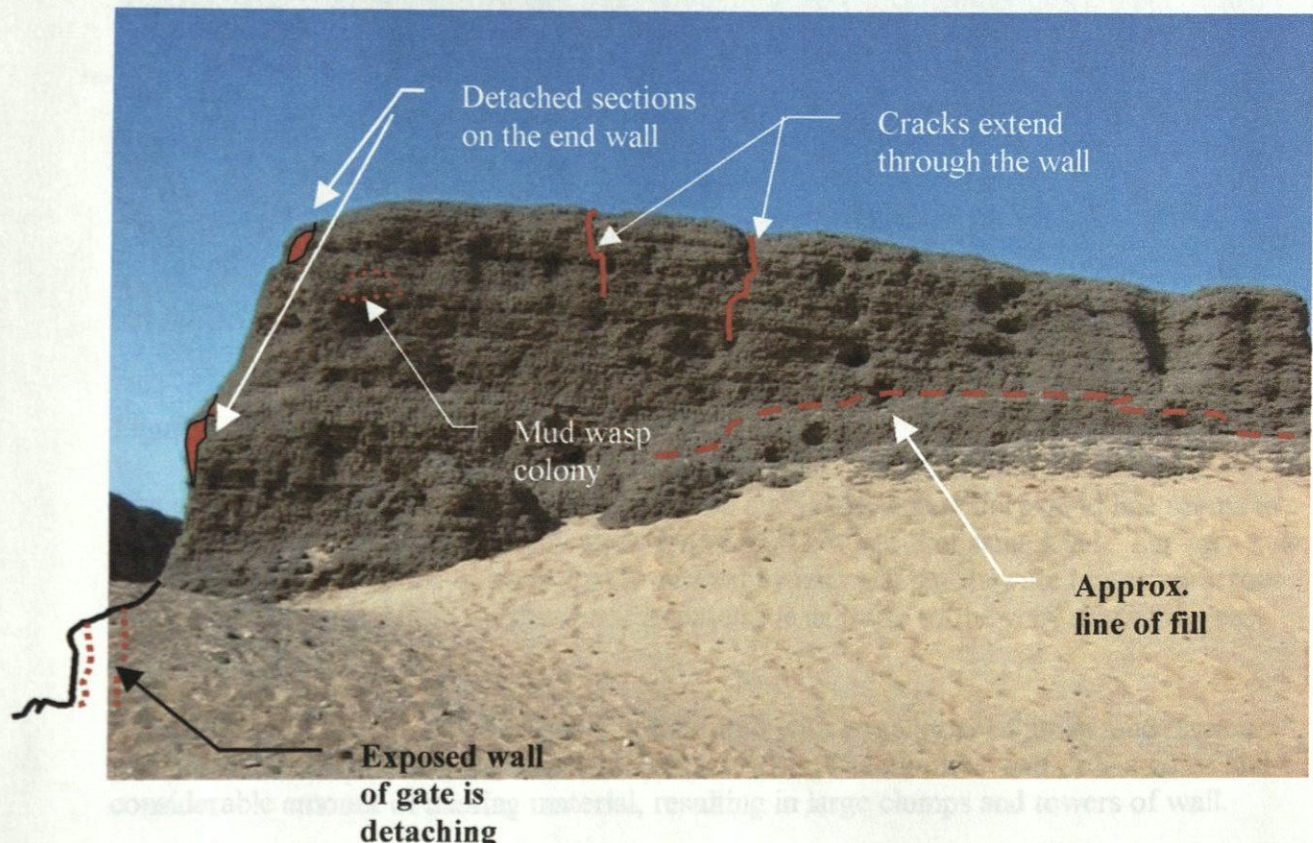
Figure 41: South elevation of a section of the south wall at the southwest gate.

The overall texture of the north side of this south wall is quite different than the south side. There appears to be more wind scouring on the south than on the north. This is not particularly surprising as the wind patterns in and around the ShUNET would not be the same

and there will be major and minor differences. Areas of micro-turbulence will also exist. There is also a greater contrast between the upper and the lower parts of the walls. The general wind patterns in the Shunet were documented during the one-day that the wind blew during the site visit. A sketch plan with the results of that documentation is included in the analysis summary of this report.

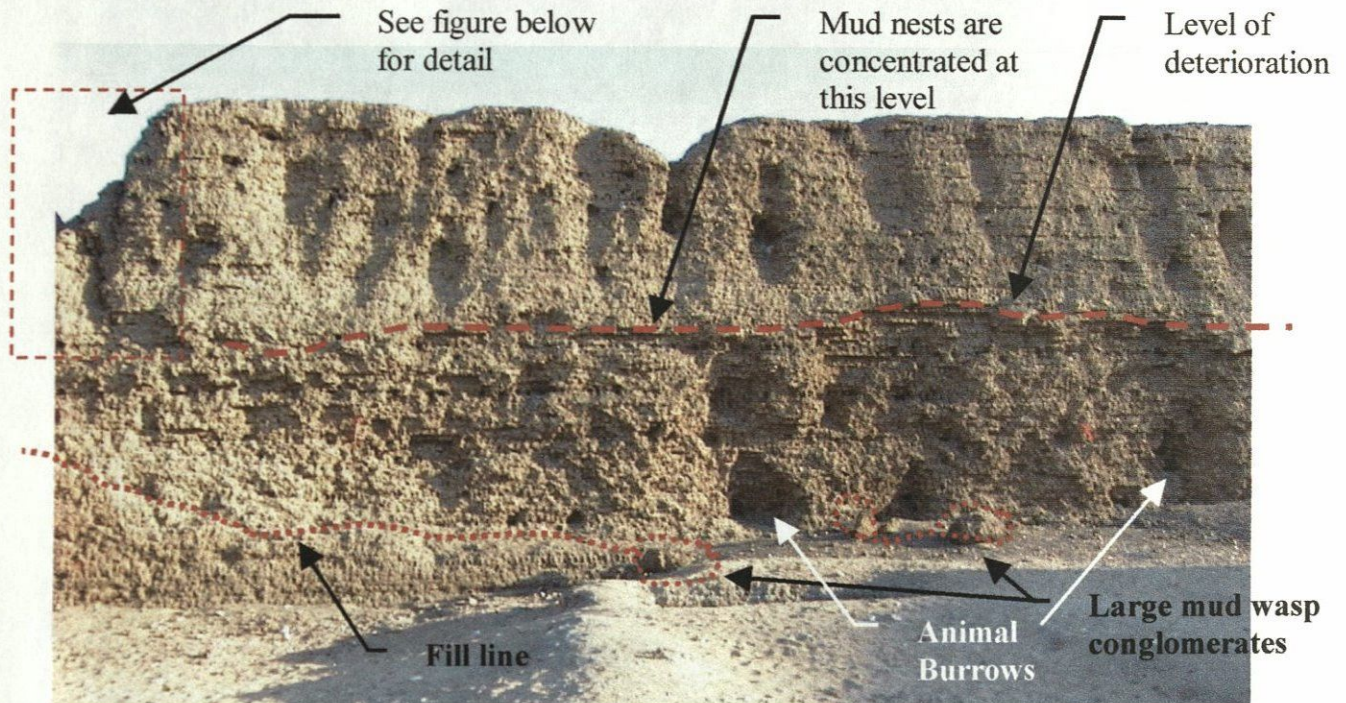
Figure 42: East end of the north side of the south wall.

The distinct difference in the wall texture above and below a near horizontal line seems to be directly associated with the concentration of mud nests at that same level. The area near the ground also has some holes probably created by animals, but they are not as numerous as on the south side of the wall, and not as extensive as those of the west side of the east wall.

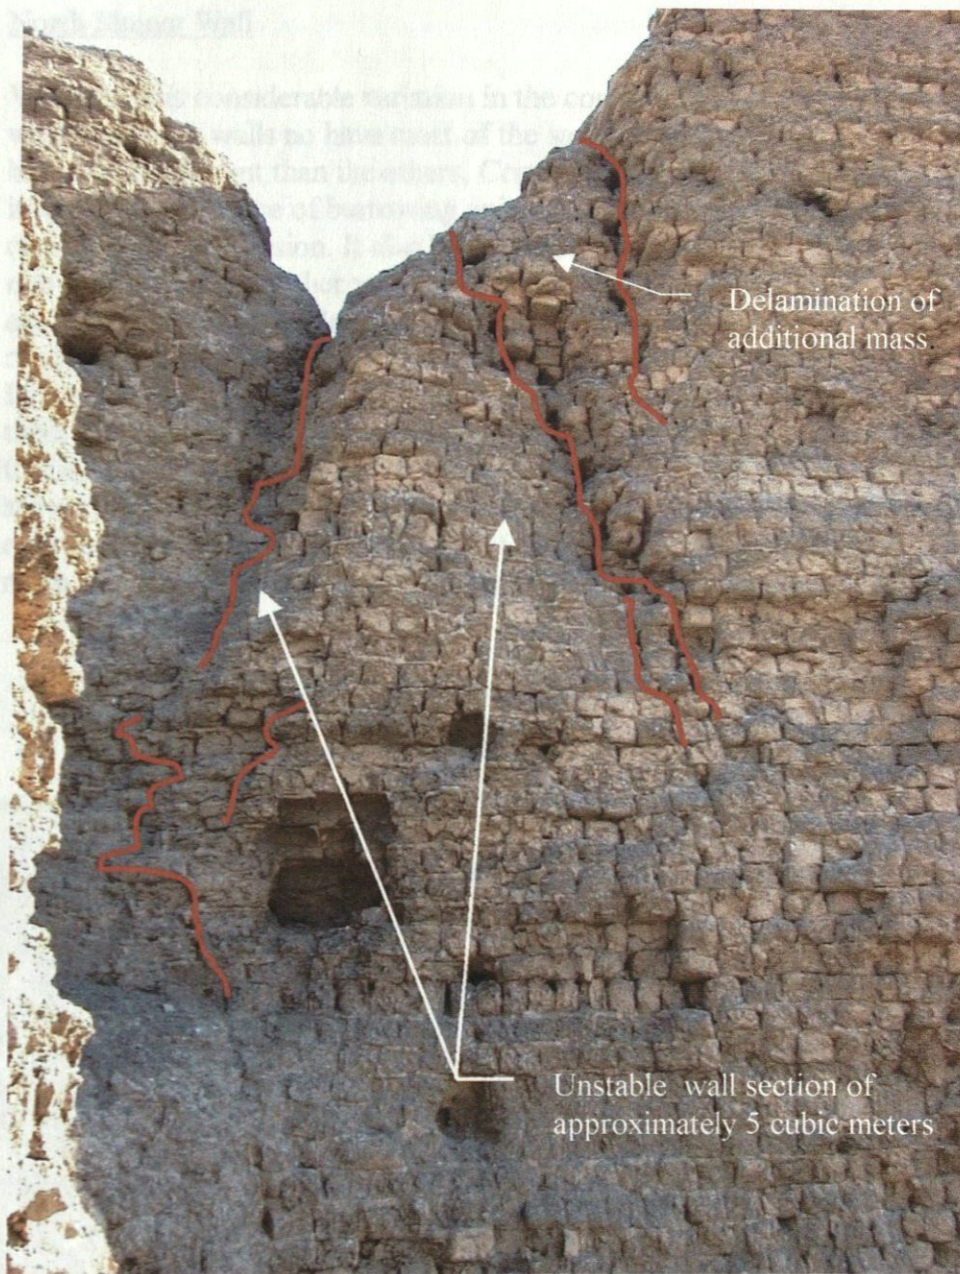
Figure 43: A detail of the east end of the south wall.

The east end of this south wall is heavily fractured with large areas of loose mud bricks, vertical and horizontal cracks, and detachments of large sections of wall. It has voids and a considerable amount of missing material, resulting in large clumps and towers of wall.

The base of the upper portion of the wall from approximately 2-4 meters above the present grade is severely eroded. The level is at least partially associated with the level of fill that existed in this area. Wind certainly had an effect as it scoured the wall immediately above the fill, but presently the highly eroded area presently provides a convenient shelf to walk on. It may have also been a convenient place to walk even when the fill was up to this height.

The detail above is just a part of this area of the wall that is in poor condition. Additional specific information is detailed in the field notes that are included in the Appendices. The conditions for the remainder of this corner are similar.

5. Install shoring and bracing at the southeast corner (Figure 43).

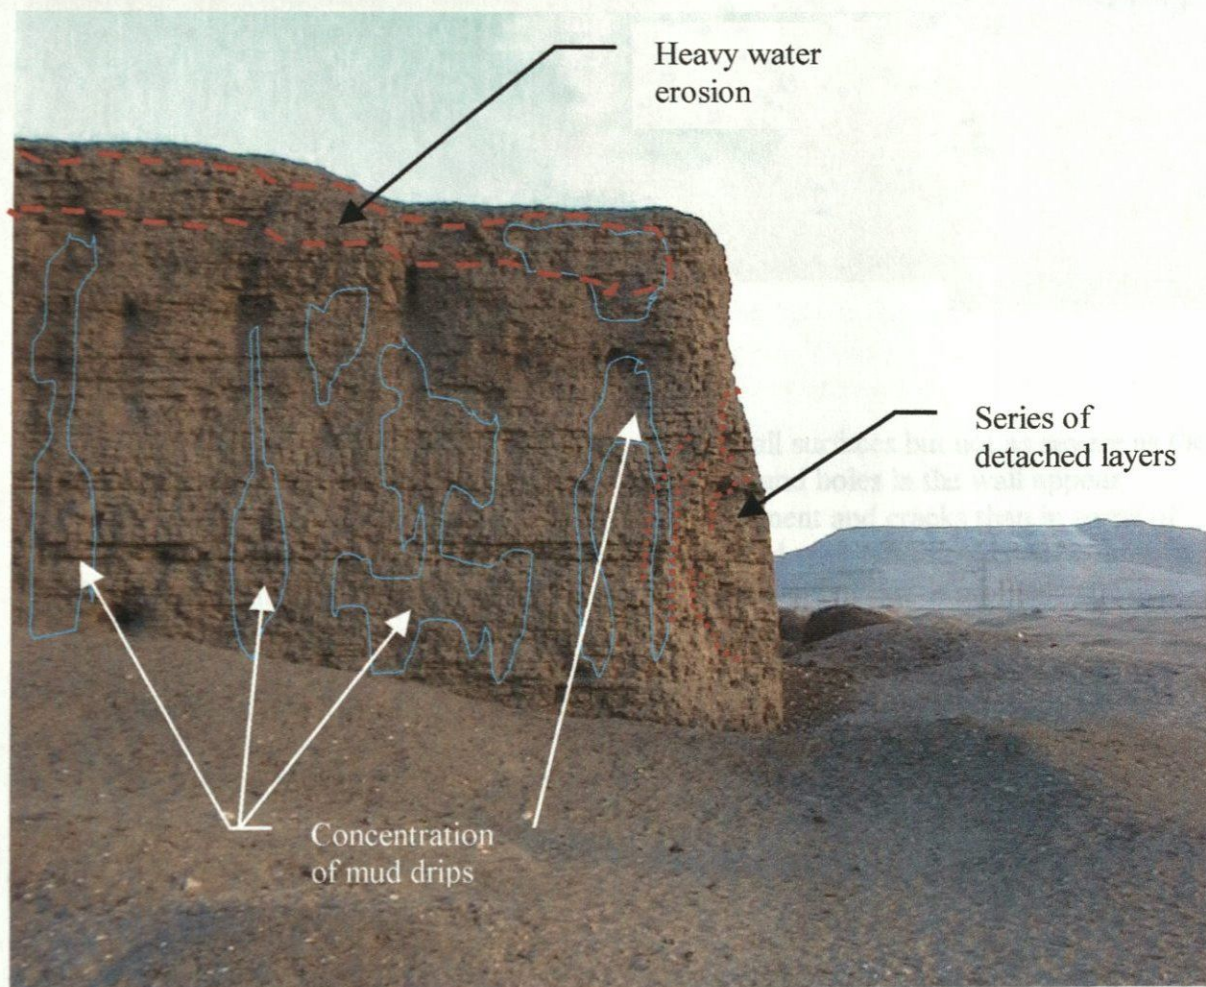
Figure 44: The west end of the north wall.

While there is considerable variation in the condition of the walls of the Shunet, the east, west and south walls no have most of the same condition types in common. The north wall however is different than the others. Certainly it also has many of the same conditions of insect nests, evidence of burrowing animals, detachment of layers, loose mud bricks, birds, cracks, and wind erosion. It also has considerable damage from water, presumably by rainwater, which the other walls do not have. The most obvious evidence of this is the amount of vertical mud drips and small rills that appear on the entire north side of this north wall. The condition is greater on the west end but it can be found everywhere. Interesting enough, there are no more drips or rills on the south side of the north wall than there is on any other wall. In addition to the drips and rills the most significant condition that appears to be associated with the water is the erosion at the top of the wall. Mortar appears to be washed out and many mud bricks are loose. The upper wall condition does exist on a few areas of the south side of the wall, but it is pervasive on the upper part of the north side. Figure 44 is a part of the north side, the west end showing the conditions.

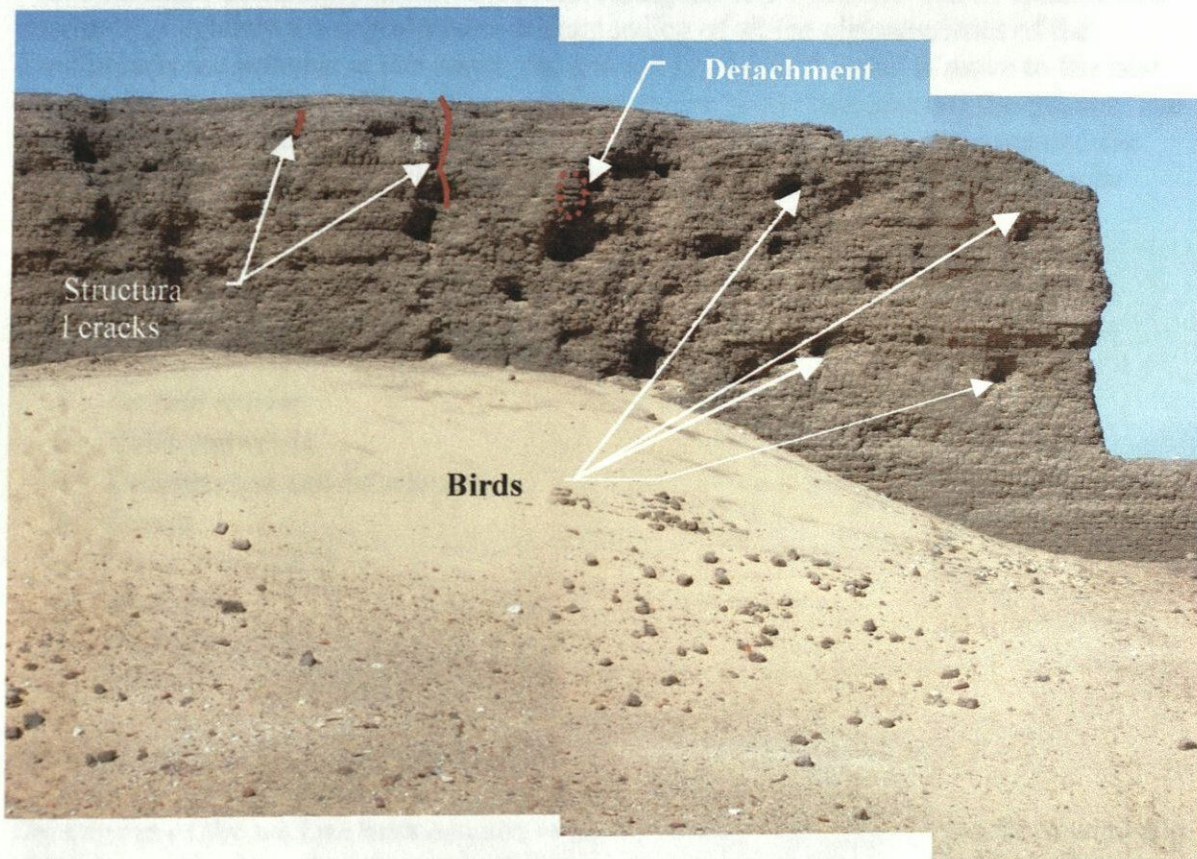
Figure 45: South side of the north wall.

The typical conditions on the south side are shown in Figure 45, which is a section of the wall from the east end of the high wall.

The general wind erosion patterns are similar to other wall surfaces but not as severe as the south and the higher sections of the east wall. The voids and holes in the wall appear similar to other walls. There is less fracturing and detachment and cracks than in some of the walls but then those conditions are normally associated with larger voids. Of course the small voids in the north wall may well grow into larger ones, but that is probably nothing that will occur rapidly.

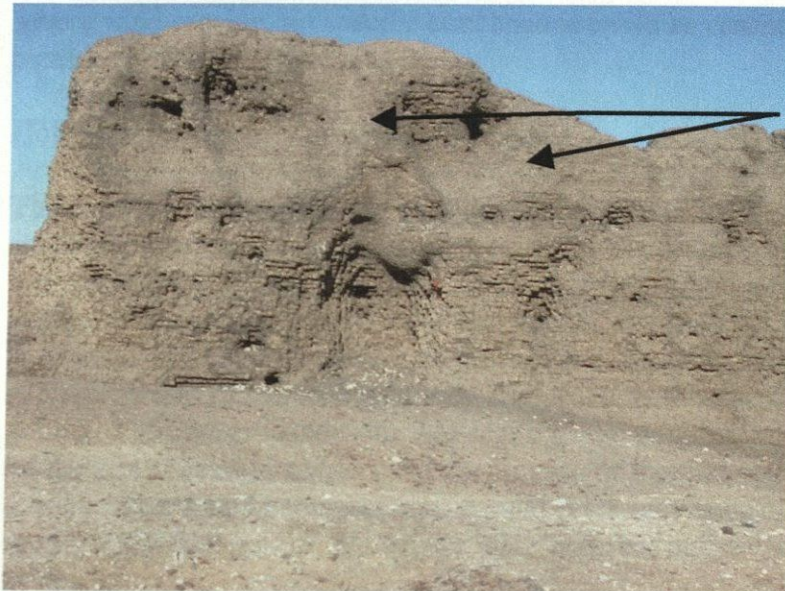
The wind did not affect all wall surfaces equally. The north side of the south wall and the west side of the high sections of the east walls appeared to be more eroded than other wall surface (Figure 46). There were also some isolated portions of walls that were eroded differentially. An example of this can also be found on various walls and probably reflects micro-turbulence in those areas. Micro-turbulence can be subtle and a new pattern can begin when one brick is dislodged from a wall, or an animal begins making a hole for a nest. The lower walls, most of which have suffered more wall loss than the upper walls are not as eroded and that is understandable. It might be possible to estimate the rate of erosion if the approximate time can be documented that a surface was exposed and a quantifiable system to measure the erosion is developed.

Upper wall areas were eroded more by the wind

Figure 46: The upper portion of the south section of high east wall is more eroded than some other wall surfaces

An important next step is to quantify the specific wind patterns in the monument in general and in specific areas as well. The use of a hand-held anemometer, a smoke gun, or just simple strips of plastic can collect a great deal of information.

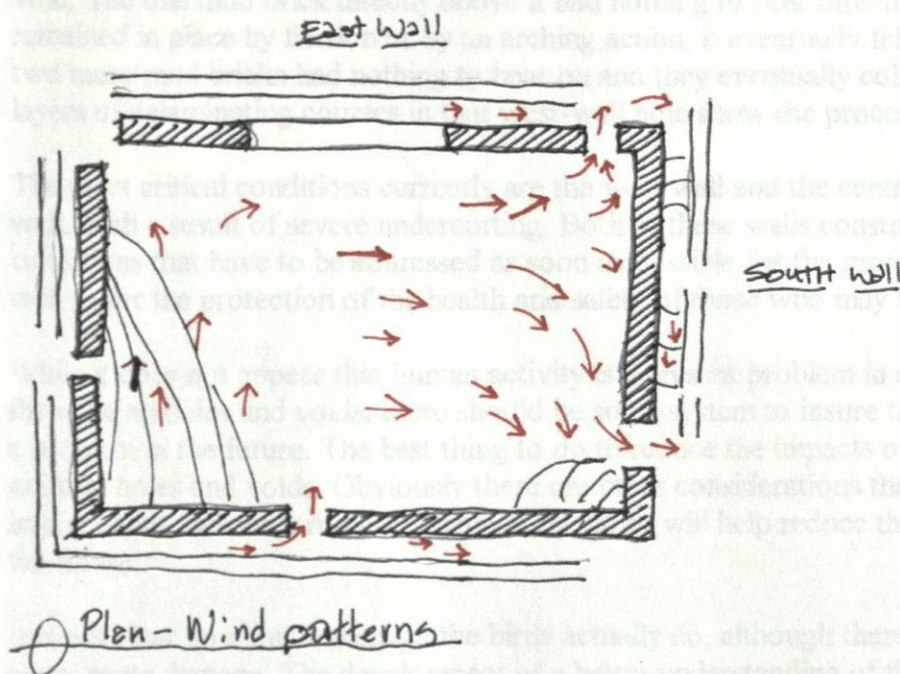
Figure 47: Sketch plan of ShUNET showing general wind pattern at ground level on January 17th.

The wind patterns that occurred and were mapped do not represent anything but that one single occurrence. However, the general pattern did seem to have some relationship to the general deposition of sand. Since the measurements were not at the level of the more

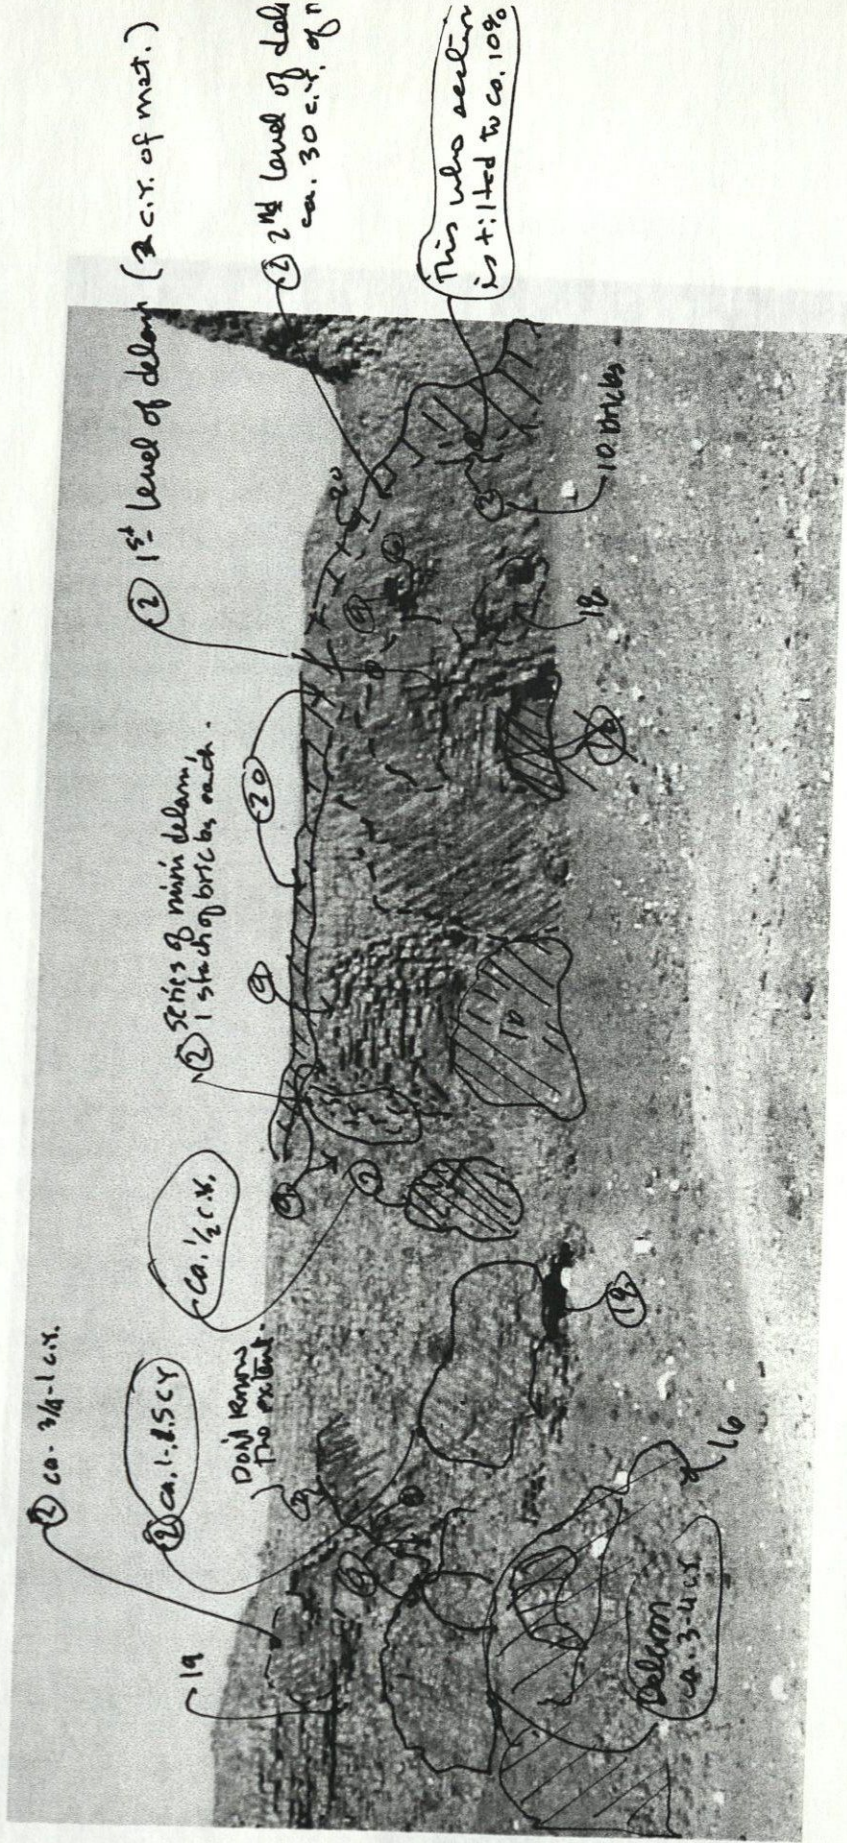
East Wall, West Elev., #4 from North

1' level below 1/2 min. cracks (vertical delam.)

General comment: The upper portion is heavily scoured similar to the north end of this overall wall. It has bird activity on this wall now and certainly less bird sign than on other walls.

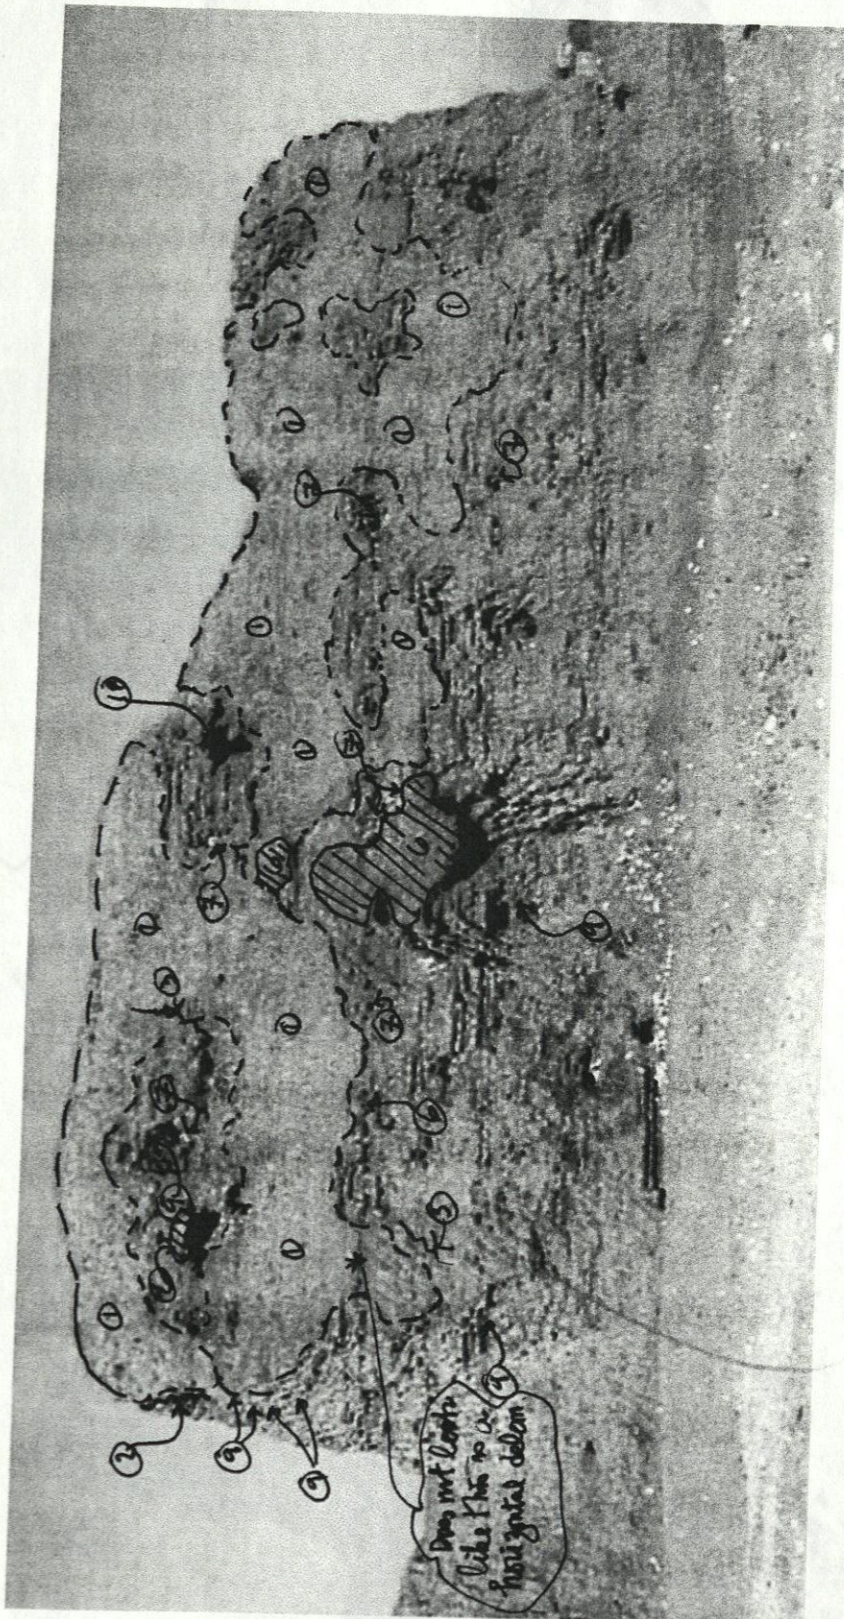
East Wall, west Elev. #5 from North

• 1 mud brick to 2 max. cracks (vertical delum)

General comment: Wall is much less wind scoured than west side; some of that is because of more fall, but also from less wind.

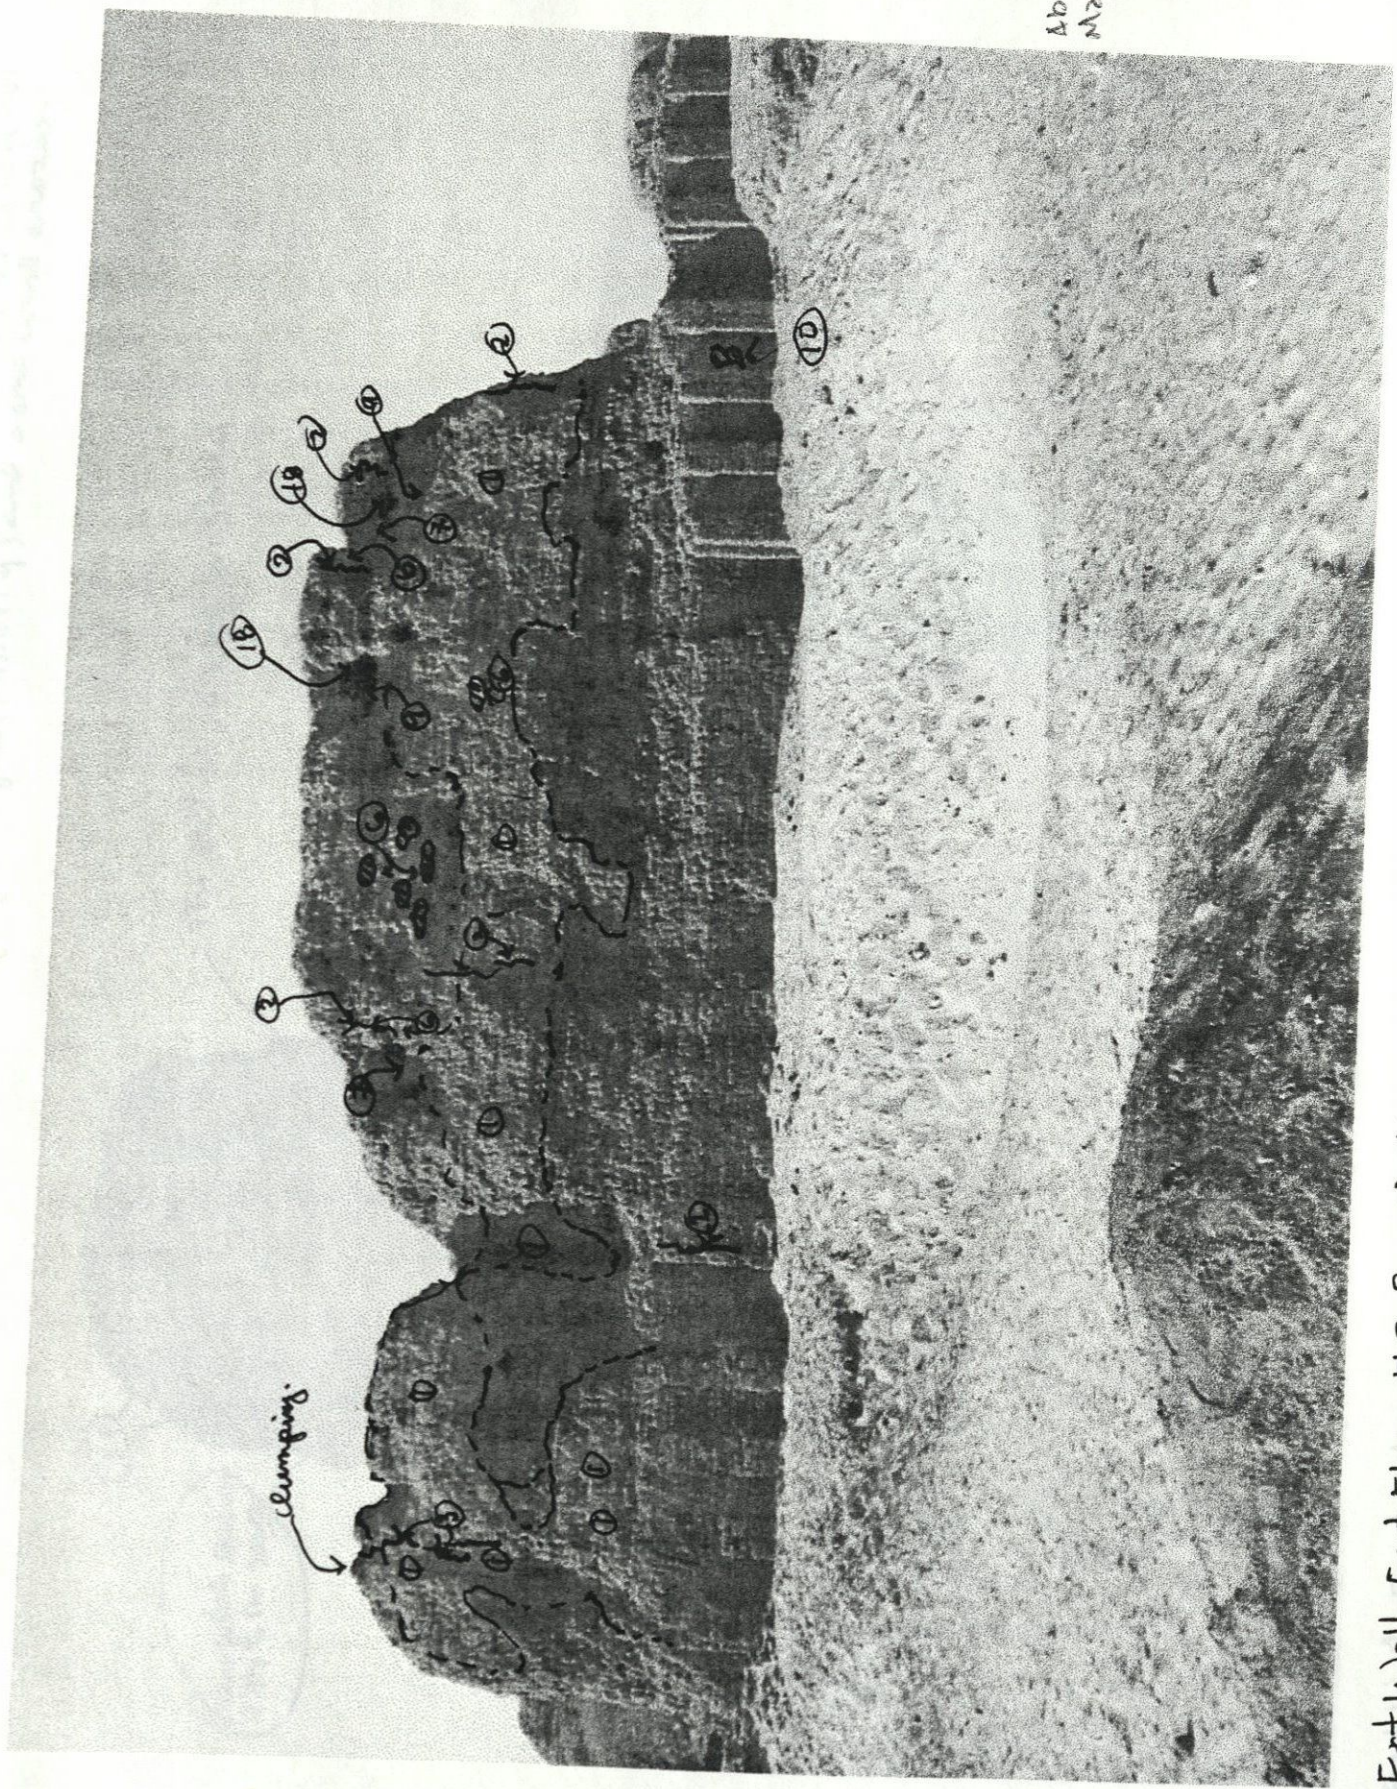
East Wall, East Elev. #2 from North

... and erosion, but I now believe that it is a combi; native
of wall fall (primarily) and some wind erosion.
