PRELIMINARY FIELD REPORT No1: Vol 3-Mud Brick Conservation

**DOCUMENTATION and CONSERVATION
of the SHUNET el ZEBIB MONUMENT
(c. 2,700 BC) Abydos, Egypt**

**PRELIMINARY FIELD REPORT NO. 1
(IN THREE VOLUMES)**

**VOLUME 3 - MUD BRICK CONSERVATION
FIELD REPORT No. 1**

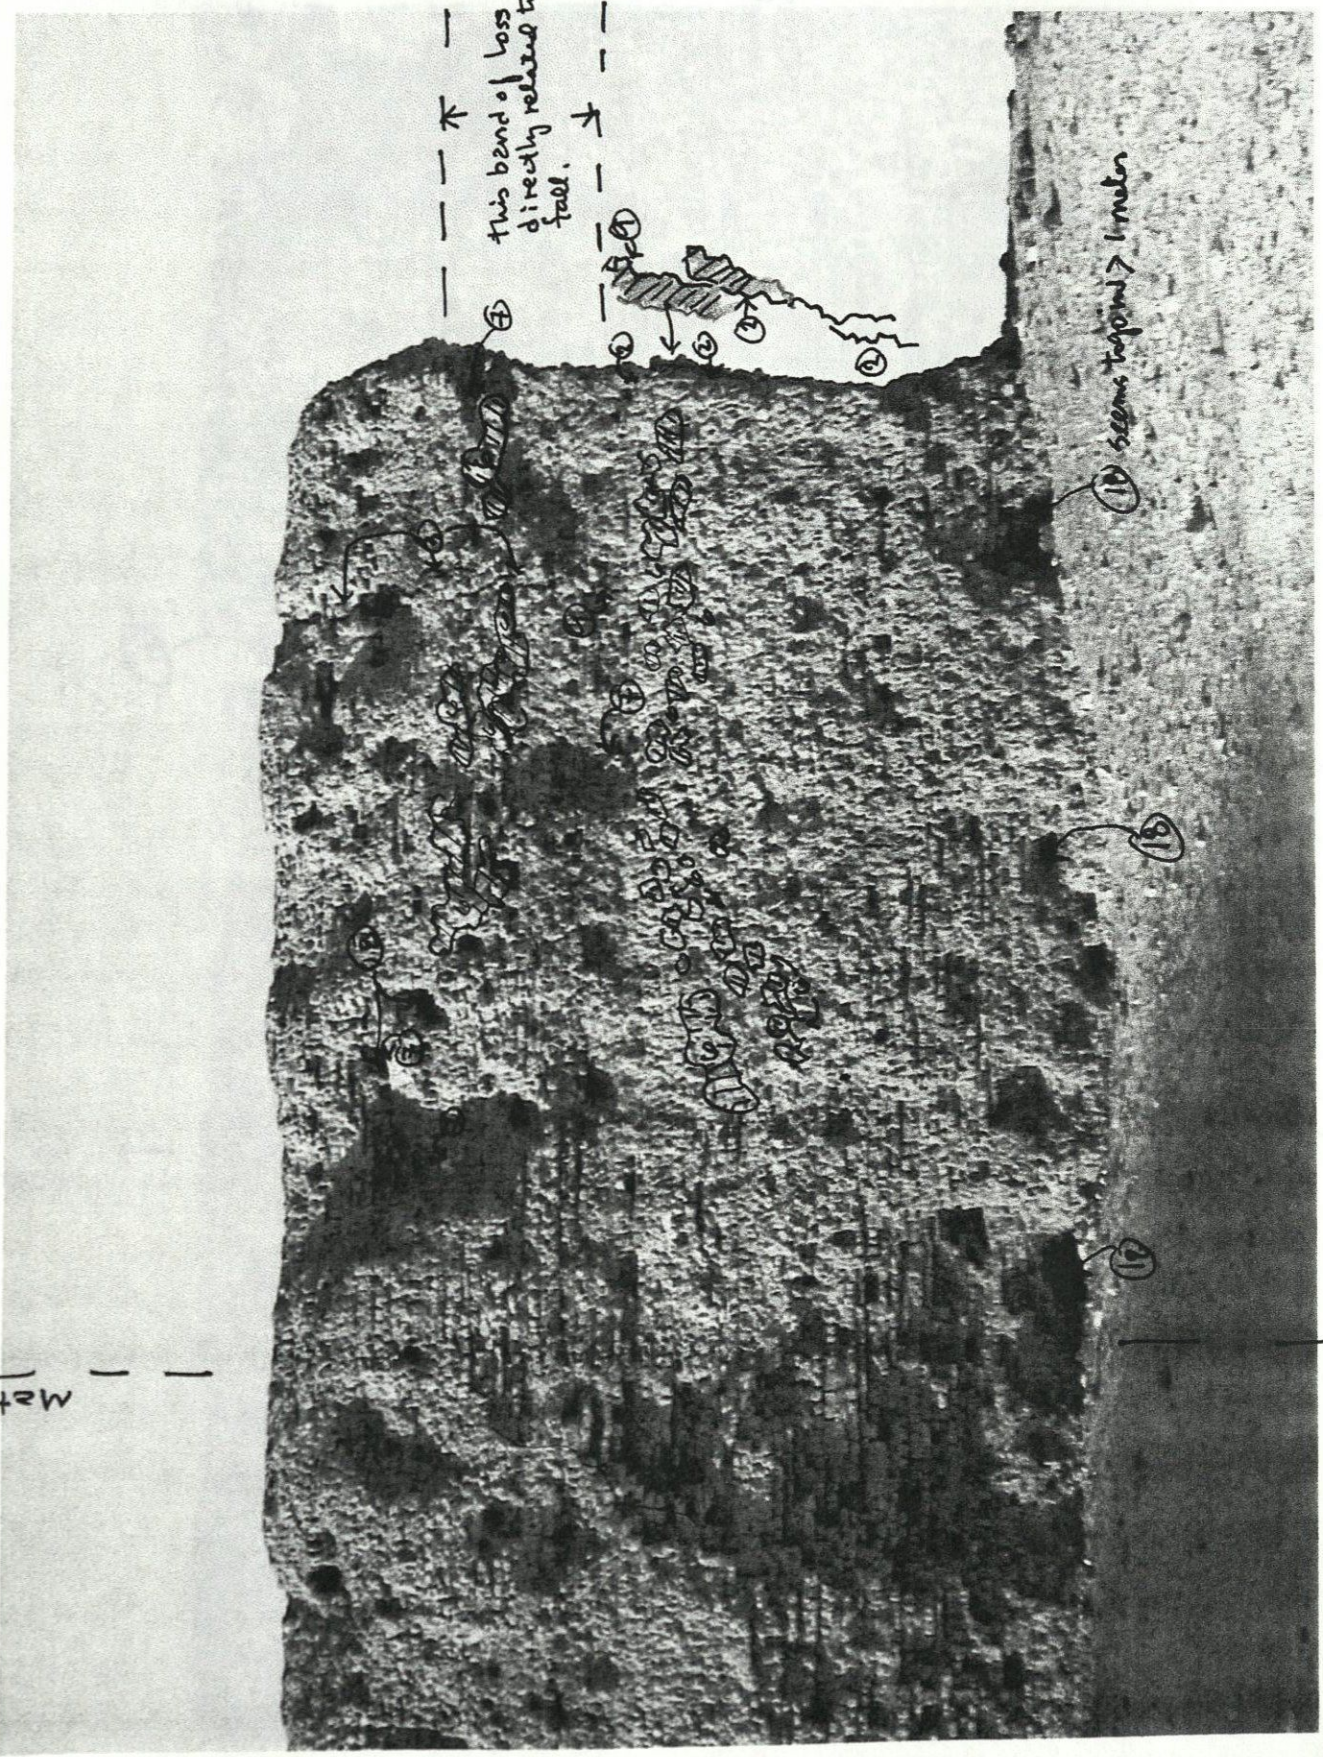
WEST Well, East Elev. # 5 from North

this band of loss seems to be directly related to hornet nest fall.

seems to extend > 1 meter

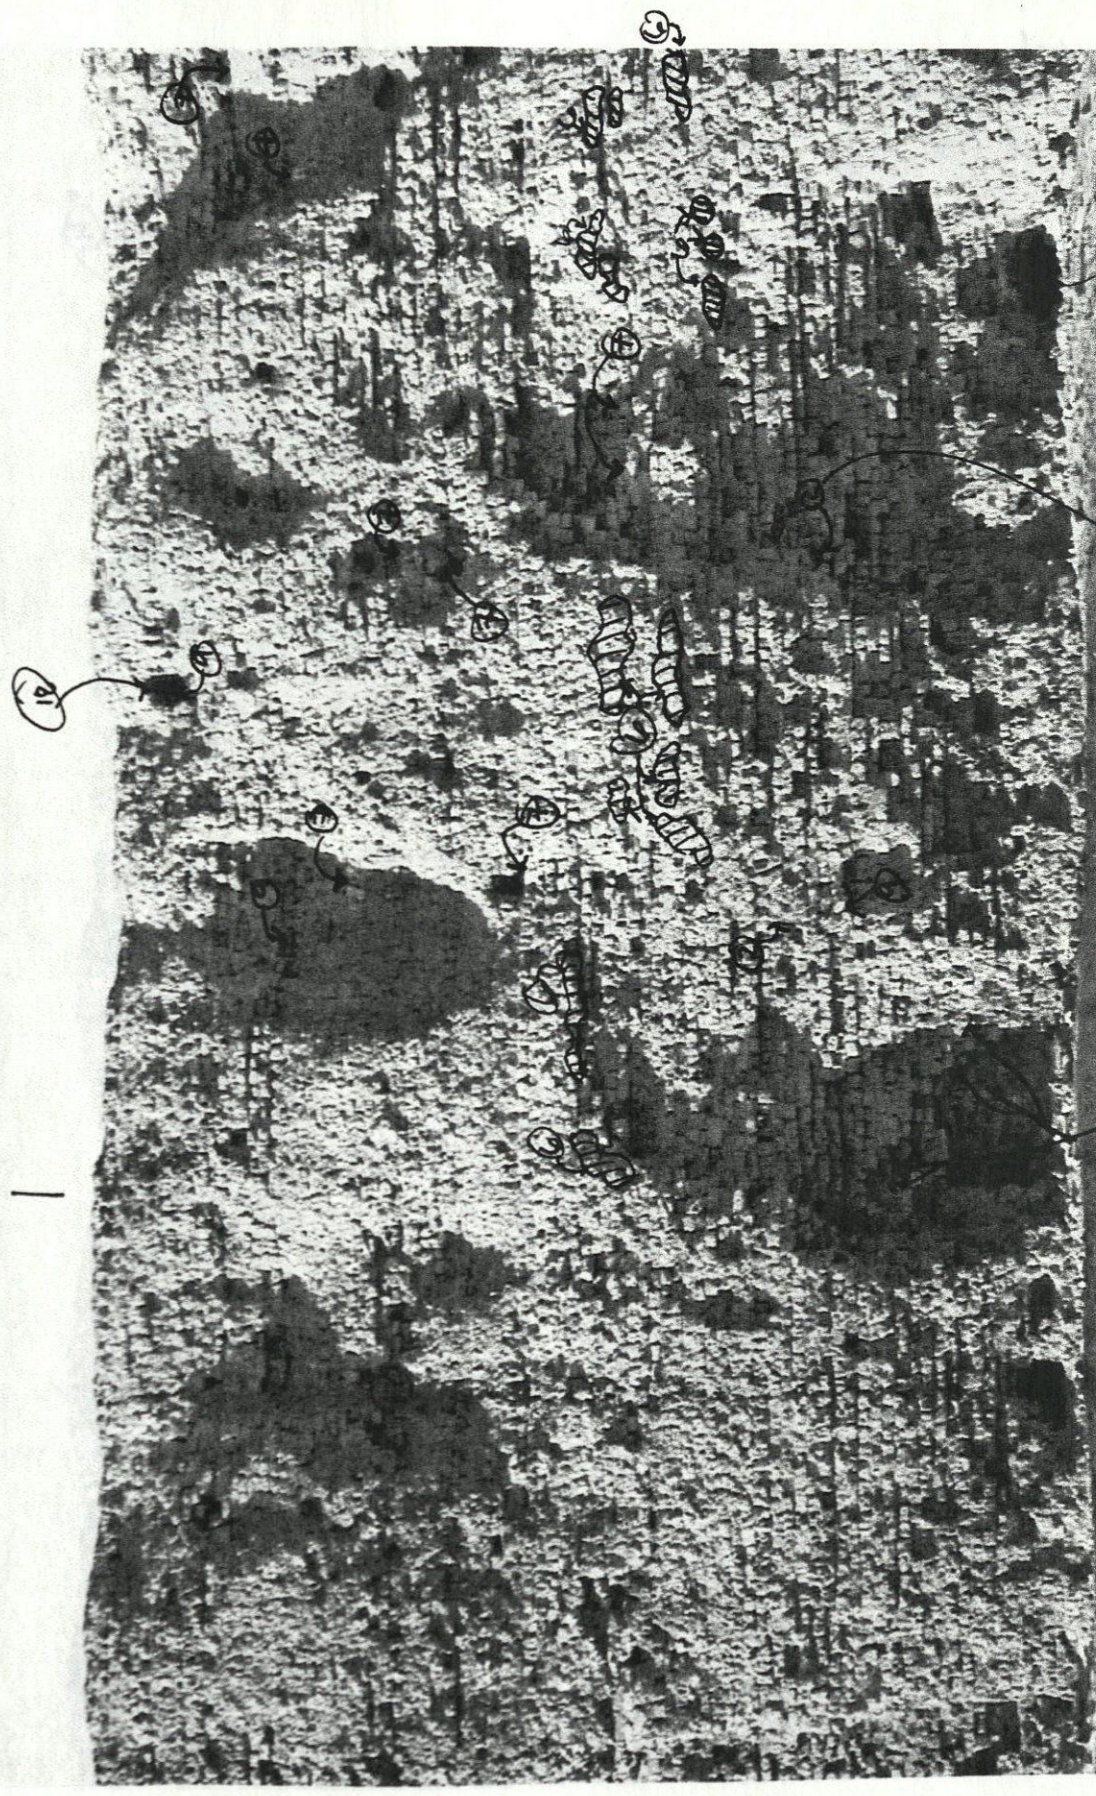
West Well, East Elev. # 6 from North

15 probably at least 12-15 inches in med. size area.

18 > 1 m. deep

Not sure if these are completely connected but probable. Relatively thin, 1-2 inches for ca. 1-2 c.m.

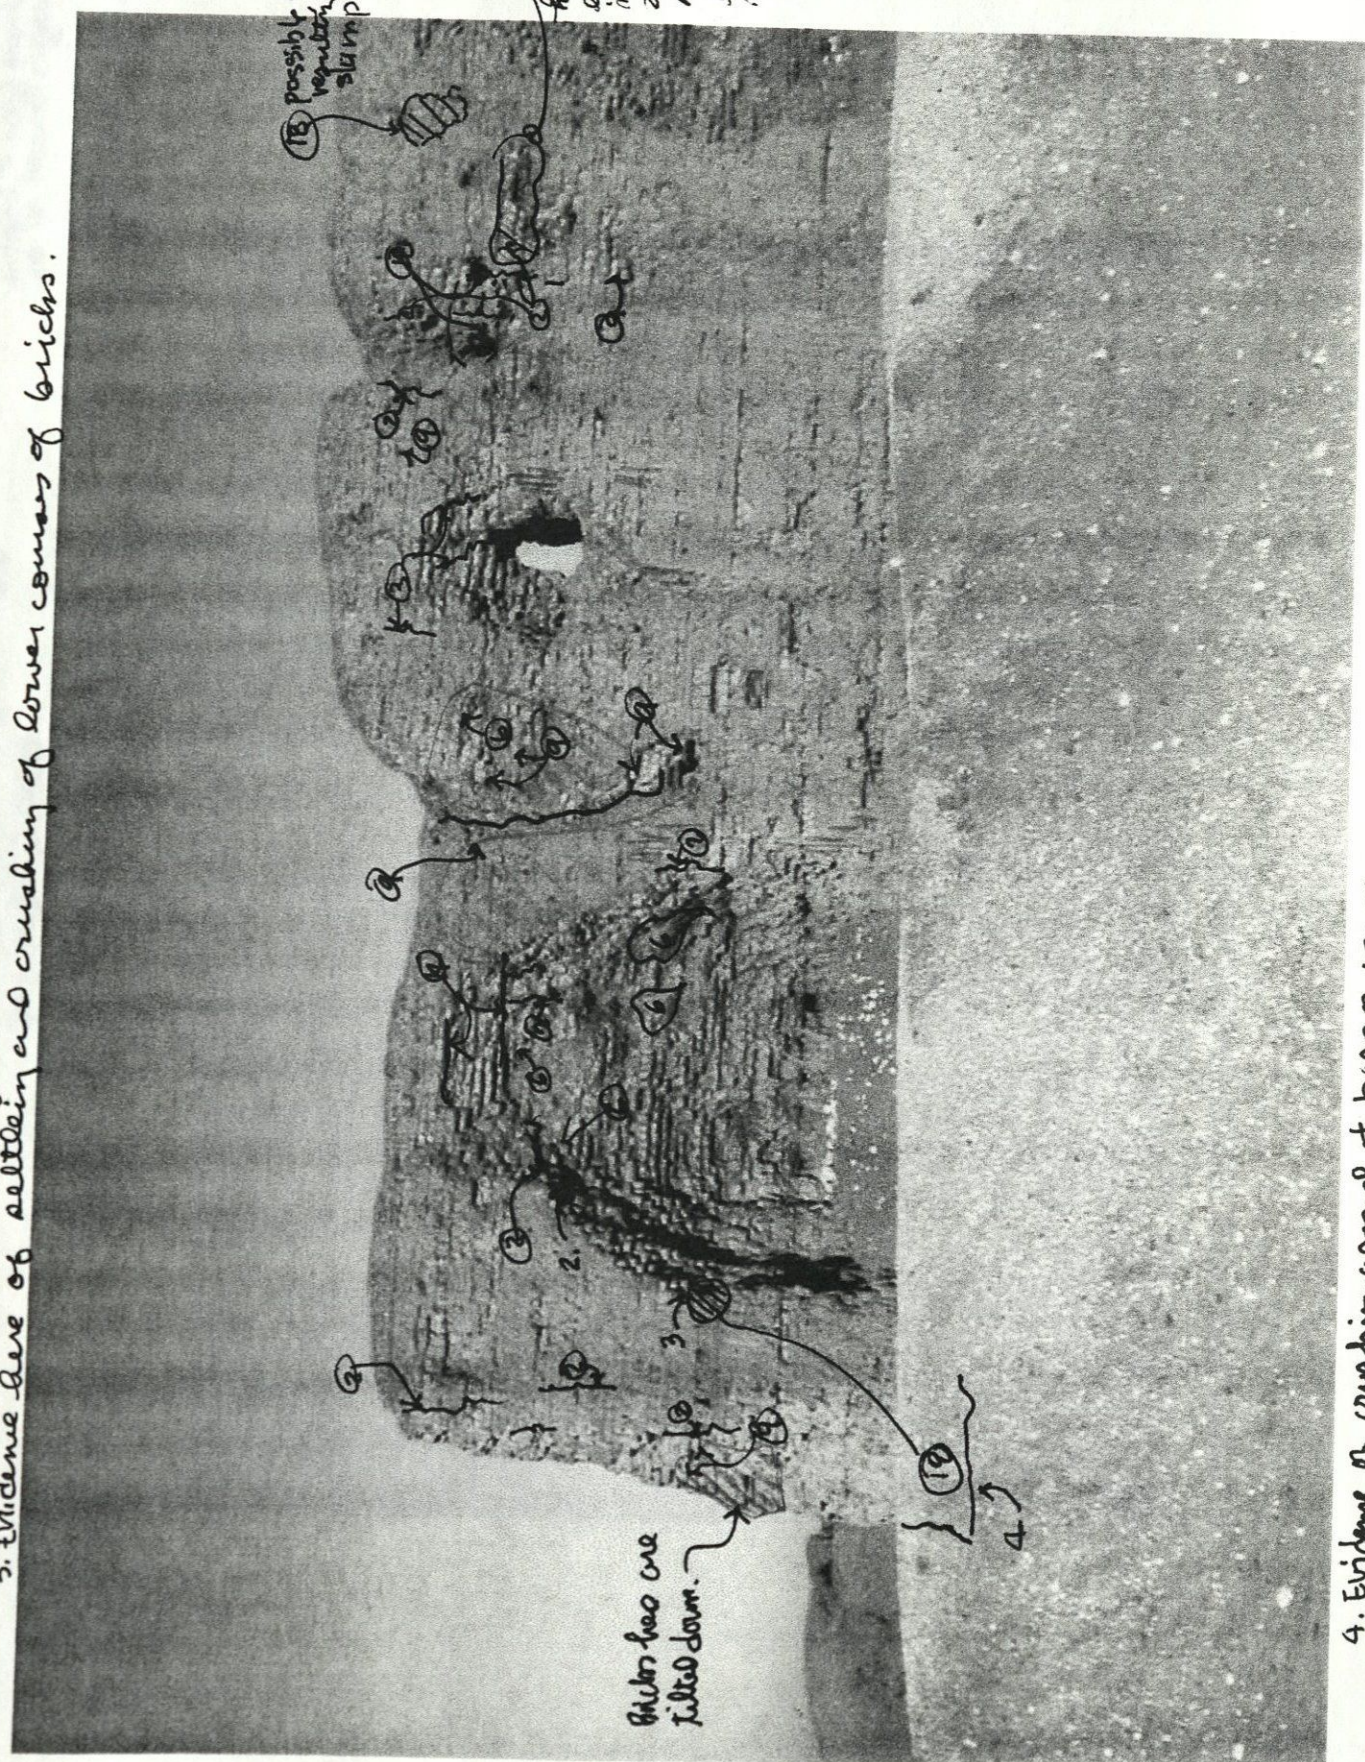
West Well, West Elev. # 1 from North

18 possible small void
 resulting from shrinkage
 & compaction of mortar

19 - these are the
 horizontal delamination
 etc. could be
 in the form of
 2-4 cm. layers of
 mortar with
 little more
 weathering.

4. Evidence of crushing around at base of corner.

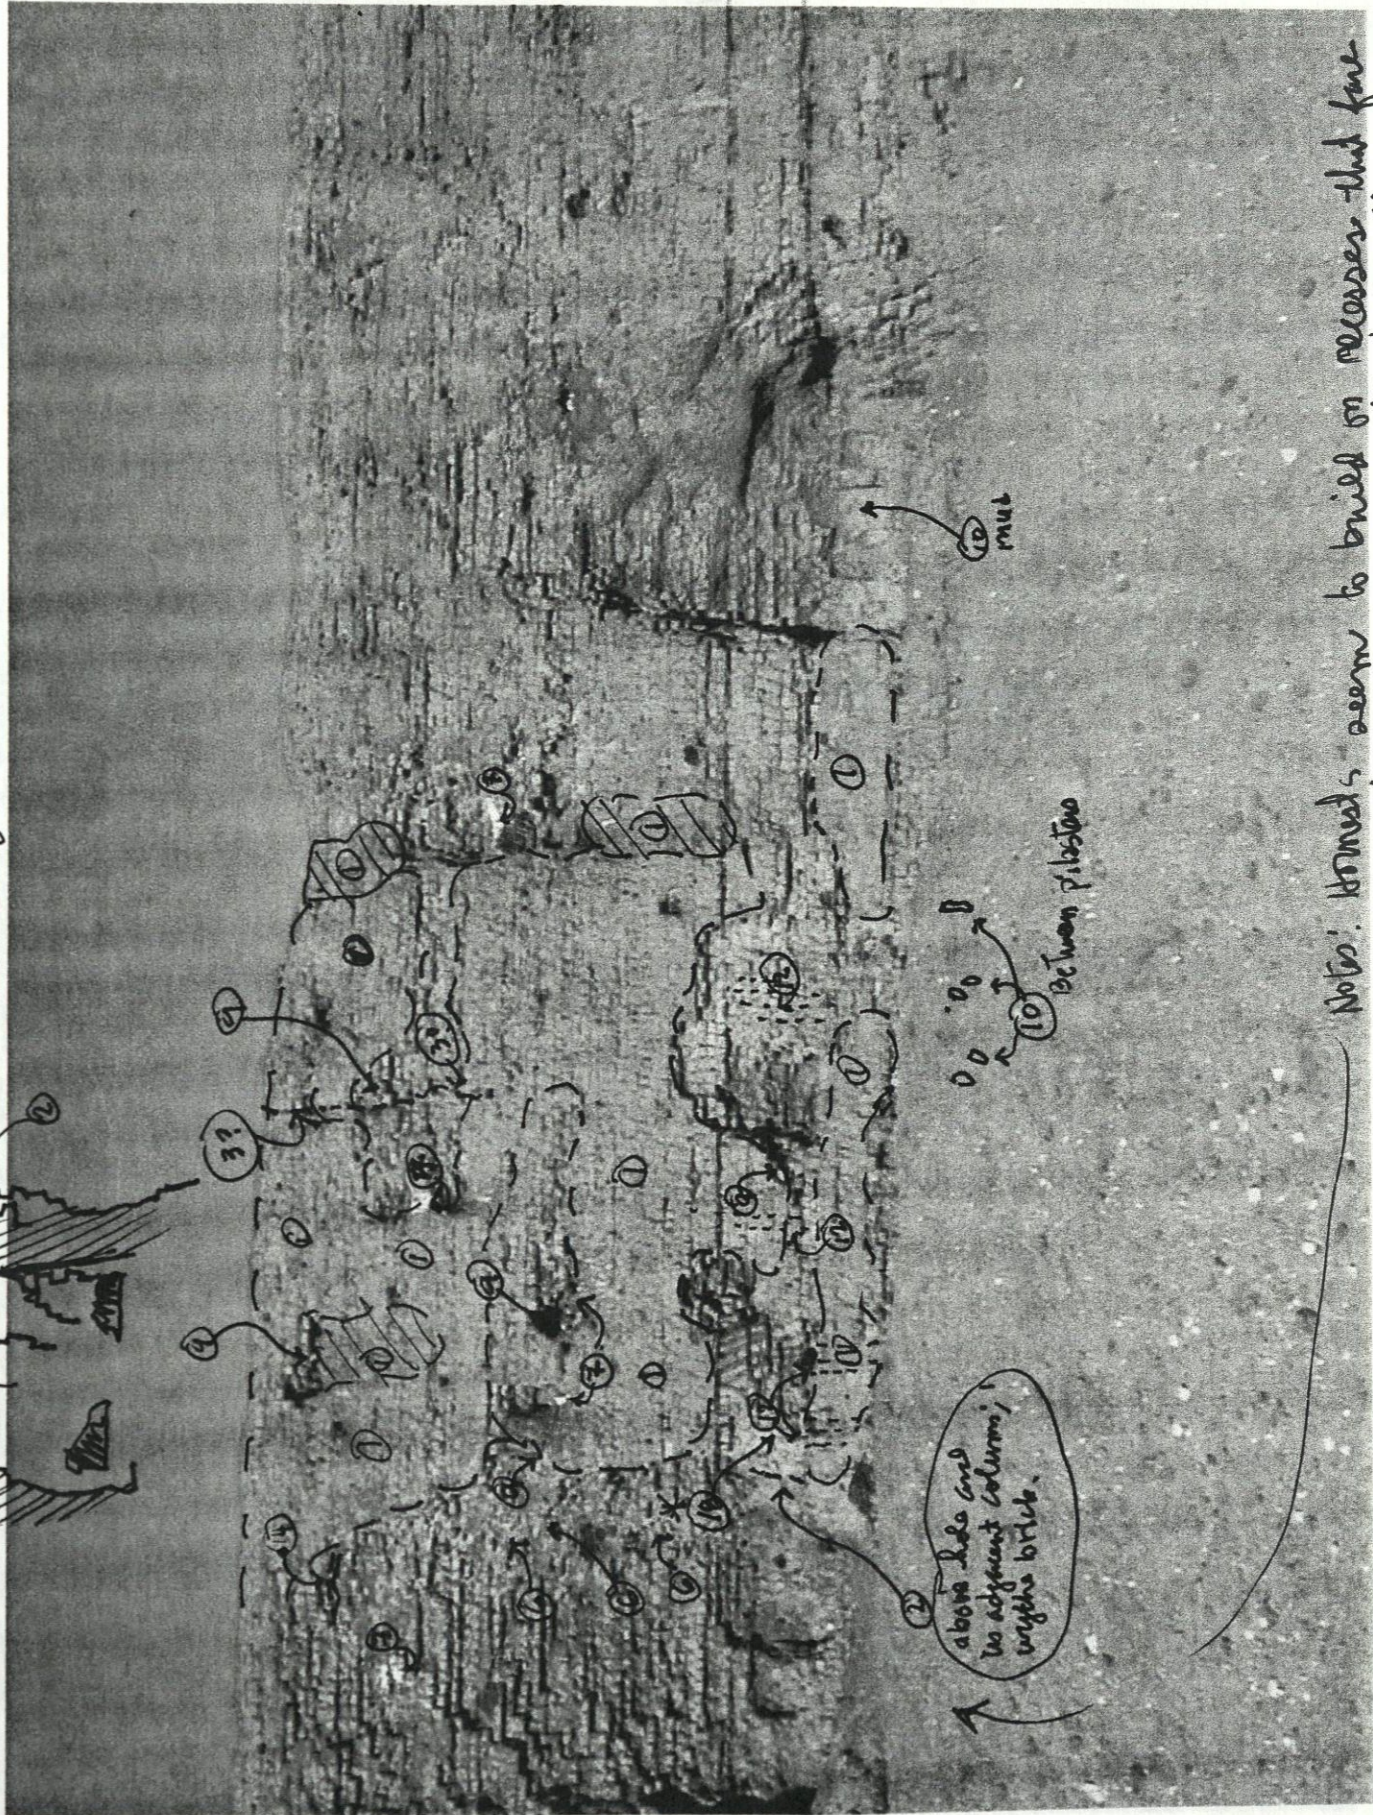
West Wall, West Elev. #6 from North

Note: Mortars seem to build in recesses that face
West. None on north side; extensive small on
south side.

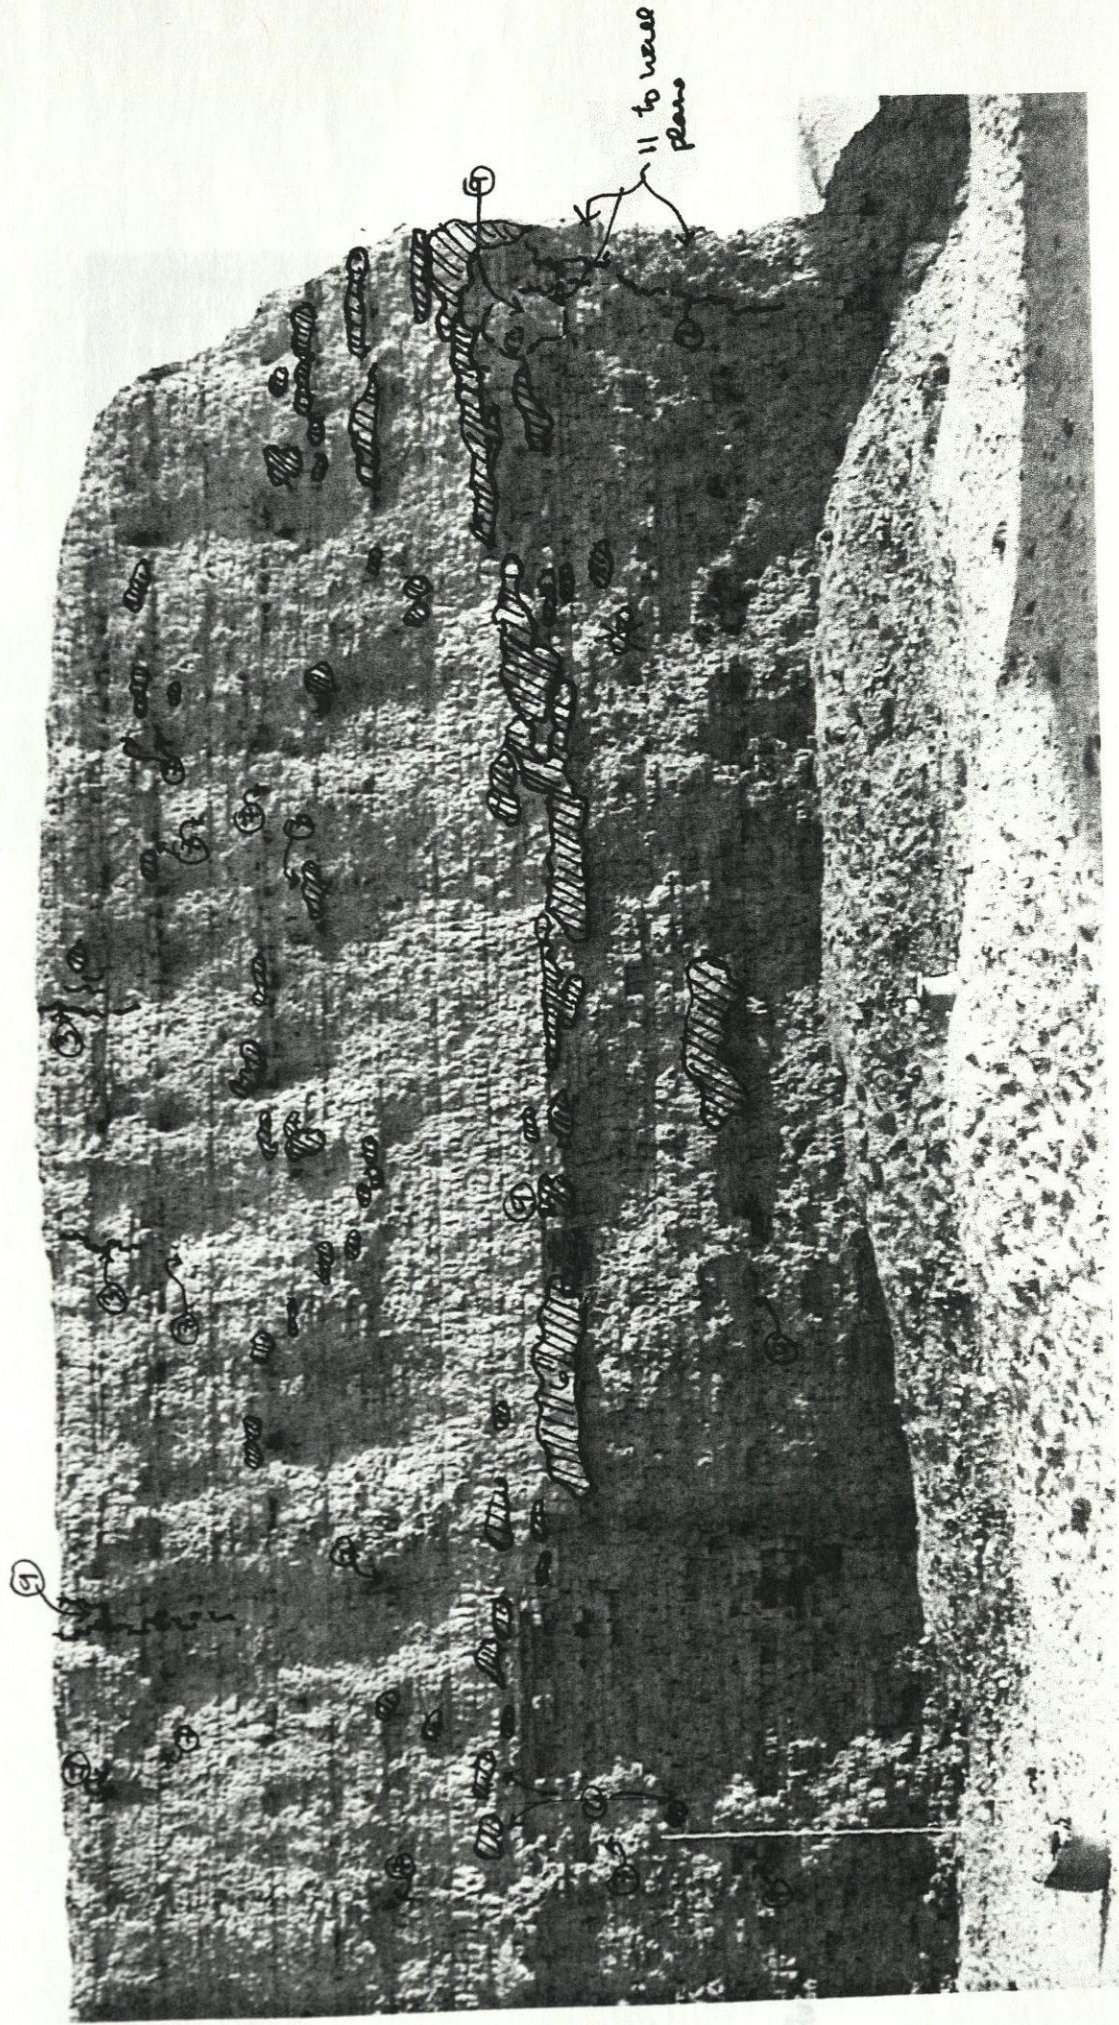
South Well, North Elev. # 2

These spots represent recent fall
or abrasion scars

No mud hills from water
No hornet nest (Ash a Zinnén)
Very few birds on this wall face

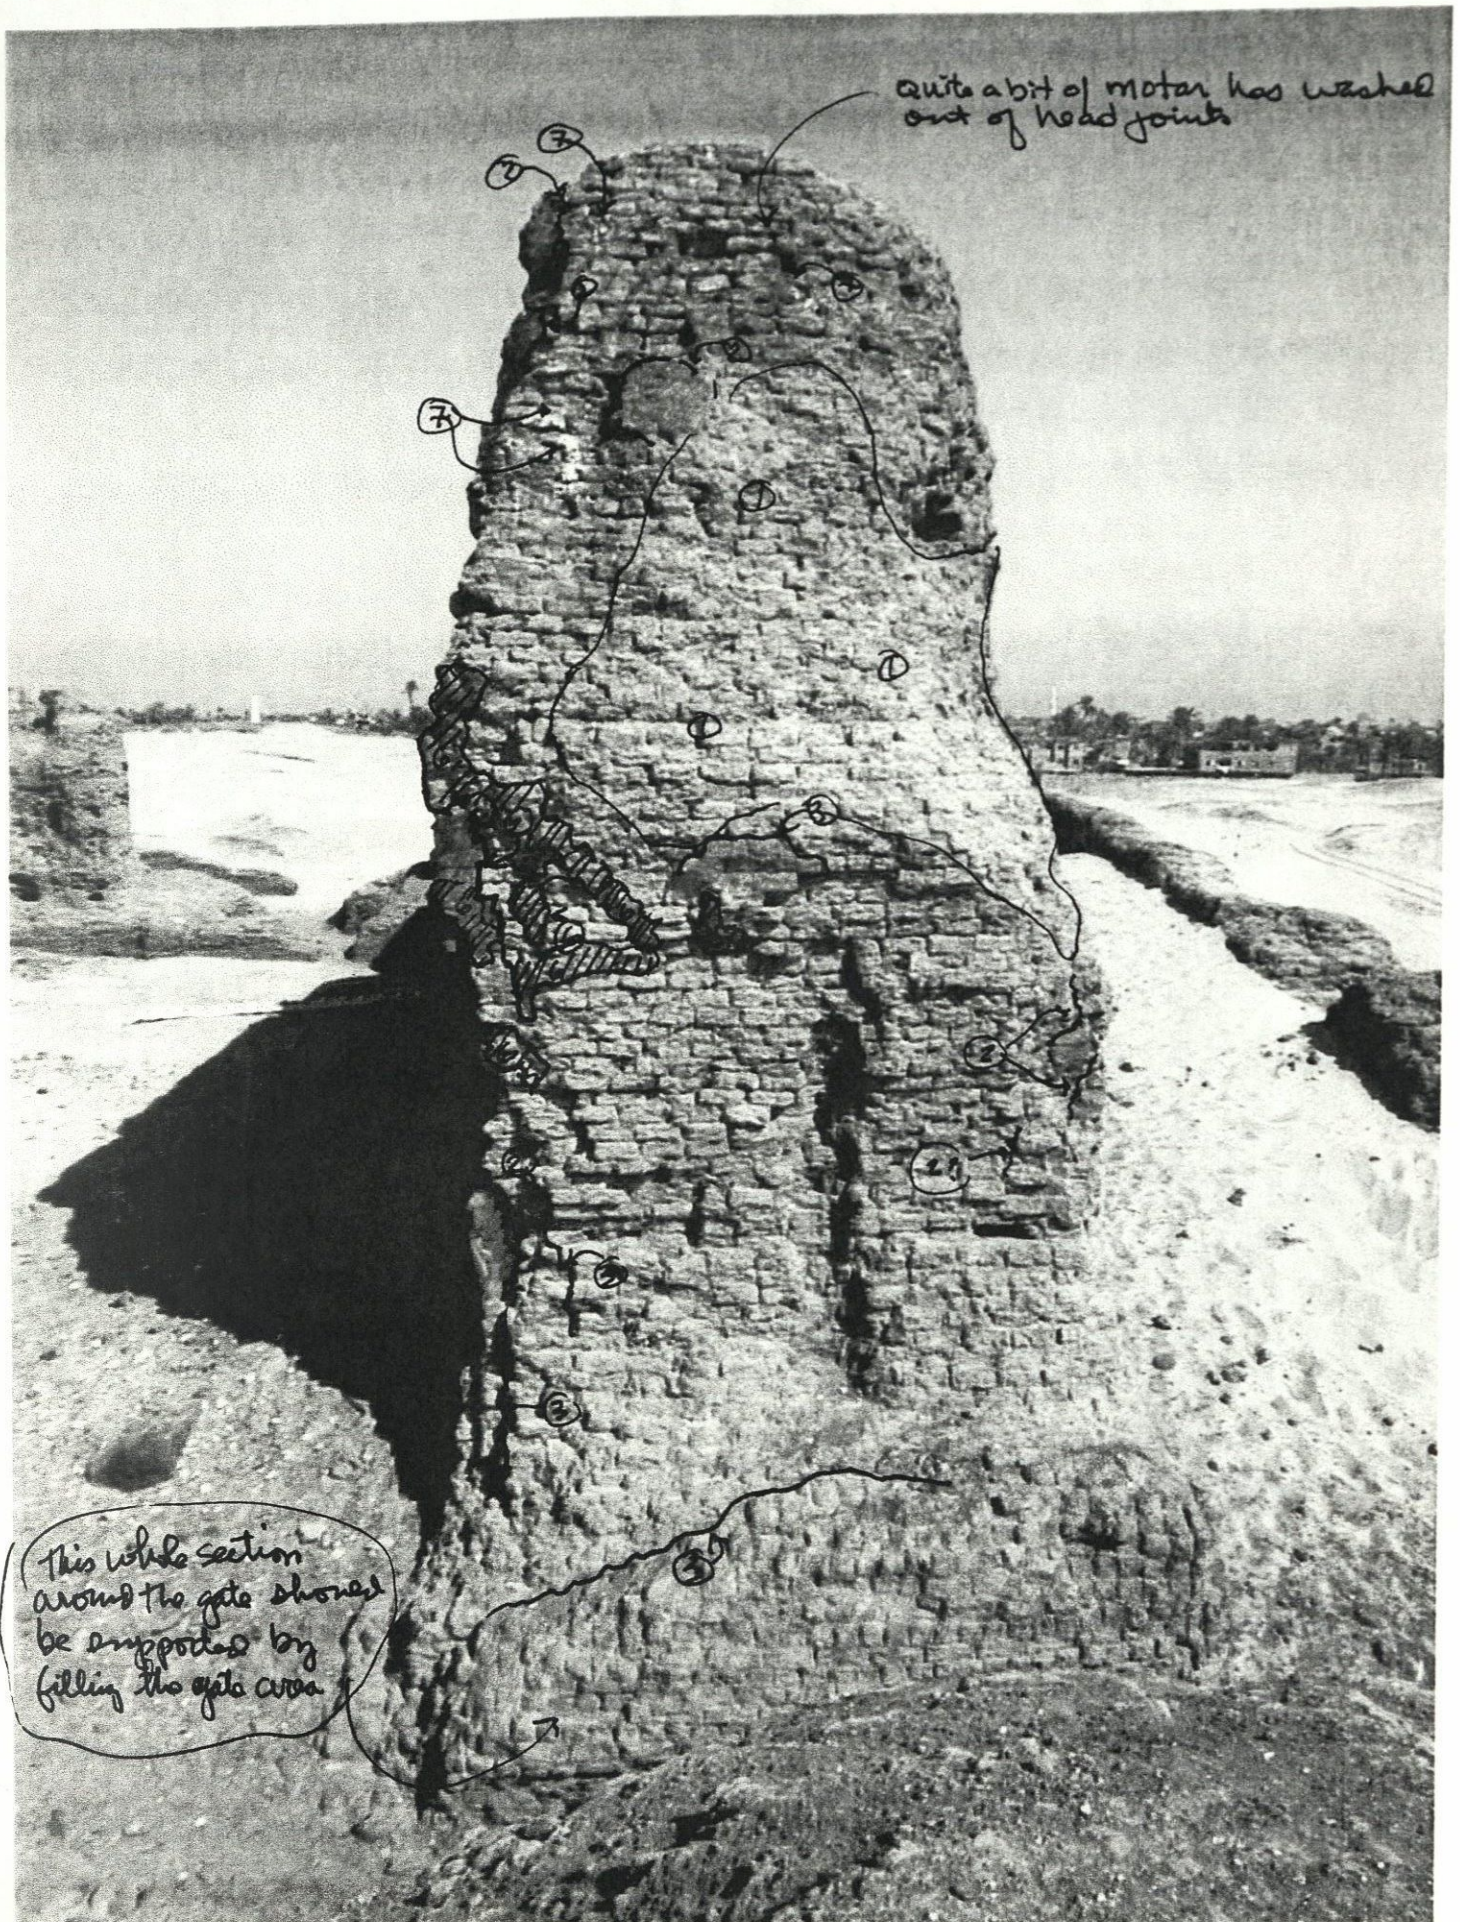
South Wall, South Elev. # 3

quite a bit of mortar has washed out of head joints

This whole section around the gate should be supported by filling the gate area

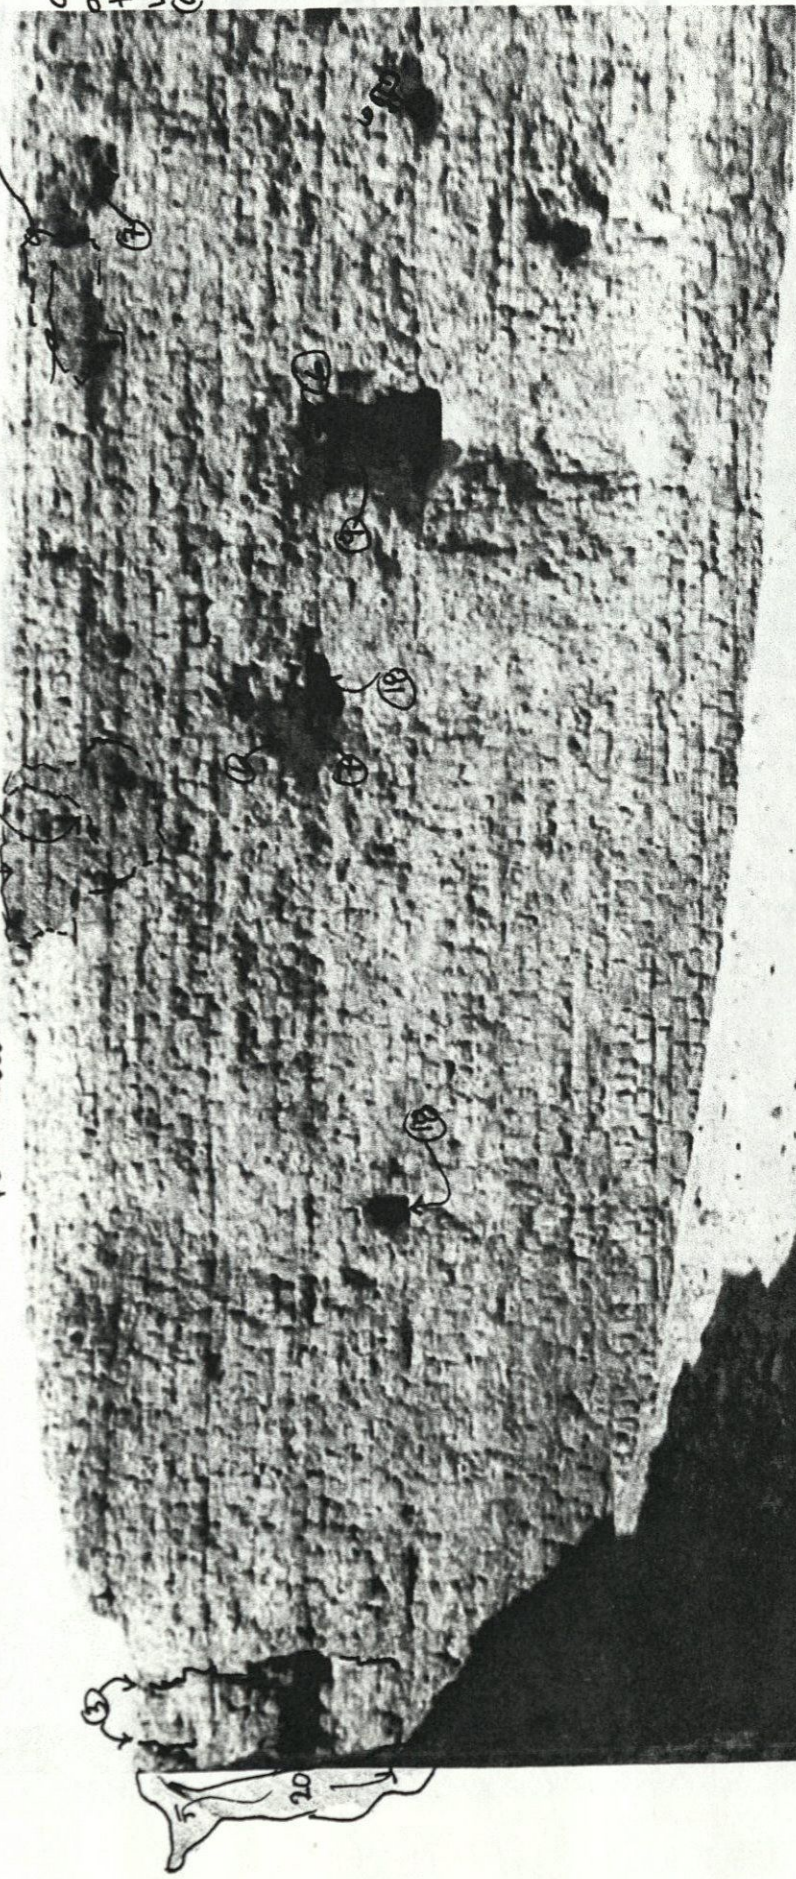
North Wall, South Elev. #1

(12) This area is eroded and may be void (seeing some) behind the surface bricks.

This area could be similar to holes in the top wall after water to penetrate (and has)

* surface is like snow, but not "snowed"

These areas look "clumpy" with a lot of eroded head joints, like just H this.

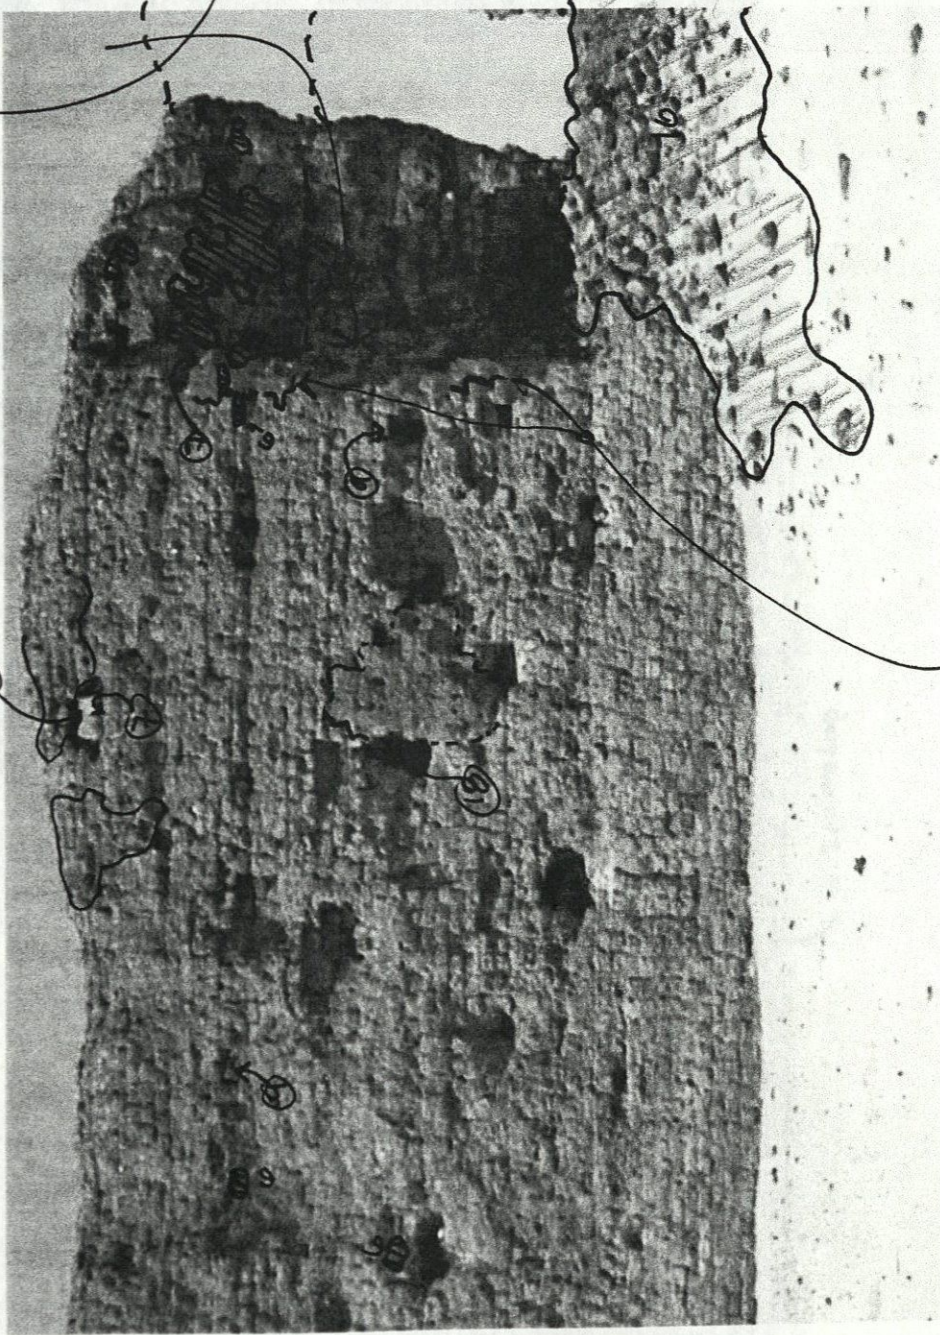
Elev. Section looking west

"clumps"

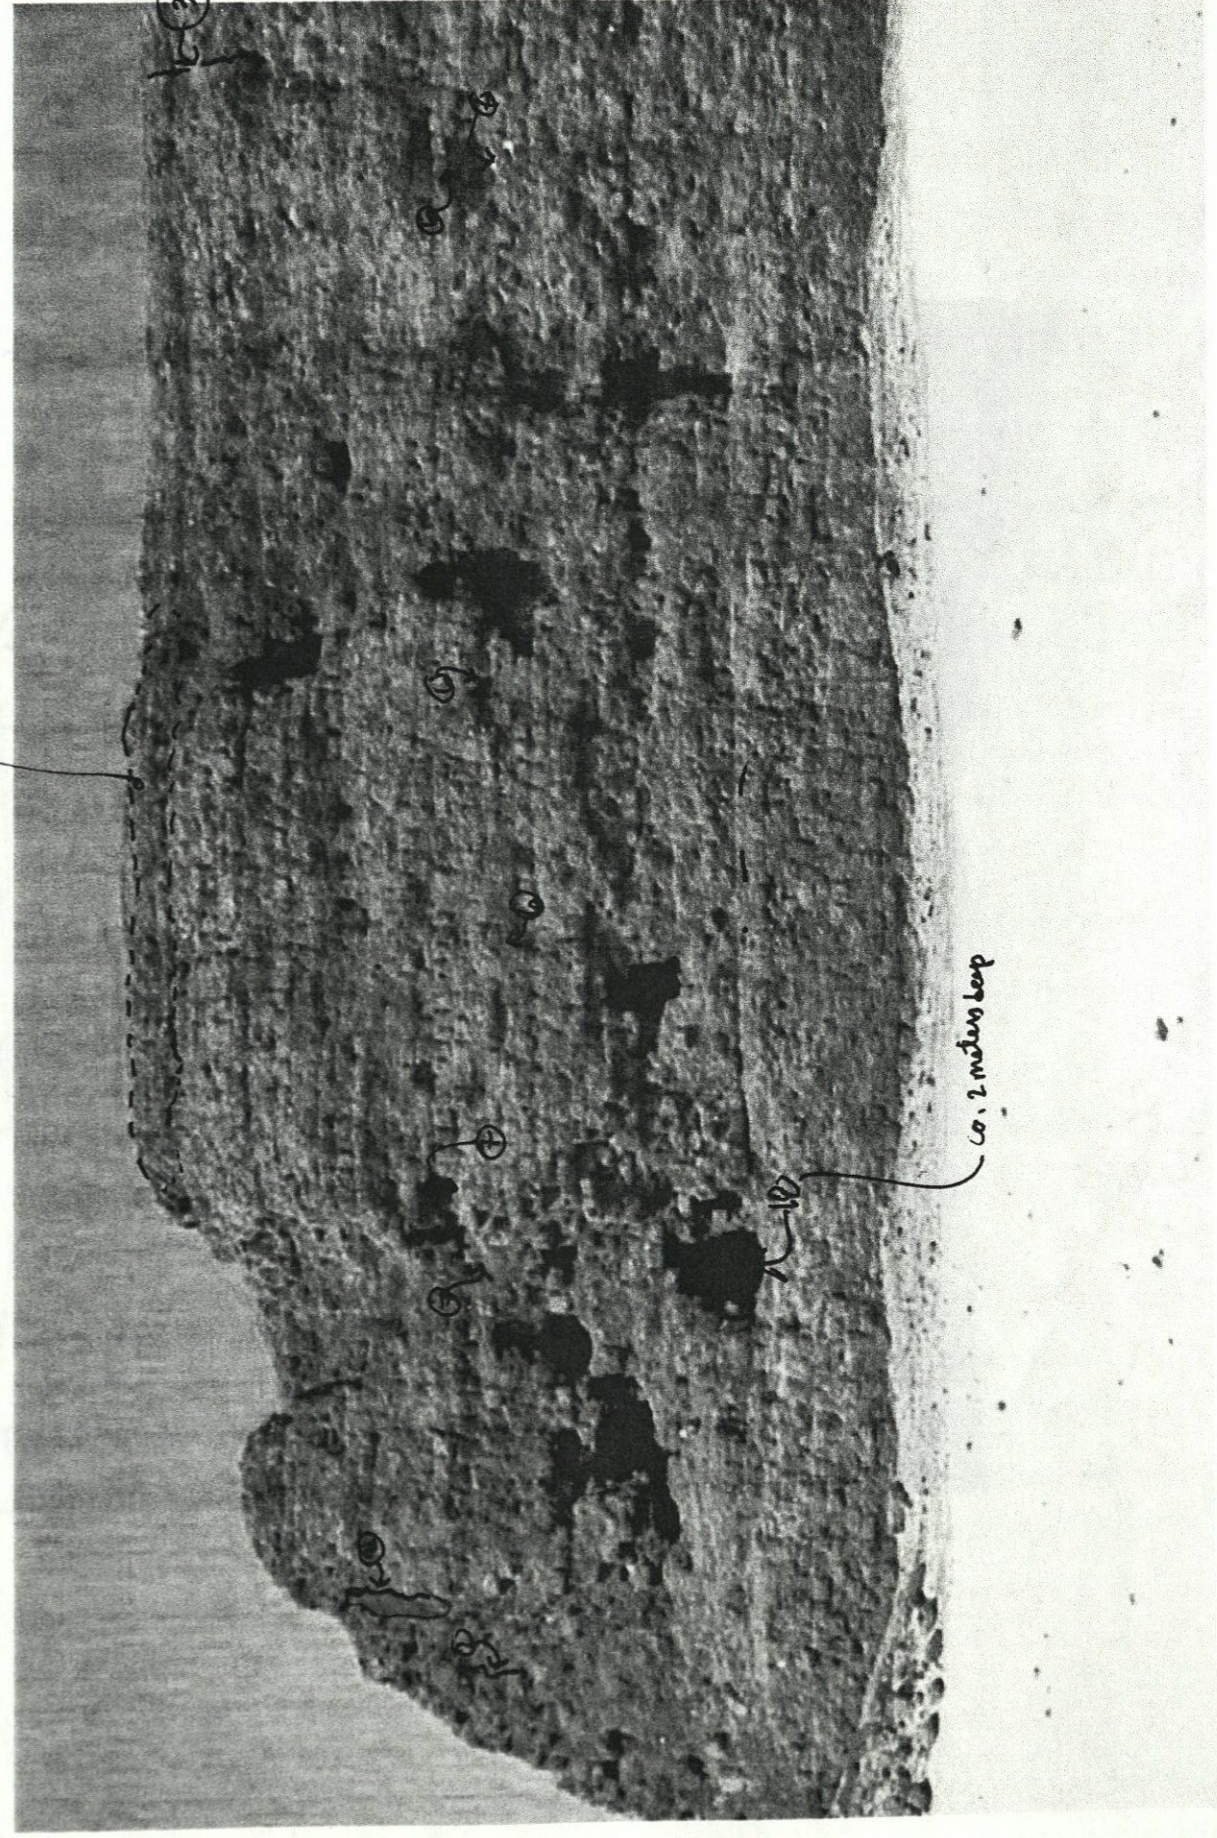
North Wall, South Elev. # 3

clumpy from water erosion

These sections are facing more to the SW than straight south and seem to be much more wind-scoured - could be a little clumpy

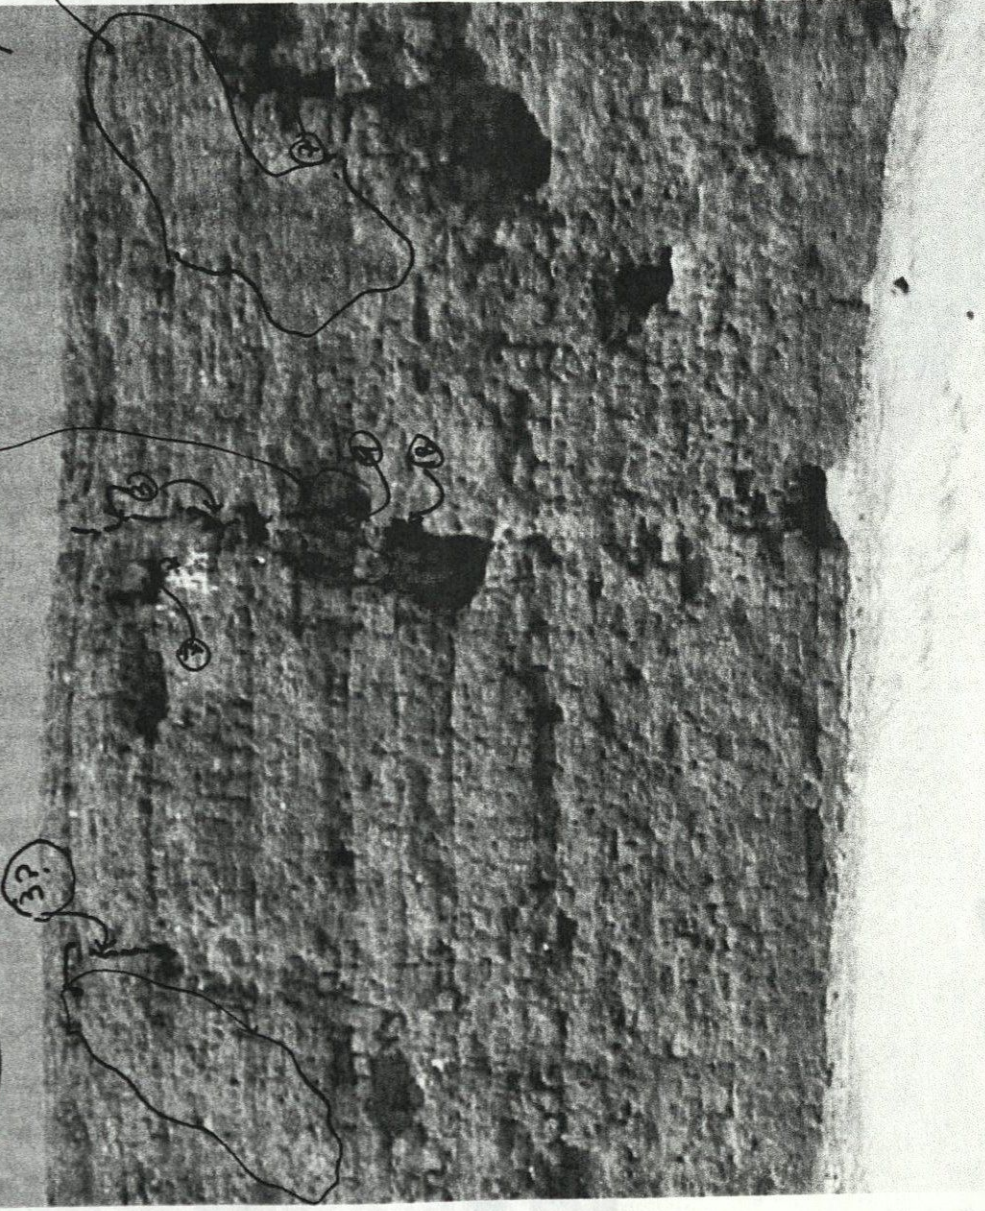
North Wall, South Elev., #4

Looks more like scoured rather than just wind eroded.
