PRELIMINARY FIELD REPORT No1: Vol 3-Mud Brick Conservation

**DOCUMENTATION and CONSERVATION
of the SHUNET el ZEBIB MONUMENT
(c. 2,700 BC) Abydos, Egypt**

**PRELIMINARY FIELD REPORT NO. 1
(IN THREE VOLUMES)**

**VOLUME 3 - MUD BRICK CONSERVATION
FIELD REPORT No. 1**

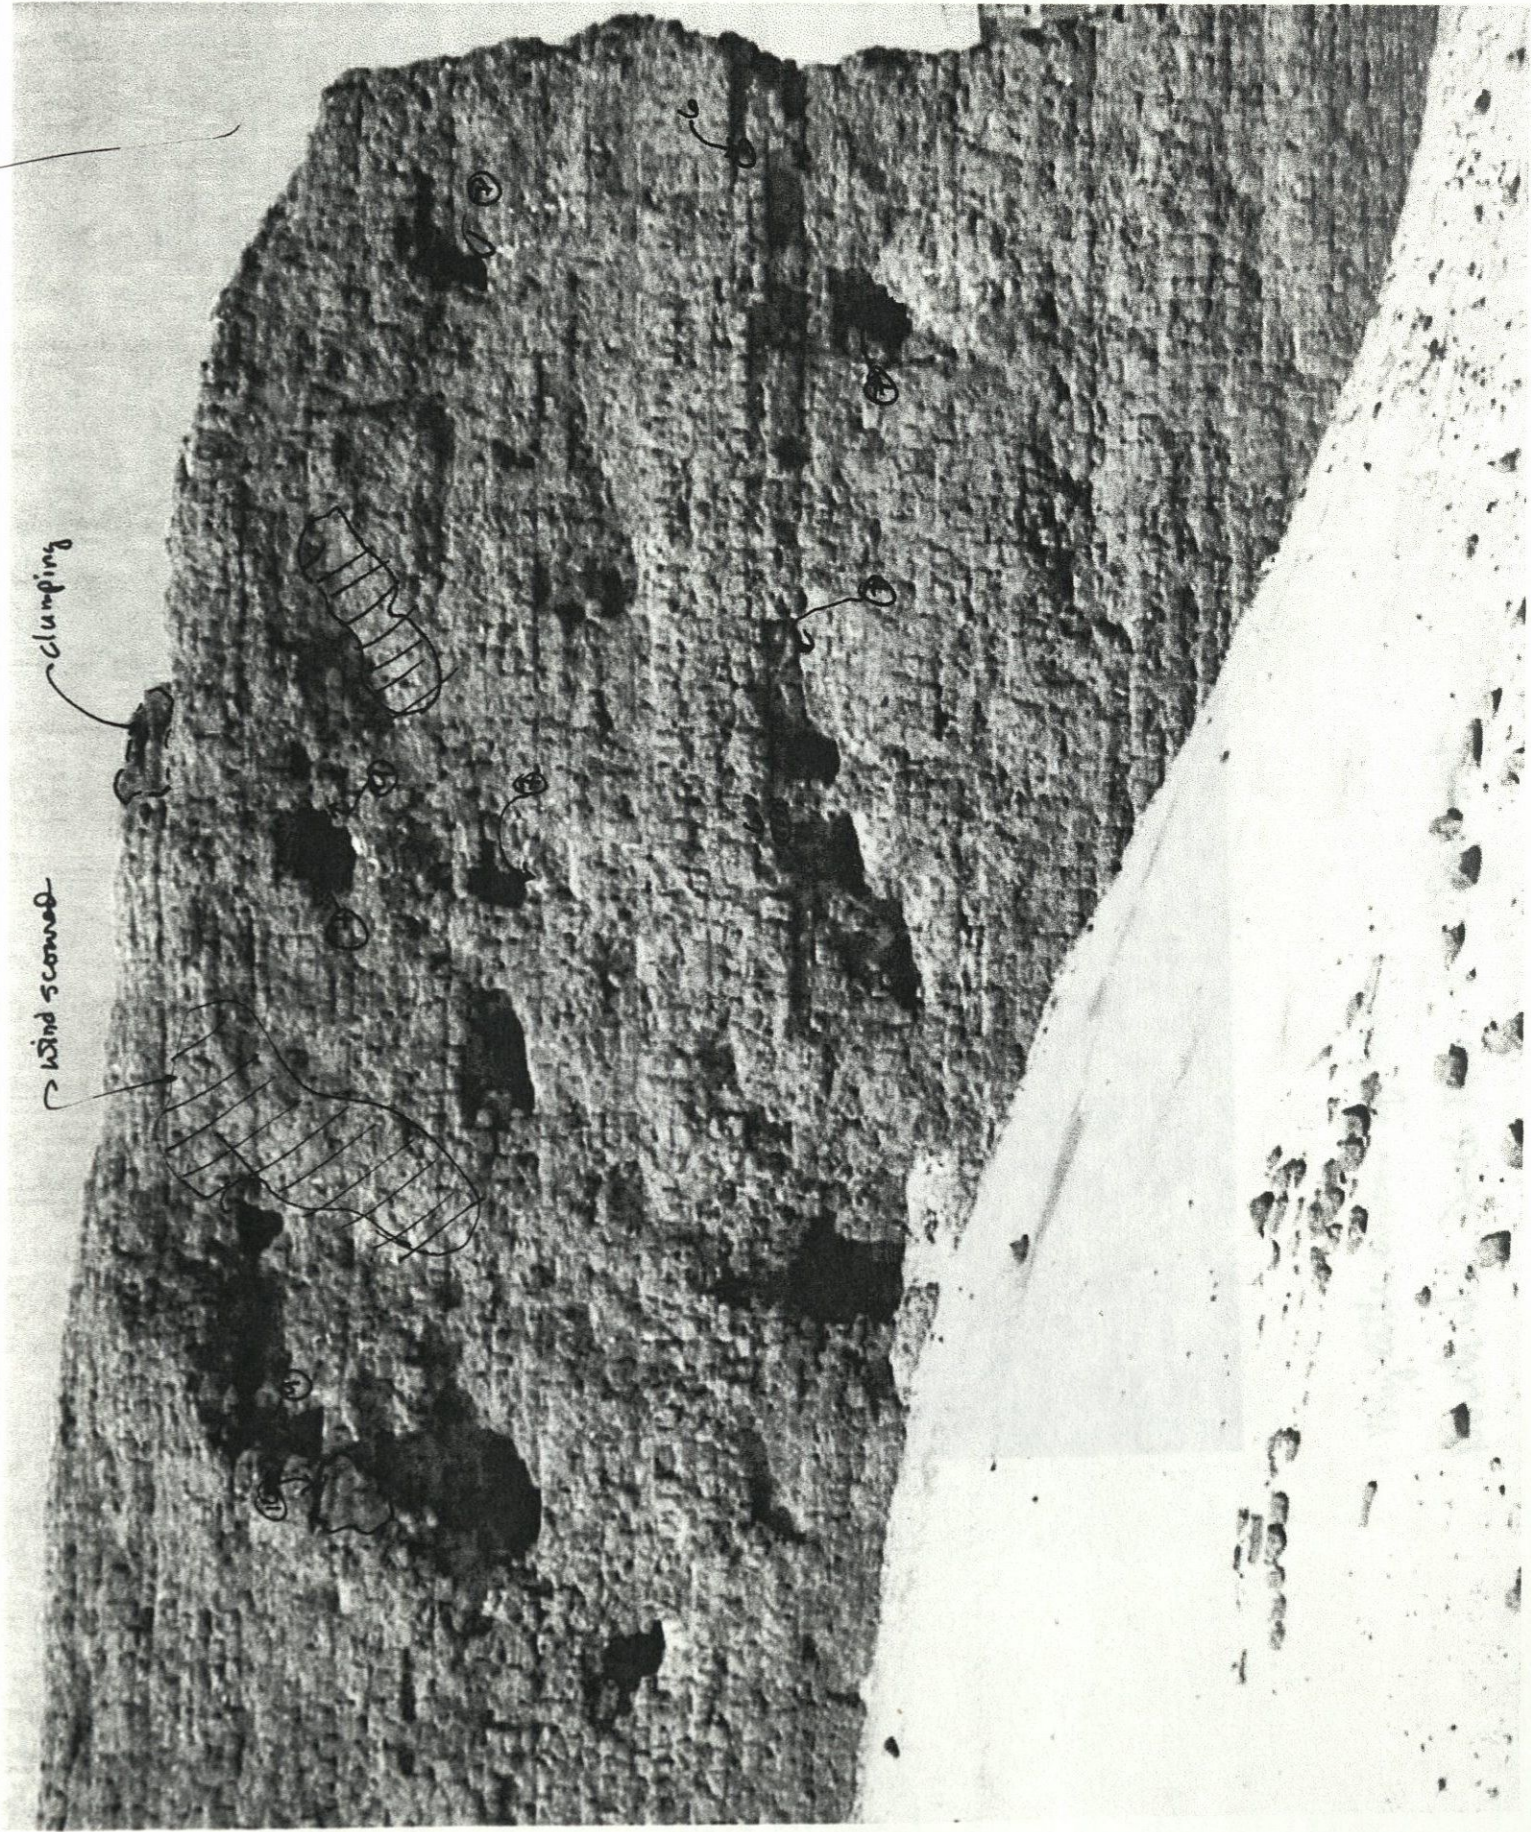
North Well, South Elev. #45

wind scoured

clumping

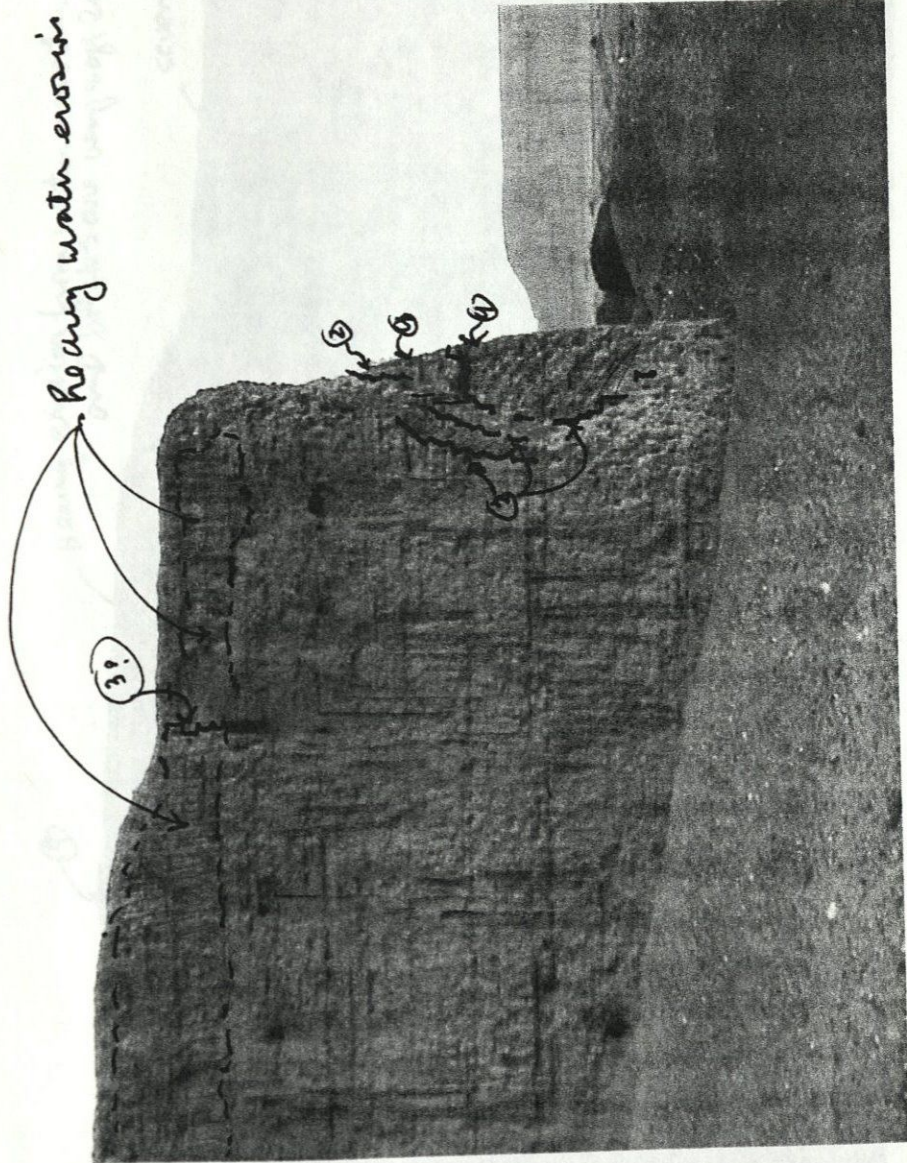
• Very little evidence of birds
 North Wall, North Ebor. # 1 from West

Heavy erosion from water - mortar is all washed out
and bricks are very soft looking & rounded edges

severe water erosion resulting
in clumping, worn
surfaces & washed away
mortar joints.
