THE FUNERARY MONUMENT OF KING KHASEKHEMWY AT ABYDOS (ca. 2700 BCE): CONSERVATION AND ARCHAEOLOGY, 1999-2006

Final report on the "Documentation and Conservation of King Khasekhemwy's Funerary Monument at Abydos," a sub-project of the Egyptian Antiquities Project of the American Research Center in Egypt

2007

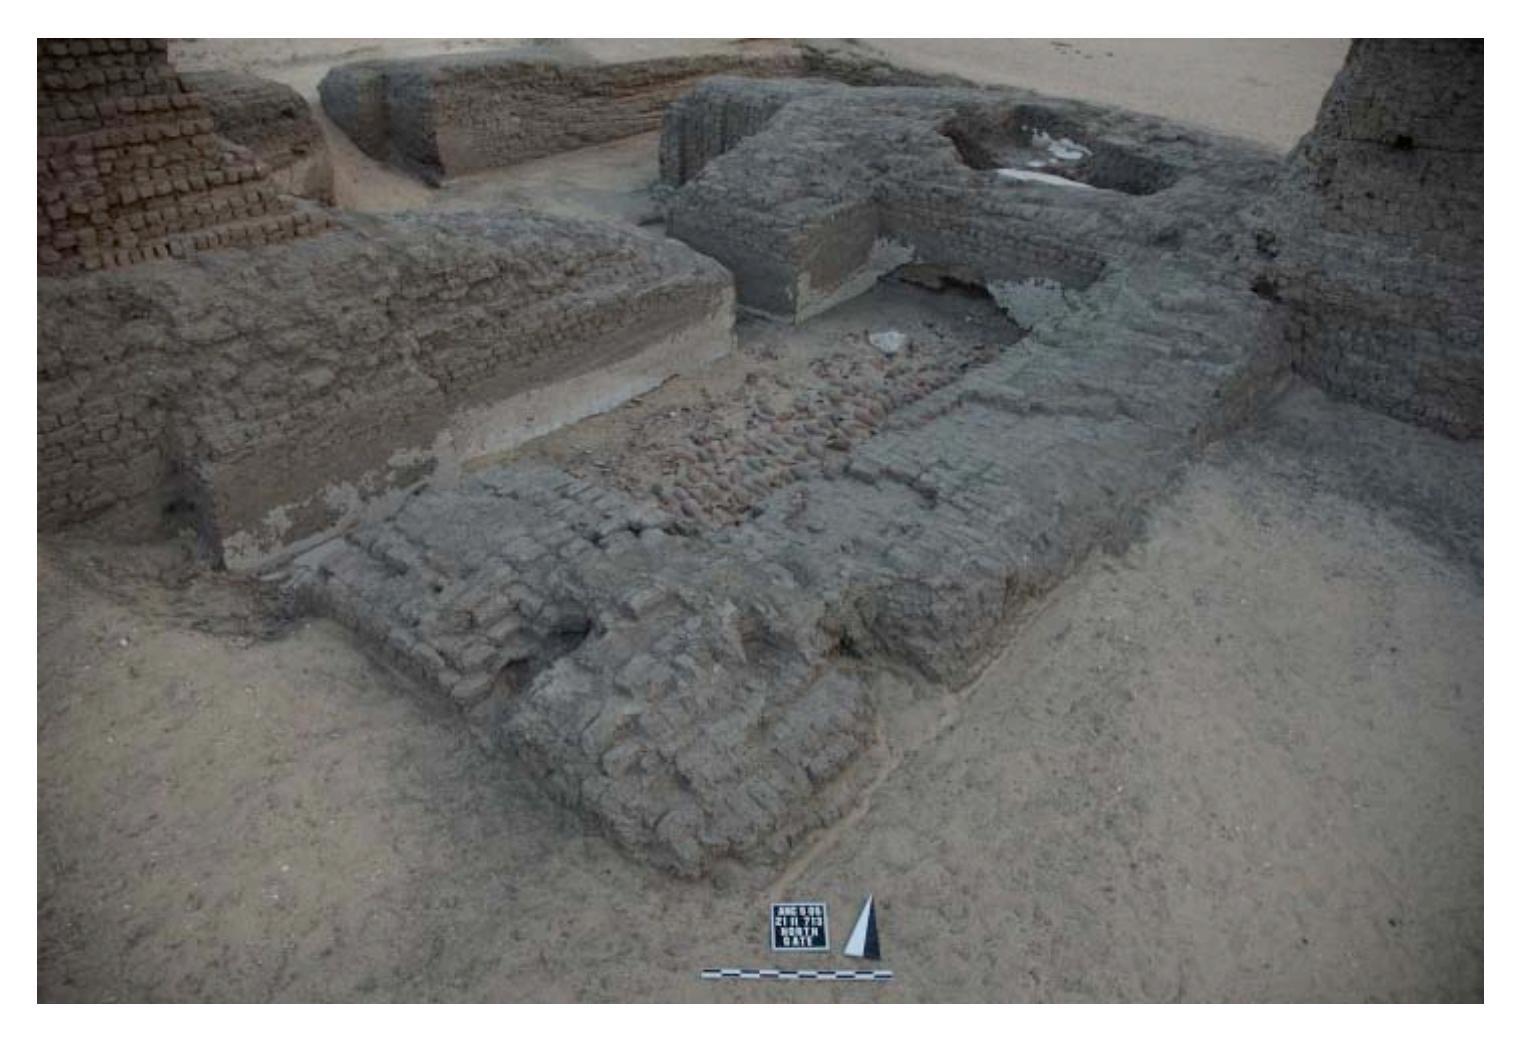
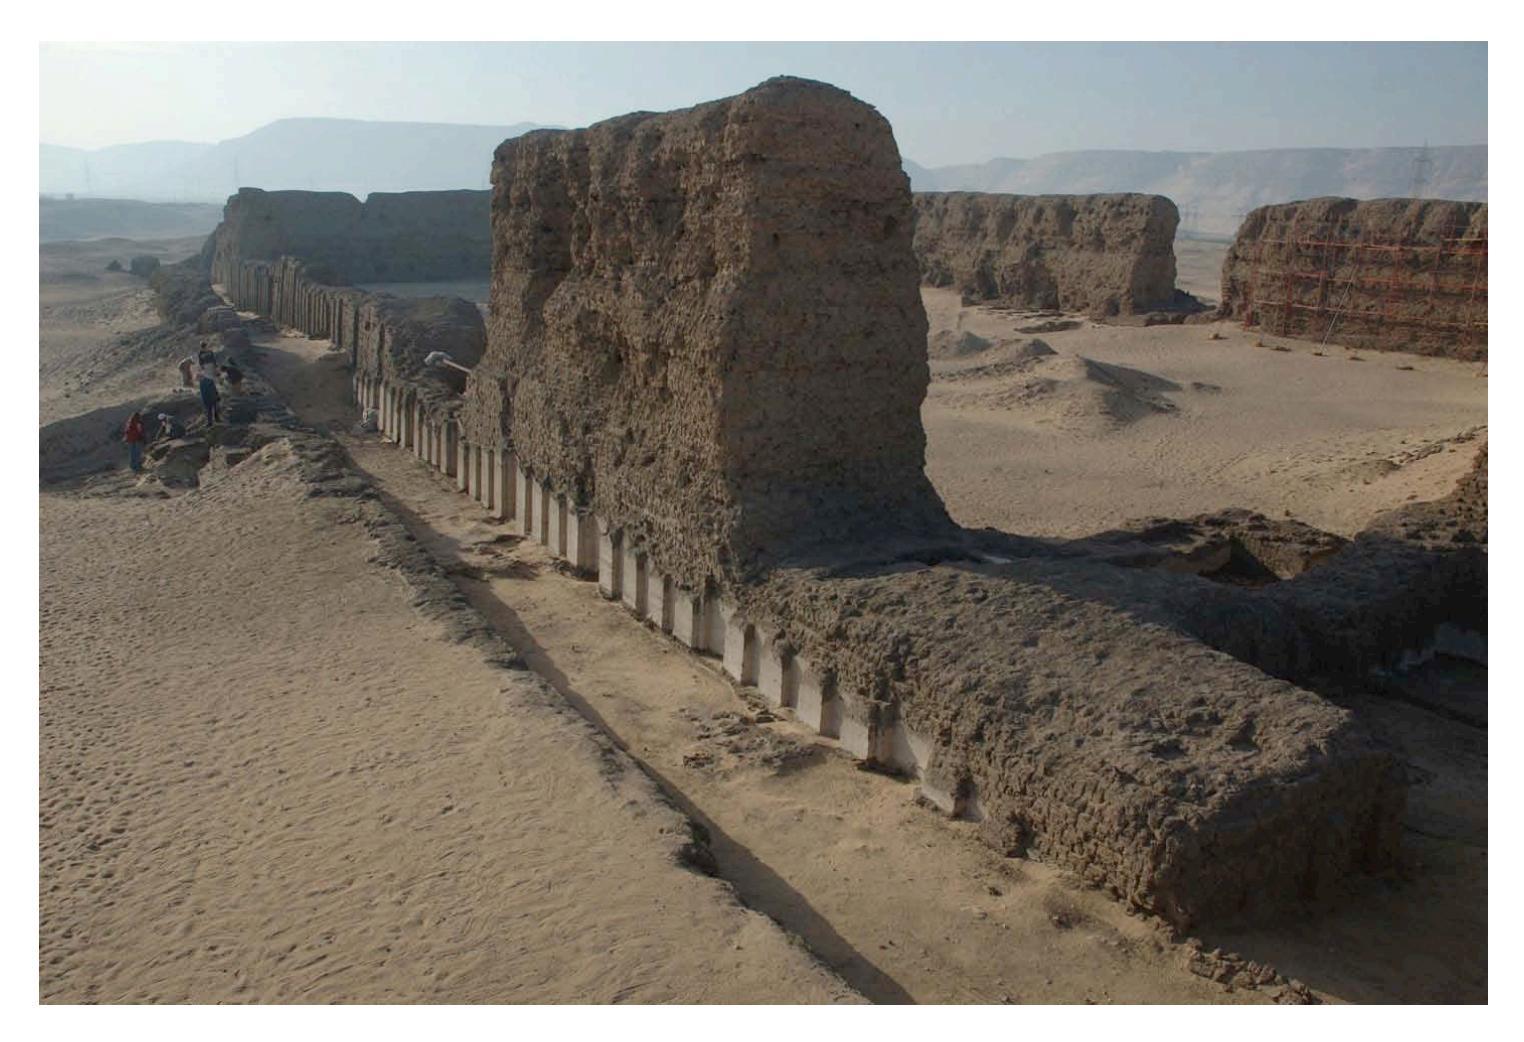
Figure 17. Interior detail of the north gateway and interior chamber with a large deposit of offering pottery (facing north); the hole cut into the end of the adjacent east wall (at upper right) is what remains of a monastic chamber from late antiquity (see following sections). (Photo: Robert Fletcher 2004-2005)

Figure 18. This foreground view of the east corridor illustrates the extent of niche and pilaster preservation on the exterior face of the east main enclosure wall; originally, the niches, pilasters and whitewash finish would have covered the full height of the main enclosure. (Photo: Robert Fletcher 2004-2005)

The northern pier of the east wall generally exhibits extensive cavitation and surface friability as well as urgent-priority through-wall cracking, erosion, undermining, detachment, overhangs, nest accretions and loose brickwork at various locations on both the interior and exterior elevations (illustrated as locations M through O in Figures 105-111). Location M designates a major structural crack that threatens one end of the northern pier with collapse, and at the other (northern) end of this pier is a second structural crack, which has essentially isolated the vertical wall end at this location (see Figures 105, 107 and 111). This vertical segment of the east wall stands to near the original height of the enclosure in an extremely unstable condition, exhibiting a combination of cracking and detachment associated with the collapse of the adjacent gateway as well as the construction and decay of a monastic cell dug into the wall from the north interior gateway chamber (see Figures 17 and 18, above).

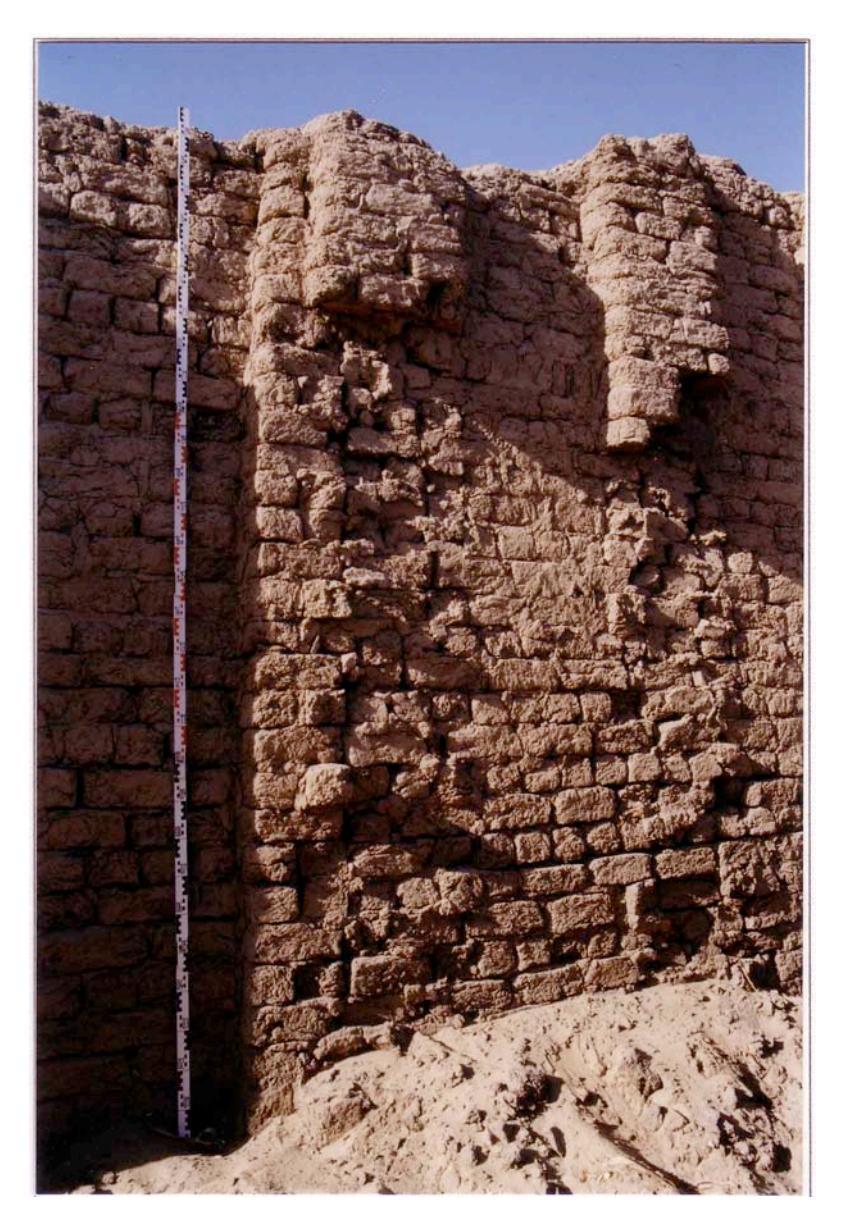
Figure 24. Detail of pilaster remains on the exterior east main enclosure wall, depicting the sheared header bricks that were originally used to bond the veneer bricks to the core of the wall. (Photo: William Remsen 2000)

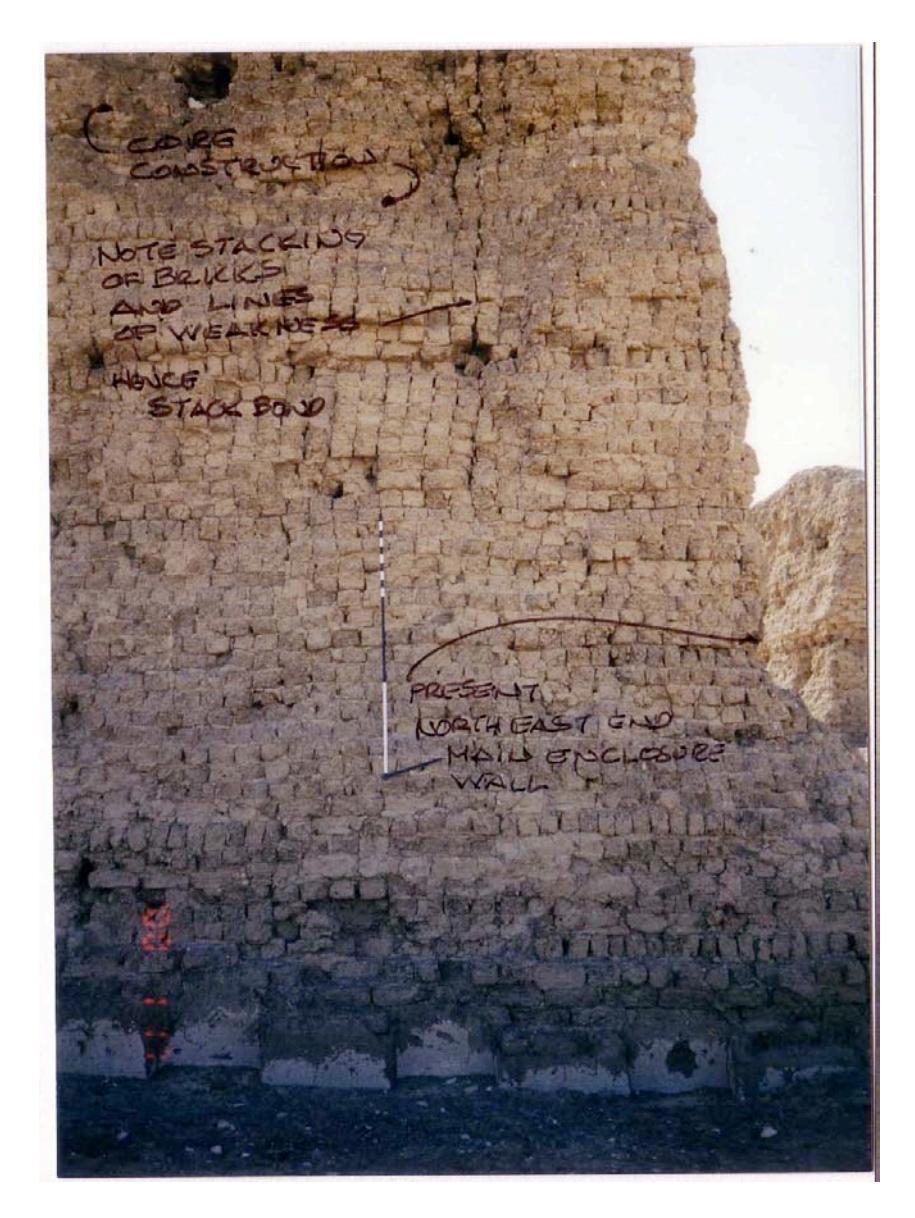
Figure 25. Detail of stack bonding in exposed wall core at the northern, exterior end of the east main enclosure wall; note vertical cracking at this location. (Photo: Conor Power 2000)

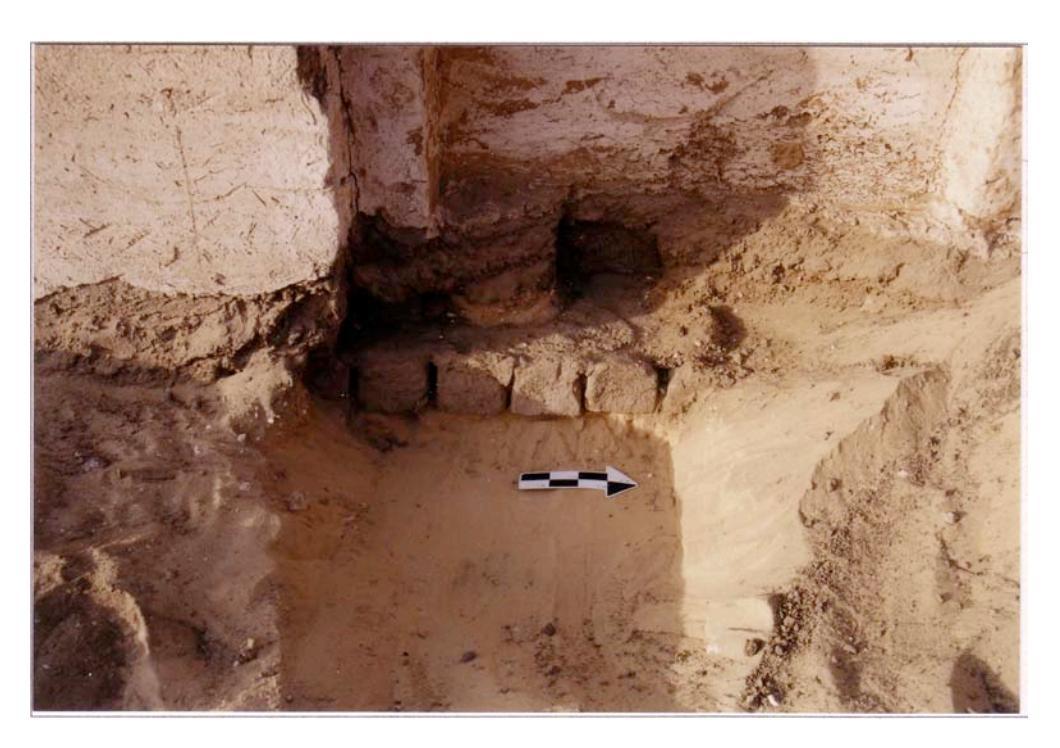
Local excavations in 2000 briefly exposed small areas at the exterior base of the east main enclosure wall, the interior base of the south main enclosure wall, and the interior base of the east perimeter wall in order to determine the foundation properties of the monument (Figures 34 and 35). Based on measured wall base elevations at these locations, the structural grade was found to slope to the south approximately two meters. The base course footing of the monument was constructed without additional foundation on a prepared surface of stiff to very stiff, fine sand. Generally speaking, the footprint of a massive and uniform wall, such as that of the Shuneh, can provide adequate structural support, provided a strong and uniform subsurface. Soil bearing studies at the site assigned an estimated bearing capacity of 4000-6000lbs per square foot of direct bearing soil. At both its assumed original and existing heights, the soil pressure produced by the monument falls well within these values. Although the sands upon which the existing structure bears are easily disturbed and must be regarded carefully, given the monument's inability to span over areas of reduced capacity, there is no evidence (such as sudden changes in elevation or excessive differential settlement) to indicate weak underlying strata or weak bearing capacity further below the footing.

Figure 34. Detail of the exterior base of the east main enclosure wall, which was revealed by local excavation at the northern end of the east corridor; note one-course-thick brick footing on a foundation of stiff sand. (Photo: William Remsen 2000)

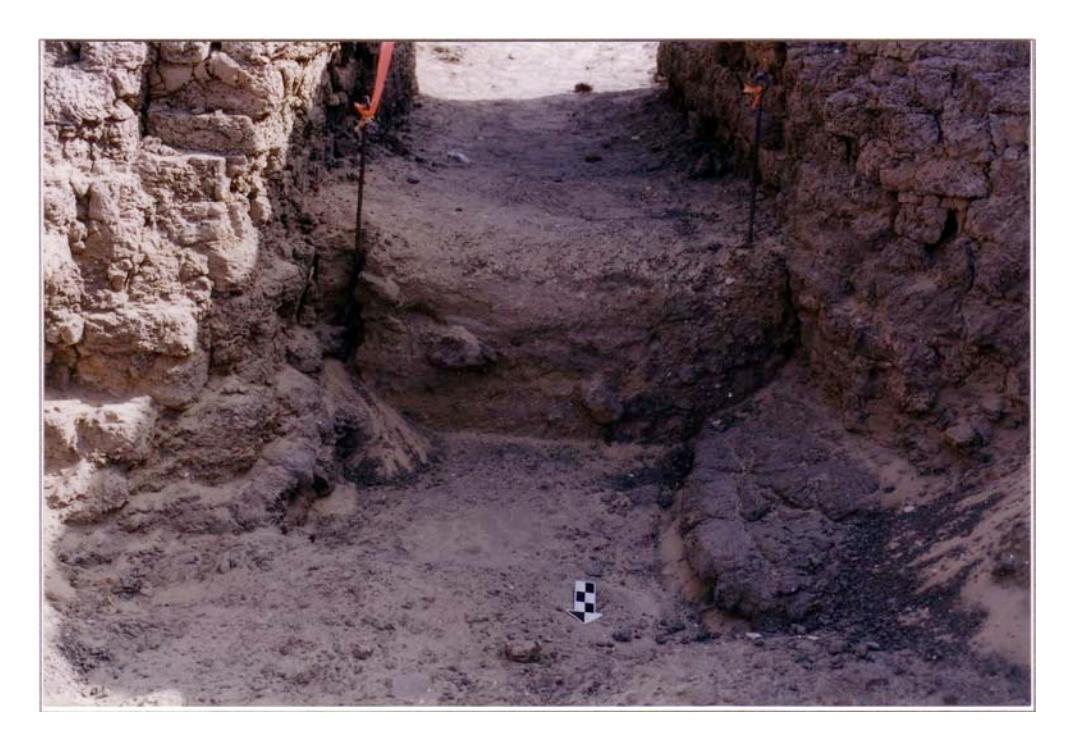
Figure 35. Detail of the interior base of the south main enclosure wall, which was revealed by local excavation at the south gateway. (Photo: William Remsen 2000)

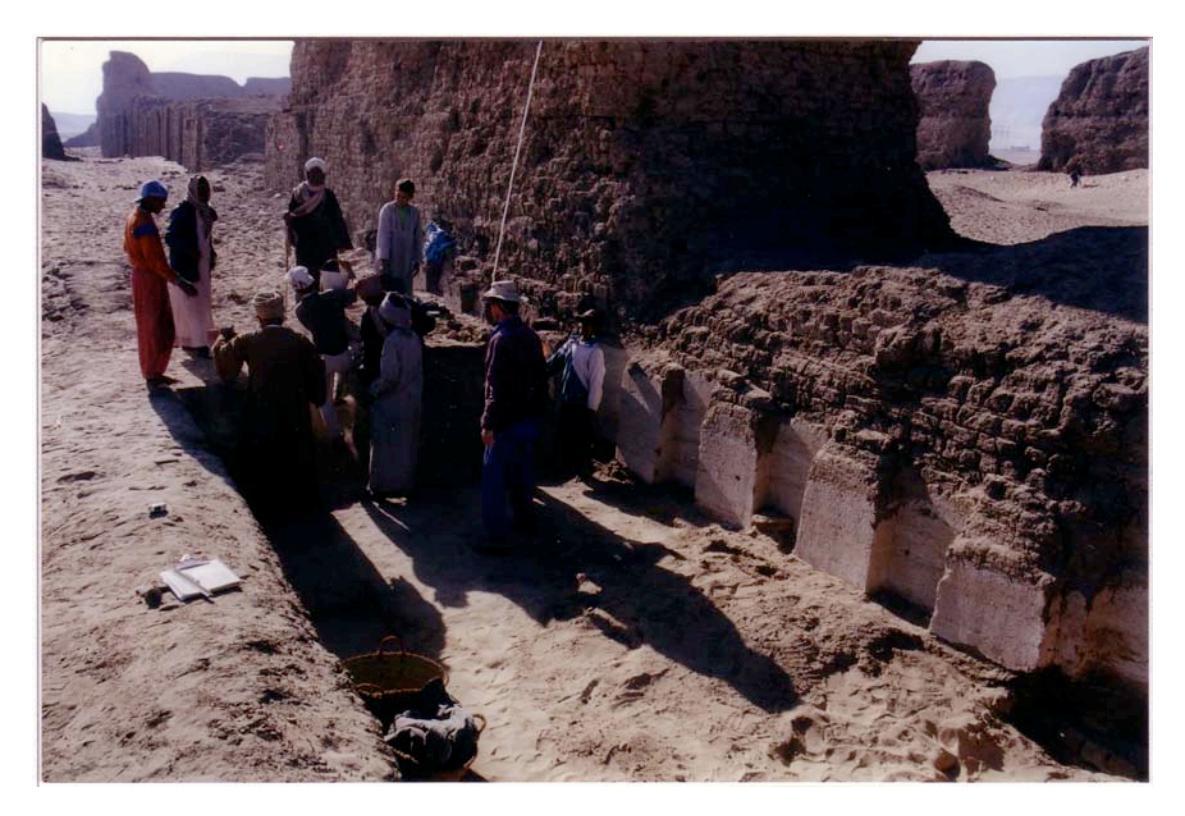
Figure 36. The area of preserved original plaster (lower right), which was revealed below grade by local excavation on the lower façade of the east main enclosure wall. (Photo: William Remsen 2000)

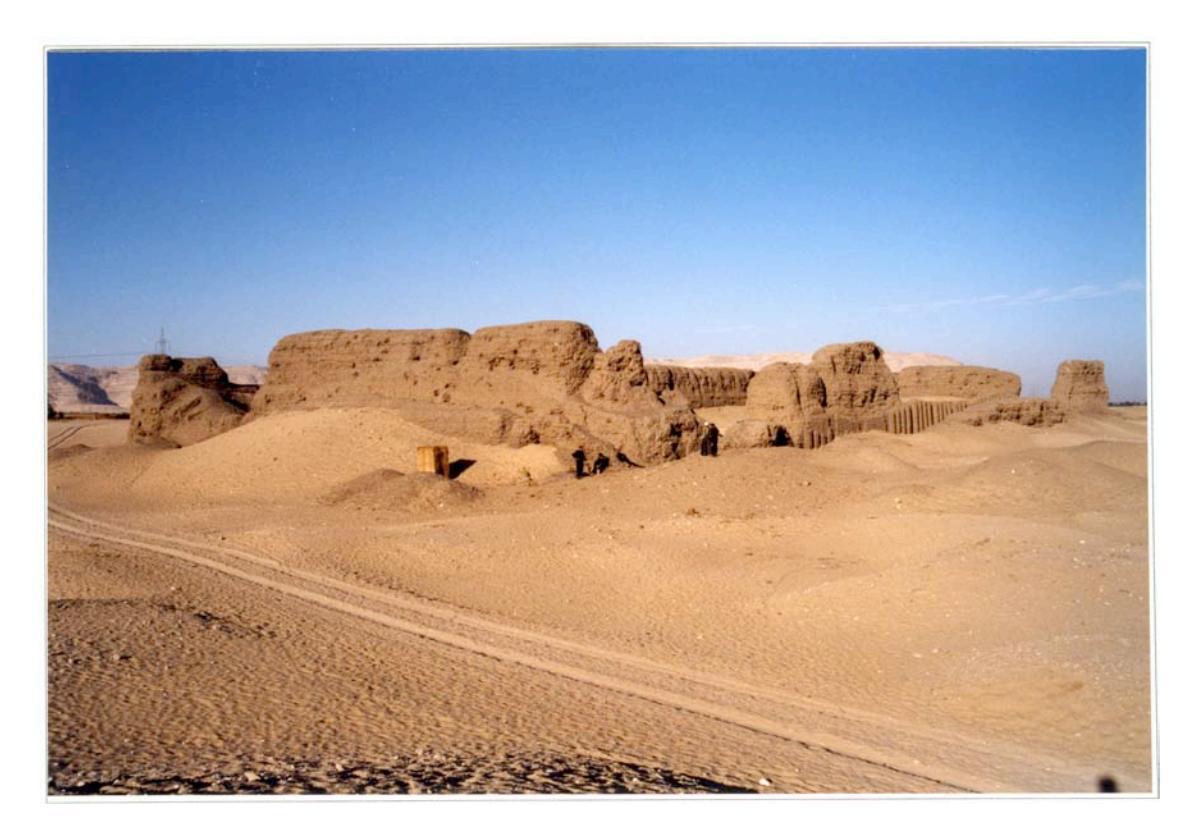
Figure 38. Exterior view of the monument from the southeast, depicting sand-dune profiles along the south and east perimeter walls, and preserved original surfaces on the south and east main enclosure walls. (Photo: William Remsen 2000)

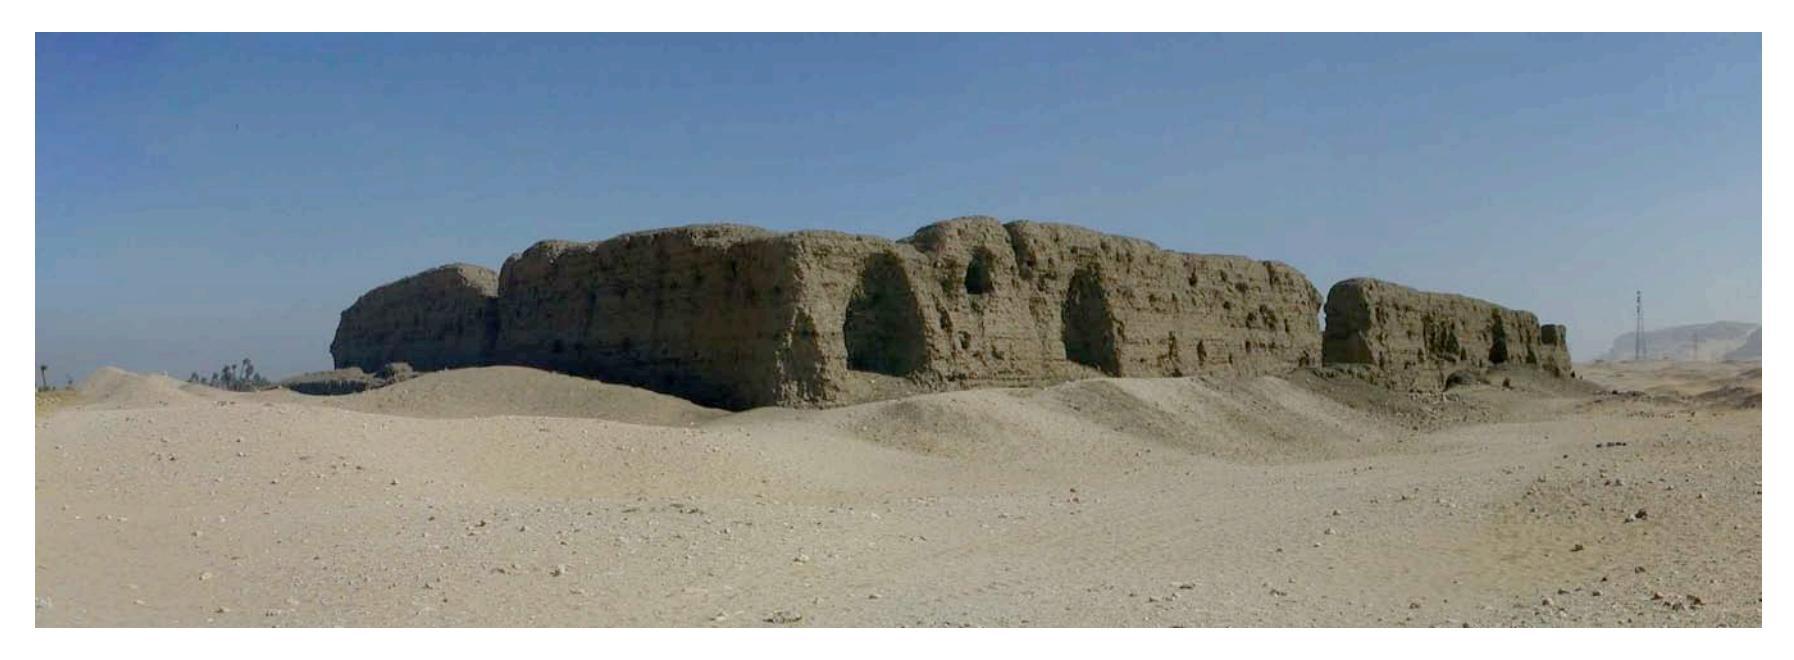
Figure 39. Panoramic view of the main enclosure from the northwest; the deep cavities visible on the exterior west wall are the collapsed remains of living spaces excavated into the original masonry during late antiquity, when the monument was occupied by an early Christian monastic community. (Photo: Robert Fletcher 2001)

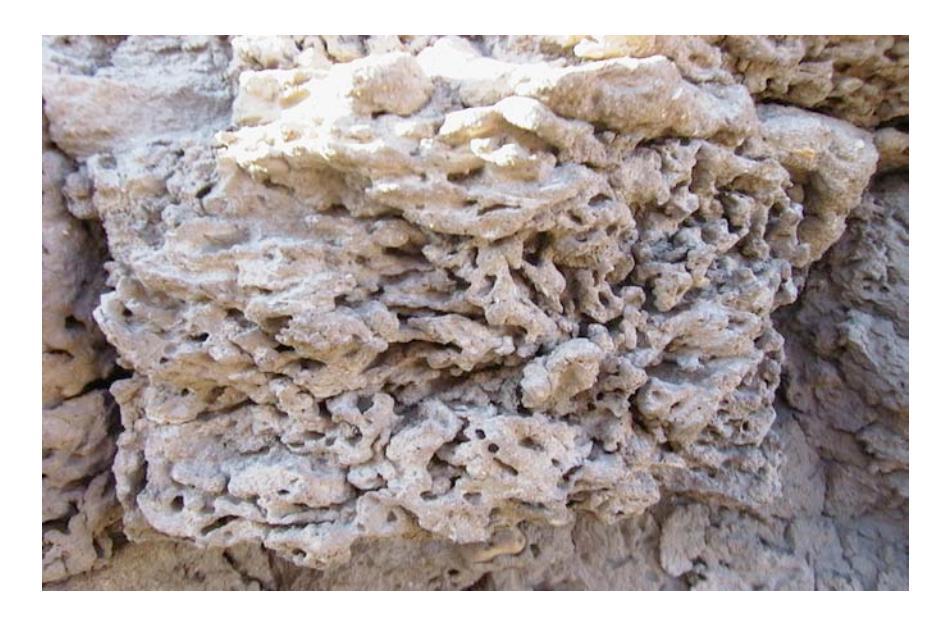
Figure 42. Detail of the surface decay pattern in a typical mud brick. (Photo: Anthony Crosby 2000)

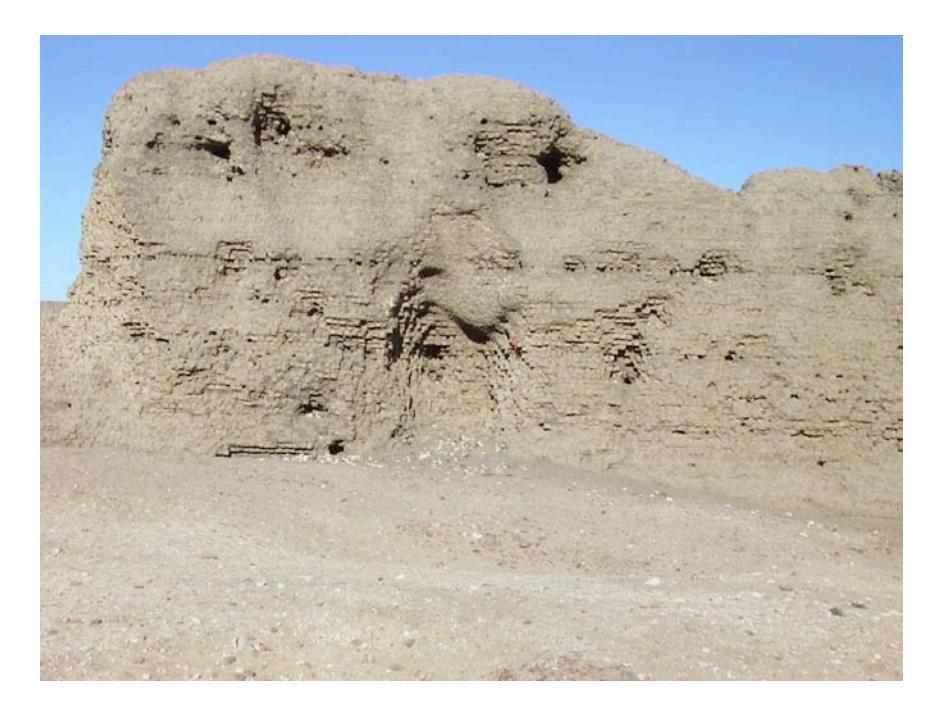
Figure 43. A high concentration of surface erosion caused by wind-sand abrasion on the upper, interior face of the east main enclosure wall. (Photo: Anthony Crosby 2000)

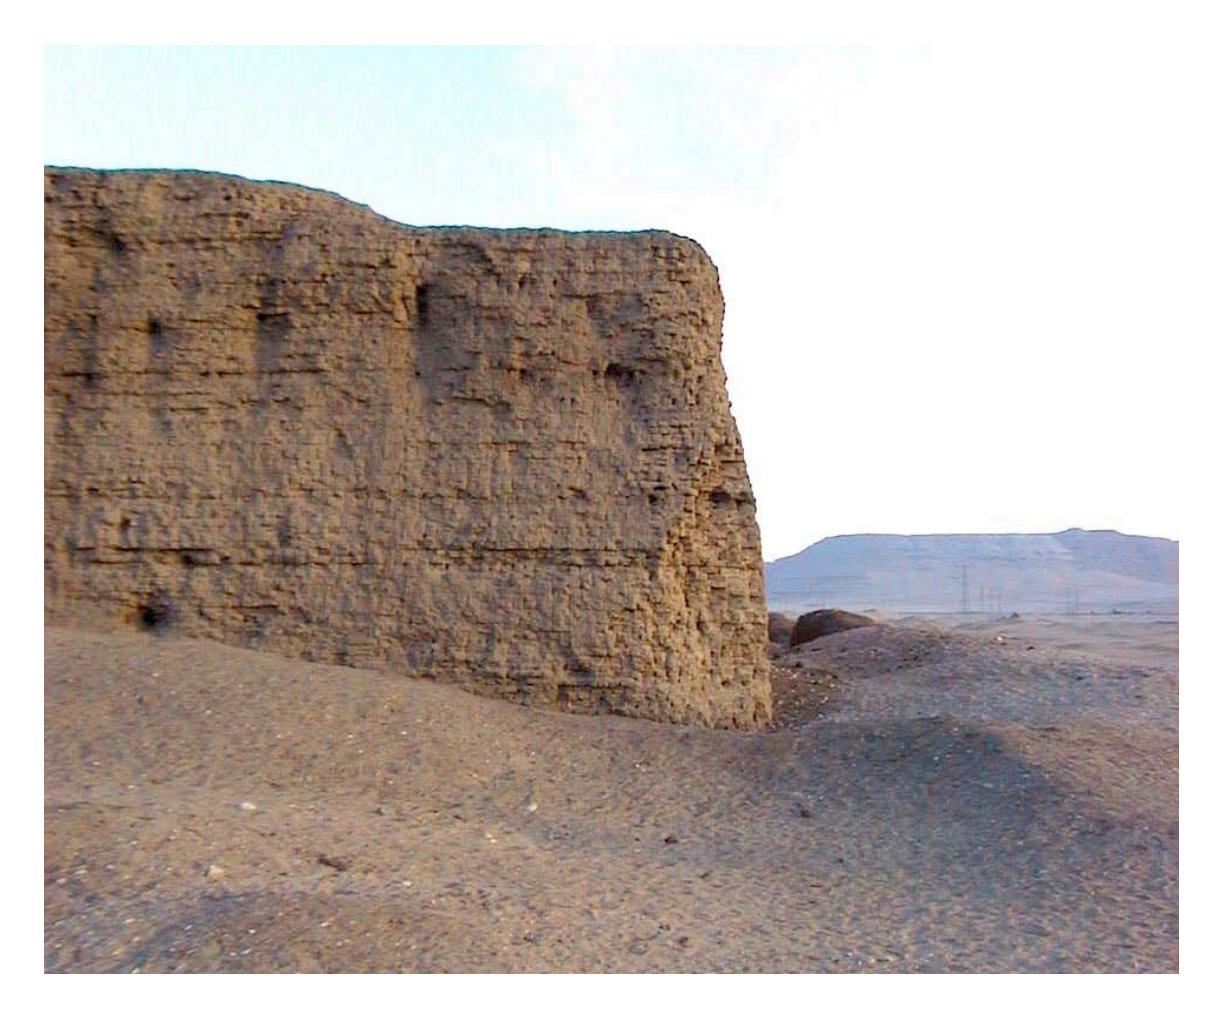
Figure 45. Heavy water erosion (near top) and mud-drip concentrations (at mid-points) on the western, exterior face of the north main enclosure wall. (Photo: Anthony Crosby 2000)

The western, exterior face of the north wall exhibits normal-priority cracking and cavitation along the length of the upper wall surface (Figures 79 and 80). The westernmost end of the wall also exhibits heavy erosion, mortar washout and loose brickwork resulting from concentrated water damage to the upper wall, and mud-drip concentrations caused by surface water runoff (Figures 81 and 82).

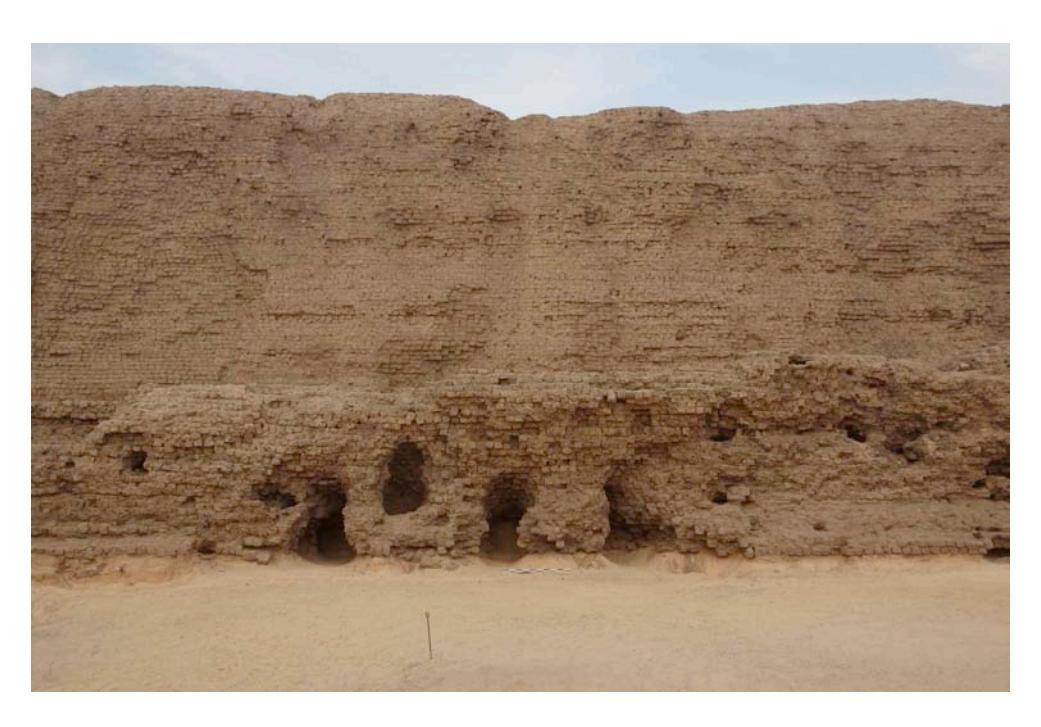
Considerable structural deterioration has occurred as a result of animal activity at the site. including that of foxes and possibly jackals, insects and birds. Canid activity has involved the burrowing of dens along the wall bases, resulting in local undermining throughout the structure (Figures 47 and 48). These dens represent rough holes, which are low and round with sandy floors, penetrating deep into the walls. They typically measure 50-75cm high by 50cm wide by 1-3m deep. Their interiors are irregular in shape and generally much larger than their openings. It was not possible to determine the relative ages of these dens or the extent of their use, and with the exception of one active fox den in the east main enclosure wall, there is no indication of canid activity in or near the majority of holes, suggesting sporadic past use and possible vacancy. The quantity of these holes within the walls may indicate that the occupants preferred the continued excavation of new dens rather than the re-use of existing dens. The loss of building material represented by these burrows corresponds to a loss of bearing support and contributes to an undermining effect, which forces the surrounding wall to act in tension rather than in compression and can lead to further cavitation and surface loss. This is a cumulative effect that acts in conjunction with other factors to produce structural conditions of instability and collapse.

Figure 47. Detail of the typical undermining and cavitation caused by fox burrowing in the wall bases. (Photo: Robert Fletcher 2005-2006)

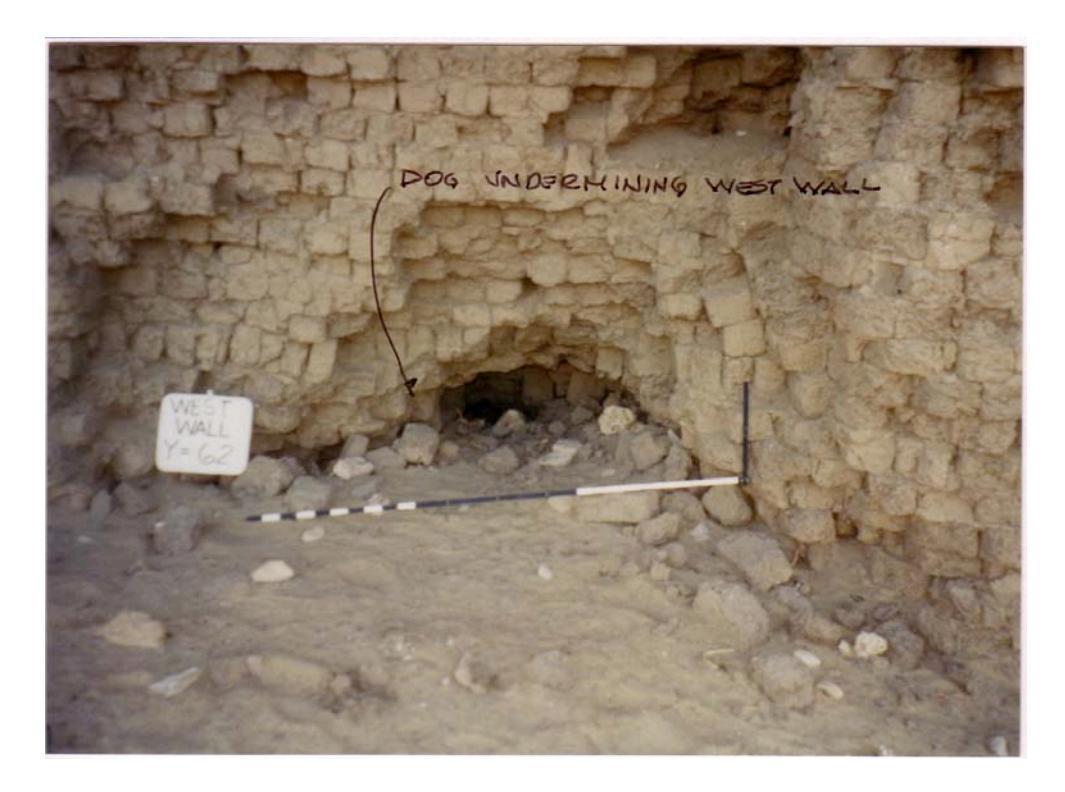
Figure 48. Detail of an undermined base location on the west main enclosure wall. (Photo: Conor Power 2000)

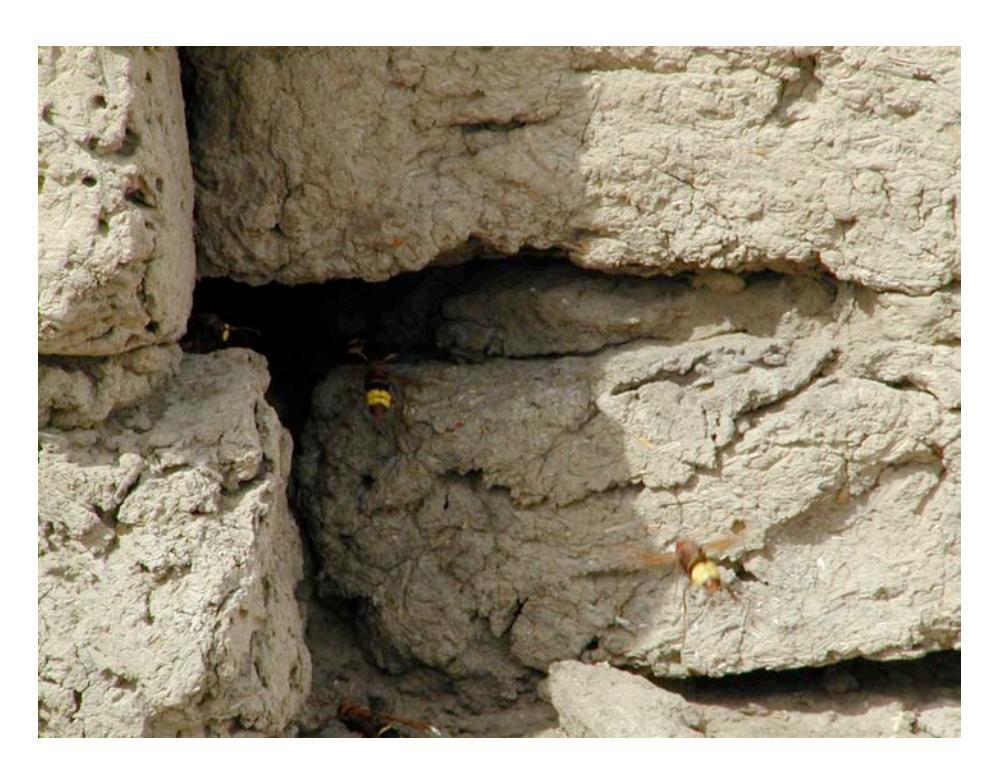
Insect damage is represented by the activities of hornets and wasps, which have had a singular impact on the standing walls and are responsible for a significant loss of wall fabric. A type of hornet long active at the site, identified as the Oriental Hornet (*Vespa orientalis*), burrows small but deep cavities into the mud brick, in which extensive paper nests are made (Figures 49-54). Nearly all of the hundreds of small to medium-sized holes that occur on all faces of the main enclosure and perimeter walls are in origin hornet-nest burrows. Characteristically disk-shaped, with smooth interior surfaces, these nest holes are frequently clustered in the walls and have been found to extend as deep as two meters into the wall fabric at some locations. While each nest represents a source of localized structural weakness and gradual collapse, numerous holes occurring in proximity interact and threaten much larger surface areas with networks of cavitation and detachment. As the conditions caused by hornet nesting affect vast areas of original wall fabric, this activity alone represents one of the single greatest threats to the overall stability of the monument.

Figure 50. Hornets entering a large void behind this apparently small hole in the upper surface of the west main enclosure wall. (Photo: Robert Fletcher 2001)

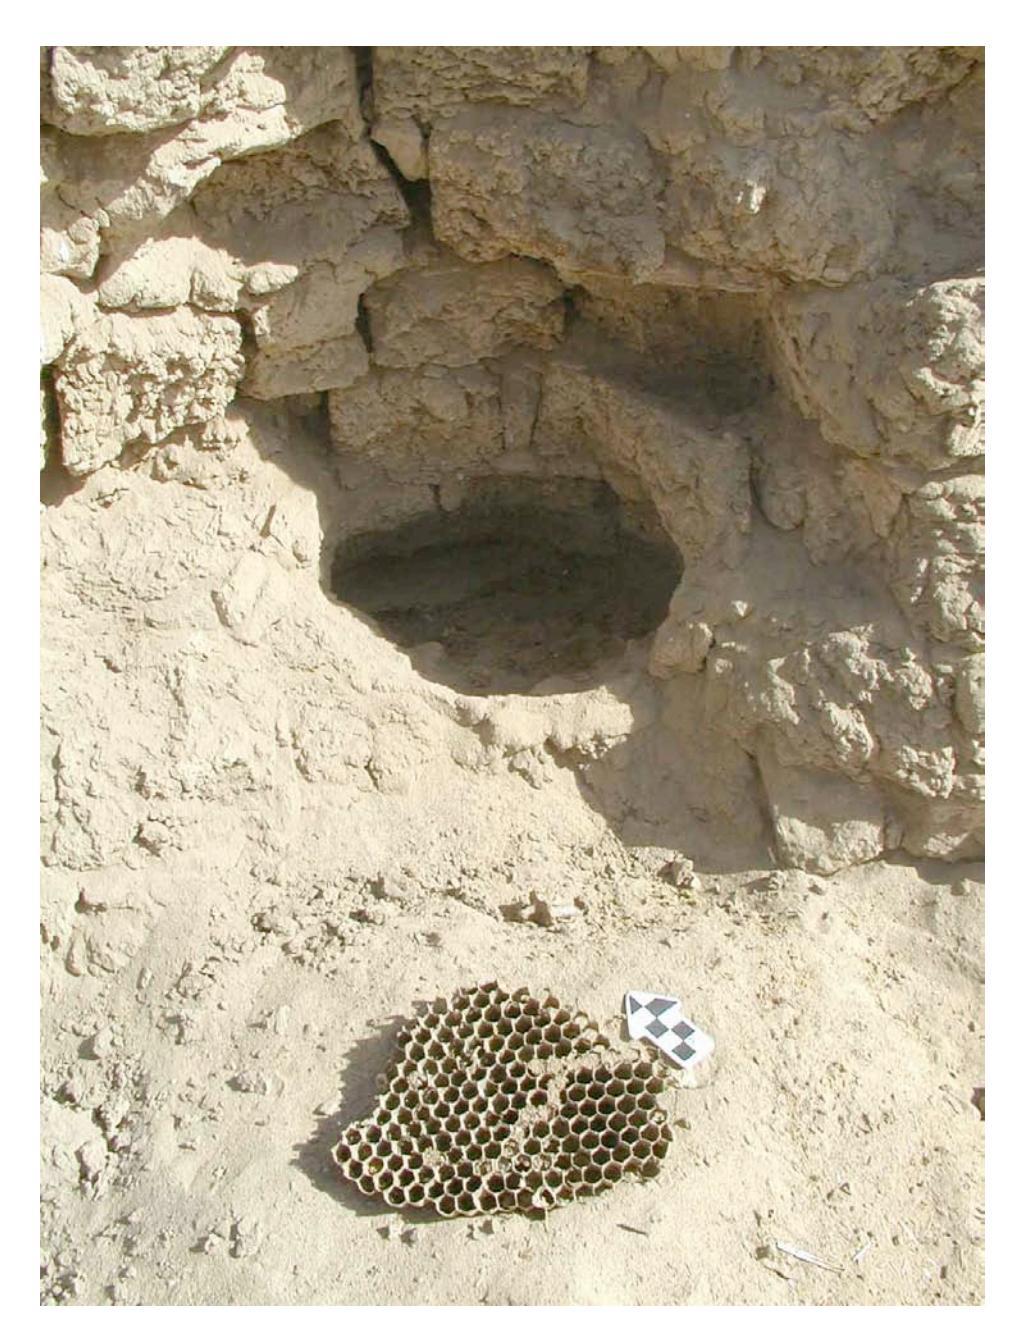
Figure 52. Detail of a hornet nest in the south perimeter wall, which has compromised the surrounding masonry. (Photo: Robert Fletcher 2001)

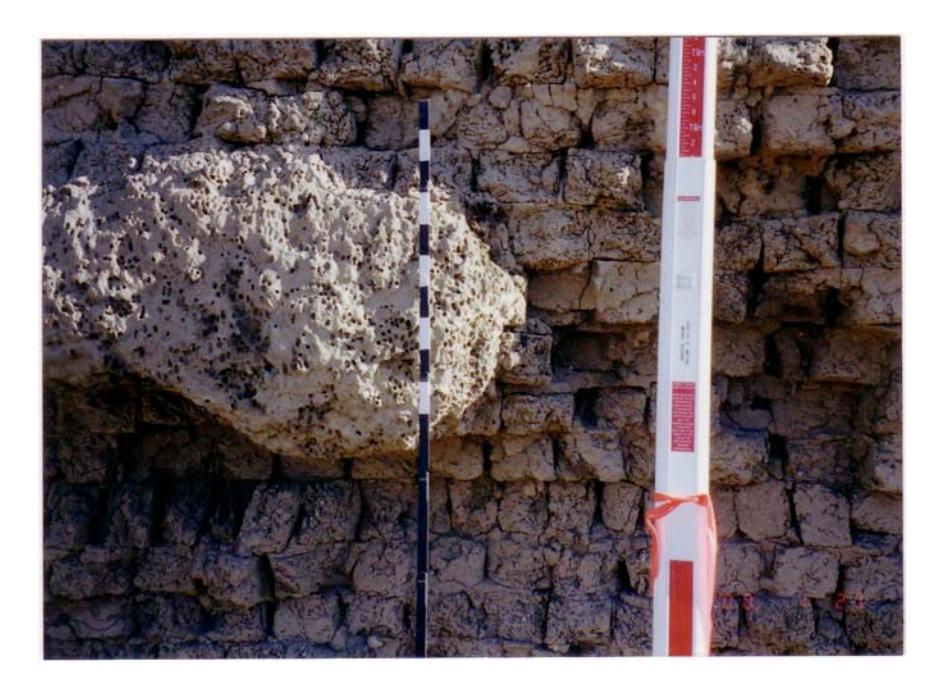
Mud-wasp activity at the monument involves pervasive nest building, which produces an accretion effect resulting in severe and progressive surface detachment and undercutting (Figures 55-59). These wasps (as-yet unidentified) do not burrow directly into the mud bricks, but rather build their irregular nests on overhangs and protrusions in the walls, which begin as small mud accretions that have occasionally enlarged to massive proportions (see Figure 57). An unidentified organic binder is added to the mud in the nests, producing an extremely tough material that is continuously expanded upon. This nest material is significantly stronger than the masonry to which it is adhered, and as the nests increase in size, the tensile strength of the mud brick is exceeded, causing separation of both the nest and the surrounding masonry from the wall. This separation exposes new overhangs that attract further nestbuilding, allowing the process to cycle over time. In areas where these accretions occur, the wall surface is gradually removed by a depth of one-to-two bricks and a height of one-to-three bricks; the width of surface detachment varies according to nest size, the largest observed exceeding 1.5m in extent. The nest material is extremely heavy and stress resistant (some specimens weighing hundreds of kilograms),

Figure 58. Detail of a typical mud-wasp nest accretion. (Photo: Conor Power 2000)

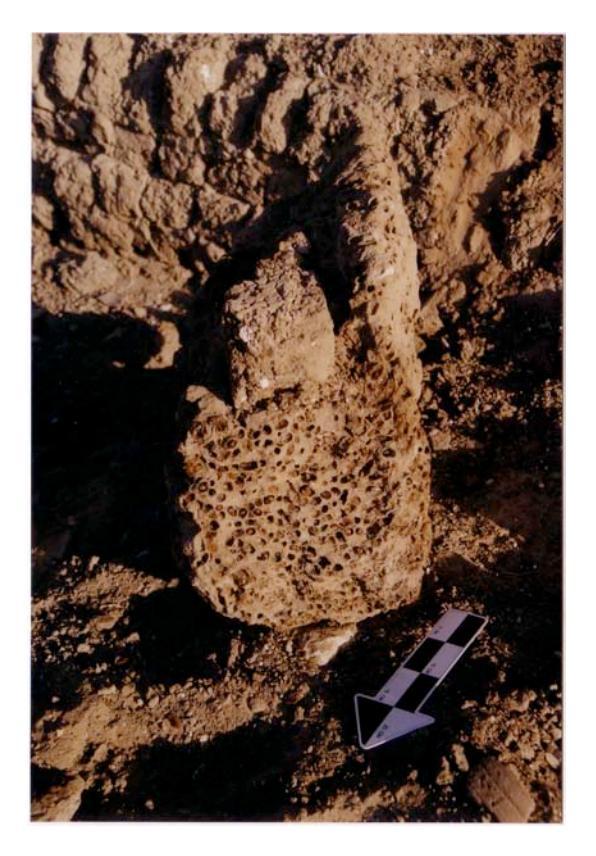
Figure 59. Detail of a bisected, fallen mud-wasp nest with attached mud brick. (Photo: William Remsen 2000)

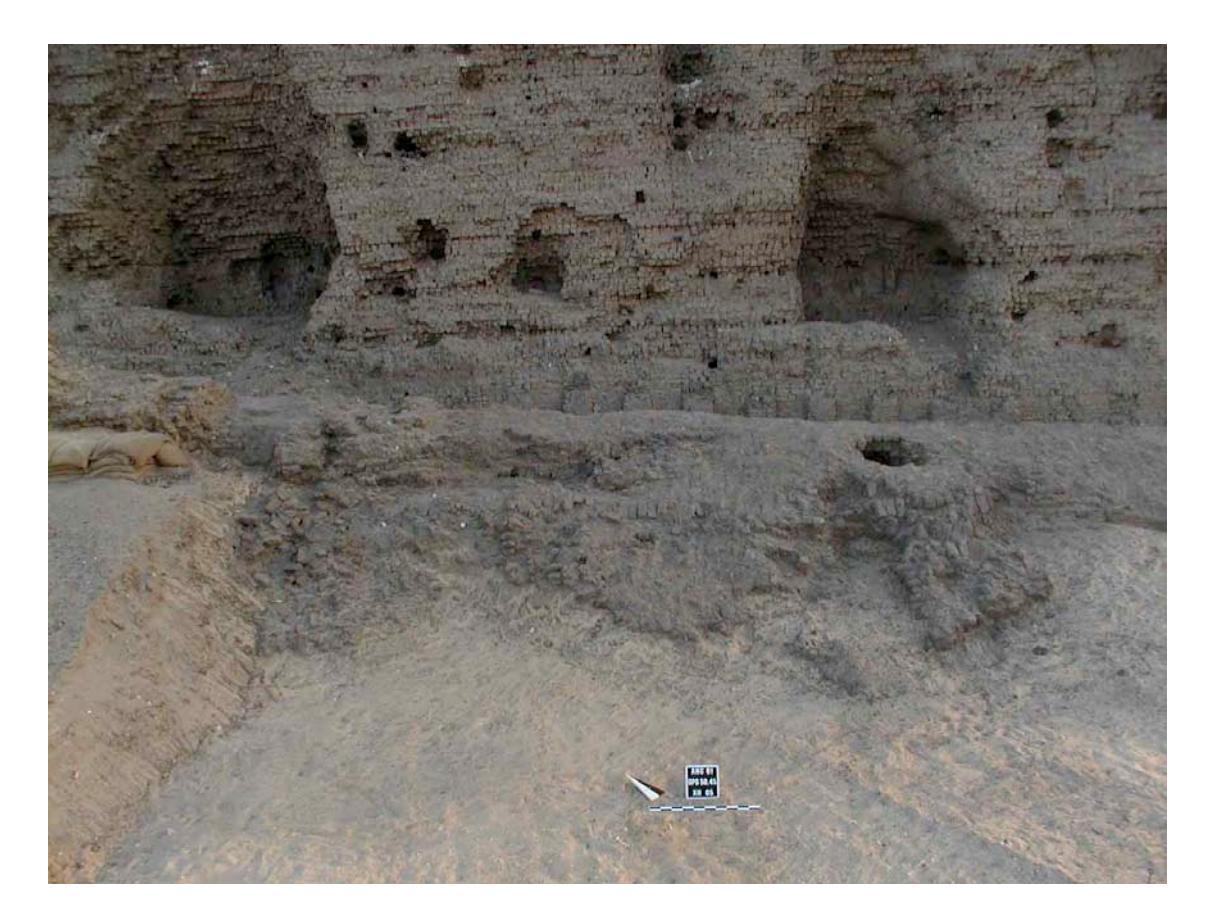
The cultural factor with the greatest adverse effect on the monument over time was its occupation in late antiquity by an early Christian monastic community. Along with the burrowing activity of insects and canids, the removal of major areas of wall fabric by human occupants of the Shuneh between the 4th and 7th Centuries CE has had a significant impact on the condition and overall structural integrity of the monument. During Late Roman/Byzantine times, large voids were excavated in a number of the walls to serve as living spaces, or "cells," for members of the monastic community. The elevations of these voids were at or above the contemporary floor levels defined by sand deposits along both the interior and exterior sides of the main enclosure and perimeter walls. The cavities represented by these monastic cells have produced an extremely critical undermining effect in several locations, leading to unstable conditions and gradual deterioration of surrounding wall areas. The cells were originally constructed to an approximate height of two meters, with secondary excavations for internal features and ancillary chambers (see Archaeological Investigation of the Monument, to follow). Such secondary installations within the cells have further compromised local wall stability. In some instances, as much as four meters of masonry was removed out of five meters of wall thickness during the process of cell construction. The structural effects associated with these cavities include calving, delamination, cracking, erosion, loose brickwork and overhangs, which have expanded into more general conditions of instability and collapse. The cavitation and overhanging brickwork resulting from the initial void progressively undercuts the fabric of the wall above and adjacent to the cell, such that the resulting deterioration extends nearly the full height of the wall in some areas (Figures 61-66).

Figure 61. The collapsed remains of two monastic cells from late antiquity in the southern, exterior face of the west main enclosure wall (background); note also the denuded surface and collapsed masonry of the west perimeter wall (foreground). (Photo: Robert Fletcher 2001-2002)
