THE FUNERARY MONUMENT OF KING KHASEKHEMWY AT ABYDOS (ca. 2700 BCE): CONSERVATION AND ARCHAEOLOGY, 1999-2006

Final report on the "Documentation and Conservation of King Khasekhemwy's Funerary Monument at Abydos," a sub-project of the Egyptian Antiquities Project of the American Research Center in Egypt

2007

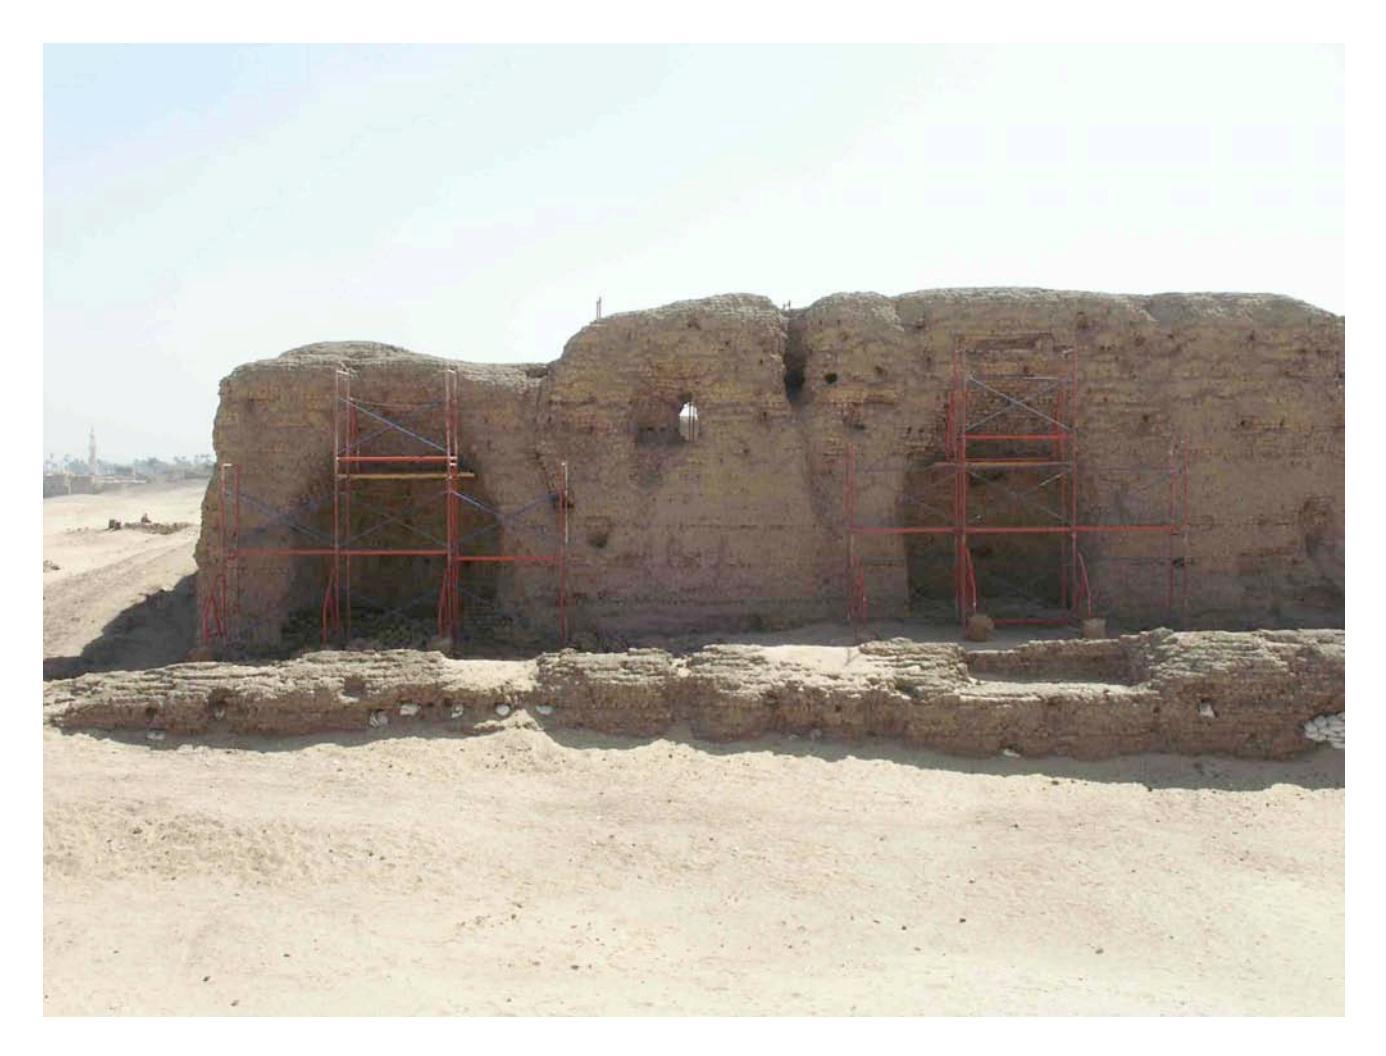
The cultural factor with the greatest adverse effect on the monument over time was its occupation in late antiquity by an early Christian monastic community. Along with the burrowing activity of insects and canids, the removal of major areas of wall fabric by human occupants of the Shuneh between the 4th and 7th Centuries CE has had a significant impact on the condition and overall structural integrity of the monument. During Late Roman/Byzantine times, large voids were excavated in a number of the walls to serve as living spaces, or "cells," for members of the monastic community. The elevations of these voids were at or above the contemporary floor levels defined by sand deposits along both the interior and exterior sides of the main enclosure and perimeter walls. The cavities represented by these monastic cells have produced an extremely critical undermining effect in several locations, leading to unstable conditions and gradual deterioration of surrounding wall areas. The cells were originally constructed to an approximate height of two meters, with secondary excavations for internal features and ancillary chambers (see Archaeological Investigation of the Monument, to follow). Such secondary installations within the cells have further compromised local wall stability. In some instances, as much as four meters of masonry was removed out of five meters of wall thickness during the process of cell construction. The structural effects associated with these cavities include calving, delamination, cracking, erosion, loose brickwork and overhangs, which have expanded into more general conditions of instability and collapse. The cavitation and overhanging brickwork resulting from the initial void progressively undercuts the fabric of the wall above and adjacent to the cell, such that the resulting deterioration extends nearly the full height of the wall in some areas (Figures 61-66).

Figure 62. Detail of two large voids in the northern, exterior face of the west main enclosure wall; these voids are the remains of monastic cells from late antiquity, which clearly illustrate the extent of original fabric loss at this location. (Photo: Matthew Adams 2004)

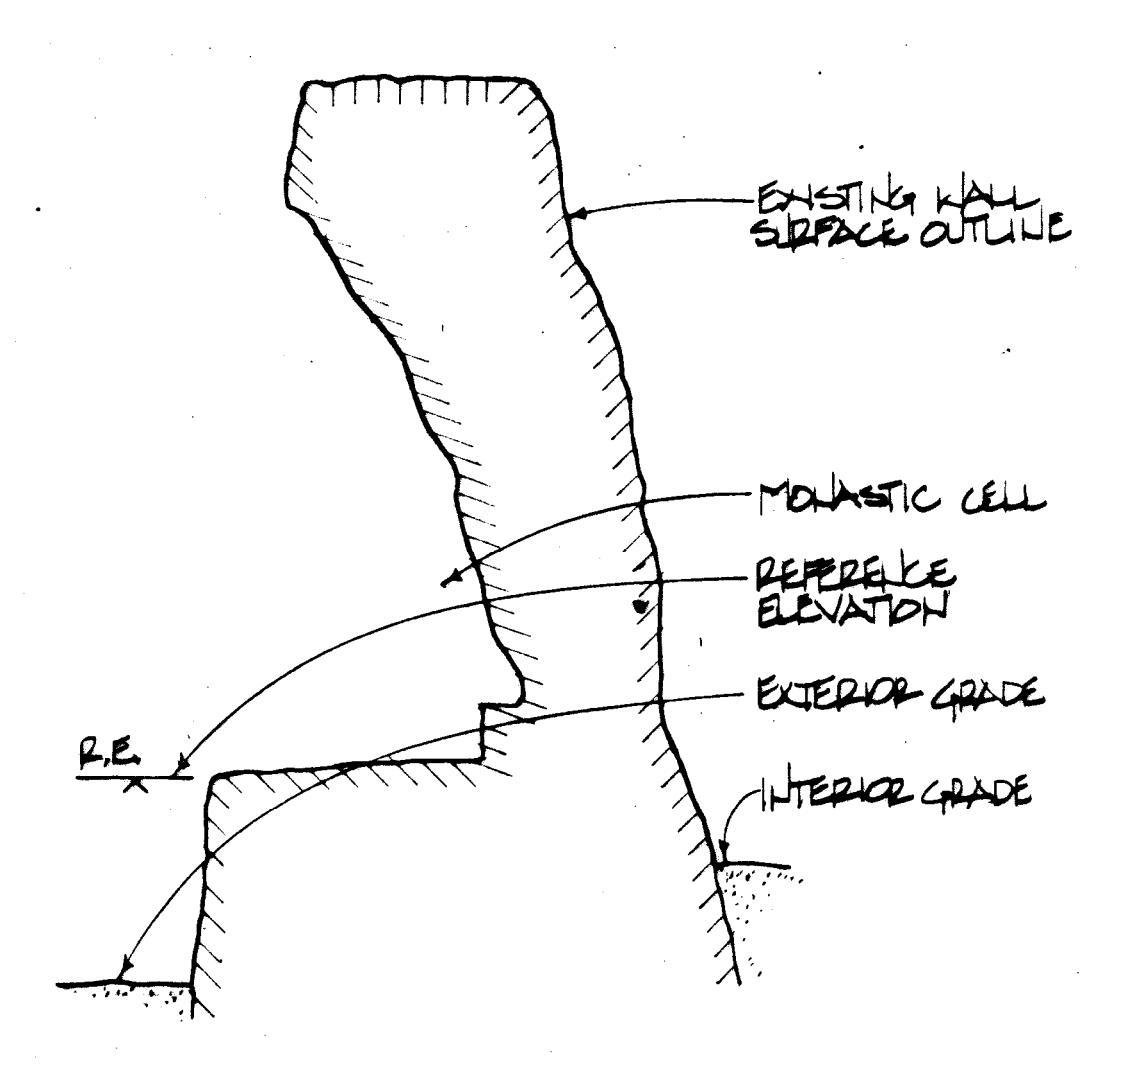
Figure 63. Schematic detail of a monastic cell void in the west main enclosure wall (scale 1: 75); this location was excavated as Operation 120 in field season 6 (see Figures 292 and 317, below). (Graphic: Conor Power 2000)

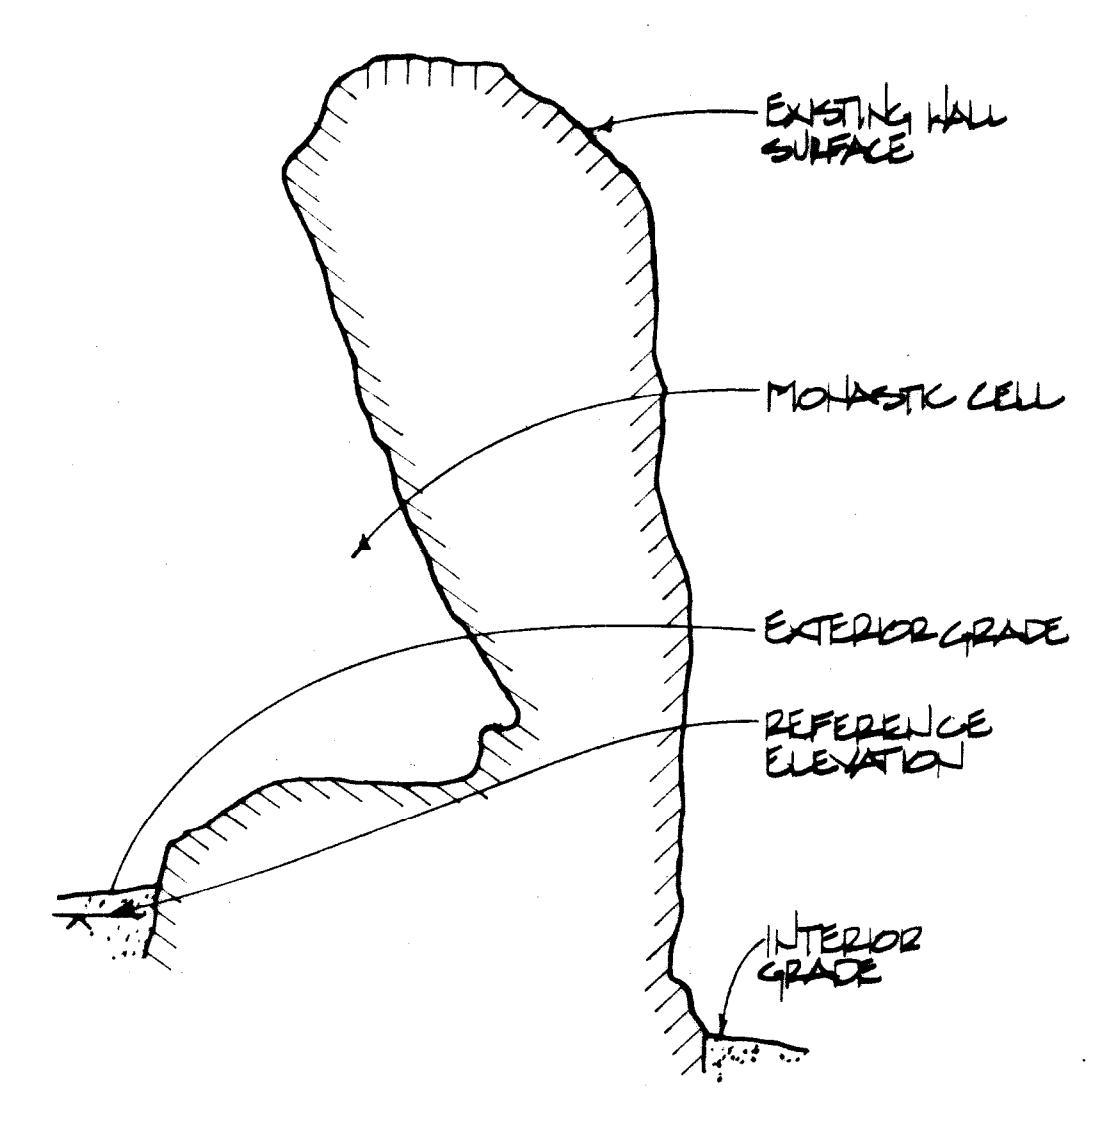
Figure 64. Schematic detail of a monastic cell void in the west main enclosure wall (scale 1: 75); this location was excavated as Operation 119 in field season 6 (see Figures 292 and 317, below). (Graphic: Conor Power 2000)

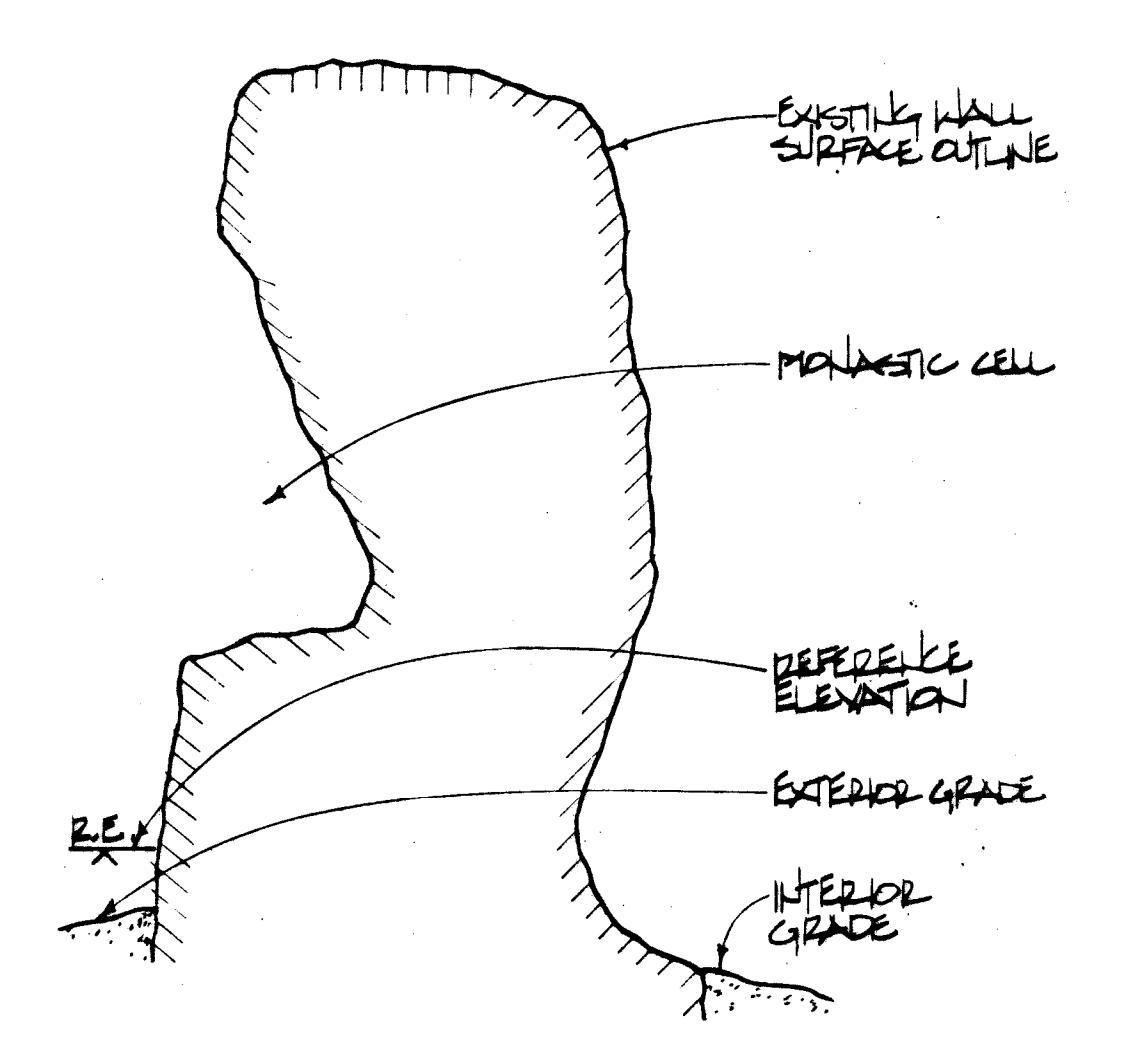
Figure 65. Schematic detail of a monastic cell void in the west main enclosure wall (scale 1: 75); this location was excavated as Operation 122 in field season 6 (see Figures 292 and 317, below). (Graphic: Conor Power 2000)

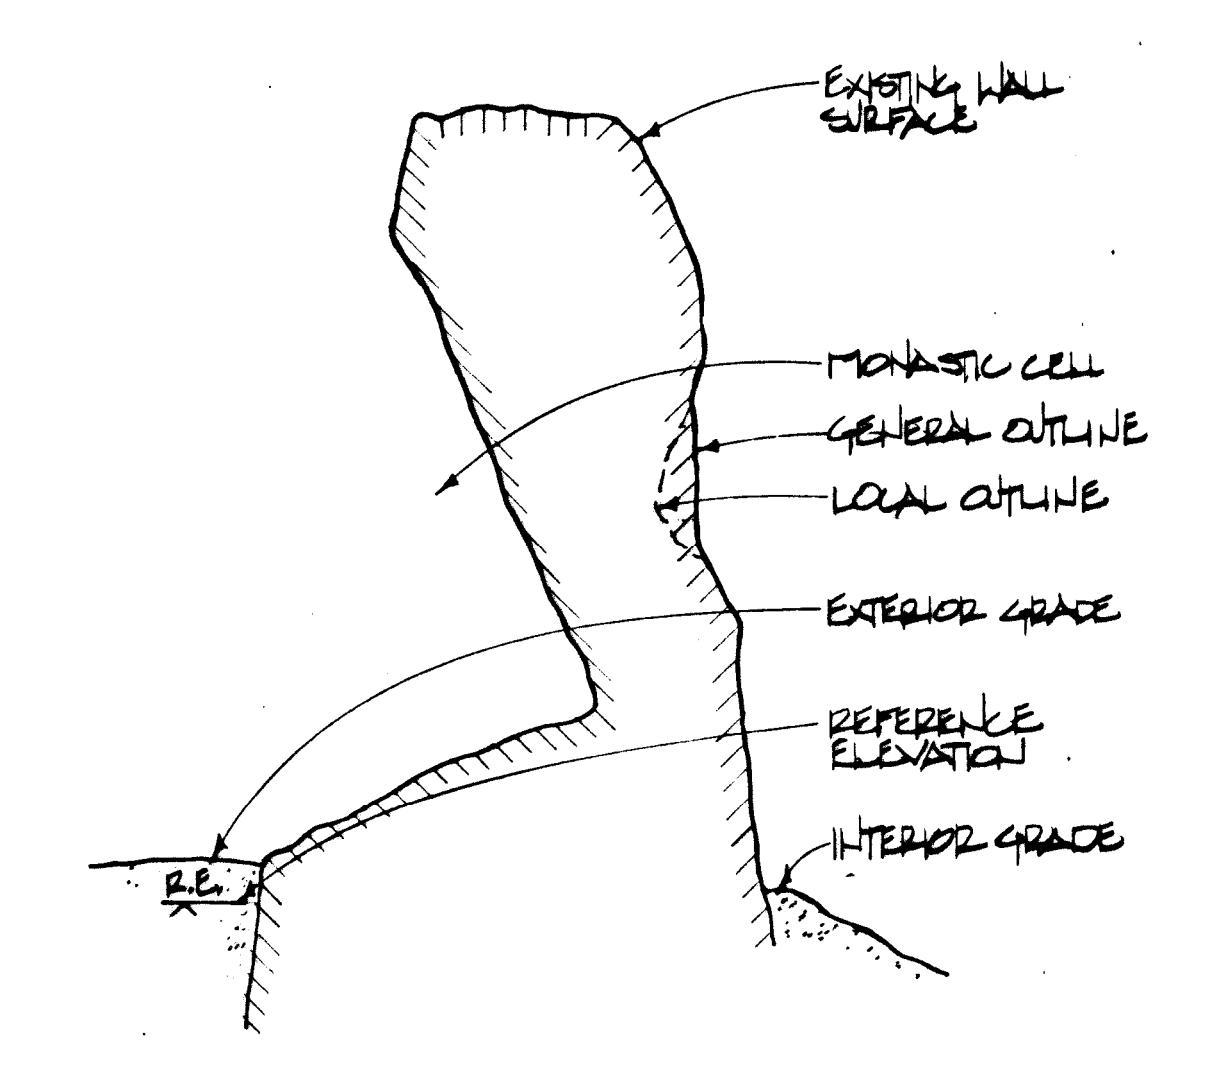
Figure 66. Schematic detail of a monastic cell void in the west main enclosure wall (scale 1: 75); this location was excavated as Operation 121 in field season 6 (see Figures 292 and 317, below). (Graphic: Conor Power 2000)

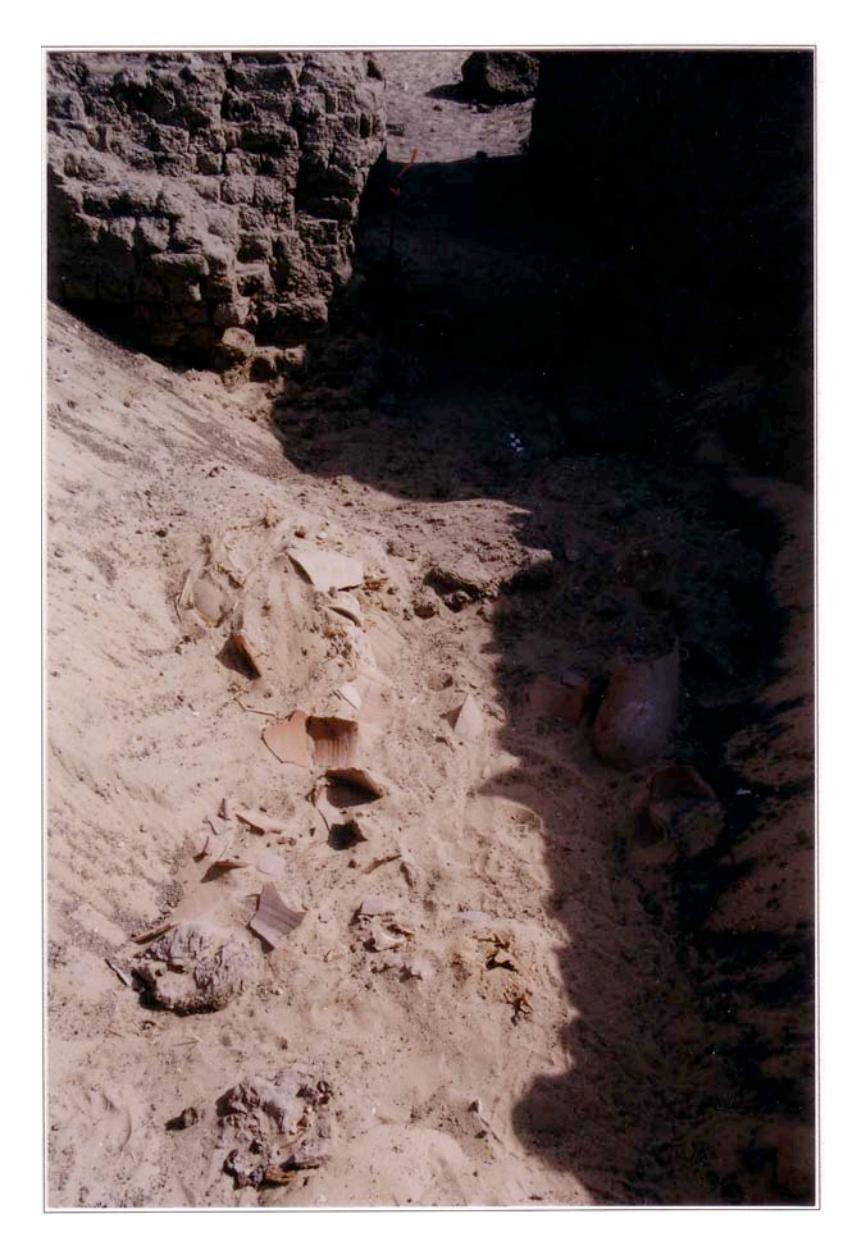
Figure 67. Detail of partially excavated, Third Intermediate/Late Period ibis burials at the southwest, interior corner of the main enclosure (adjacent to the south gateway). (Photo: William Remsen 2000)

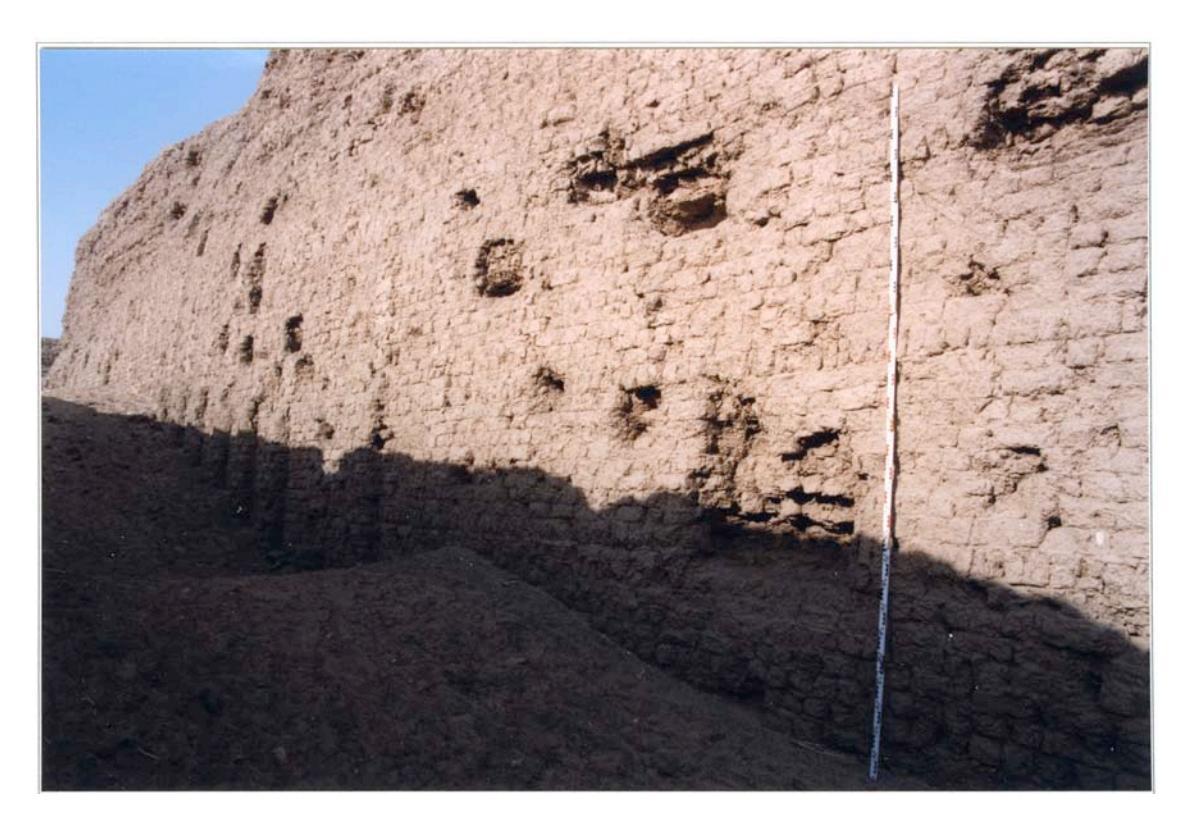
Figure 68. Detail of the cavities in the exterior face of the south main enclosure wall (lower left), which were found by Mariette to contain the burials of infants and children, probably dating to the Third Intermediate Period. (Photo: William Remsen 2000)

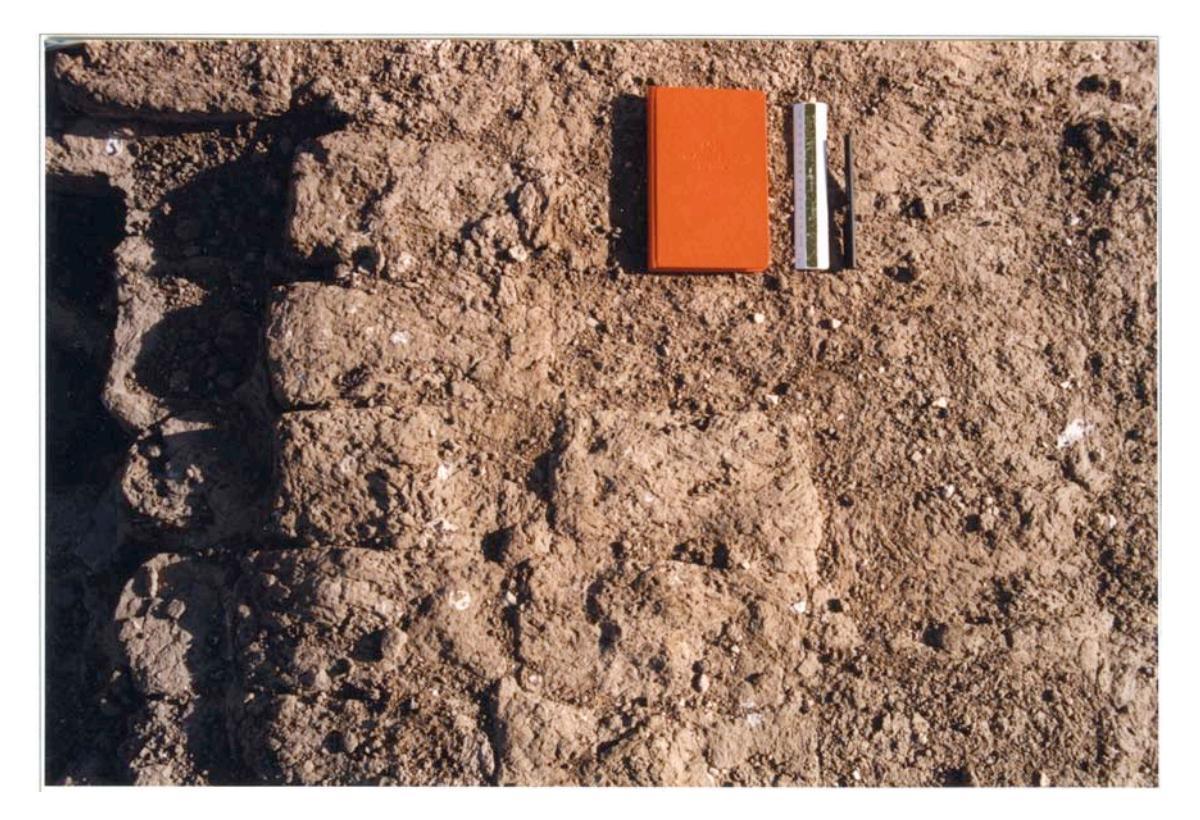
Figure 69. Detail of the weathered brick surface on the top of the south main enclosure wall. (Photo: William Remsen 2000)

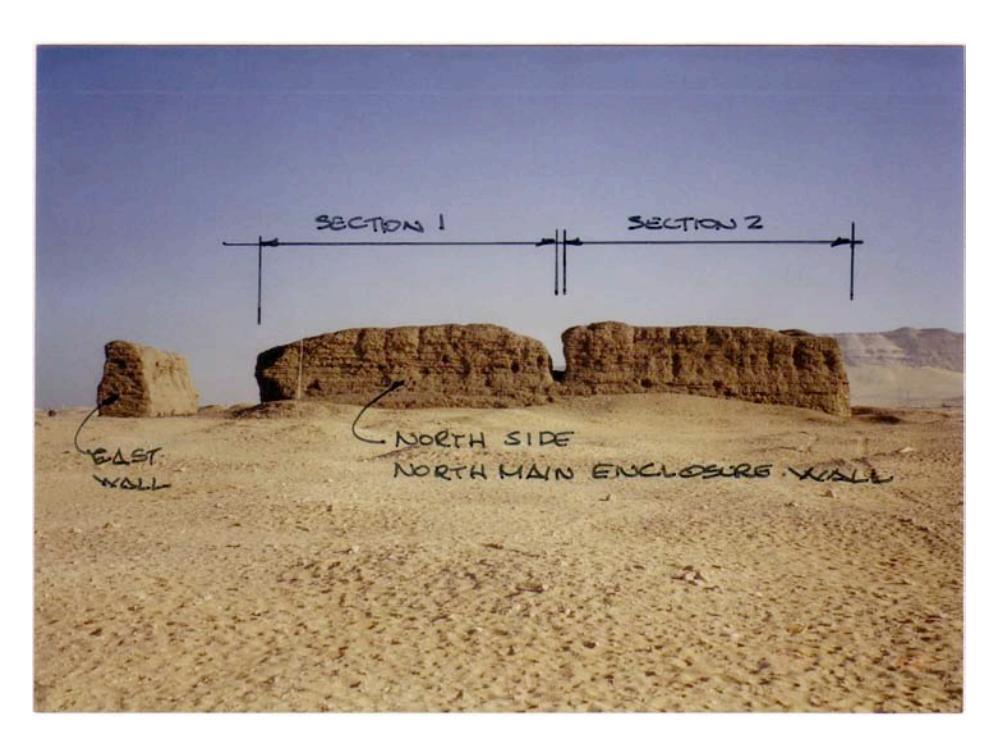
The north main enclosure wall is defined by a narrow cleft separating an eastern from a western portion (Figure 73). The intact segments of this wall represent a particular set of conditions characterized by weathering effects not generally observed elsewhere on the monument.

Figure 73. The eastern and western, exterior faces of the north main enclosure wall (noted as sections 1 and 2, respectively). (Photo: Conor Power 2000)

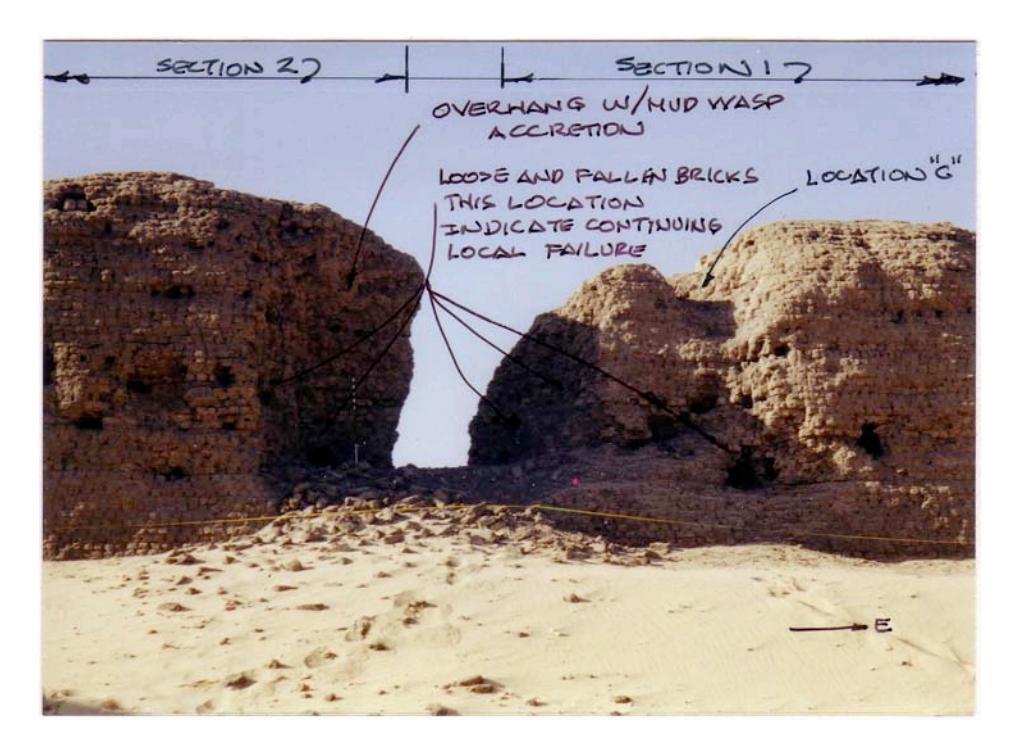
The exterior face of the north main enclosure wall generally exhibits moderate cavitation, detachment, cracking, erosion and surface friability as a result of weathering and insect activity. The central void separating the eastern and western sections exhibits urgent-priority cavitation, erosion, calving and loose brickwork stemming from local wall failure as well as an unstable overhang associated with mud-wasp nest accretion (Figures 74-76). Earlier stages of wall failure at this location are visible in photographs from the early 20th Century (Ayrton et al. 1904:Pls. 5[1, 3], 6[1]), and it is likely that this failure was caused by a combination of weathering effects and animal activity over an extended period of time. Cleaning of the void in 2001 produced evidence that it may originally have been created for a monastic cell, however, as no plaster or other cell traces were preserved, the presence of a cell at this location is inconclusive. The collapse of the wall top that spanned this void until recently was exacerbated by expansion of the mud-wasp nest accretion still visible on the upper surface of the cavity and by torrential rains that occurred in the mid-1990s (see Figure 76).

Figure 75. Structural conditions adjacent to the central void in the north main enclosure wall include urgentpriority erosion, cavitation and unstable brickwork (noted as location C). (Photo: Conor Power 2000)

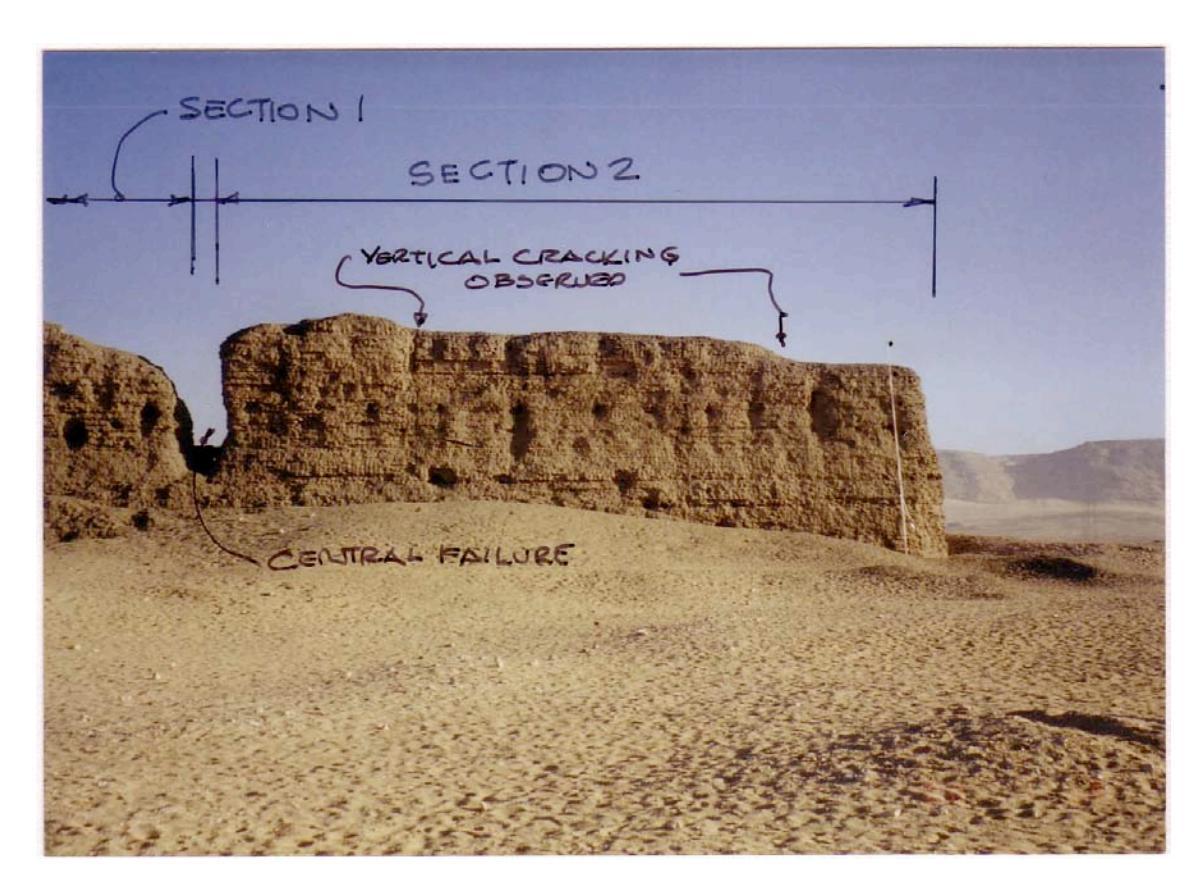
The western, exterior face of the north wall exhibits normal-priority cracking and cavitation along the length of the upper wall surface (Figures 79 and 80). The westernmost end of the wall also exhibits heavy erosion, mortar washout and loose brickwork resulting from concentrated water damage to the upper wall, and mud-drip concentrations caused by surface water runoff (Figures 81 and 82).

Figure 80. Detail of surface erosion and cracking at the western, exterior end of the north main enclosure wall. (Photo: Conor Power 2000)

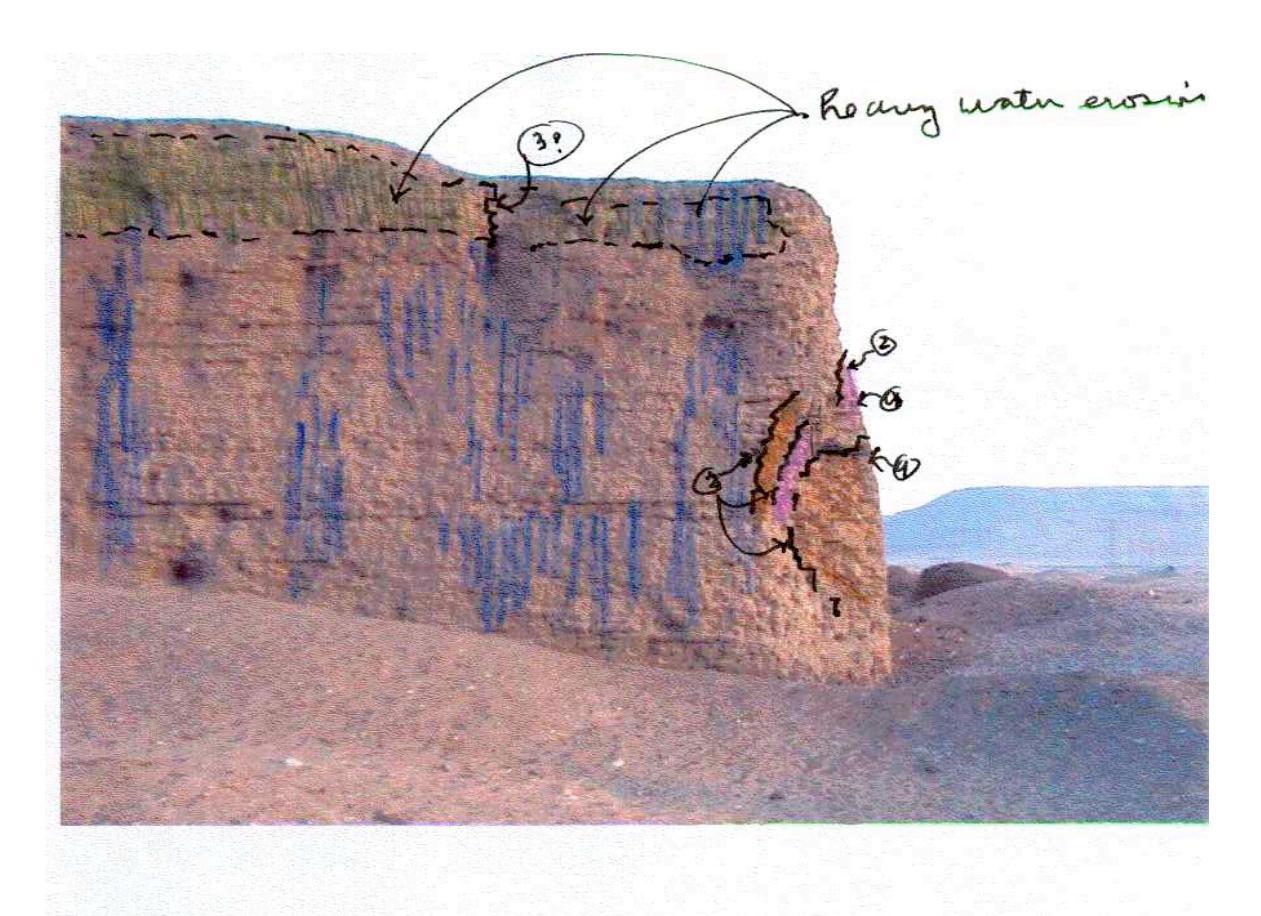
Figure 81. Locations of water erosion (noted in green) and mud drips (noted in blue) at the western, exterior end of the north main enclosure wall. (Photo/graphic: Anthony Crosby 2000)

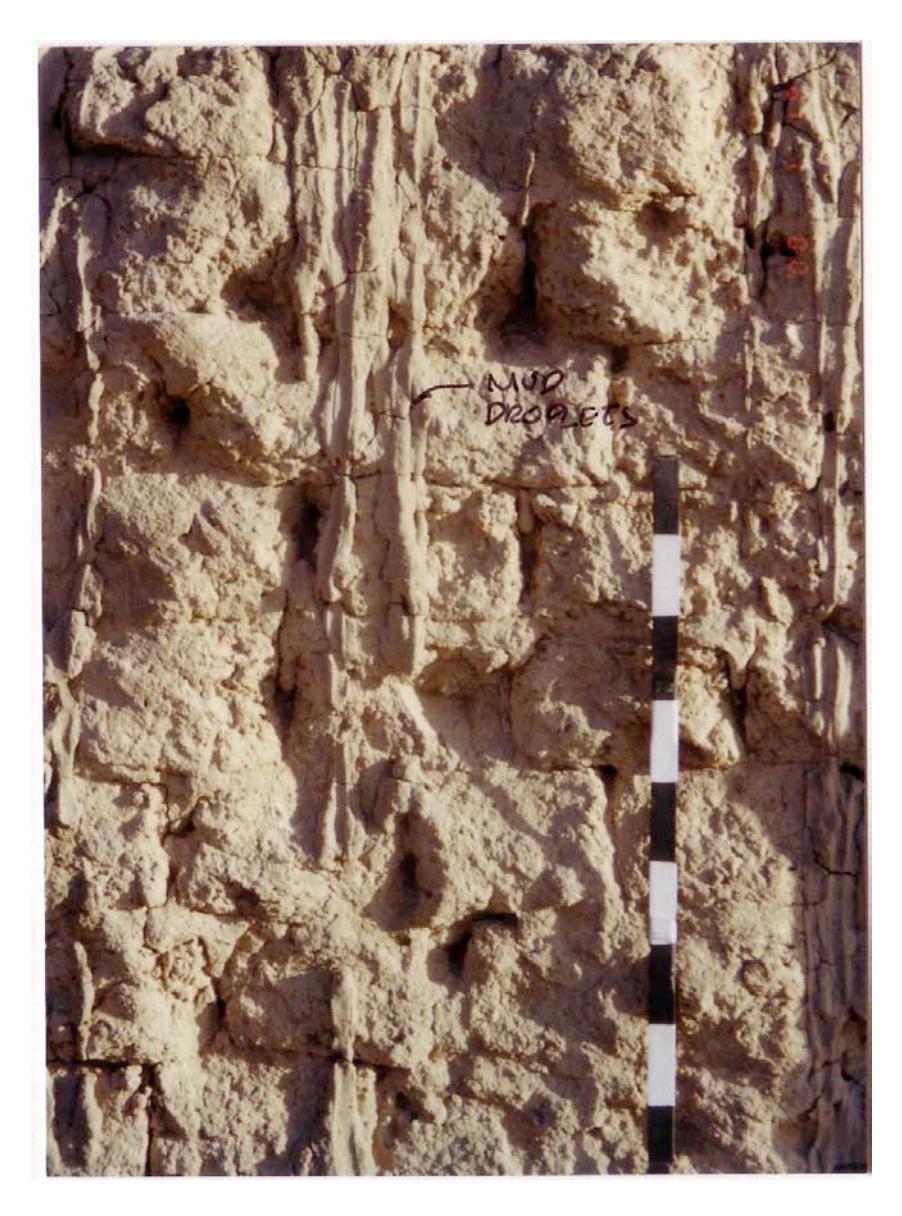
Figure 82. Detail of a mud-drip concentration at the western, exterior end of the north main enclosure wall. (Photo: Conor Power 2000)

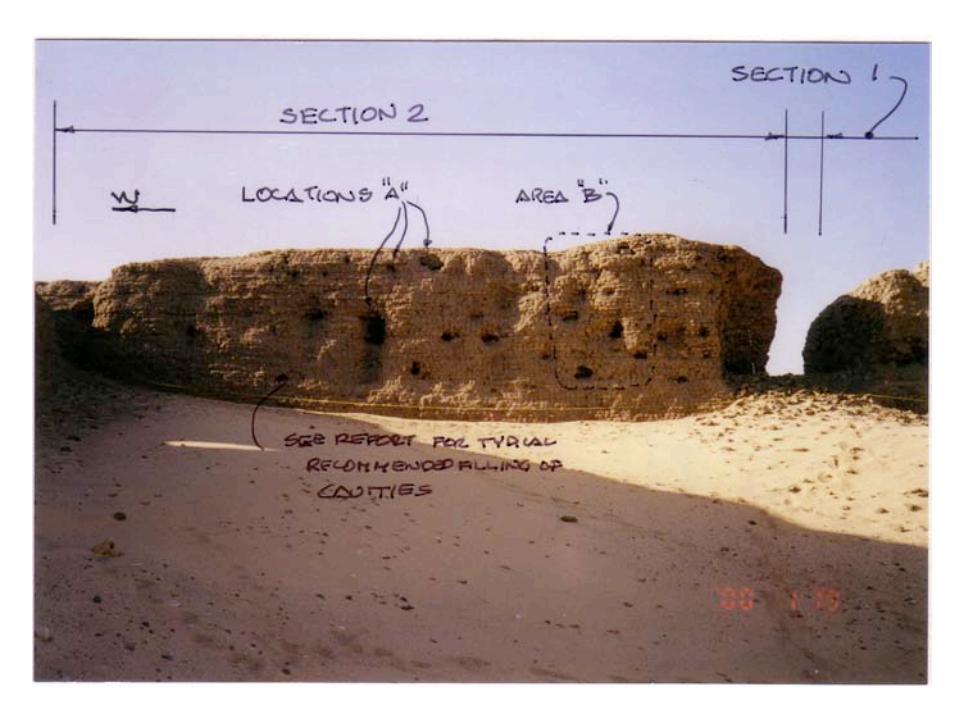
The interior elevation of both the eastern and western sections of the north wall exhibit normal to urgent-priority cavitation, calving, cracking and loose brickwork associated with extensive hornet nesting and bird activity (Figures 83 and 84).

Figure 83. Urgent-priority cavitation caused by insect activity on the western, interior face of the north main enclosure wall (noted as section 2). (Photo: Conor Power 2000)

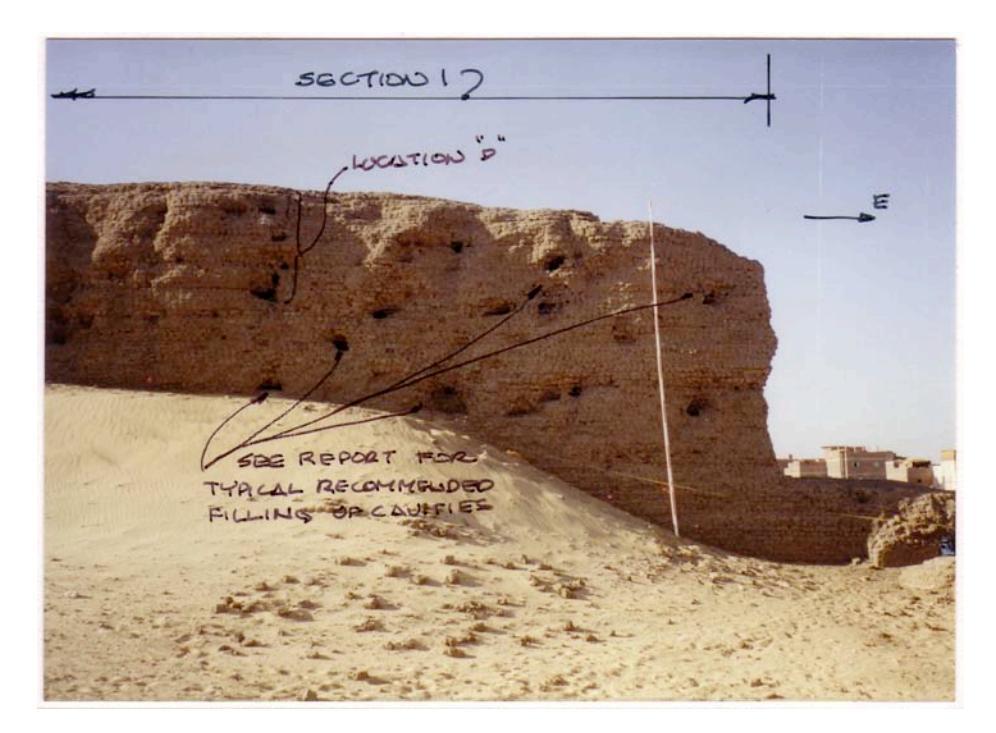
Figure 84. Normal-priority cavitation and surface detachment on the eastern, interior face of the north main enclosure wall (noted as section 1). (Photo: Conor Power 2000)

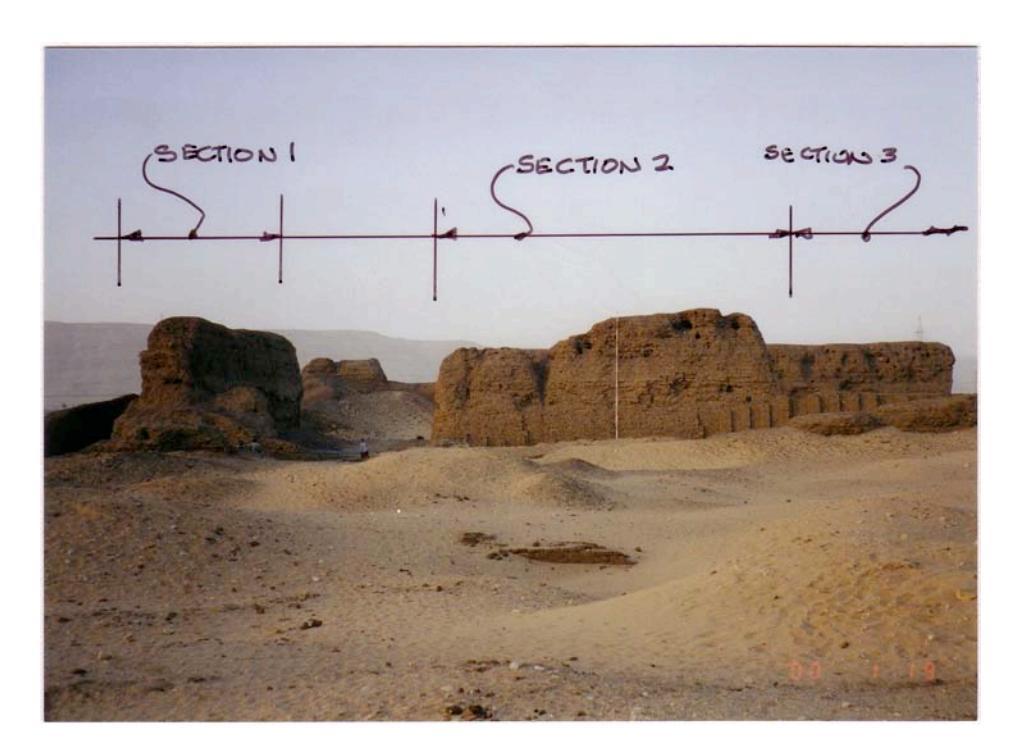
The east main enclosure wall is characterized by the absence of the upper part of its central portion, which collapsed at an unknown time, leaving two standing piers on either side (to the north and south) of a long, low central section (Figures 85 and 86).

Figure 85. Southern and central, exterior faces of the east main enclosure wall (noted as sections 2 and 3, respectively). (Photo: Conor Power 2000)

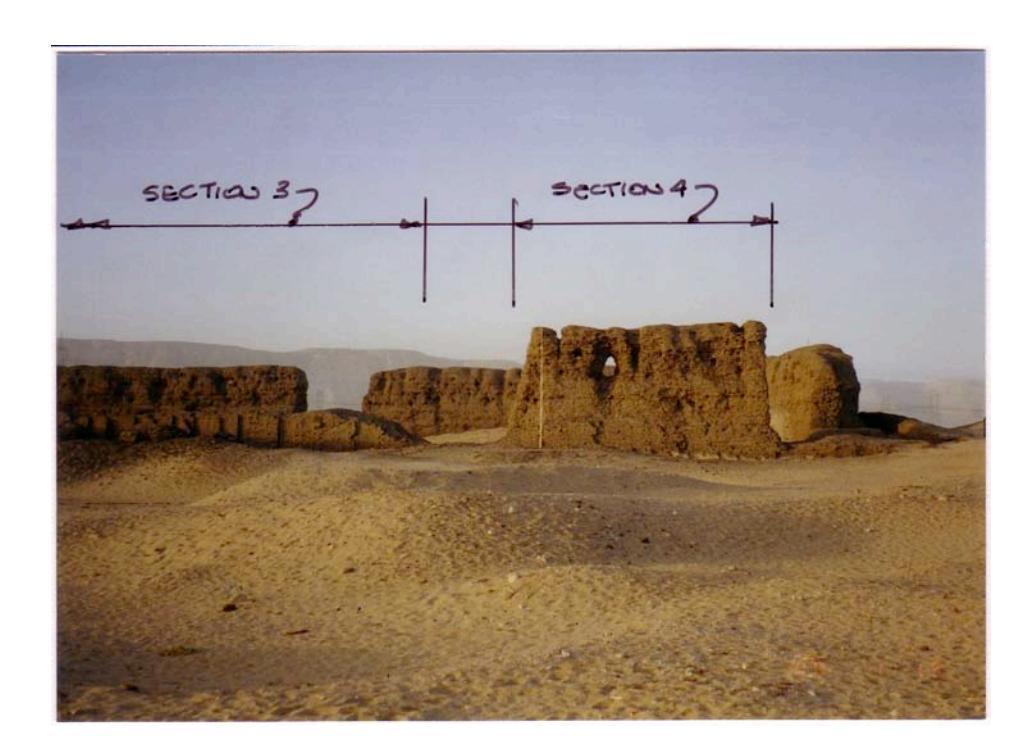
Figure 86. Central and northern, exterior faces of the east main enclosure wall (noted as sections 3 and 4, respectively). (Photo: Conor Power 2000)

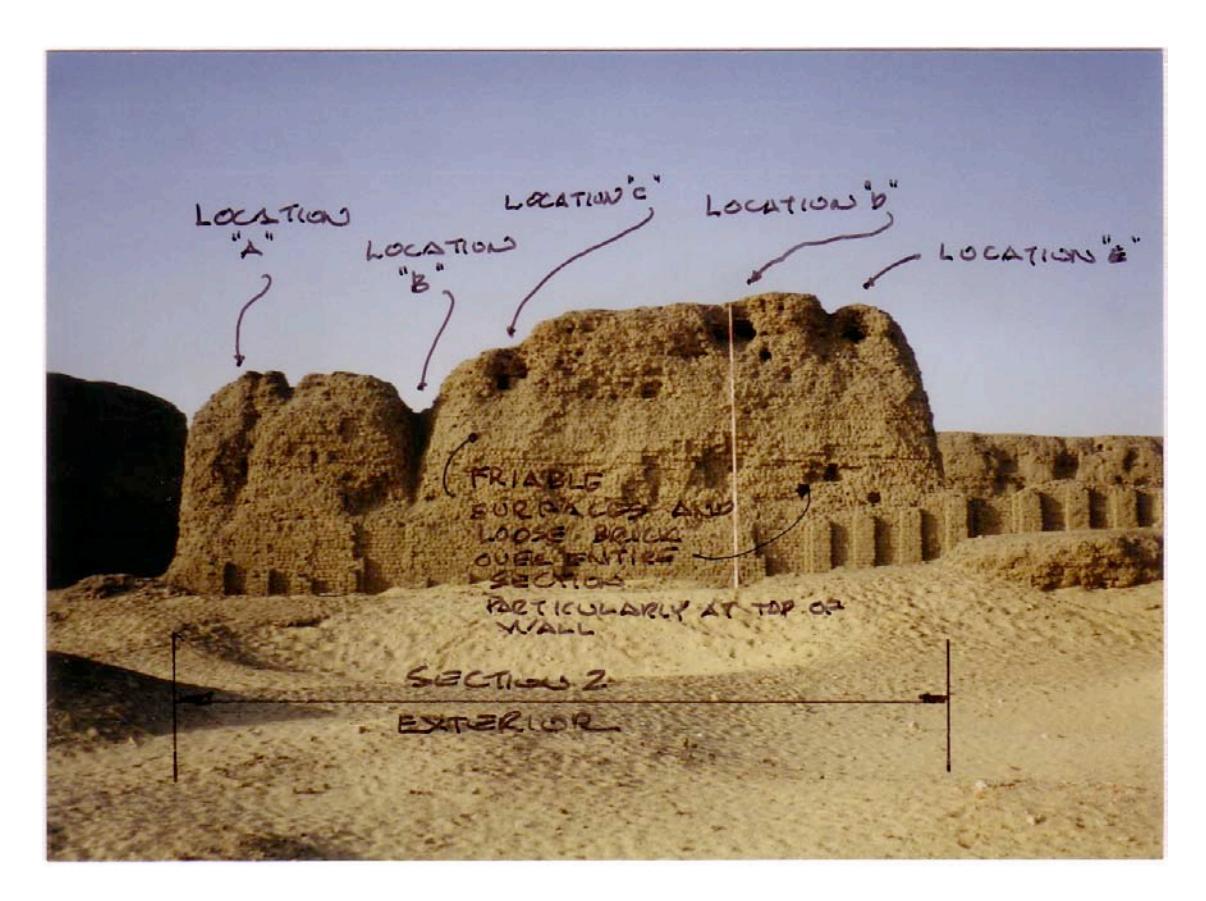
The southern, exterior face of the east wall exhibits five local conditions, illustrated as locations A through E in Figures 87-90, including an urgent-priority crack in the top three meters of the southern wall end, and specific locations of high to urgent-priority cavitation, erosion, loose brickwork and unstable brick masses. The southern, interior face exhibits distinct locations of urgent-priority undermining, cavitation, erosion, corbelling and cracking, and of normal-priority cavitation and loose and overhanging brickwork, illustrated as locations F through I in Figures 91-94.

Figure 87. Specific structural conditions on the southern, exterior face of the east main enclosure wall, noted as locations A-E (see details, below). (Photo: Conor Power 2000)

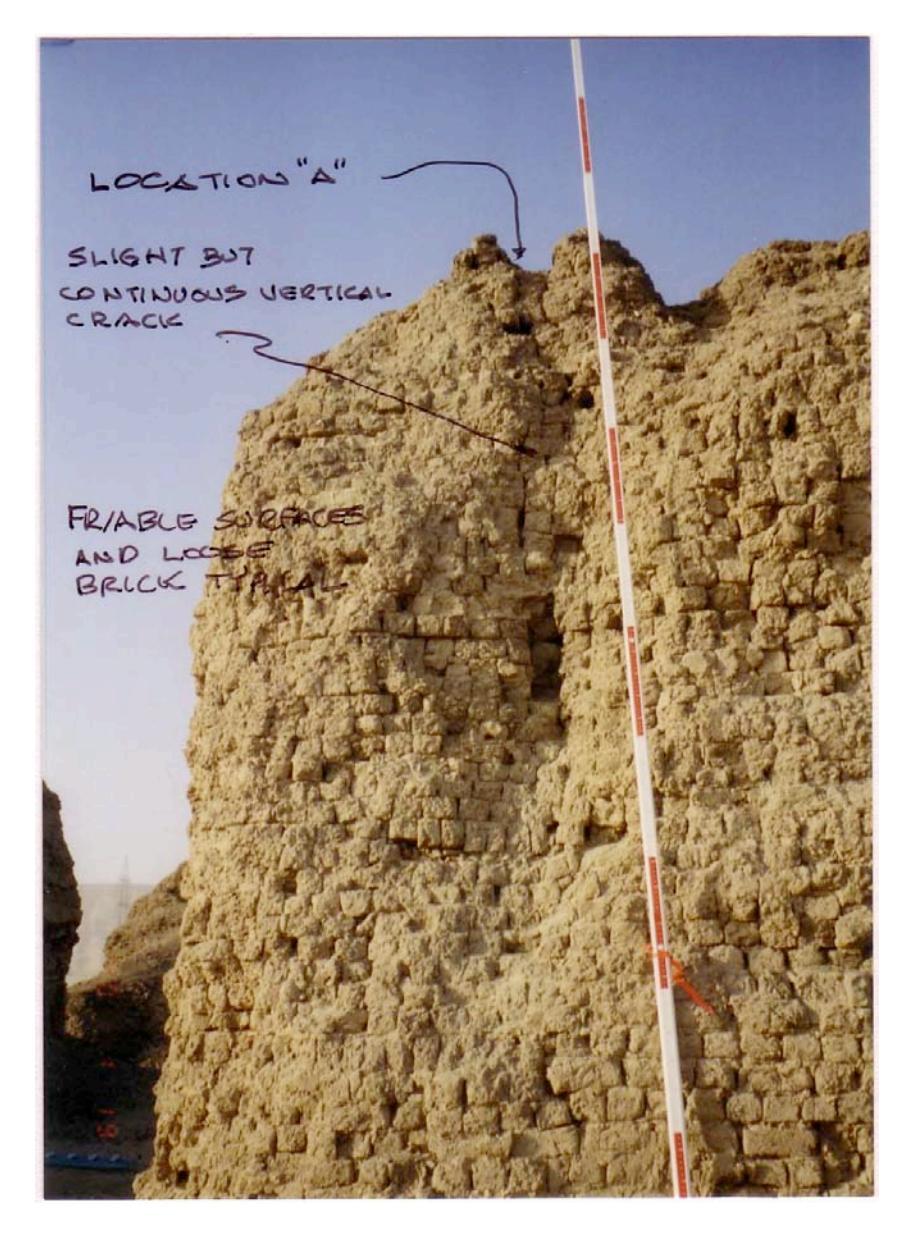
Figure 88. Detail of a vertical crack in the upper surface of the east main enclosure wall (noted as location A). (Photo: Conor Power 2000)

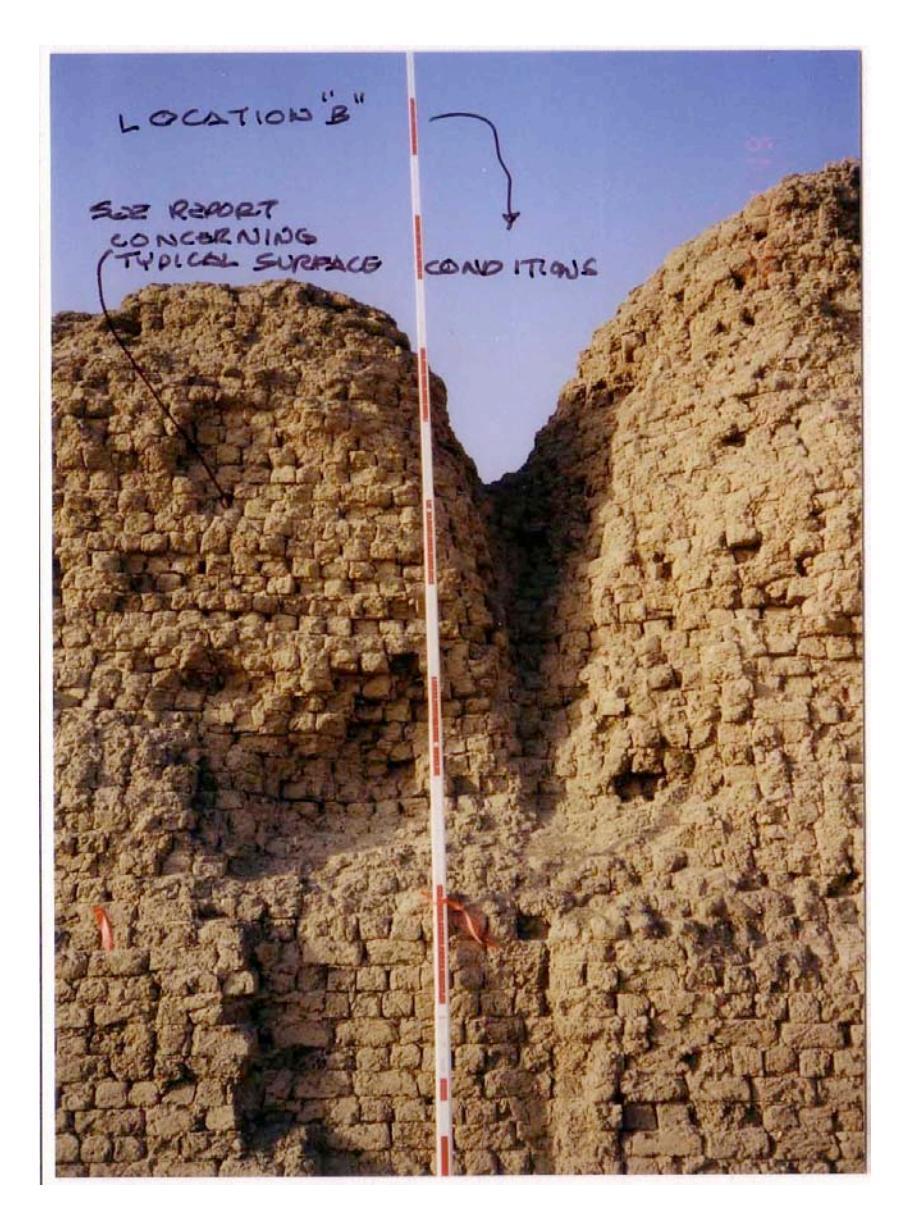
Figure 89. Detail of high-priority erosion in the upper surface of the east main enclosure wall (noted as location B). (Photo: Conor Power 2000)
