THE FUNERARY MONUMENT OF KING KHASEKHEMWY AT ABYDOS (ca. 2700 BCE): CONSERVATION AND ARCHAEOLOGY, 1999-2006

Final report on the "Documentation and Conservation of King Khasekhemwy's Funerary Monument at Abydos," a sub-project of the Egyptian Antiquities Project of the American Research Center in Egypt

2007

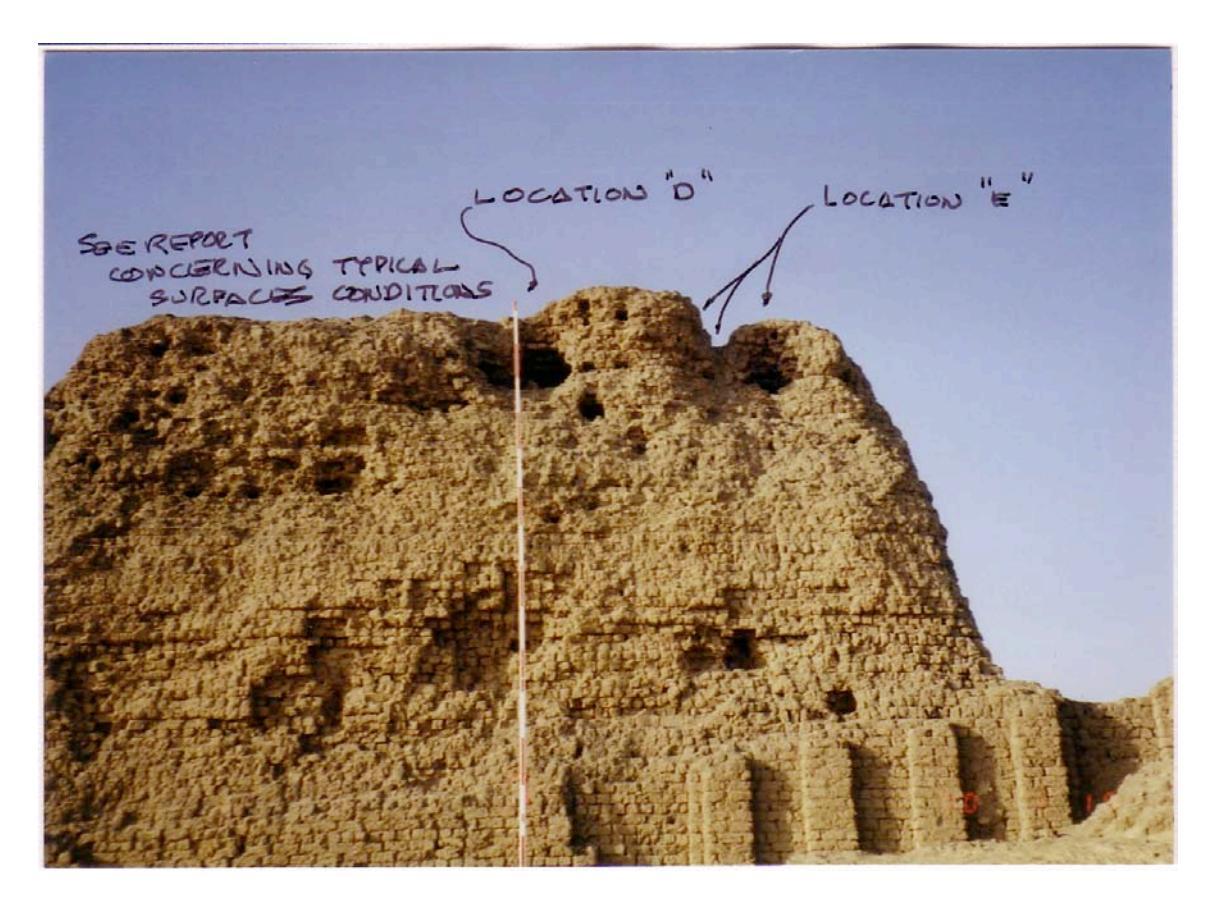
Figure 90. Details of urgent-priority cavitation and unstable brick masses on the exterior face of the east main enclosure wall (noted as location D) and urgent-priority cavitation, erosion and overhanging brickwork (noted as location E). (Photo: Conor Power 2000)

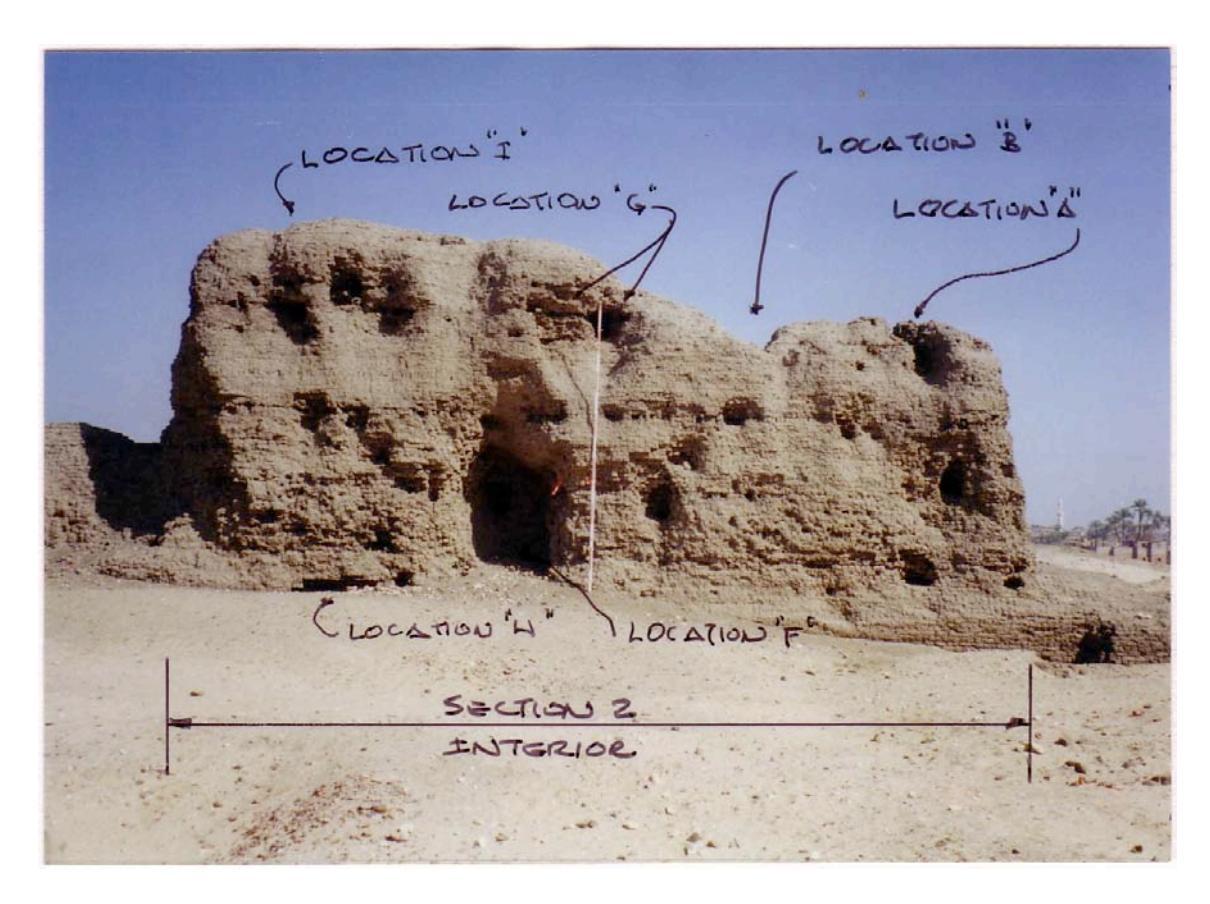
The southern, exterior face of the east wall exhibits five local conditions, illustrated as locations A through E in Figures 87-90, including an urgent-priority crack in the top three meters of the southern wall end, and specific locations of high to urgent-priority cavitation, erosion, loose brickwork and unstable brick masses. The southern, interior face exhibits distinct locations of urgent-priority undermining, cavitation, erosion, corbelling and cracking, and of normal-priority cavitation and loose and overhanging brickwork, illustrated as locations F through I in Figures 91-94.

Figure 91. Specific structural conditions on the southern, interior face of the east main enclosure wall, noted as locations F-I (see details, below). (Photo: Conor Power 2000)

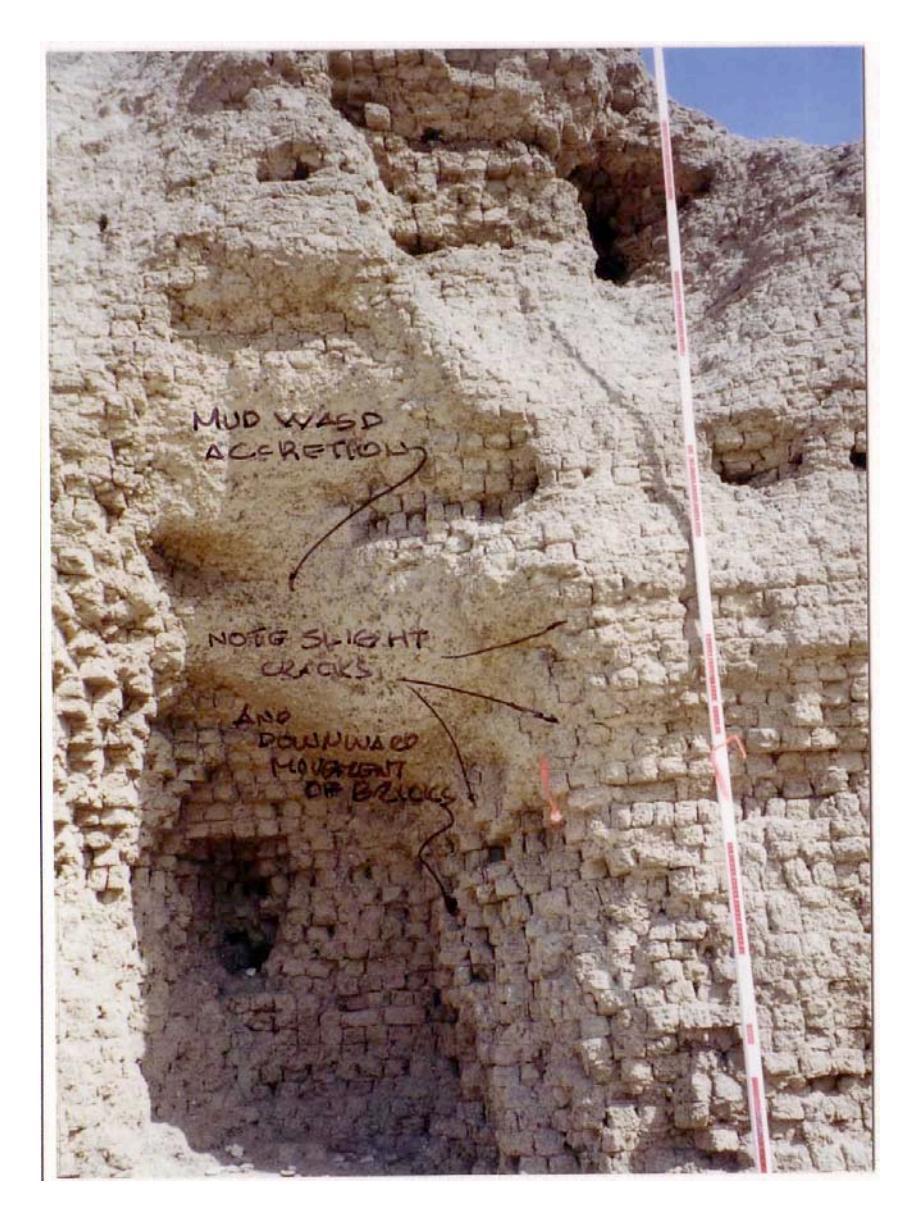
Figure 92. Detail of urgent-priority cavitation and cracking on the southern, interior side of the east main enclosure wall (noted as location F in Figure 91, above and Figure 93, below); note especially the large mud-wasp nest accretion on the upper surface of the wall cavity at lower left. (Photo: Conor Power 2000)

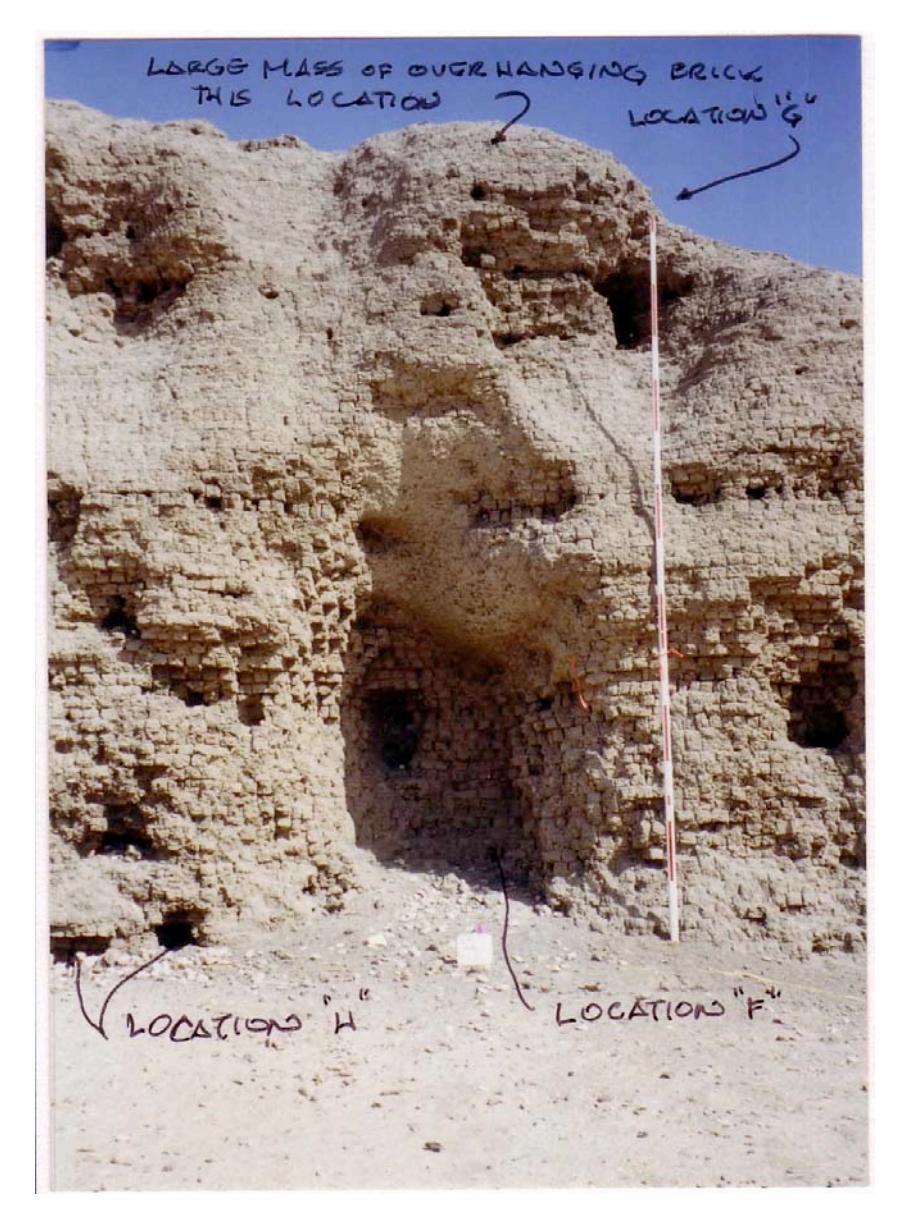
Figure 93. Detail of urgent-priority corbelling, cavitation and erosion on the southern, interior face of the east main enclosure wall (noted as location G). (Photo: Conor Power 2000)

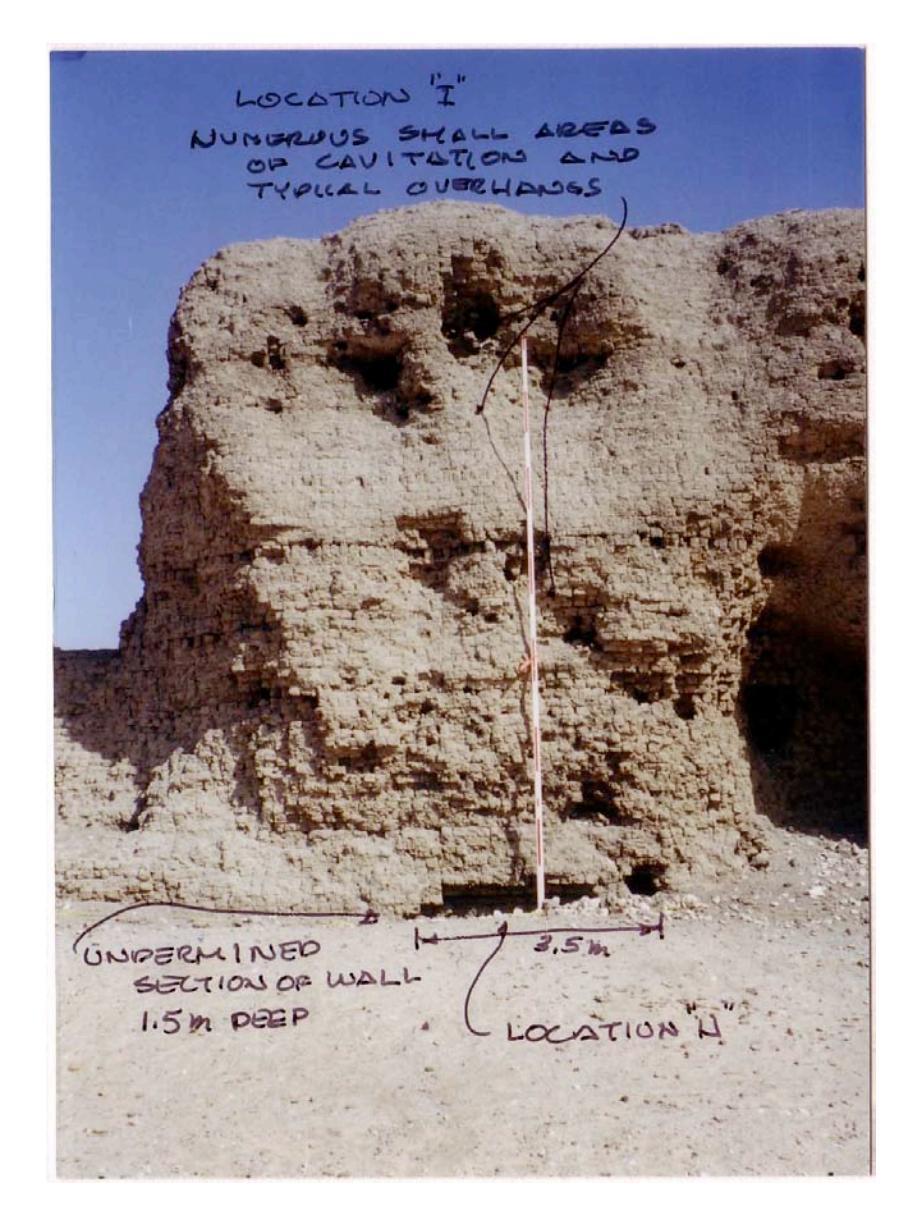
Figure 94. Details of urgent-priority undermining and cavitation on the southern, interior face of the east main enclosure wall (noted as location H) and normal-priority cavitation, overhangs and loose brickwork (noted as location I). (Photo: Conor Power 2000)

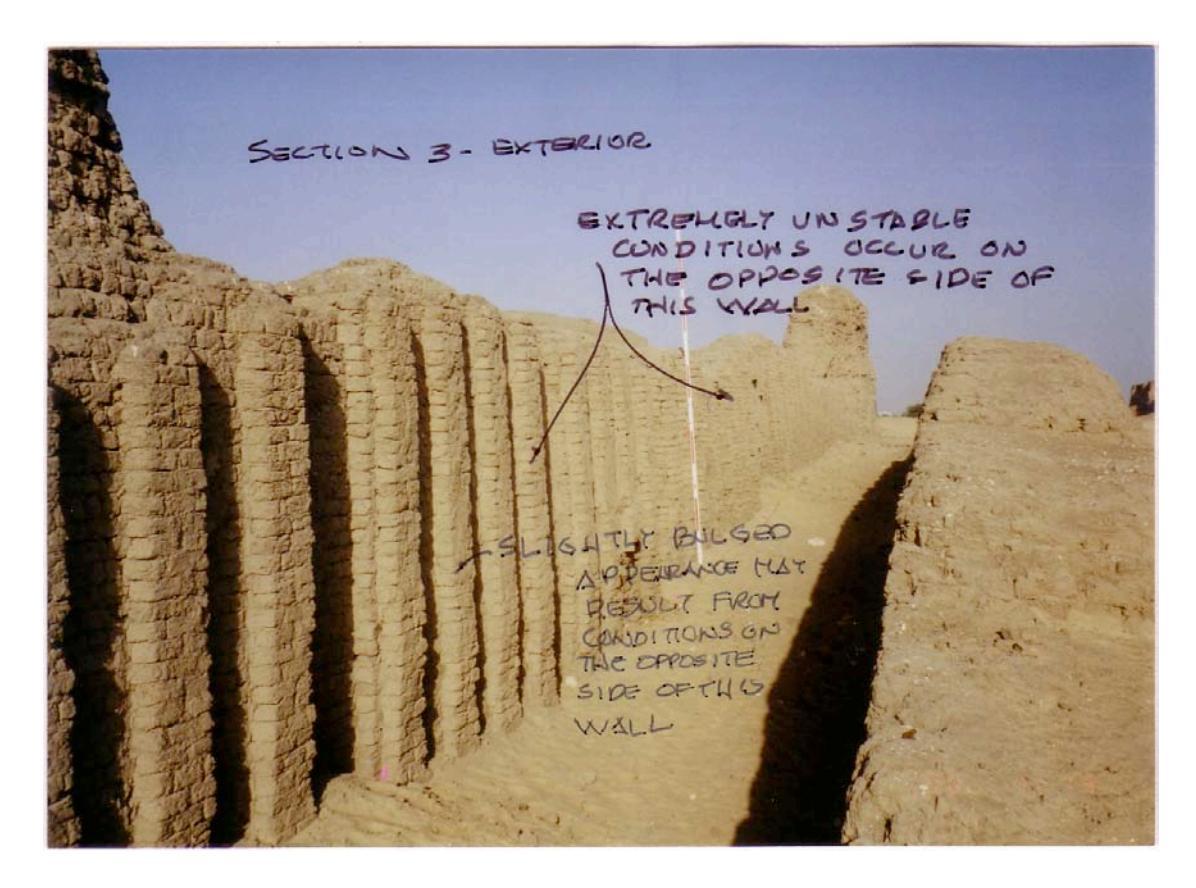
The central, exterior side of the east wall is in remarkably good condition with low-priority pilaster detachment and cracking (Figures 95-98). However, the interior side of the low, central portion of the east wall is in extremely poor condition, exhibiting locations of urgent-priority undermining, cavitation, cracking and active surface detachment (illustrated as locations J and K in Figures 99-103), as well as a large, rotated wall mass (illustrated as location L in Figures 99 and 104). The undermining of the interior wall base in this area as a result of extensive animal burrowing is among the most critical of existing structural conditions at the monument.

Figure 95. The central, exterior face of the east main enclosure wall (noted as section 3). (Photo: Conor Power 2000)

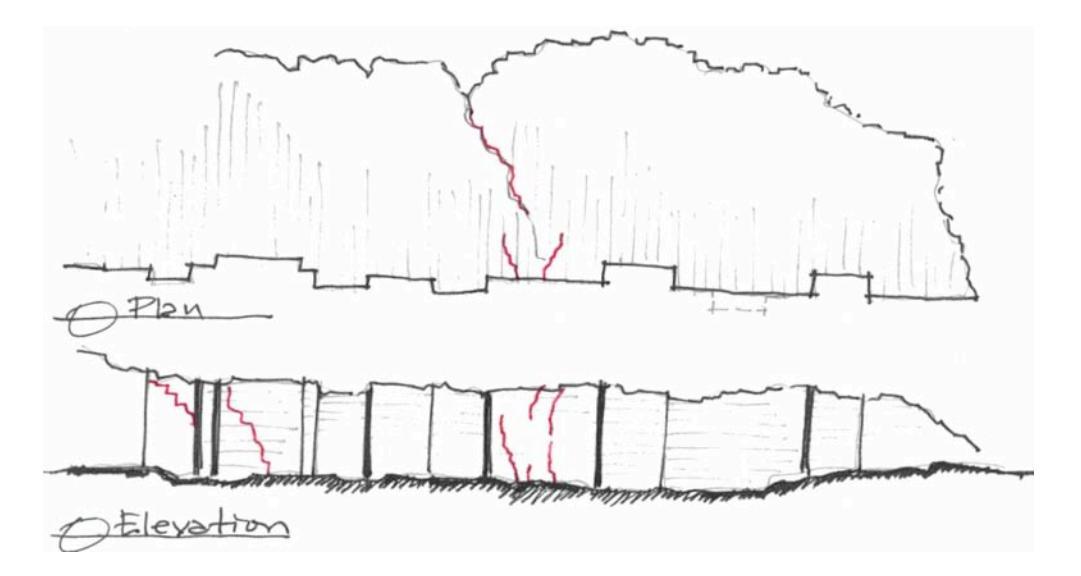
Figure 97. Relationships of pilasters and cracks (noted in red) on the central, exterior face of the east main enclosure wall. (Graphic: Anthony Crosby 2000)

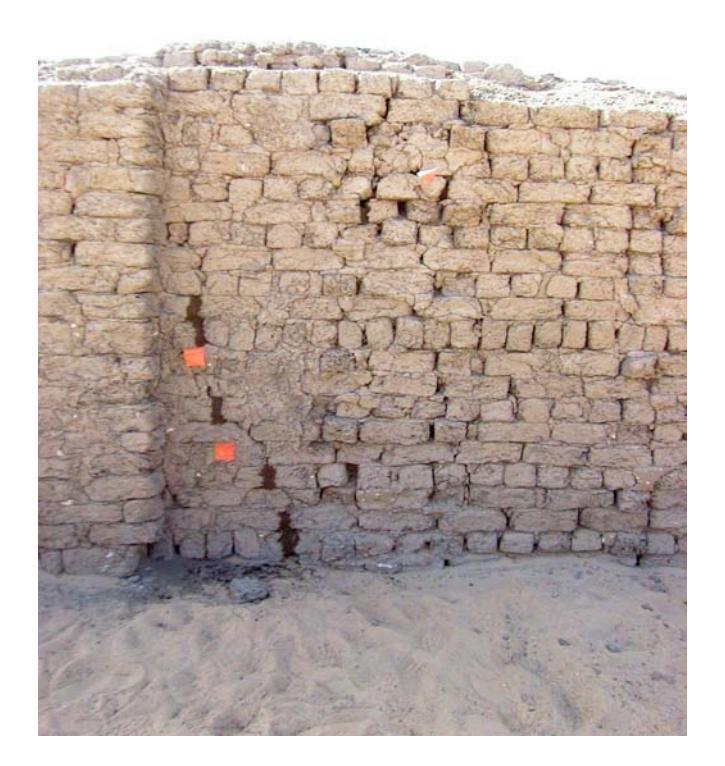
Figure 98. Detail of cracking in the exterior face of the east main enclosure wall as depicted in the sketch elevation of Figure 97, above. (Photo: Anthony Crosby 2000)

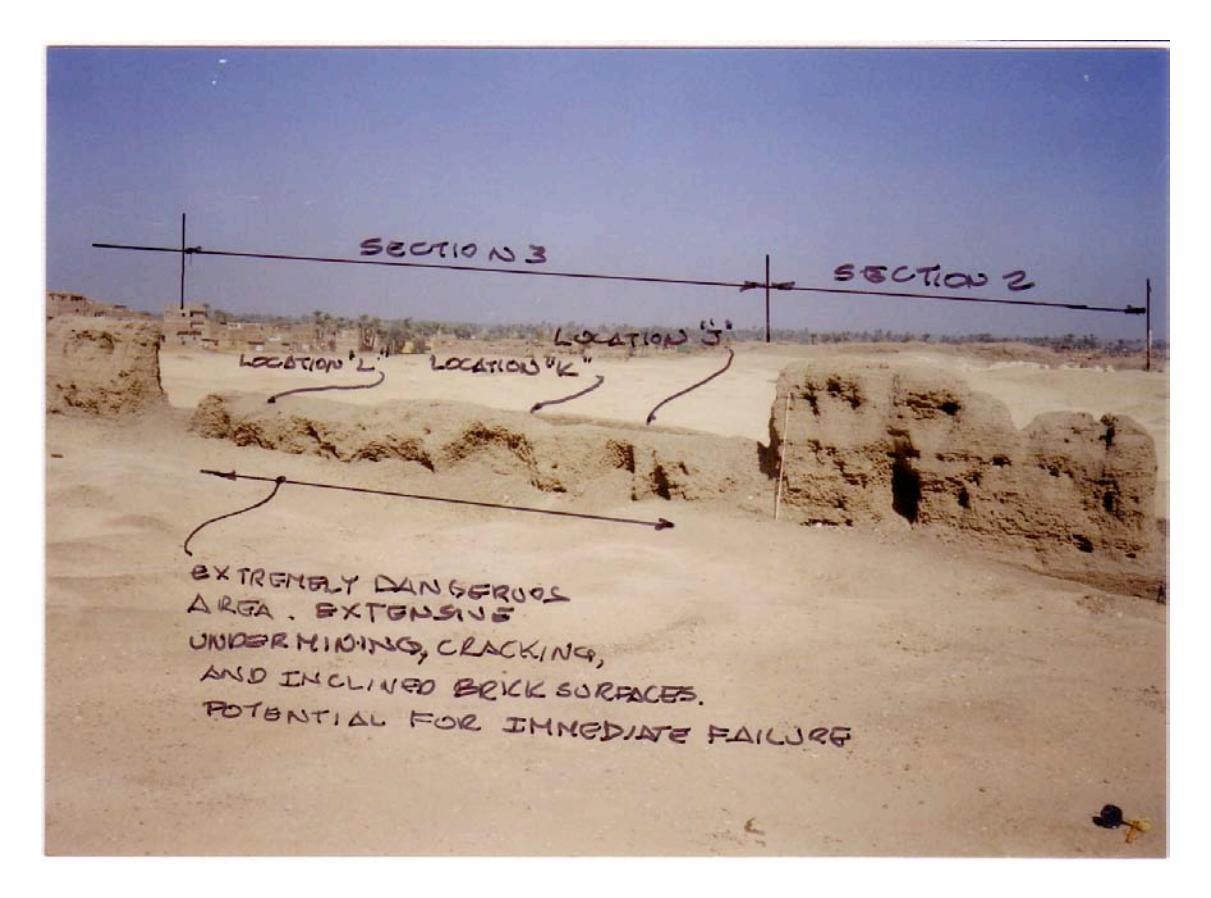
Figure 99. Specific structural conditions on the central, interior face of the east main enclosure wall, noted as locations J-L (see details, below). (Photo: Conor Power 2000)

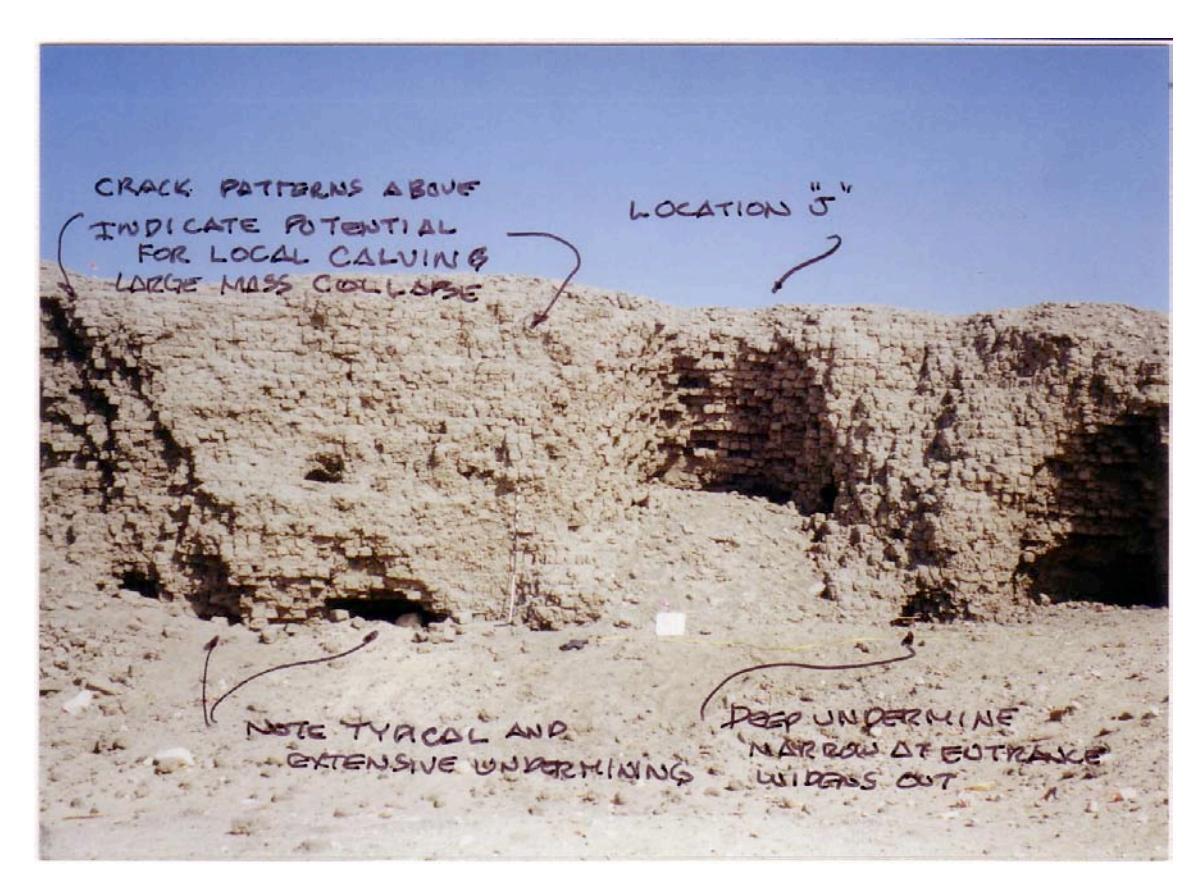
Figure 100. Details of undermining on the lower, interior side of the east main enclosure wall (lower left), as well as urgent-priority cavitation, cracking and calving (noted as location J). (Photo: Conor Power 2000)

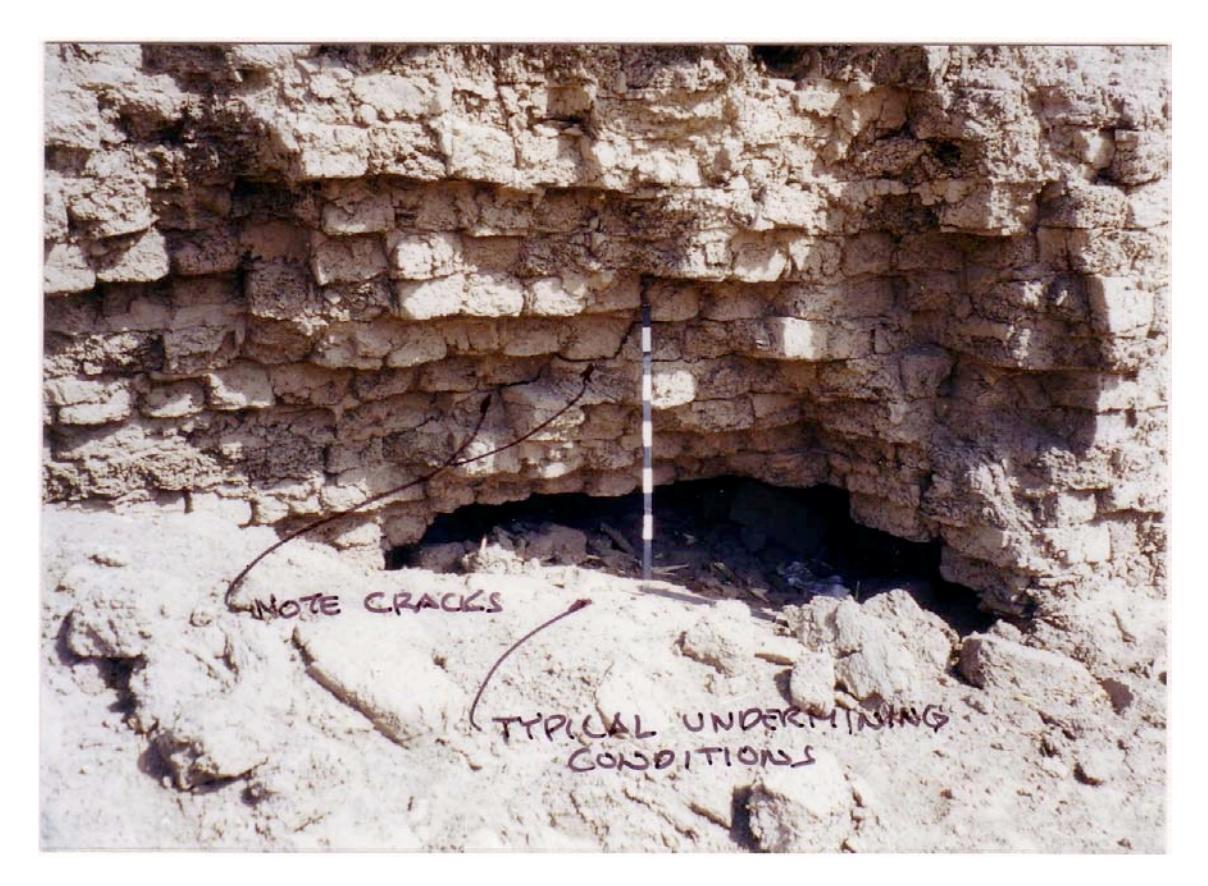
Figure 101. Detail of undermining to the interior base of the east main enclosure wall. (Photo: Conor Power 2000)

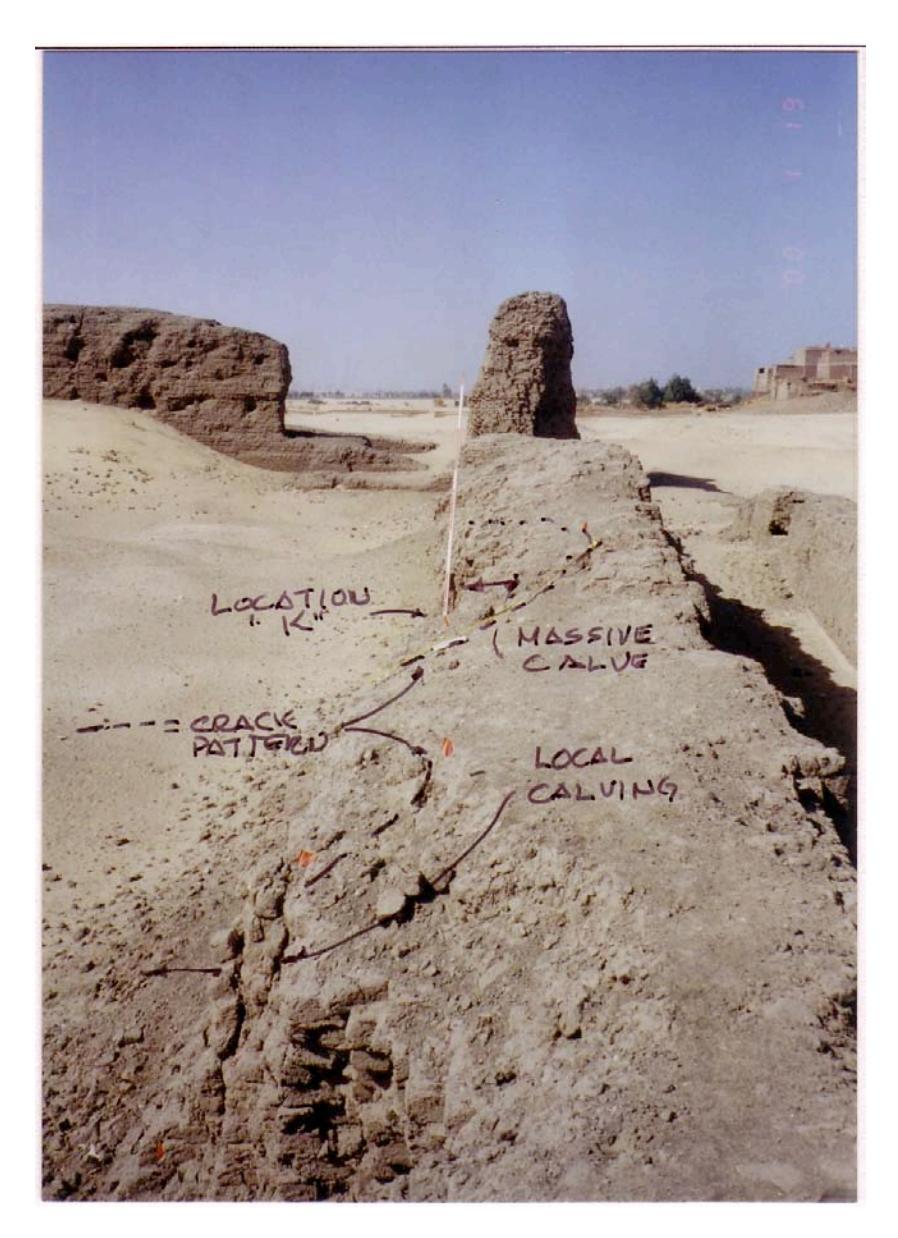
Figure 102. Detail of cracking and calving on the lower, interior side of the east main enclosure wall (noted as location K). (Photo: Conor Power 2000)

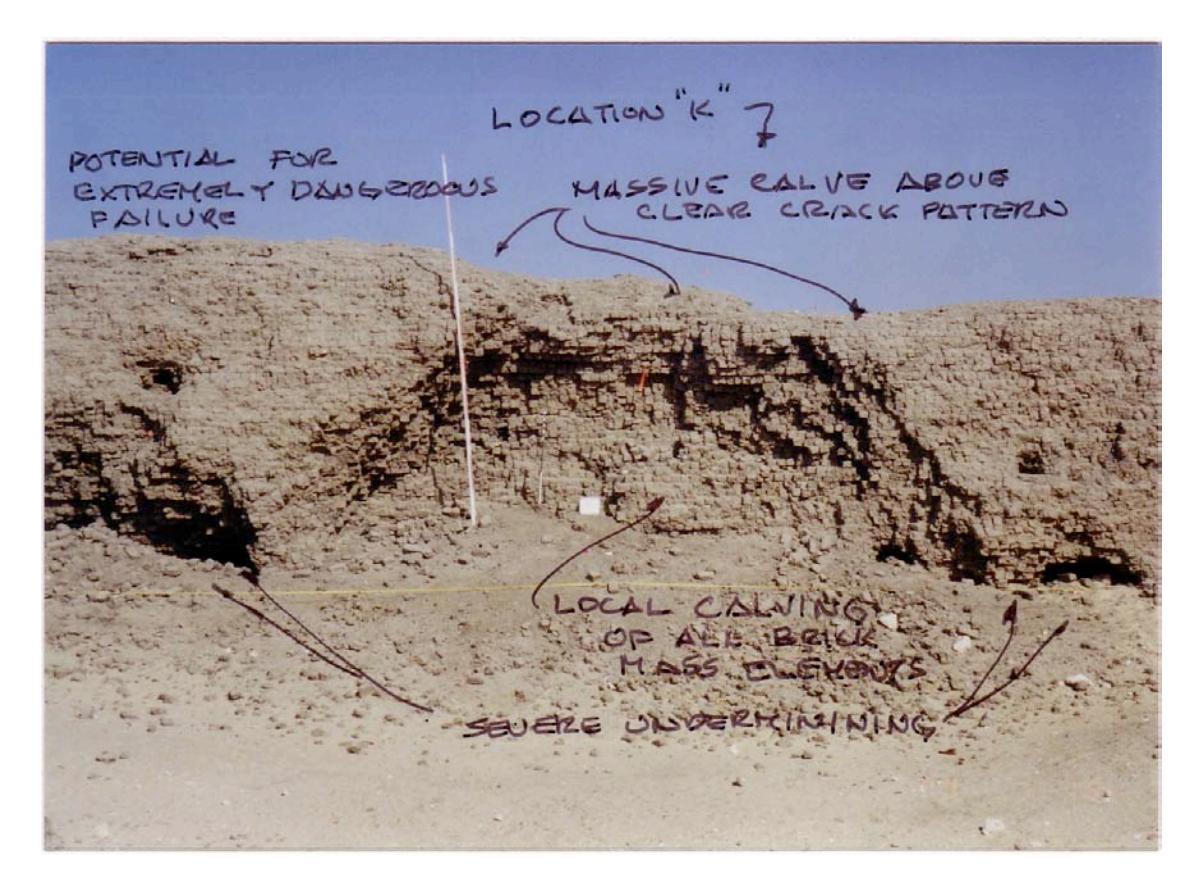
Figure 103. Detail of local undermining, cracking and calving on the interior side of the east main enclosure wall (noted as location K). (Photo: Conor Power 2000)

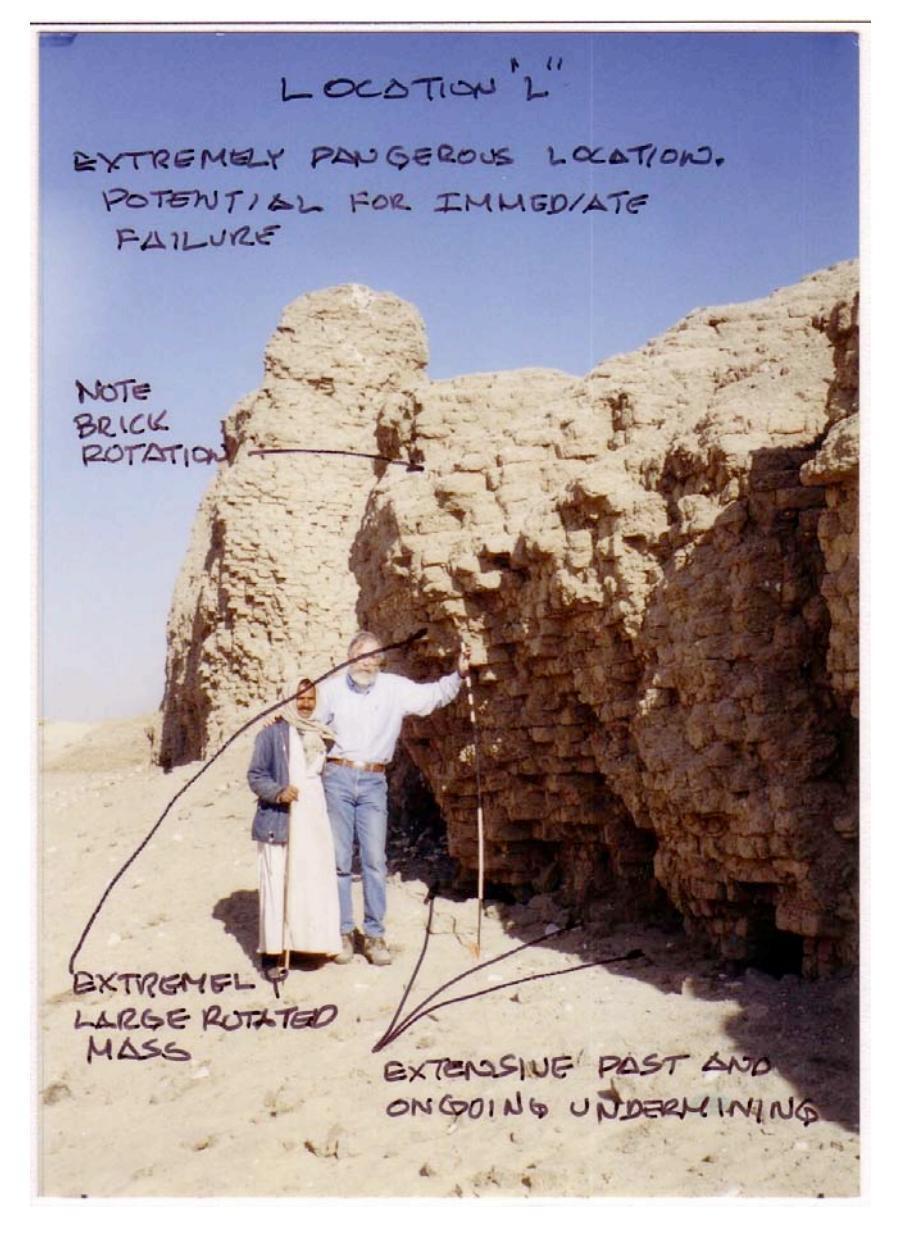
Figure 104. Detail of a large rotated wall mass on the interior side of the east main enclosure wall (noted as location L). (Photo: Conor Power 2000)

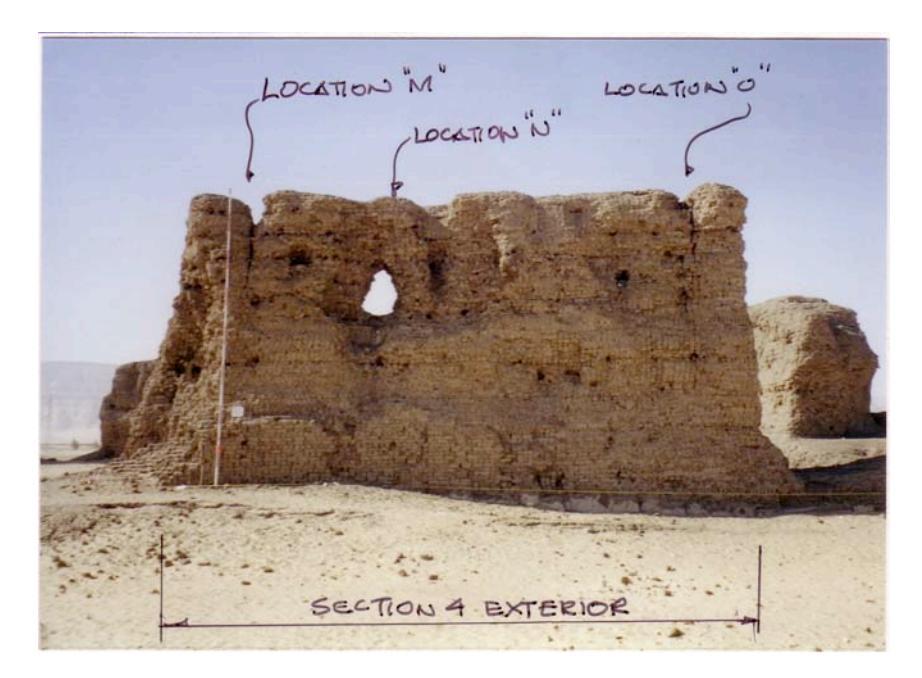
The northern pier of the east wall generally exhibits extensive cavitation and surface friability as well as urgent-priority through-wall cracking, erosion, undermining, detachment, overhangs, nest accretions and loose brickwork at various locations on both the interior and exterior elevations (illustrated as locations M through O in Figures 105-111). Location M designates a major structural crack that threatens one end of the northern pier with collapse, and at the other (northern) end of this pier is a second structural crack, which has essentially isolated the vertical wall end at this location (see Figures 105, 107 and 111). This vertical segment of the east wall stands to near the original height of the enclosure in an extremely unstable condition, exhibiting a combination of cracking and detachment associated with the collapse of the adjacent gateway as well as the construction and decay of a monastic cell dug into the wall from the north interior gateway chamber (see Figures 17 and 18, above).

Figure 105. Specific structural conditions on the northern, exterior face of the east main enclosure wall, noted as locations M-O (see details, below). (Photo: Conor Power 2000)

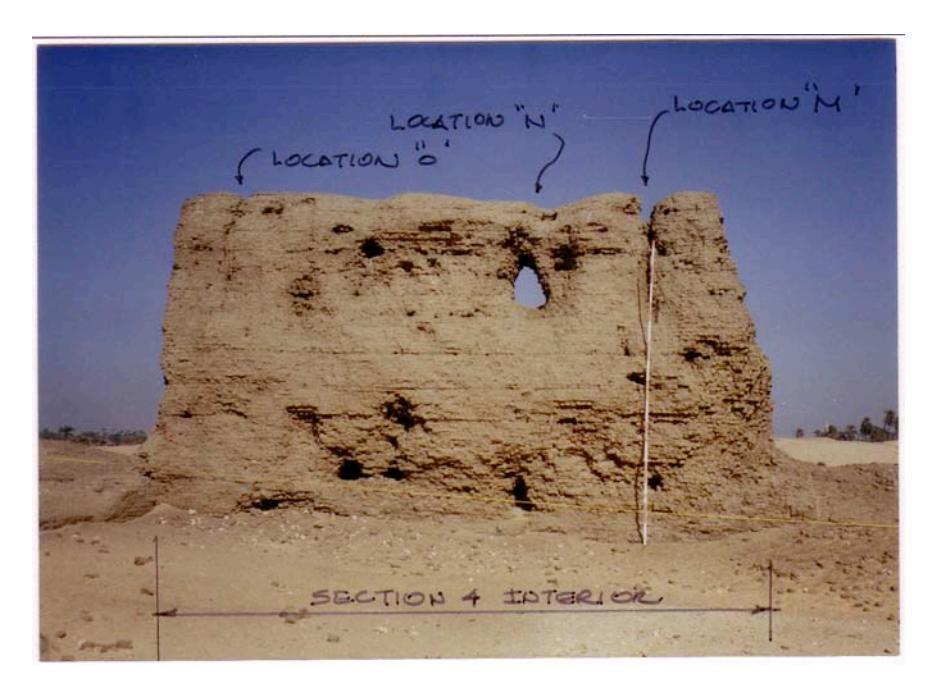
Figure 106. Specific structural conditions on the northern, interior face of the east main enclosure wall, noted as locations M-O (see details, below). (Photo: Conor Power 2000)

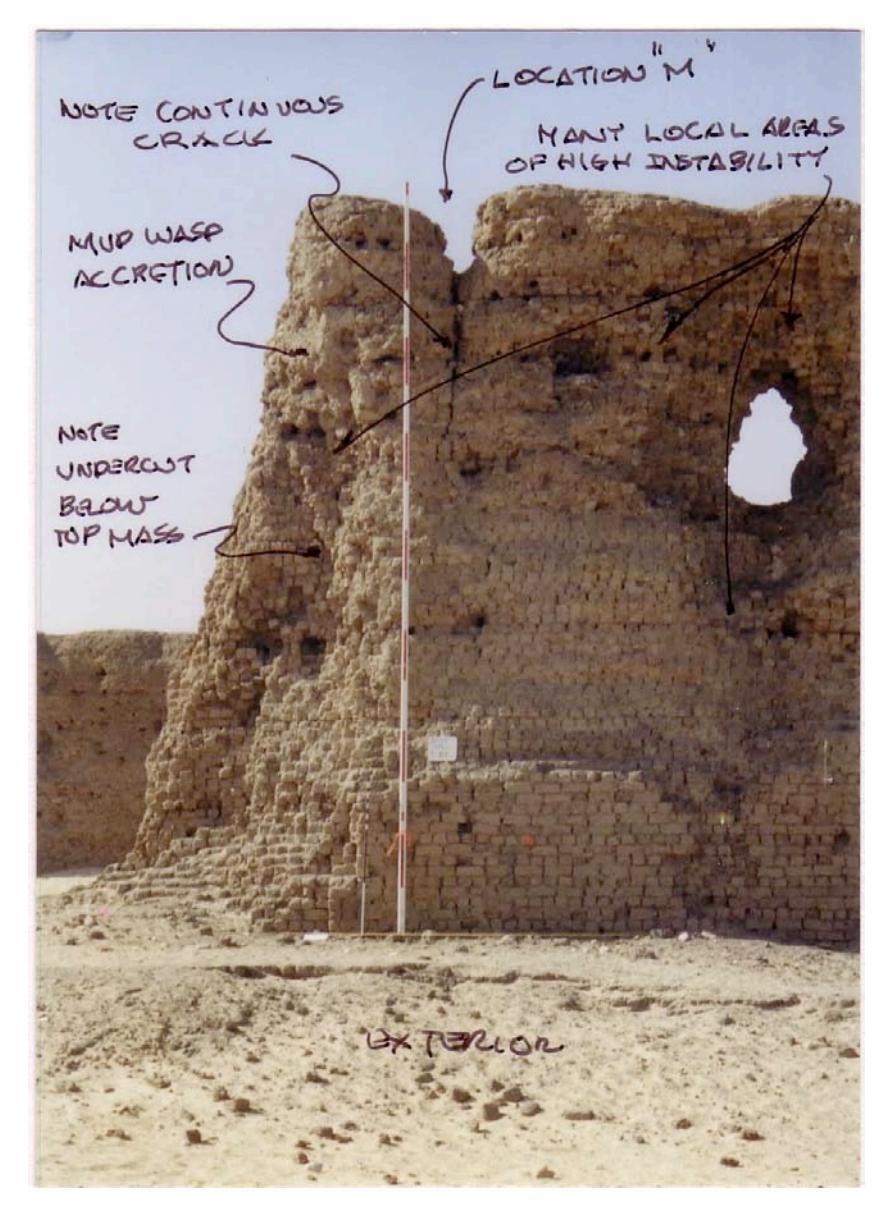
Figure 107. Exterior detail of an urgent-priority through-wall crack in the northern pier of the east main enclosure wall (noted as location M). (Photo: Conor Power 2000)

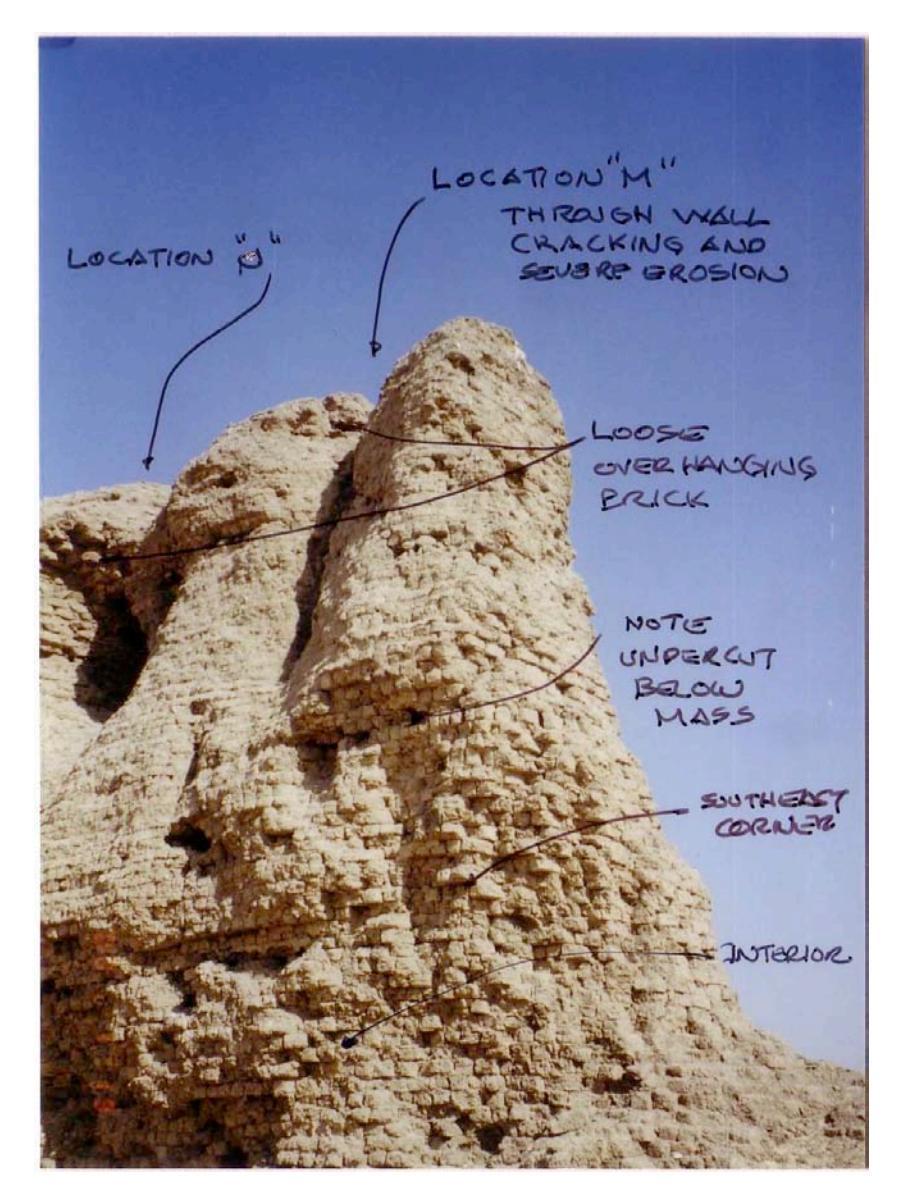
Figure 108. Details of cracking, erosion, detachment and overhanging brickwork on the northern, interior face of the east main enclosure wall (noted as locations M and N). (Photo: Conor Power 2000)

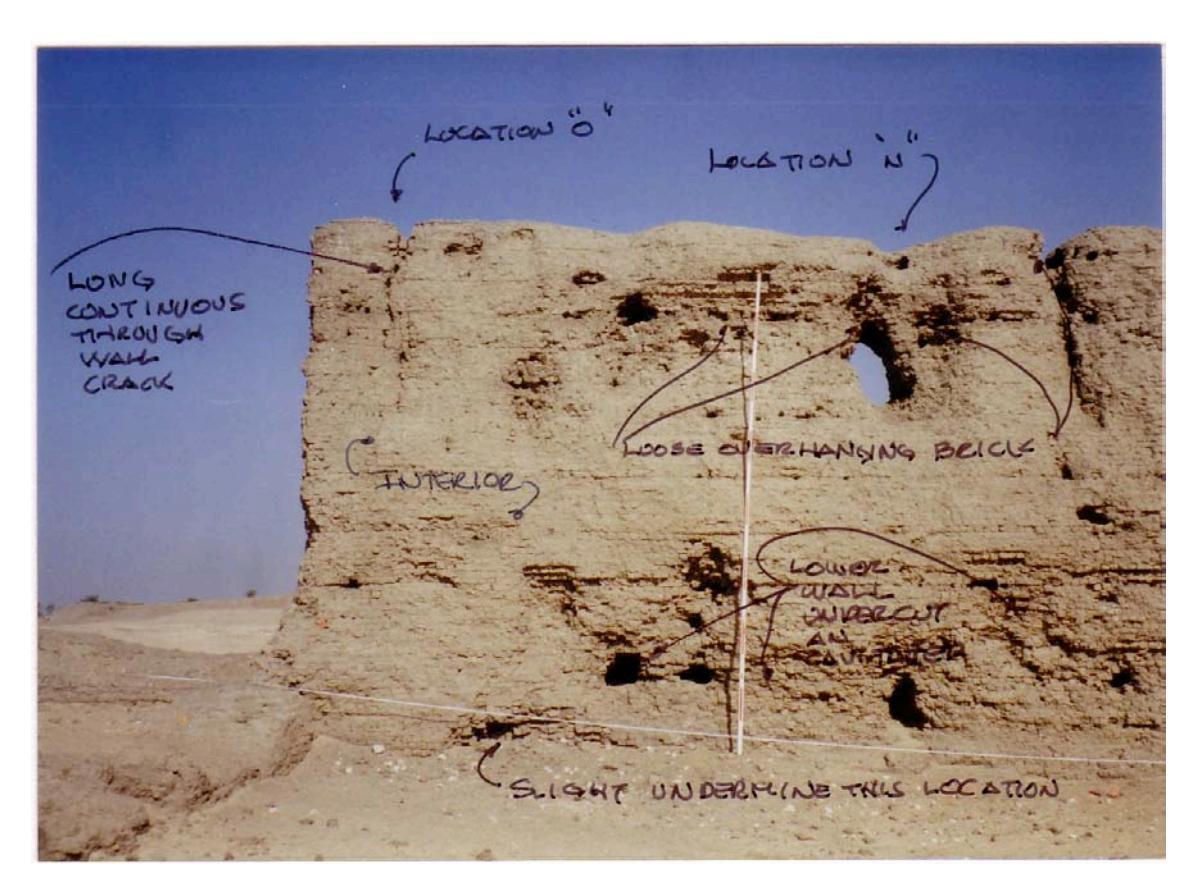
Figure 110. Structural conditions at the northern, interior end of the east main enclosure wall. (Photo: Conor Power 2000)

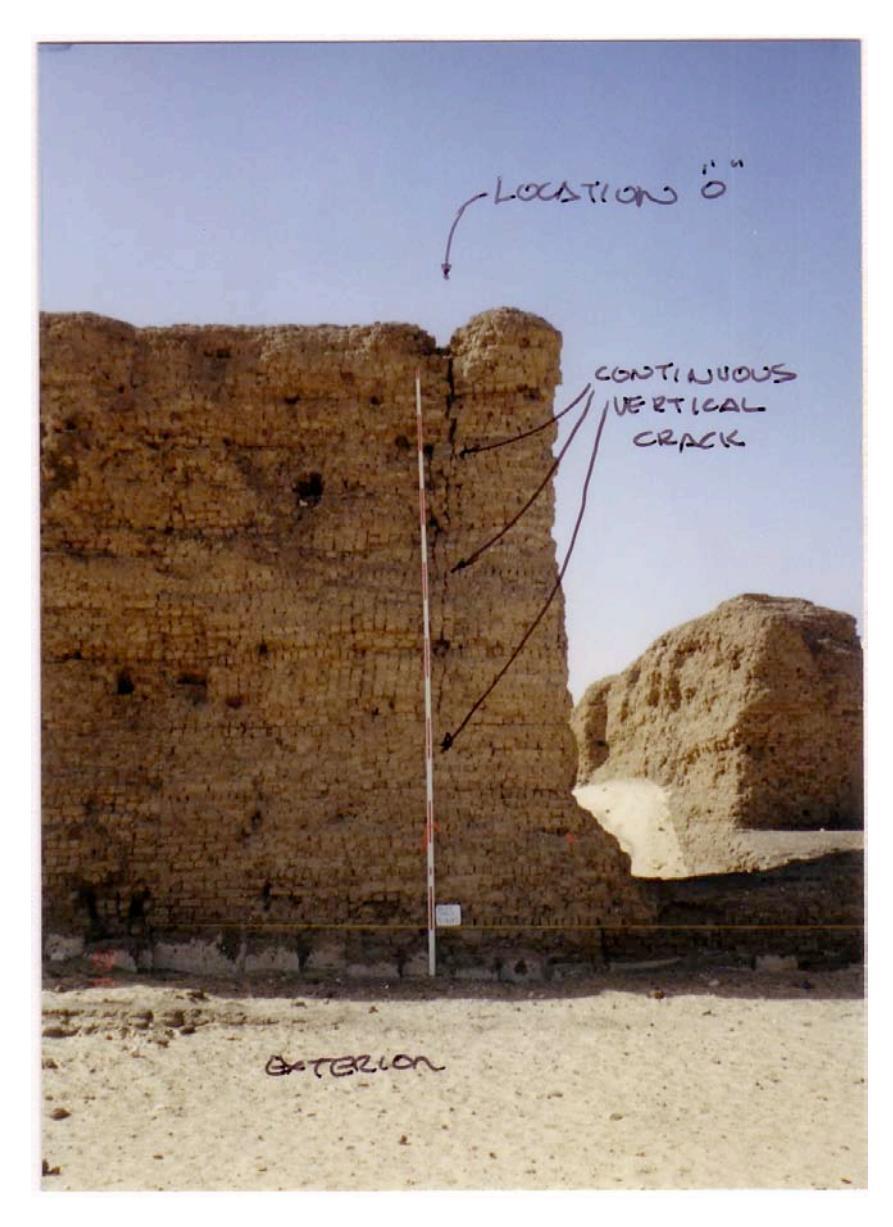
Figure 111. Exterior detail of a through-wall crack behind the highly unstable northern wall end of the east main enclosure wall (noted as location O). (Photo: Conor Power 2000)

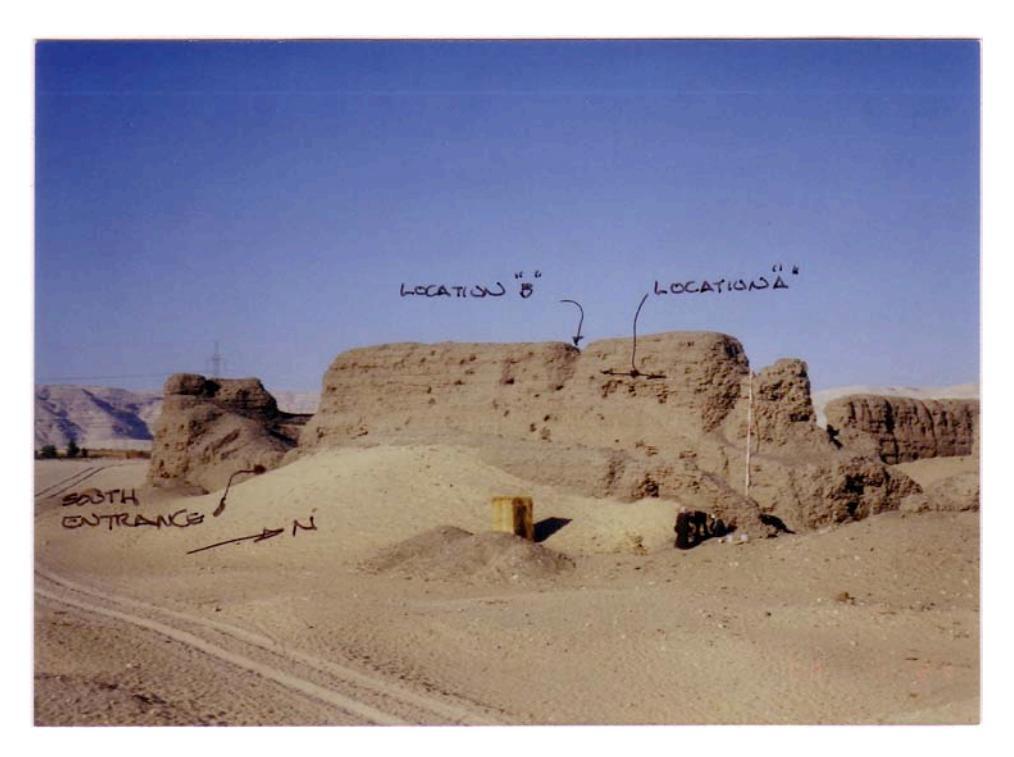
The core of the south main enclosure wall, which is essentially intact, is characterized by a distinctive texture on its interior side resulting from mud wasp and other animal activity, and by moderate surface loss on its exterior side (Figures 112 and 113).

Figure 112. The exterior face of the south main enclosure wall. (Photo: Conor Power 2000)
