THE FUNERARY MONUMENT OF KING KHASEKHEMWY AT ABYDOS (ca. 2700 BCE): CONSERVATION AND ARCHAEOLOGY, 1999-2006

Final report on the "Documentation and Conservation of King Khasekhemwy's Funerary Monument at Abydos," a sub-project of the Egyptian Antiquities Project of the American Research Center in Egypt

2007

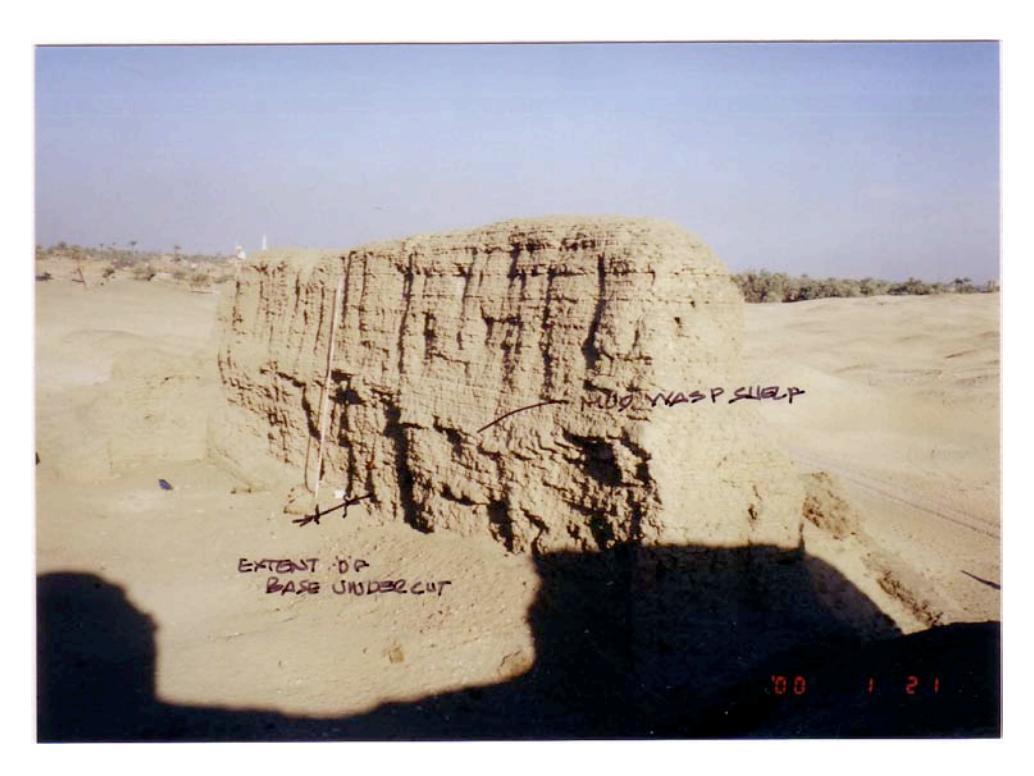
The core of the south main enclosure wall, which is essentially intact, is characterized by a distinctive texture on its interior side resulting from mud wasp and other animal activity, and by moderate surface loss on its exterior side (Figures 112 and 113).

Figure 113. The interior face of the south main enclosure wall. (Photo: Conor Power 2000)

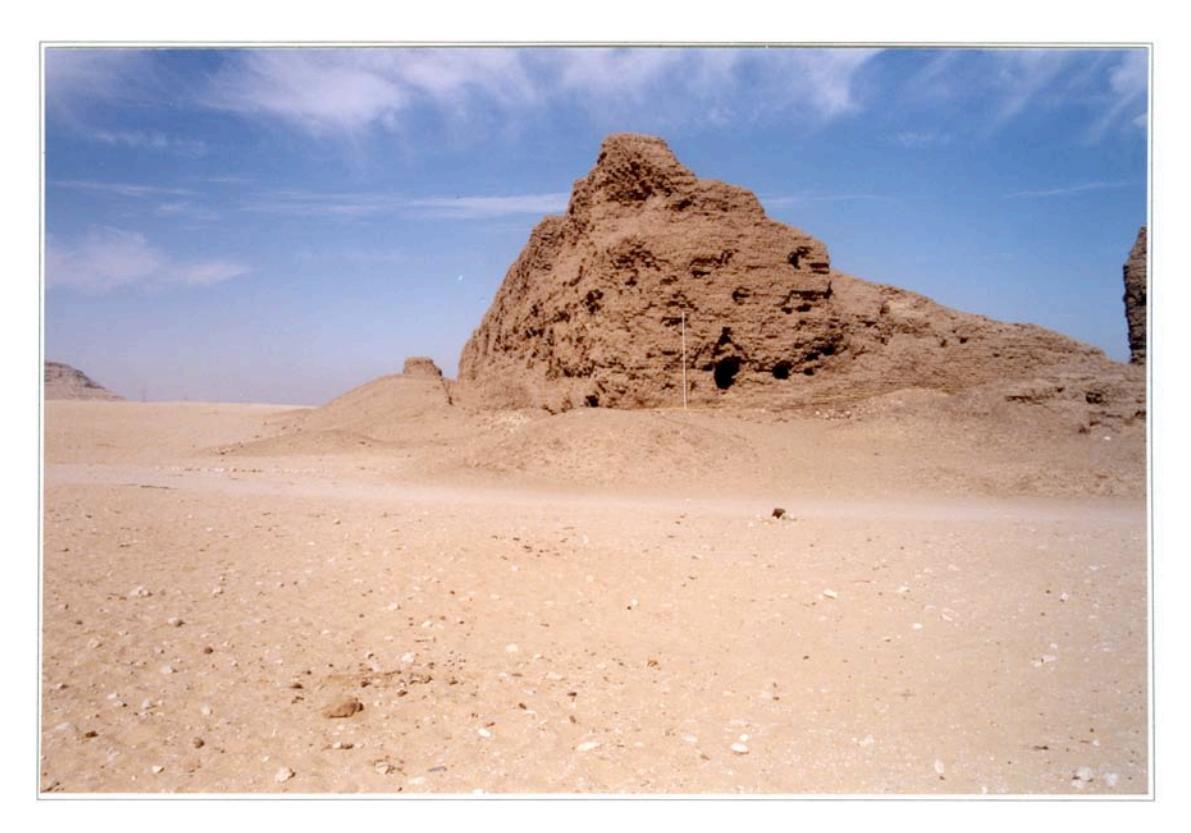
Figure 114. Southwest corner of the perimeter and main enclosures, at the intersection of the west and south enclosure walls; note the area of the south gateway at upper right. (Photo: William Remsen 2000)

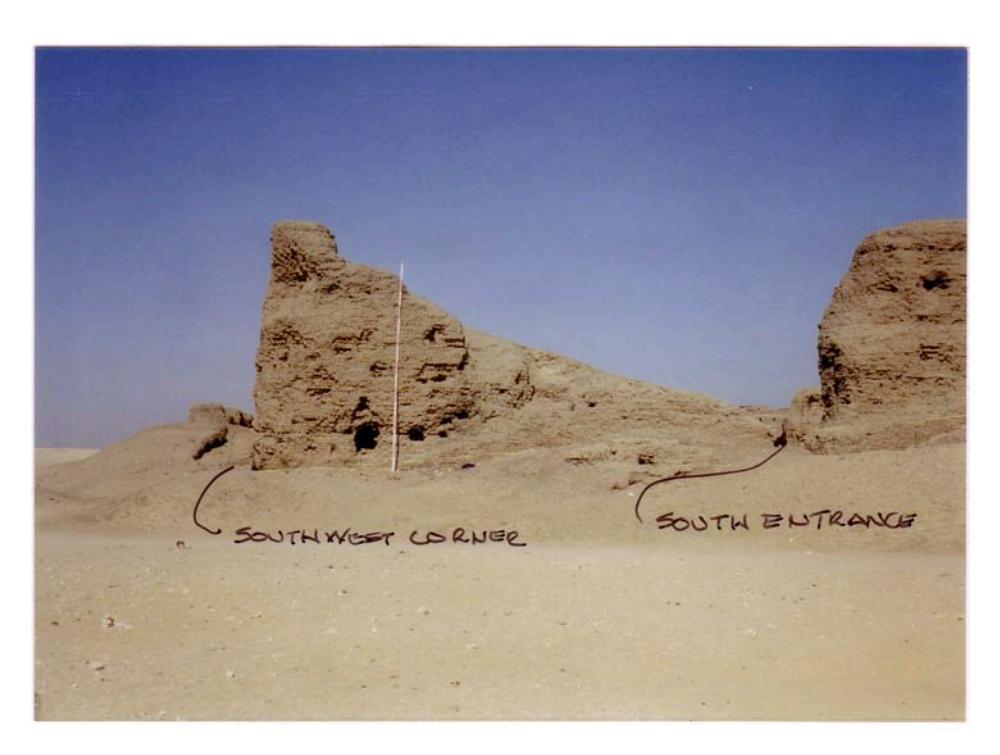
The western, exterior corner of the south wall exhibits undermining, calving and loose brickwork associated with deep penetrations into the wall base, which are the result of both 19th Century archaeological activity and animal burrowing (Figures 114-116). Just east of this corner is a significant concentration of hornet burrows. On the interior side of this corner, a large sand dune/debris fan has built up against the surface, covering the full interior elevation of both the south and west walls at this intersection (Figure 117). The presence of this debris fan suggested that a massive failure may have previously occurred at this location, and just above the accumulation, a large mass of masonry was seen to be missing from the upper part of the south wall. Excavation in 2005-2006 revealed the extent and nature of the debris fan, which consisted of brick masonry collapsed from the wall above, and cleaning of the existing wall top at this location revealed the existence of a small monastic cell, which almost certainly contributed to the local failure of the wall (see Archaeological Investigation of the Monument, to follow).

Figure 115. The western, exterior corner of the south main enclosure wall (adjacent to the south gateway). (Photo: Conor Power 2000)

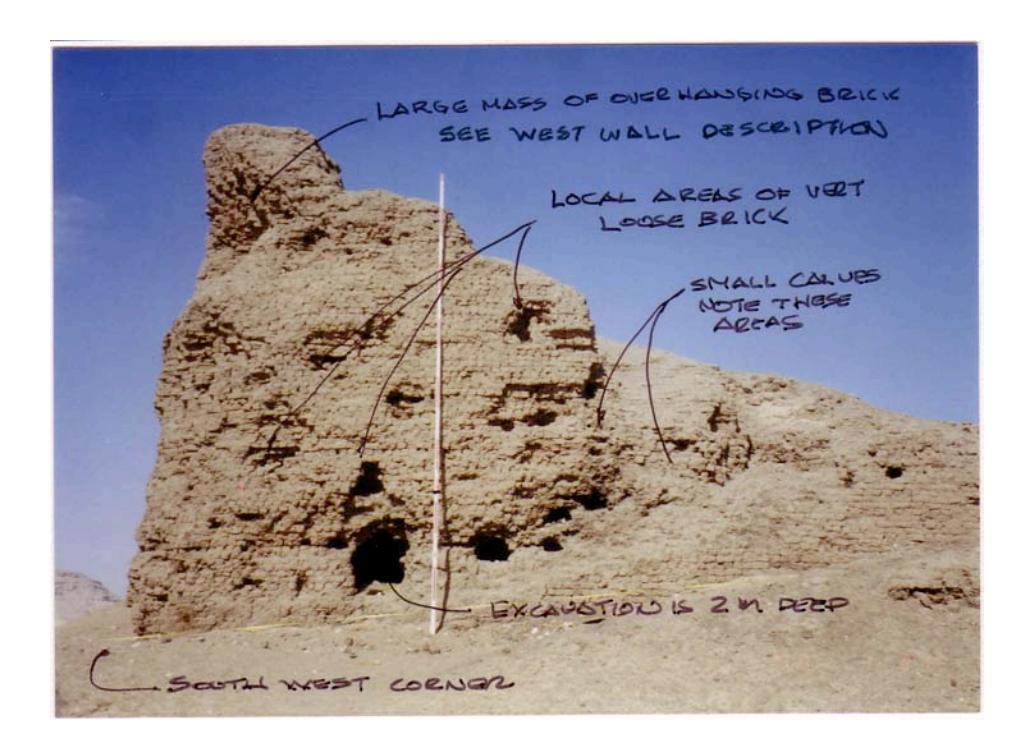
Figure 116. Detail of the large cavities at the western, exterior corner of the south main enclosure wall. (Photo: Conor Power 2000)

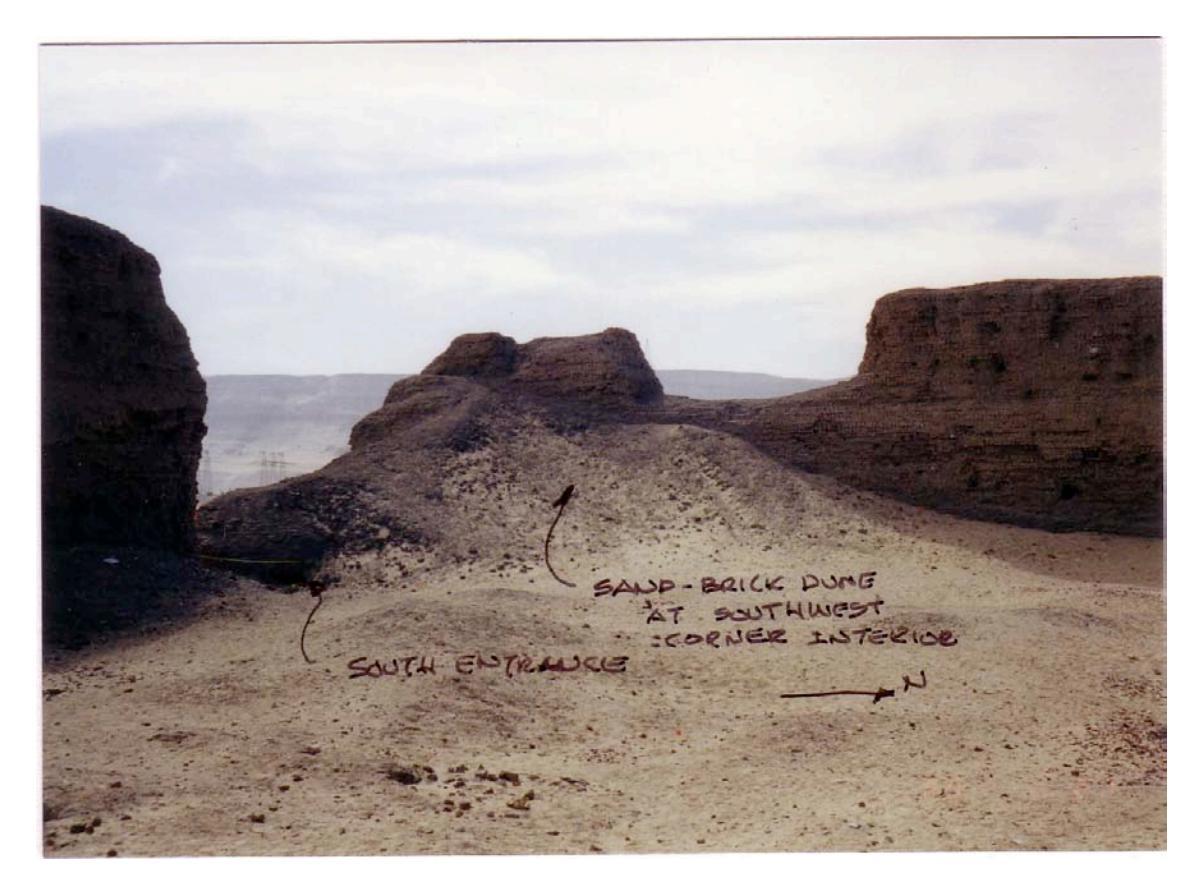
Figure 117. Detail of the large sand dune/debris fan that has built up against the southwestern, interior corner of the main enclosure. (Photo: Conor Power 2000)

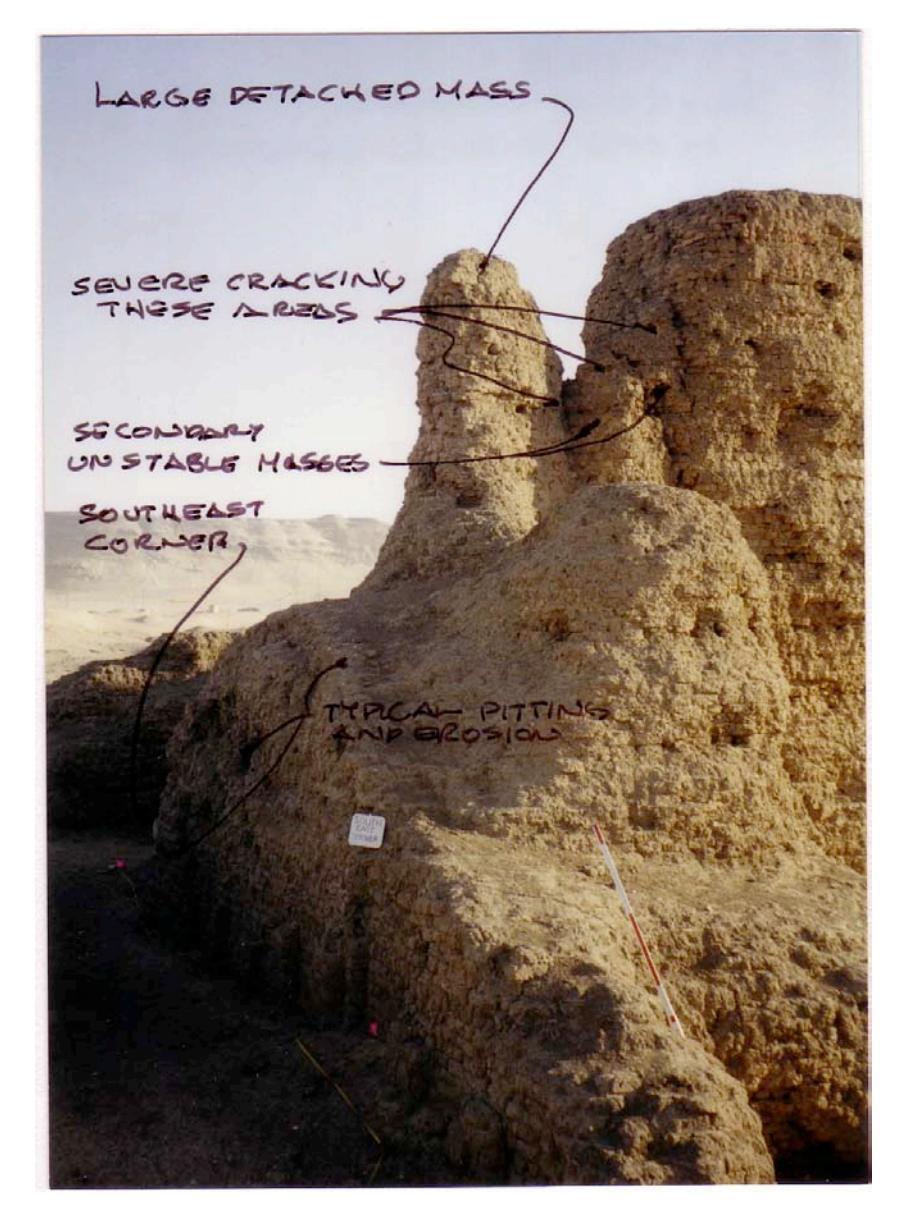
The eastern corner of the south wall exhibits urgent-priority through-wall cracking, calving and erosion behind the vertical face of the eastern wall end. Primary and secondary detached brick masses and high-priority cavitation occur at this location, resulting in conditions of extreme instability (Figures 118 and 119).

Figure 118. Detail of the large detached brick mass at the eastern end of the south main enclosure wall. (Photo: Conor Power 2000)

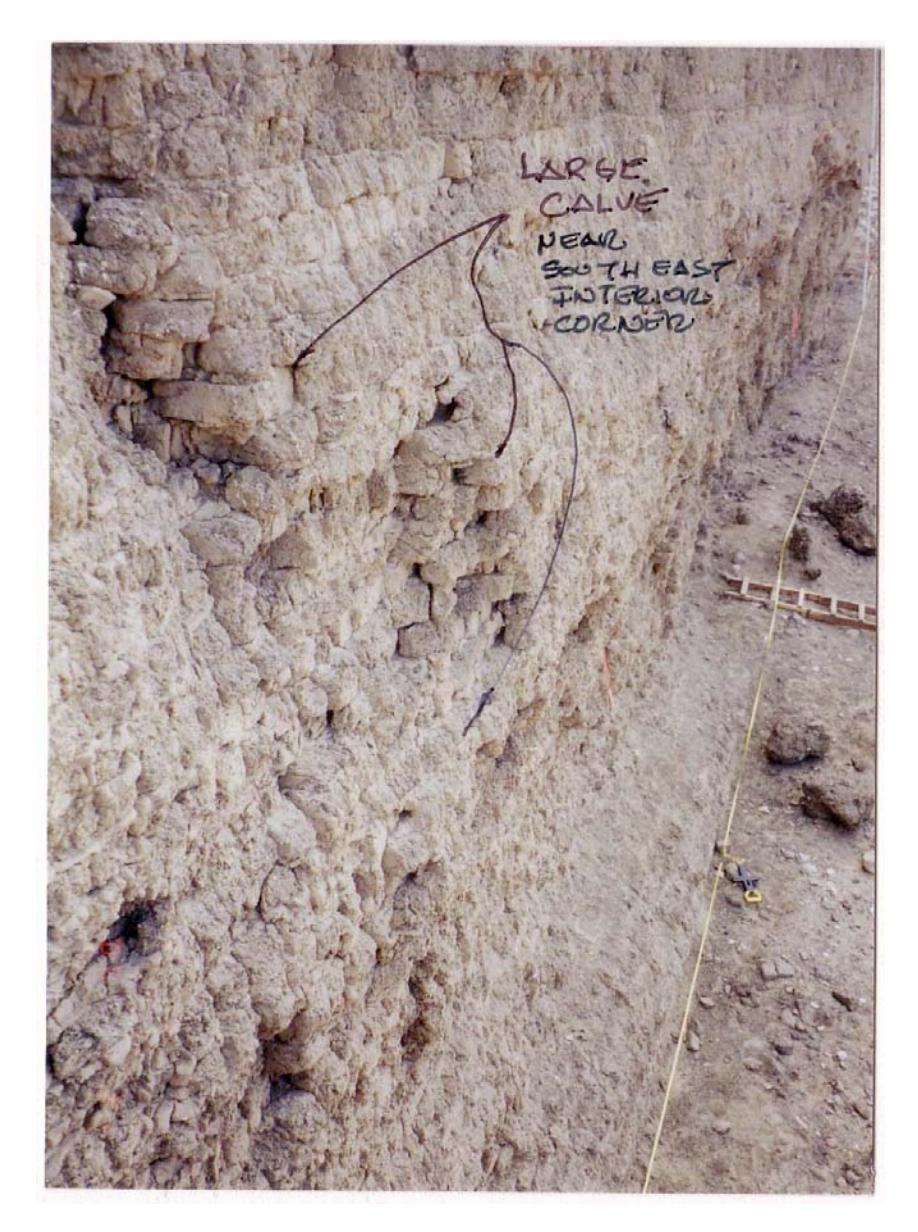
Figure 119. Detail of calving behind the eastern, vertical end of the south main enclosure wall. (Photo: Conor Power 2000)

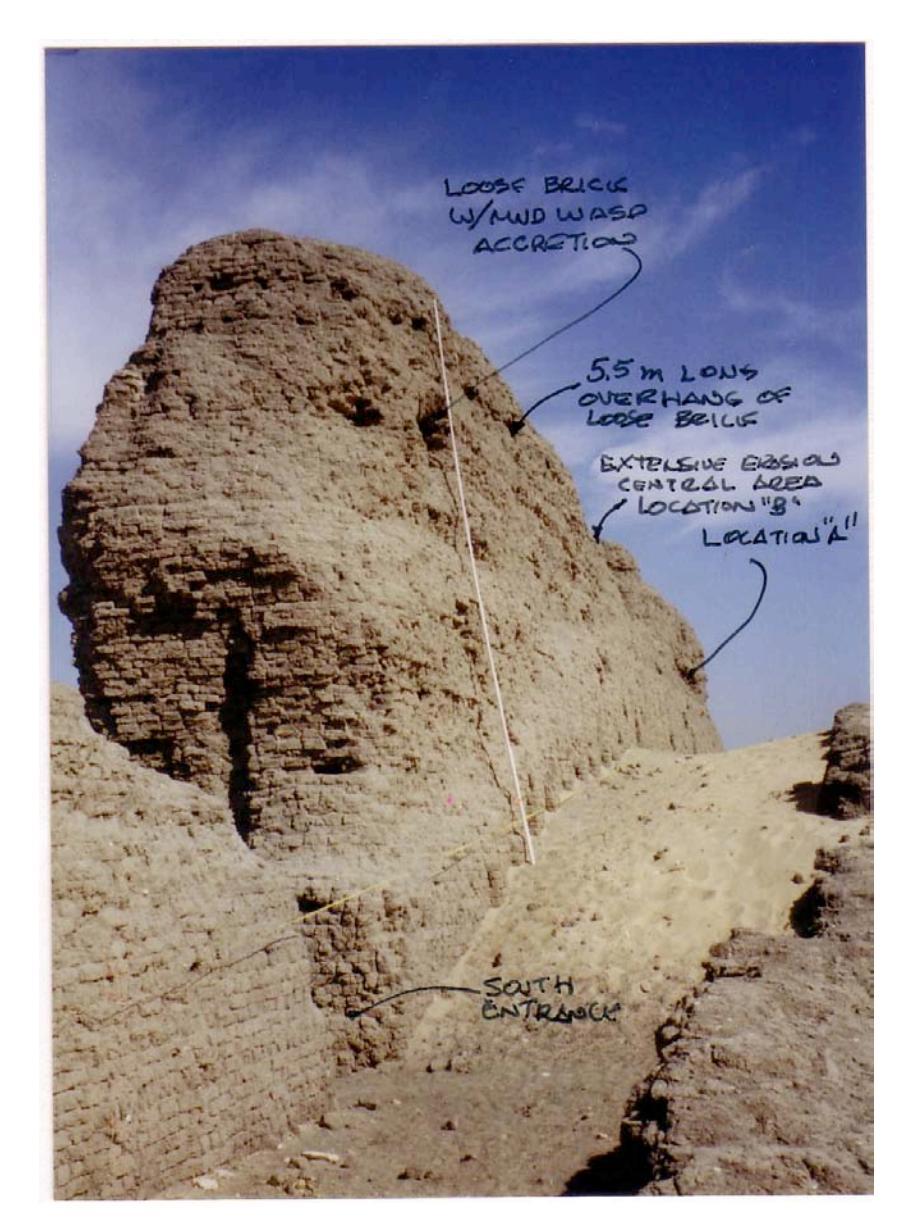
Where accessible, the exterior surface of the south wall is in relatively good condition and generally exhibits normal-priority cavitation, erosion, surface friability, local cracking, and loose and overhanging brickwork (Figure 120). The central part of the exterior elevation is presently inaccessible due to the presence of a large sand deposit that fills the south corridor and extends some meters out from the exterior side of the south perimeter wall.

Figure 120. The exterior face of the south main enclosure wall, looking east from the south gateway. (Photo: Conor Power 2000)

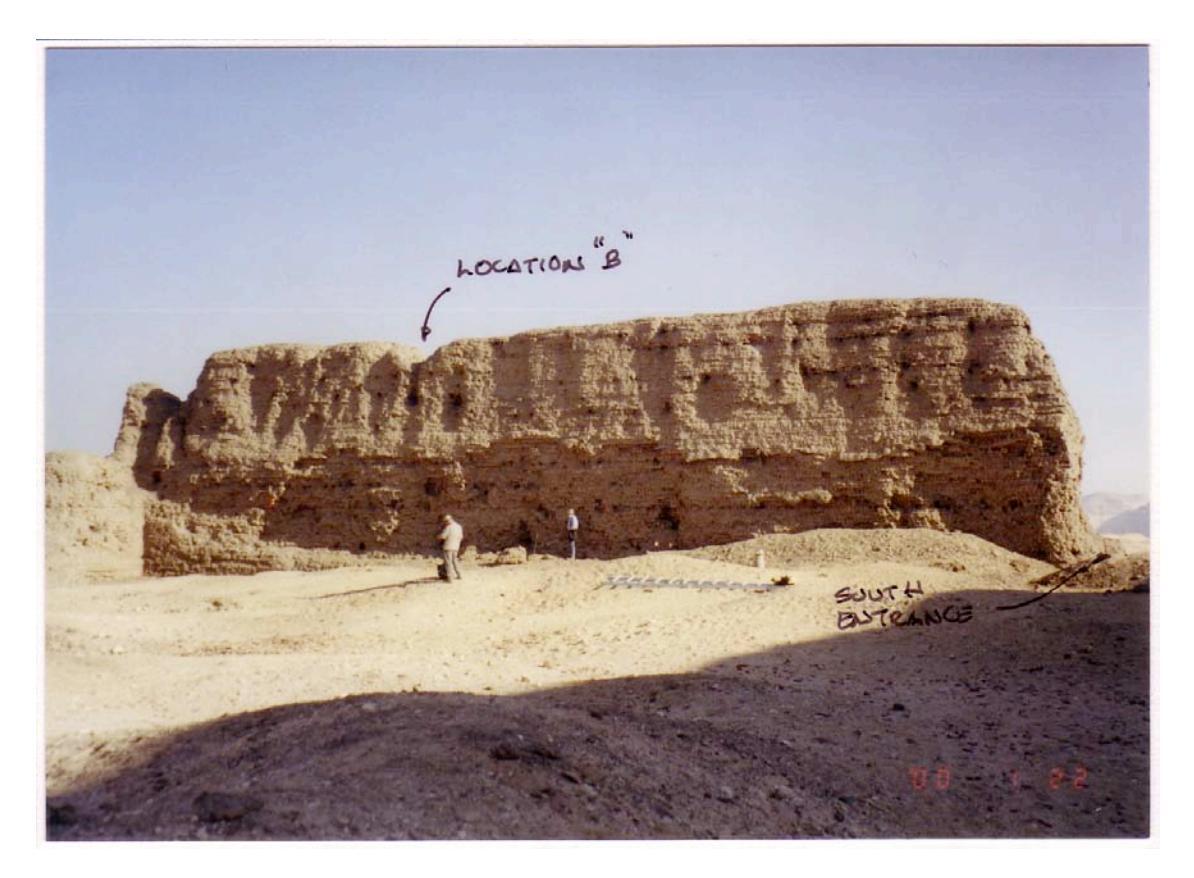
The interior surface of the south wall exhibits high-priority undercutting along the entire length of the lower wall face, primarily the result of long-term mud-wasp nest accretion and detachment. In addition, there is urgent-priority cavitation and loose brickwork at multiple locations along the wall base resulting from probable canid burrowing, moderate-to-severe head-joint erosion and loose brickwork at numerous locations along the upper wall surface, and one location of urgent-priority erosion in the wall top (Figures 121-123).

Figure 121. The undercutting of the interior face of the south main enclosure wall is represented by a dramatic variation in surface texture below the mid-line of the wall (through center). (Photo: Conor Power 2000)

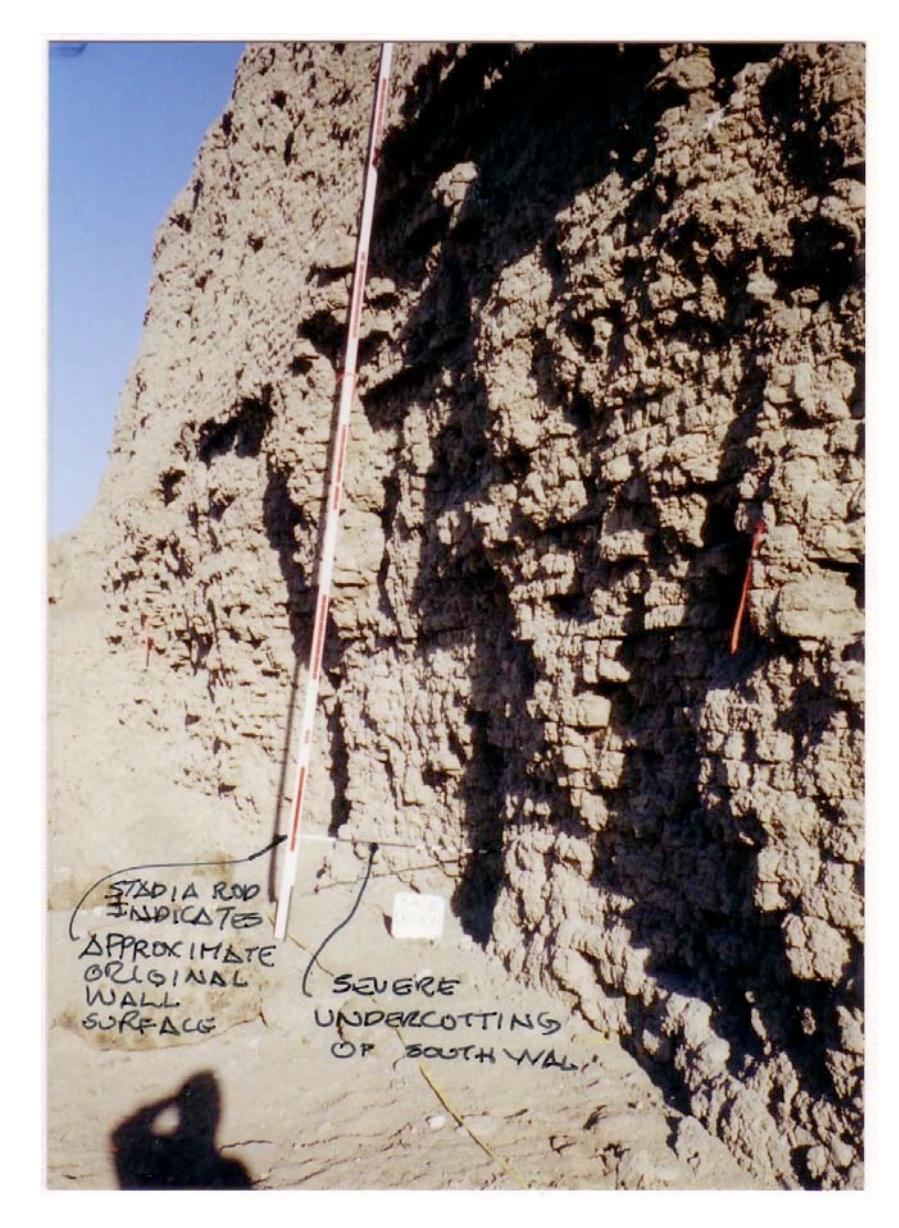
Figure 122. Detail of the undercut interior surface of the south main enclosure wall. (Photo: Conor Power 2000)

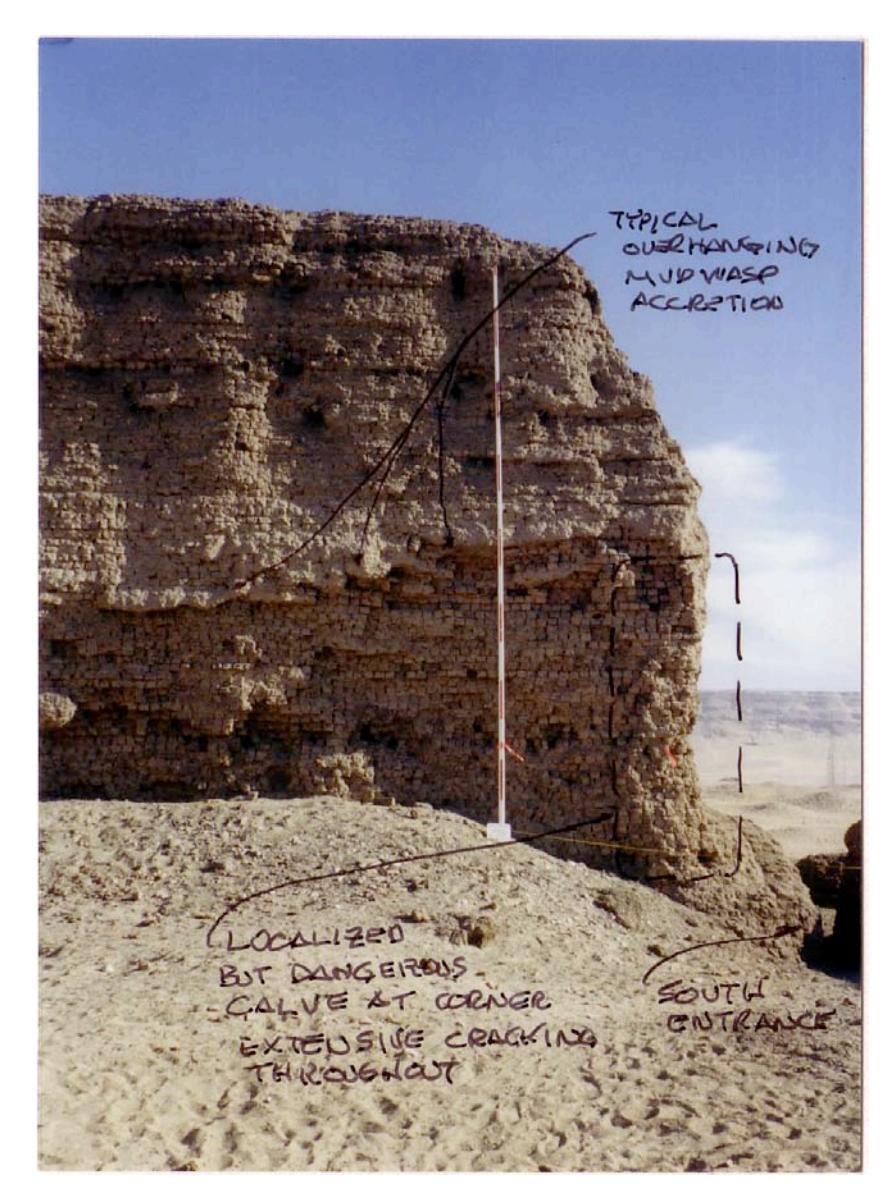
The area of the south gateway is in an unstable condition due to very significant cracking and calving behind the vertical wall end that forms the east side of the gateway opening in the main enclosure, as illustrated in Figures 124 and 125.

Figure 124. Urgent-priority cracking and calving behind the eastern, vertical end of the south gateway. (Photo: Conor Power 2000)

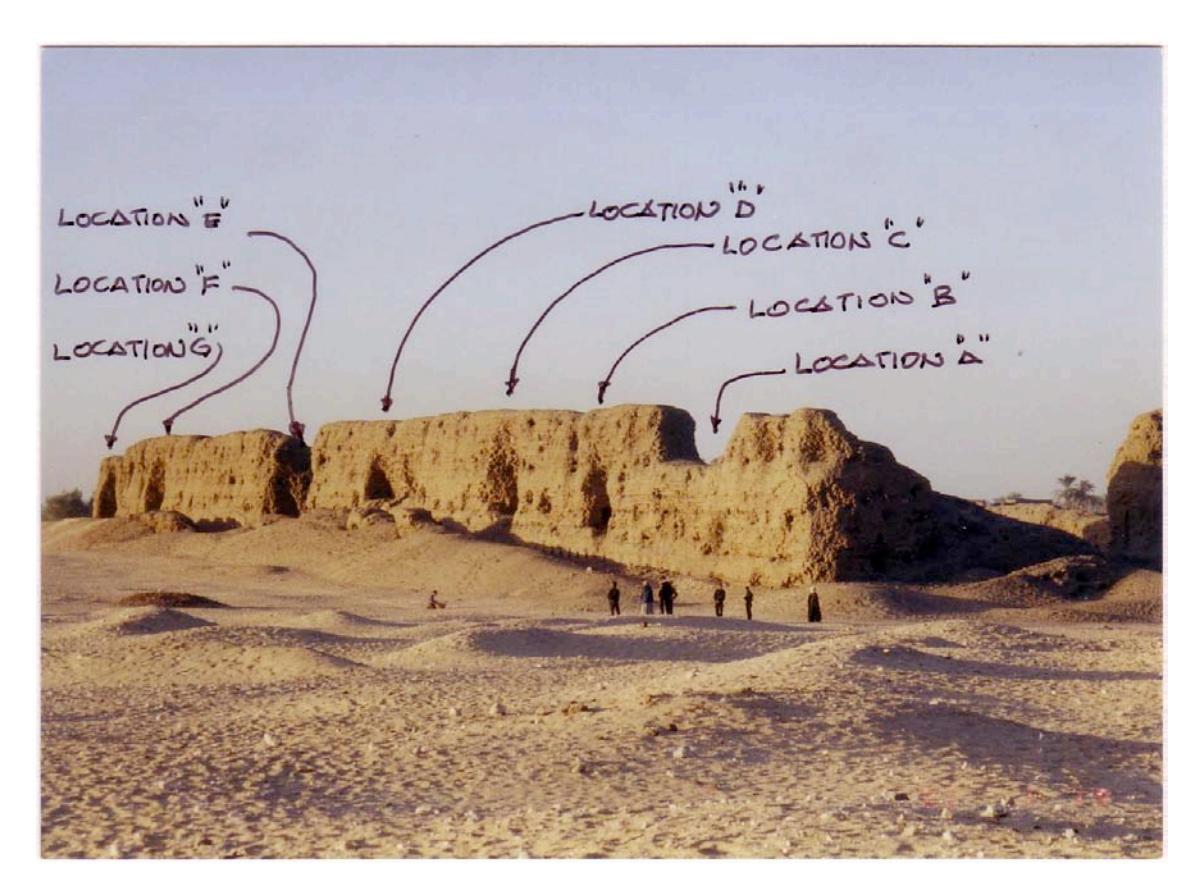
The opening where the west gateway originally stood divides the west main enclosure wall into roughly equivalent northern and southern sections, as depicted in Figure 126. The exterior face of the west wall is characterized by the presence of six large voids up to three meters deep, the result of late antique occupation of the monument, while the interior side is characterized throughout by especially severe undermining and cavitation as a result of long-term animal burrowing in the walls.

Figure 126. Specific structural conditions on the exterior side of the west main enclosure wall, noted as locations A-G (see details, below); location E represents the area of the west gateway, and the deep cavities visible at locations B, C, D, F and G are the remains of monastic cell locations from late antiquity. (Photo: Conor Power 2000)

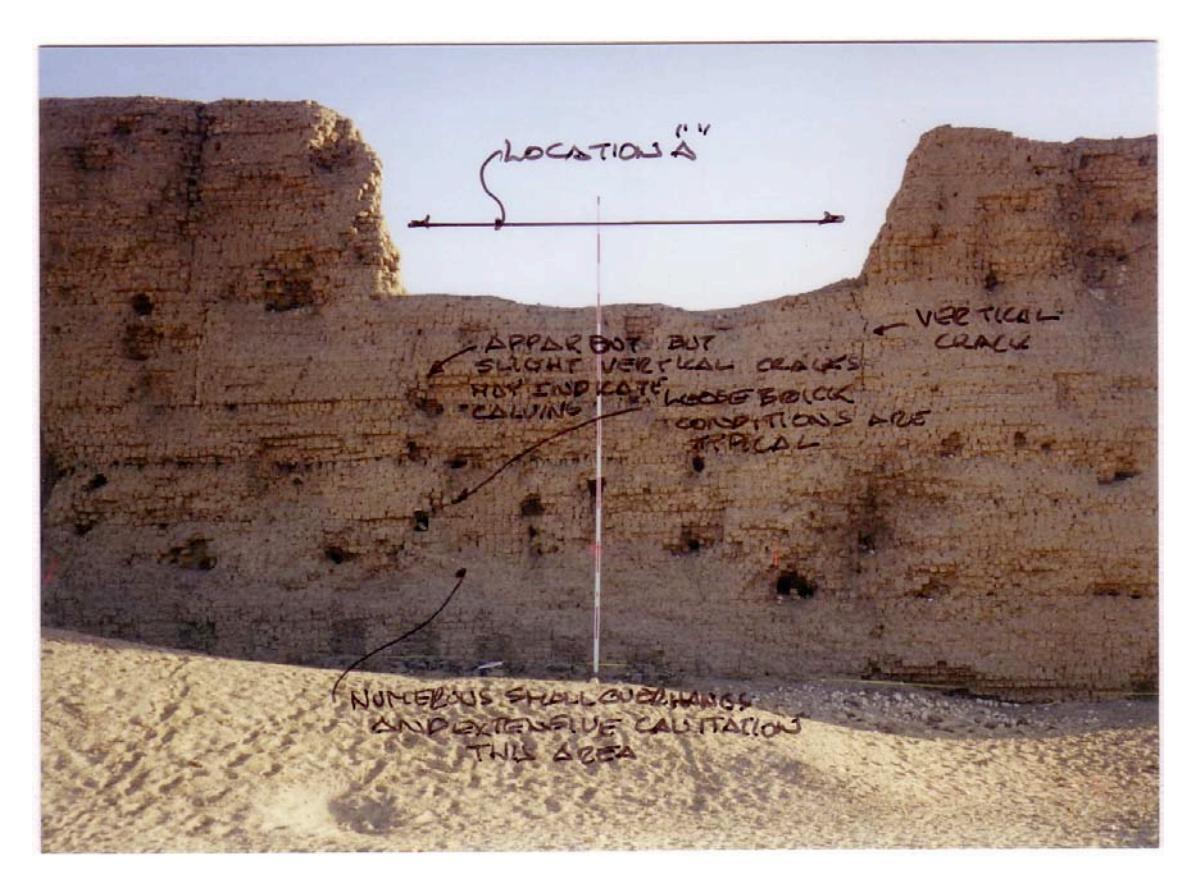
The southern portion of the west wall is characterized by a large gap in the upper masonry, illustrated as location A in Figures 126 and 127. The exterior surface adjacent to this location exhibits high-priority vertical cracking, mortar-joint erosion and surface detachment as well as a low-priority through-wall crack possibly resulting from differential settlement. Additionally, the southern, exterior face of the west wall exhibits severe undercutting, detachment, cracking, corbelling and loose and overhanging brickwork associated with the presence of four monastic cell cavities in this area, illustrated as locations B, C and D in Figures 128-135. The southern corner of the west wall exhibits cracking, erosion and loose and overhanging brickwork in the upper wall surface, as well as several undermined locations in the wall base, as depicted in Figures 136-140. This undermined area represents part of the highly unstable southwestern corner of the main enclosure, at the intersection of the south and west walls (see also the preceding discussion of the south main enclosure wall).

Figure 127. Detail of a large gap in the upper, southern portion of the west main enclosure wall (noted as location A). (Photo: Conor Power 2000)

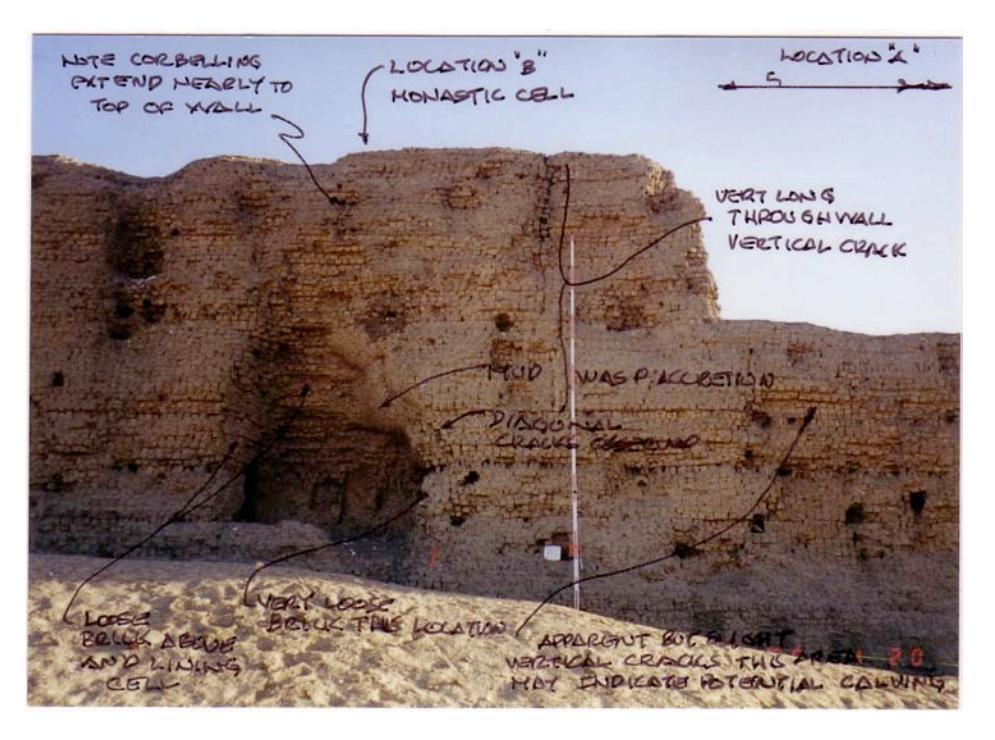
Figure 128. Detail of a monastic cell cavity and large mud-wasp nest accretion in the southern, exterior face of the west main enclosure wall (noted as location B). (Photo: Conor Power 2000)

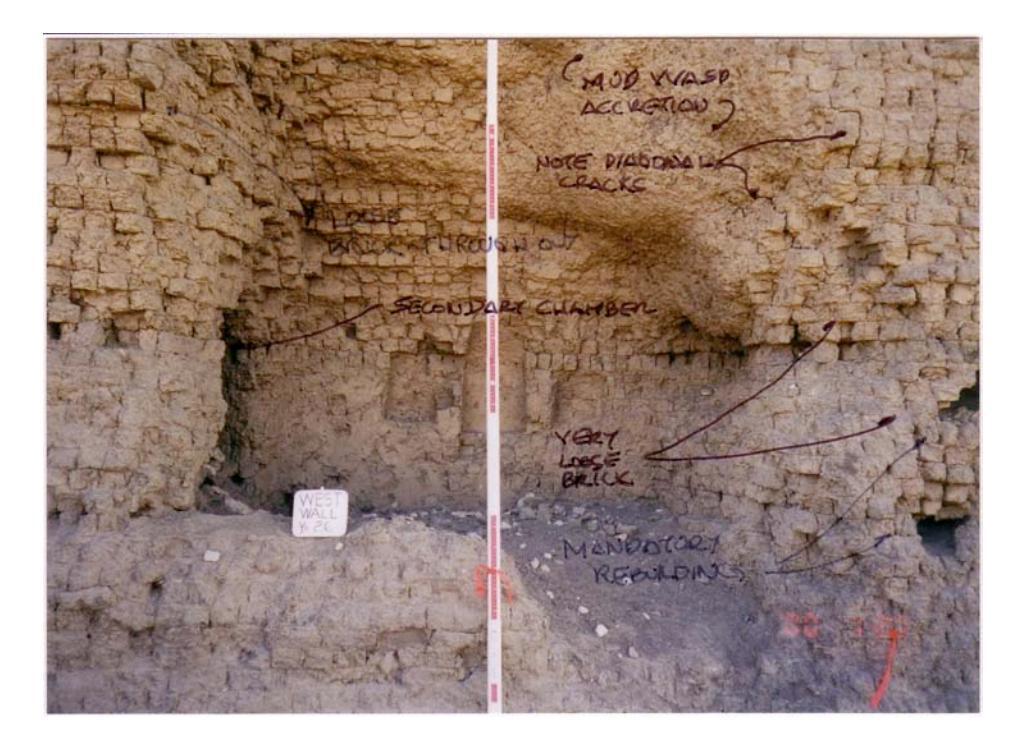
Figure 129. Detail of the monastic cell cavity noted as location B in Figures 126 and 128, above; note the entrance to an ancillary chamber at left. (Photo: Conor Power 2000)

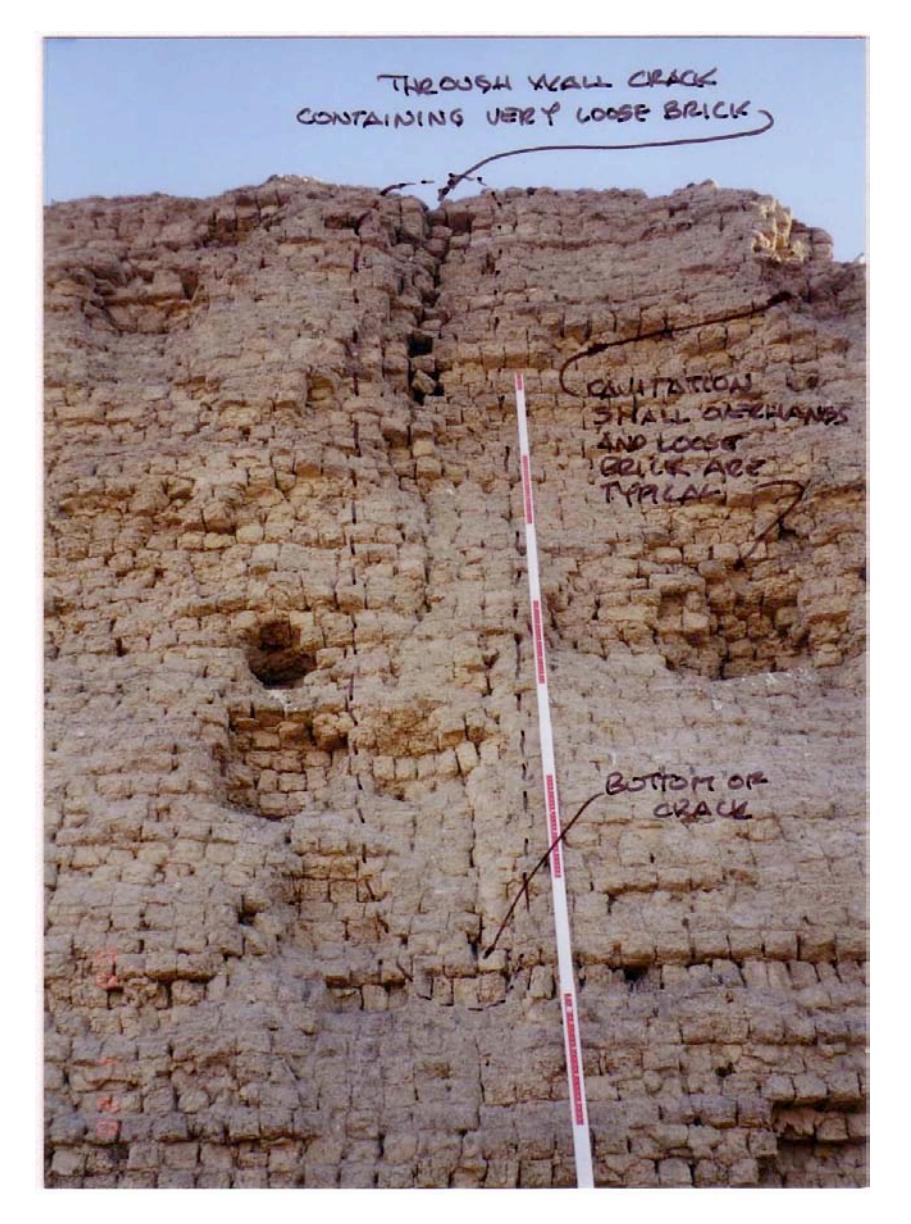
Figure 130. Detail of vertical cracking and cavitation near the cell void noted as location B in Figures 126 and 128, above. (Photo: Conor Power 2000)

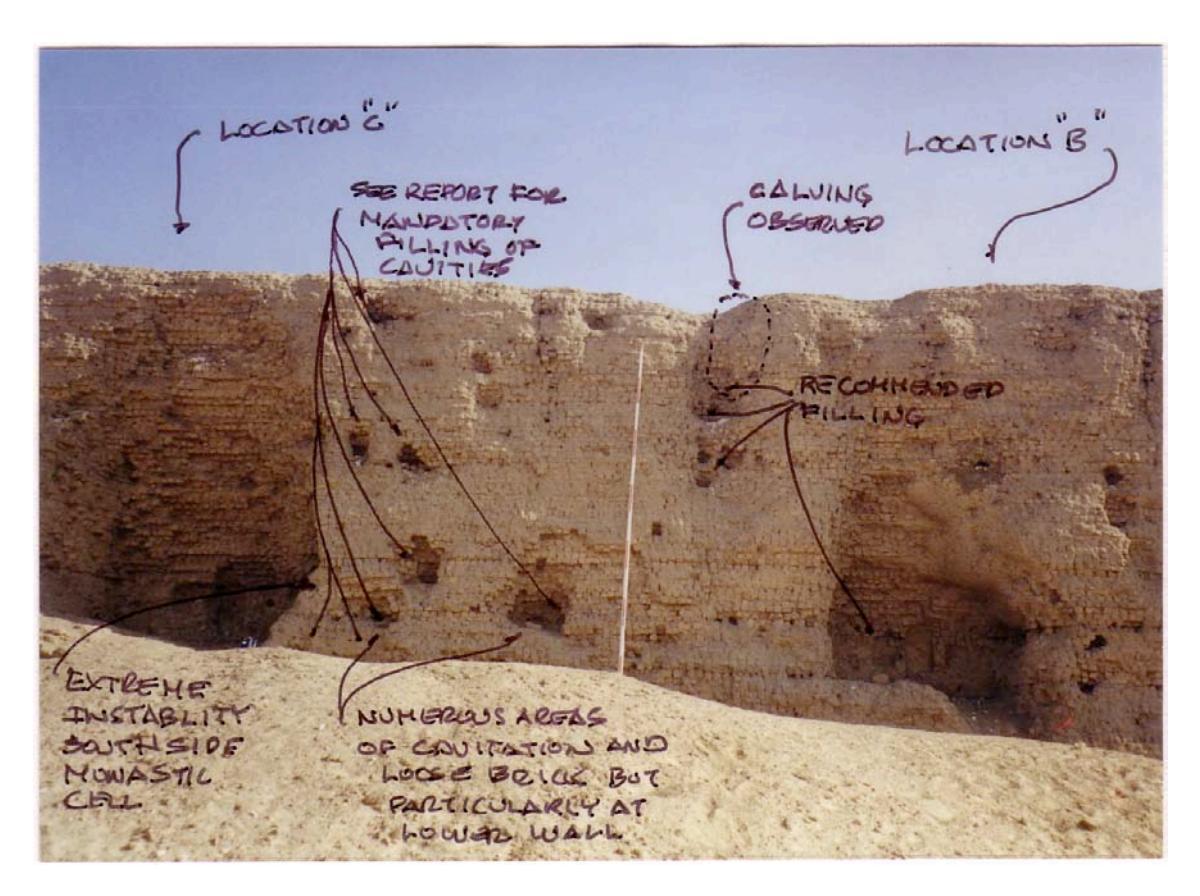
Figure 131. Detail of undercutting in the southern, exterior face of the west main enclosure wall resulting from the construction and decay of the two monastic cell cavities visible at right and at left (noted as locations B and C, respectively). (Photo: Conor Power 2000)

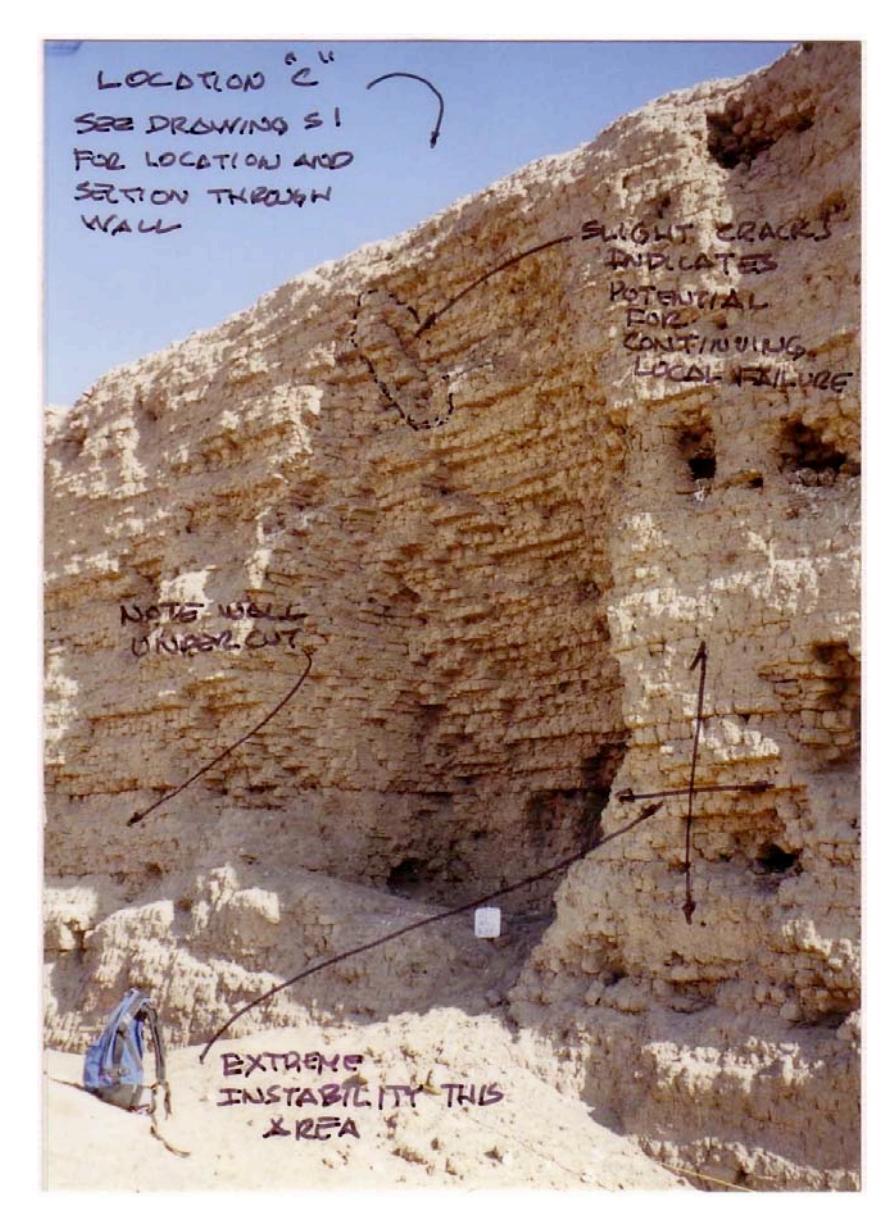
Figure 132. Detail of undercutting and corbelling near the monastic cell cavity noted as location C on the southern, exterior face of the west main enclosure wall. (Photo: Conor Power 2000)

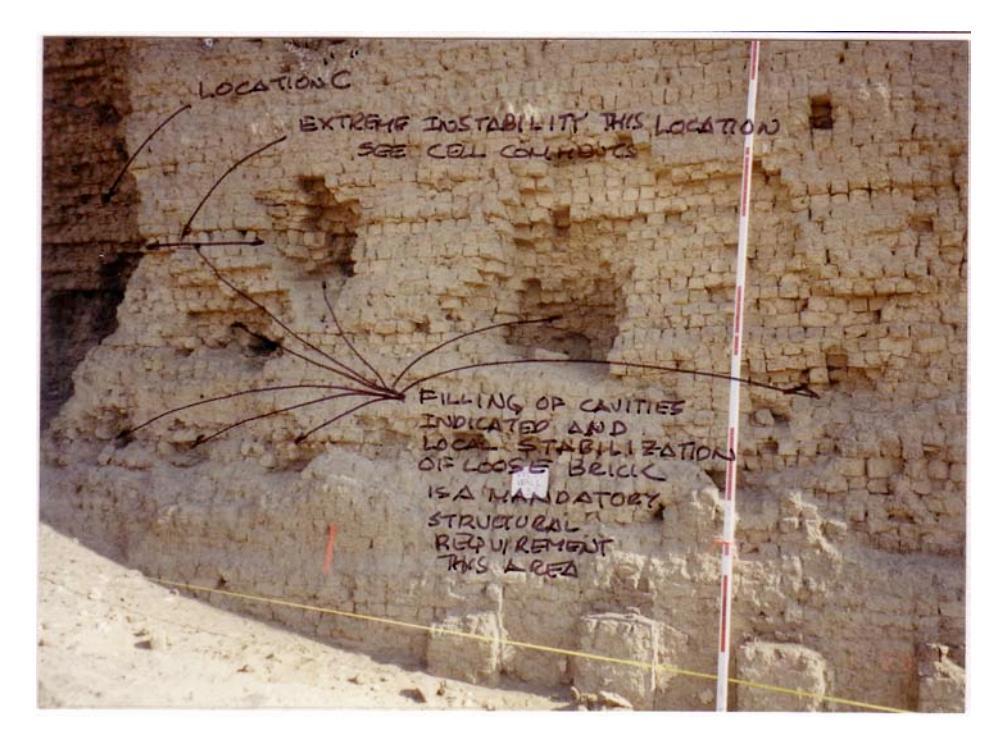
Figure 133. Detail of cavitation and loose brickwork near the monastic cell cavity noted as location C on the southern, exterior face of the west main enclosure wall. (Photo: Conor Power 2000)

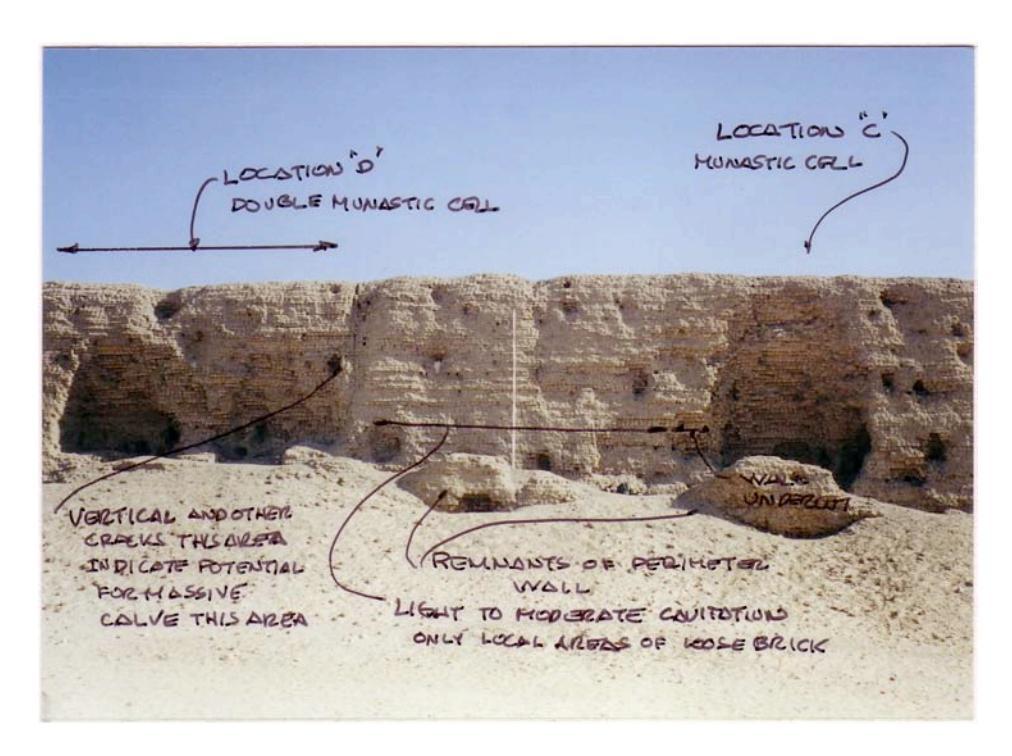
Figure 134. Details of monastic cell cavities in the southern, exterior face of the west main enclosure wall (noted as locations C and D); note that location D represents two adjacent cell voids. (Photo: Conor Power 2000)

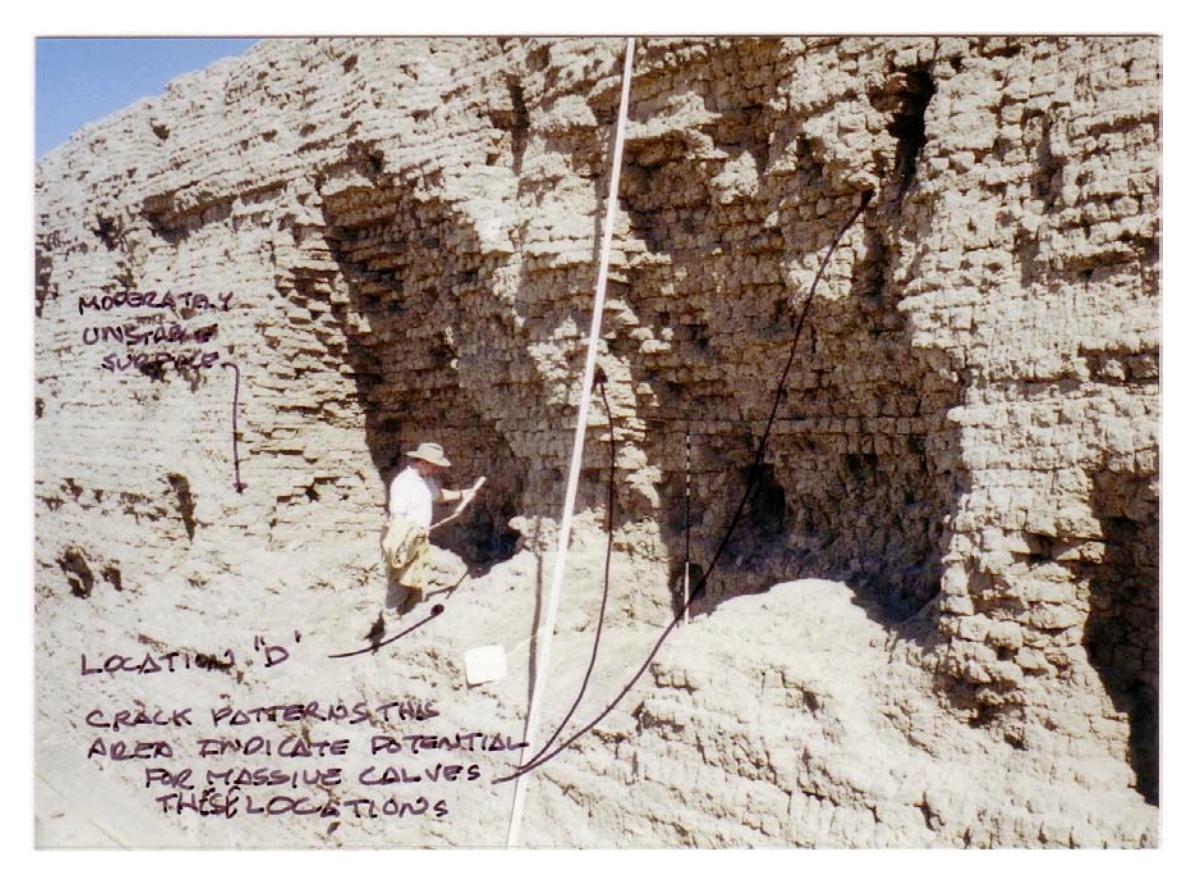
Figure 135. Detail of cracking, calving and local failures near two monastic cell cavities (noted as location D) on the southern, exterior face of the west main enclosure wall. (Photo: Conor Power 2000)
