THE FUNERARY MONUMENT OF KING KHASEKHEMWY AT ABYDOS (ca. 2700 BCE): CONSERVATION AND ARCHAEOLOGY, 1999-2006

Final report on the "Documentation and Conservation of King Khasekhemwy's Funerary Monument at Abydos," a sub-project of the Egyptian Antiquities Project of the American Research Center in Egypt

2007

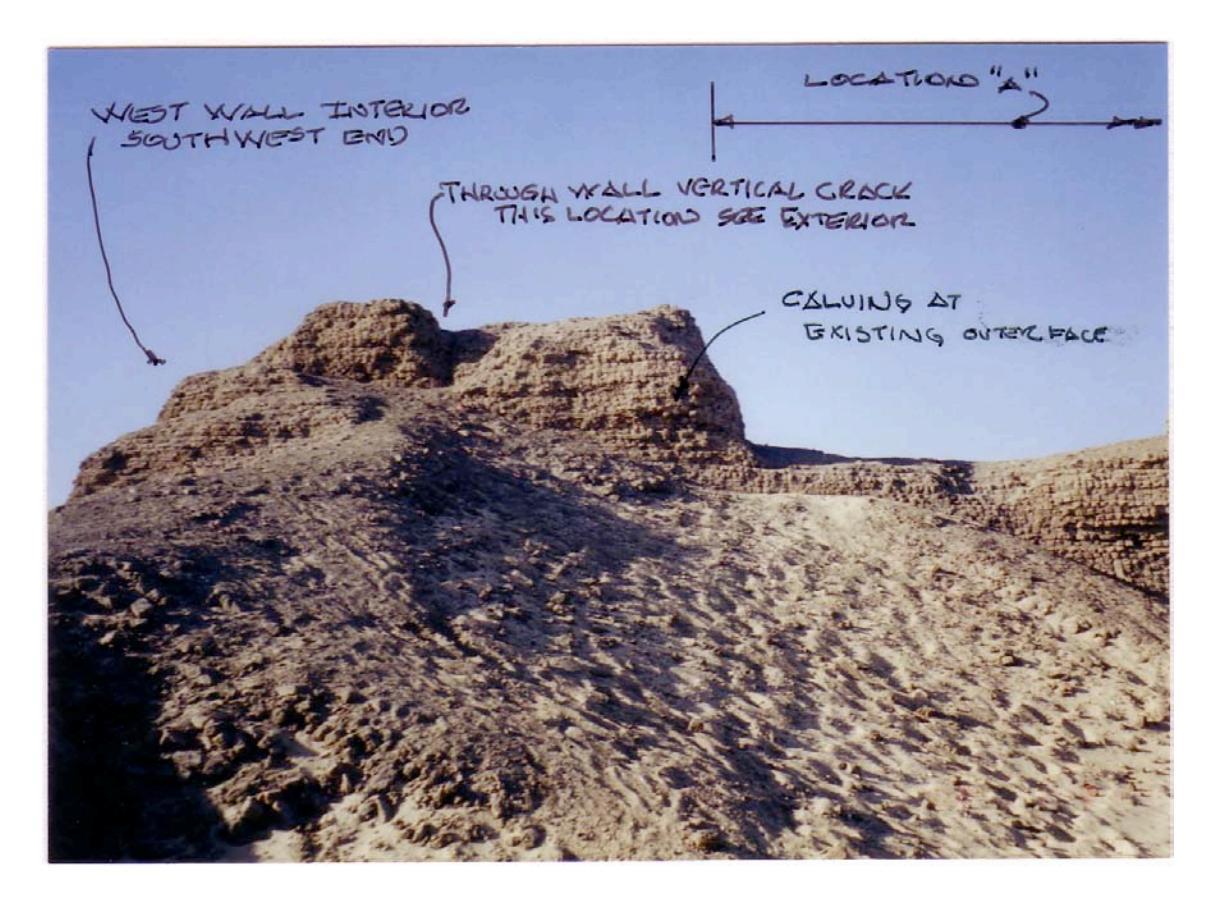
Figure 138. Interior detail of the through-wall crack pictured in Figures 136 and 137 (above) at the top, southern corner of the west main enclosure wall; note the reach of the sand dune/debris fan to the top of this interior elevation. (Photo: Conor Power 2000)

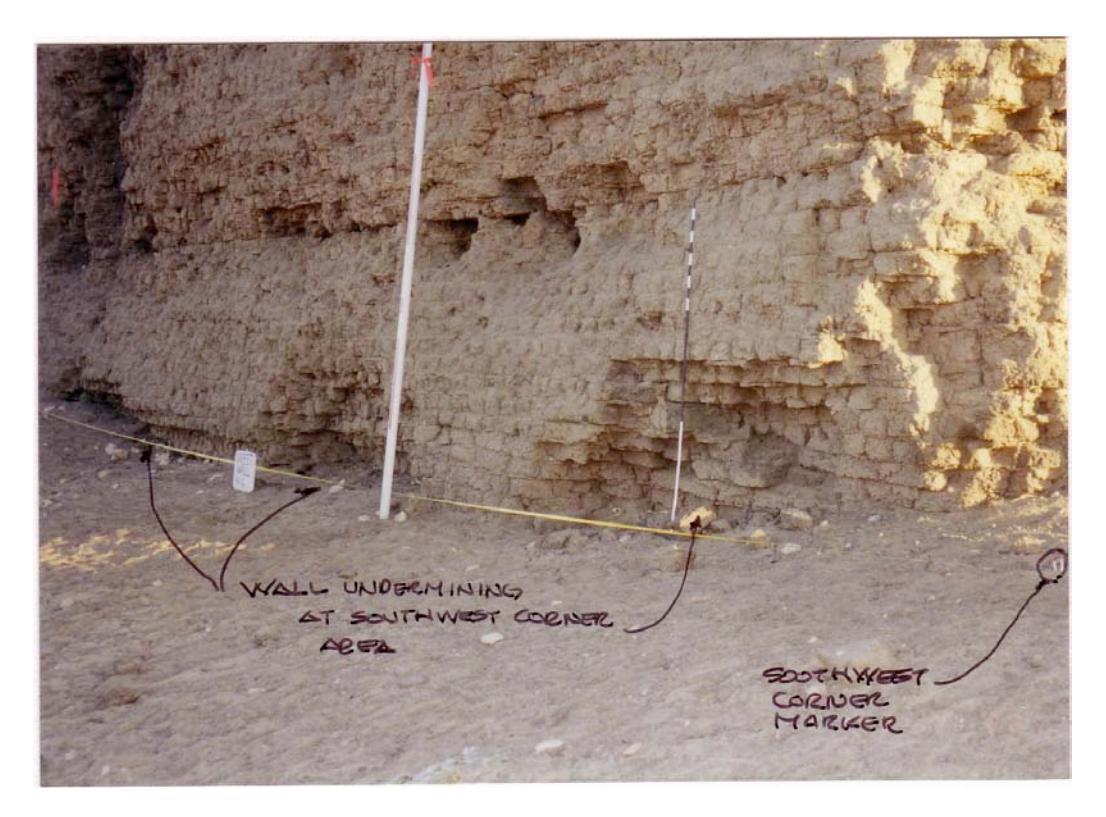
Figure 139. Detail of undermining at the southern, exterior corner of the west main enclosure wall. (Photo: Conor Power 2000)

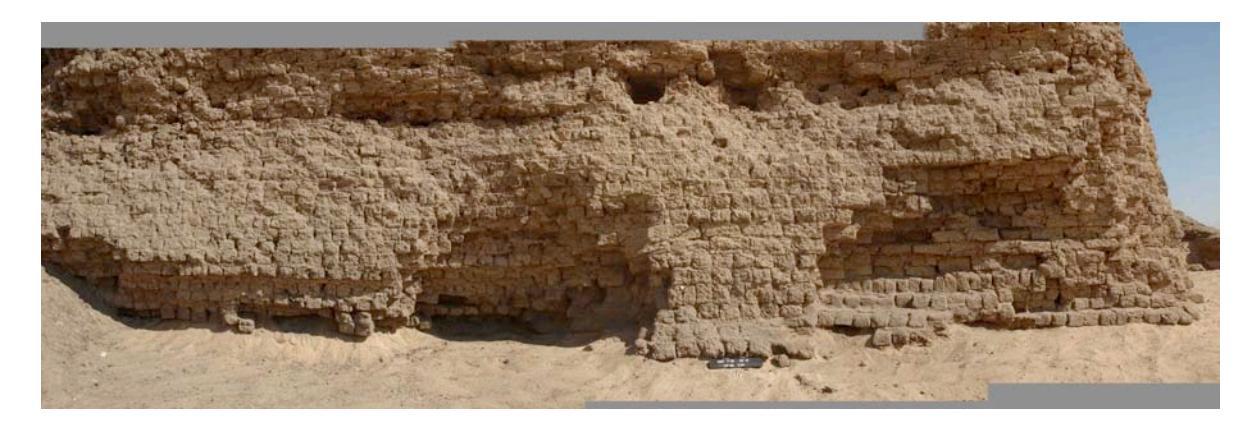
Figure 140. Composite detail of the undercut wall base at the southern, exterior corner of the west main enclosure wall. (Photo: Robert Fletcher 2004-2005)

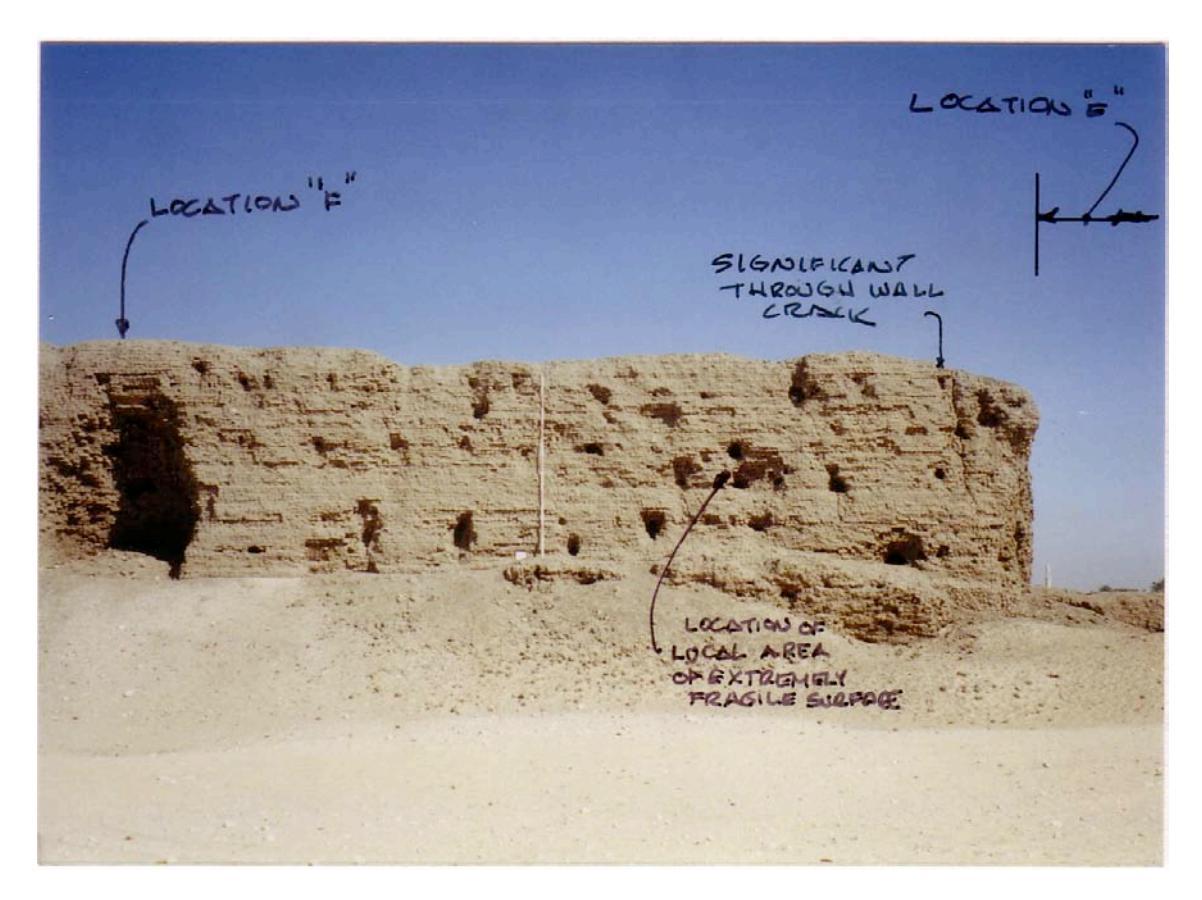
The northern portion of the west wall is generally characterized by excessive cavitation, cracking, erosion, surface friability and loose brickwork throughout (Figures 141-148). The northern, exterior face of the west wall exhibits deep undercutting, cavitation, detachment and loose brickwork extending nearly the full height of the wall from two former monastic cell cavities (illustrated as locations F and G). In addition, there are two large, through-wall voids in the upper masonry between the cell cavities (illustrated as cavities 1 and 2). The loss of wall fabric in this area has resulted in extremely unstable and hazardous conditions, particularly near the northern wall end.

Figure 141. Structural conditions on the northern, exterior face of the west main enclosure wall. (Photo: Conor Power 2000)

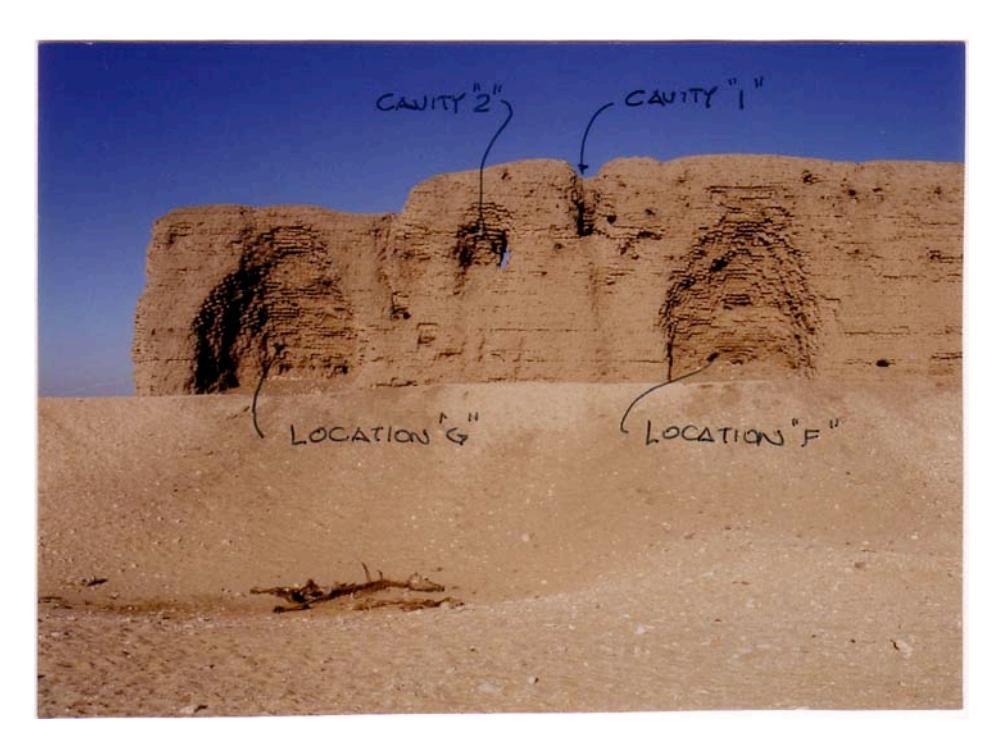
Figure 142. Monastic cell cavities and through-wall voids at the northern, exterior end of the west main enclosure wall, noted as locations F and G and cavities 1 and 2, respectively (see details, below). (Photo: Conor Power 2000)

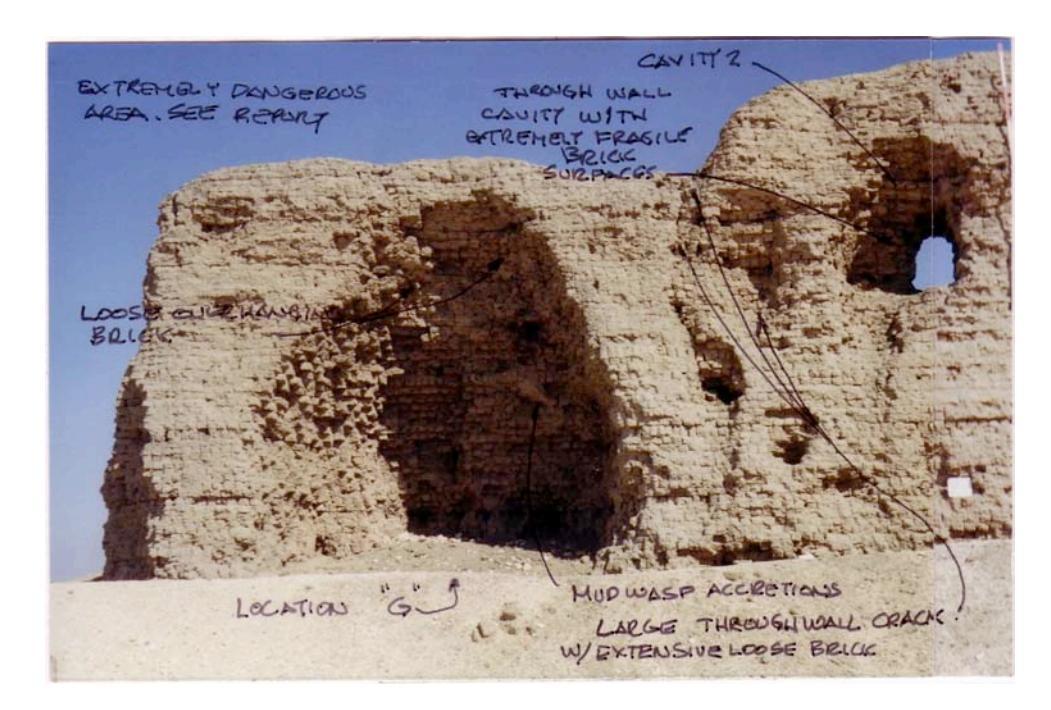
Figure 143. Details of extreme cavitation at and near the monastic cell cavity noted as location G and the through-wall void noted as cavity 2 at the northern, exterior end of the west main enclosure wall. (Photo: Conor Power 2000)

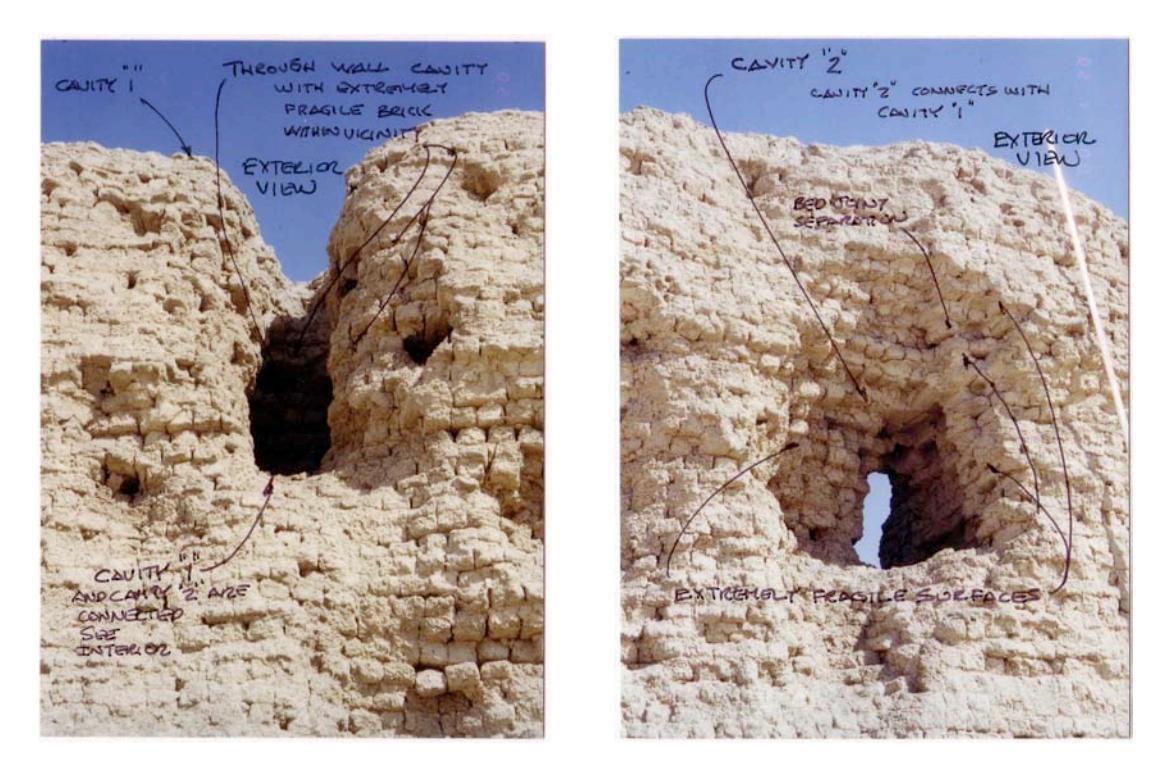
Figures 144, 145. Exterior details of the through-wall cavities in the upper, northern portion of the west main enclosure wall (noted as cavities 1 and 2). (Photos: Conor Power 2000)

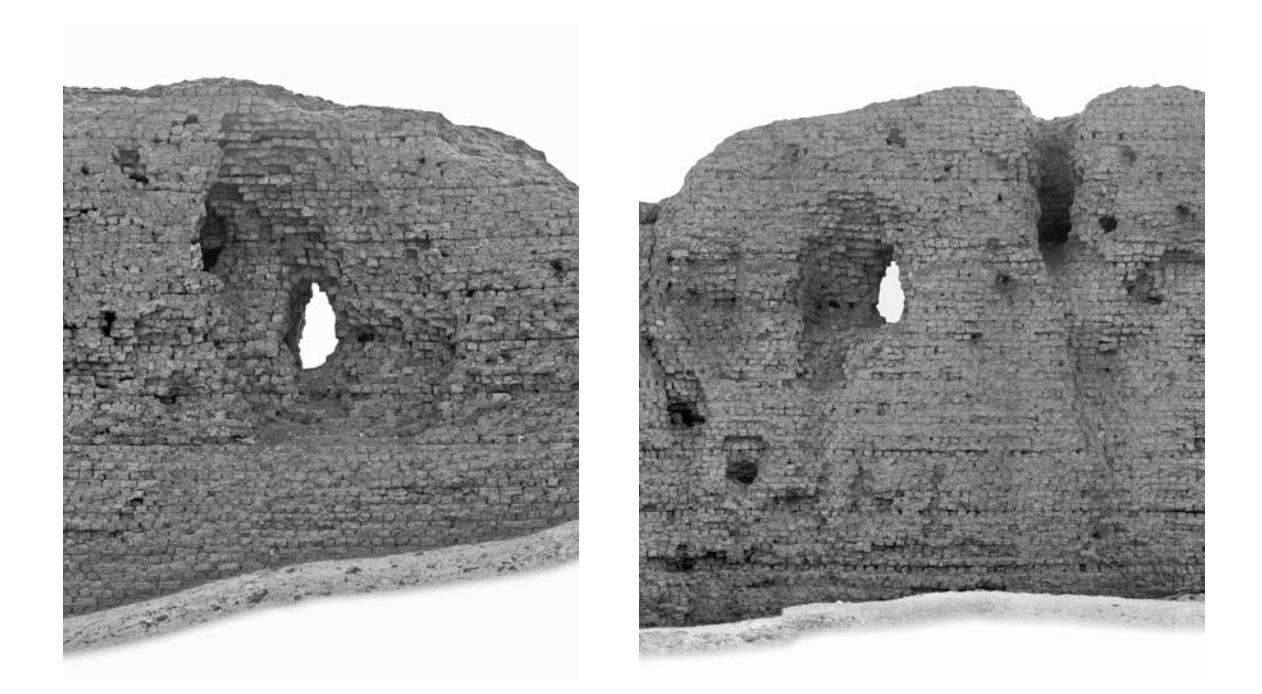
Figures 146, 147. Interior and exterior details (at left and right, respectively) of the through-wall holes noted as cavities 1 and 2 in Figures 142-145, above; these large holes interact as a cavity system within the wall. (Photoelevations: Heritage 3D, Inc. 2001)

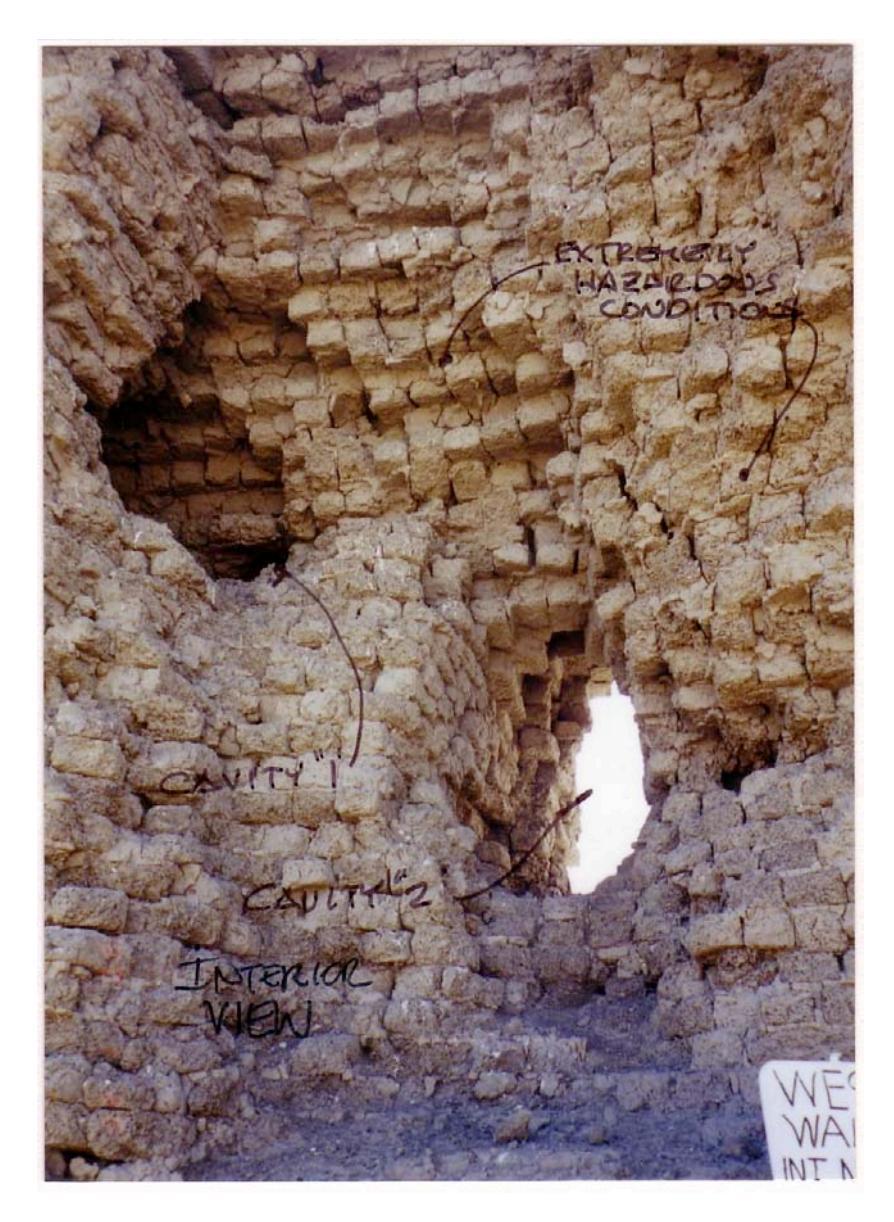
Figure 148. Interior detail of the through-wall cavity system in the upper, northern portion of the west main enclosure wall. (Photo: Conor Power 2000)

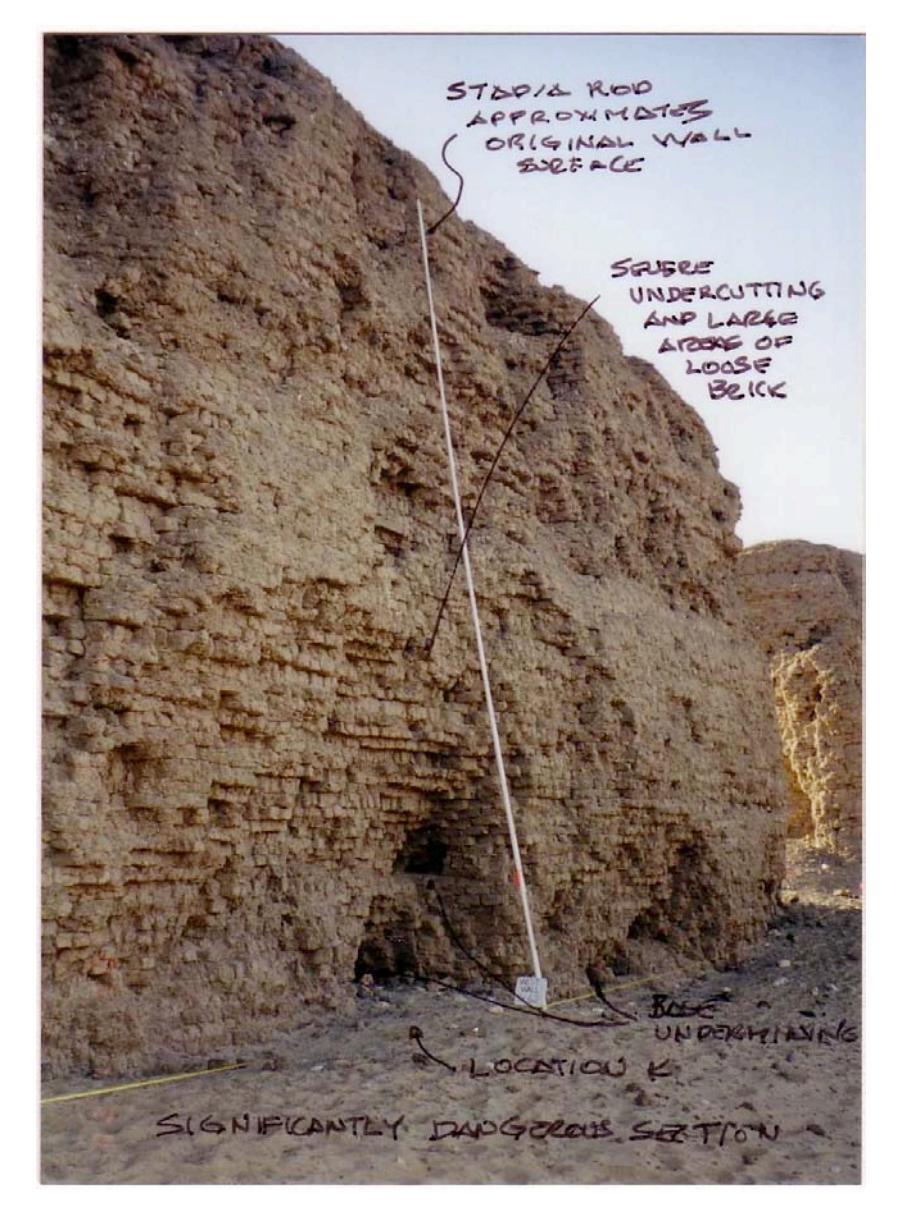
The extent of cavitation resulting from both canid and insect activity on the interior side of the west wall is particularly significant (Figures 149-152). The southern, interior face exhibits deep undercutting, local undermining, joint erosion and loose and overhanging brickwork at numerous locations along the entire elevation of the wall (illustrated as locations H through K), and the northern, interior face is likewise extremely cavitated, friable and highly unstable throughout (see Figure 152).

Figure 151. Detail of undercutting and loose brickwork on the southern, interior face of the west main enclosure wall (noted as location K). (Photo: Conor Power 2000)

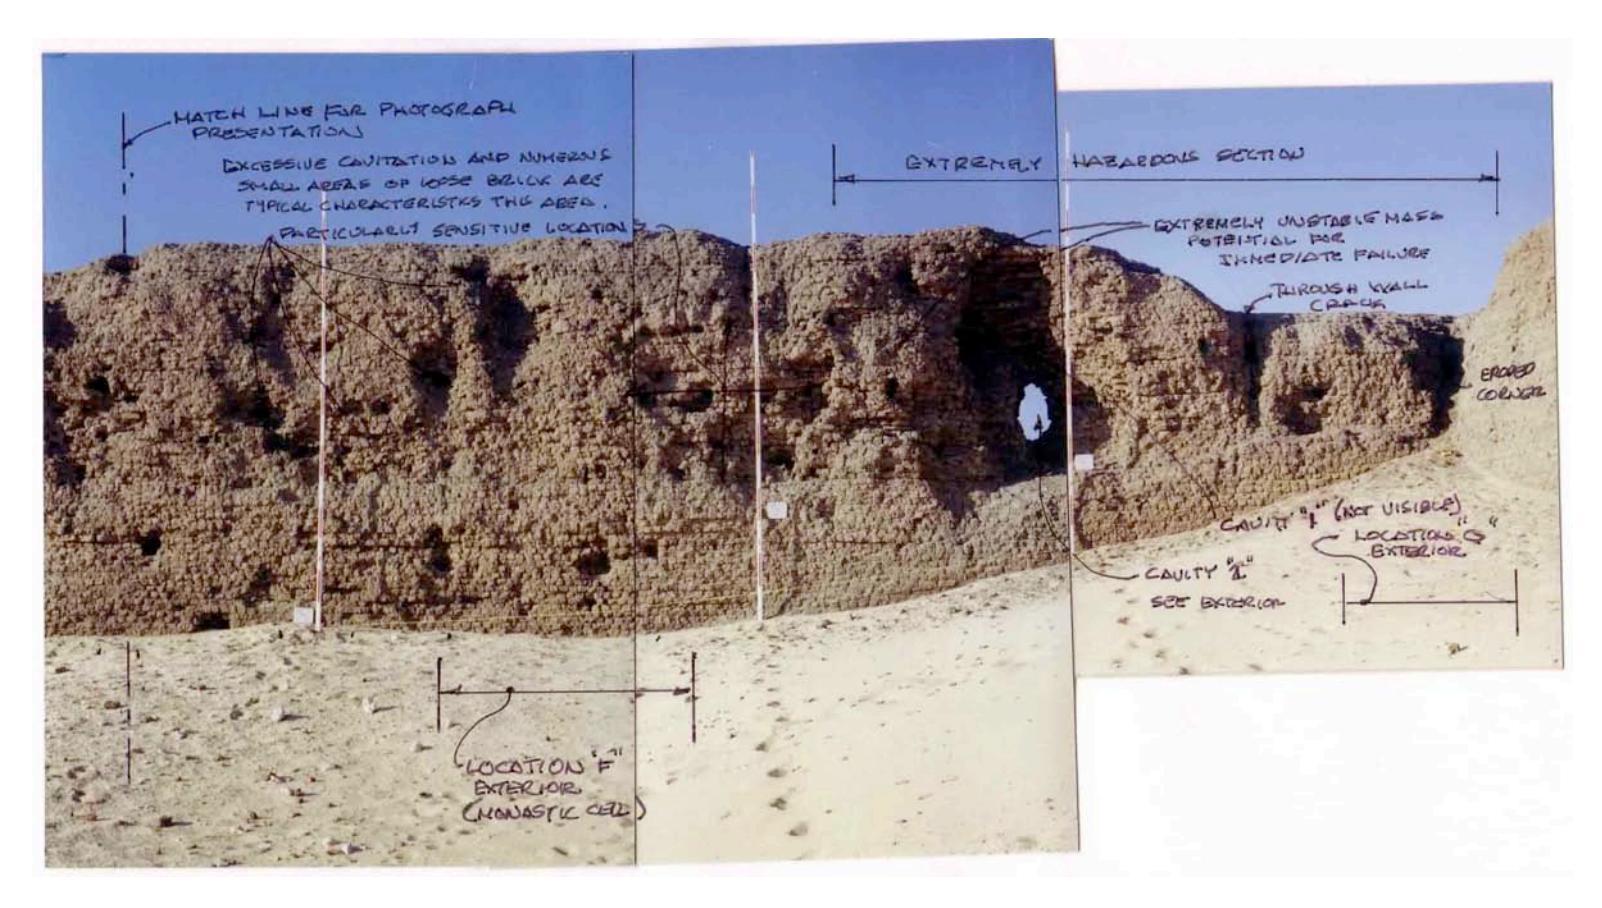
Figure 152. Structural conditions on the northern, interior face of the west main enclosure wall; note the interior detail of cavity 2 pictured in Figures 142-148, above. (Composite photo: Conor Power 2000)

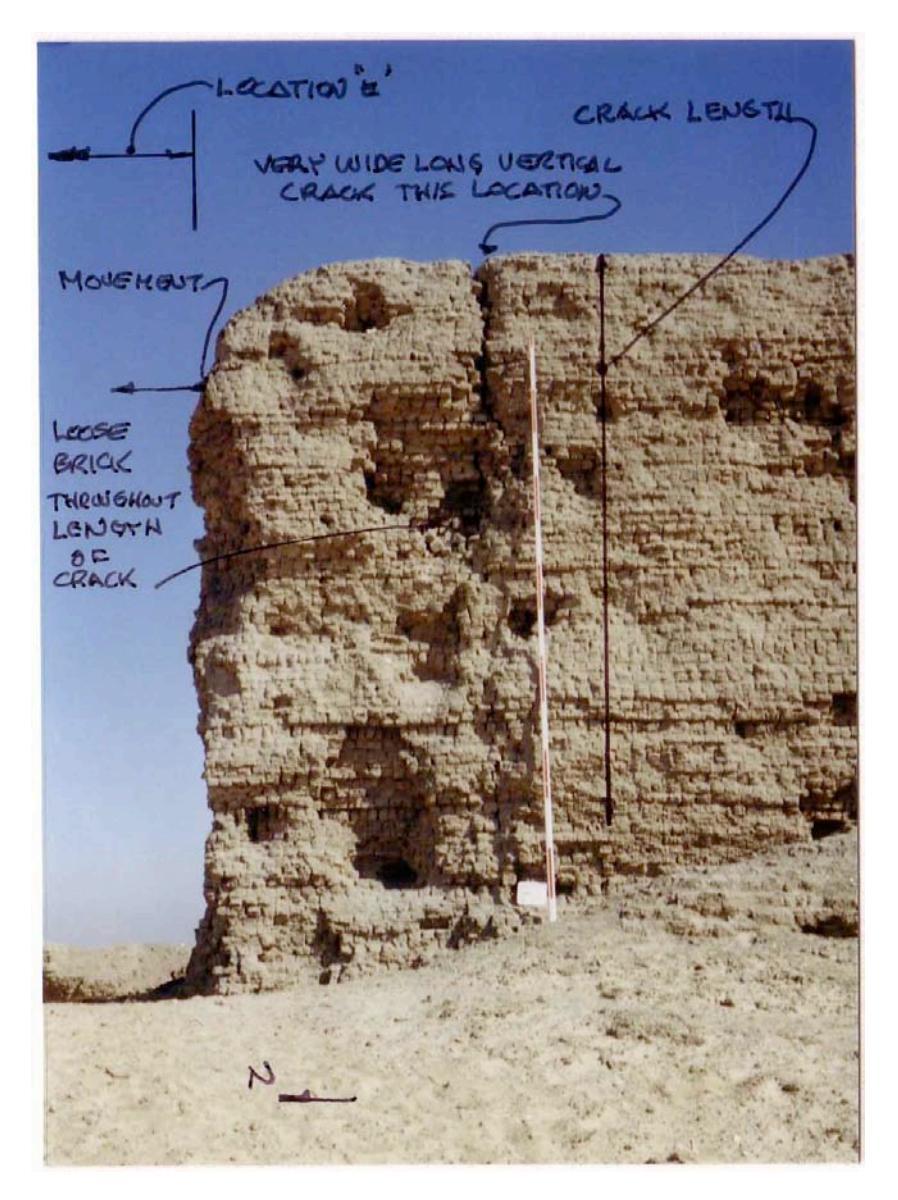
The west gateway area of the main enclosure (illustrated as location E) is characterized by extremely unstable conditions (Figures 153-157). Urgent-priority structural cracks occur behind the vertical wall ends on either side of the gateway opening, and each vertical end exhibits undercutting, detachment, erosion, loose brickwork and unstable brick masses resulting from structural failure as well as from the construction of monastic cells into the wall ends on both sides of the gateway opening.

Figure 153. Exterior detail of a through-wall crack behind the southern, vertical end of the west gateway (noted as location E). (Photo: Conor Power 2000)

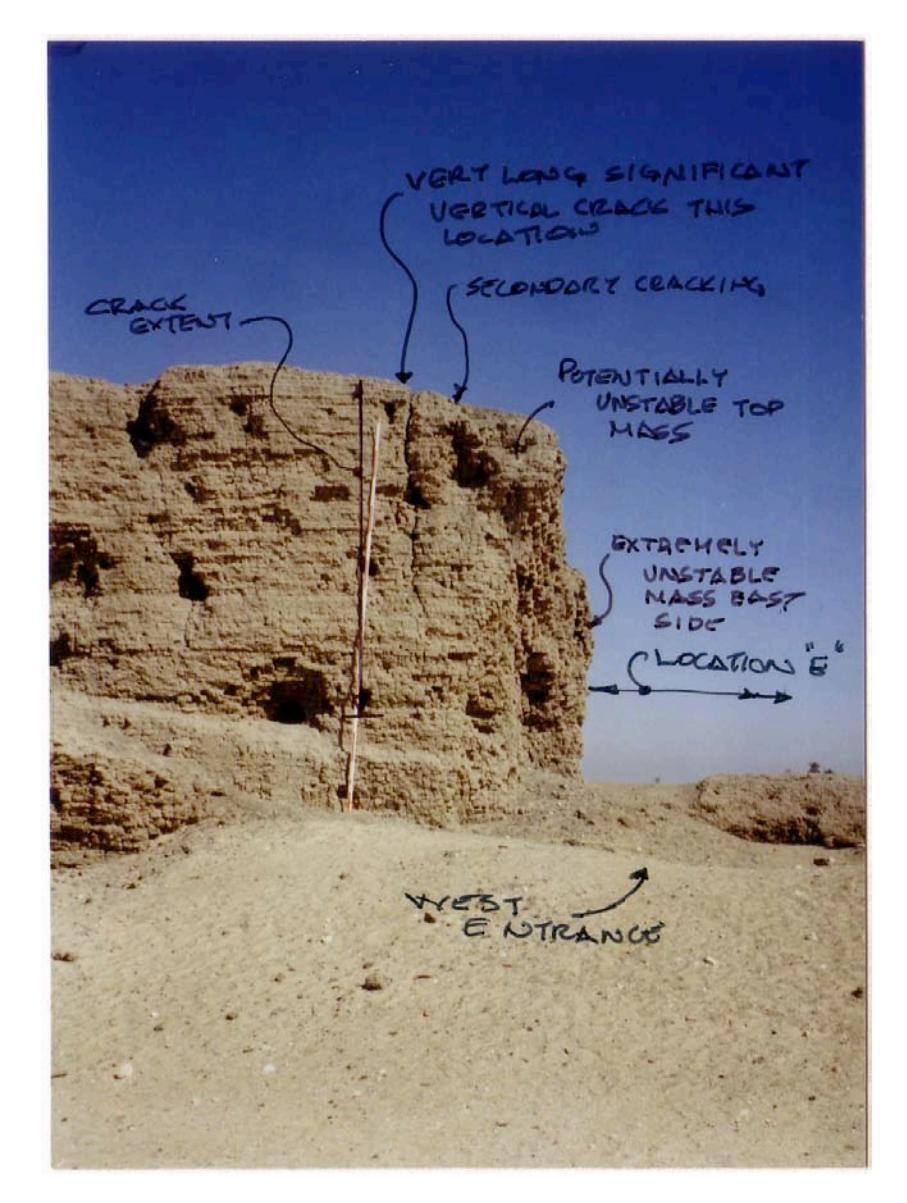
Figure 154. Interior detail of a through-wall crack behind the southern, vertical end of the west gateway (noted as location E). (Photo: Conor Power 2000)

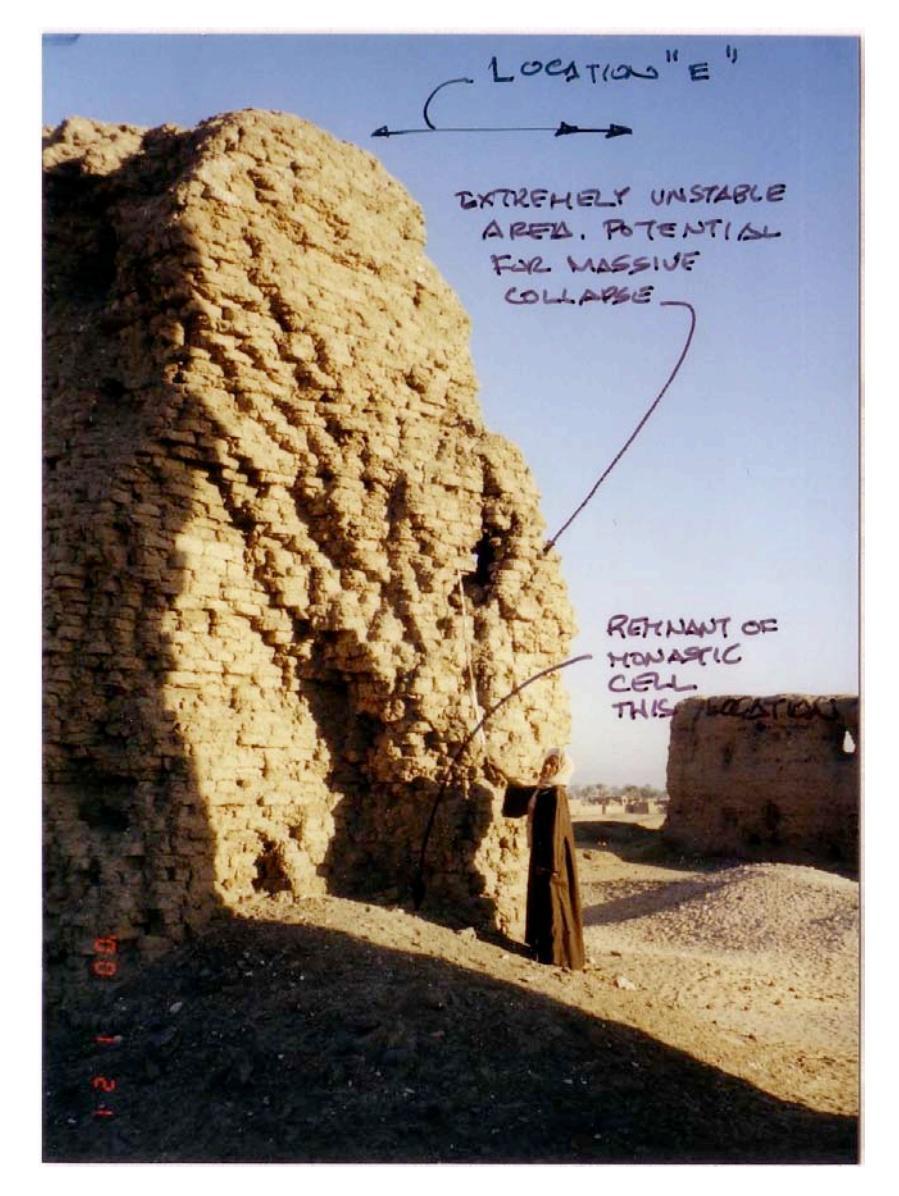
Figure 155. Detail of the undercutting and detachment resulting from monastic cell construction in the northern, vertical end of the west gateway (noted as location E). (Photo: Conor Power 2000)

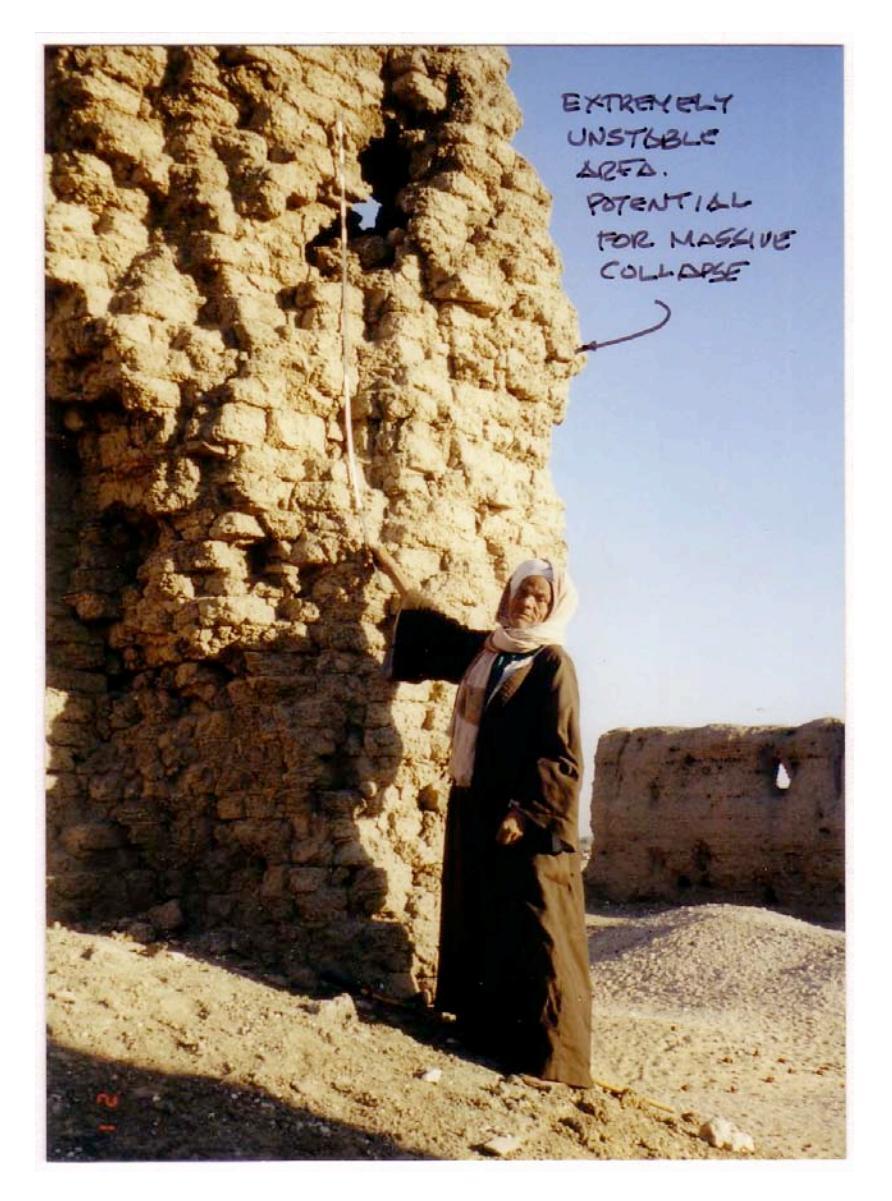
Figure 156. Detail of an unstable brick mass on the northern, vertical end of the west gateway. (Photo: Conor Power 2000)

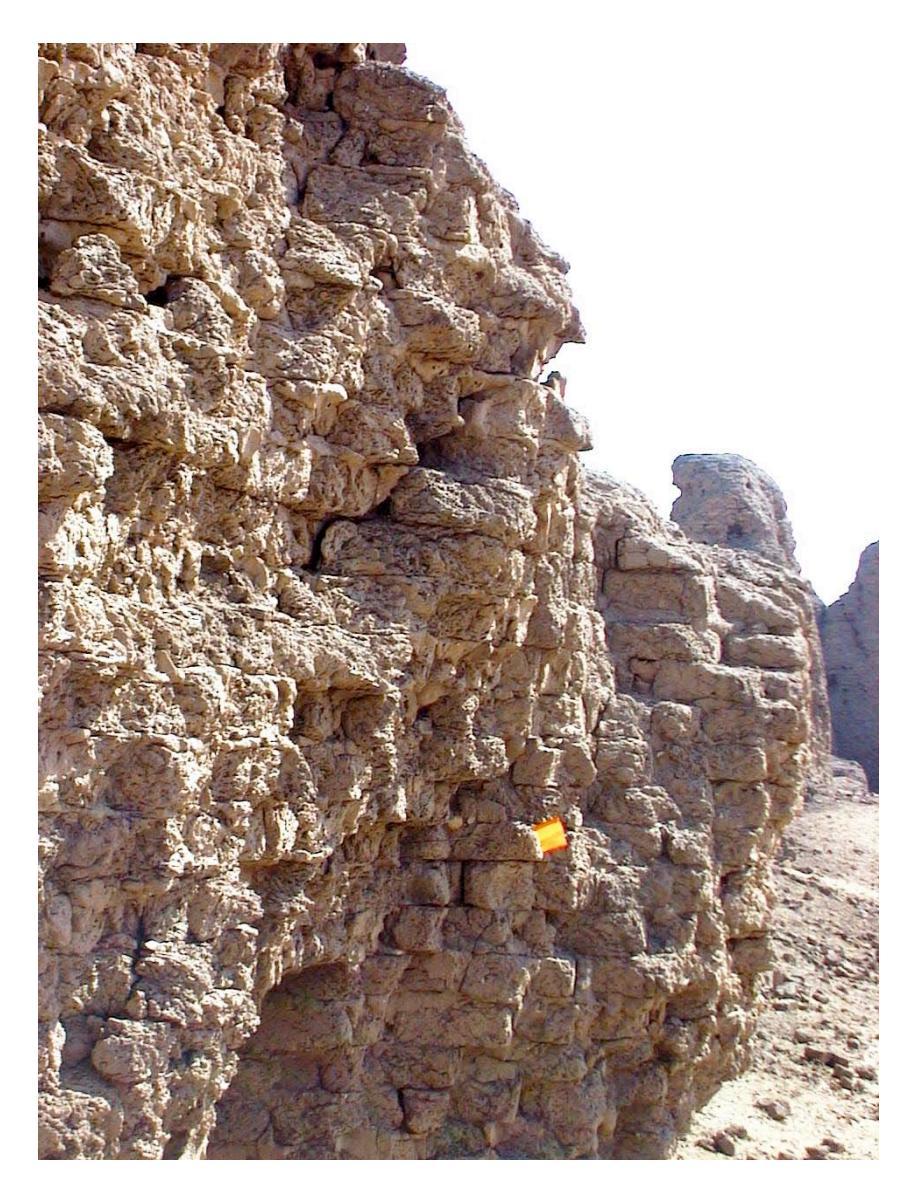
Figure 181. Detail of a crack repair on the east main enclosure wall that requires mud grouting because of its depth in the structure. (Photo: Anthony Crosby 2001)

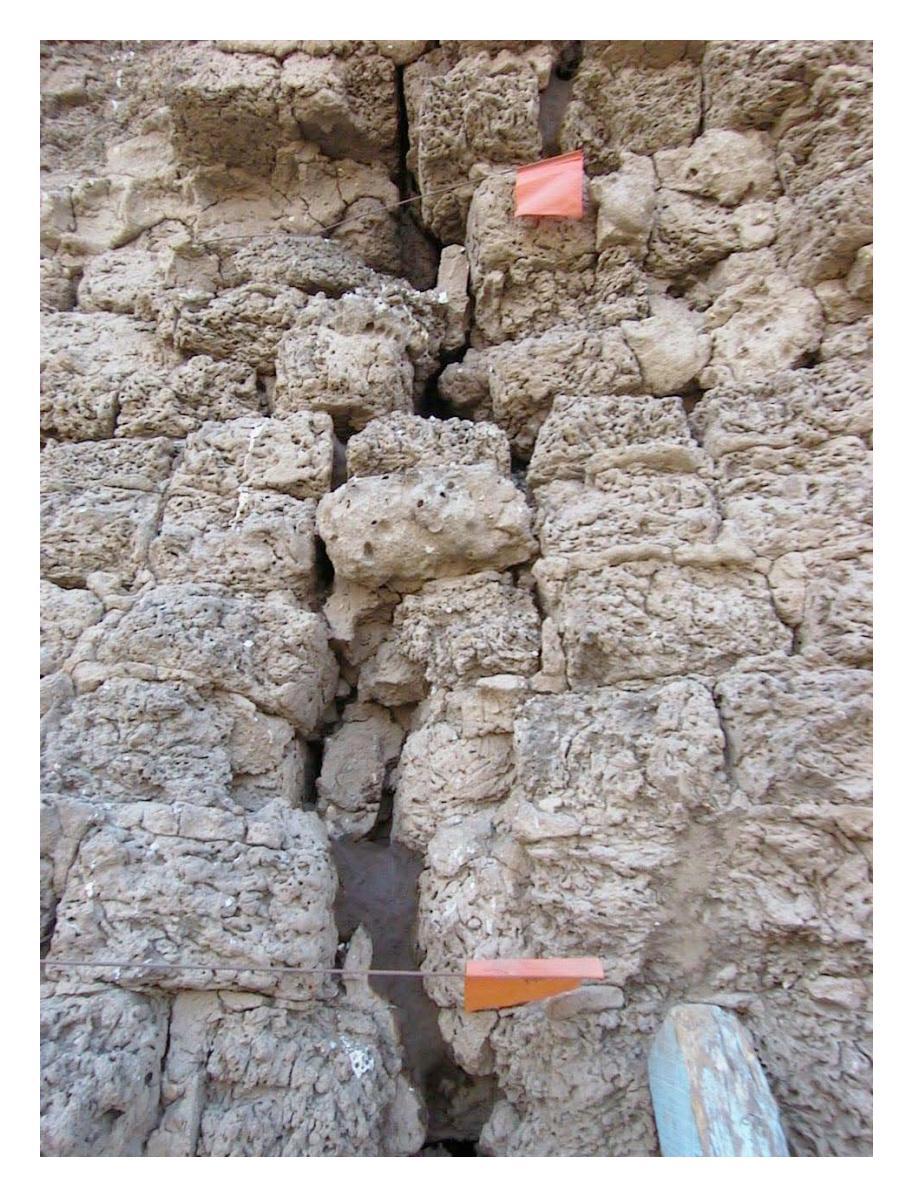
Figure 182. Detail of a through-wall crack repair on the west main enclosure wall that requires a combination of mud grouting, structural ties and the addition of new mud bricks. (Photo: Anthony Crosby 2001)

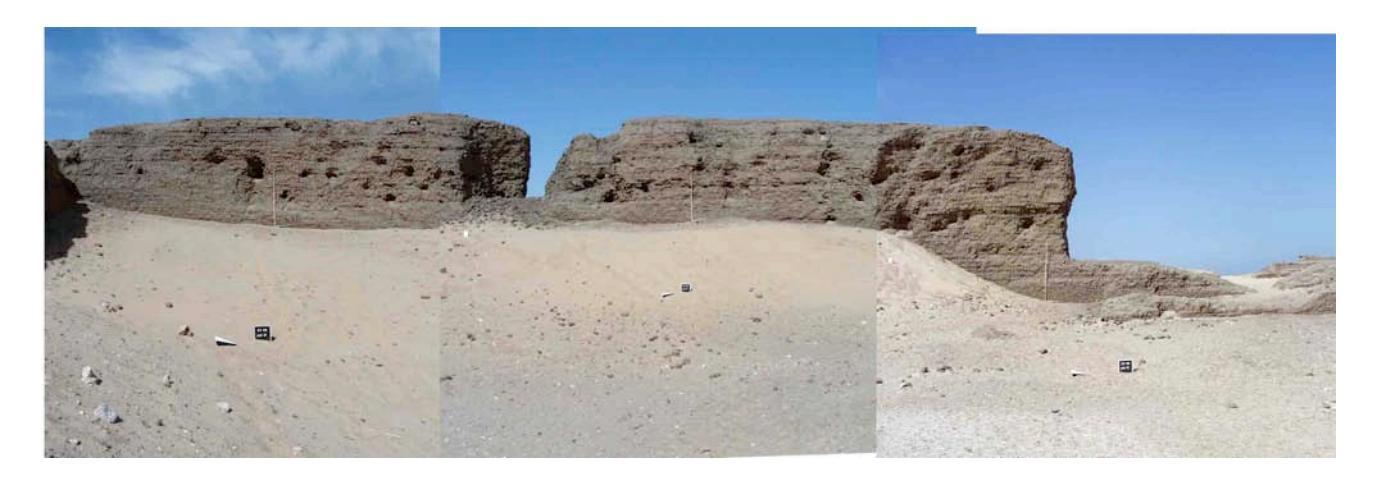
Figure 191. The interior face of the north main enclosure wall, prior to conservation work. (Photo: Richard Barnes 2000)

During field season 5 (spring 2004), the large gap in the central portion of the north main enclosure wall was filled in with new masonry to provide structural support for the original fabric on both sides of the gap and to reestablish the stability of this major wall section (Figures 191 and 192; see also Figure 165, above). The repair to this area represented the first full-scale example of the aesthetic that characterizes the conservation work at the Shuneh. The existing coursing of the original wall fabric on each side of the gap was followed in the installation of new masonry. The contours of the existing eroded wall top were used to define the line of the top of the new construction, which does not extend to the full height of the adjacent areas of the wall in order to reflect the major loss that occurred at this location. The new masonry was constructed to reflect the irregular texture of the surrounding eroded wall surfaces, and the joints between bricks were roughly pointed with mud mortar to reduce the visibility of sharp head joints that contrasted with the surrounding original fabric and to aid in blending the textures of the new and original work (Figure 193).

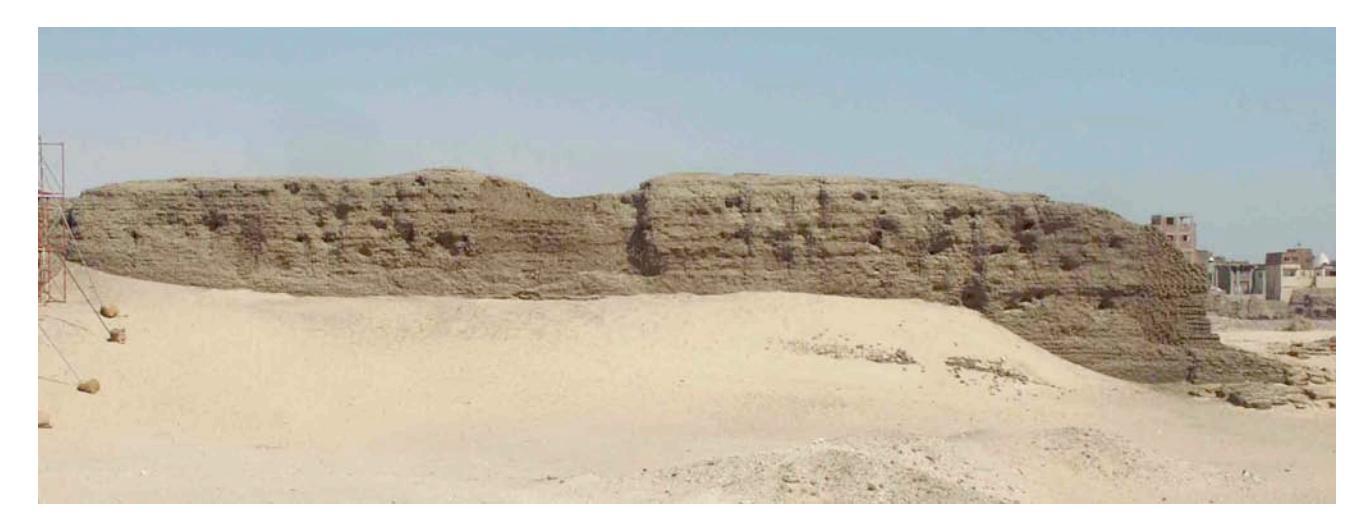
Figure 192. The interior face of the north main enclosure wall, following reconstruction of the central void and stabilization of the eastern wall end (at right). (Photo: Matthew Adams 2004)

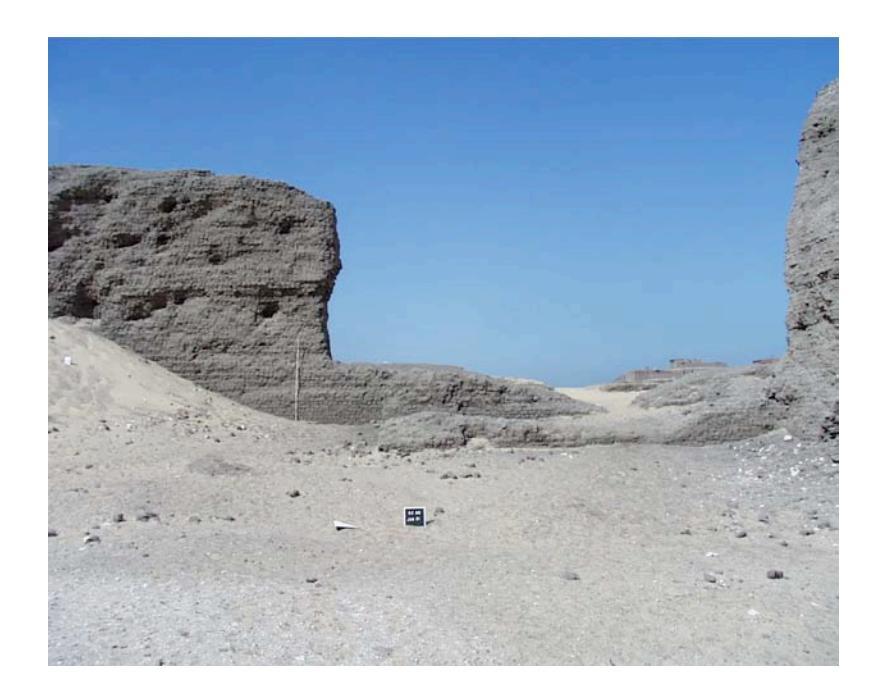
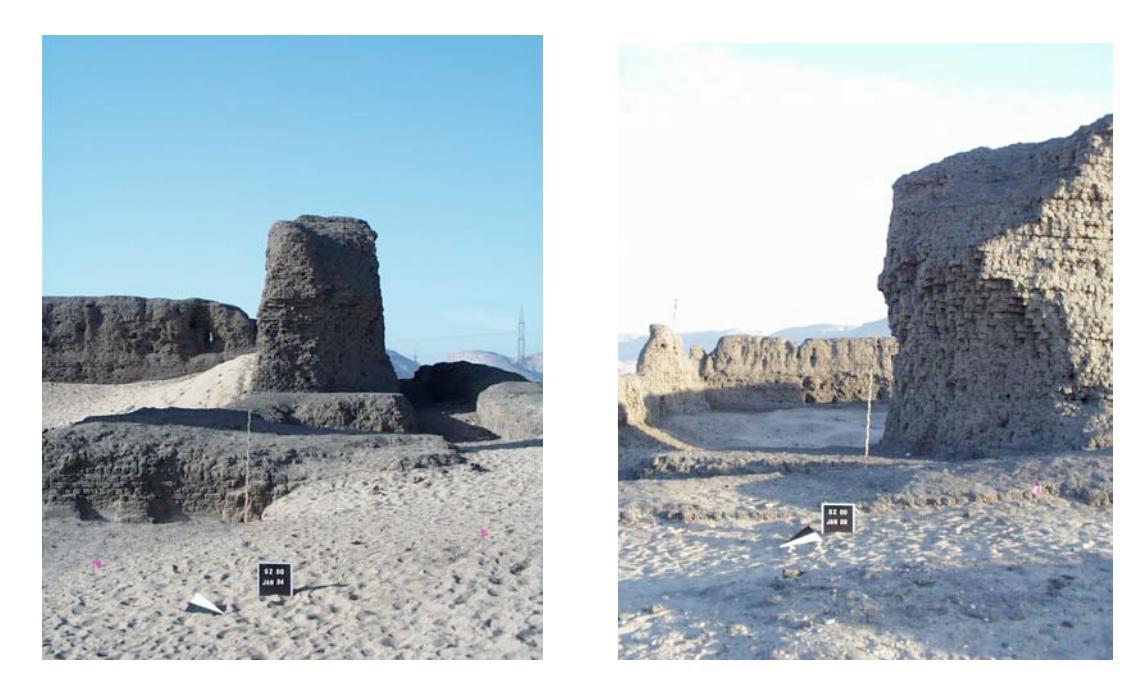
Figures 194, 195, 196. Three details of the eastern, vertical end of the north main enclosure wall prior to architectural stabilization, facing north (top), west (bottom left), and south (bottom right). (Photos: Richard Barnes 1999)

The eastern wall end of the north main enclosure wall (adjacent to the north gateway), which exhibited a high-priority overhang in danger of collapse, was buttressed in field season 5 by a supporting mass of new masonry (Figures 194-199; see also Figures 191 and 192). Careful examination of this area produced no evidence of post-Second Dynasty cultural features that may have contributed to the losses at this end of the wall, although both the flatness of the existing wall surface below the overhang and the existence of a monastic cell on the opposite side of the north gateway suggest that such a feature may once have been present.¹⁶ The work at the eastern end of the north wall during field season 5 was only the first stage in the comprehensive stabilization of the east wall in field seasons 6 and 7 (see below). The eastern end of this new construction was left untextured to allow it to be easily incorporated into the overall stabilization of the gateway, which will be completed in future seasons.
