THE FUNERARY MONUMENT OF KING KHASEKHEMWY AT ABYDOS (ca. 2700 BCE): CONSERVATION AND ARCHAEOLOGY, 1999-2006

Final report on the "Documentation and Conservation of King Khasekhemwy's Funerary Monument at Abydos," a sub-project of the Egyptian Antiquities Project of the American Research Center in Egypt

2007

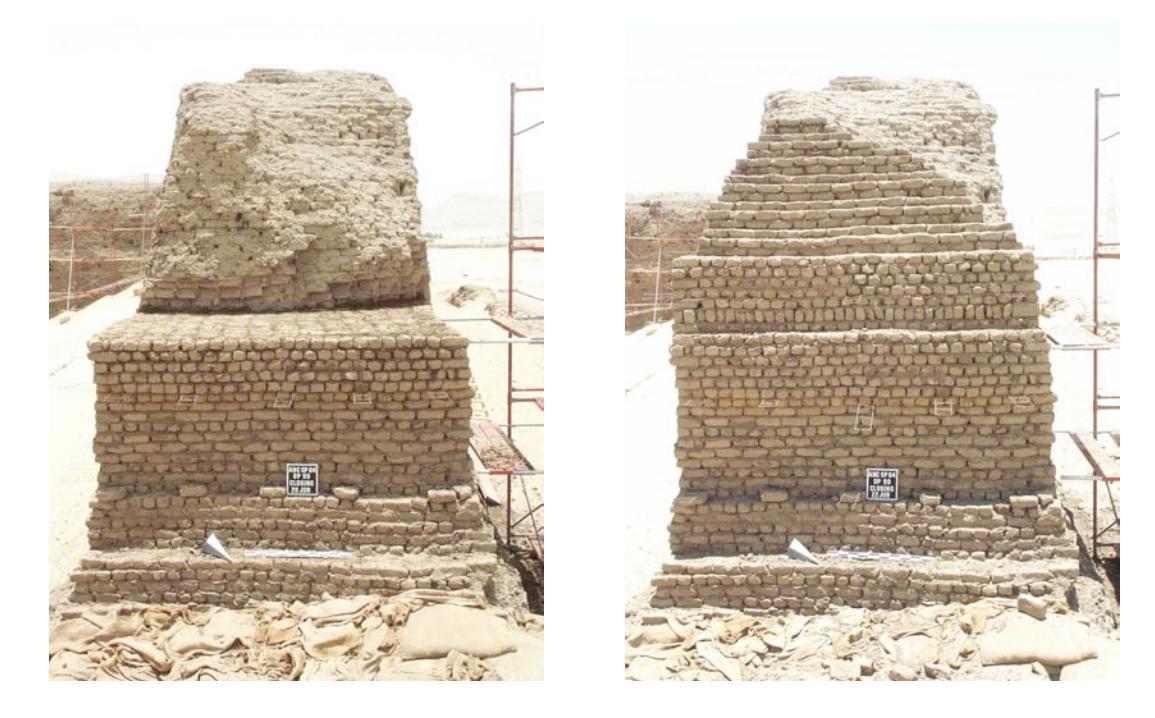
Figures 198, 199. Details of the eastern end of the north main enclosure wall during stabilization; once completed, the sharp ledges and vertical faces will disappear and the buttress will provide essential structural support for this side of the north gateway area. (Photos: Robert Fletcher 2004-2005)

The eastern wall end of the north main enclosure wall (adjacent to the north gateway), which exhibited a high-priority overhang in danger of collapse, was buttressed in field season 5 by a supporting mass of new masonry (Figures 194-199; see also Figures 191 and 192). Careful examination of this area produced no evidence of post-Second Dynasty cultural features that may have contributed to the losses at this end of the wall, although both the flatness of the existing wall surface below the overhang and the existence of a monastic cell on the opposite side of the north gateway suggest that such a feature may once have been present.¹⁶ The work at the eastern end of the north wall during field season 5 was only the first stage in the comprehensive stabilization of the east wall in field seasons 6 and 7 (see below). The eastern end of this new construction was left untextured to allow it to be easily incorporated into the overall stabilization of the gateway, which will be completed in future seasons.

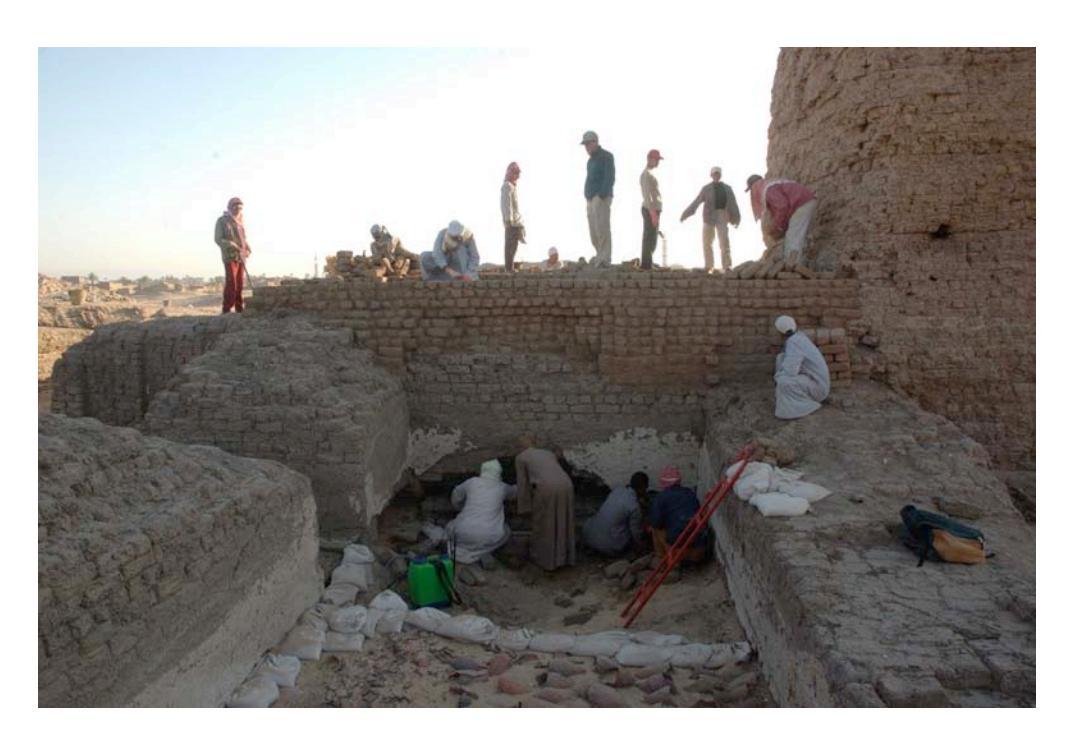
Figure 202. Detail of the north interior gateway chamber during stabilization of the northern base of the east main enclosure wall; the deep hole cut through the wall base at this location has been filled and new masonry is being installed to support reconstruction of the vertical wall end (see Figures 200 and 201, above). (Photo: Robert Fletcher 2004-2005)

collapse of the wall above the cell void contributed to major losses of original fabric at this location (Figures 200 and 201). At some point in the past (probably during the 19th Century), a deep hole was cut through the floor of the cell and the underlying masonry of the wall, well into the sterile sand and gravel deposits beneath.¹⁷ The void created in the sand deposits under the wall resulted in the localized collapse of several courses of masonry from the bottom of the wall. The base of the wall at the eastern end of the north interior gateway chamber had been undermined as well, possibly by an attempt to penetrate under the wall from the west at the same time the hole was dug through the wall nearby. Localized collapses associated with this undermining interacted with those associated with the hole, creating a significant area of instability at the base of the wall. The undermined, lower part of the wall at the eastern end of the interior gateway chamber was stabilized with new masonry during field season 6 (Figures 202 and 203). The new masonry that is below grade steps out slightly from the plane of the wall face to provide a stable base, but is not left visible. The new masonry above grade (which is visible) follows the original wall face. The void under the base of the wall at the bottom of the hole was filled with compacted sand to stabilize the area, and the shaft of the hole was filled with new masonry. Once the lower part of the wall was stable, work on the vertical wall end above could proceed.

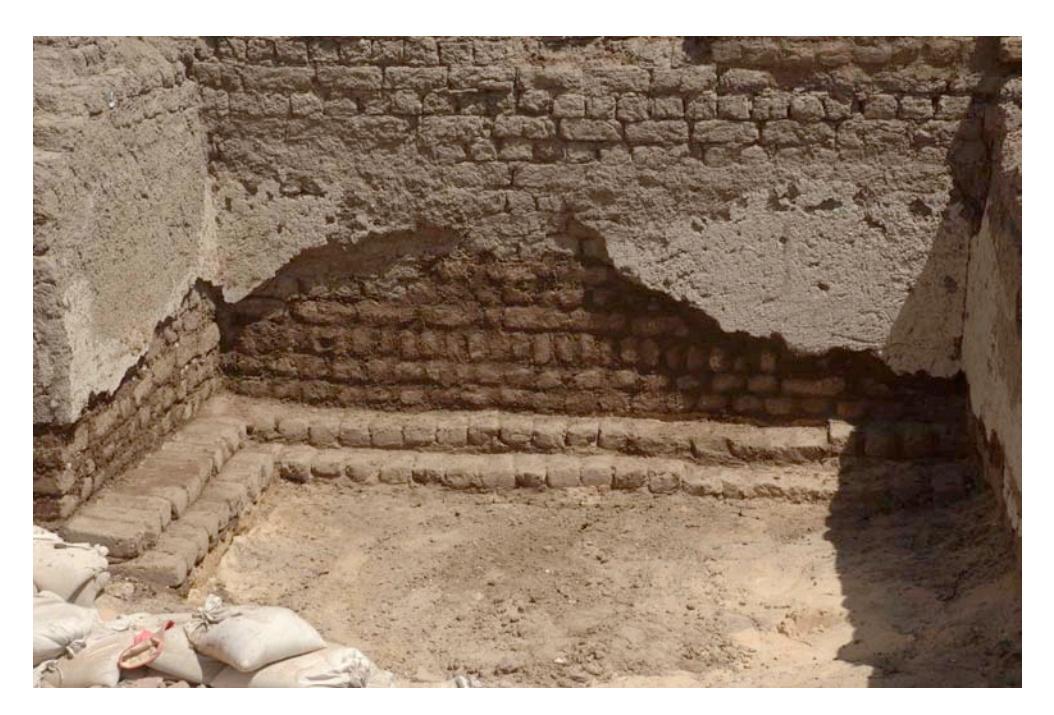
Figure 203. Detail of the reconstructed wall base at the eastern end of the north interior gateway chamber (also the northern base of the east main enclosure wall); the two masonry courses projecting beyond the plane of the wall, which stabilize the wall base, are below grade and not visible in the completed intervention. (Photo: Robert Fletcher 2004-2005)

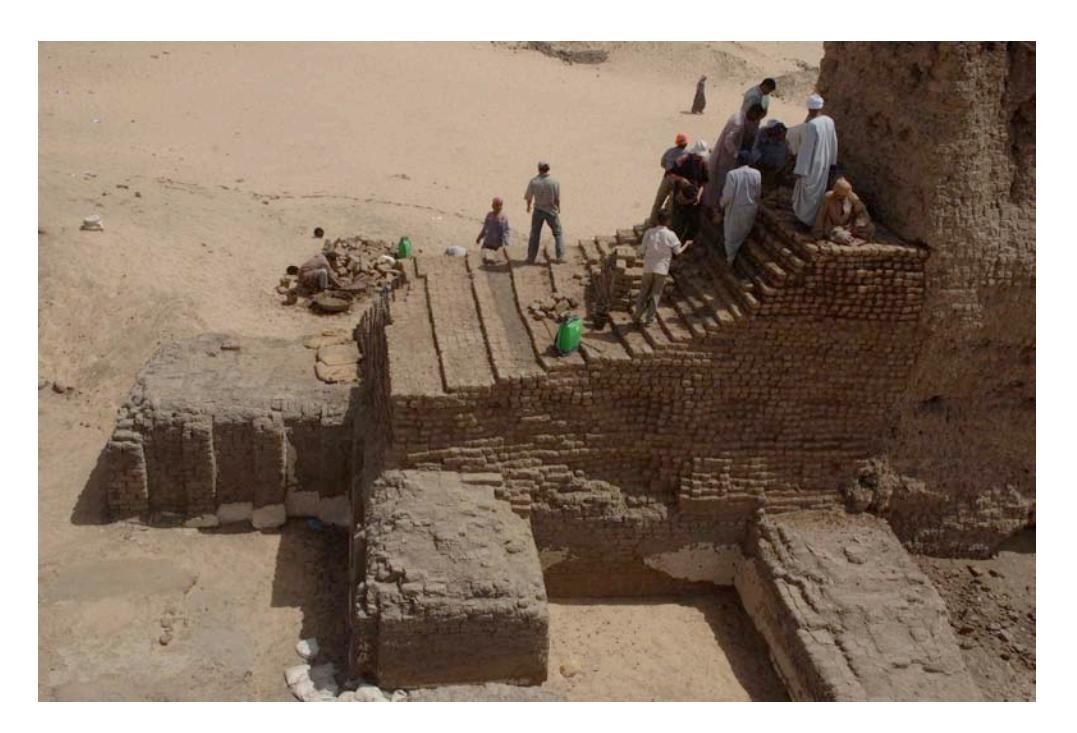
Figure 204. The northern end of the east main enclosure wall during architectural stabilization. (Photo: Robert Fletcher 2004-2005)

A large section of new masonry was installed during field seasons 6 and 7 (2004-2005, 2005-2006) to support the unstable northern wall end of the east wall, and by the close of field season 7, this supporting masonry was brought to within two meters of the existing wall top (Figures 204-206). Sheets of geogrid were incorporated into the new construction to provide horizontal reinforcement (see Figure 205). As the work at this location is not yet completed, sections of these sheets remain visible as of 2007, protruding from the northern side of the new, still untextured, masonry. Like the new masonry at the eastern end of the north wall, the new masonry at the northern end of the east wall will be incorporated into the comprehensive stabilization of the entire north gateway area in future seasons.

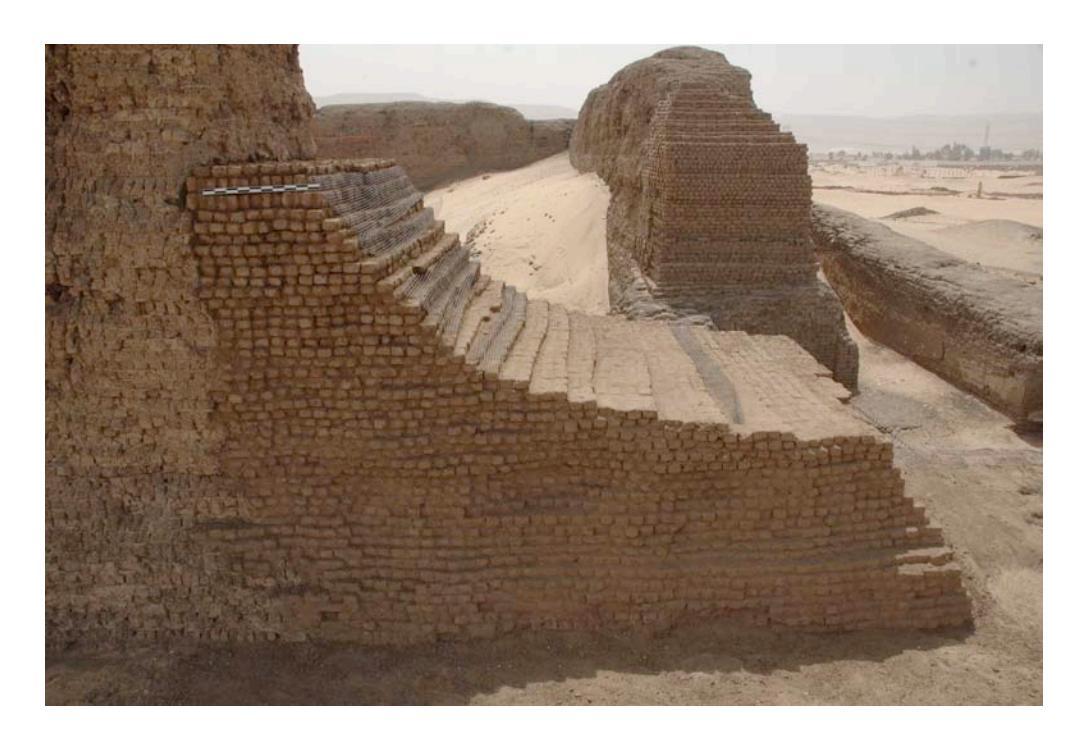
Figure 205. Detail of the new masonry support at the northern end of the east main enclosure wall at the close of field season 6; the use of geogrid at this location allowed the new masonry to be strongly keyed to the existing construction. (Photo: Robert Fletcher 2004-2005)

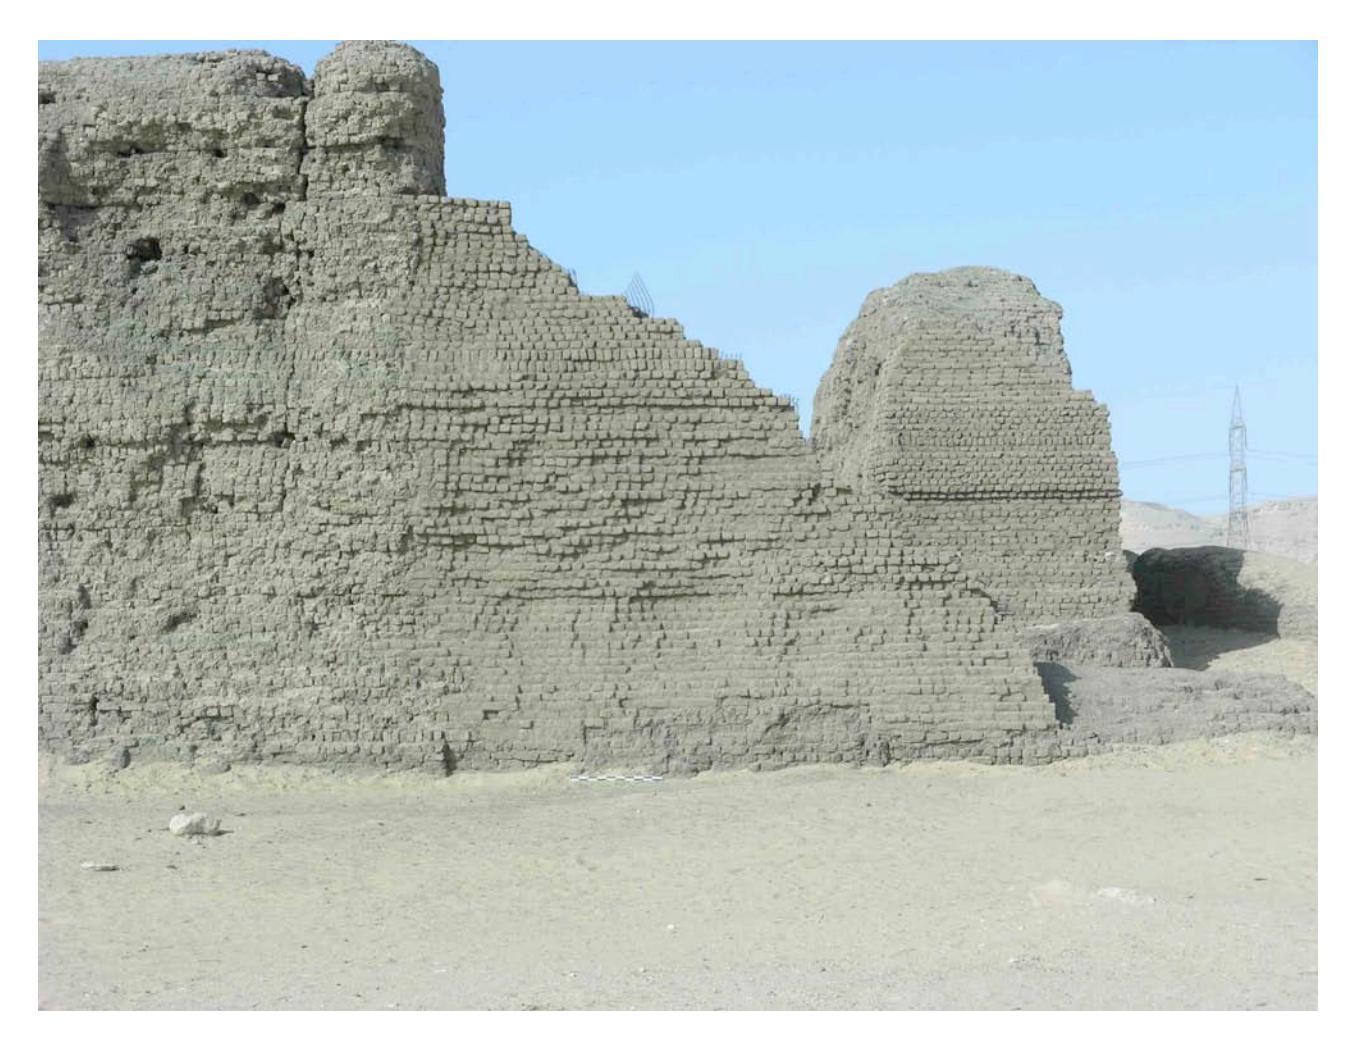
Figure 206. Stabilization of the northern end of the east main enclosure wall at the close of field season 7. (Photo: Matthew Adams 2005-2006)

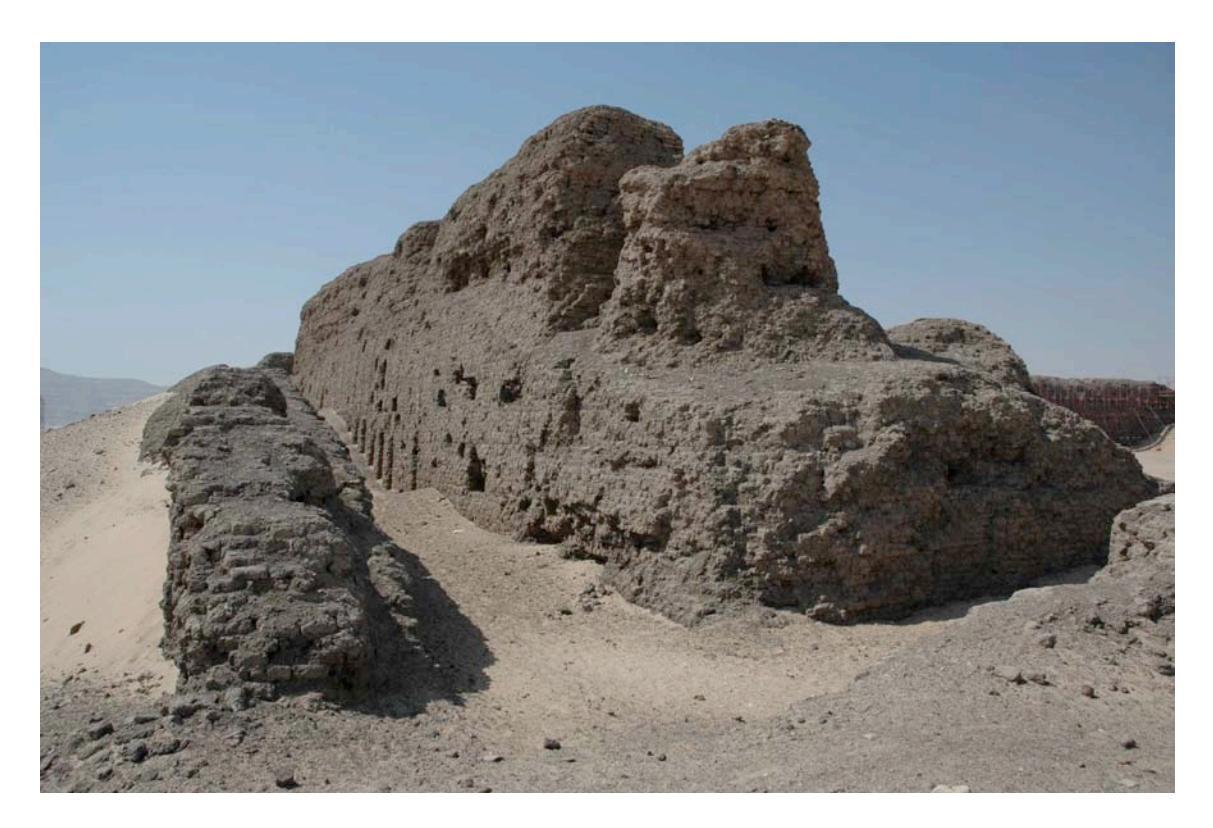
Deep vertical cracks and heavy erosion at the eastern end of the south main enclosure wall (adjacent to the east gateway) have combined to create highly unstable, urgent-priority conditions, including significant calving and unstable brick masses, with one essentially freestanding column of masonry representing a particular area of concern (Figure 207). The features of greatest concern were stabilized during field season 6 (2004-2005) with the addition of new supporting masonry (Figure 208). The new construction follows the original coursing of the adjacent wall, and has been built so as to support unstable portions of the wall, while reflecting in its contours the highly eroded character of this corner area. The conservation work at this location will be incorporated into the comprehensive stabilization of the east gateway area in future seasons.

Figure 207. The southeastern corner of the main enclosure and perimeter walls, prior to architectural stabilization; the freestanding brick mass at the eastern end of the south main enclosure wall (upper right) was extremely unstable prior to conservation work. (Photo: Robert Fletcher 2004-2005)

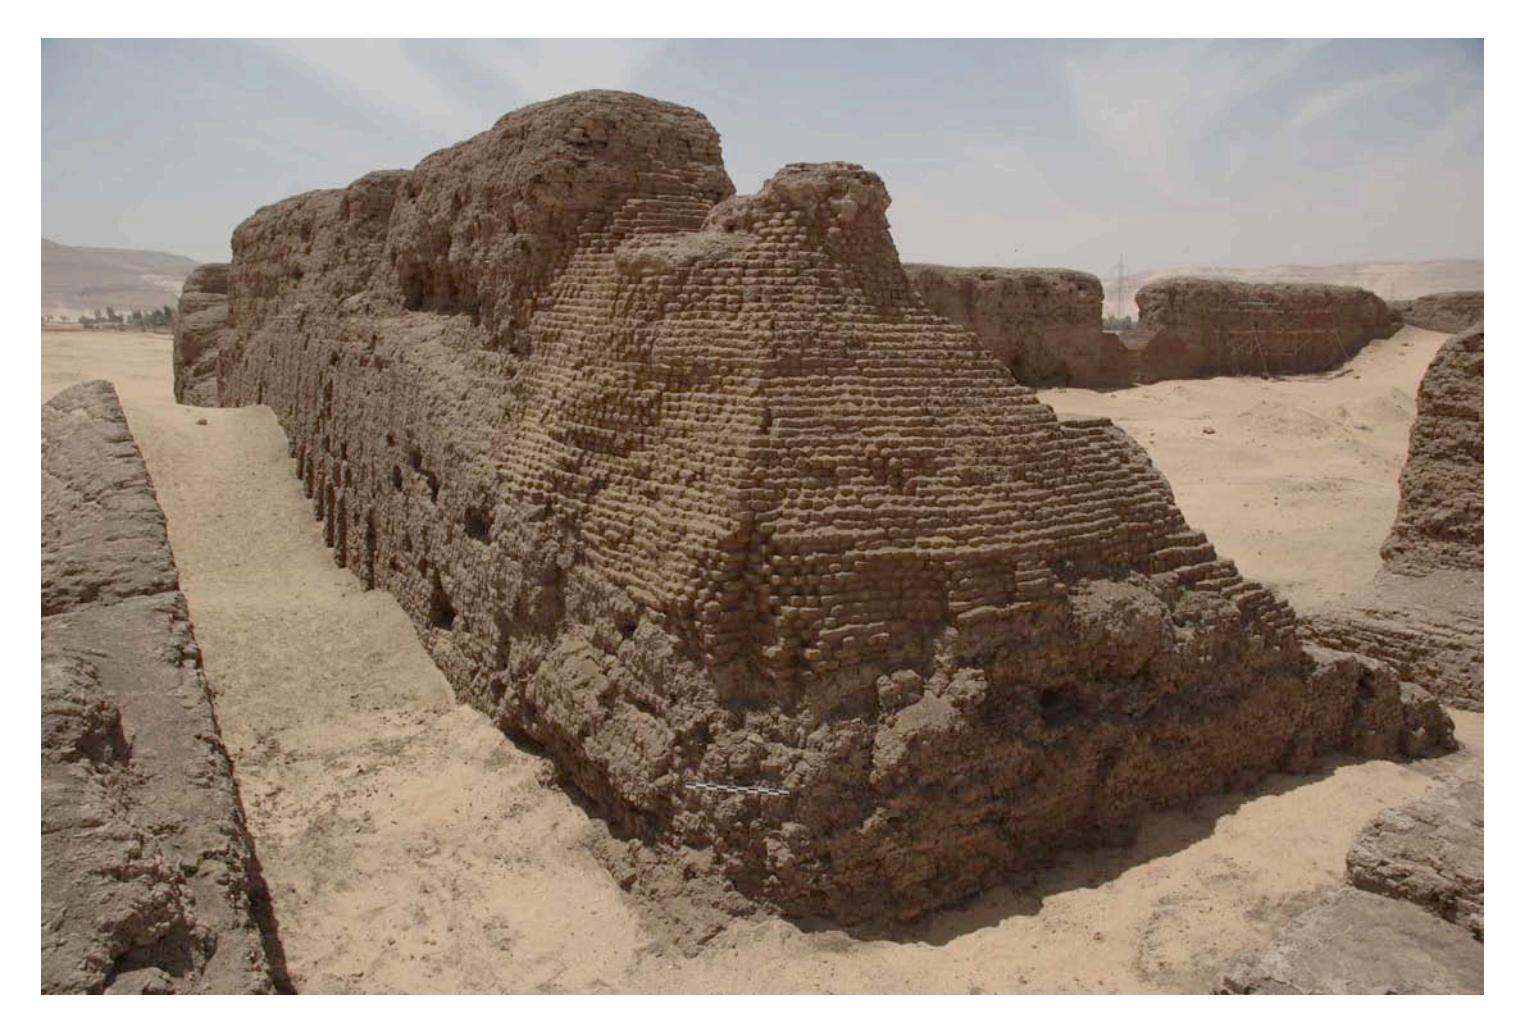
Figure 208. The eastern corner of the south main enclosure wall completely stabilized at the close of field season 6; this work represents the first stage in the comprehensive stabilization of the east gateway area. (Photo: Robert Fletcher 2004-2005)

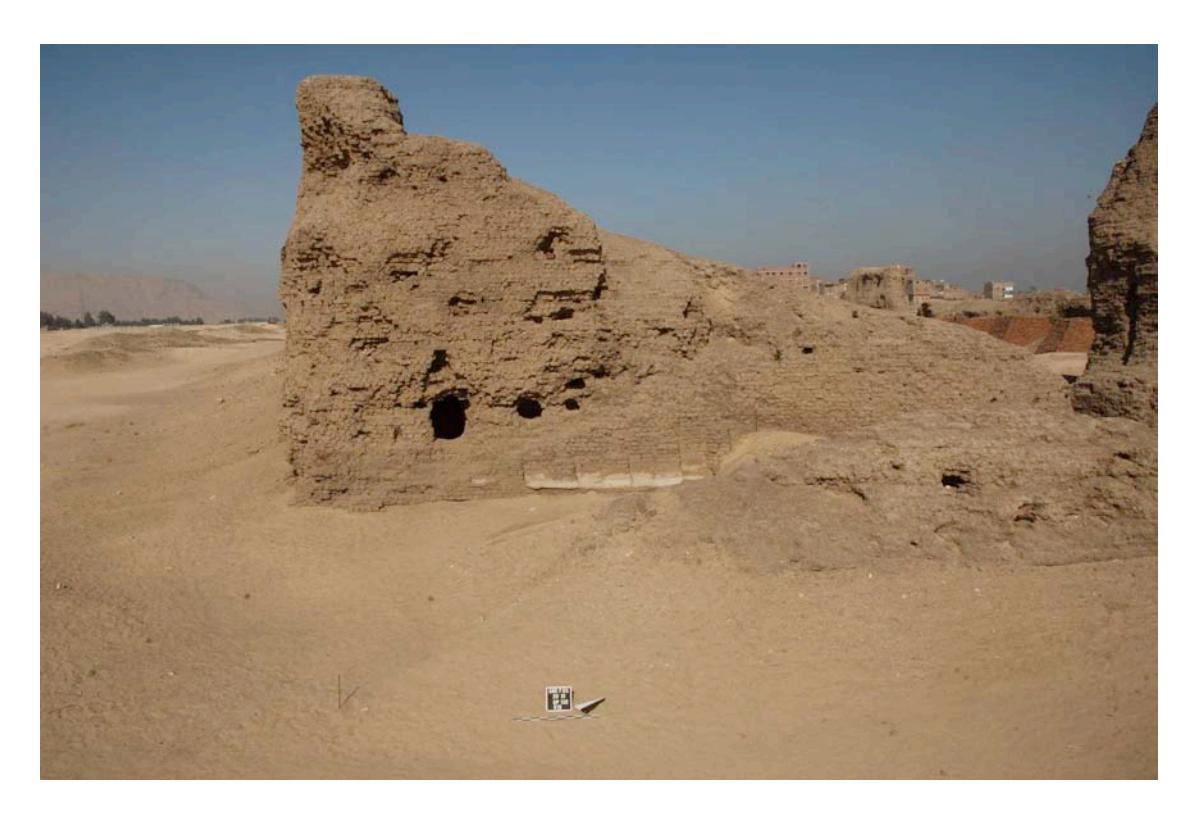
¹⁷ Similar holes were found cut into the southwest and northwest corners of the main enclosure, penetrating below the base of the wall into the sterile sand deposits below. These holes are the result of deliberate tunneling and are thought to represent the work of Mariette's agents in search of foundation deposits during the mid-19th Century.

Figure 209. Detail of the southwest, exterior corner of main enclosure (adjacent to the south gateway) prior to conservation work; the large void (left center) is the result of deliberate tunneling in the mid-19th Century and the smaller holes nearby are the result of hornet nesting. (Photo: Robert Fletcher 2004-2005)

The southwest, exterior corner of the main enclosure, at the intersection of the west and south walls, was stabilized in field season 7 (2005-2006). This area was affected by significant cavitation along the base of the west wall, missing masonry and overhangs at the corner itself, hornet holes on both sides of the corner, and a deep man-made tunnel cut from the south side through the masonry of the wall into the underlying sand and gravel deposits (Figures 209 and 210). Like similar holes at the northwest and northeast corners of the main enclosure, this tunnel was probably dug by Mariette's workers in the 19th Century. The missing masonry along the wall base at this location was replaced, as illustrated in Figures 211 to 213. Below grade, the new masonry was constructed with a footing that extends slightly beyond the original line of the wall to provide a stable base for the new masonry, and above grade, the new construction follows the original wall line. Complete stabilization of the wall base also included filling the man-made tunnel and adjacent hornetnest holes. The upper portion of the wall at the southwest corner, which exhibits highly unstable overhangs, will be repaired in a future season.

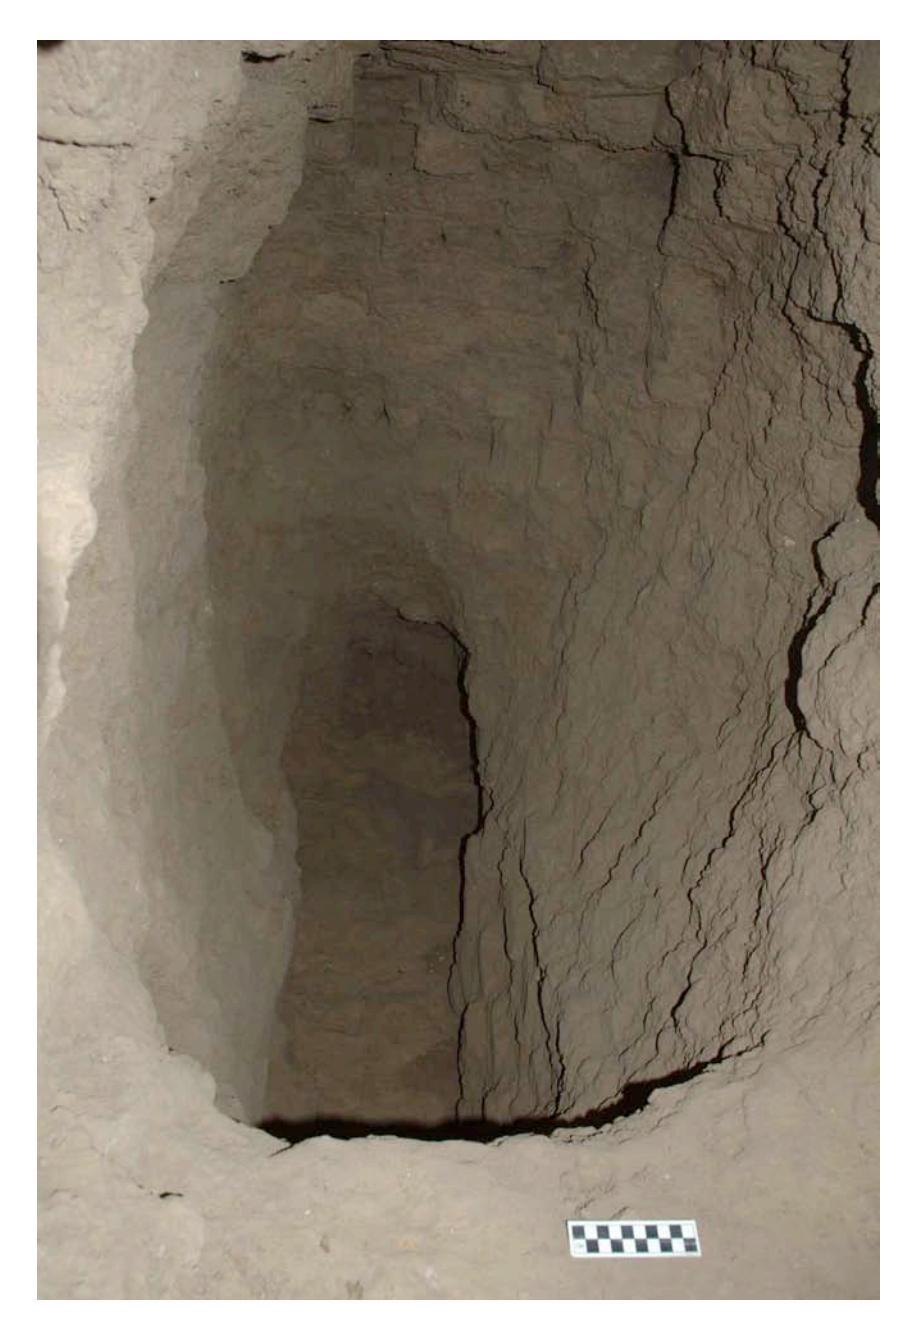
Figure 210. Detail of the large hole penetrating below the wall base at the southwest corner of the main enclosure, pictured in Figure 209 (above); this tunnel was likely excavated by agents of Auguste Mariette in the mid-19th Century. (Photo: Robert Fletcher 2004-2005)

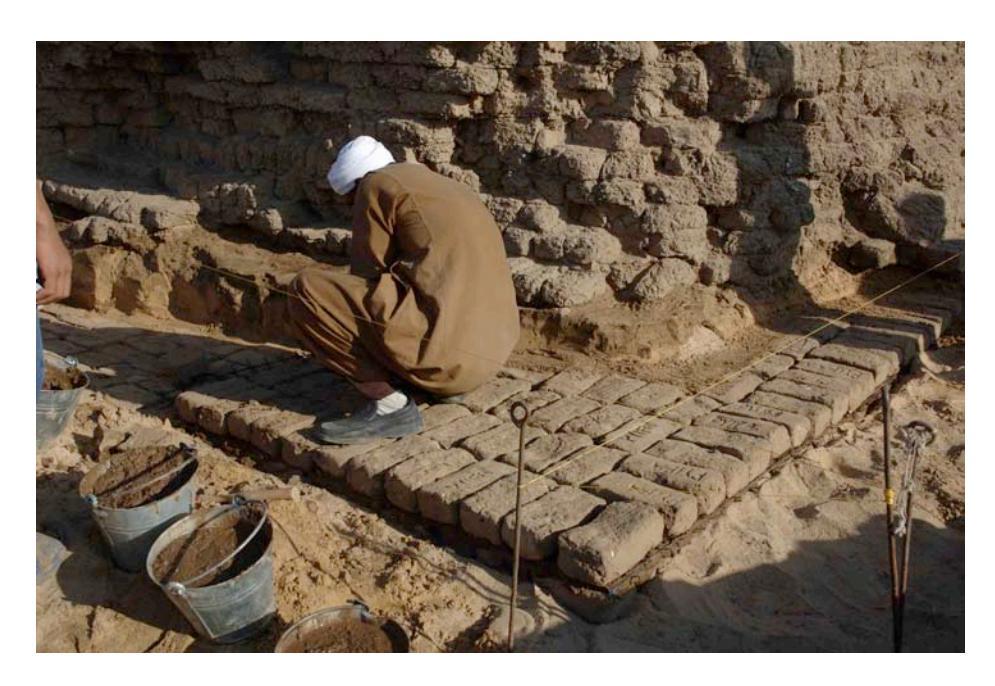
Figure 211. New masonry courses were laid below grade and beyond the wall plane at the base of the southwest corner of the main enclosure to provide a stable base for new construction in field season 7. (Photo: Robert Fletcher 2005-2006)

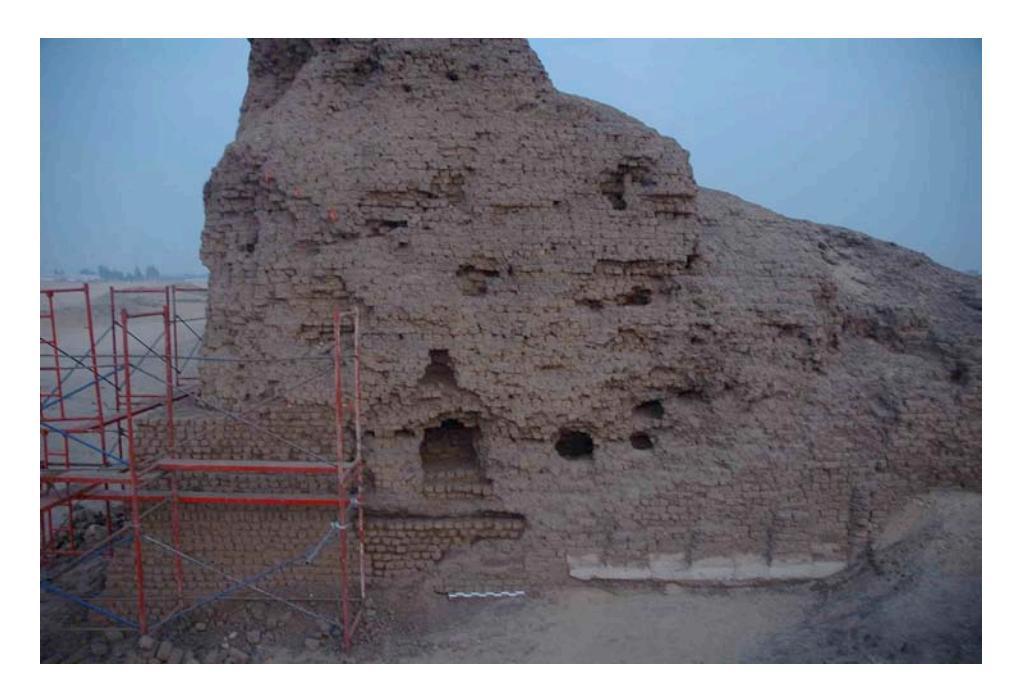
Figure 212. Stabilization work in progress at the southwest corner of the main enclosure; the extent of missing original masonry can be judged by the thickness of the new construction, which follows the original line of the wall above grade. (Photo: Robert Fletcher 2005-2006)

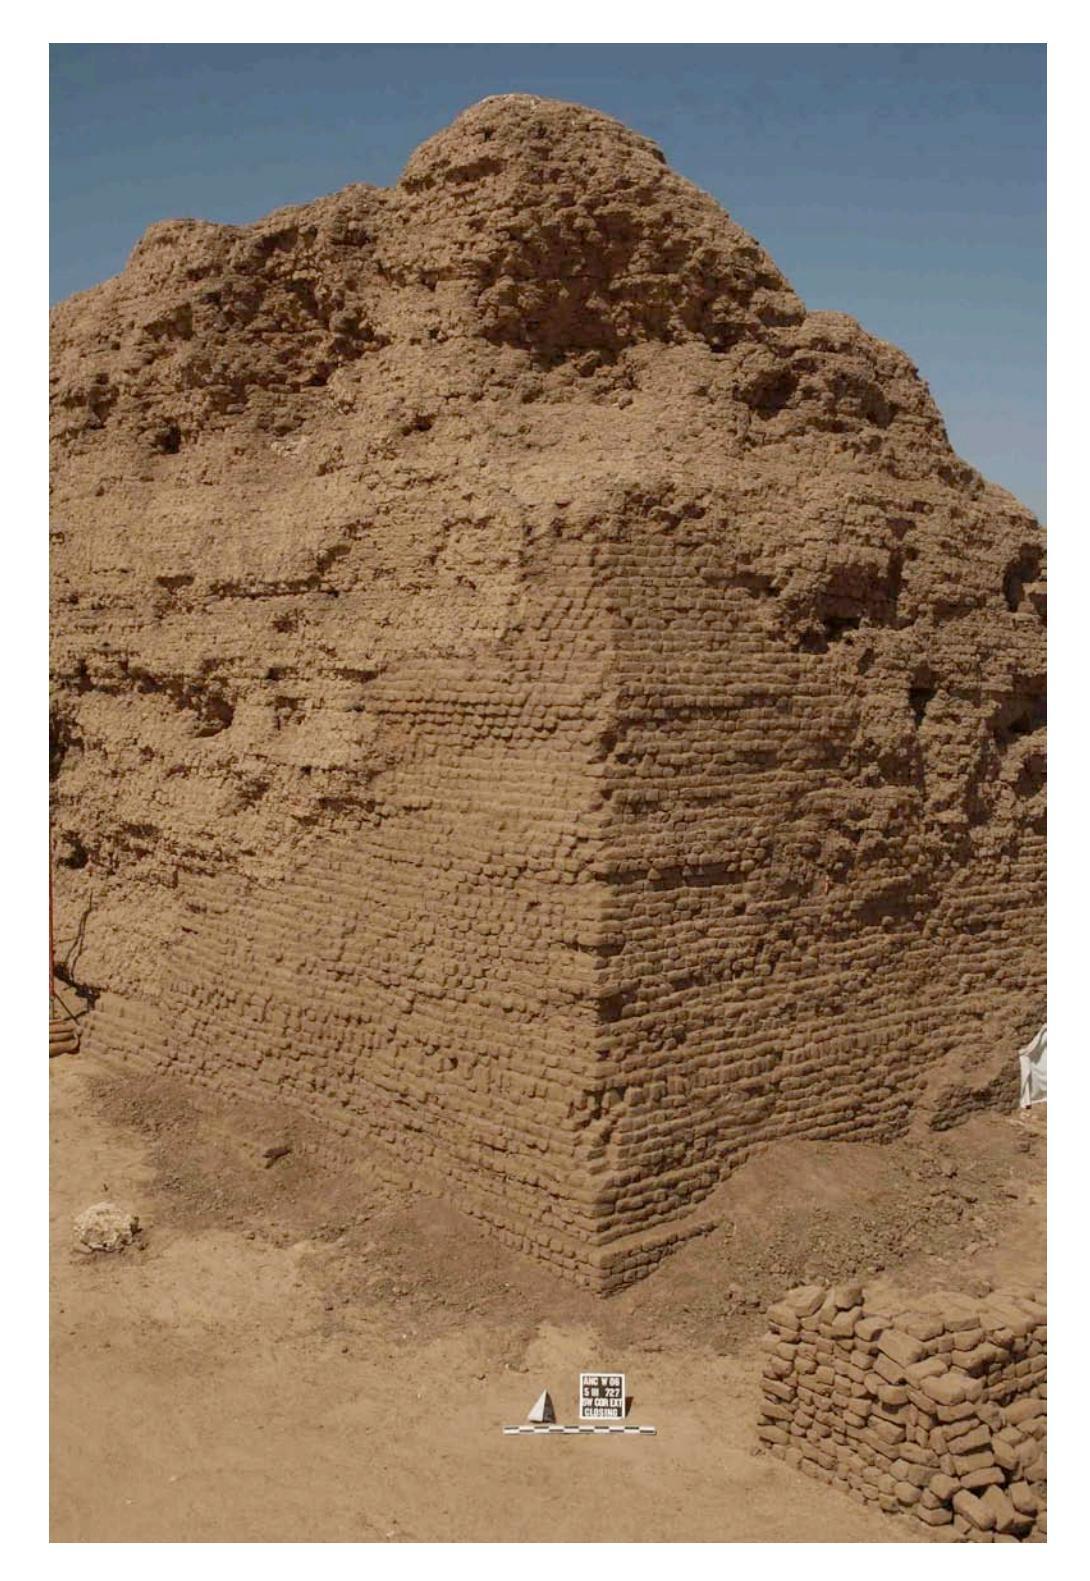
Figure 213. Completed area of stabilization on the lower, exterior portion of the southwest corner of the main enclosure at the close of field season 7. (Photo: Jason Goodman 2005-2006)

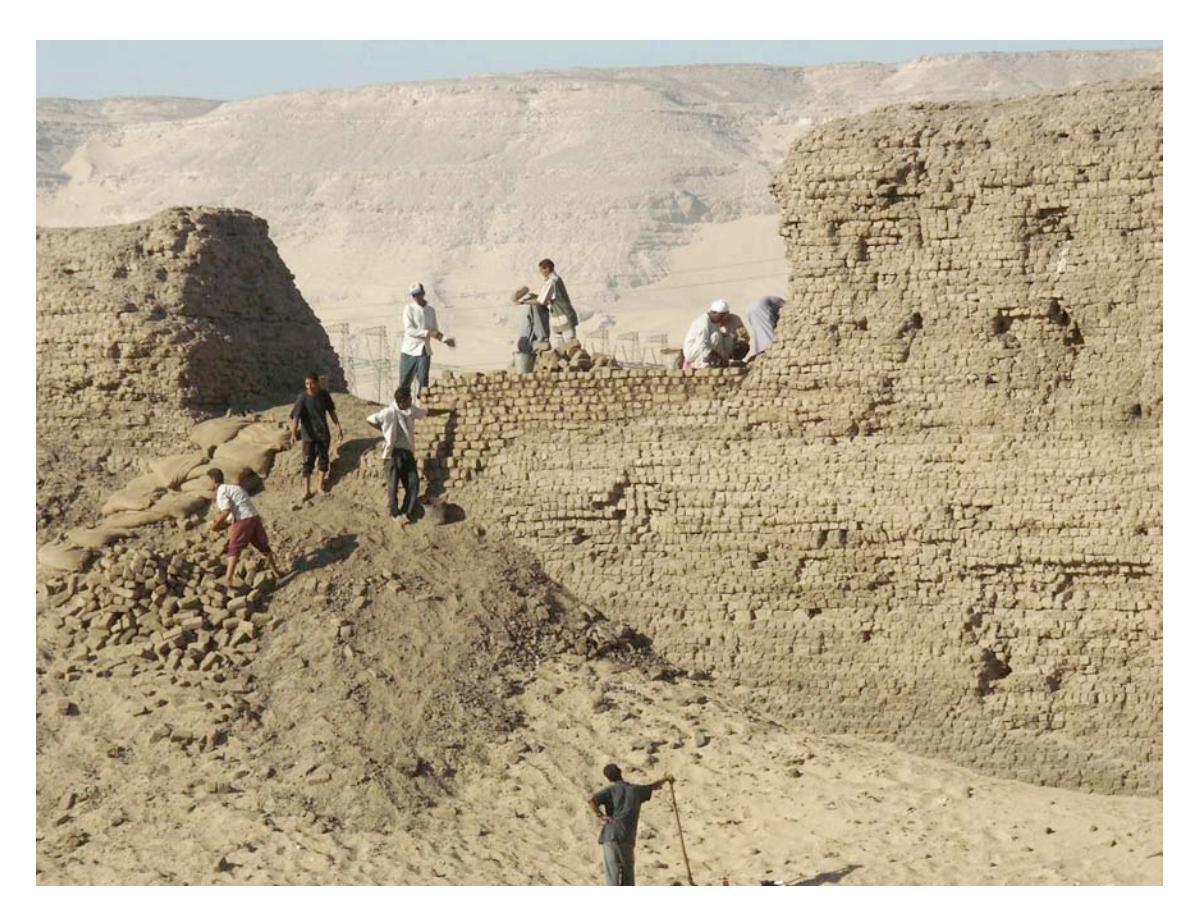
At the southern end of the west main enclosure wall, a large gap in the upper masonry posed high-priority structural risks (Figures 214 and 215). The sides of this gap were defined by opposing vertical wall ends, each associated with significant structural cracks. During field season 5 (spring 2004), a supporting section of new masonry was constructed against the northern side of the gap, and in field season 6 (2004-2005), the remainder of the gap was filled (Figures 216 and 217). The coursing of the original wall fabric was followed and the texture of the surrounding eroded wall surfaces was carried into the new construction, the top of which was contoured to follow the undulating lines of the existing wall top. The infilling of this large gap provides necessary structural support for the adjacent original fabric and eliminates the threat of further losses in this area. Because the new construction does not reach the full height of the wall, the slightly lower profile of the infilling makes a subtle but noticeable visual reference to the previous loss of fabric.

Figure 214. Interior detail of the gap in the upper, southern portion of the west main enclosure wall prior to architectural stabilization. (Photo: Matthew Adams 2004)

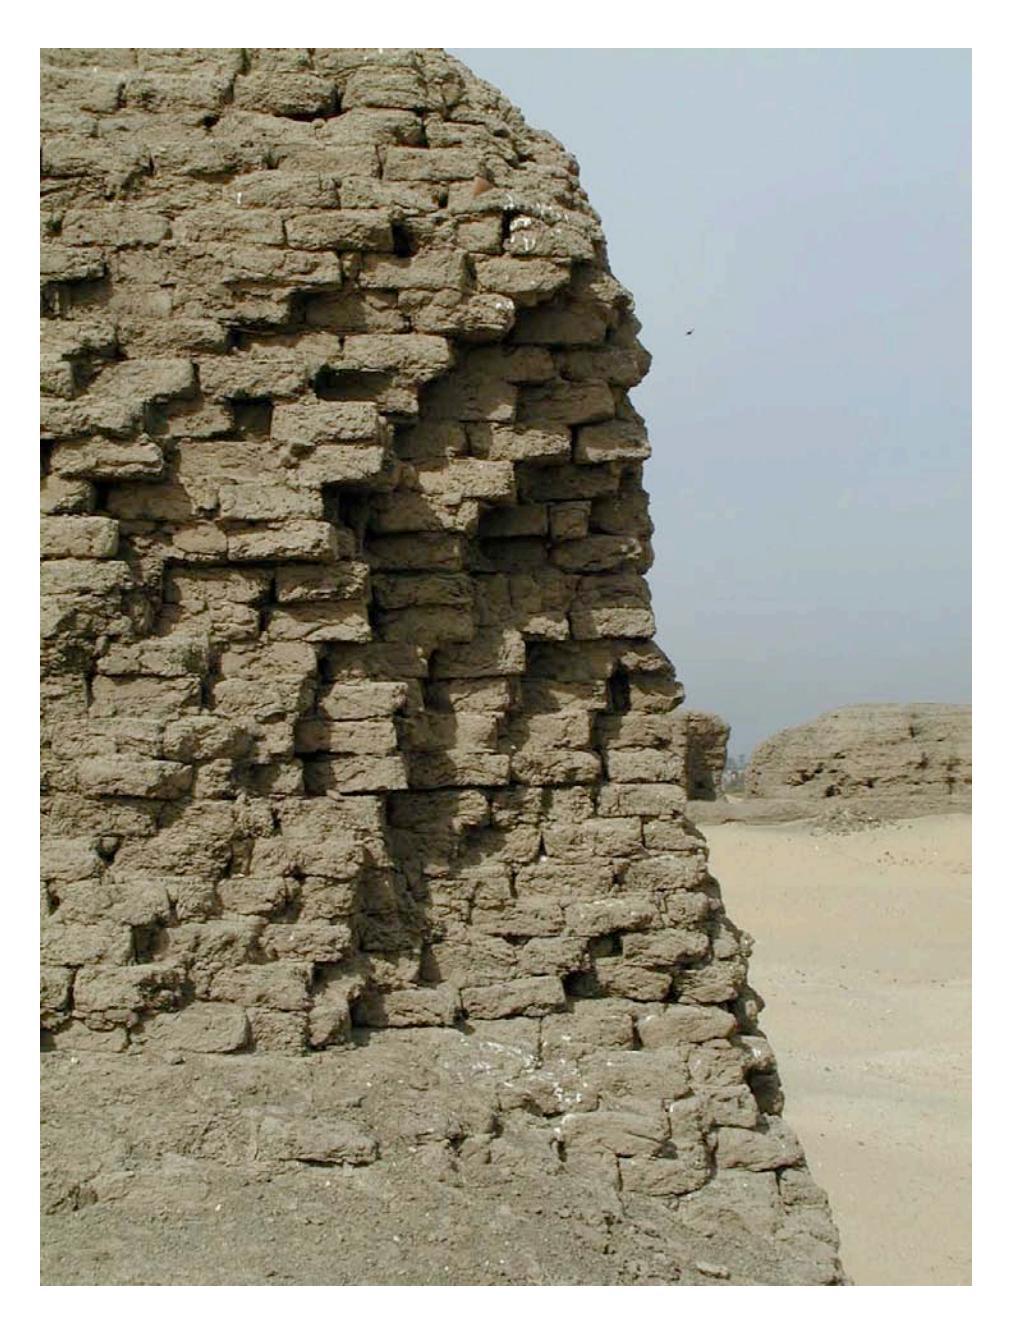
Figure 215. Detail of brick loss on the northern, vertical end of the gap in the upper west main enclosure wall pictured in Figure 214 (above); the arrow shows a hornet in flight to an active nest opening at this location. (Photo: Robert Fletcher 2001-2002)

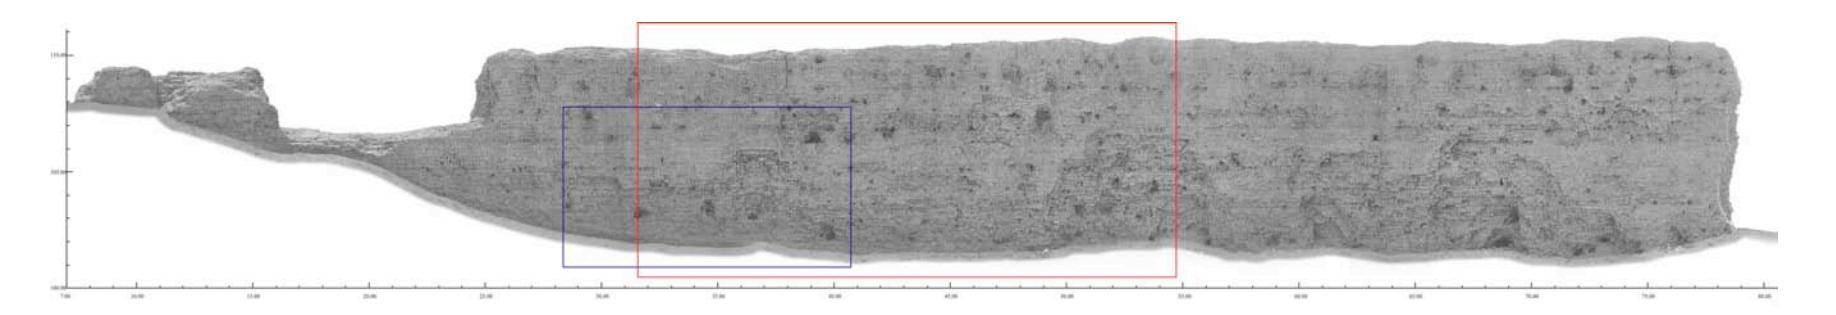
On the southern, interior face of the west main enclosure wall, new masonry was installed in stages along the lower wall face during field seasons 6 and 7 (2004-2005, 2005-2006). The lower portion of this interior elevation was heavily affected by cavitation, undermining and unstable overhangs, which threatened the stability of the upper wall (Figures 218 and 219). The urgent-priority condition of this wall was in large part the result of canid burrowing and insect activity, although ancient pitting associated with ibis burials may also have been a contributing factor. Excavation in field seasons 6 and 7 exposed the base of

Figure 218. Rectified photoelevation of the southern, interior face of the west main enclosure wall, illustrating the condition of the wall in 2001 prior to conservation work; the details noted in red and blue are pictured in Figures 221 and 222 (respectively), below. (Photoelevation: Heritage 3D, Inc. 2001)

the wall, permitting its condition to be evaluated. All undermined areas, holes and voids were cleaned, and loose brickwork was removed prior to installing new masonry. A compacted sand base was prepared along the base of the wall, on which a footer was laid that extended slightly out from the original plane of the wall face, providing a solid base for the new construction above. This footer, as elsewhere, is below grade in the finished repair and will not be visible. Above grade, the new masonry followed the plane of the original wall face. The original masonry coursing was followed in the new work, and the finished wall surface was textured to reflect the eroded and undulating surfaces of the surrounding original wall. The new brickwork was built up to meet overhanging areas, providing structural support for the upper part of the wall (Figures 220-224). Because the upper parts of the new masonry in this area are relatively thin, mechanical ties were used in combination with geogrid to anchor the new work to the original fabric of the wall. The stabilization work along the lower, interior side of the west wall provides a particularly clear example of the approach being followed in the conservation program at the Shuneh. The texture of the new construction blends with that of the original masonry when viewed from a distance, but it is easily distinguishable upon close inspection (Figure 225). At the close of field season 7, a solid base of new construction had been established and the stabilization of the lower part of the southern, interior face of the west wall was complete.

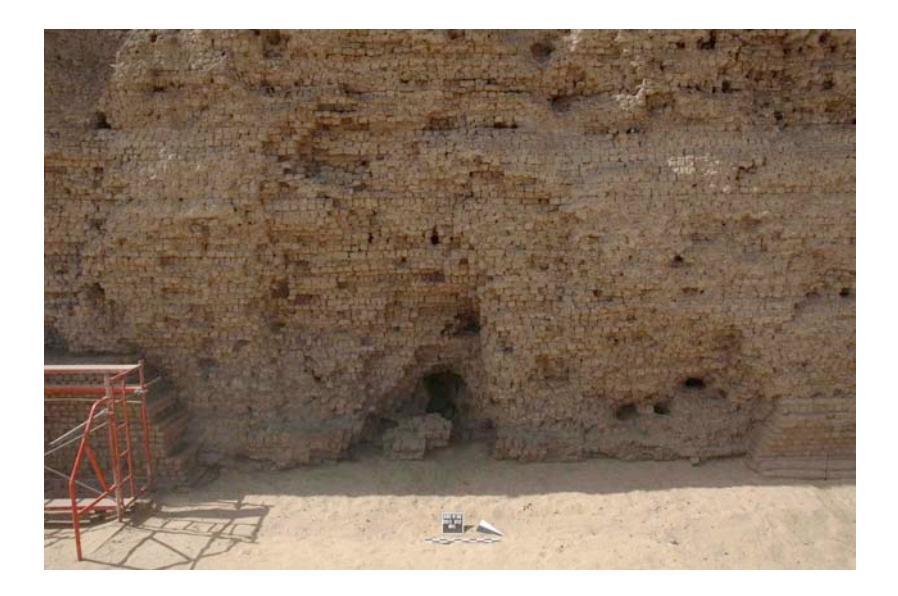
Figure 219. Detail of the typical undercutting caused by animal burrowing on the interior side of the west main enclosure wall. (Photo: Robert Fletcher 2004-2005)

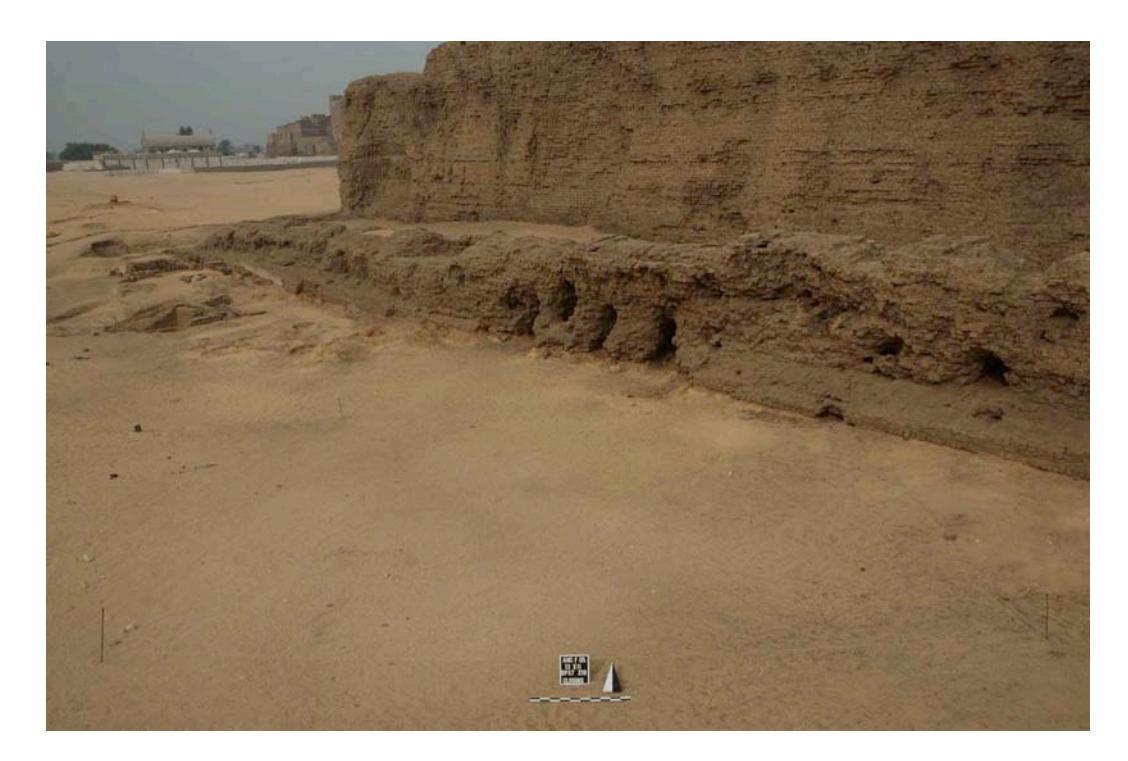
In addition to the work completed on each of the main enclosure walls, part of the northern, exterior side of the west perimeter wall was stabilized with new masonry during field season 7 (2005-2006). This area was in an extremely unstable condition as a result of significant wind erosion, hornet nesting and extensive animal burrowing, some of which had penetrated completely through the thickness of the wall (Figure 226). In order to prevent further losses, new masonry was constructed to support the remaining original fabric in the most critical area, at the center of the northern portion of the wall (Figure 227). Because the new masonry is relatively thin in this area, geogrid and mechanical ties were used to anchor it to the existing wall. A temporary sandbag buttress was constructed to support a second highly unstable area, as depicted in Figure 228. The remainder of the northern, exterior side of the west perimeter wall (to the north and south of the repaired area) remains to be stabilized in a future season.

Figure 226. The northern, exterior portion of the west perimeter wall prior to architectural stabilization; the outer surface of this wall has been heavily damaged by wind erosion, animal burrowing and insect activity. (Photo: Robert Fletcher 2005-2006)

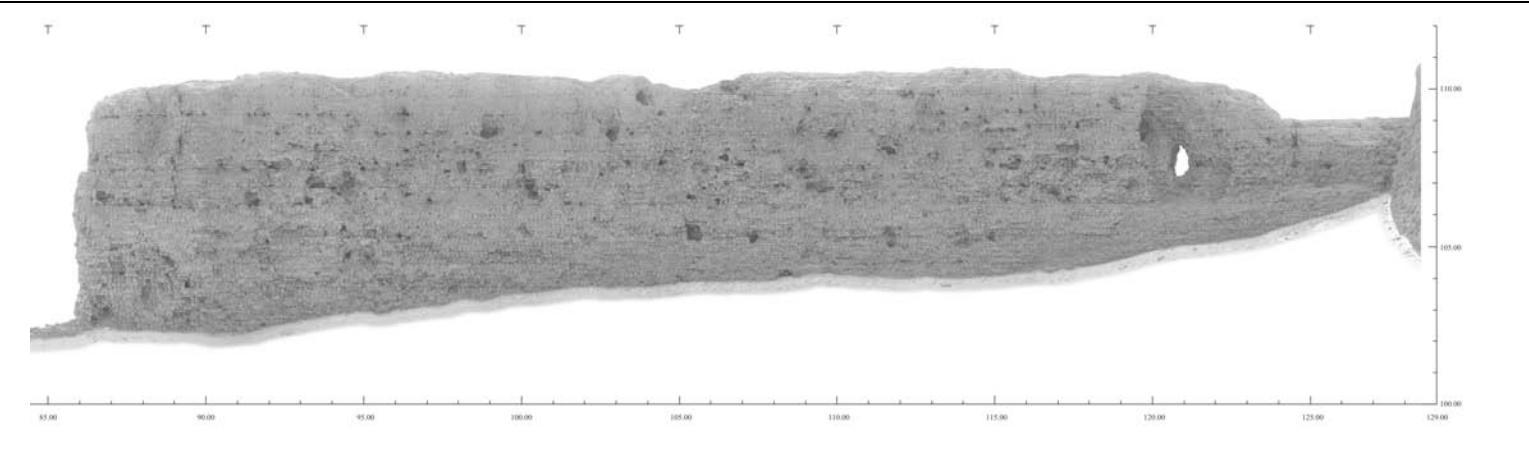
Figure 230. Rectified photoelevation of the northern, interior face of the west main enclosure wall prior to conservation work; note the through-wall hole system at far right. (Photoelevation: Heritage 3D, Inc. 2001)
