THE FUNERARY MONUMENT OF KING KHASEKHEMWY AT ABYDOS (ca. 2700 BCE): CONSERVATION AND ARCHAEOLOGY, 1999-2006

Final report on the "Documentation and Conservation of King Khasekhemwy's Funerary Monument at Abydos," a sub-project of the Egyptian Antiquities Project of the American Research Center in Egypt

2007

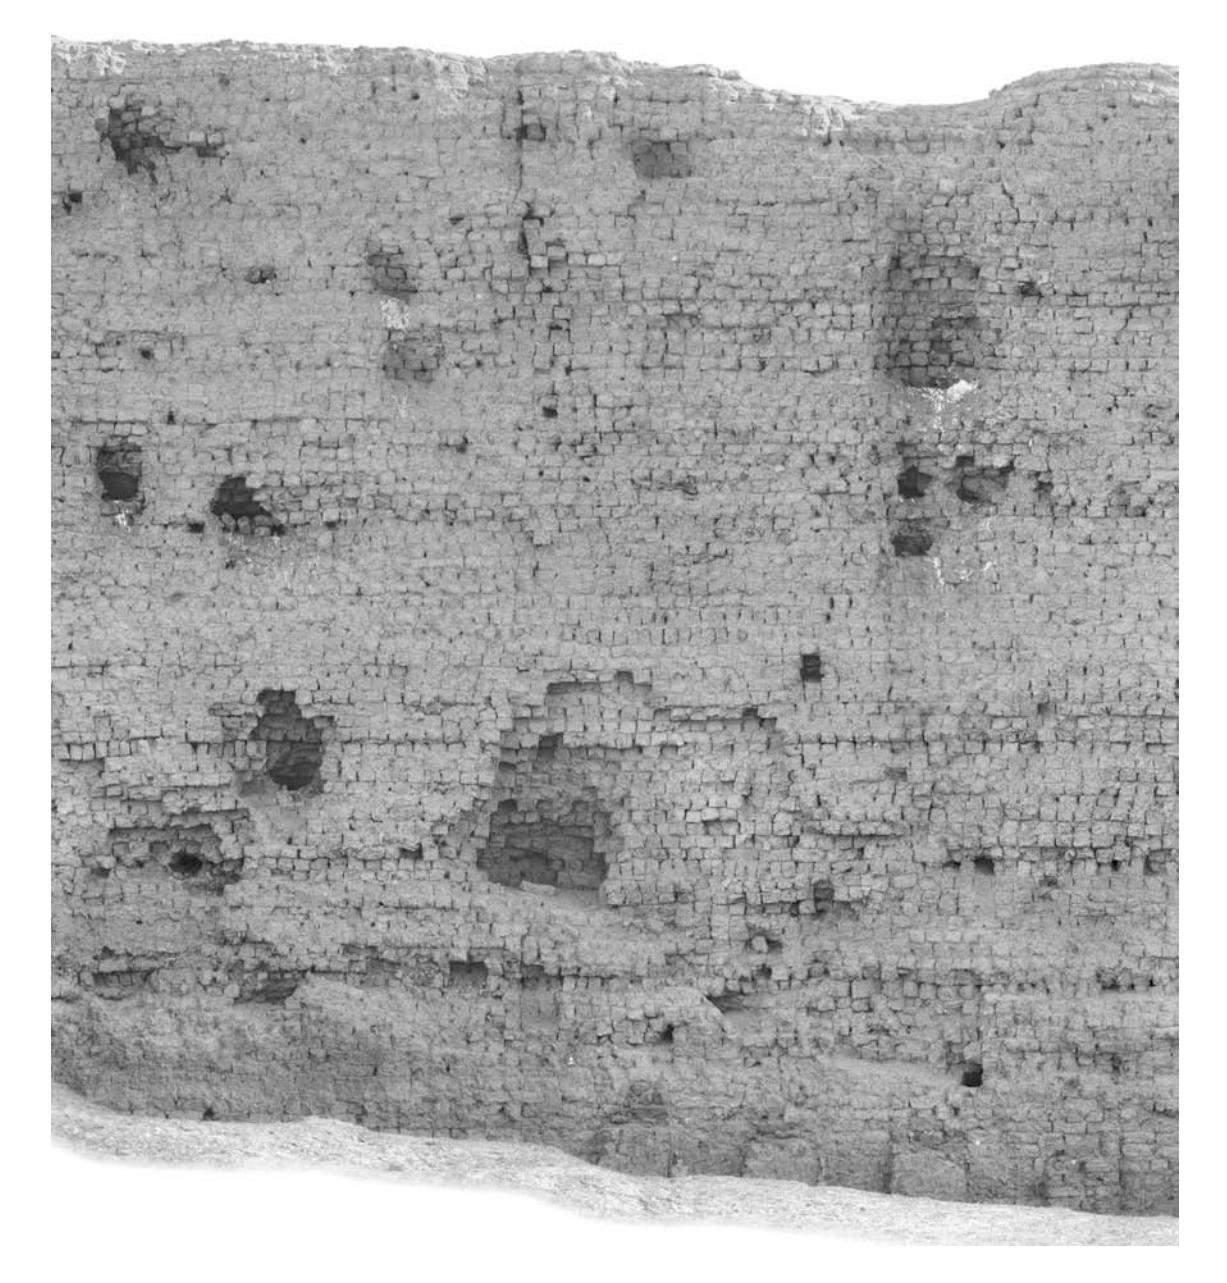
Figure 232. Detail of the typical distribution of small to medium-sized holes resulting from hornet activity in the exterior face of the west main enclosure wall, prior to stabilization. (Photoelevation: Heritage 3D, Inc. 2001)

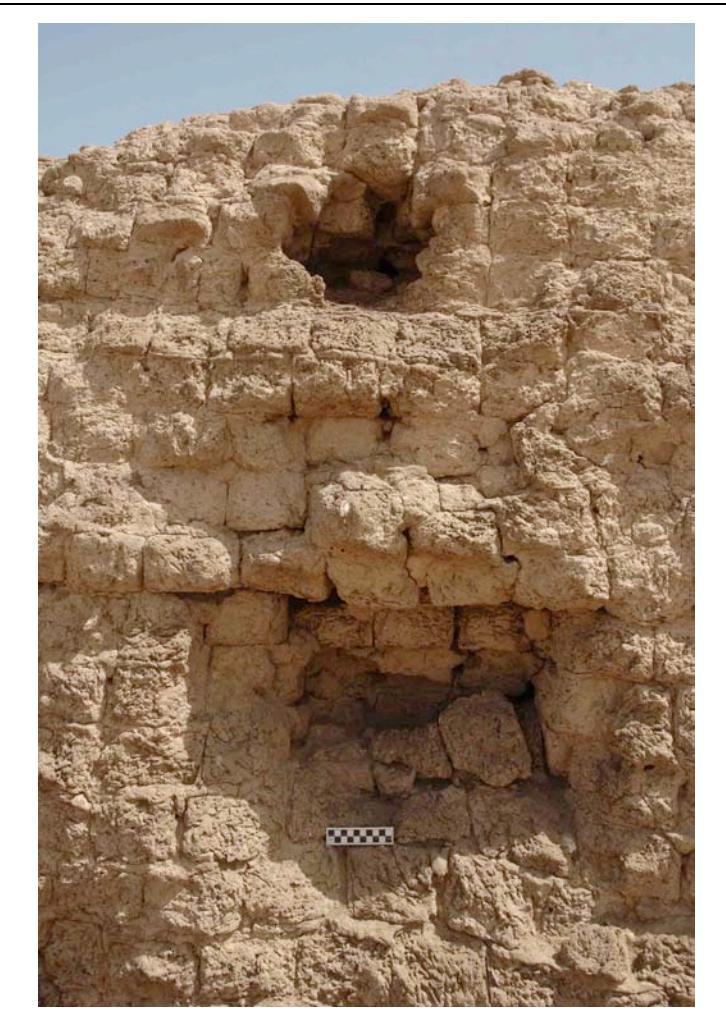
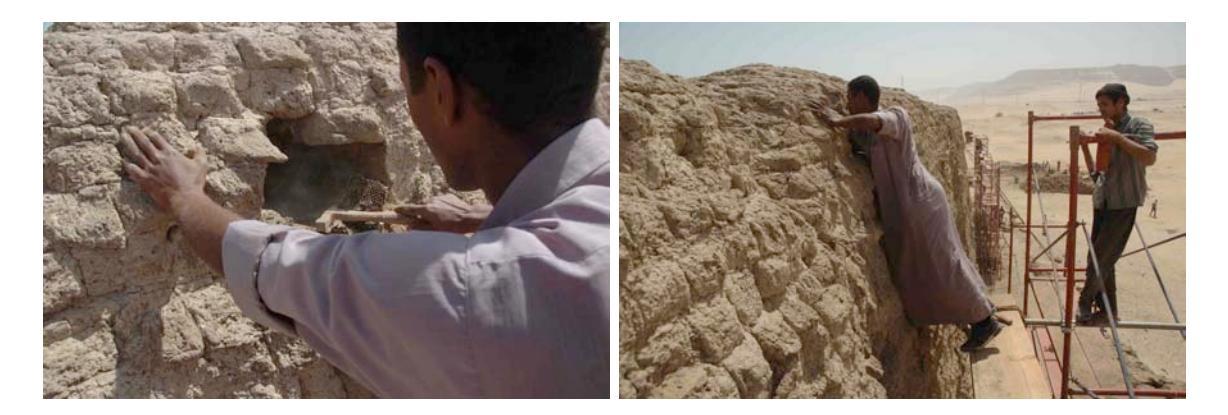
Figures 233, 234, 235. Details of two small holes in the upper, exterior face of the west main enclosure wall prior to stabilization (top) and during cleaning and repair (bottom, left and right); note that the actual extent of hornet-nest excavation into the wall is greater than the full extension of a man's arm (bottom right). (Photos: Jason Goodman 2005-2006)

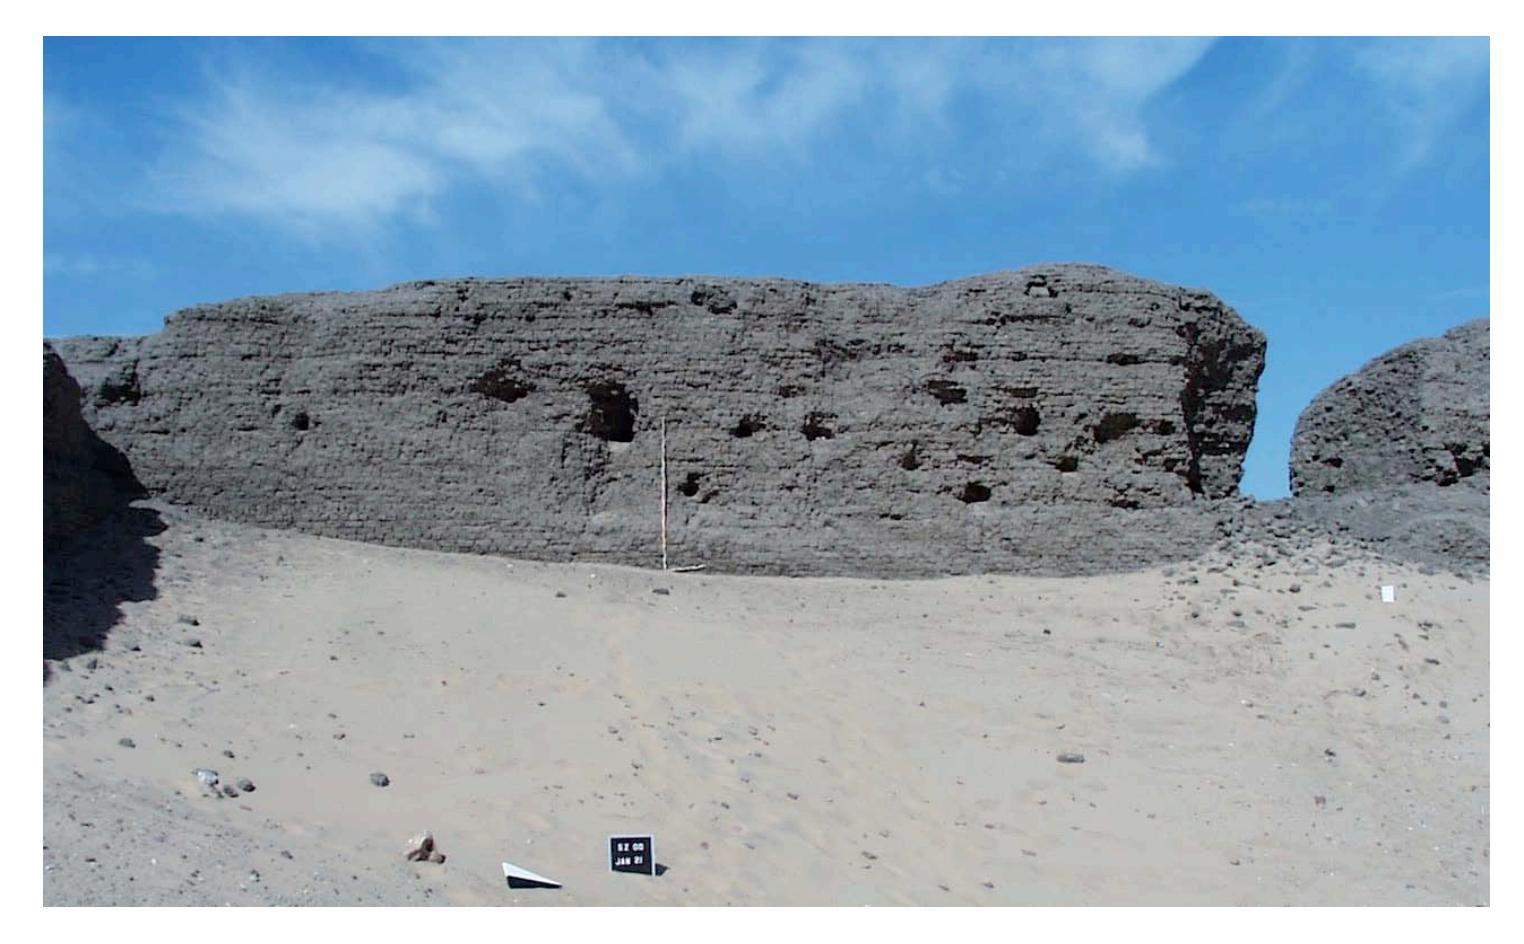
Figure 239. The western, interior face of the north main enclosure wall prior to architectural stabilization. (Photo: Richard Barnes 2000)

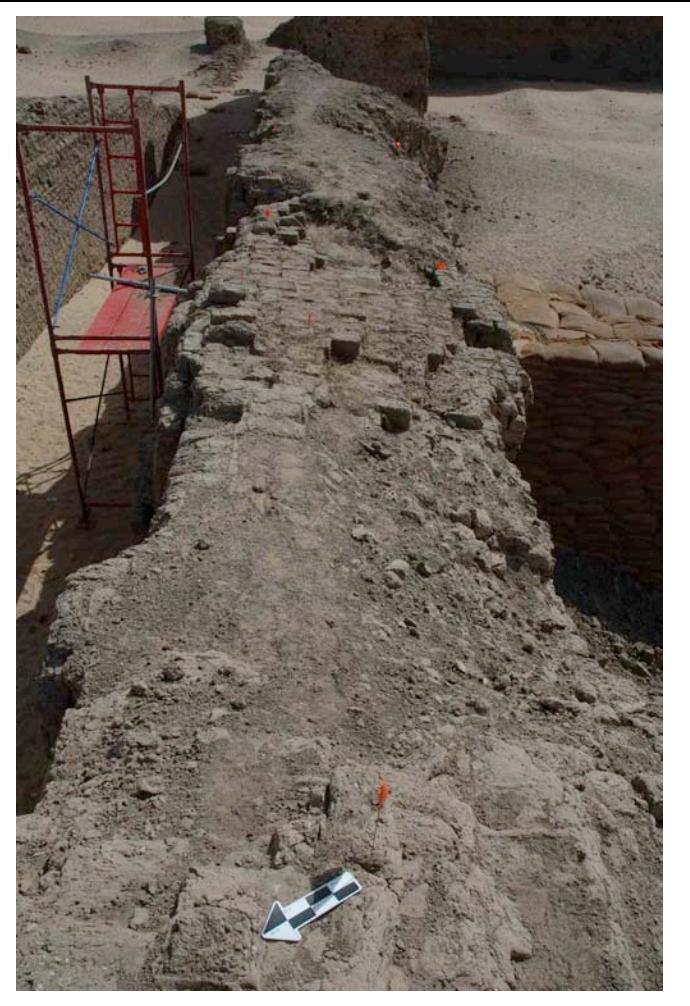
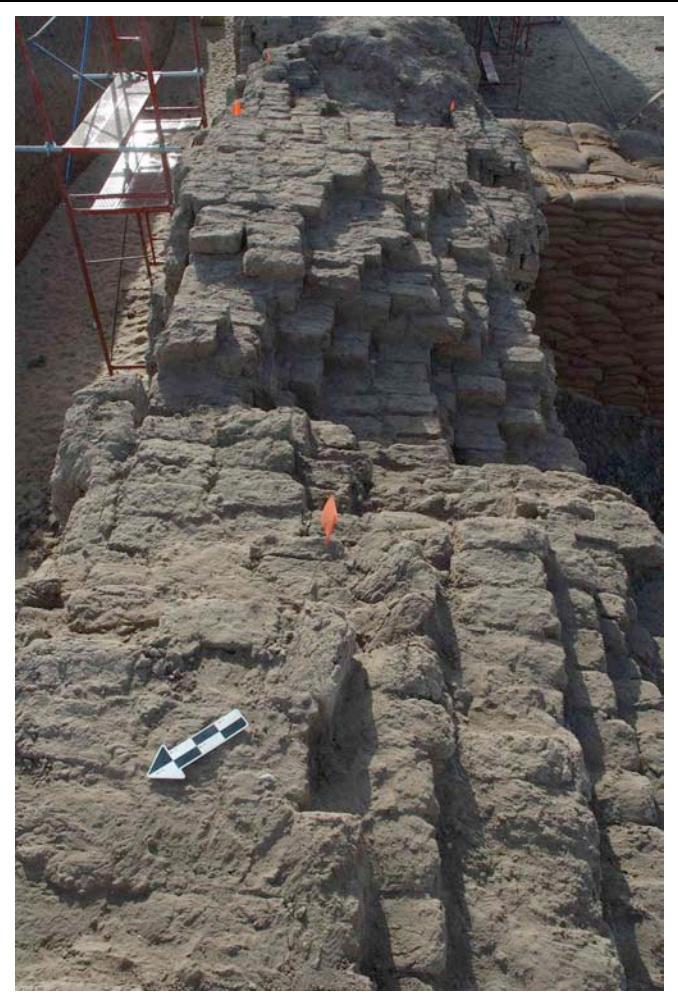
An urgent-priority through-wall crack in the central portion of the east main enclosure wall was stabilized and reinforced with new brickwork and geogrid during field season 5, and a second, related crack was opened and mended at this location in the following season (Figures 246-250). In association with these crack repairs, a large-scale mudbrick capping operation was implemented along the top of the east main enclosure wall in field season 5

Figures 248, 249. Details of stabilization work in progress on the top, central portion of the east main enclosure wall; the flagged area in the background (left and right) represents the structural crack that was stitched and capped in field season 5 (pictured in Figures 246 and 247, above) and the eroded area in the foreground represents the top of another deep structural crack in preparation for repair. (Photos: Robert Fletcher 2004-2005)

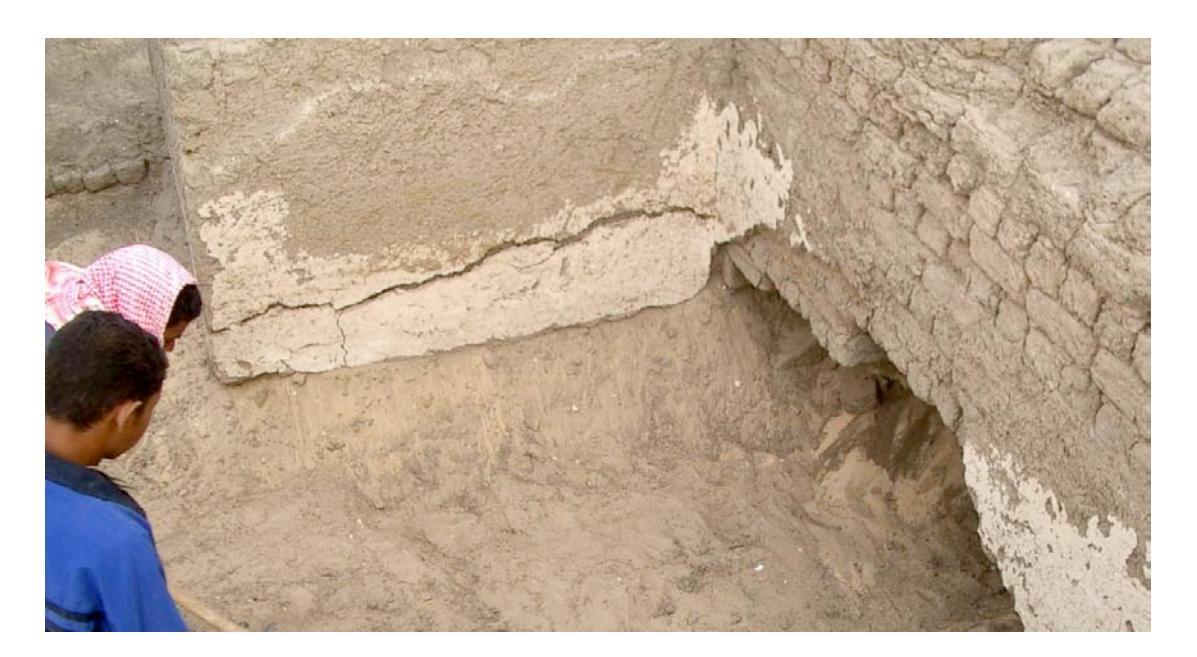
Figure 251. Detail of detached plaster in the north interior gateway chamber prior to removal and stabilization. (Photo: Robert Fletcher 2004-2005)

and carried into field season 6 (see Figures 247 and 250). Finally, during work on the northern end of the east main enclosure wall in field season 6, a large section of delaminated, original wall plaster was successfully reattached to its original location in the north interior gateway chamber (Figures 251-254; see also Figures 185-189 and 201-203, above).

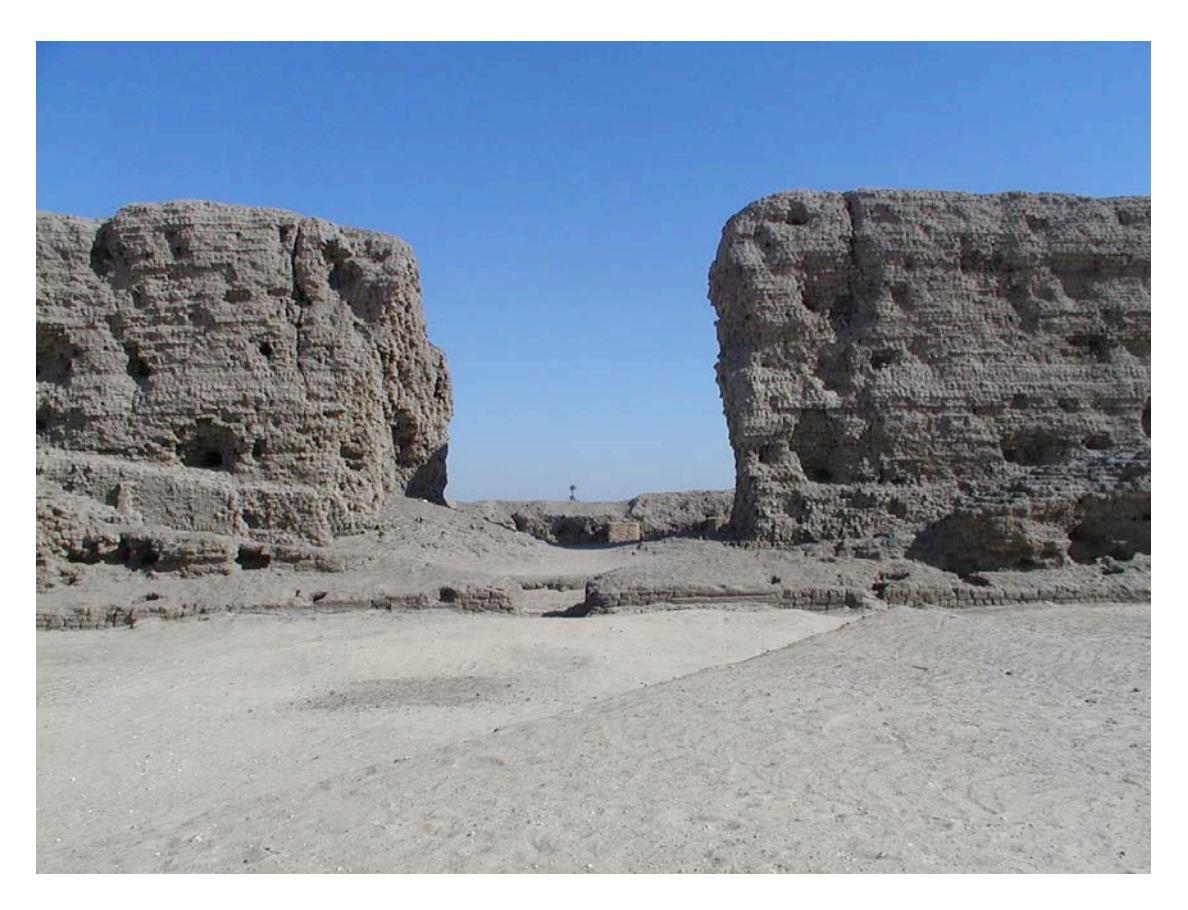
Stabilization of the west gateway began in field season 6 (2004-2005) and continued in field season 7 (2005-2006). As documented in early field seasons, the condition of the west gateway was extremely unstable. Inherent structural weakness and the loss of its original, presumably wooden, lintels had led to the collapse of the masonry above the gateway opening, which probably initiated the gradual cascading losses of additional original fabric

Figure 255. Exterior detail of the west gateway area prior to excavation or conservation work. (Photo: Robert Fletcher 2001)

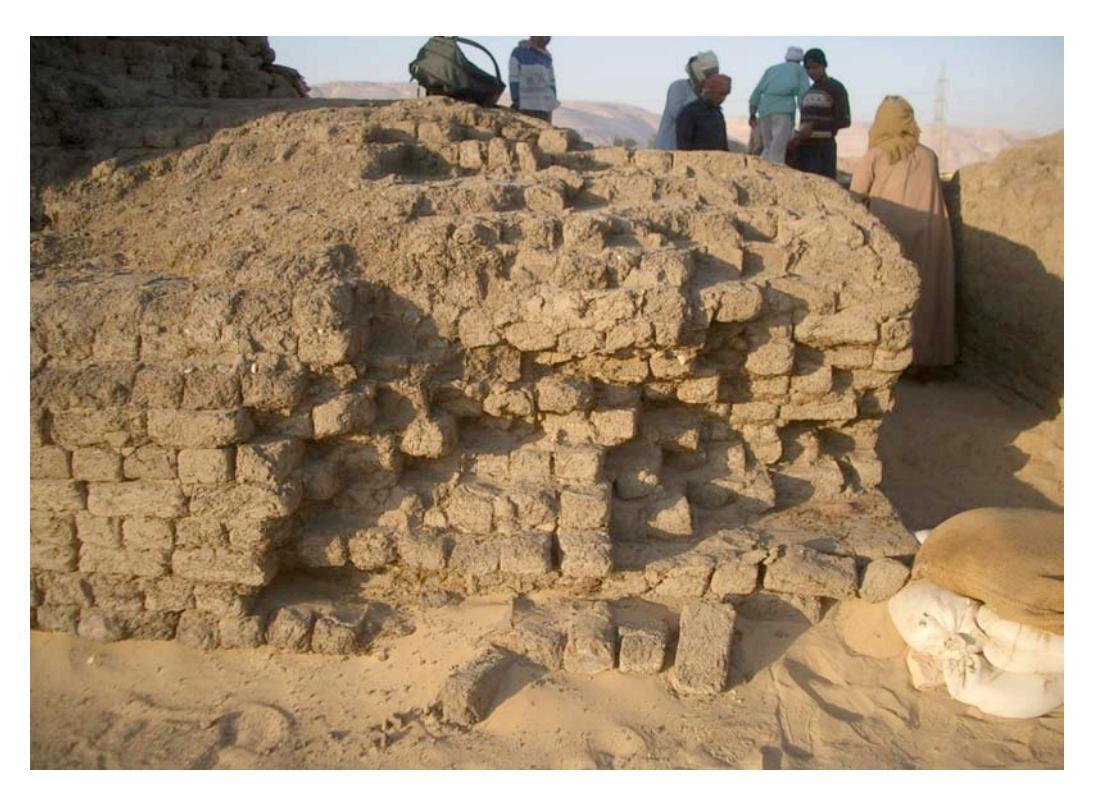
Figure 260. Detail of the base on the northern side of the west gateway opening, prior to stabilization. (Photo: Anthony Crosby 2004-2005)

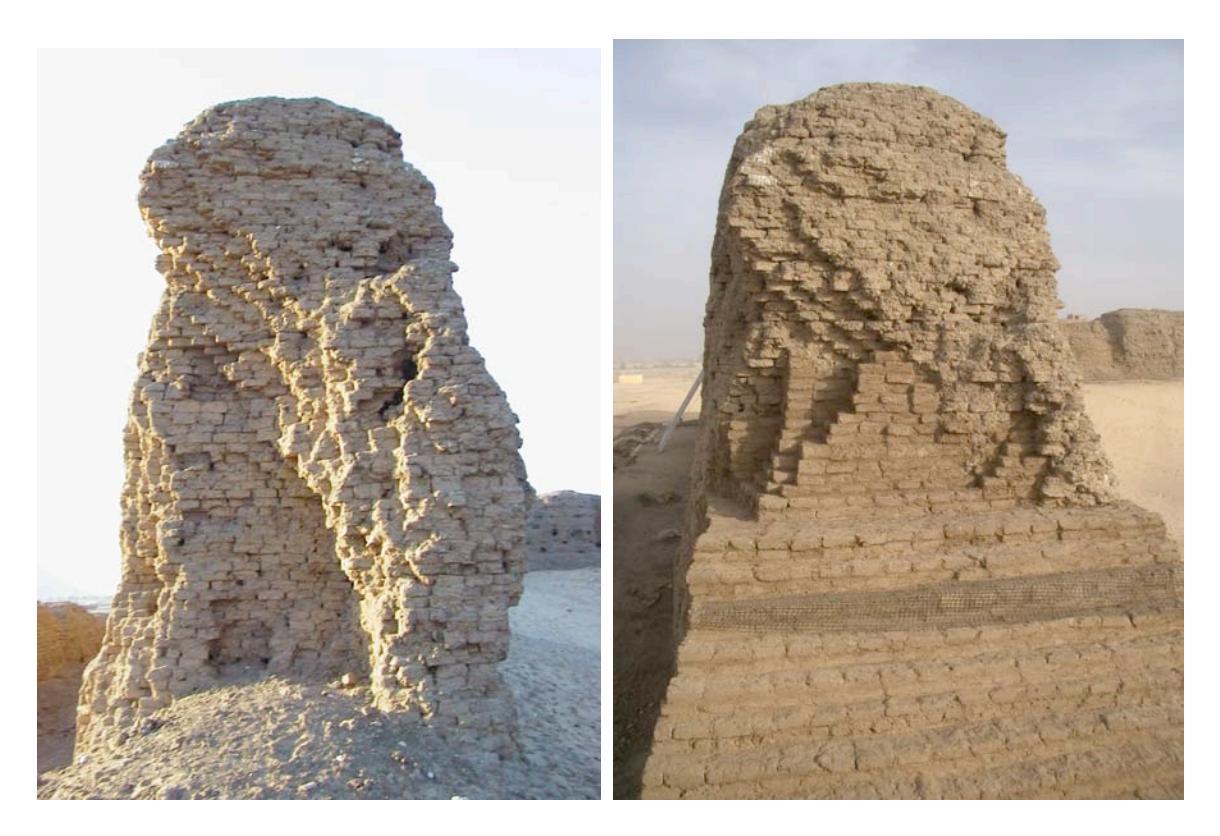
Figures 262, 263. Condition of the vertical wall end on the northern side of the west gateway prior to conservation (left) and following partial reconstruction (right). (Photos: Anthony Crosby 2000, 2005)

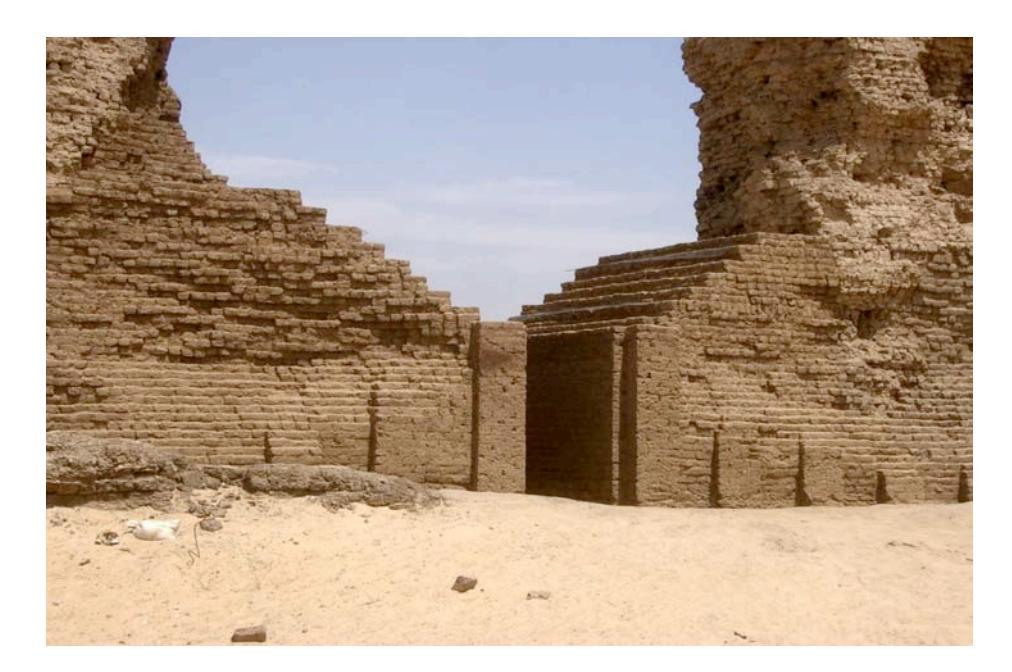
Figure 264. The overall effect of initial gateway stabilization in the west main enclosure wall following the first phase of reconstruction. (Photo: Anthony Crosby 2005)

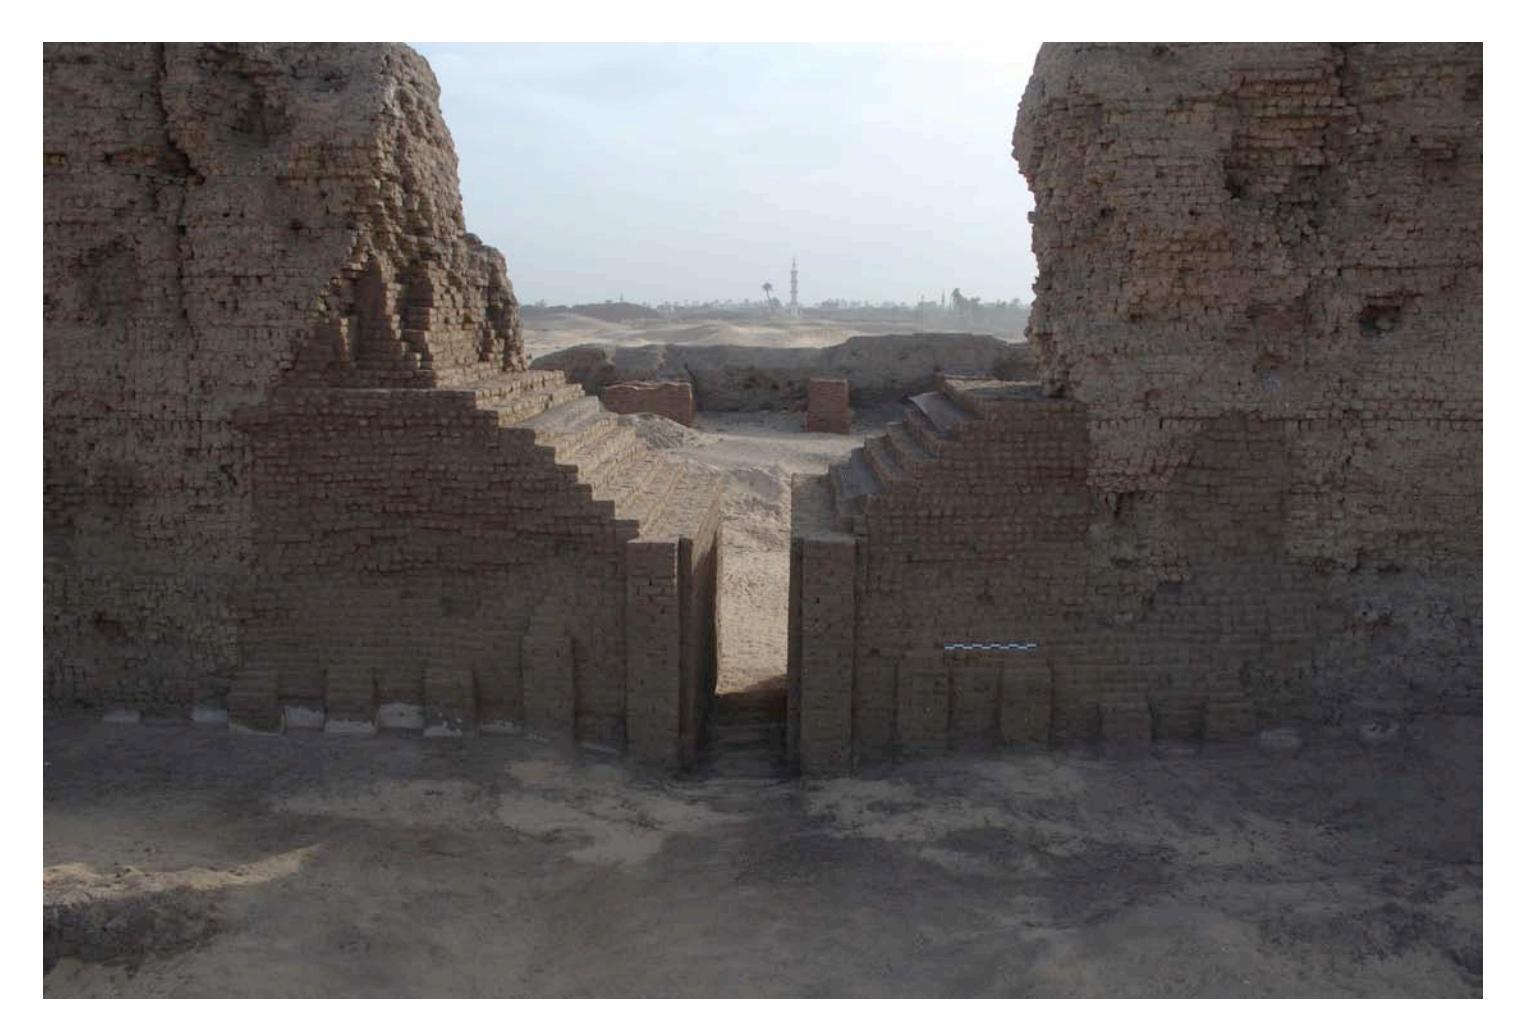
Figure 265. The partially reconstructed west gateway area at the close of field season 6. (Photo: Robert Fletcher 2004-2005)

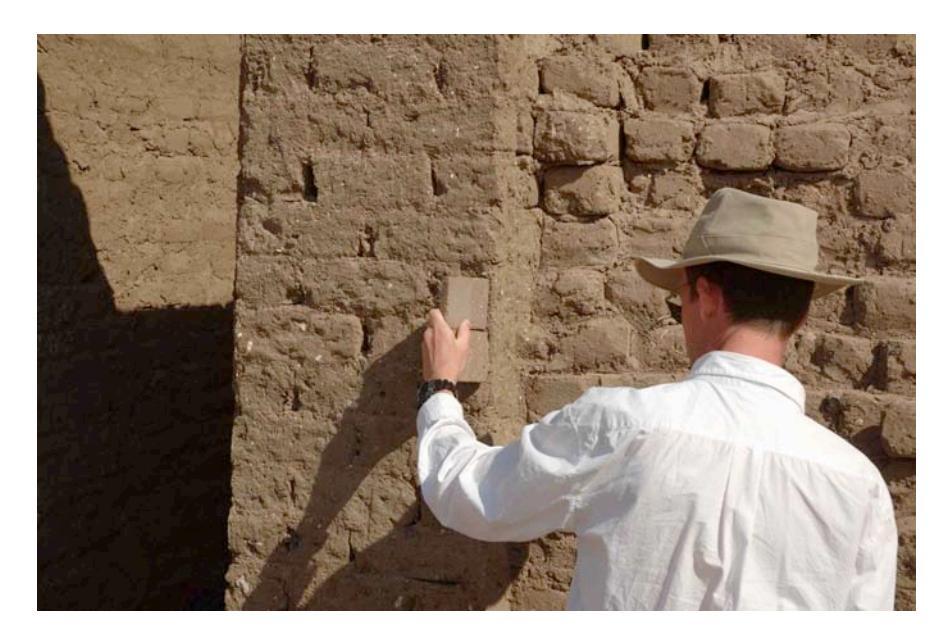
Figure 266. Testing to match the color of reinforced concrete, for use in partial gateway reconstruction, to the surrounding, original brickwork. (Photo: Robert Fletcher 2005-2006)

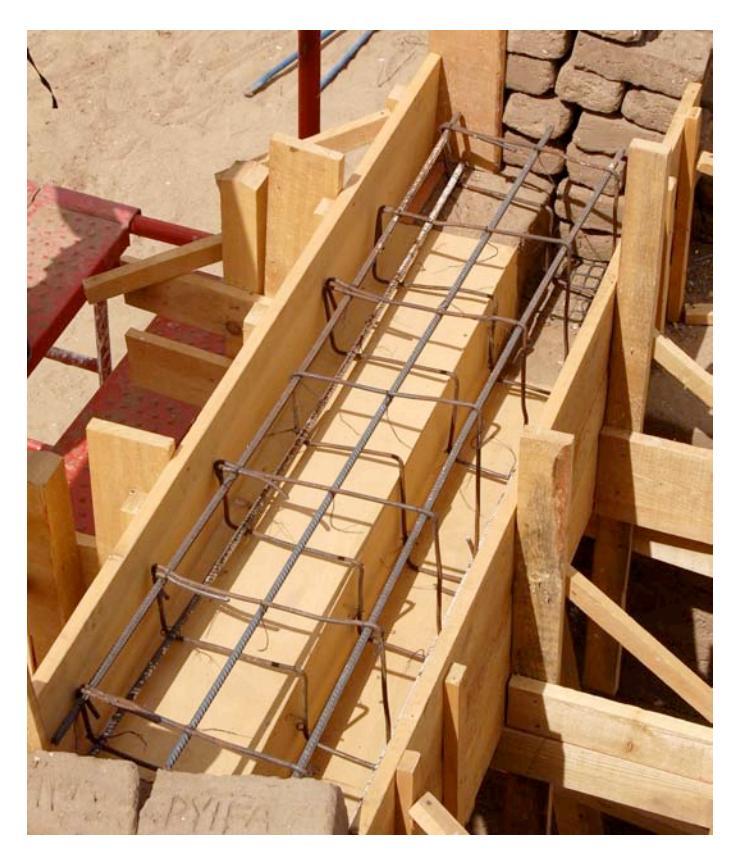
Figure 267. Wooden forms constructed for the roof lintels on the interior and exterior sides of the west gateway. (Photo: Anthony Crosby 2005)

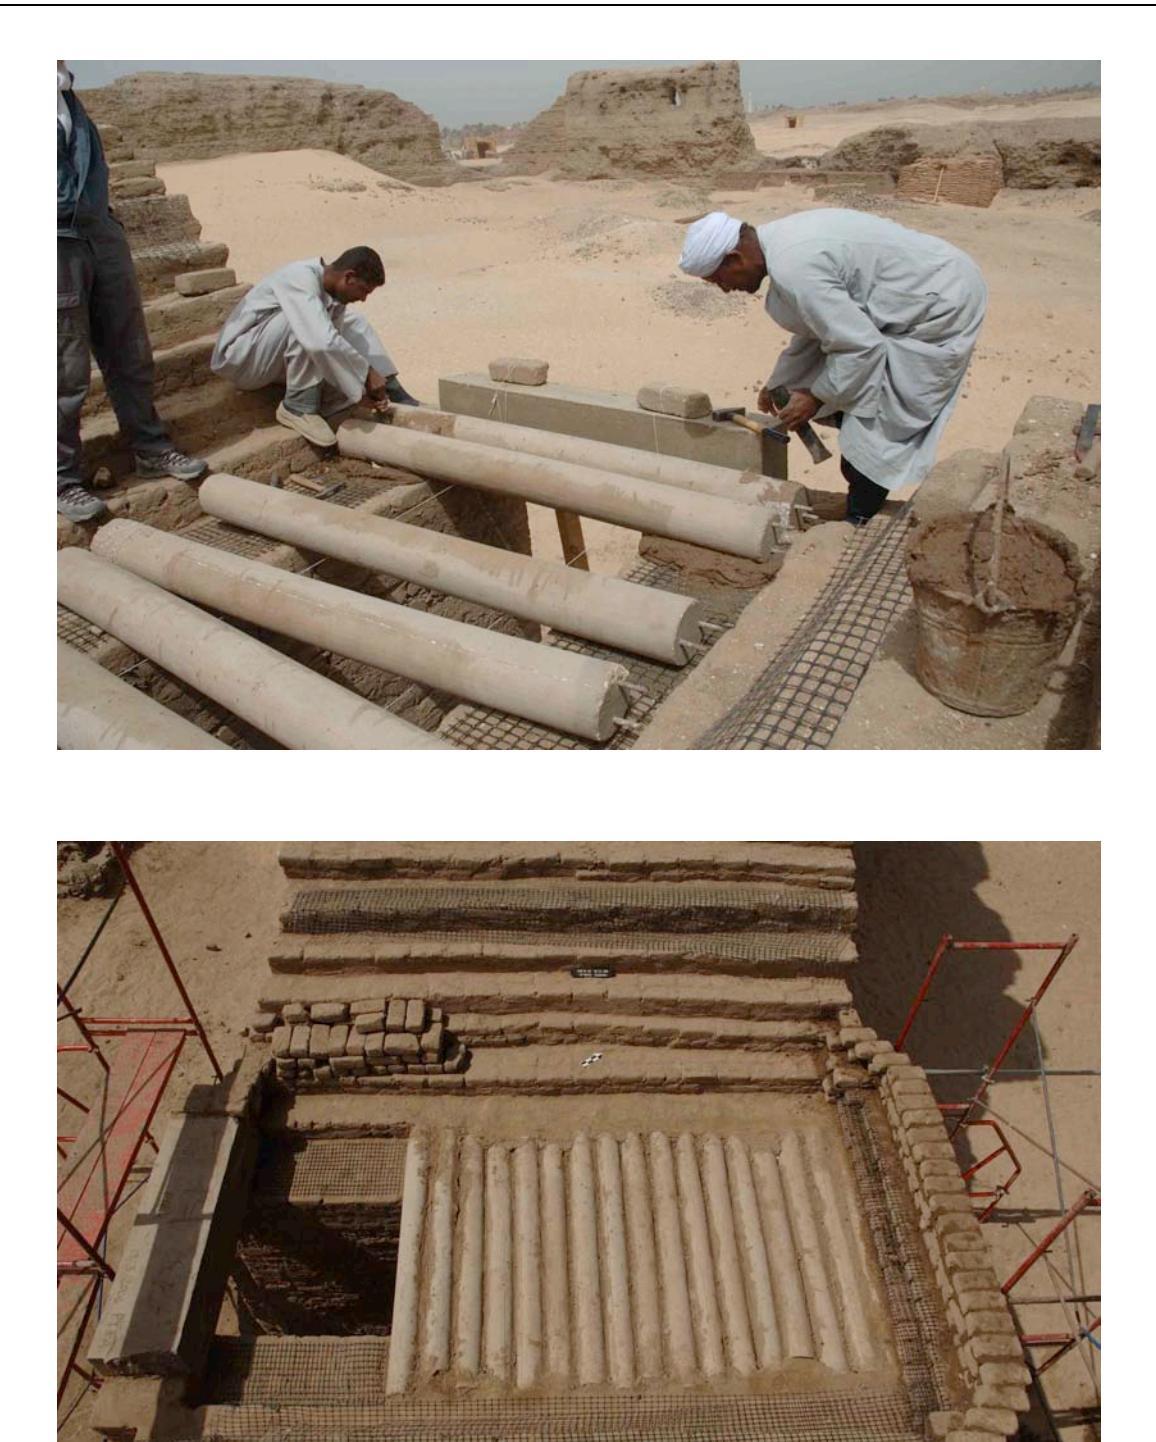
Figures 268, 269. Spanning the west gateway with reinforced-concrete poles, which were first cast in segments of heavy plastic pipe until fully set and then raised manually, maneuvered into place above the gateway opening and set into mud mortar; geogrid was placed under the poles on each side of the opening to provide a secure base for the mortar, which was also used to seal the seams between poles. (Photos: Jason Goodman 2005-2006)

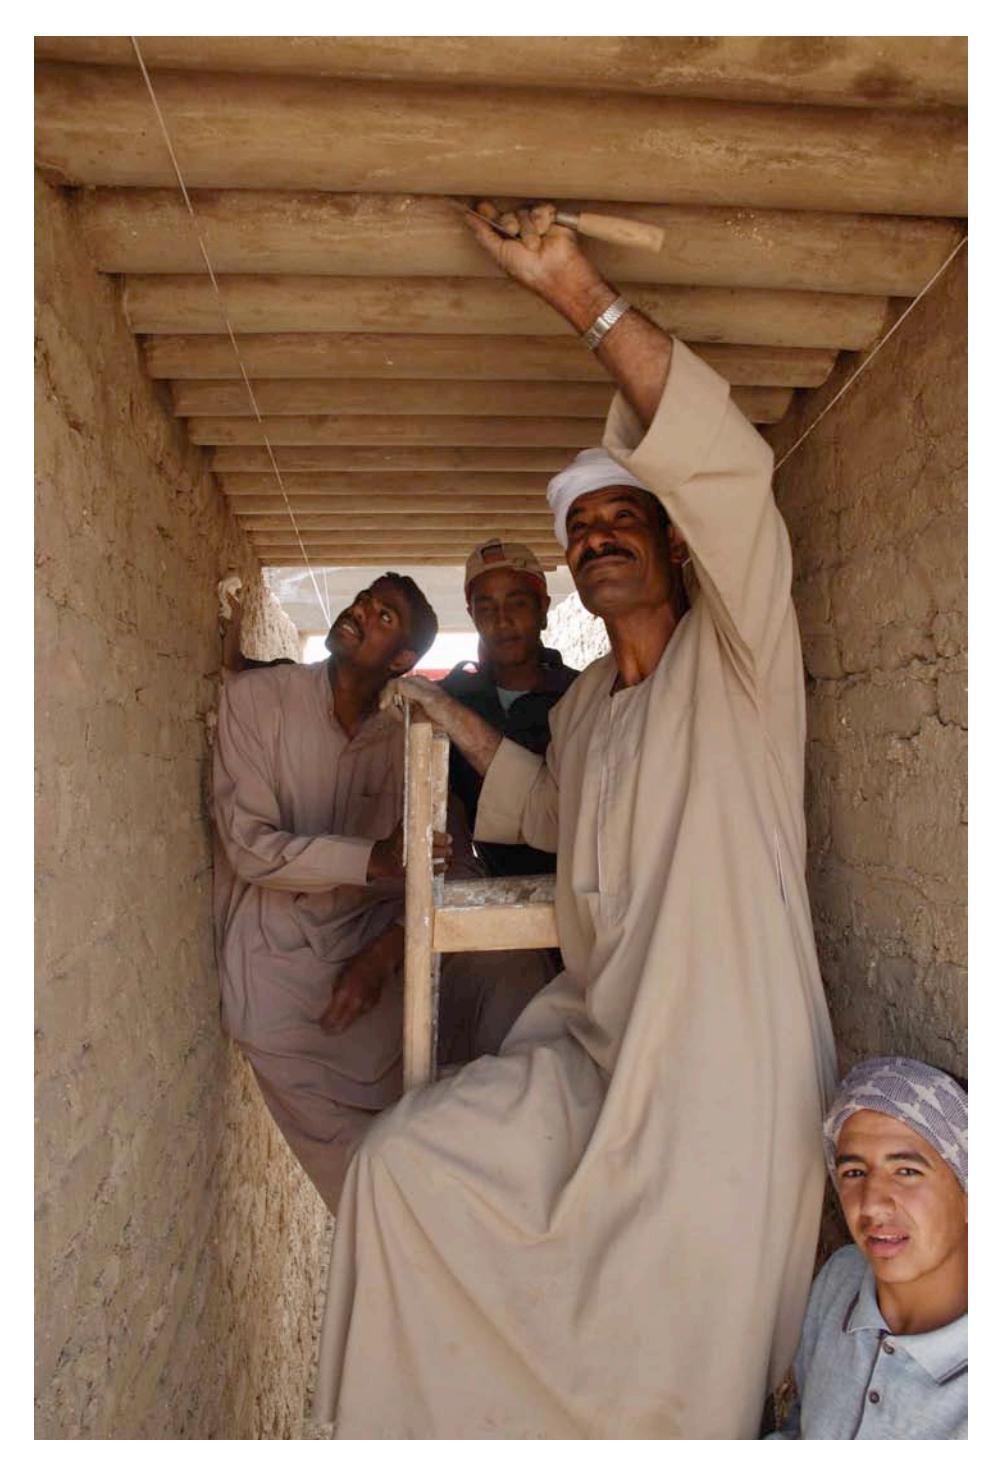
Figure 270. Pointing the underside of each seam in the roof of the west gateway during partial reconstruction. (Photo: Jason Goodman 2005-2006)

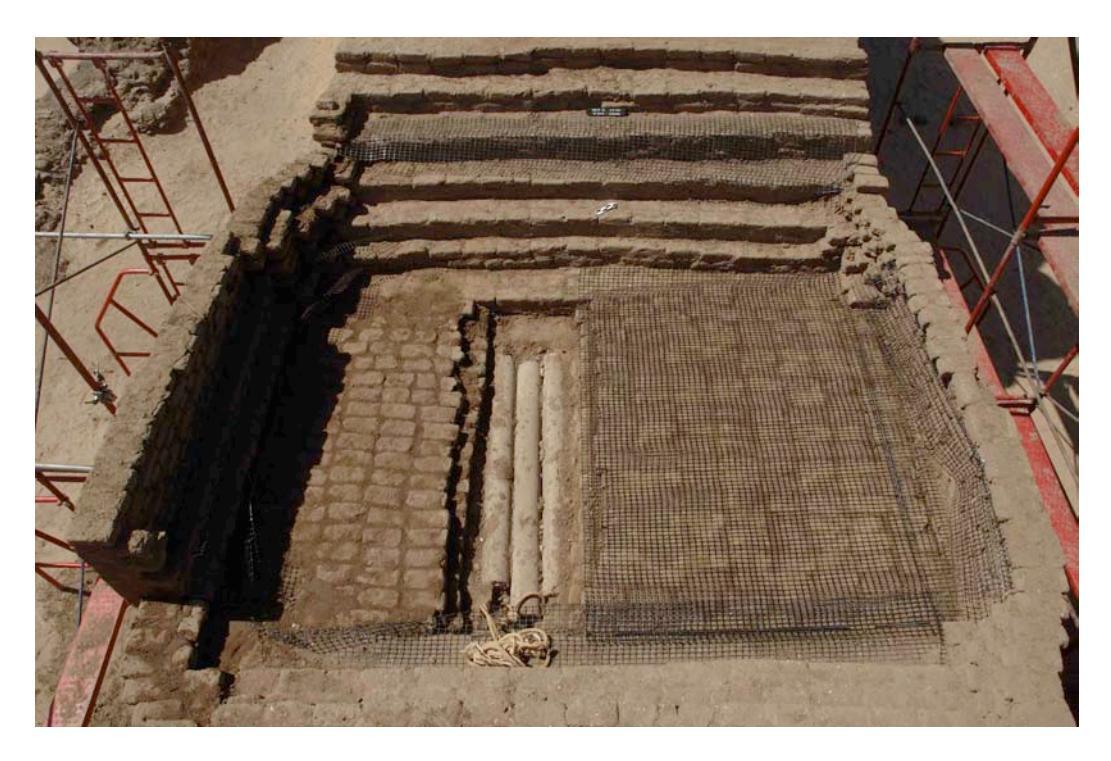
Figure 273. Stabilization in progress above the fully roofed west gateway opening, with geogrid installed for horizontal reinforcement. (Photo: Jason Goodman 2005-2006)

atop the new construction, but the pole elements were cast nearby and manually raised into position. Once the roofing of the gateway was completed, construction continued above the opening (see Figures 273 and 274). Geogrid was used to provide horizontal reinforcement to the masonry above the gateway opening. During field season 7, the new masonry reached a height of approximately one meter above the roof of the gateway, significantly below the projected top of the finished repair (see Figure 275). In a future season, the new masonry above the gateway will come within 1-2m of the existing wall tops on either side. This masonry will provide necessary structural support for the upper parts of the adjacent, vertical wall ends and will eliminate the risk of further significant losses in the gateway area. A gently sloping "dip" in the projected profile of the wall top will make a visual reference to the collapse of this part of the original wall.

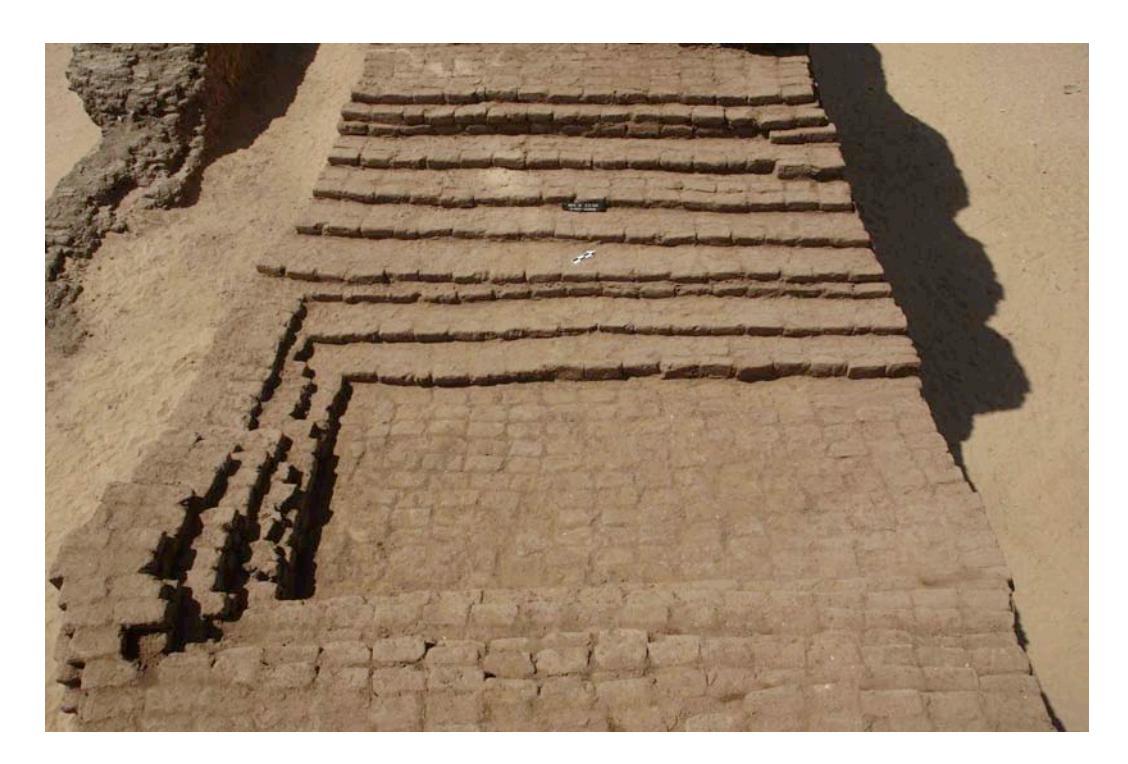
Figure 274. The top of the new construction above the west gateway opening at the close of field season 7. (Photo: Jason Goodman 2005-2006)

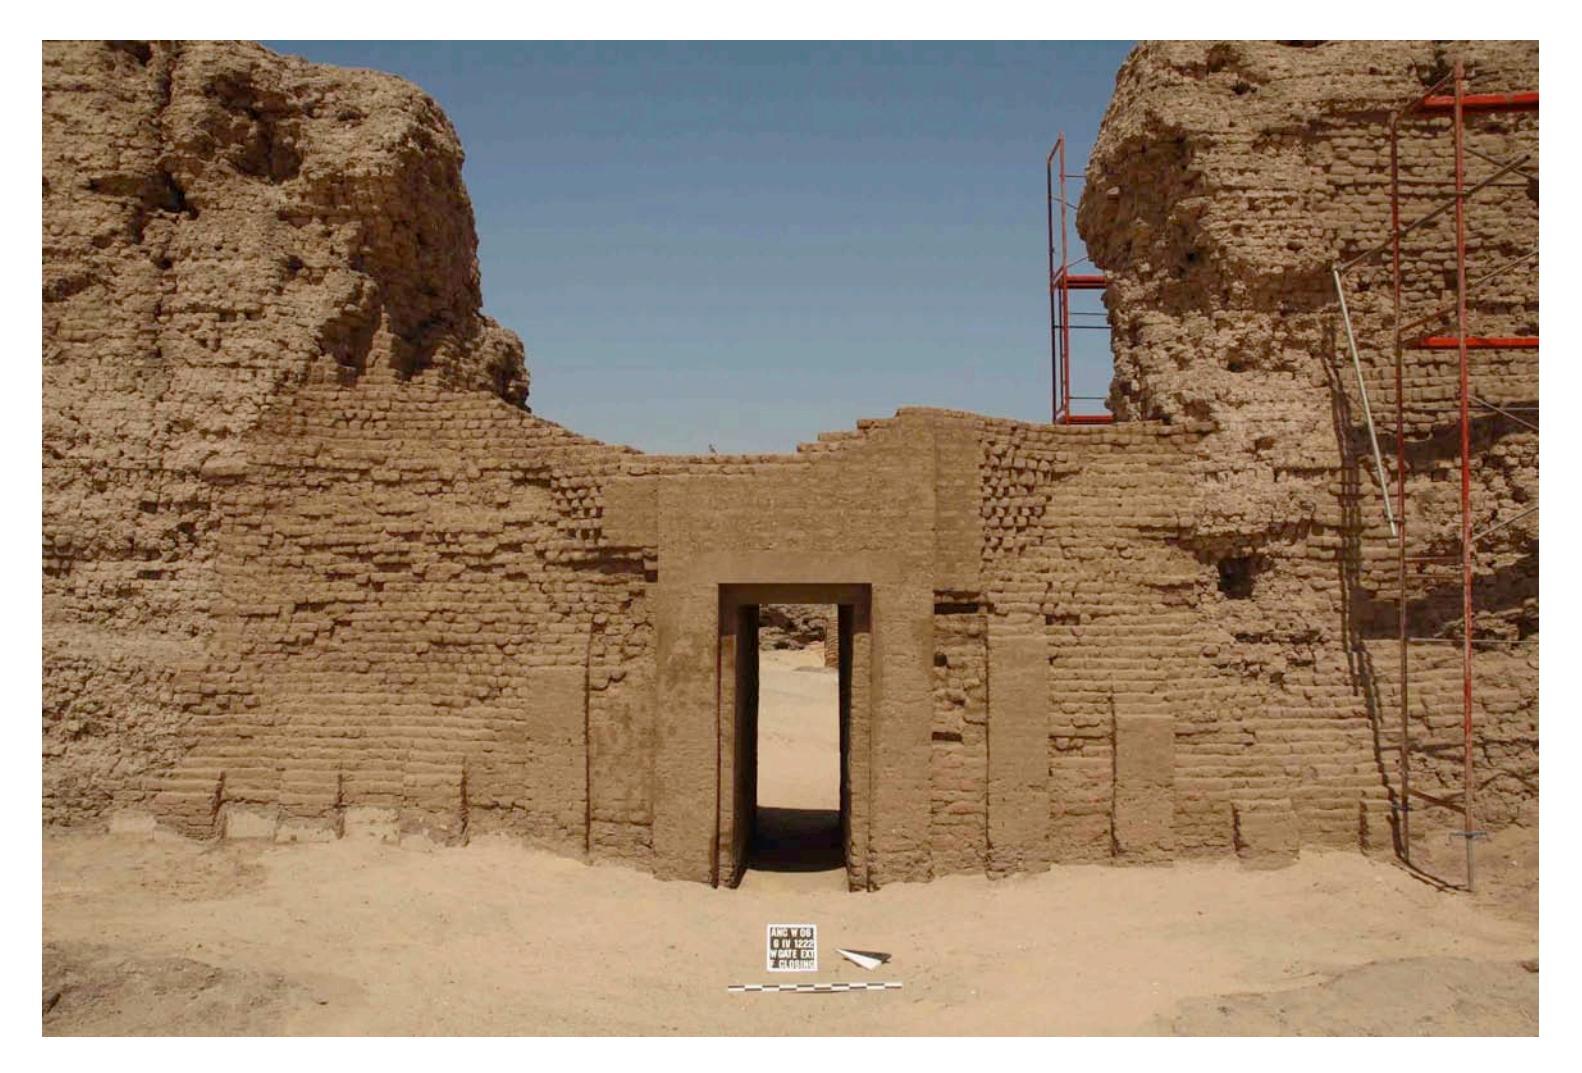
Figure 275. Exterior detail of the west gateway area following initial stabilization and partial reconstruction, pictured at the close of field season 7. (Photo: Jason Goodman 2005-2006)
