THE FUNERARY MONUMENT OF KING KHASEKHEMWY AT ABYDOS (ca. 2700 BCE): CONSERVATION AND ARCHAEOLOGY, 1999-2006

Final report on the "Documentation and Conservation of King Khasekhemwy's Funerary Monument at Abydos," a sub-project of the Egyptian Antiquities Project of the American Research Center in Egypt

2007

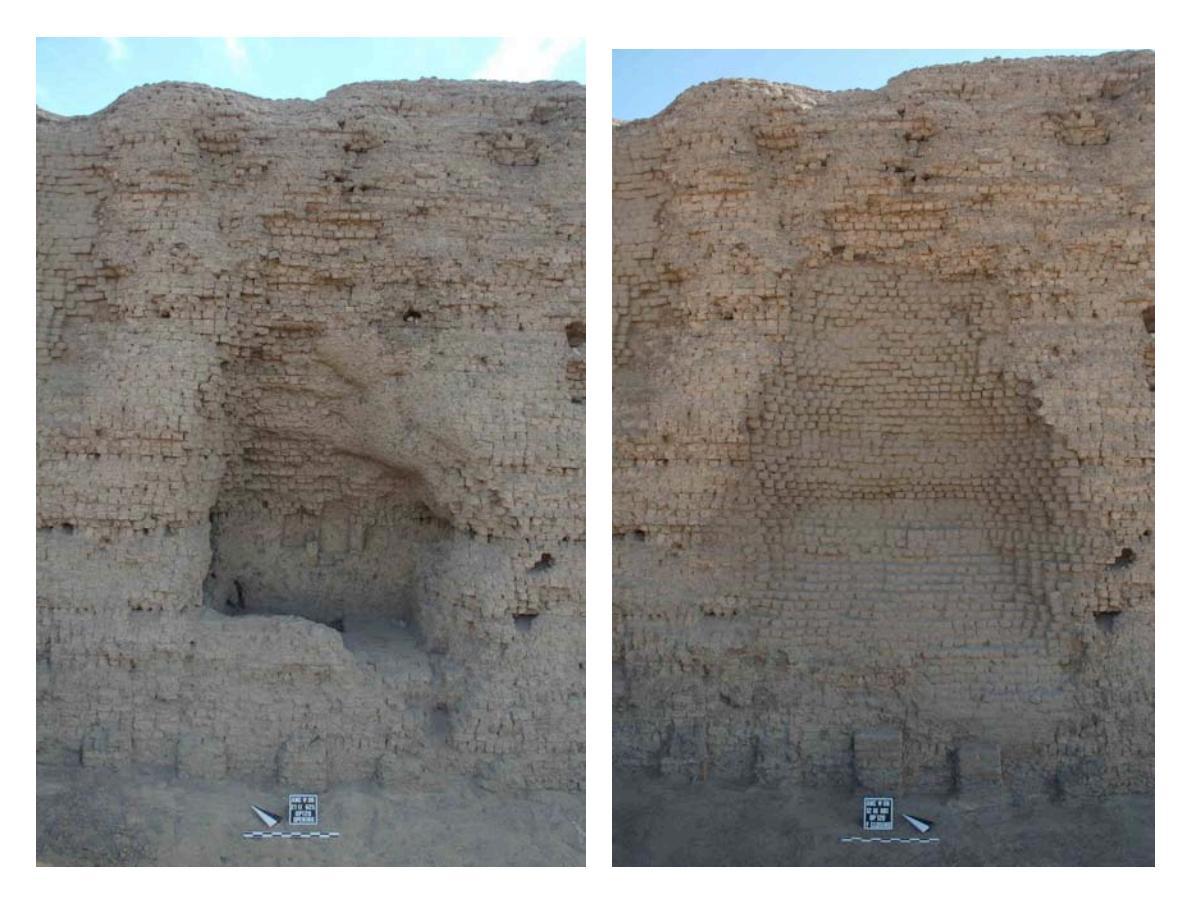
The voids in the west wall created by the creation and subsequent collapse of two monastic cells in the northern area represent the greatest threats to the general stability of this wall. The original fabric of the wall above and adjacent to these voids was in danger of collapse and required structural support. The most practical means of providing this support in keeping with the project's basic conservation approach is to replace the missing masonry from the voids, thereby providing support for the original wall fabric that is at risk and reestablishing the local stability of affected areas. This treatment involves the installation of new brickwork in the cell voids, which is built up to support the surrounding original fabric above and adjacent to the cavities (Figures 276 and 277). Although reconstruction of the missing masonry in these areas does not destroy the remains of the cells, and the interventions are ultimately reversible, the new masonry does obscure the cells indefinitely. As such, all monastic features that are to be altered by conservation work are systematically documented as part of the monument's archaeological record, which includes photography and detailed architectural illustration in plan, elevation and section. In this way, although the features themselves become inaccessible, their archaeological and architectural detail is captured and preserved. In addition, significant features of the cells, such as plastered surfaces, receive conservation treatment as needed, and all original features are covered prior to new construction by a protective layer of clean, sieved sand (approximately 5cm thick) that separates them from the new, infilled masonry. As the level of new construction rises in a cell, the new masonry is held back approximately 5cm from preserved vertical surfaces and other original features, and clean sand is deposited between these features and the new brick masonry (Figures 278-283). The finished exterior surface of the new brick infilling is held back from the existing wall face and is constructed with a slightly concave profile to create a visual reference to the presence of the cells and to thus preserve the significance of their phase in the history of the monument (see Figure 277).

Figures 276, 277. Details of a monastic cell cavity on the exterior face of the west main enclosure wall before and after intervention (left and right, respectively), illustrating the general method of cell-void stabilization. (Photos: Jason Goodman 2005-2006)

The monastic cell excavated as Operation 120 was not as large as a number of others in the west wall, and the void it created in the wall was consequently relatively small (see Figure 292). The cell void was excavated in field season 6 and architecturally documented in field season 7 (see Archaeological Investigation of the Monument, to follow). The basic process of stabilization was the same as in other cell voids, including the use of a sand barrier to protect preserved original features and the use of geogrid for horizontal reinforcement in the new construction. In the course of infilling, a large and apparently inactive mud-wasp nest was removed from the upper part of the cell void to allow the new masonry to key with the original fabric of the wall (Figures 301 and 302). Loose and overhanging brickwork at the upper edge of the cell void was also removed, and a large hornet nest hole adjacent to the northern, top end of the void was filled. The before and after condition of this cell void is illustrated in Figures 276 and 277, above.

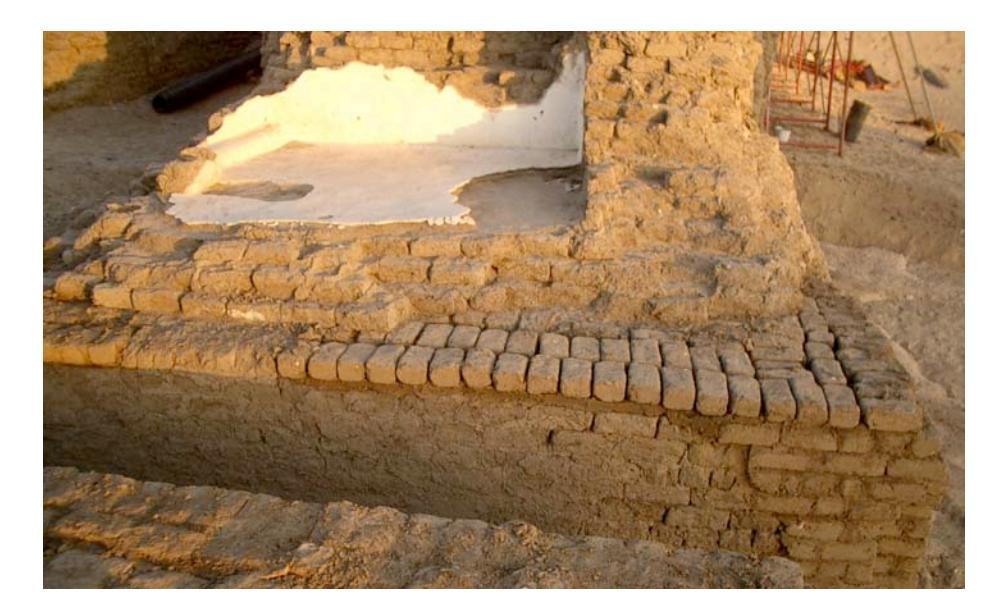
Figure 278. Preliminary stabilization of the wall base adjacent to a monastic cell in the west gateway. (Photo: Anthony Crosby 2005)

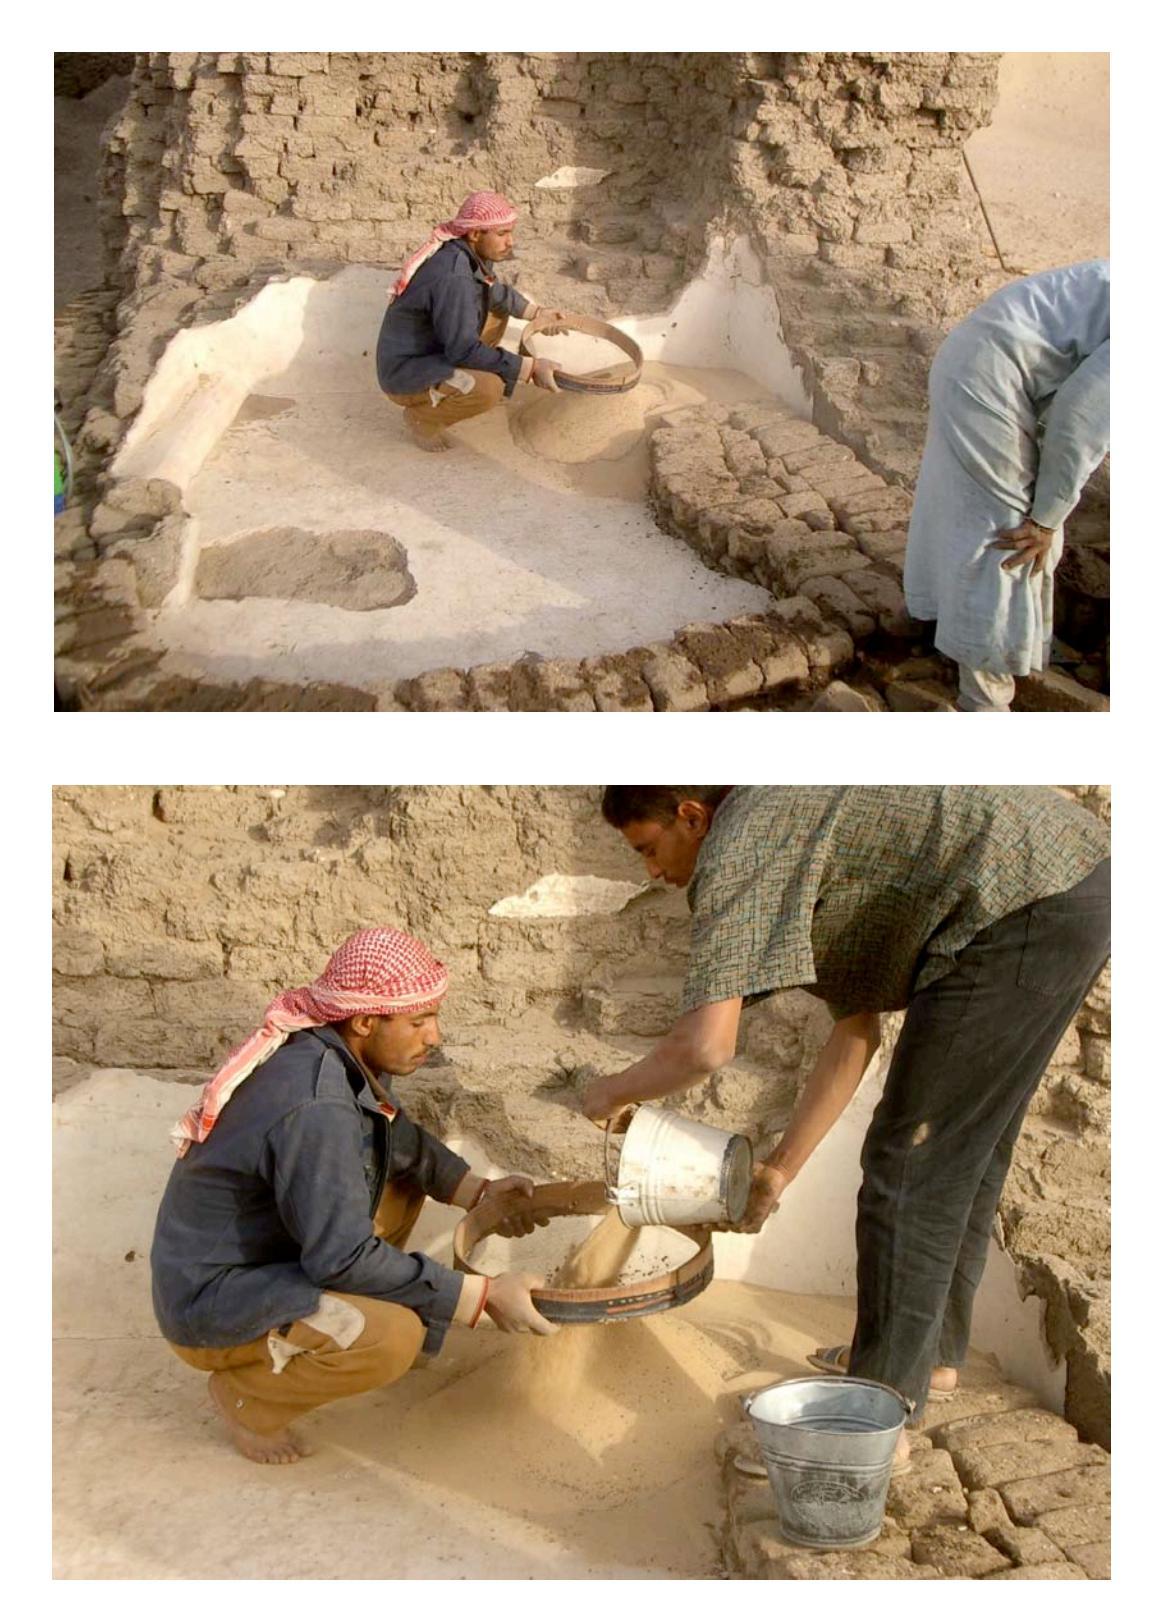
Figures 279, 280. Adding a layer of clean sand to protect the plastered floor and walls of the monastic cell pictured in Figure 278, above, prior to installing new masonry. (Photos: Anthony Crosby 2005)

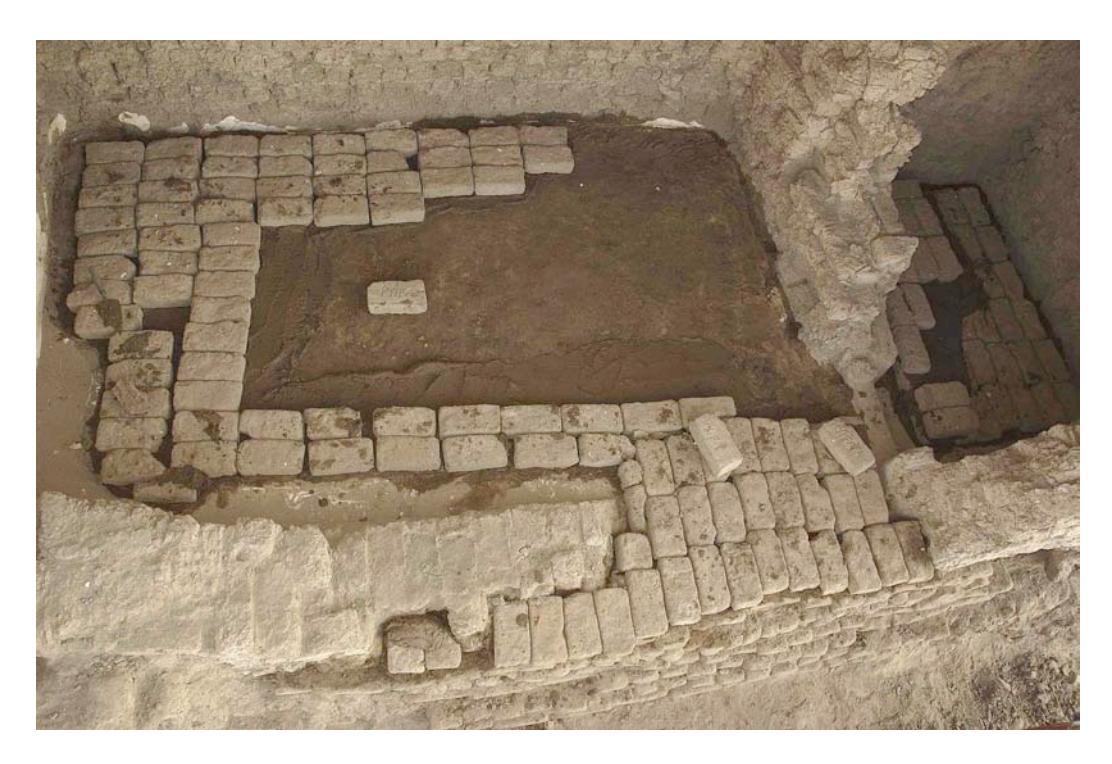
Figure 281. Detail of partially infilled masonry above the protected floor of a monastic cell cavity in the west main enclosure wall. (Photo: Robert Fletcher 2005-2006)

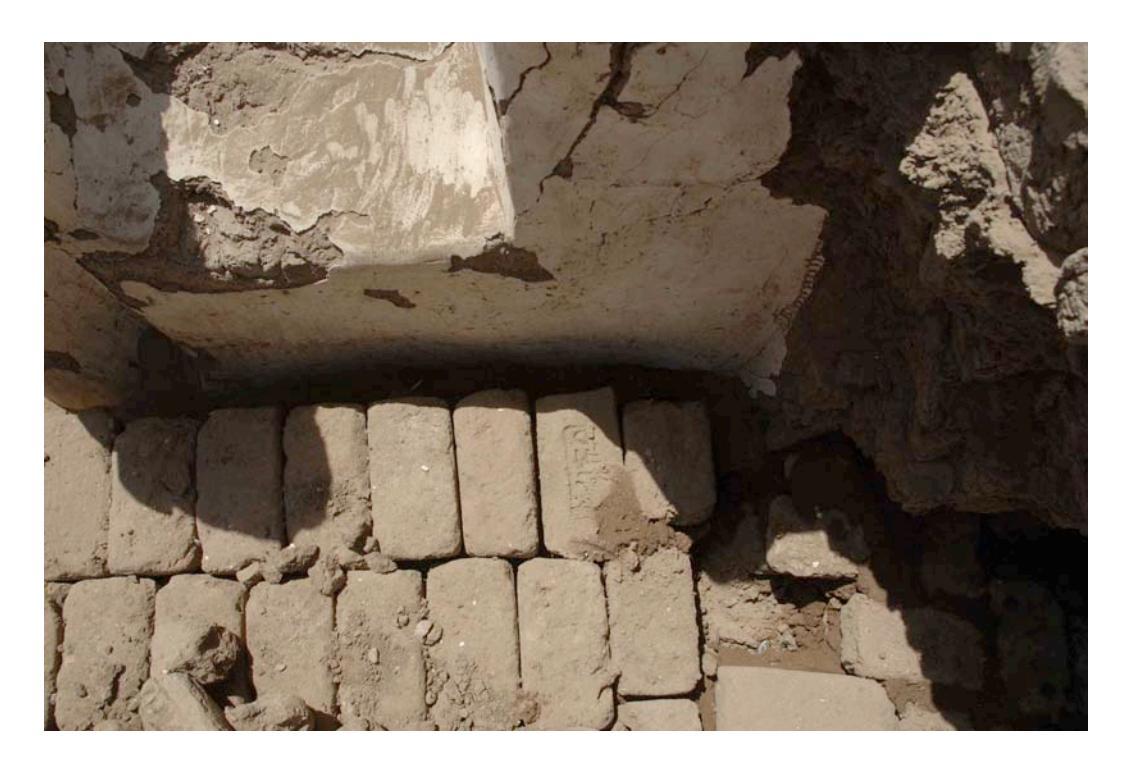
Figure 282. Detail of the typical 5cm gap left between new brick infilling and preserved cell walls. (Photo: Jason Goodman 2005-2006)

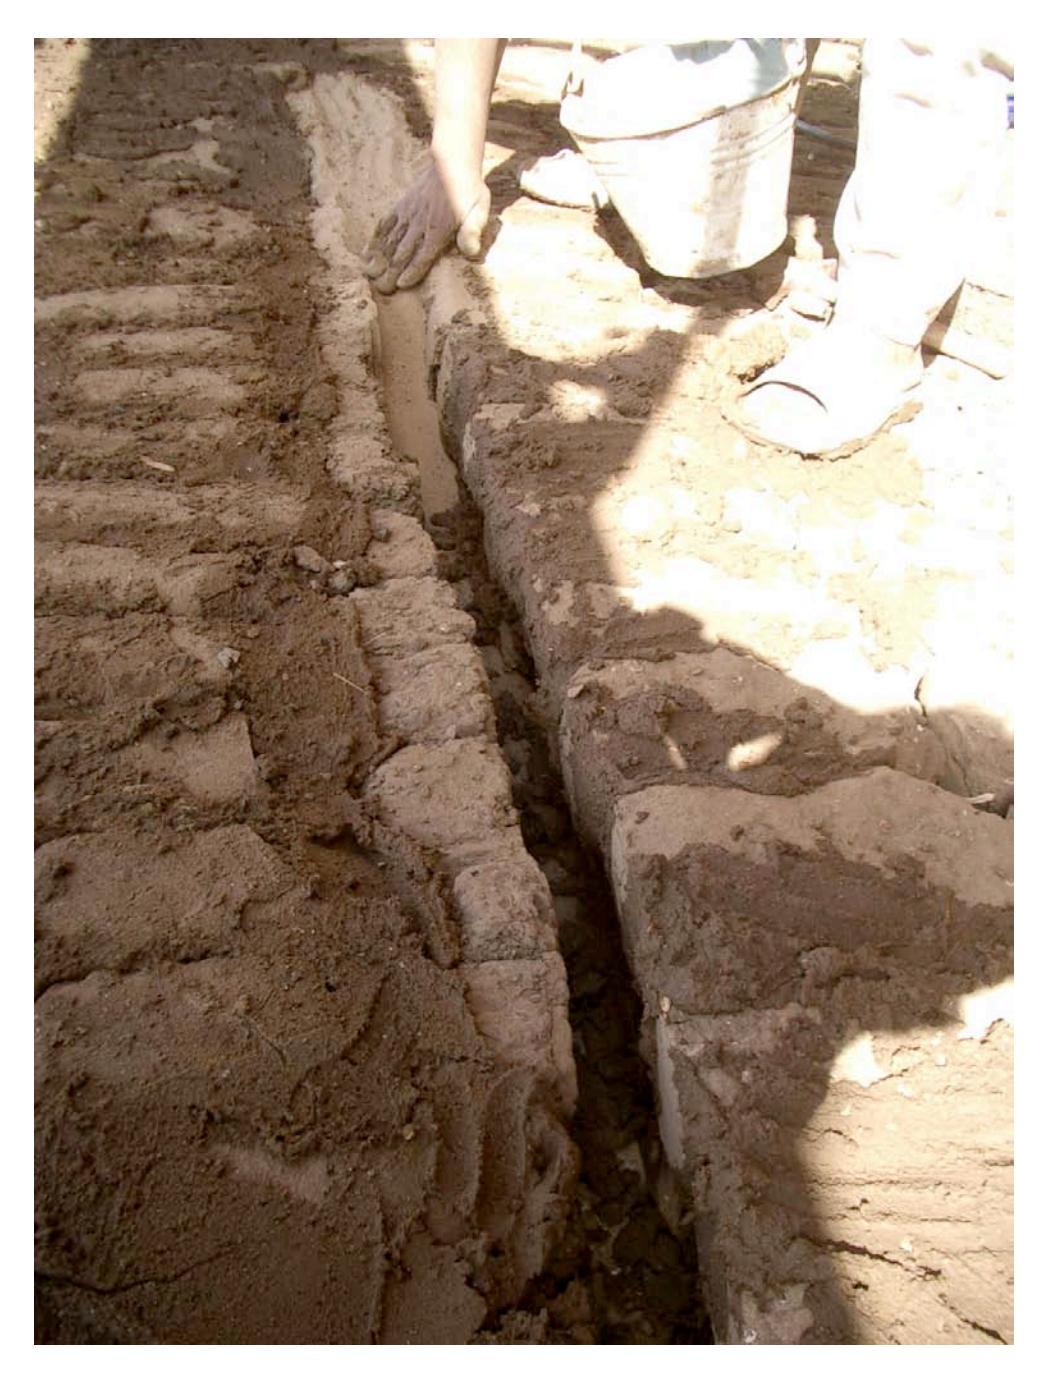
Figure 283. Adding clean sand to the protective gap left between the brick infilling and the original wall plaster of a monastic cell. (Photo: Anthony Crosby)

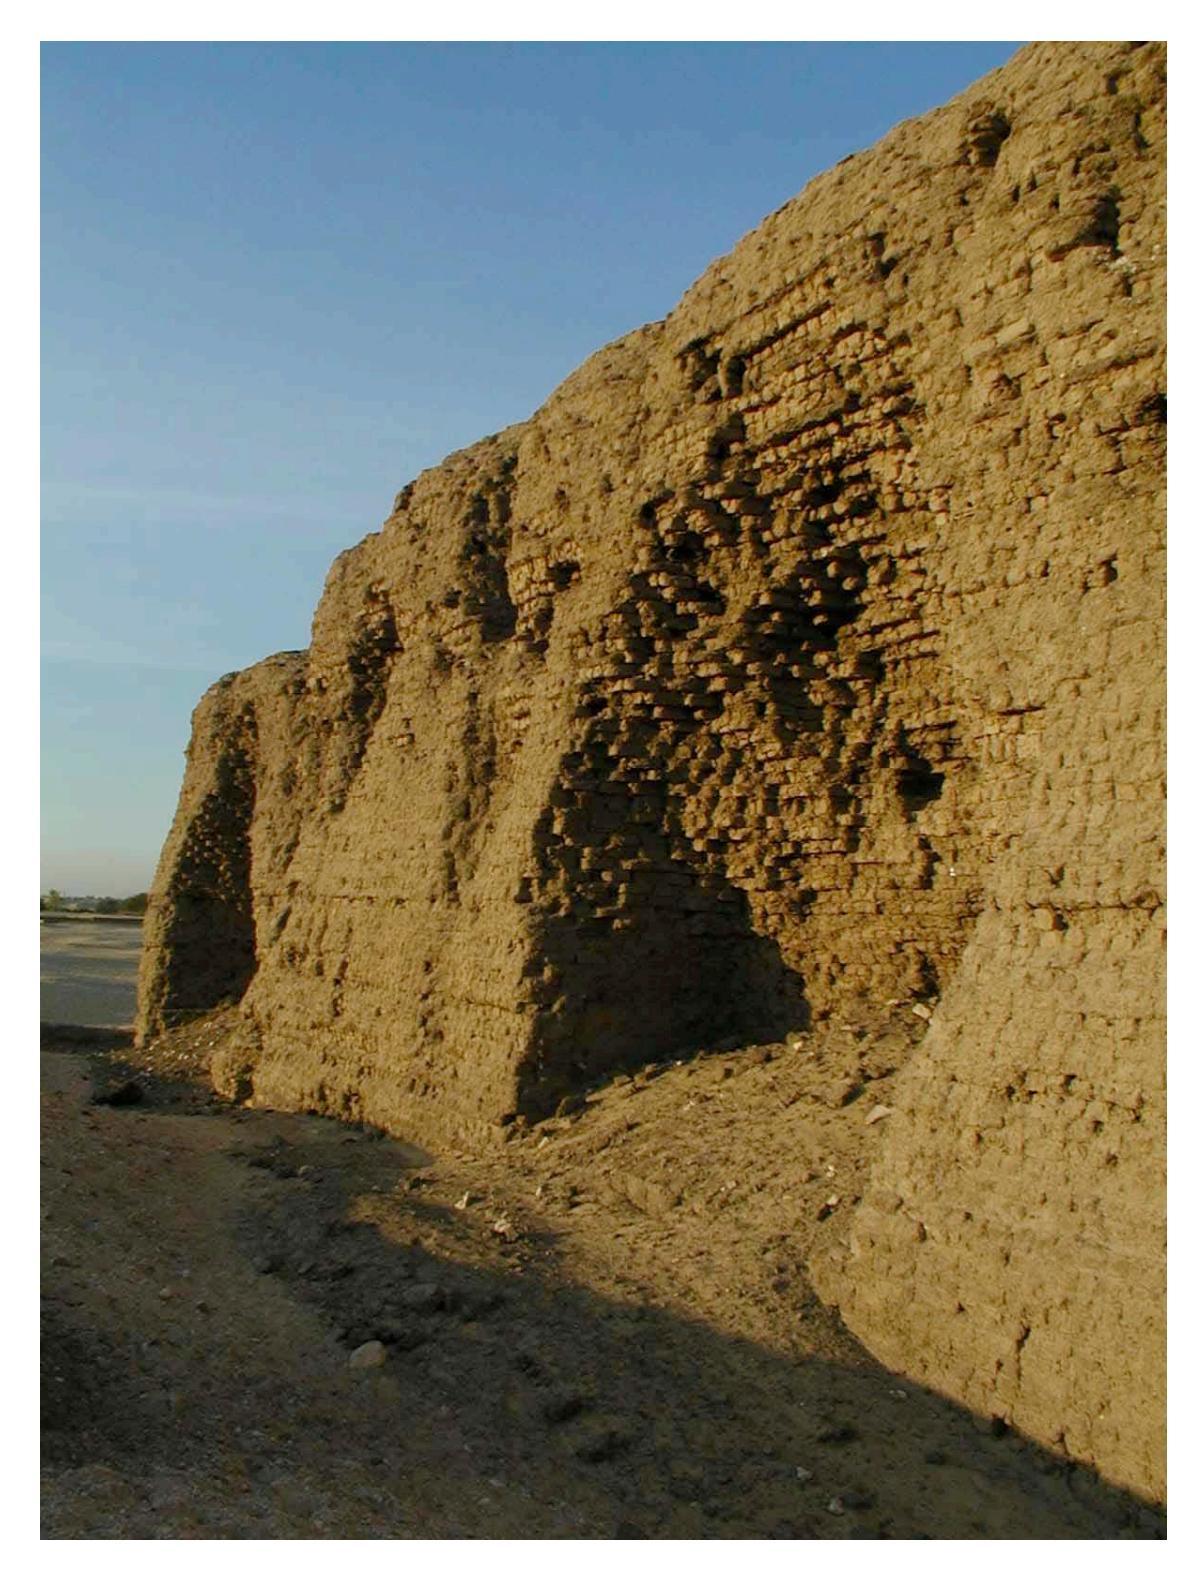
Figure 284. The remains of two collapsed monastic cells in the northern, exterior face of the west main enclosure wall, prior to excavation or conservation work; these cell voids, which were excavated as Operations 100 and 101 (left and right, respectively), were stabilized during field seasons 5 and 6. (Photo: Robert Fletcher 2001)

Immediately south of Operation 100, a second cell void, excavated as Operation 101, was stabilized during field season 6 (Figures 290 and 291; see also Figure 284). The finished condition of both Operations 100 and 101 illustrate the general method and outcome of cell-void treatment at the monument. The new masonry filling the wall cavities supports the original wall fabric above and adjacent to the cells, thus re-establishing structural stability in the surrounding areas, but is slightly recessed to create a concave profile (see Figures 289 and 291). This profile is a visual reference to the presence of the cell, as an important phase in the history of the monument.

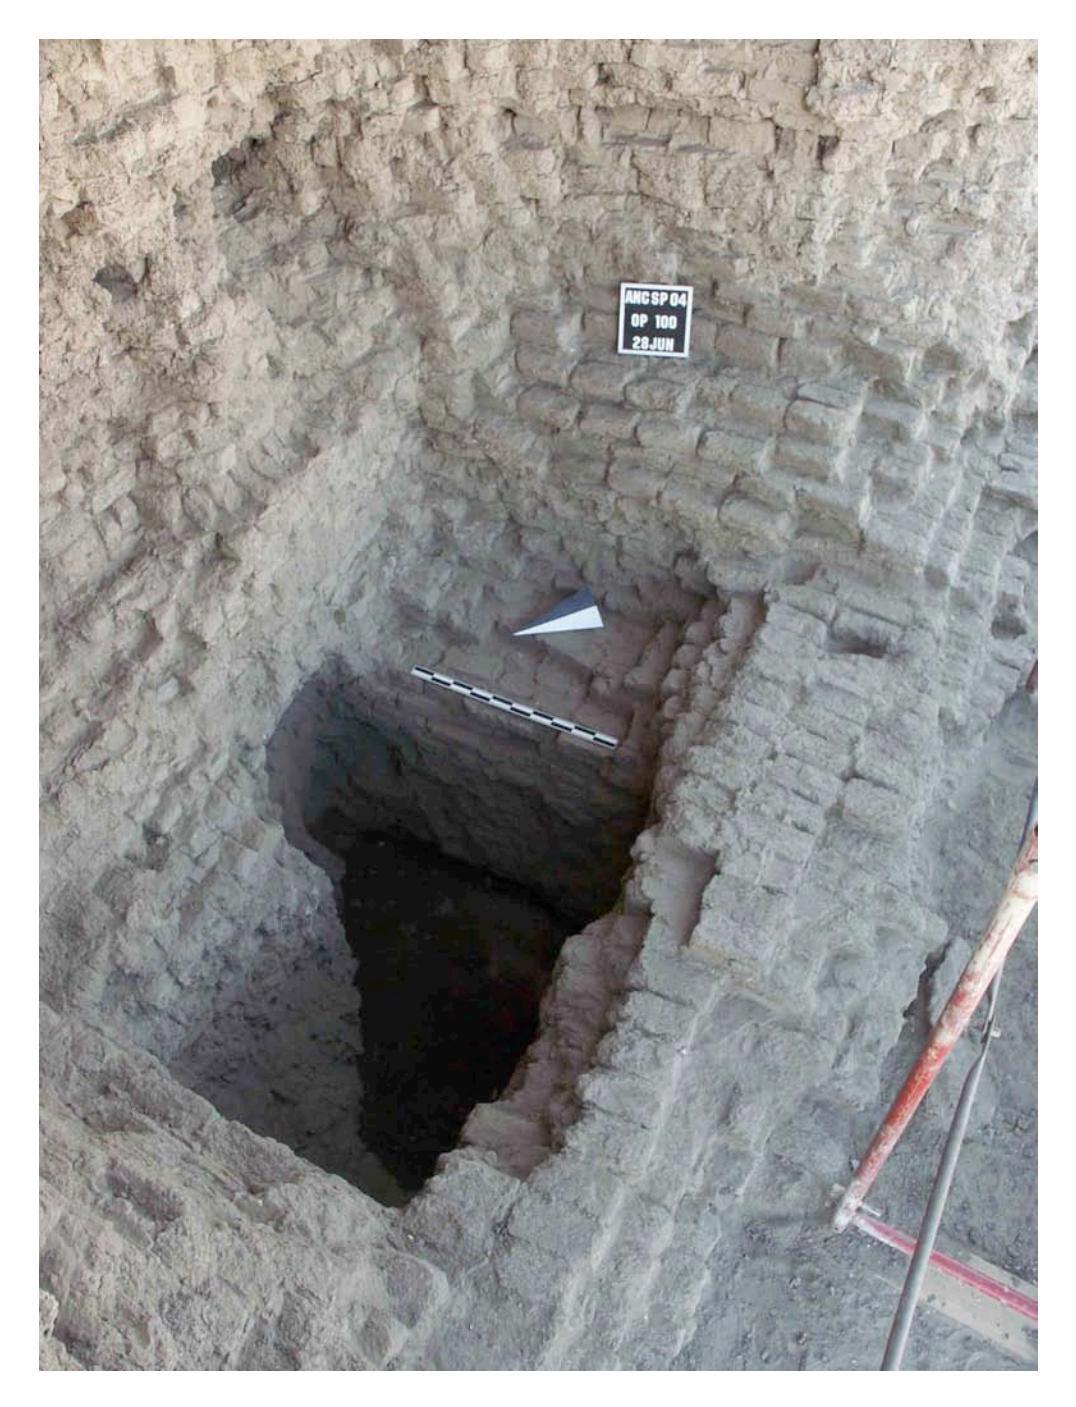
Figure 285. Detail of the cell void excavated as Operation 100, during architectural stabilization; the first stage of stabilization was to fill the void at the bottom of the hole (below the wall base) with clean sand and to then fill the hole itself with new masonry. (Photo: Matthew Adams 2004)

Stabilization of the cell voids in the exterior side of the west main enclosure wall began in field season 5 (spring 2004), and by the end of field season 7 (2005-2006), work in all six of the cell voids on this side of the wall had been completed. Stabilization of the northernmost cell void on the west wall, excavated as Operation 100, began in field season 5 (Figures 284-287). The first stage of this operation was to fill a deep pit that had been dug (probably in the mid-19th Century during Mariette's work at the site) through the floor of the cell and the original masonry of the wall to a depth of more than 1.5m below the base of the wall into the underlying sand deposits. Following excavation and documentation of the hole (see Archaeological Investigation of the Monument, to follow), three new mud bricks (stamped "PYIFA") were placed at the bottom of the pit, which was then filled with compacted sand. The purpose of the sand bed was to re-establish support for the wall base. which had been significantly undercut by the pitting, and to provide a stable base for new masonry that would fill both the hole and the cell void above. At the close of field season 5, the infilling of the hole had been completed and new masonry was built up approximately 1m in the cell void (see Figure 287). As work continued in field season 6 (2004-2005), the remainder of the cell void was filled with new masonry and the stabilization of this cell was completed (Figures 288 and 289).

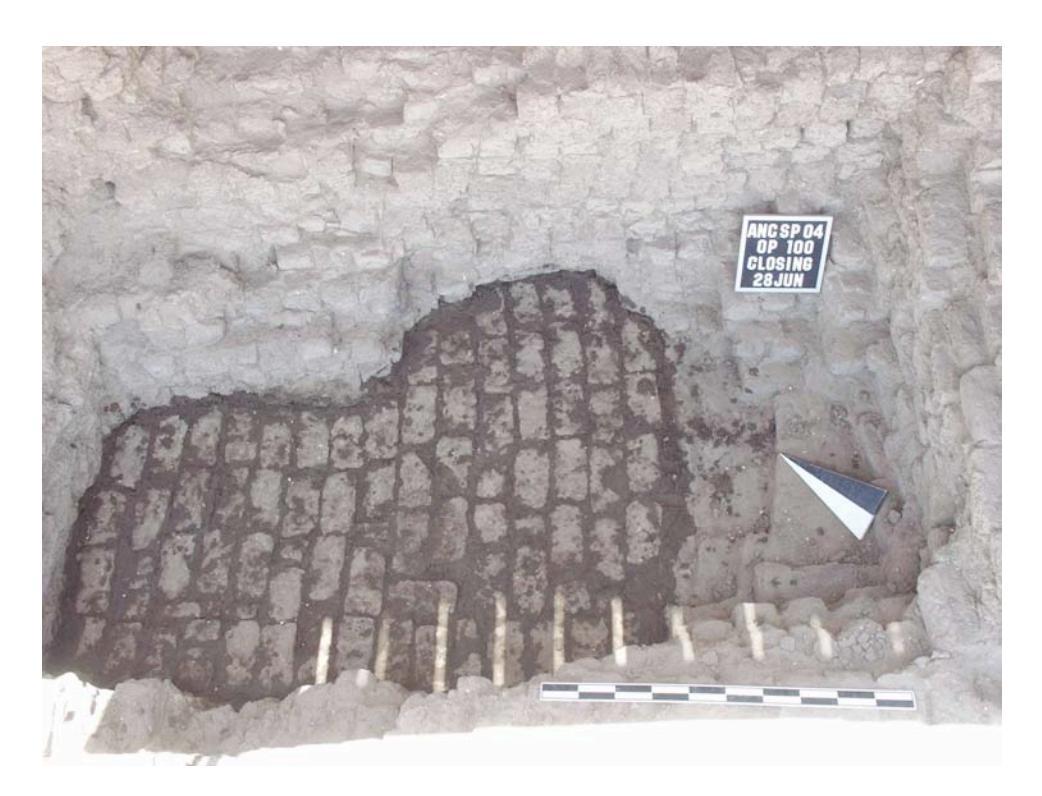
Figure 286. Detail of the cell void excavated as Operation 100, during architectural stabilization; the pit cut through the cell floor has been filled in and stabilized. (Photo: Matthew Adams 2004)

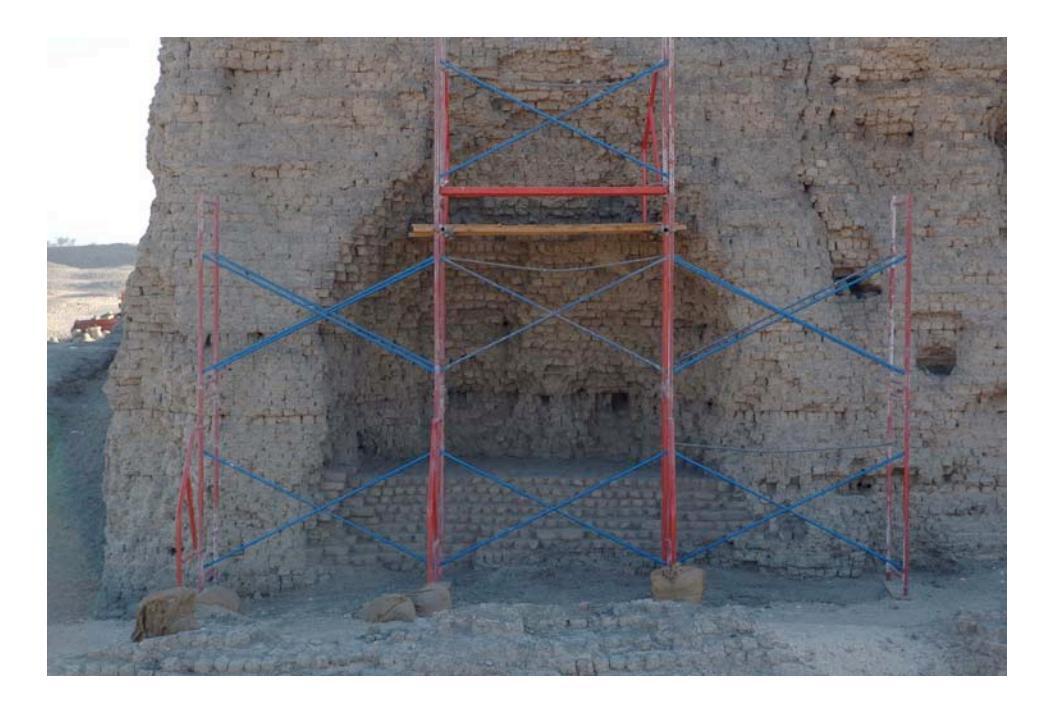
Figure 287. The cell void excavated as Ooperation 100, during architectural stabilization; the cell void has been filled in with new masonry to an approximate height of 1m. (Photo: Matthew Adams 2004)

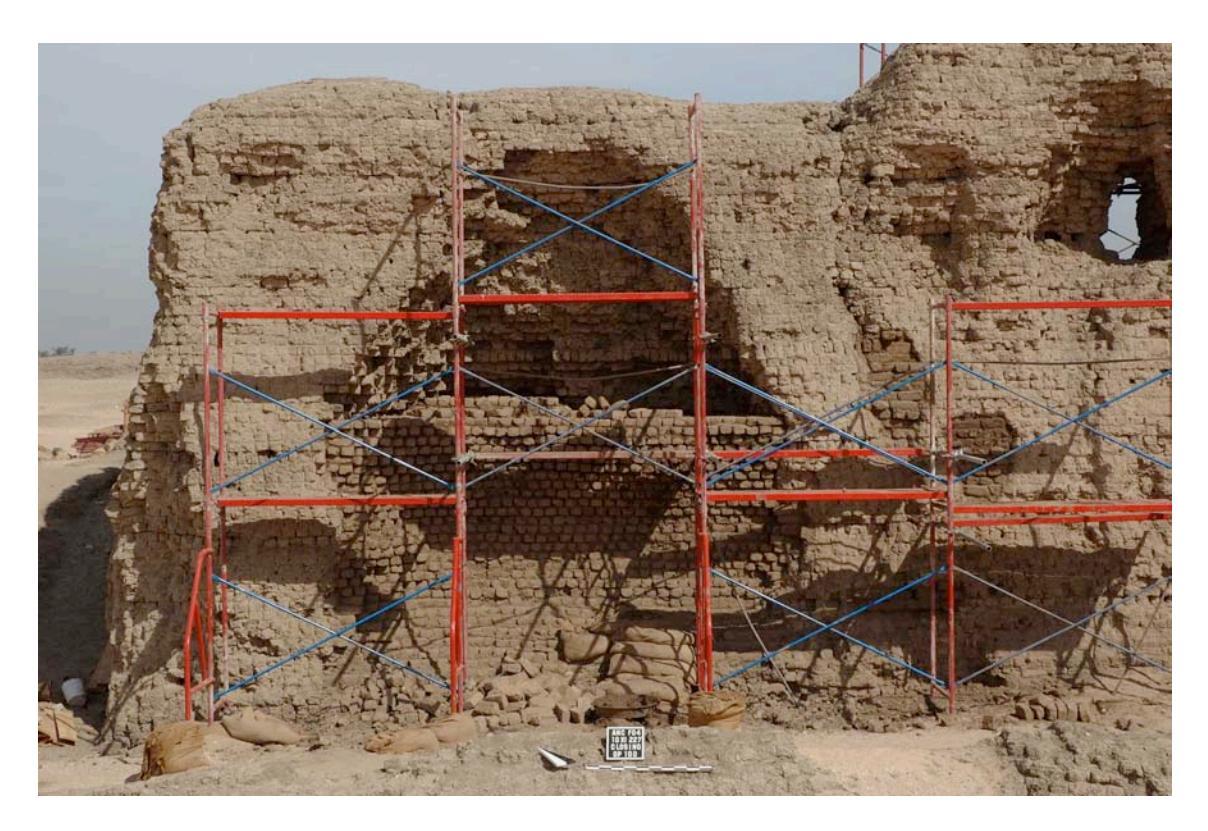
Figure 288. Continued stabilization of the northernmost cell void on the west main enclosure wall in field season 6. (Photo: Robert Fletcher 2004-2005)

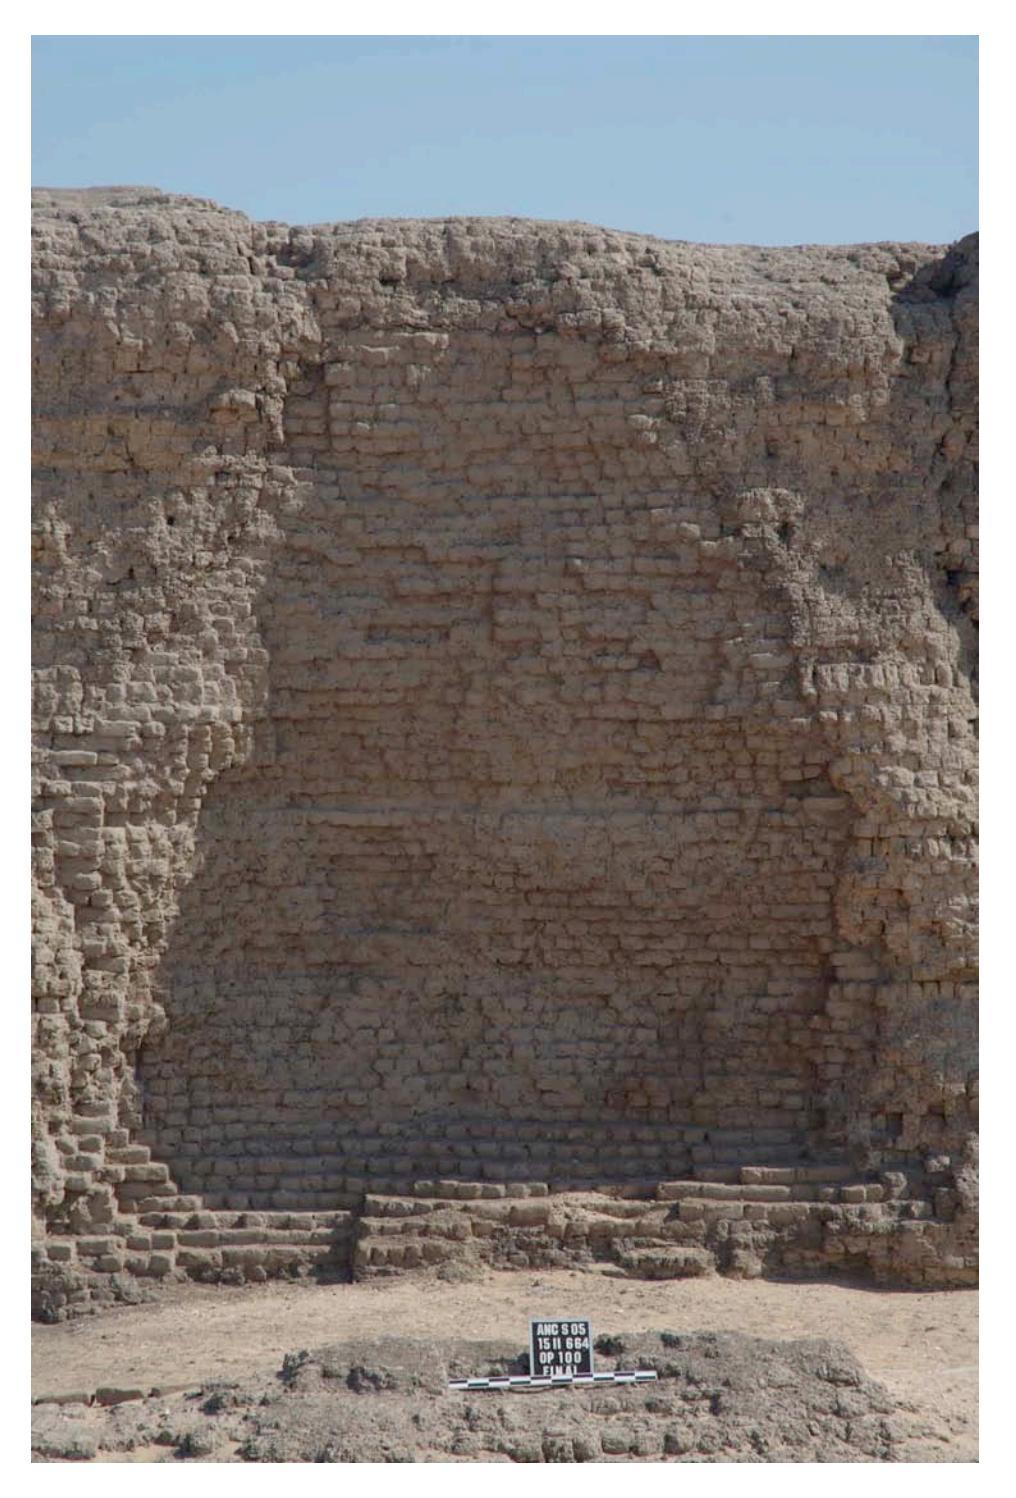
Figure 289. The cell void excavated as Operation 100, completely stabilized; note especially the concave profile of the reconstructed area, which creates a visual reference to the now-concealed monastic features. (Photo: Robert Fletcher 2004-2005)

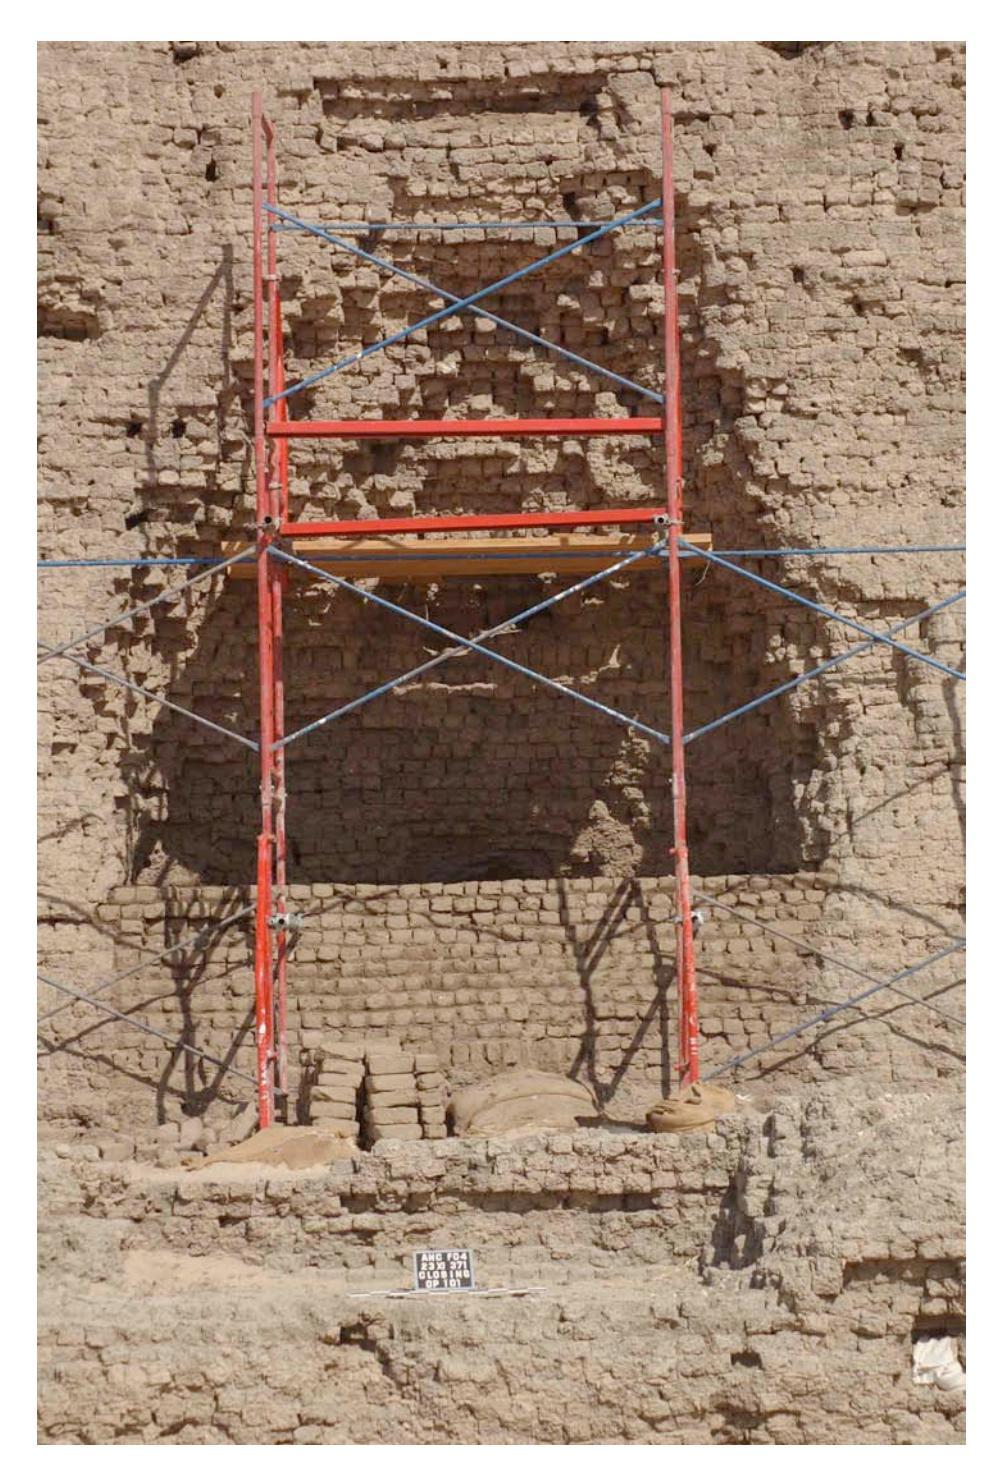
Figure 290. Stabilization work in progress on the cell void excavated as Operation 101 on the northern, exterior face of the west main enclosure wall. (Photo: Robert Fletcher 2004-2005)

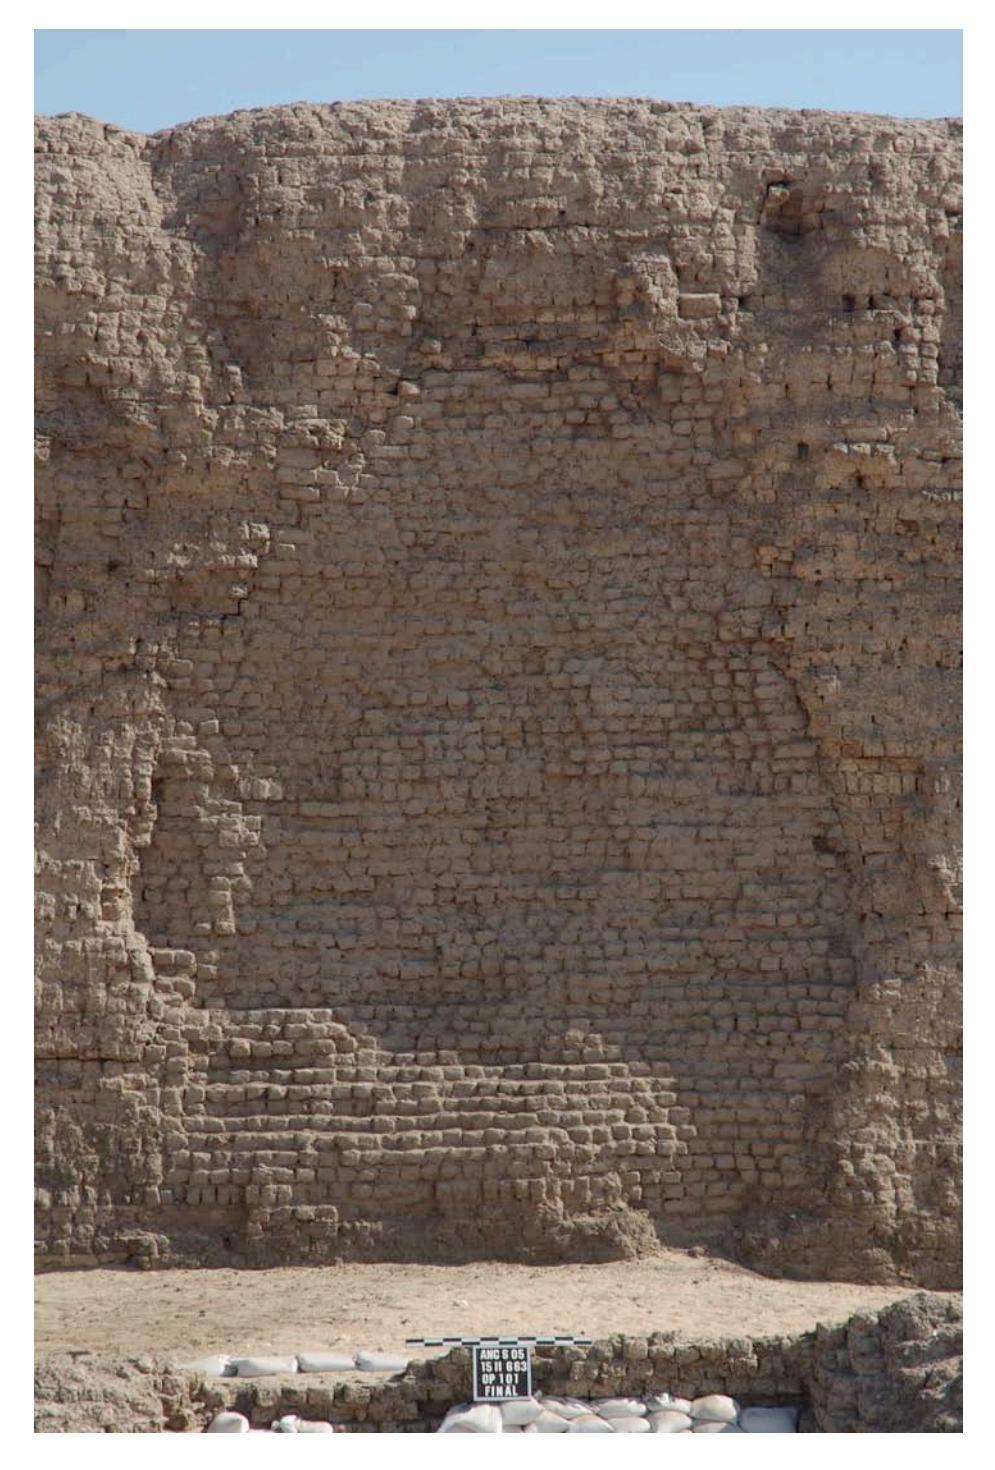
Figure 291. The cell void excavated as Operation 101, completely stabilized. (Photo: Robert Fletcher 2004-2005)

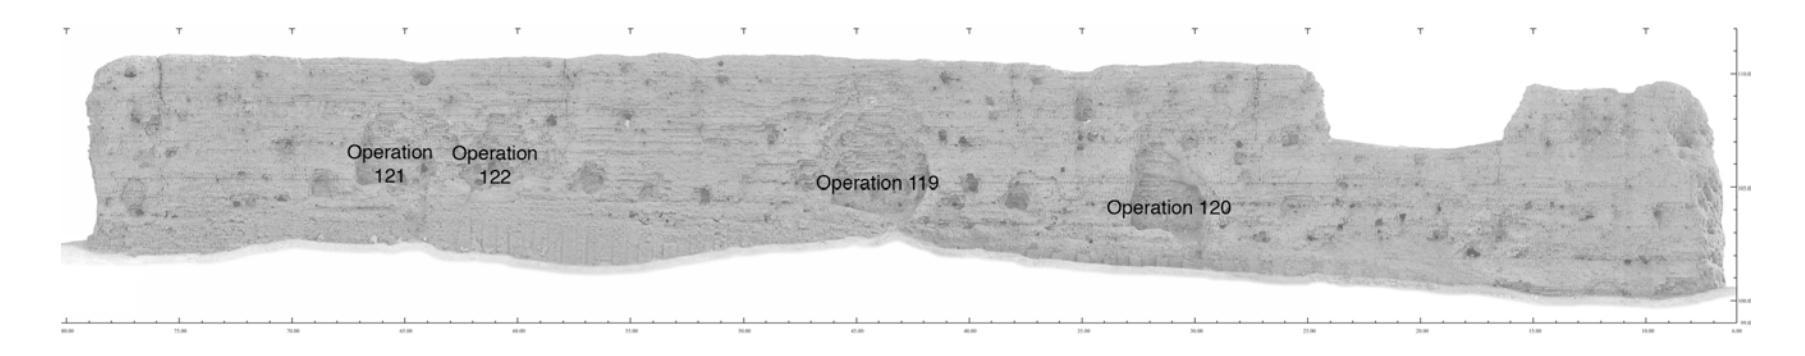
Figure 292. Rectified photoelevation of the exterior, southern face of the west main enclosure wall, indicating the locations of the cell voids excavated as Operations 119, 120, 121 and 122, all of which were architecturally documented and stabilized in field season 7 (see details below). (Photoelevation: Heritage 3D, Inc. 2001)

Four additional cell voids in the southern, exterior face of the west main enclosure wall, excavated as Operations 119, 120, 121 and 122, were stabilized during field season 7 (Figure 292). The cell void filled in Operation 119, located in the middle of the southern wall face, consisted of a main cell and smaller ancillary chamber (Figures 293 and 294). This cell was excavated in field season 6 and architecturally documented and stabilized in field season 7 (Figures 295-300). The stabilization work at this location began with filling a series of shallow pits in the floor of each chamber with new brickwork and covering all original surfaces with a protective barrier layer of clean, sieved sand. The sand was then wetted and compacted to provide a level base for the first course of new masonry. Both the main and side chambers were filled in with new mudbrick masonry. As the level of new construction was raised, it was set back 3-5cm from the original finish of preserved vertical surfaces and sand was added to this space to protect these features. Layers of geogrid provided horizontal reinforcement for the new masonry. As the level of new construction reached the upper part of the concavity, eroded bricks in the overhanging original masonry were removed and these spaces were used to key the new masonry with the original wall fabric. As with all such cell-void locations, the brick infilling was held back from the outer face of the wall to indicate the presence of late antique monastic features (see Figure 300).

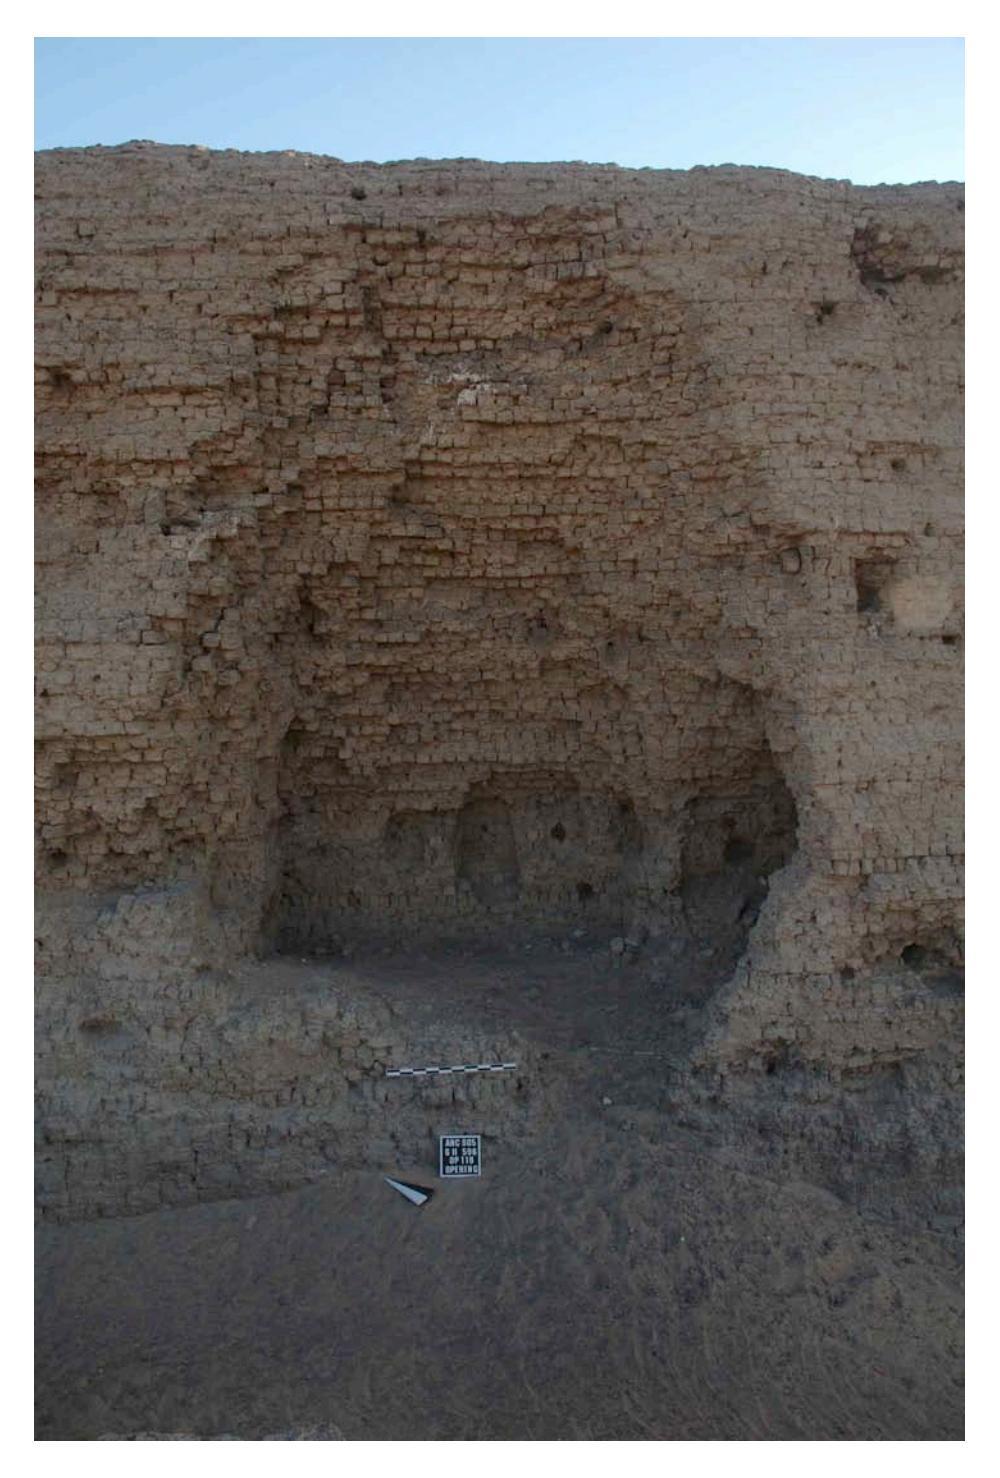
Figure 293. Detail of the cell void noted as Operation 119, prior to excavation or conservation work. (Photo: Robert Fletcher 2004-2005)
