THE FUNERARY MONUMENT OF KING KHASEKHEMWY AT ABYDOS (ca. 2700 BCE): CONSERVATION AND ARCHAEOLOGY, 1999-2006

Final report on the "Documentation and Conservation of King Khasekhemwy's Funerary Monument at Abydos," a sub-project of the Egyptian Antiquities Project of the American Research Center in Egypt

2007

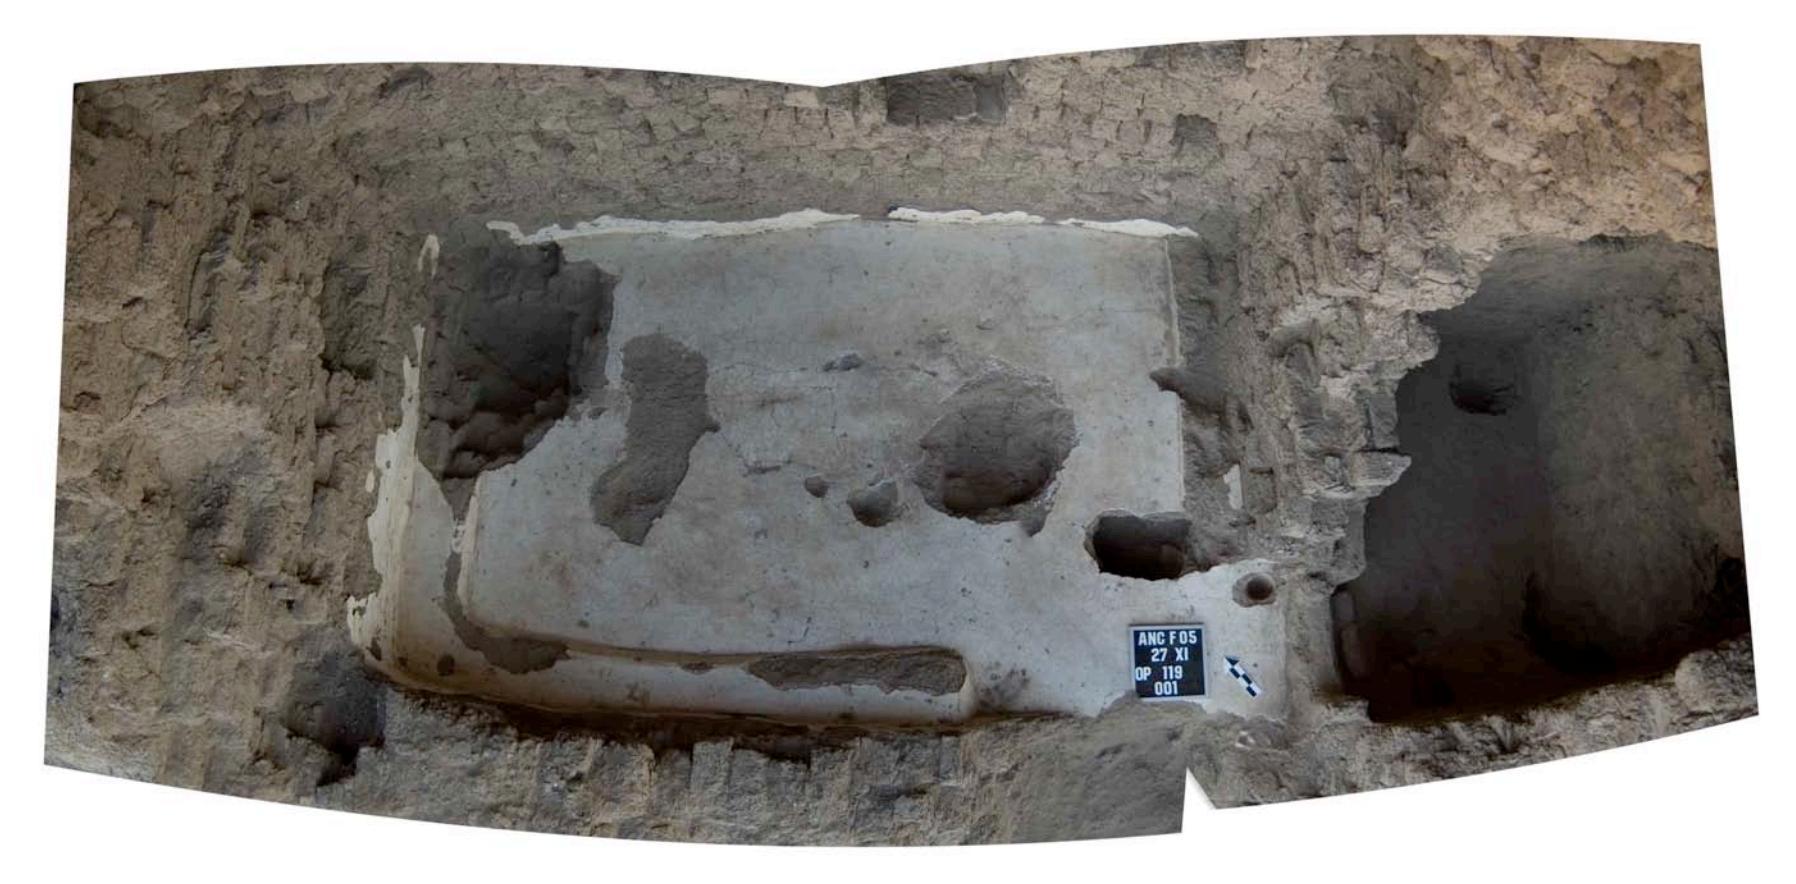
Figure 294. Interior detail of the main chamber (at left) and smaller ancillary chamber (at right) in the cell void excavated as Operation 119, prior to architectural stabilization; unlike the main chamber, the secondary chamber was finished in mud plaster only; the inward notch at the bottom of the frame represents the main entrance to the cell from the exterior side of the west main enclosure wall. (Composite photo: Robert Fletcher 2005-2006)

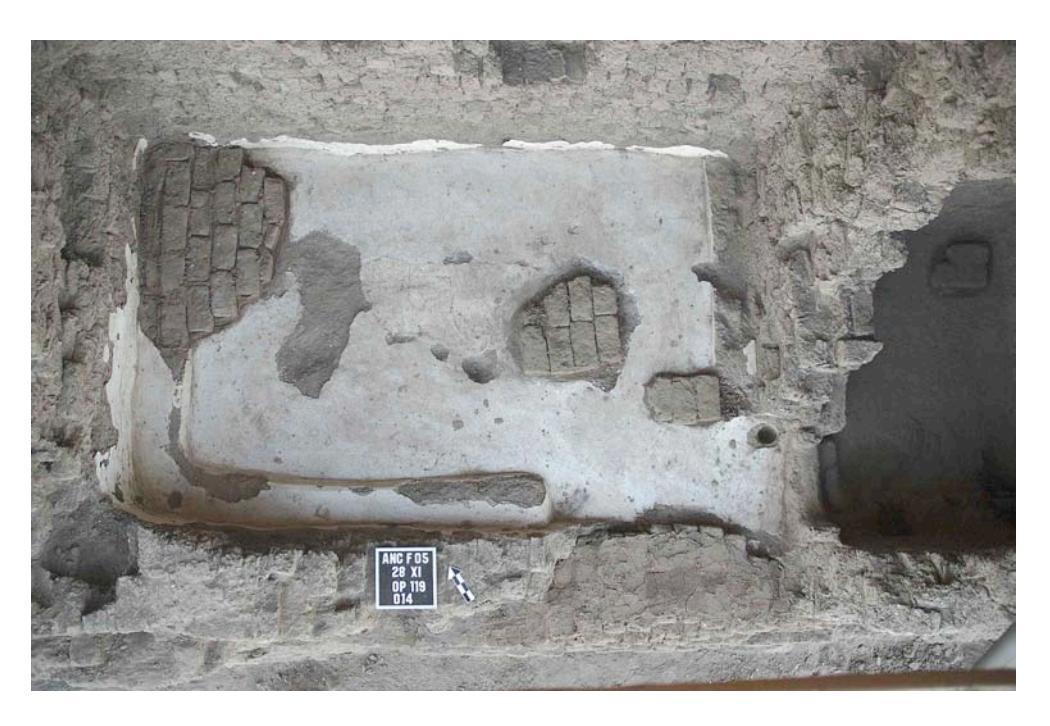
Figure 295. Detail of the cell void excavated as Operation 119, during stabilization; the holes in the floor of the main chamber have been filled with new mud bricks. (Photo: Robert Fletcher 2005-2006)

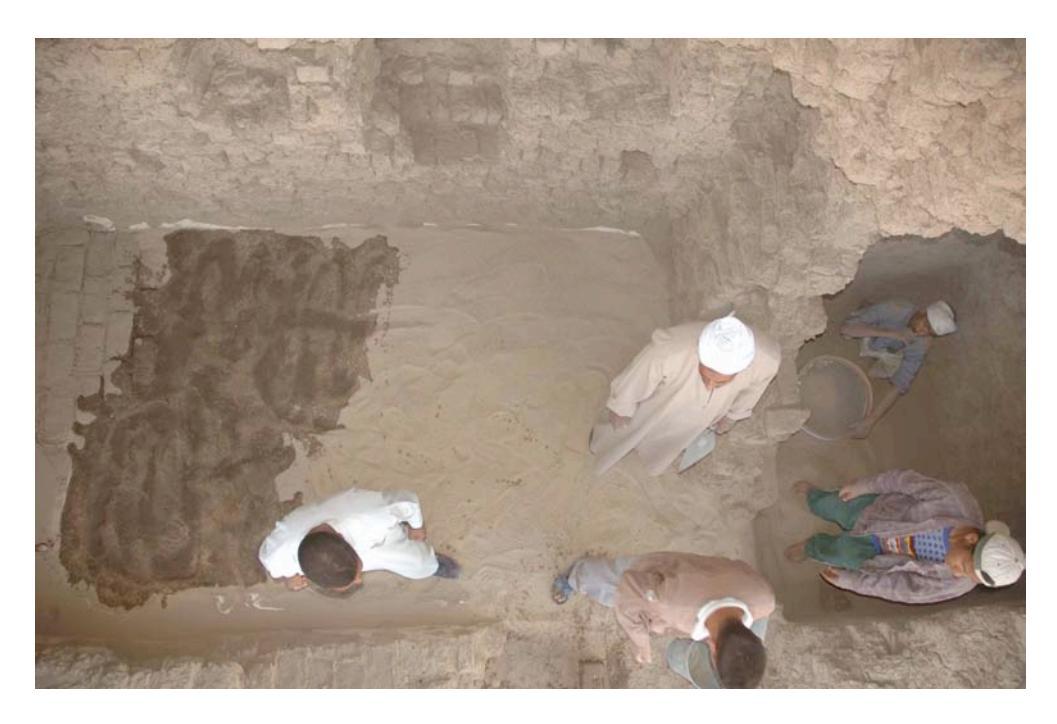
Figure 296. Detail of the cell void excavated as Operation 119, during stabilization; original surfaces have been covered by a protective barrier layer of finely sieved sand, which was then wetted and compacted prior to the installation of new masonry. (Photo: Robert Fletcher 2005-2006)

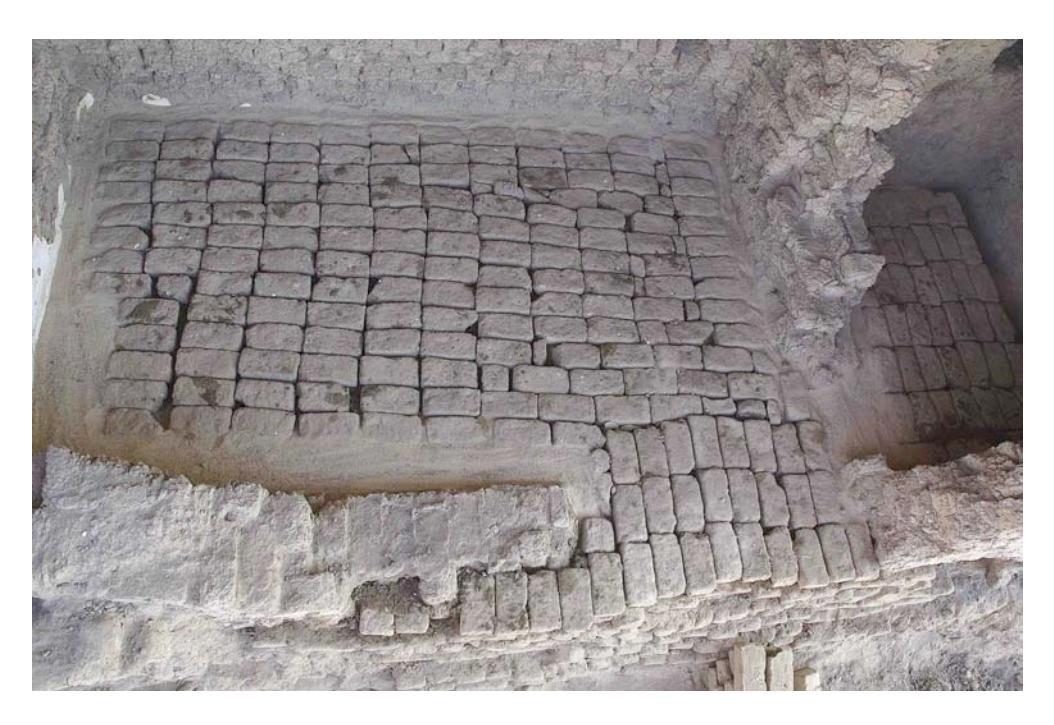
Figure 297. Detail of the cell void excavated as Operation 119, during stabilization; the first course of new mud brick has been laid and the protective space around the edges of the infilling has been filled with clean sand to aid in preserving the original surfaces and features of the cell. (Photo: Robert Fletcher 2005-2006)

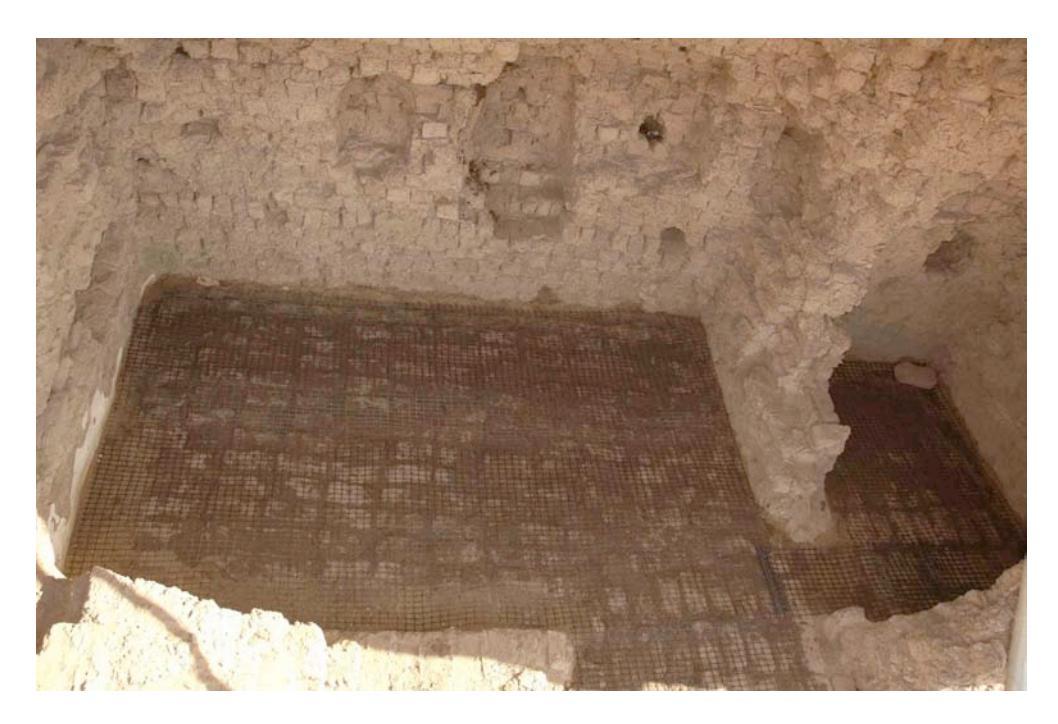
Figure 298. Detail of the cell void excavated as Operation 119, during stabilization; layers of geogrid were placed between new masonry courses to provide horizontal reinforcement. (Photo: Robert Fletcher 2005-2006)

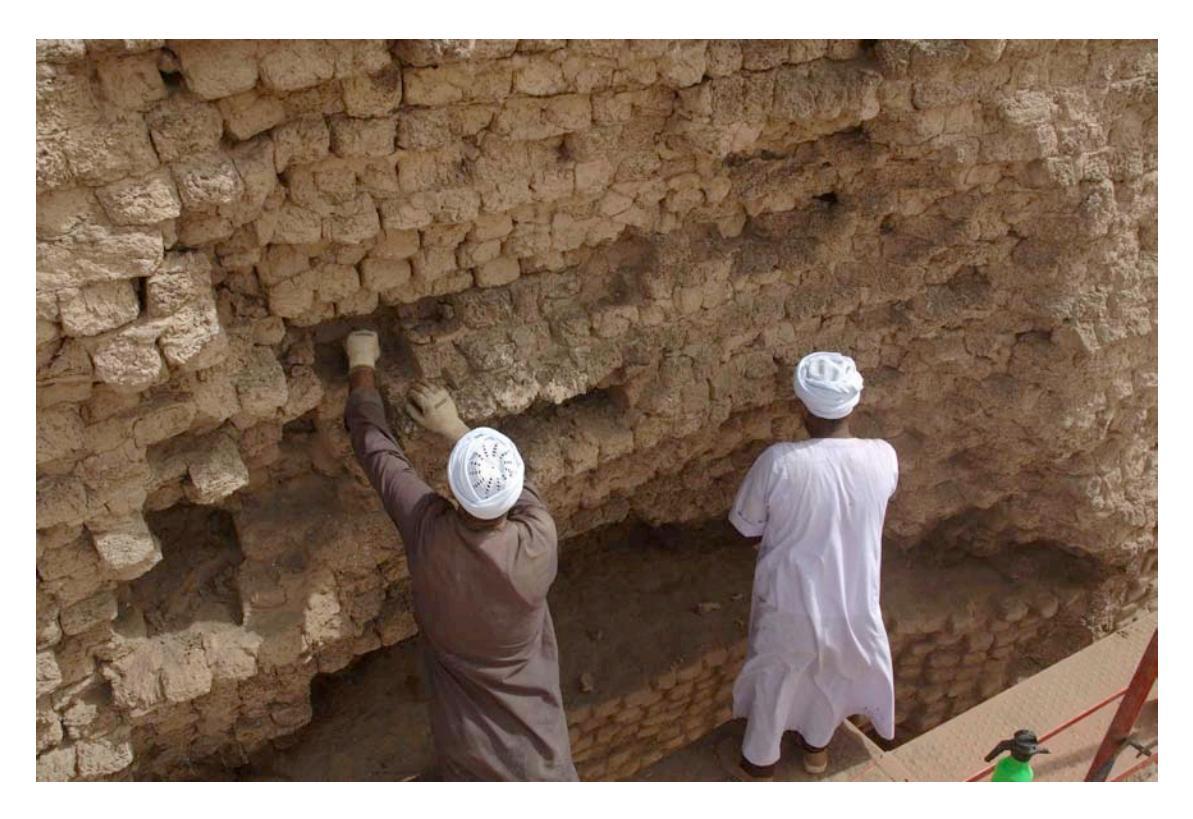
Figure 299. Detail of the cell void excavated as Operation 119, during stabilization; the depth of infilling was gradually reduced as the level of new construction reached the upper part of the wall cavity, and loose bricks in this area were removed to create spaces for toothing the new masonry to the existing fabric of the wall. (Photo: Jason Goodman 2005-2006)

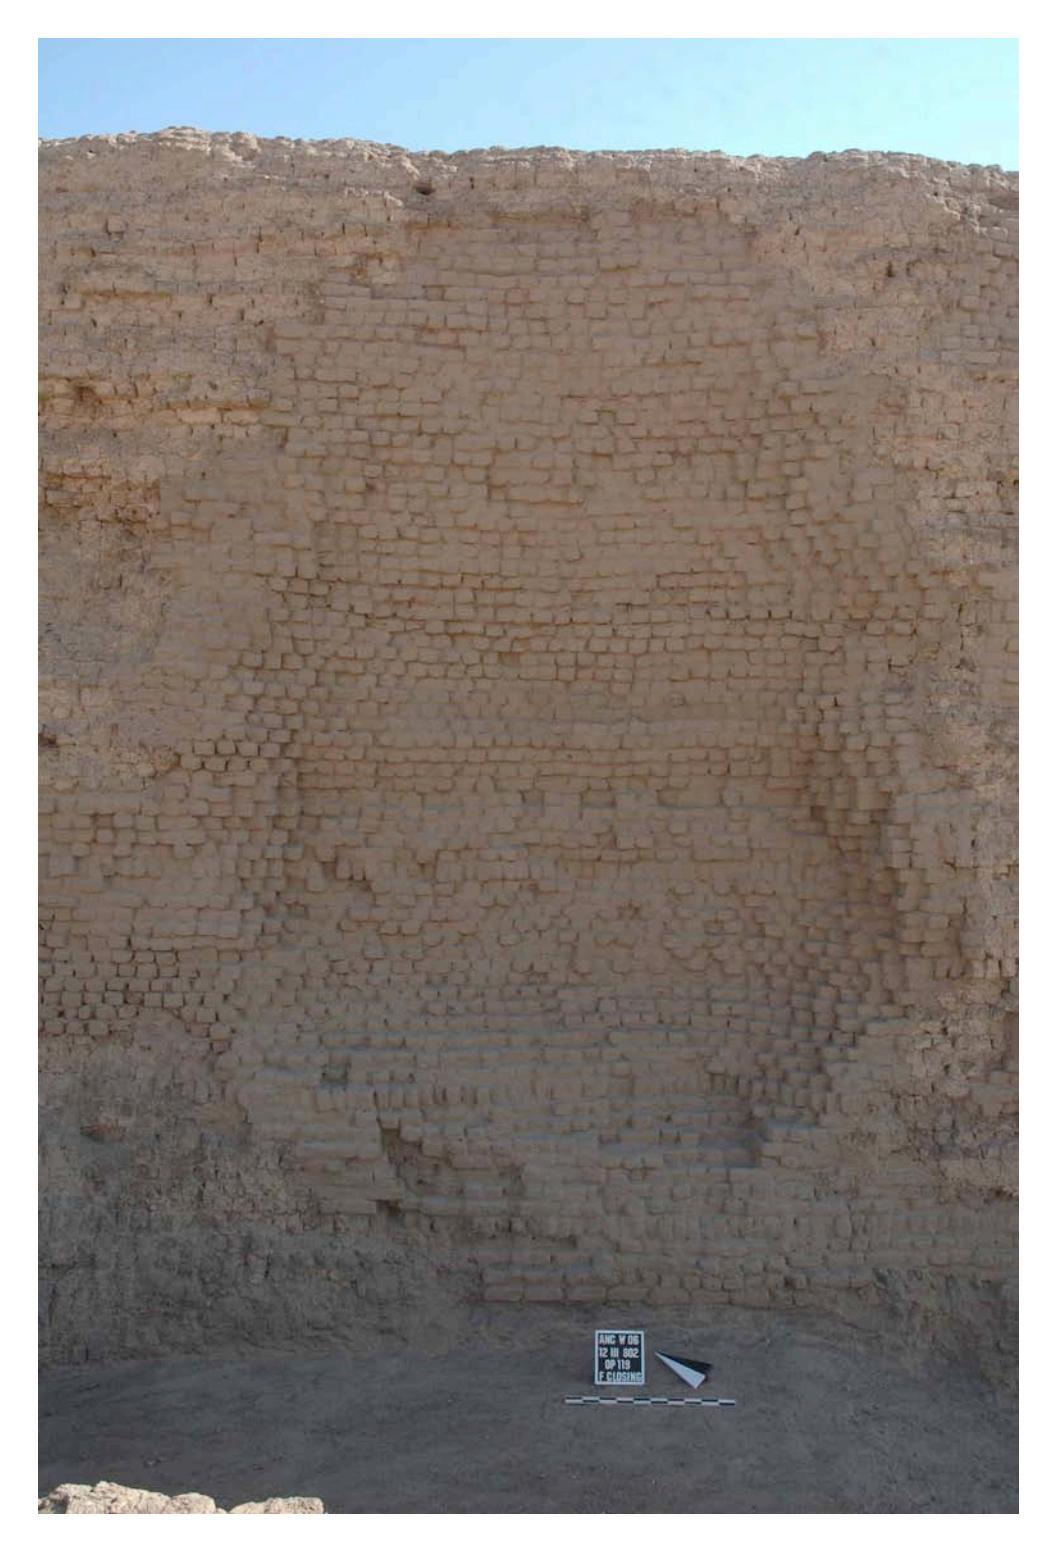
Figure 300. Detail of the cell void excavated as Operation 119, completely stabilized; note again the concave profile of the new construction to provide a visual cue to the presence of the cell in the wall. (Photo: Jason Goodman 2005-2006)

Four additional cell voids in the southern, exterior face of the west main enclosure wall, excavated as Operations 119, 120, 121 and 122, were stabilized during field season 7 (Figure 292). The cell void filled in Operation 119, located in the middle of the southern wall face, consisted of a main cell and smaller ancillary chamber (Figures 293 and 294). This cell was excavated in field season 6 and architecturally documented and stabilized in field season 7 (Figures 295-300). The stabilization work at this location began with filling a series of shallow pits in the floor of each chamber with new brickwork and covering all original surfaces with a protective barrier layer of clean, sieved sand. The sand was then wetted and compacted to provide a level base for the first course of new masonry. Both the main and side chambers were filled in with new mudbrick masonry. As the level of new construction was raised, it was set back 3-5cm from the original finish of preserved vertical surfaces and sand was added to this space to protect these features. Layers of geogrid provided horizontal reinforcement for the new masonry. As the level of new construction reached the upper part of the concavity, eroded bricks in the overhanging original masonry were removed and these spaces were used to key the new masonry with the original wall fabric. As with all such cell-void locations, the brick infilling was held back from the outer face of the wall to indicate the presence of late antique monastic features (see Figure 300).

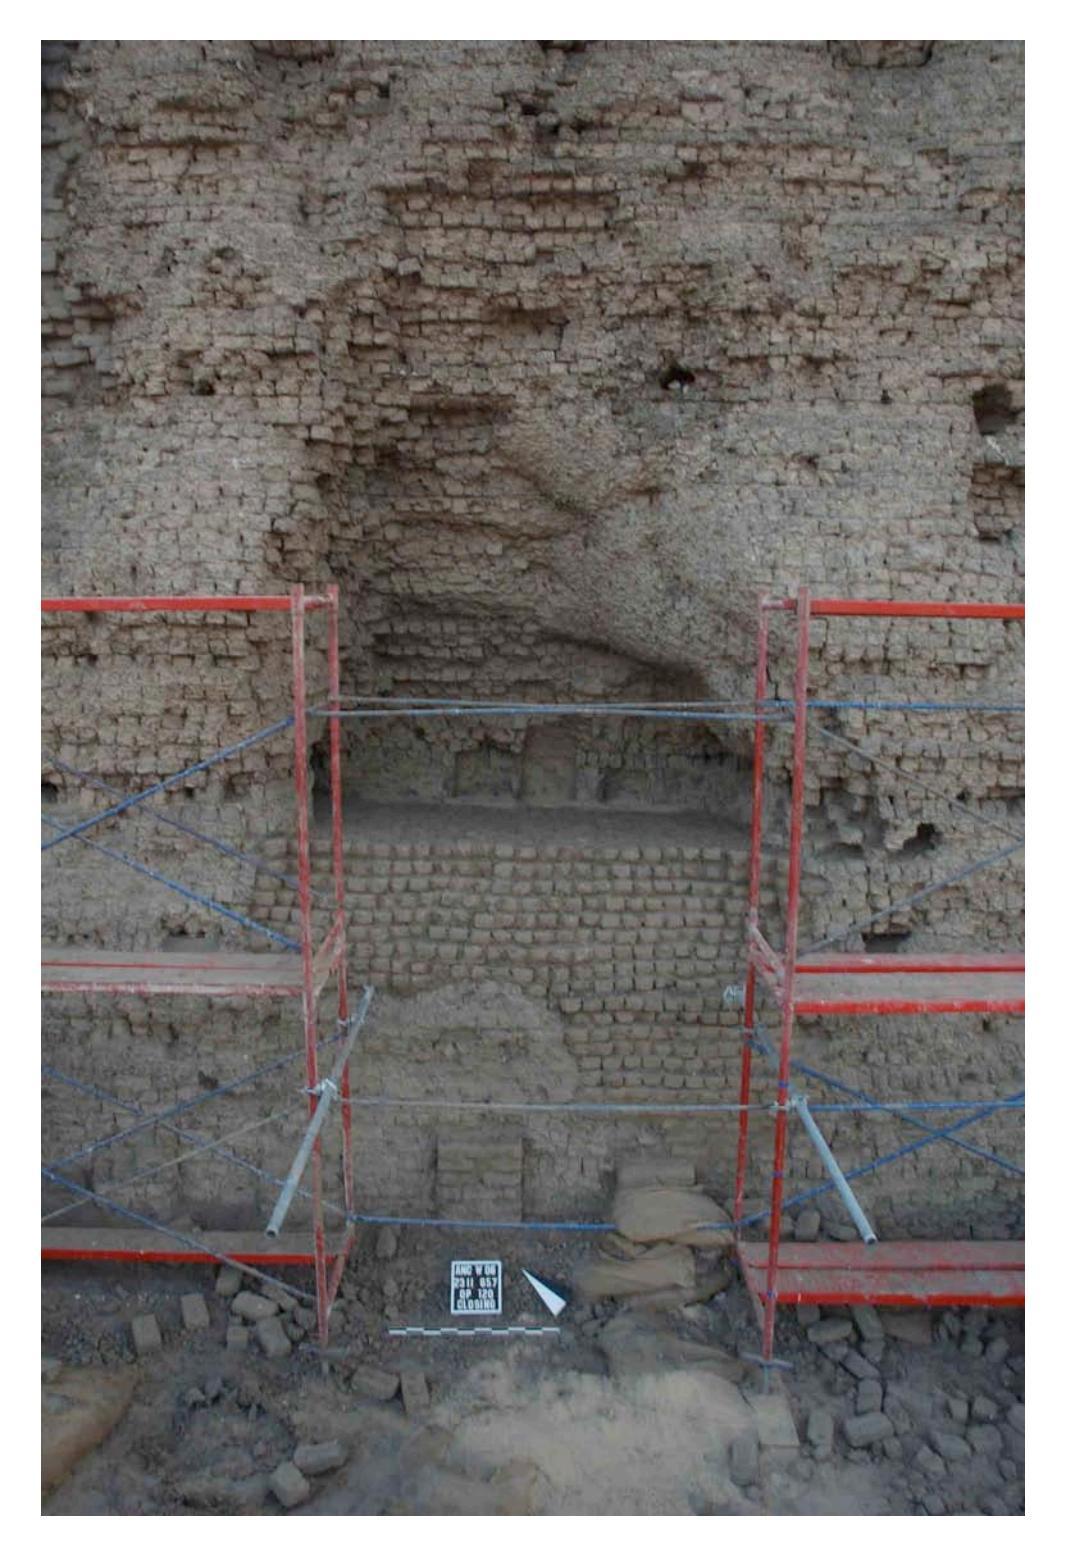
Figure 301. Detail of the cell void excavated as Operation 120, during stabilization; as the level of infilling reached the upper part of the void, the large mud-wasp nest (seen at upper right) was removed. (Photo: Jason Goodman 2005-2006)

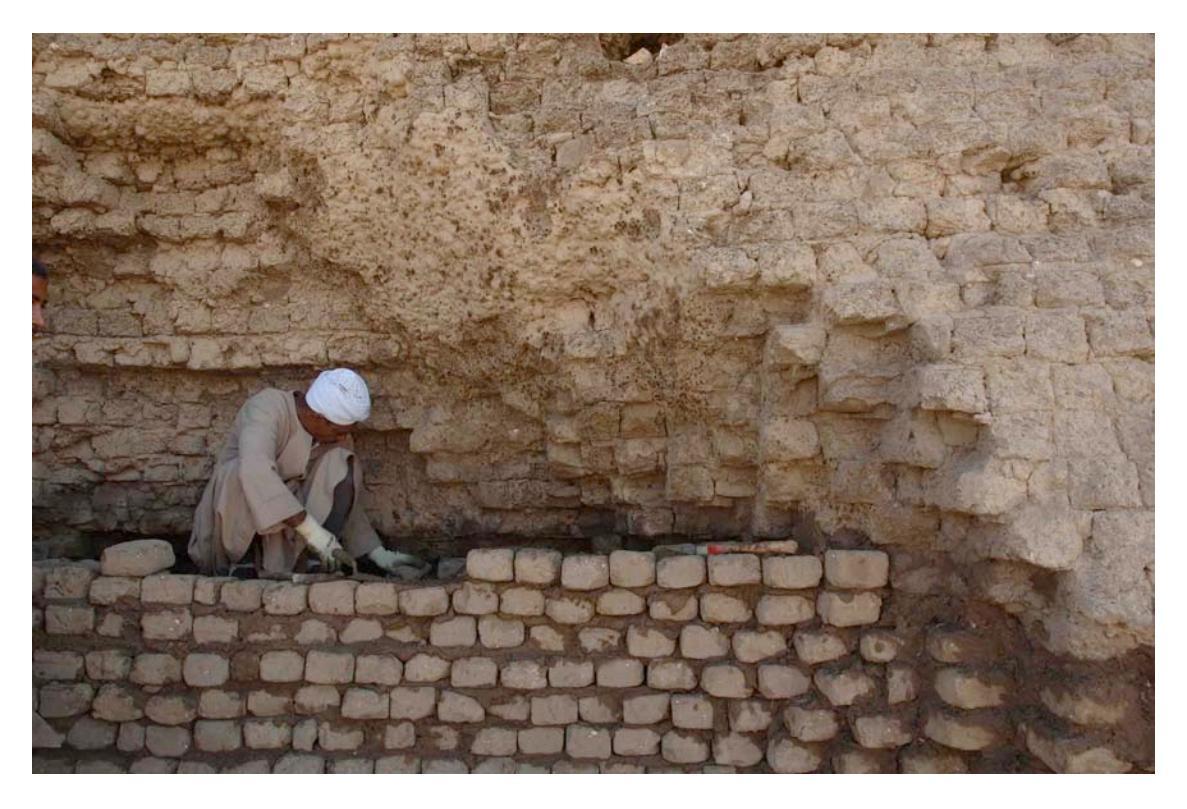
Figure 302. Detail of the cell void excavated as Operation 120, during stabilization; the gradual removal of the mud-wasp nest accretion (upper center) allowed the new brick masonry to key sufficiently with the surrounding, original wall fabric. (Photo: Jason Goodman 2005-2006)

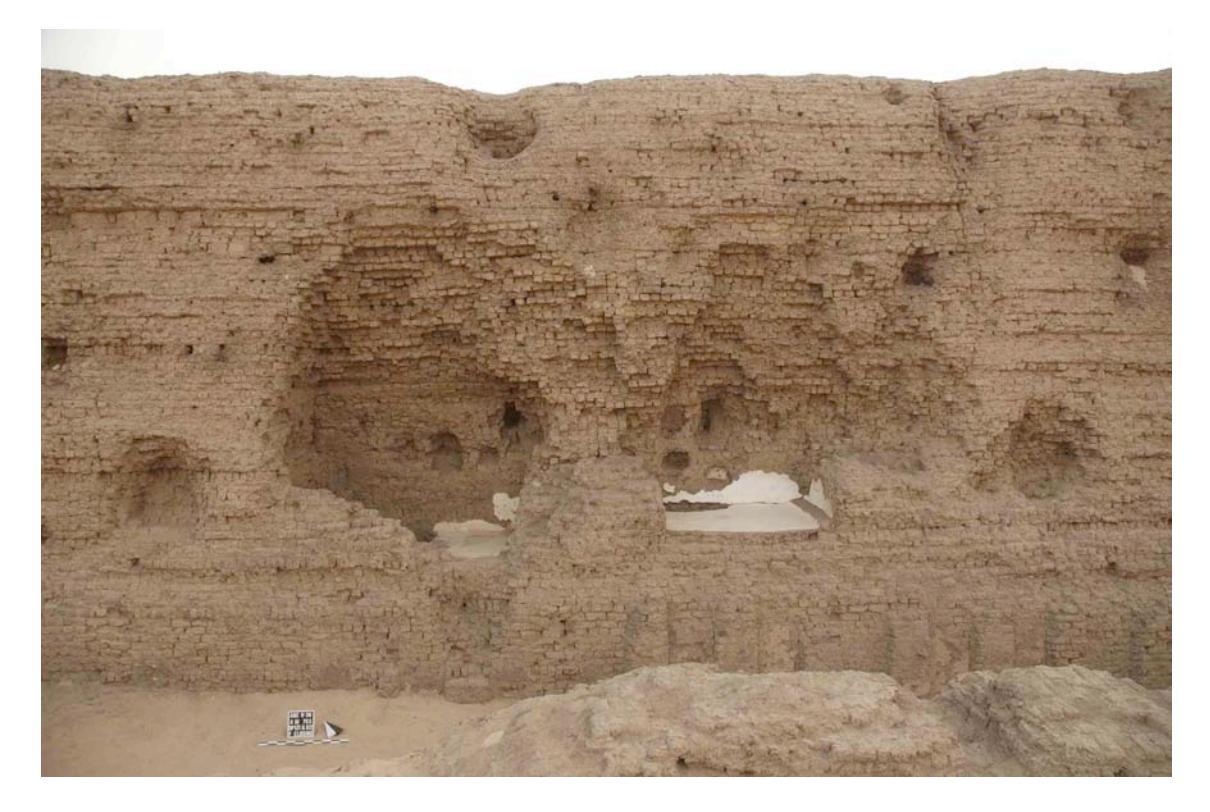
Figure 303. Detail of the cell voids excavated as Operations 121 (left) and 122 (right), prior to conservation work; note the deep vertical crack to the upper right of Operation 122, which is structurally related to the cell voids. (Photo: Jason Goodman 2005-2006)

The cell voids excavated as Operations 121 and 122 represent two adjacent cells (see Figure 292). The more northern of these cells, Operation 121, was the substantially larger of the two. Both of these cells were excavated in field season 6 and documented in field season 7, prior to architectural stabilization. The plaster floors in both cells were covered with a protective barrier layer of sand, and a large pit that had been cut through the floor at the northern end of the cell chamber in Operation 121 was filled with new brick masonry (Figures 303-305). Unlike the pits in the cells at the northern ends of the east and west main enclosure walls, this pit did not penetrate through the base of the wall. The original masonry that was left to form a wall between the two cells at this location had collapsed long ago, and, as the infilling of both cells rose, the new masonry spanned the space between them (Figures 306 and 307). As in other operations, horizontal reinforcement was provided by layers of geogrid, which spanned between the two cells to securely anchor the new masonry of each cell together. The finished, fully stabilized cells at this location are illustrated in Figure 308.

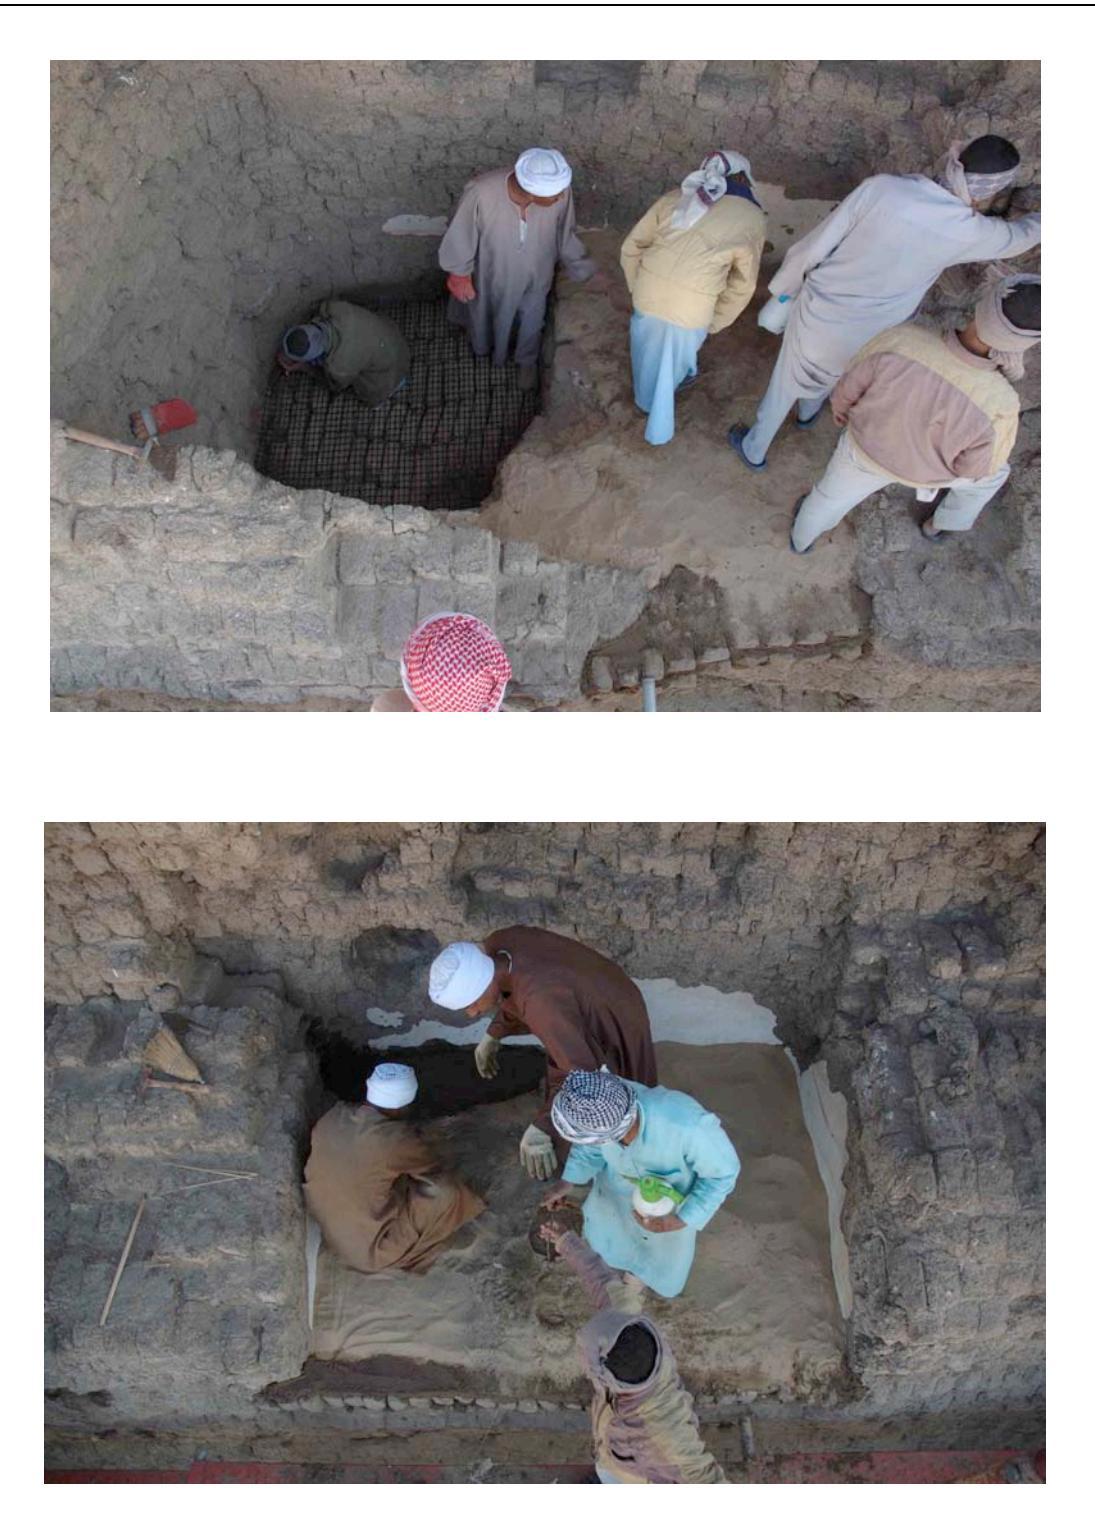
Figure 304, 305. Details of the cell void excavated as Operation 121, during stabilization; a large pit cut through the floor of this cell is being filled with new brick masonry (top) and a barrier layer of clean sand has been laid on the plaster floor to protect the preserved original features of the cell (top, at right, and bottom). (Photos: Jason Goodman 2005-2006)

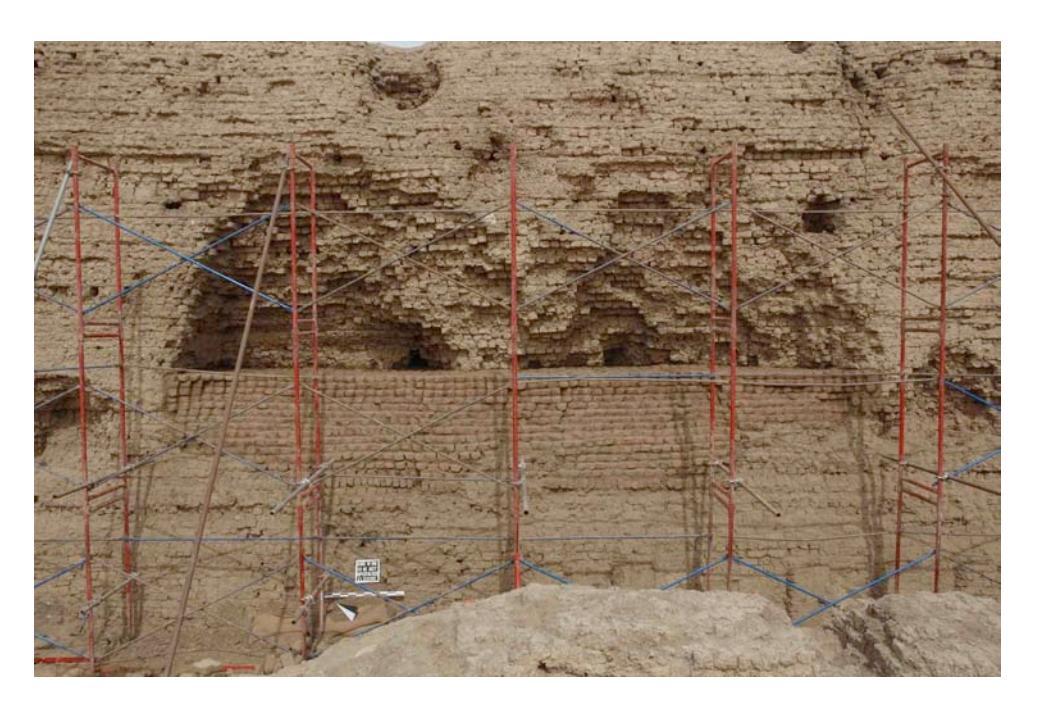
Figure 306. Detail of the cell voids excavated as Operations 121 and 122, during stabilization; because the original masonry dividing these two cells had collapsed previously, the infilling of this area comprised a single construction. (Photo: Jason Goodman 2005-2006)

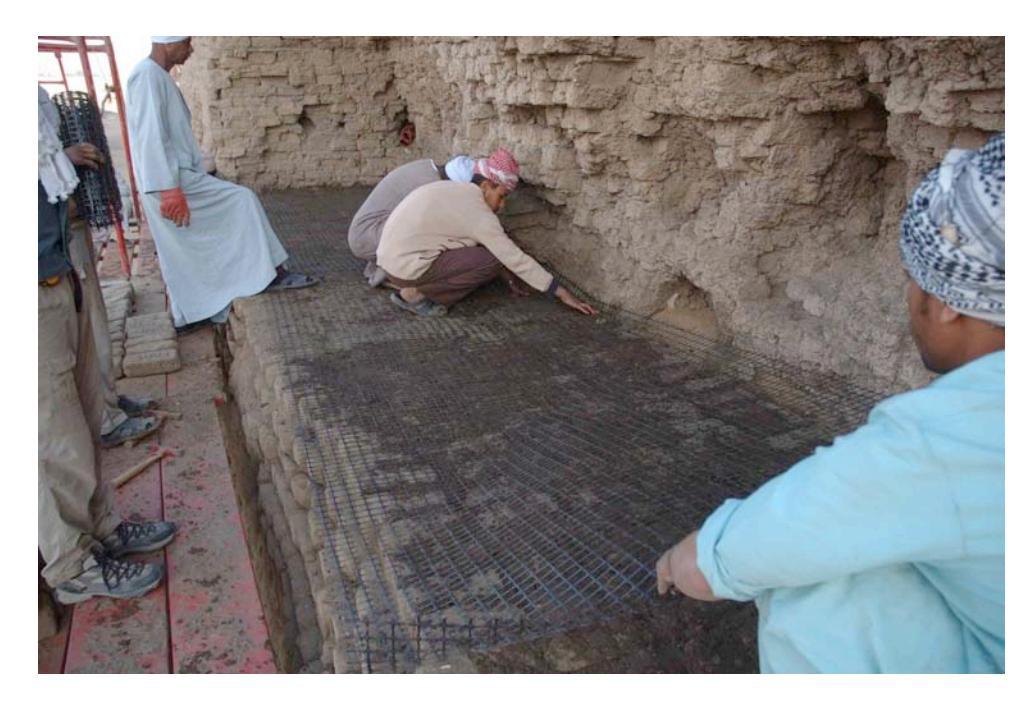
Figure 307. Detail of the cell voids excavated as Operations 121 and 122, during stabilization; layers of geogrid are being installed between new masonry courses to provide lateral reinforcement across the length of the new construction. (Photo: Jason Goodman 2005-2006)

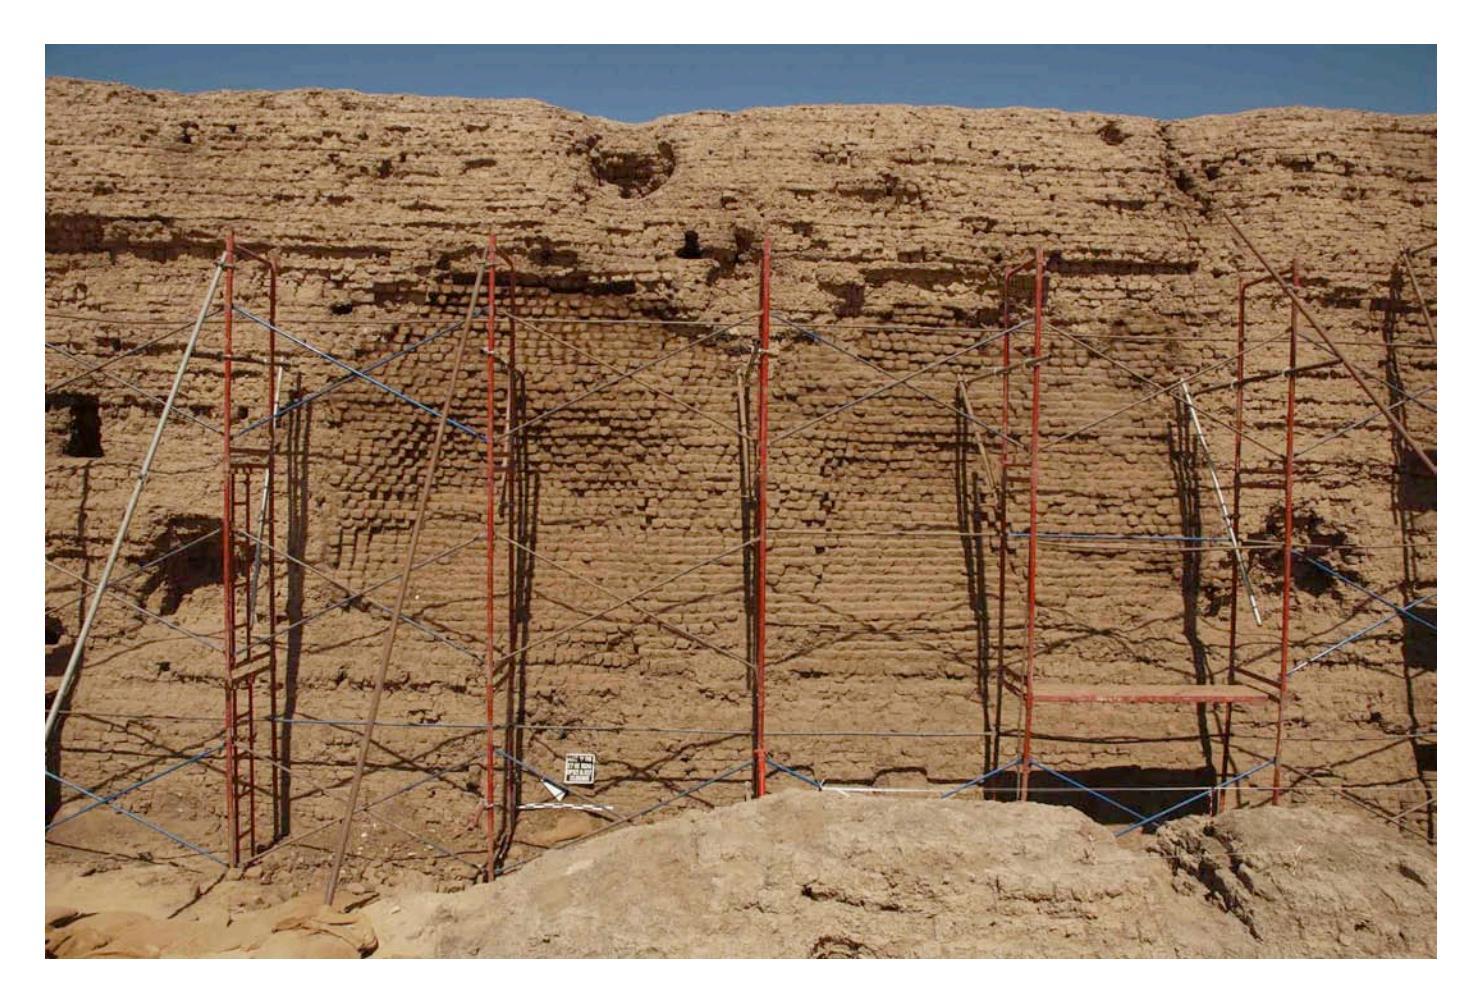
Figure 308. Detail of the cell voids excavated as Operations 121 and 122, completely stabilized. (Photo: Jason Goodman 2005-2006)

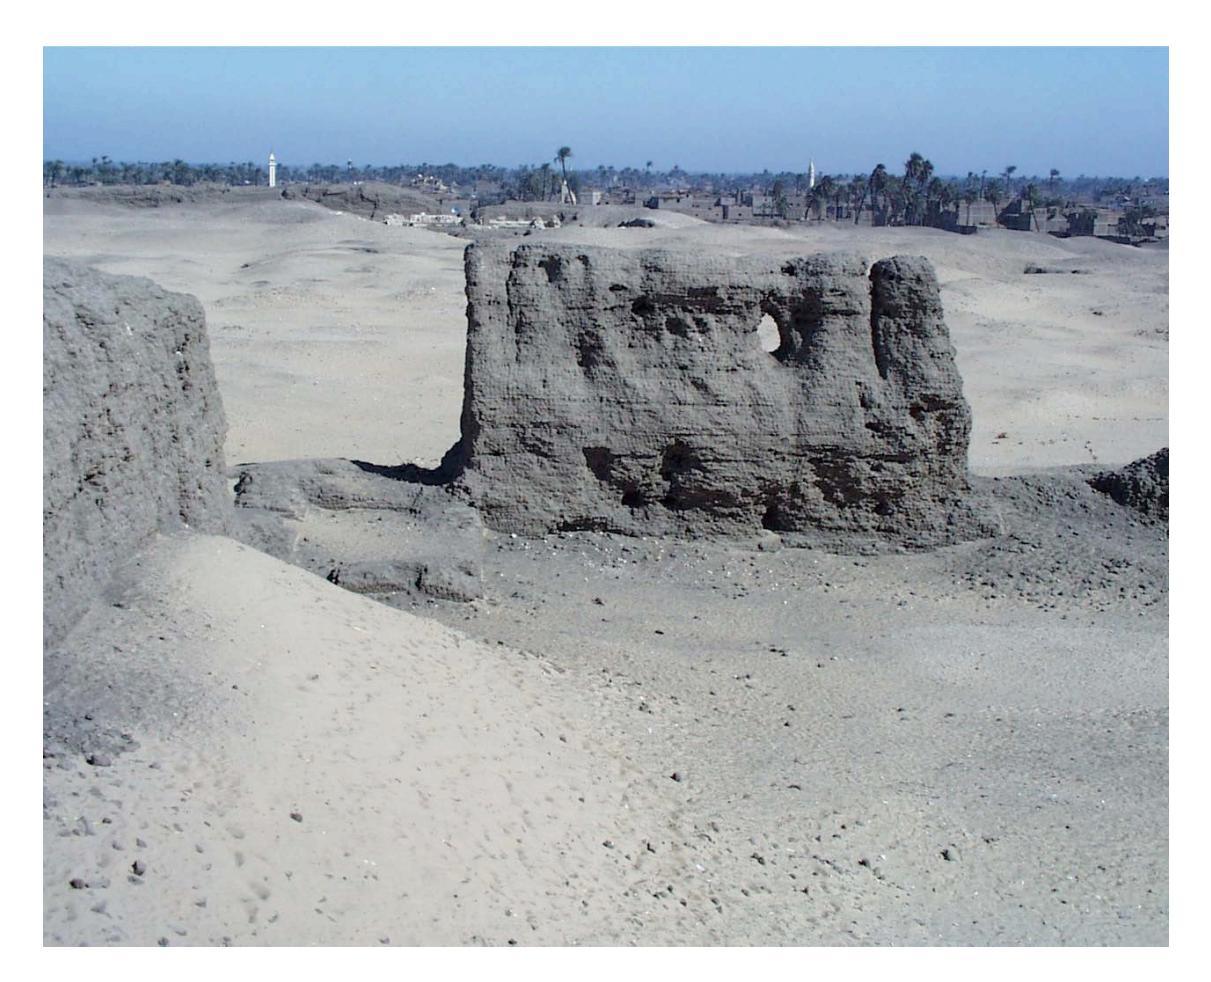
Figure 309. Interior detail of the tall, standing pier at the northern end of the east main enclosure wall; the low area at right, adjacent to the vertical wall end, was excavated as Operation 102 in field season 6, and was architecturally documented and stabilized in field season 7 (see details, below). (Photo: Matthew Adams 1999)

Another type of condition created by the collapse of a monastic cell is represented by a suite of features in the lower, central portion of the east main enclosure wall, adjacent to the tall northern pier (Figures 309 and 310). This area was excavated as Operation 102 in field season 6 (2004-2005), and architecturally documented and stabilized in field season 7 (2005-2006). The suite consisted of a white-plastered, main interior chamber, a small side chamber, and a mud-plastered forecourt. The main and side chambers were excavated into the wall from the interior side, and the forecourt was built up against the wall face. From a conservation standpoint, the set of conditions at this location were distinct from those in which the cell is represented by a void in a still-standing wall. Here, nothing remained of the original masonry that once stood above the cell. On the northern side of the cell is an unstable vertical wall end, affected by structural cracks and a large through-wall hole. The base of the wall in this area has been significantly undermined by activities associated with the adjacent cell. On the east (exterior) side, the original fabric of the wall adjacent to the main cell chamber was also unstable, as the cell had penetrated almost completely through the wall, leaving less than one meter of original masonry intact on this side. This is of particular importance, because the exterior side of the east wall incorporates a wellpreserved section of the original facade that represents a defining feature of the monument. In addition, the wall to the south of the cell is heavily undermined and affected by largescale cavitation and extensive networks of structural cracks. The animal burrows under the wall base penetrate into the smaller side chamber of the main cell, and have destroyed the southern wall of this ancillary chamber. The conditions affecting the area of Operation 102 were of urgent priority and required immediate stabilization.

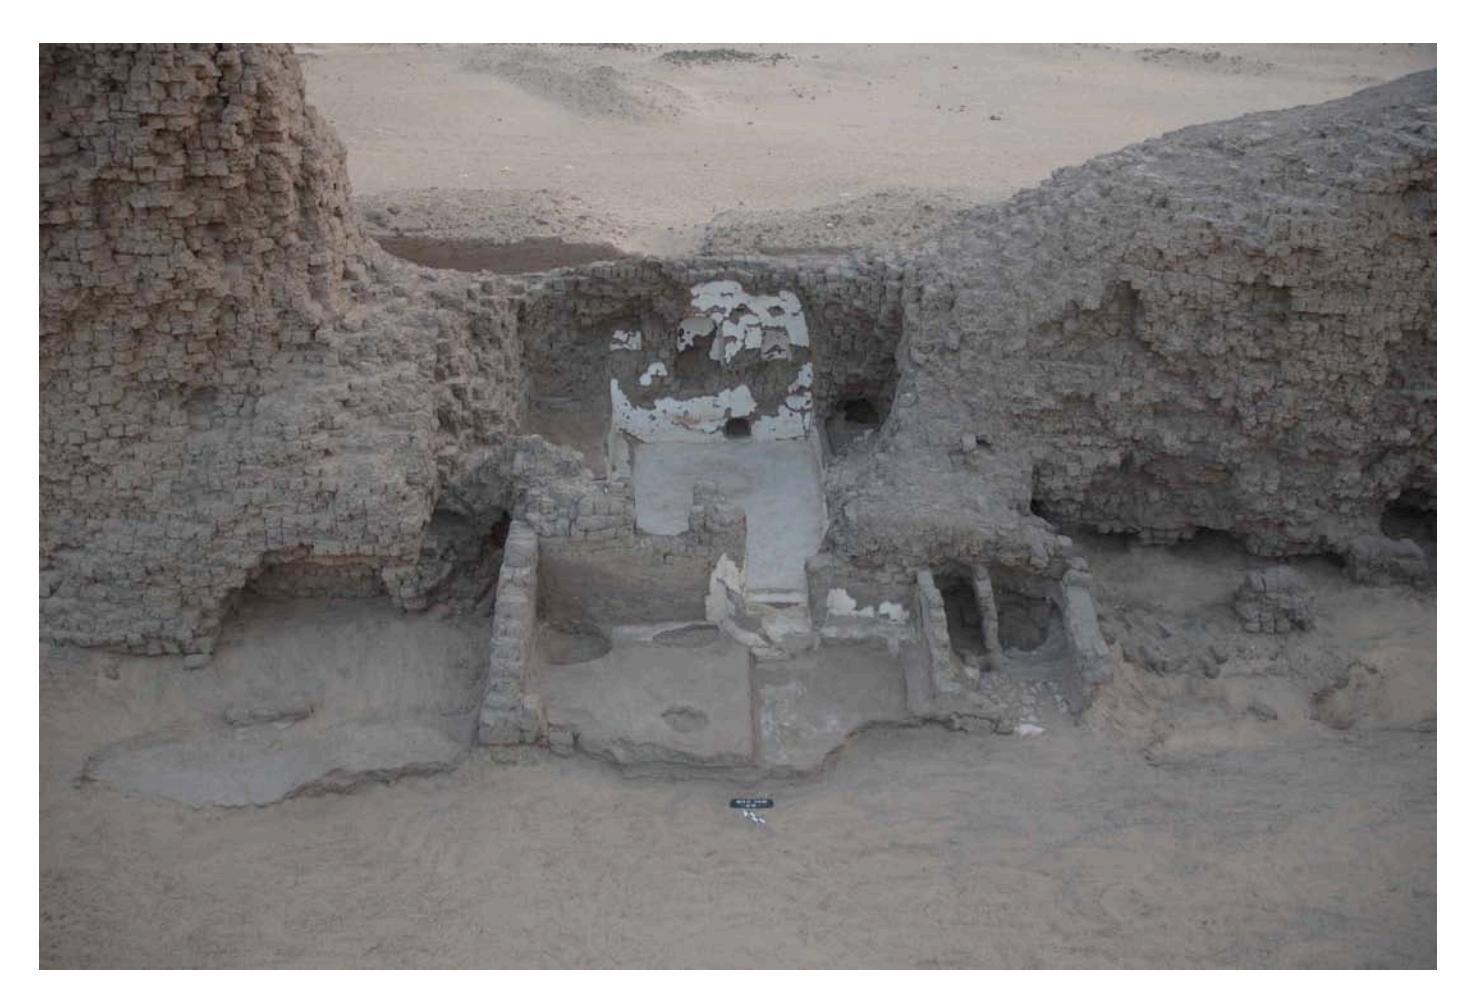
Figure 310. The suite of monastic features excavated as Operation 102 in the lower, central portion of the east main enclosure wall, prior to conservation work; note here that the walls and floor of the forecourt were artifically truncated by early archaeological excavations at the monument. (Photo: Jason Goodman 2005-2006)

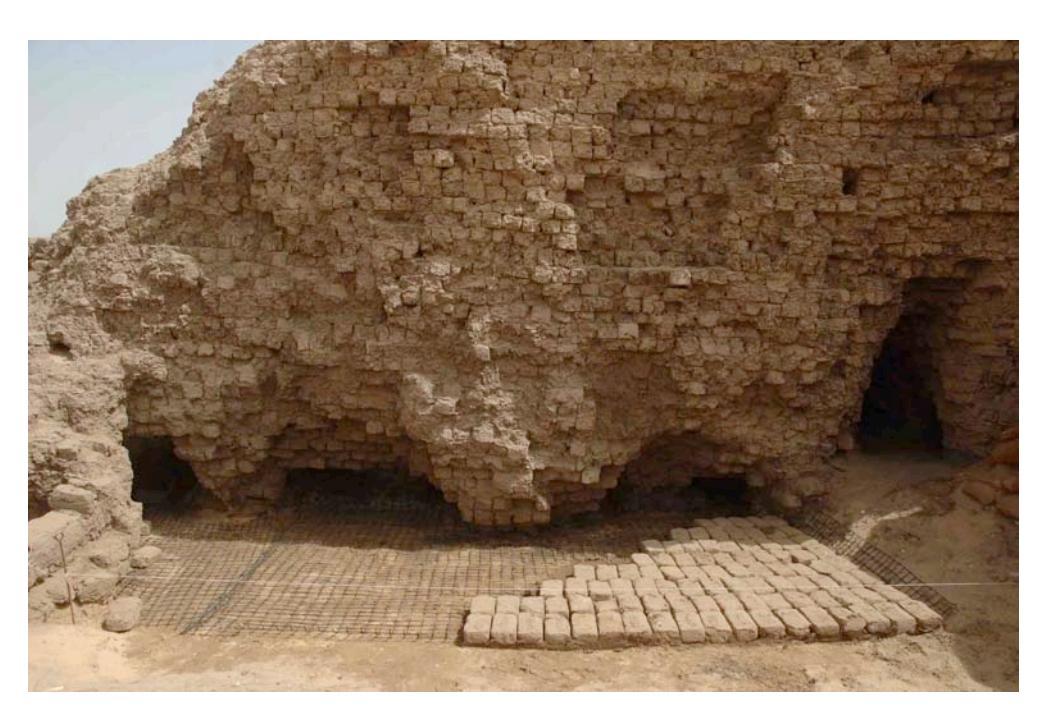
Figure 311. Detail of stabilization work in progress on the northern, interior side of the east main enclosure wall, adjacent to the monastic cell noted as Operation 102; a layer of geogrid was used to provide a secure base for the new masonry in this heavily undermined area. (Photo: Jason Goodman 2005-2006)

The initial step in Operation 102 was to install new masonry to support the undermined wall base on both sides of the monastic suite (Figures 311 and 312). This step was also critical to reducing the general instability of the tall northern pier, and to reinforcing the overall stability of the central portion of the east wall, as dangerously undermined as it has been by animal burrows that contributed to the collapse of the mid-upper wall portion. The method used to buttress these wall base locations with new construction will eventually be used to stabilize the full length of the central, interior portion of the east wall. A platform was excavated slightly below the level of the original wall base in the sand adjacent to the wall. This sand was wetted, compacted and reinforced with geogrid to provide a stable base for the new construction, which was then built up to meet and support the original fabric of the wall. Once the base of the wall was stabilized on both sides of the cell, infilling proceeded in the interior chambers (Figures 313 and 314). This infilling was necessary to provide a base for the large masonry section that will be required to support the adjacent vertical wall end on the northern pier of the east wall. Prior to new construction inside the cell, all plastered surfaces and significant features were covered by a protective barrier layer of finely sieved sand, and as the level of infilling rose, a 3-5cm gap was left adjacent to all finished surfaces and filled with clean sand (Figures 315 and 316). Because the floor and walls of the forecourt lay beyond the original line of the enclosure wall, this area was left unencumbered by new masonry. The new brickwork was recessed adjacent to the doorway and window between the forecourt and interior cell chamber to provide visual references to these features. The walls and mud floor of the forecourt, as well as other related features that lay outside the line of the enclosure wall, were reburied with sand.
