THE FUNERARY MONUMENT OF KING KHASEKHEMWY AT ABYDOS (ca. 2700 BCE): CONSERVATION AND ARCHAEOLOGY, 1999-2006

Final report on the "Documentation and Conservation of King Khasekhemwy's Funerary Monument at Abydos," a sub-project of the Egyptian Antiquities Project of the American Research Center in Egypt

2007

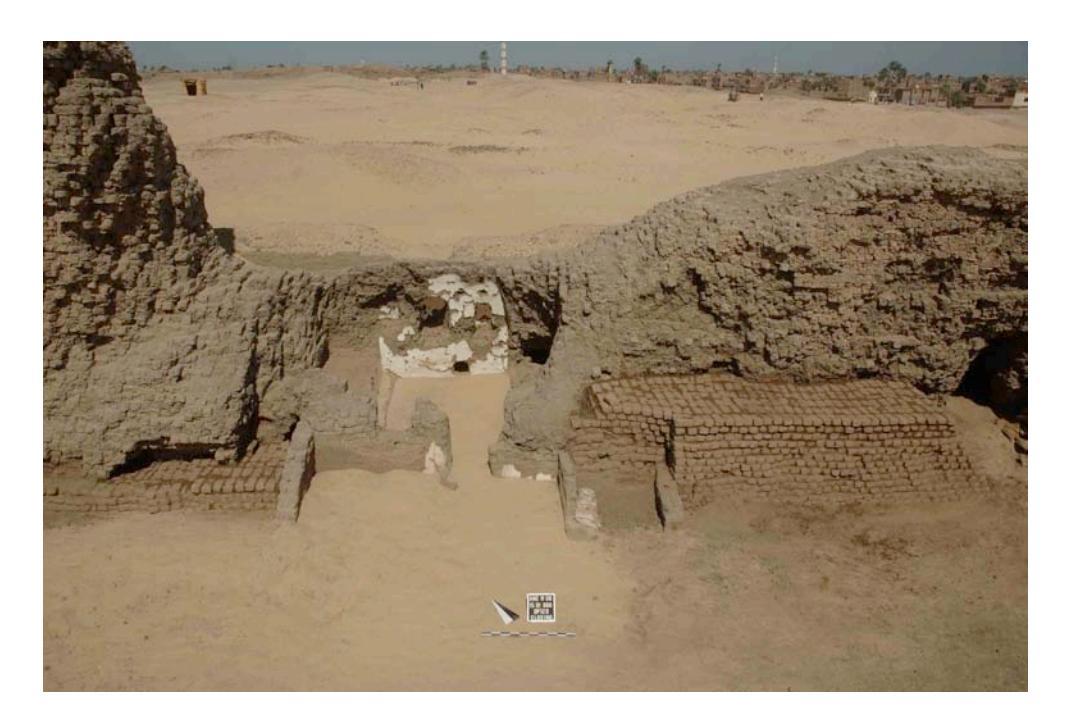
Figure 312. Detail of the stabilized wall base on either side of the monastic cell noted as Operation 102, prior to infilling the interior cell chambers. (Photo: Jason Goodman 2005-2006)

The initial step in Operation 102 was to install new masonry to support the undermined wall base on both sides of the monastic suite (Figures 311 and 312). This step was also critical to reducing the general instability of the tall northern pier, and to reinforcing the overall stability of the central portion of the east wall, as dangerously undermined as it has been by animal burrows that contributed to the collapse of the mid-upper wall portion. The method used to buttress these wall base locations with new construction will eventually be used to stabilize the full length of the central, interior portion of the east wall. A platform was excavated slightly below the level of the original wall base in the sand adjacent to the wall. This sand was wetted, compacted and reinforced with geogrid to provide a stable base for the new construction, which was then built up to meet and support the original fabric of the wall. Once the base of the wall was stabilized on both sides of the cell, infilling proceeded in the interior chambers (Figures 313 and 314). This infilling was necessary to provide a base for the large masonry section that will be required to support the adjacent vertical wall end on the northern pier of the east wall. Prior to new construction inside the cell, all plastered surfaces and significant features were covered by a protective barrier layer of finely sieved sand, and as the level of infilling rose, a 3-5cm gap was left adjacent to all finished surfaces and filled with clean sand (Figures 315 and 316). Because the floor and walls of the forecourt lay beyond the original line of the enclosure wall, this area was left unencumbered by new masonry. The new brickwork was recessed adjacent to the doorway and window between the forecourt and interior cell chamber to provide visual references to these features. The walls and mud floor of the forecourt, as well as other related features that lay outside the line of the enclosure wall, were reburied with sand.

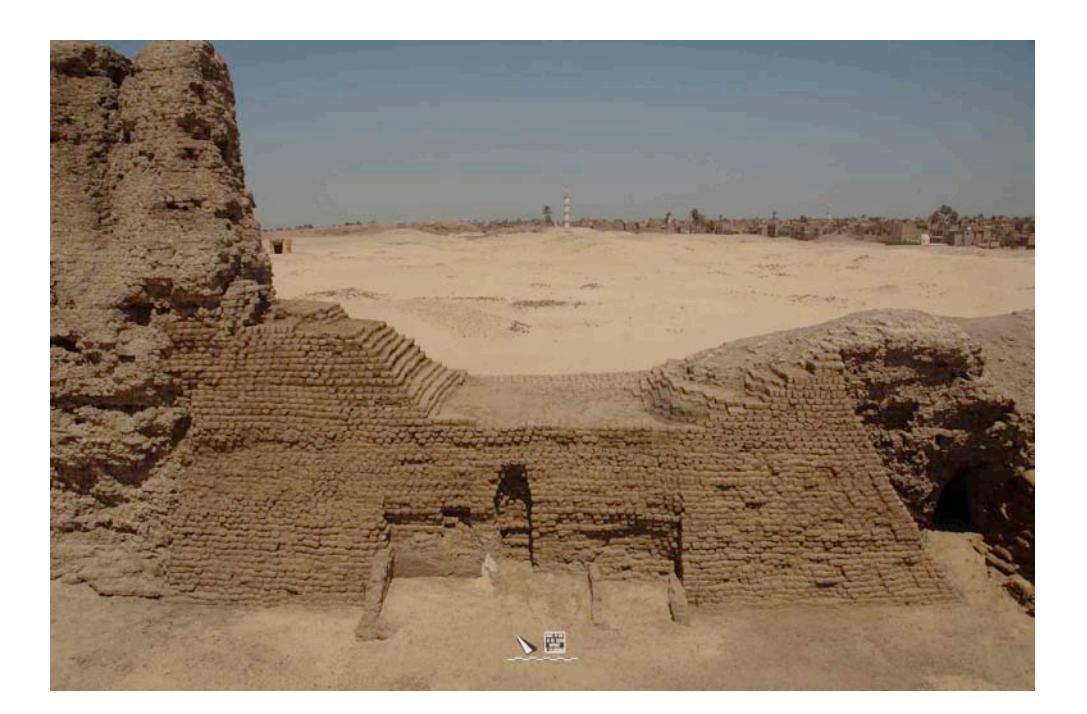
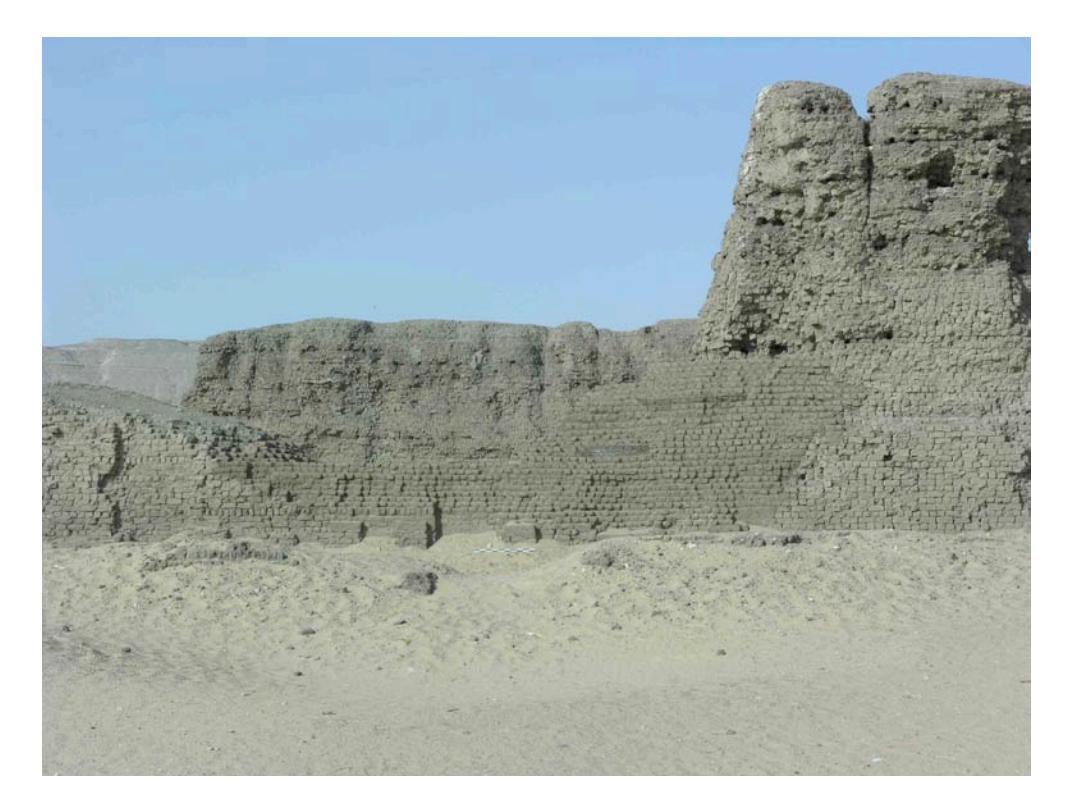
Figures 313, 314. Interior and exterior details of the monastic cell area noted as Operation 102, completely stabilized at the close of field season 7 (top and bottom, respectively); the solid base of new construction created at this location will support additional masonry required to stabilize the adjacent vertical wall end. (Photos: Jason Goodman 2005-2006)

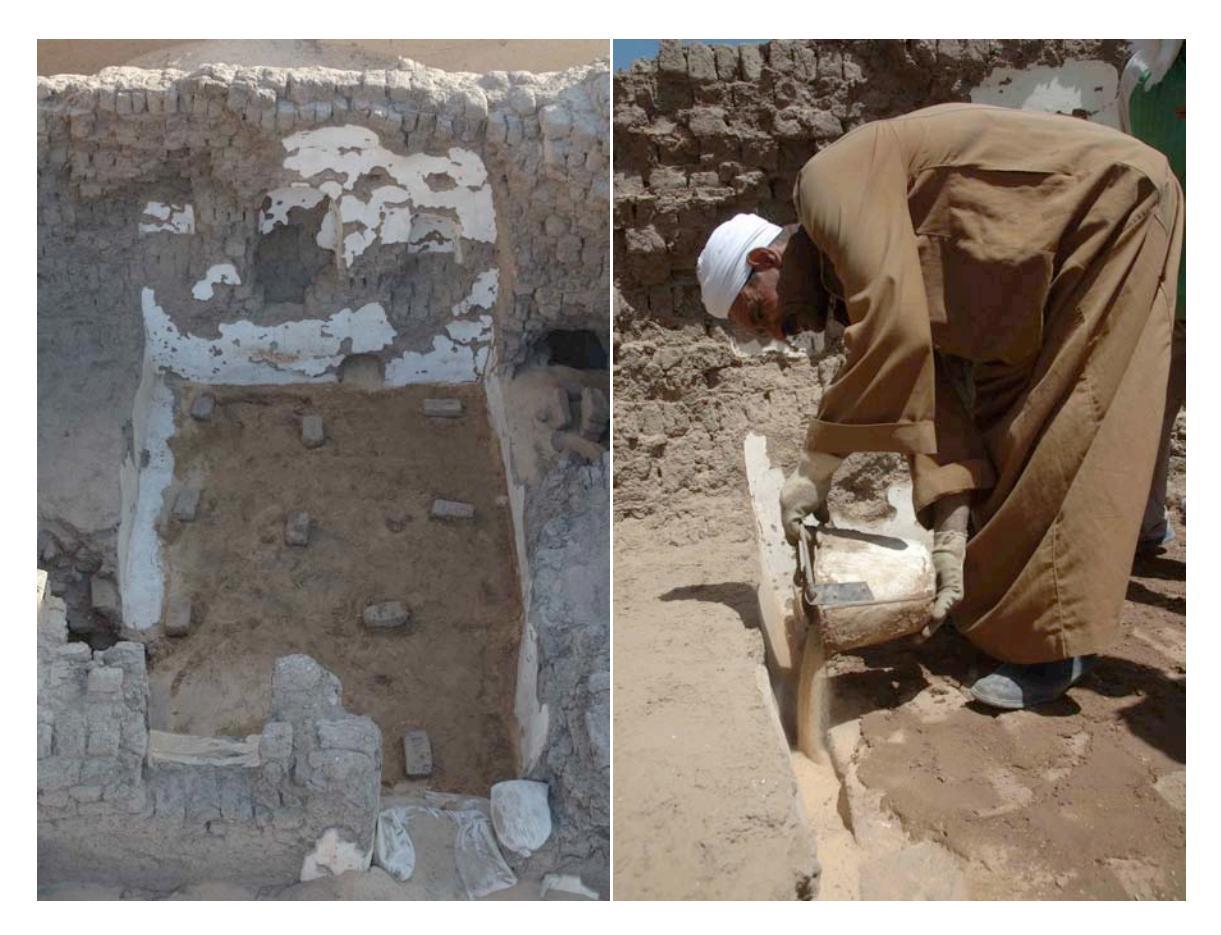
Figures 315, 316. A protective barrier layer of clean sand covers the plaster floor and walls of the monastic cell noted as Operation 102, prior to infilling (left) and clean sand is added to the protective gap between original surfaces and new masonry (right). (Photos: Jason Goodman 2005-2006)

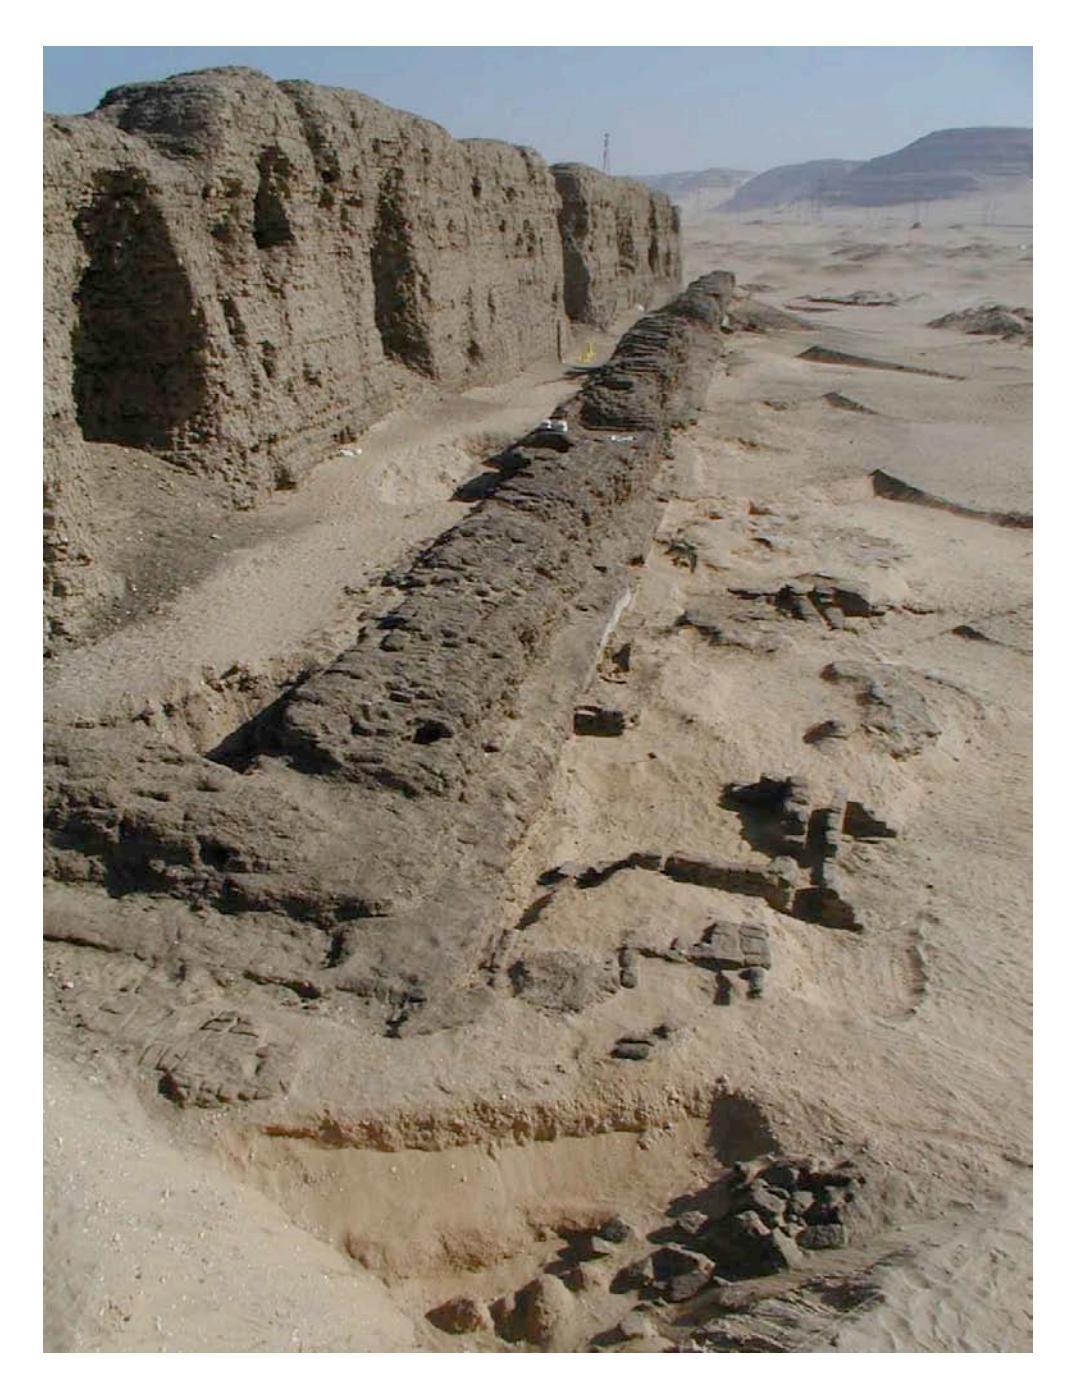
The excavated areas of Operations 56-59 were carefully cleaned and documented and the condition of the west perimeter wall was evaluated. In some areas, brick debris from the collapse of major sections of the wall was identified. The preserved wall, which is at no location higher than 3m, has been affected by the same factors that have adversely affected other areas of the monument, including animal burrows, which have in some cases penetrated through the entire thickness of the wall, wind scour, insect damage, localized collapses and deliberate brick removal, all of which have contributed to significant undercutting in the wall. The most critically unstable areas were buttressed with temporary sandbag supports. For almost the entire length of the west perimeter wall, from the northwest corner to the gateway opening, the part of the wall subject to periodic exposure above grade has been significantly denuded, such that a "shelf" (roughly half a meter wide) exists a few courses up from the base of the wall (see Figure 417).

Figure 417. The west main enclosure and perimeter walls, facing south from the northwest corner during excavation in field season 4; note the traces of original plaster and whitewash finish on the exterior face of the perimeter wall (at center), the remains of shaft tombs likely dating to the Middle Kingdom and small areas of Dynasty 2 mud surface (at right), and stacks of bricks left over from the original construction (at lower left). (Photo: Robert Fletcher 2001-2002)

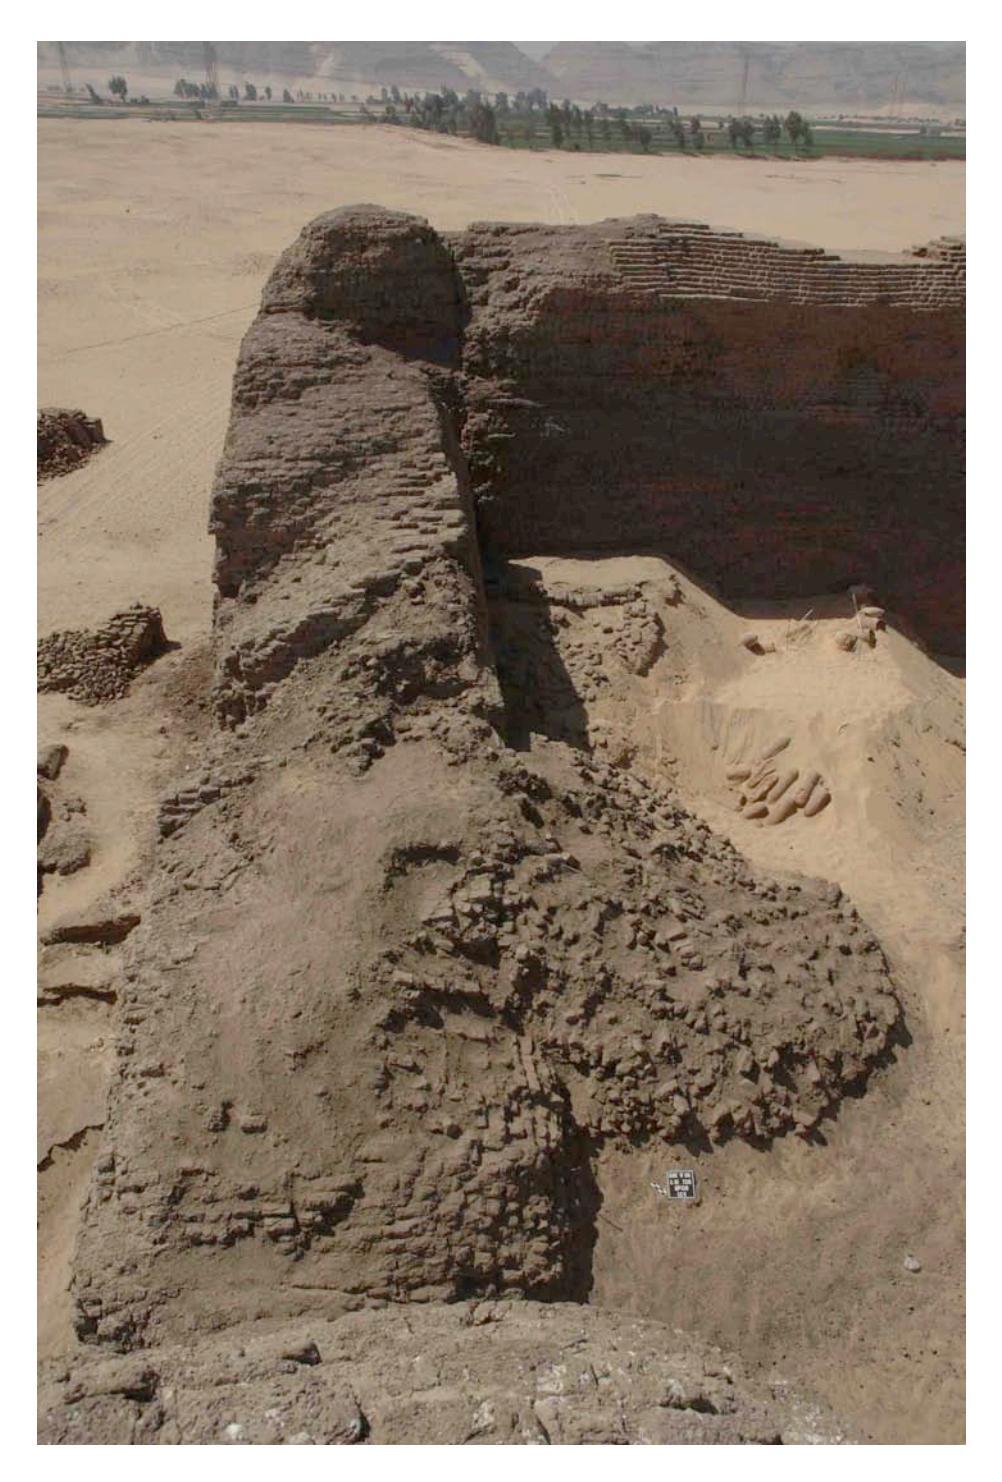
Figure 420. The top of the south main enclosure wall, facing west from the south gateway during excavation in field season 7; note the collapsed portion of original masonry (at lower right). (Photo: Jason Goodman 2005-2006)

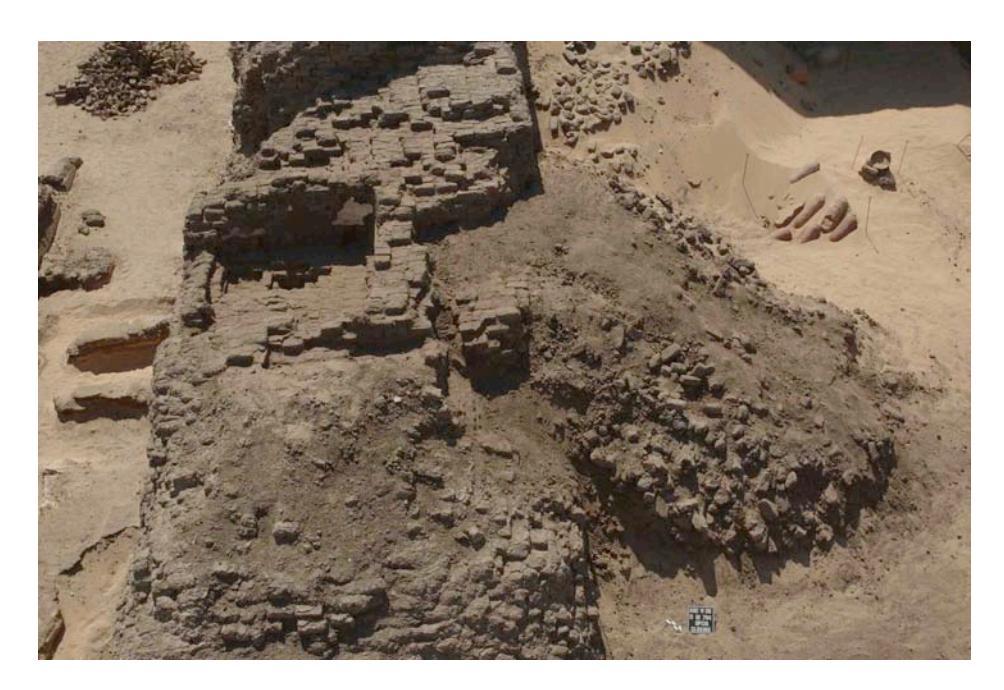
Excavation in Operation 136 on the eroded top of the south main enclosure wall, between the southwest corner and the south gateway area, revealed that a small room or cell had been cut into the wall from the exterior side (Figures 420-422). Unlike most other such rooms, the front, or southeast, wall of this cell appears to have been built up in brick after the cavity had been created, rather than by leaving original masonry in place. This construction method may relate to the relatively small size of the space. The degree of erosion of the front wall made the position of the entryway uncertain. Nothing of the actual floor surface was left in place, and judging by the level of the bottom of the preserved wall plaster, it appears that the floor and brick masonry underneath were robbed out to well below the original floor level, prior to the accumulation of the erosional deposit containing fragments of wall plaster. At the time the cell was in use, the ground level of the adjacent south corridor must have been substantially higher than in recent times, as access would have been quite difficult otherwise. Presumably, the excavations of a century ago resulted in the present ground level, as is the case elsewhere in the perimeter corridor.

Figure 421. Detail of the monastic cell (at left) excavated in Operation 136 at the top of the south main enclosure wall; the construction of this cell was responsible for structural instability leading to the collapse of the upper wall section in this area. (Photo: Jason Goodman 2005-2006)

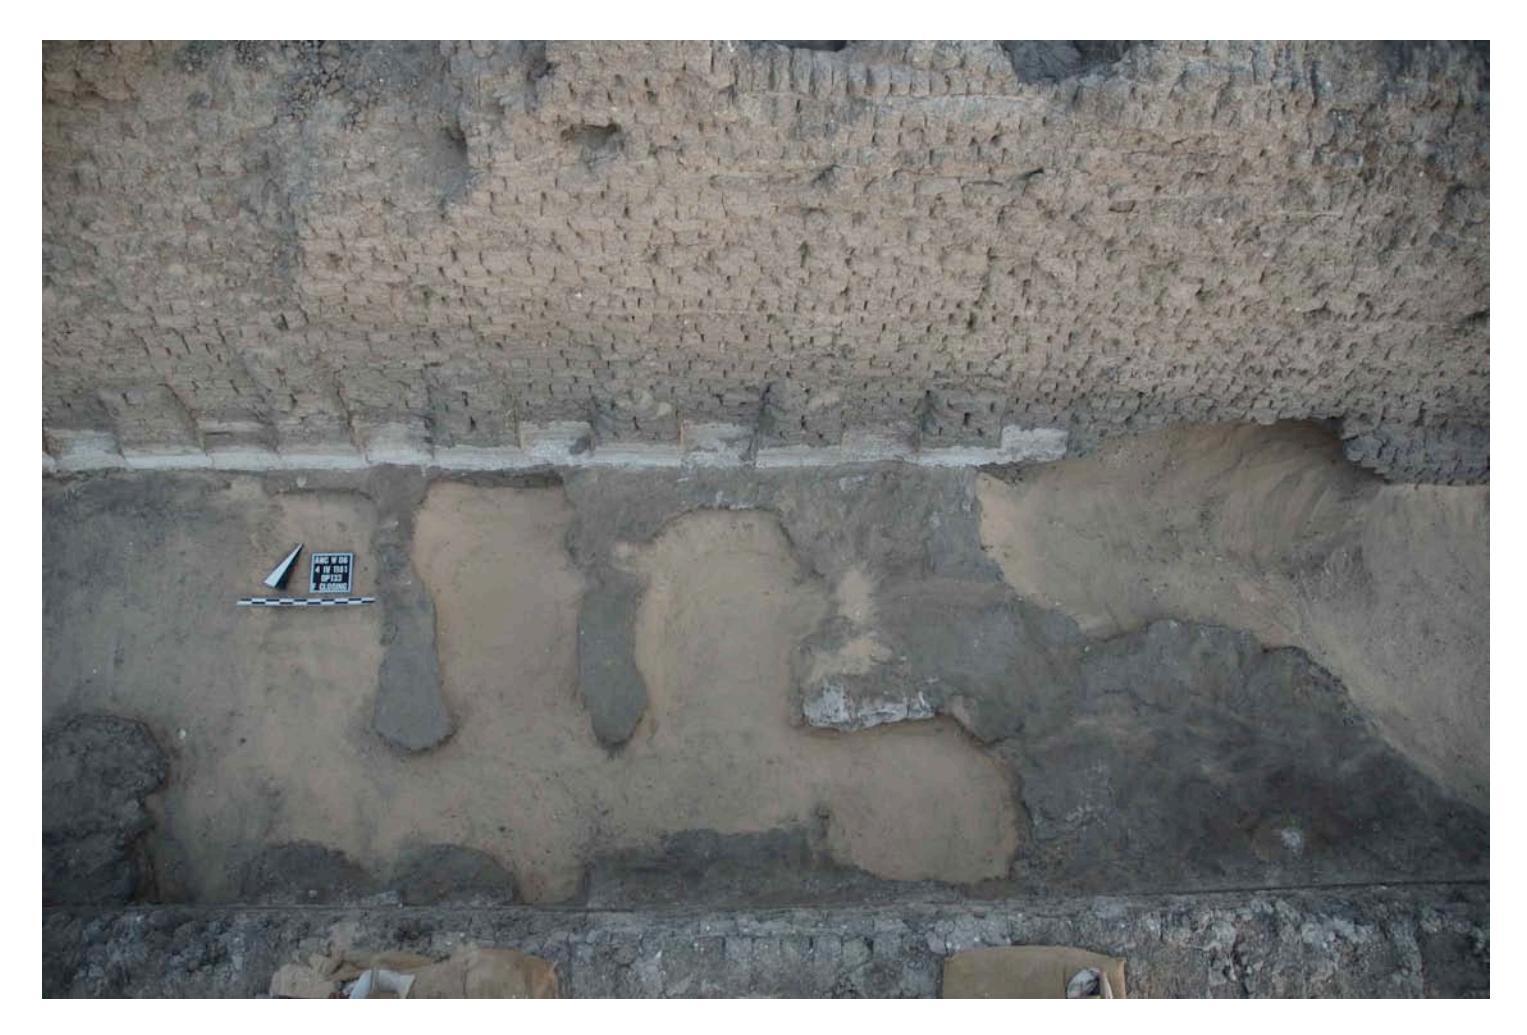
The perimeter corridor between the south gateway and the southwest corner of the main enclosure was excavated in Operations 132 and 133, during field seasons 6 and 7 (Figure 424). Excavation reached the original Dynasty 2 floor level and found that the mud plaster floor had been cut by a series of parallel holes spanning the entire width of the corridor area (Figure 425). The pattern seen here is very similar to that in the north corridor (see above), and the parallel holes are probably the sondages of earlier excavations (most likely those of E. R. Ayrton in 1902-1903). A roughly circular hole cut through the Dynasty 2 mud floor, and bordered on the northwest side by a large stone set into the floor, appears to have served a particular purpose some years after Ayrton's excavations. The hole contained a foul-looking greenish deposit that had clearly once been liquid, as well as many broken eggshells, a wooden matchbox, a metal tube for "Kolynos Dental Cream," and a fragment of a paper envelope postmarked 26 January 1922, at which time W. M. F. Petrie and his small team were living inside the Shuneh. The hole appears either to have been a refuse pit for Petrie's team, or else its privy, an interpretation perhaps supported by the peculiar deposit found inside.

Figure 425. The excavated area of Operation 133 in the south corridor; note the preserved original finish on the lower part of the south main enclosure wall (through center), as well as the remains of the Dynasty 2 mud-plaster corridor floor and the pitting of floor resulting from early excavations in this area, including a hole presumably used as a refuse pit or privy by W. M. F. Petrie's team in the early 1920s (at lower right). (Photo: Jason Goodman 2005-2006)

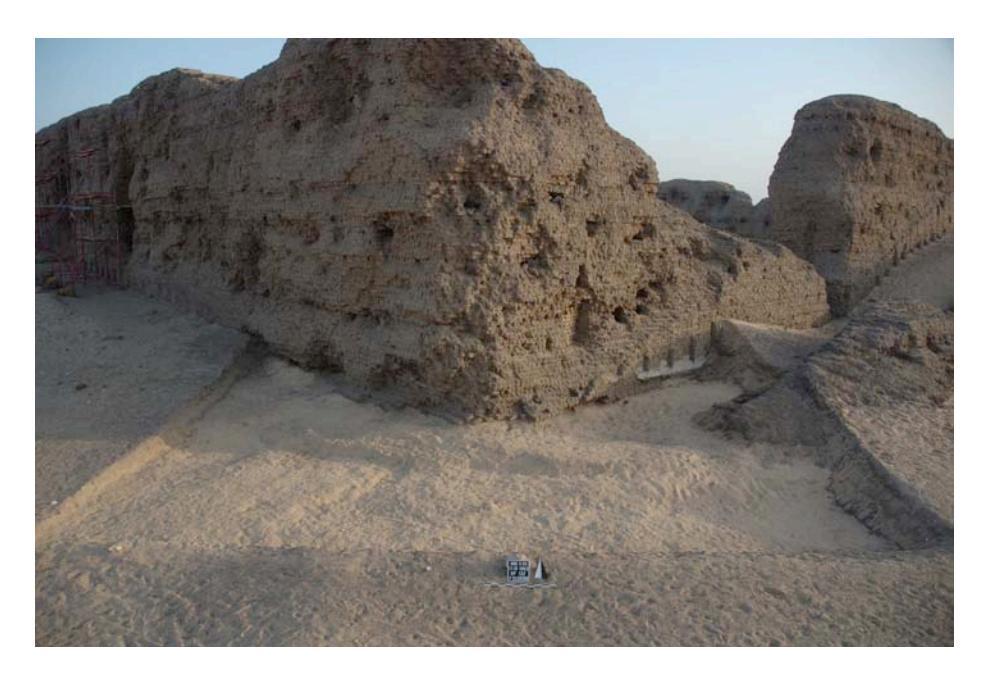
Excavation in Operations 40, 41 and 44 revealed the complete loss of the southwest corner of the perimeter wall (Figures 430 and 431). It appears that natural wind scour has reduced the ground surface at the southwest corner and along the exterior side of the west perimeter wall to a level below the wall base. Consequently, no trace of Dynasty 2 floor or other features remains in this area. A few highly eroded fragments of wooden coffins were found, which were probably originally placed in pits cut through the early floor (as with the coffins encountered in Operations 38 and 39), but wind scouring has removed the overlying deposits through which the pits may have been cut.

Figure 430. The excavated area of Operation 132 at the southwest corner of the enclosure (see also Figure 426, above); note the complete loss of this corner of the perimeter wall due to wind erosion. (Photo: Robert Fletcher 2004-2005)

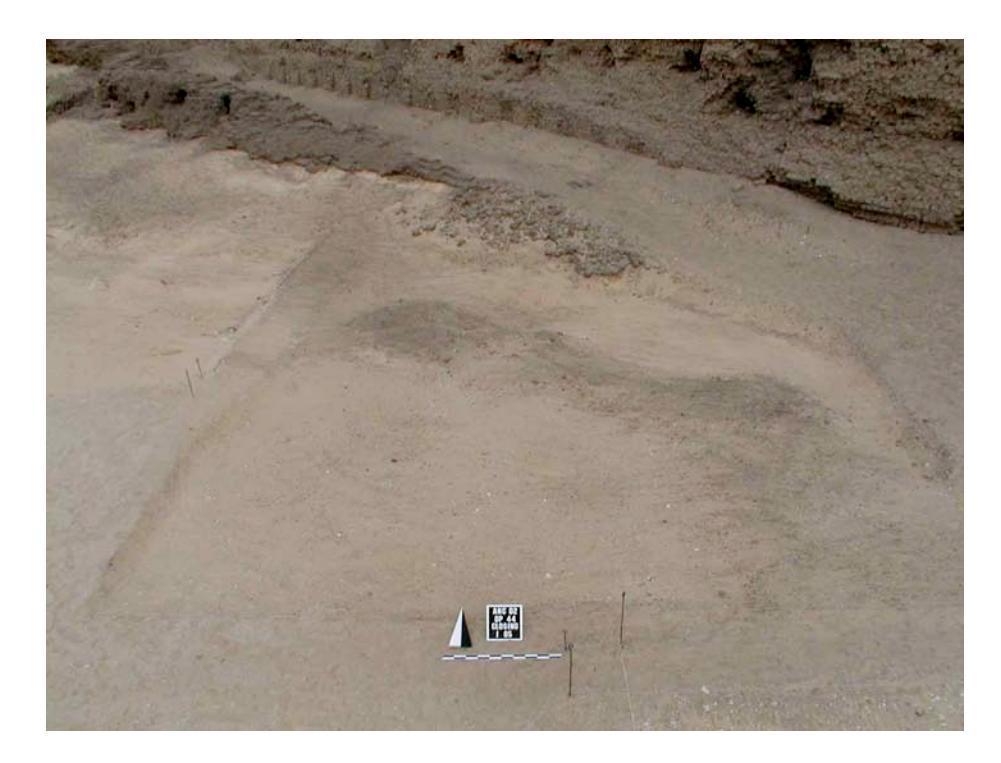
Figure 431. The excavated area of Operation 44 at the southwest corner of the enclosure; note the extent of preservation of the west perimeter wall approaching this corner, represented by the mass of mudbrick debris (at center). (Photo: Robert Fletcher 2001-2002)

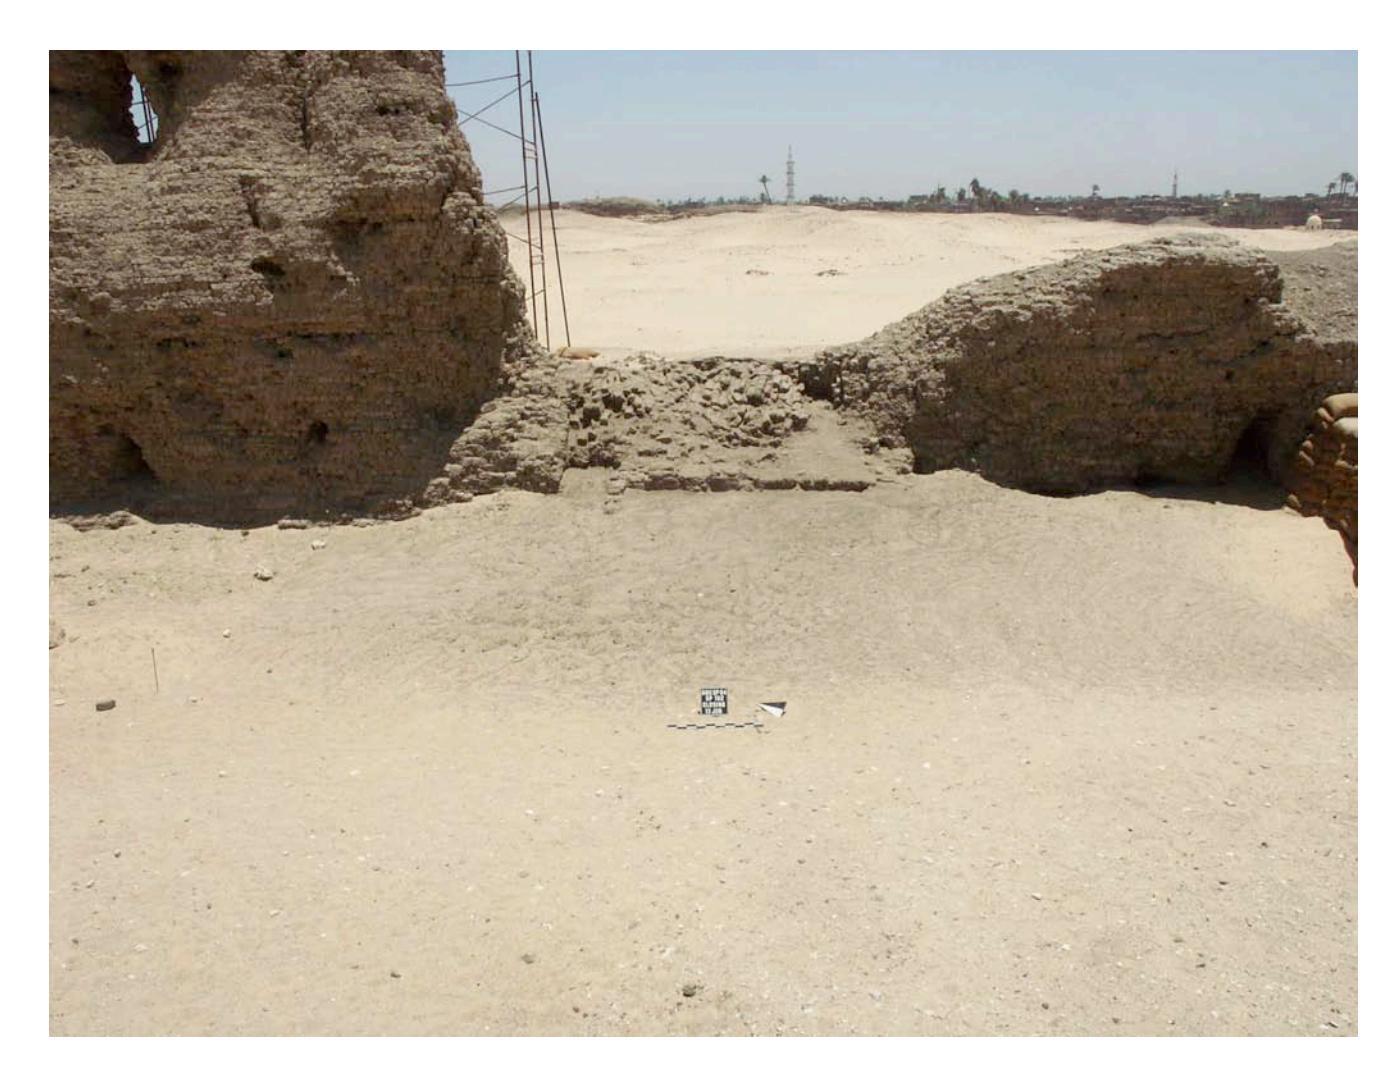
The excavated area of Operation 102 was situated along the interior side of the east main enclosure wall, adjacent to a highly unstable vertical wall end (Figure 432). Excavation in field season 5 (spring 2004) exposed the collapsed roof of a cell belonging to the monastic occupation of the monument during late antiquity (Figure 433). At the rear (east side) of the cell, the lime plaster finish of the room's interior was visible. Removal of the collapsed brickwork and excavation of the cell's interior were undertaken in field season 6 (2004-2005), and detailed architectural documentation of the cell area was completed in field season 7 (2005-2006).

Figure 432. The excavated area of Operation 102 on the interior side of the east main enclosure wall. (Photo: Matthew Adams 2004)

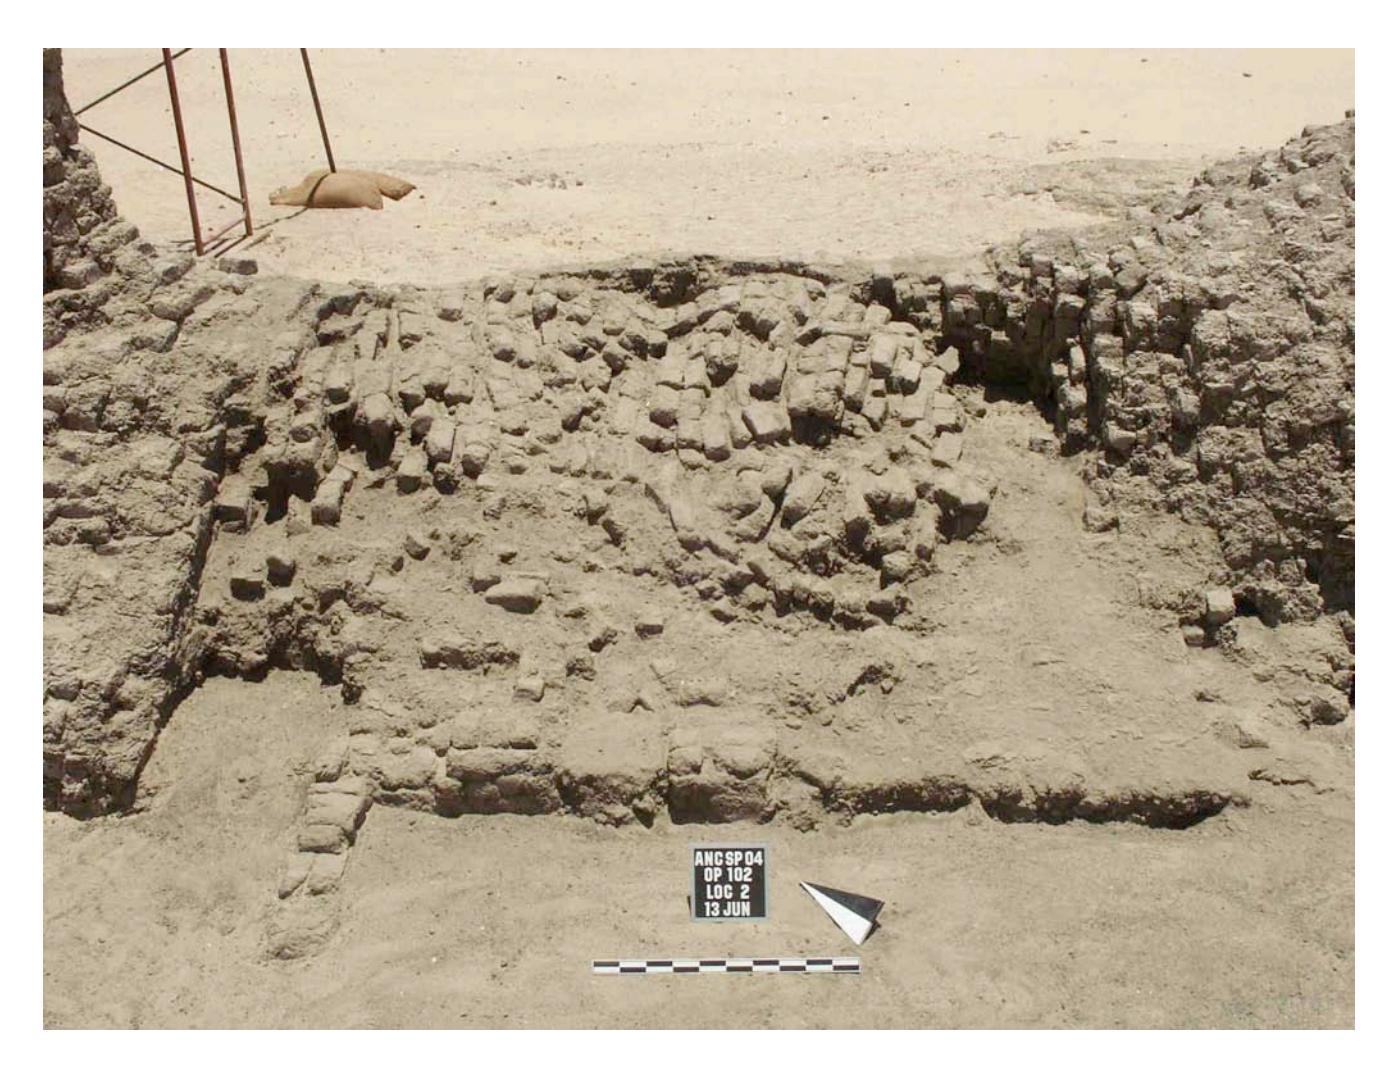
Excavation of the monastic cell in Operation 102 revealed that the entire mass of original masonry above the cell (to the east) had collapsed into it. The size of the cell void appears to have been the major cause of this collapse. The monastic cell excavated in Operation 102 penetrates more deeply into the wall than any other cell excavated at the Shuneh. There is less than 75cm of original masonry remaining on the east side of the cell, however the volume of masonry found inside the cell is not sufficient to suggest that the wall in this area stood to anything near its original height at the time of the collapse. Some major losses to the upper part of the wall in this area must have occurred prior to the construction of the cell, and the height of the wall at that time may have been similar to the adjacent area of wall on the south side of the cell. Like most other cells at the Shuneh, this one was finished in hard white lime plaster, but the force of the masonry collapse heavily damaged the plaster finish of the walls. The collapse apparently occurred some time after the cell had been abandoned, as the floor was covered by an accumulation of wind blown sand, which served to protect it from the collapsing masonry. Like a number of the cells in the exterior side of the west main enclosure wall, this cell had a set of three niches cut into the rear (east) wall, consisting of a larger central niche flanked by two smaller niches, all of which were finished in lime plaster. An additional unplastered niche or hole was revealed at floor level in the back wall of the cell. On the north side of the cell, a wide niche had been cut into the masonry of the enclosure wall, creating a sleeping platform with a raised line of bricks, or "pillow," at its eastern end. The foot (or west end) of the sleeping platform, as well as the wall that would have formed the western side of the large niche, were heavily damaged by the roof collapse. Along the edge of the floor below the bed was a low plastered bench, similar to those in Room 3 of the suite discovered in the west perimeter wall during field season 4 (see Figure 405, above). The west wall of the cell had two openings, one being a small window and the other being a doorway. Just inside the doorway, two pieces of limestone had been set into the floor, apparently to make a solid stepping place in a high traffic location. Also just inside the doorway was a small stone door pivot, which provides evidence that the opening was closed by a wooden door. The doorway also featured a raised, plastered threshold. Traces of black line drawings were preserved on both the east and south walls of the cell, most of which appear to depict boats, some with rigging and steering oars (Figures 434-436).

Figure 433. Detail of the monastic cell area excavated in Operation 102; the collapsed mudbrick represents a fallen section of original Dynasty 2 masonry from above the ceiling of the cell. (Photo: Matthew Adams 2004)

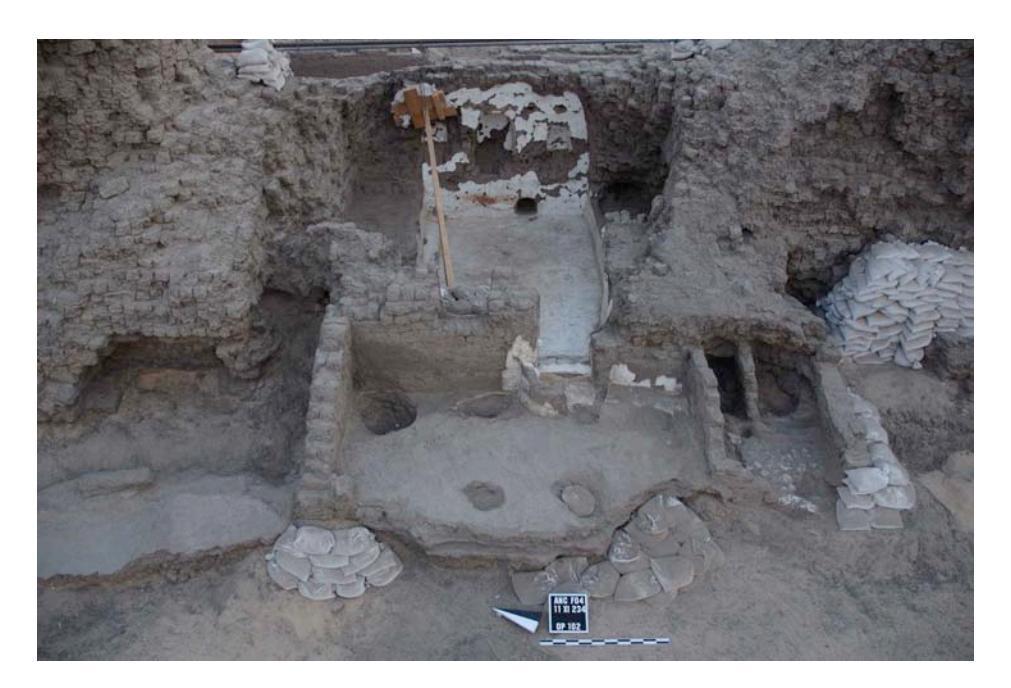
Figure 437. Interior detail of the monastic cell excavated in Operation 102, which was temporarily braced with boards and sandbags in field season 6 to provide support during the excavation of the cell area. (Photo: Robert Fletcher 2004-2005)

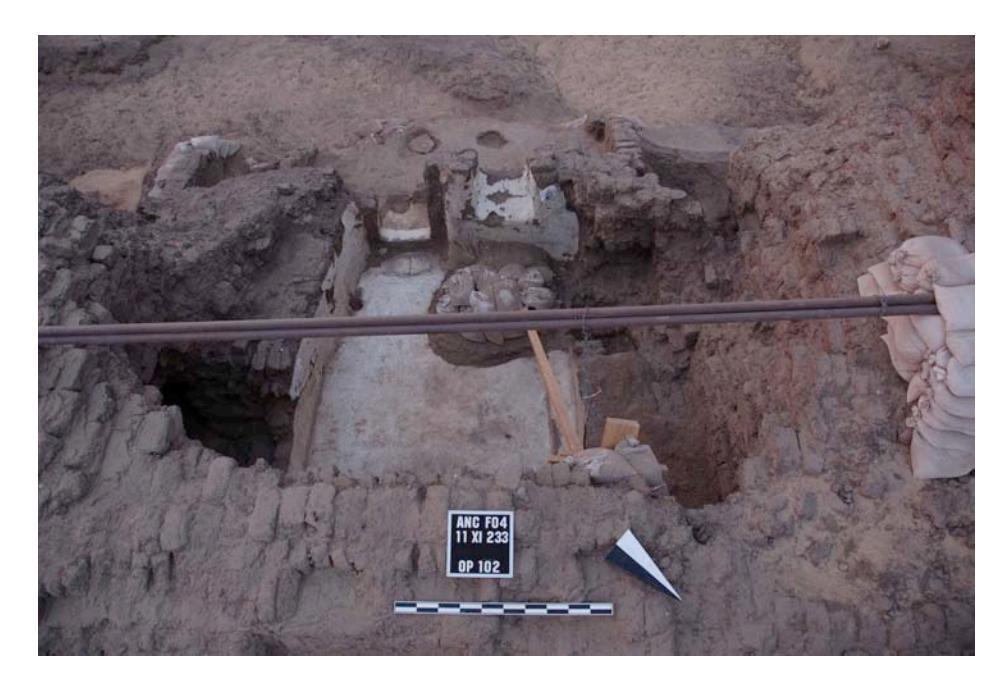
Figure 438. Exterior detail of the temporary bracing in Operation 102. (Photo: Robert Fletcher 2004-2005)

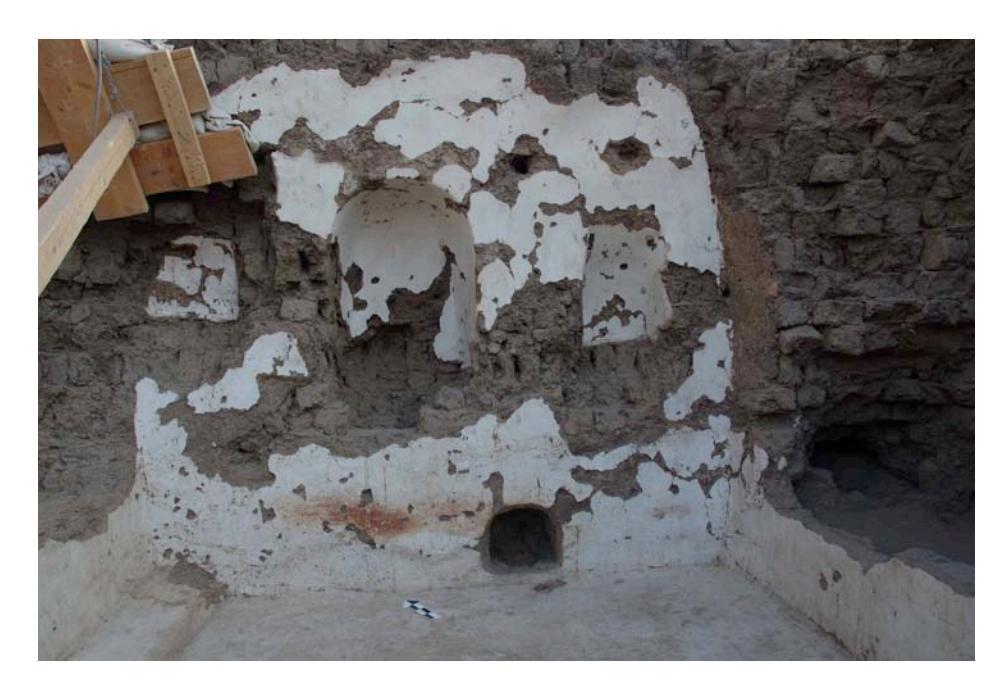
Figure 439. Interior detail of the temporary bracing in the northeastern area of Operation 102; note also the small side chamber, perhaps for storage, at lower right, and the small niche near floor level, which is an unusual feature among the monastic cells excavated at the Shuneh (Photo: Robert Fletcher 2004-2005)

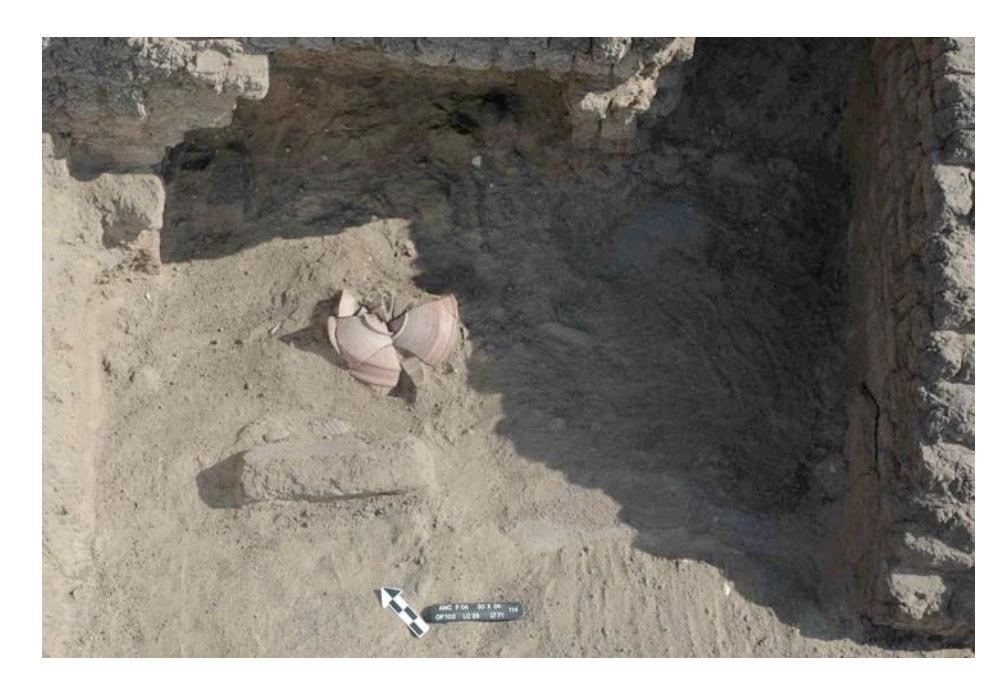
On the north side of the court were the remains of a mud basin feature. Like the floor of the adjacent court, this basin had been cut through by the same trenching event, and only the east part survives. A number of *mahmara* (mud mixing basin) features relating to the construction of the enclosure have been found, but this feature differs from those in that its interior surface was quite smooth, whereas construction basins are frequently quite rough and show clear signs of the working of the wet mud. The edge of this basin feature consisted of a raised ridge of smoothed mud plaster. Damage to the area east of the basin obscured the exact relationship of the feature to the adjacent cell and court, but additional key evidence was found in field season 7. There was a void at the base of the enclosure wall adjacent to the basin, and this appears to have been a deliberately cut feature, probably contemporary with the cell, court and basin. A number of complete or reconstructable ceramic vessels were found in this area, as well as a leather object that may very well be a monk's cap (Figures 440-442).

Figure 440. Detail of the void cut into the base of the east main enclosure wall, just north of the monastic cell and forecourt in Operation 102; note the northern wall of the court (at right) and the remains of a large ceramic bowl (at center). (Photo: Robert Fletcher 2004-2005)

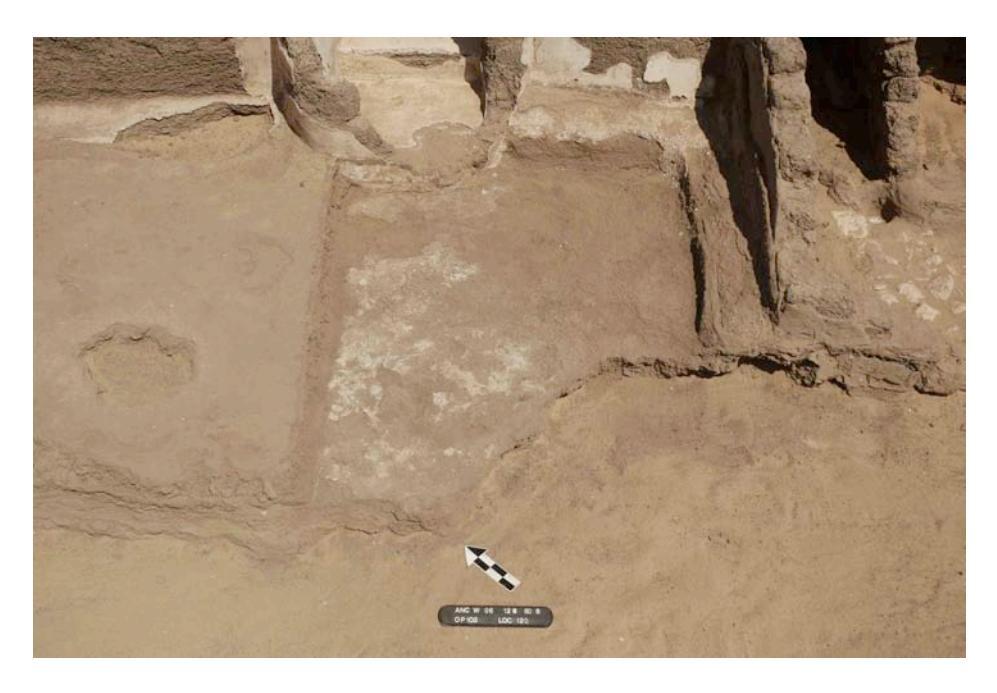
Figure 448. The mud floor of the forecourt in Operation 102, facing east. (Photo: Jason Goodman 2005-2006)

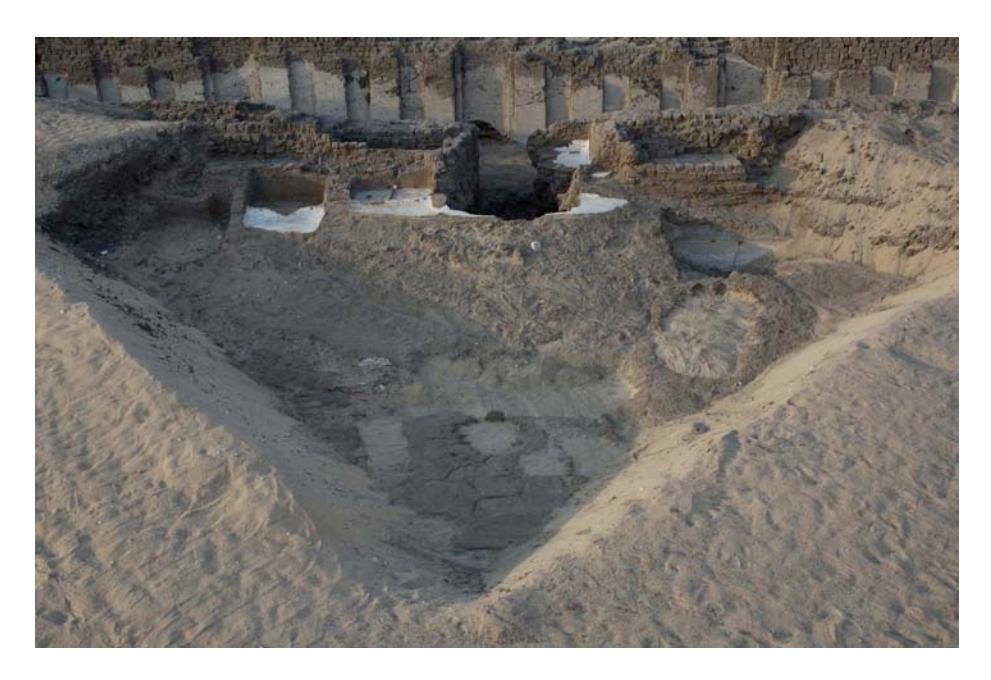
In field season 7, a small test cut was made through the mud plaster floor of the court adjacent to the cell, to permit examination of earlier floor surfaces and the original configuration of some features of the court (Figures 448 and 449). In its earlier phase, the court had low, white-plastered benches built along its eastern and southern sides. The earlier floor was heavily worn, and thin, eroded lenses of lime plaster were preserved on its surface, suggesting that repeated replasterings gradually raised the floor level and obscured the benches.

Figure 449. Detail of the test cut made through the mud floor pictured in Figure 448, above, during field season 7; in its earlier phase, the court had low plastered benches along two walls. (Photo: Jason Goodman 2005-2006)

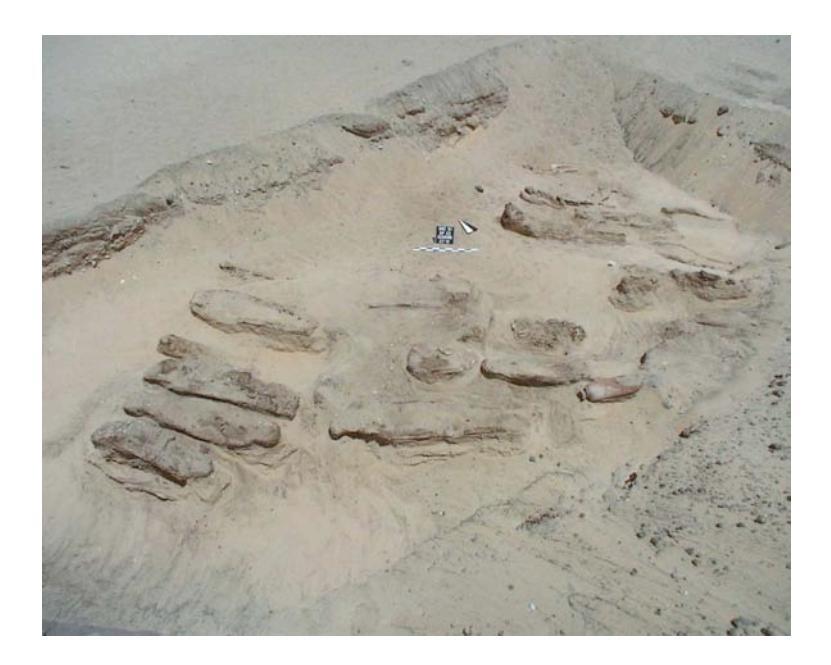
Figure 456. The excavated area of Operation 23 on the exterior side of the east perimeter wall; the deposition of a large number of later burials in this area has destroyed any Early Dynastic features that may originally have been present. (Photo: Robert Fletcher 2001)
