THE FUNERARY MONUMENT OF KING KHASEKHEMWY AT ABYDOS (ca. 2700 BCE): CONSERVATION AND ARCHAEOLOGY, 1999-2006

Final report on the "Documentation and Conservation of King Khasekhemwy's Funerary Monument at Abydos," a sub-project of the Egyptian Antiquities Project of the American Research Center in Egypt

2007

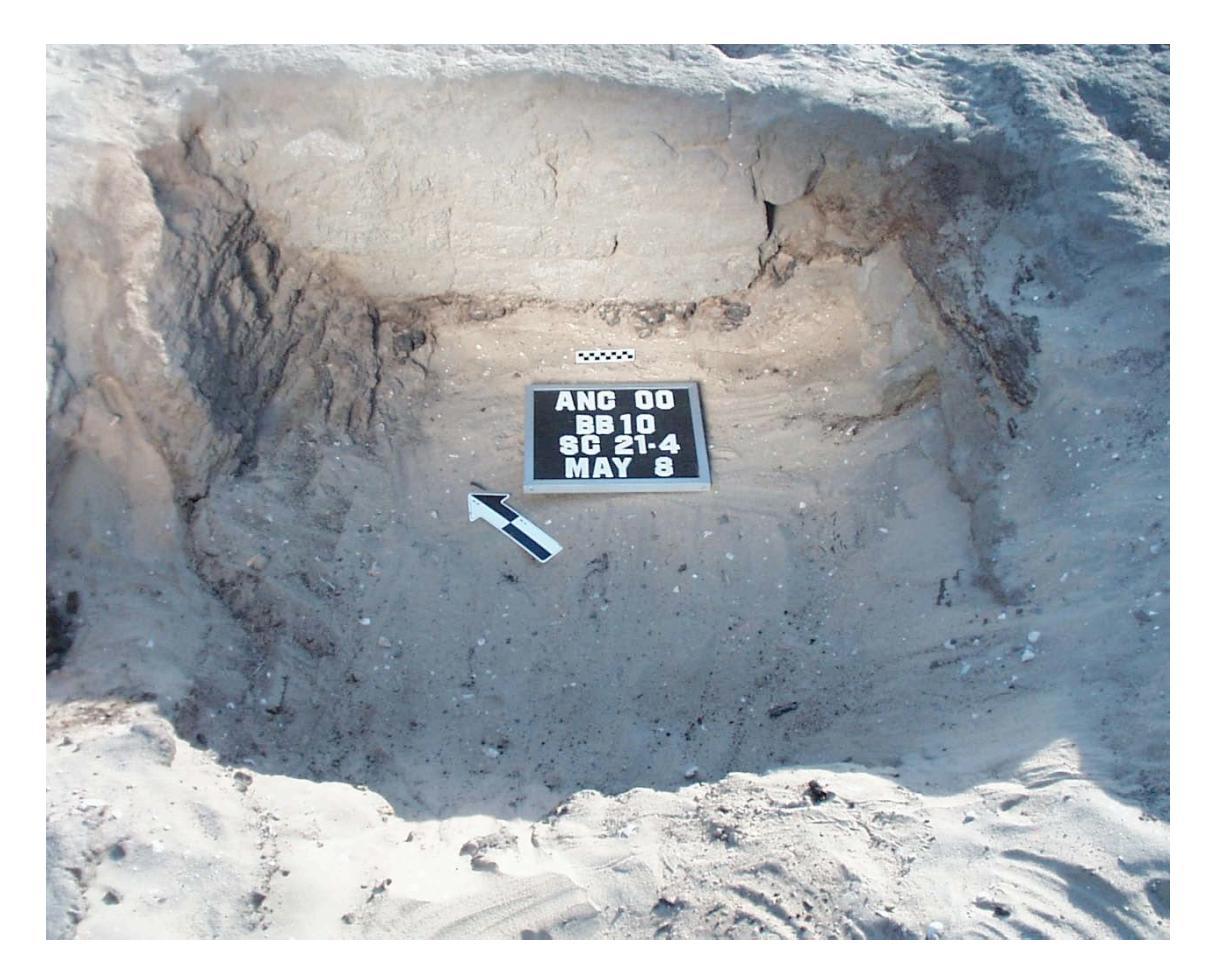
In Boat Grave 10, the 1991 test cut was re-exposed (Figure 463), and the area between it and a large ancient pit to the east was fully excavated. The first stage of the excavation entailed the careful removal of the mudbricks that had been used, anciently, to fill the hull. Under the bricks, a thick layer of frass, the organic residue left by wood-consuming insects, was encountered, which preserved the lines of the boat's hull (Figure 464). In some areas the original wood of the boat had been completely destroyed by insects. In many areas, however, there was substantial preservation of the wood. Significant lengths of the boat's wooden planks were revealed as the frass was removed (Figures 465 and 466). Substantial parts of five planks from the bottom of the hull were found, as well as the remains of three planks on the south side of the hull, and one on the north side. In some cases, important features relating to the boat's construction were well preserved or clearly indicated. The boat appears to have had parallel sets of closely spaced slots or mortises cut in its planks (Figures 467-469). The mortises ran from the top of each plank to the side. Rope lashing appears to have been woven through these mortises, binding the planks together laterally. There was no evidence for lateral wooden ribs or of any other internal supporting structure. In the spaces between the planks were found the remains of bundles of what may have been tightly packed reeds or plant fiber, and it appears that these may have been used as a kind of sealant between the planks, to prevent water from penetrating the hull. This type of boat construction is known as sewn boat technology, and it is otherwise unattested in an Egyptian context (Ward 2006, 2003). No artifacts other than the remains of the boat itself were found in the excavated portion of the interior of Boat Grave 10.

Figure 463. The 1991 section cut in Boat Grave 10, after it was re-exposed in field season 2; the trough-like profile of the wooden boat hull is visible in the dark wood and frass under the mudbrick masonry that filled the interior of the boat, and at left and right are the brick sidewalls of the grave structure. (Photo: Matthew Adams 2000)

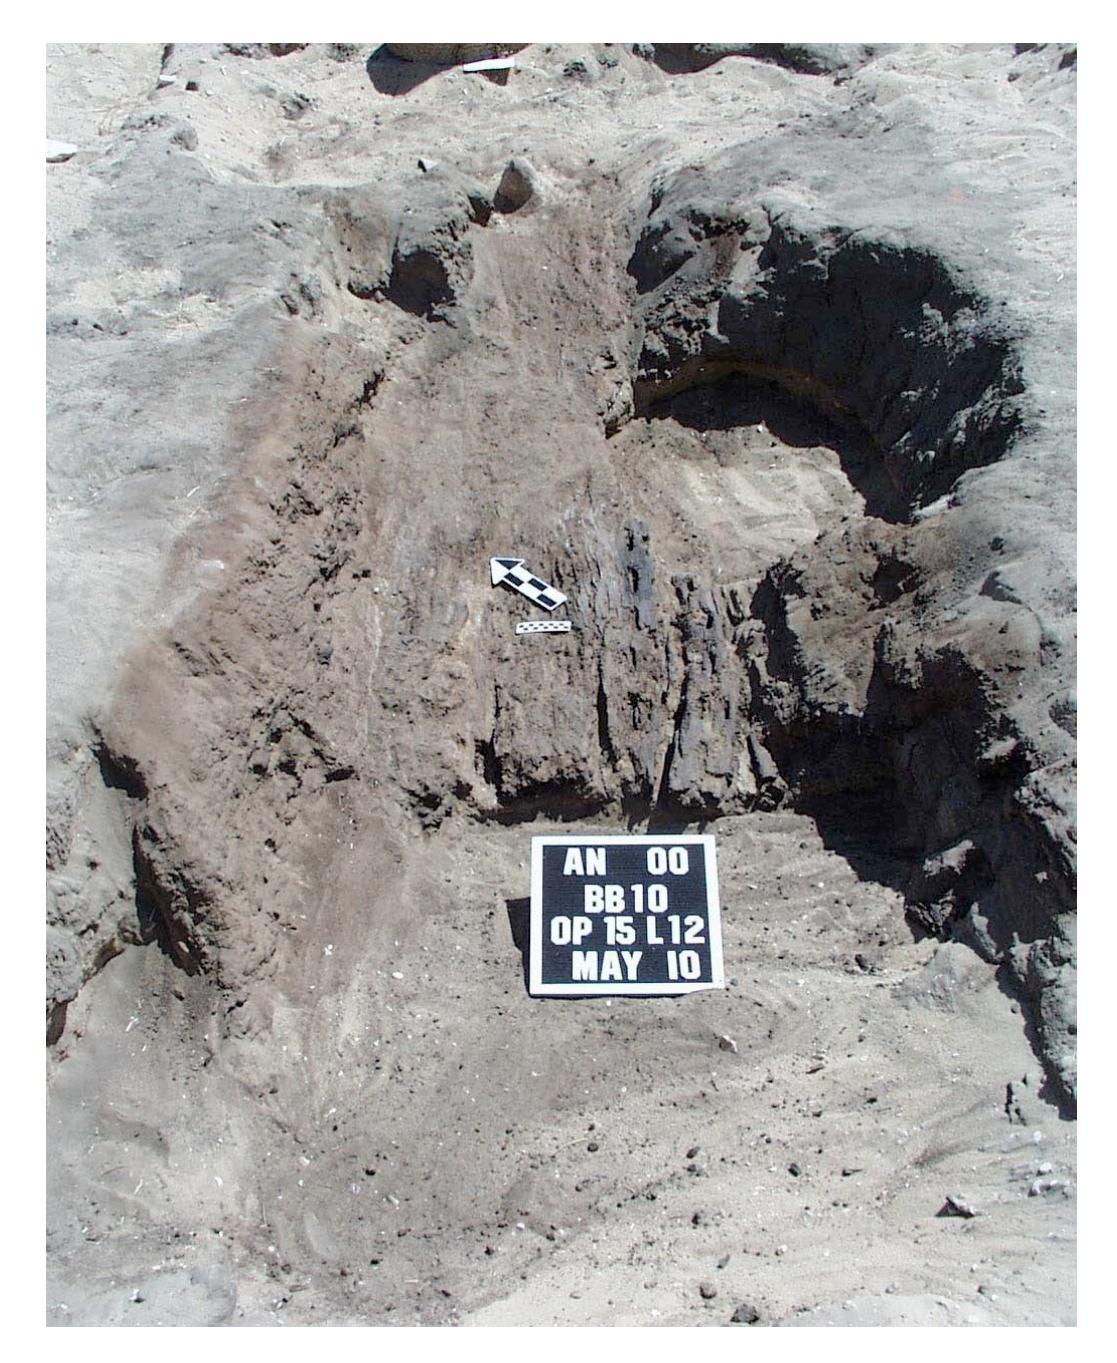
In general, the condition of the preserved wood in Boat Grave 10 was found to be extremely poor. The wood was almost completely lacking in structural integrity, being heavily checked, with the wood fabric physically separated into small roughly cube-shaped sections, which retain their original relative positions in each plank, as long as the plank is not disturbed, but lacking any physical bond (see Figure 469). Given its condition, none of the wood could be removed without significant conservation. During the course of the excavation, the wood was cleaned, examined and consolidated by conservators Lawrence

Figure 464. The interior portion excavated in Boat Grave 10, after removal of the mudbrick masonry that filled the hull; cleaning has revealed two relatively well-preserved planks from the bottom of the hull, while the remainder is still obscured by frass, the waste product of wood consumption by insects. (Photo: Matthew Adams 2000)

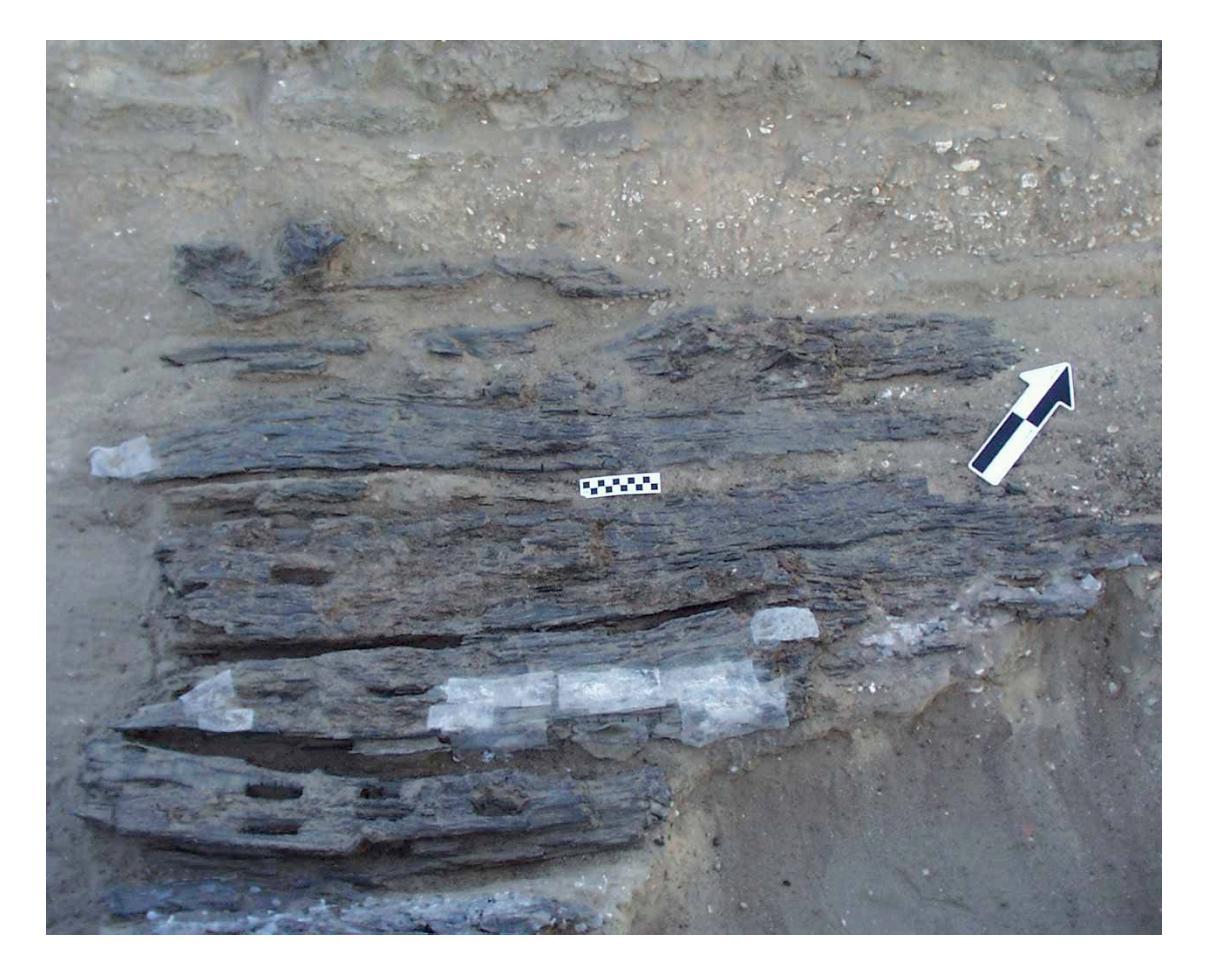
Figure 468. The bottom planks of the hull of Boat Grave 10; mortise holes are clearly visible in several of the planks, which in some cases have been filled with cellulose powder as part of the conservation process, indicated by the white areas covered with tissue on the plank second from the bottom in this photograph. Pitting has destroyed the remains of the hull at left and right. (Photo: Matthew Adams 2000)

Becker and Deborah Schorsch (of the Metropolitan Museum of Art), using a variety of methods as determined by the condition of each piece. The primary consolidant employed was cyclododecane, a wax with a low melting point and with the special property that it gradually sublimates at room temperature, leaving little residue. Through the liberal application of cyclododecane, sometimes in combination with other consolidants and supporting materials such as cellulose powder and conservation grade tissue paper, each plank was consolidated (Figure 473). The consolidant materials alone provided structural support and maintained the integrity of each plank. The basic conservation method involved first the application of melted cyclododecane to all exposed surfaces of each plank (Figure 474). Once the top and sides had been consolidated, the plank was carefully lifted by hand and rotated around its longitudinal axis until the underside (the exterior side of the hull) was exposed (Figure 475). This would then be similarly treated. Once the entire plank had been consolidated, it could be lifted and placed in a specially sized and padded box, which was completely lined with Marvel Seal, as was its lid, which, when closed, created a controlled micro-environment (Figure 476). Each plank could then be transported from the excavation site to the Abydos field house for further cleaning, conservation, documentation, analysis and storage. All the remains of the wooden hull exposed in Boat Grave 10 in field season 2 were successfully removed.

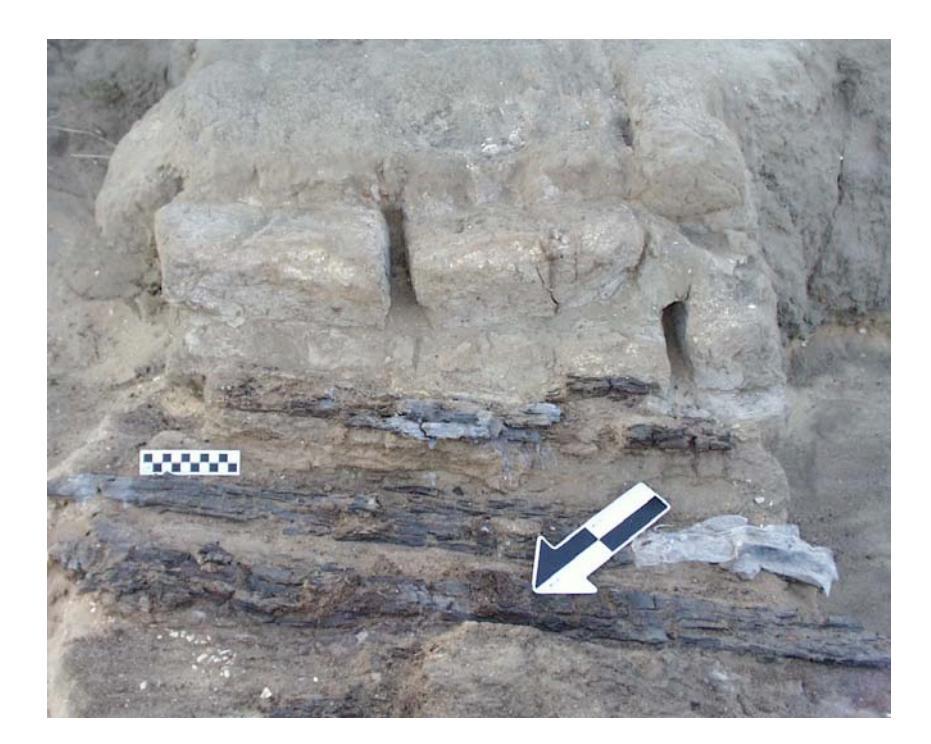
In a few areas on the south side of the boat in Boat Grave 10, where the wood of the hull had rested directly against bricks or mud, there were the remains of pigment (Figures 470 and 471). Based on careful examination of these remains, it appears that the boat was, at least in part, painted yellow. Traces of similar pigment were detected on the brickwork of one other boat grave, Boat 13, adjacent to the remains of the wooden hull (Figure 472).

Figure 470. South side of the excavated interior portion of Boat Grave 10; note that where the side of the hull touched the bricks of the grave's sidewalls, yellow pigment has adhered to the bricks. (Photo: Matthew Adams 2000)

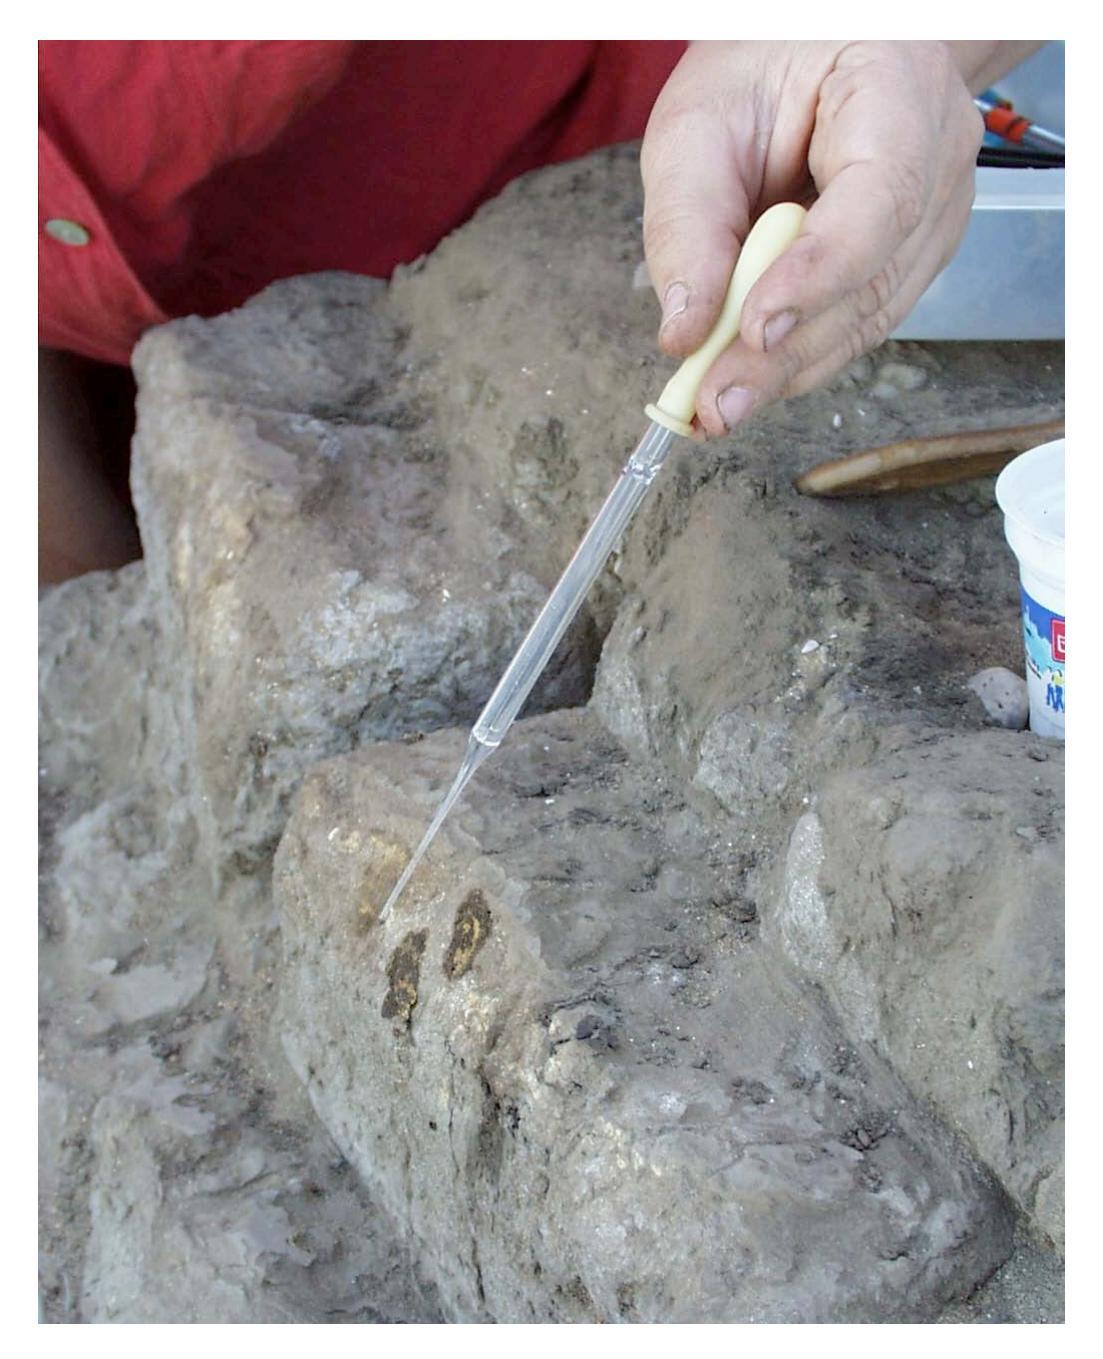
Figure 471. Detail of the traces of yellow pigment on the bricks of the south sidewall of Boat Grave 10, as they are consolidated. (Photo: Matthew Adams 2000)

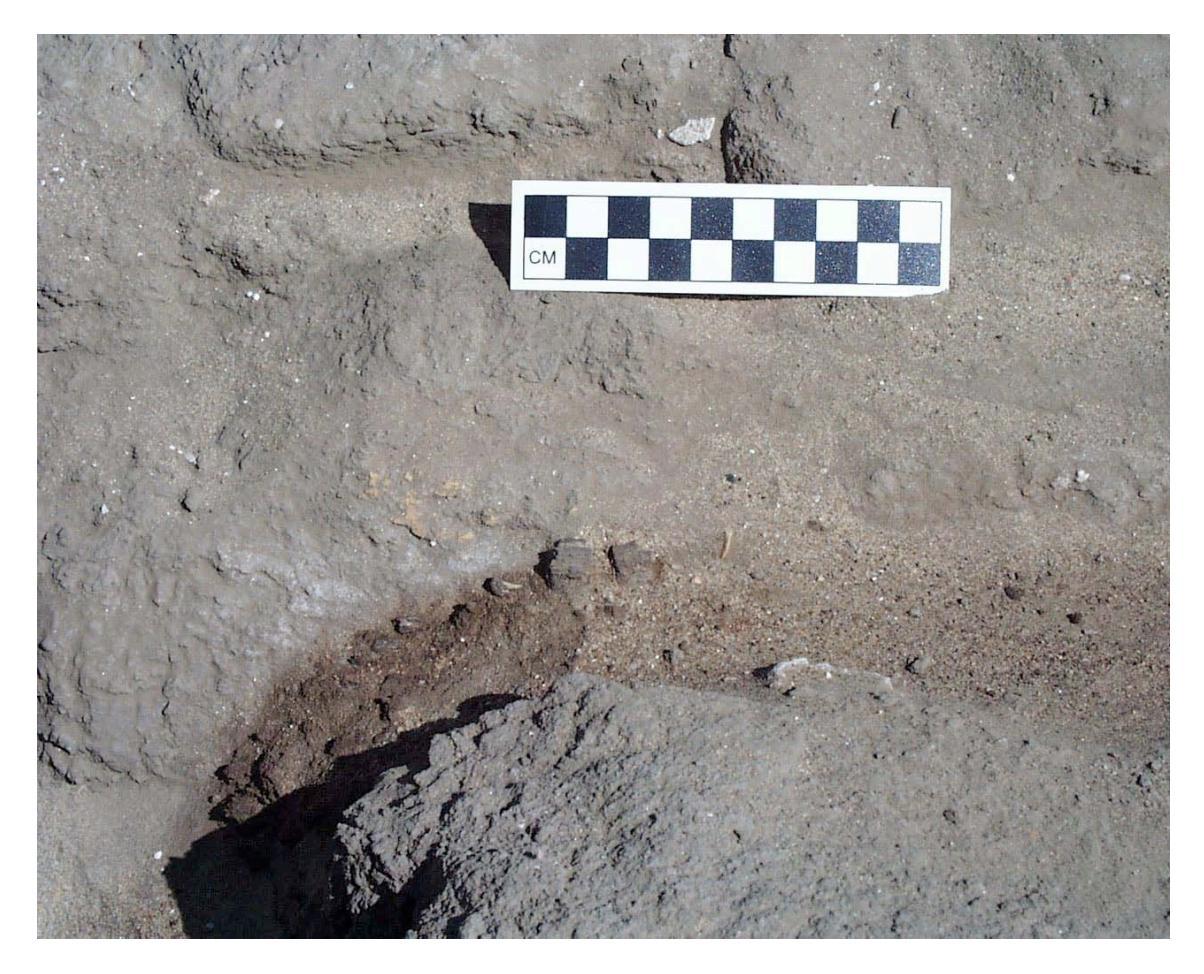
Figure 472. Traces of yellow pigment on a brick of the sidewall adjacent to the remains of the wooden hull in Boat Grave 13. (Photo: Matthew Adams 2000)

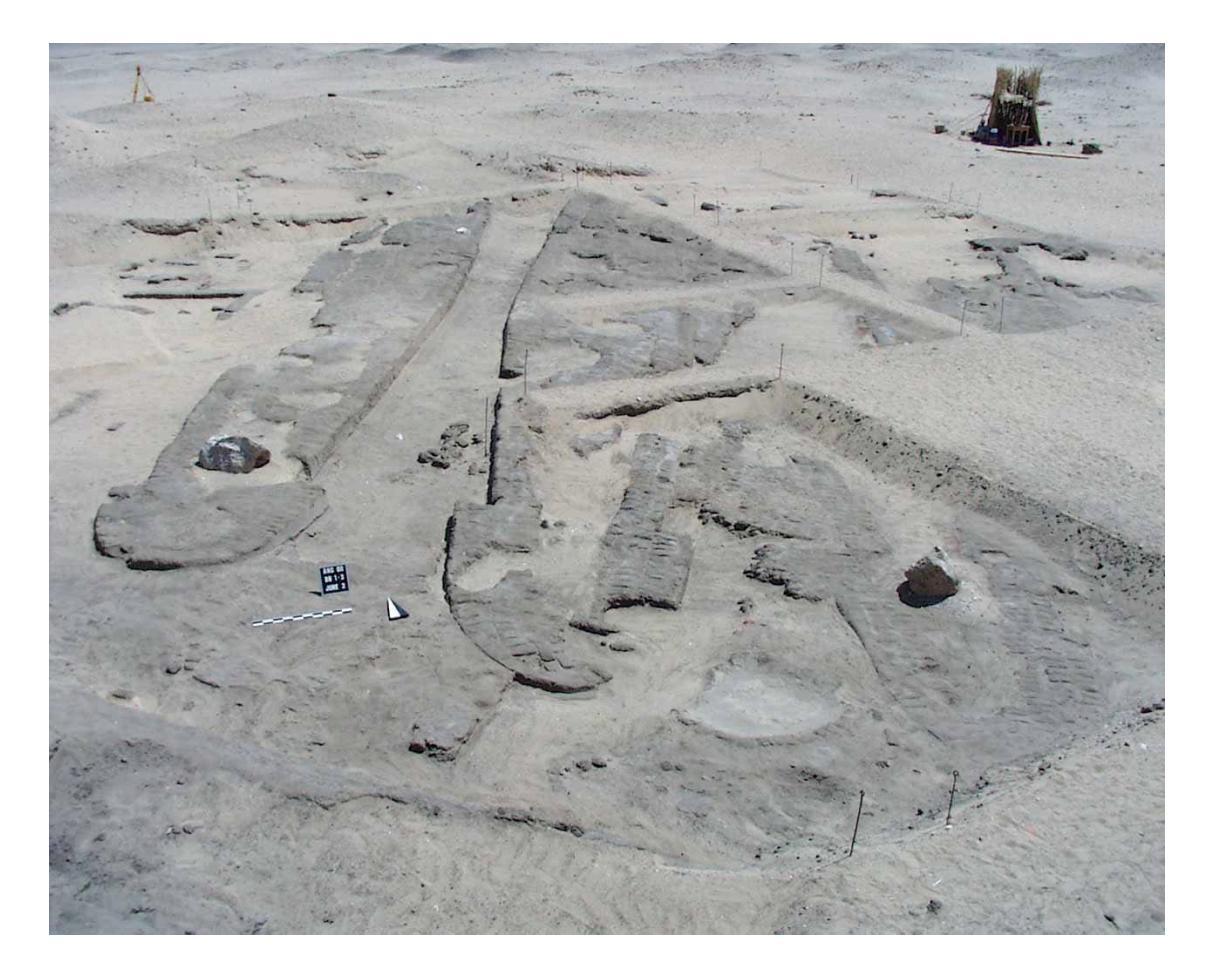
A number of the boat graves have large desert boulders encased in the brickwork at each end (see Figure 478), and it seems likely that these may have acted as symbolic anchors, permanently fixing each boat in position. Alternatively, the large stones at the ends could have been simple props, used to hold up the prow and stern of each hull, which in longitudinal profile were higher at the ends than in the middle. One grave (10) exhibited evidence in the masonry of its east end that a wooden pole approximately 10cm in diameter had been set into the brickwork (Figure 479), which is reminiscent of the wooden flagpoles sometimes found in front of Egyptian temple pylons of later periods.

Figure 478. Boat Graves 1, 2 and 3 (from left to right, respectively). The ancient pitting damage to the mudbrick grave structures is clearly visible. At the far left are the remains of tomb shafts, the construction of which damaged the north side of Boat Grave 1. In the foreground at lower left is the denuded east perimeter wall of Khasekhemwy's enclosure. Between it and the west ends of the boat graves is a deposit of mudbrick debris probably associated with the construction of the Shuneh, as is the small plaster mixing basin between the ends of Boat Graves 2 and 3. The fact that this construction debris is deposited against the boat graves suggests that the boat graves pre-date the construction of the Shuneh. A small test cut located between the west end of Boat Grave 2 and the perimeter wall confirmed that the boat grave pre-dates the construction of the perimeter wall. Note the boulders at the ends of Boat Graves 1 and 3. (Photo: Matthew Adams 2000)
