TECHNICAL REPORT

“Conservation of the Shunet el-Zebib, Abydos”

***“Conservation of King Khasekhemwy’s Funerary Monument at Abydos”  
Technical Report on 2012 Fieldwork***

Matthew Douglas Adams  
Institute of Fine Arts, New York University

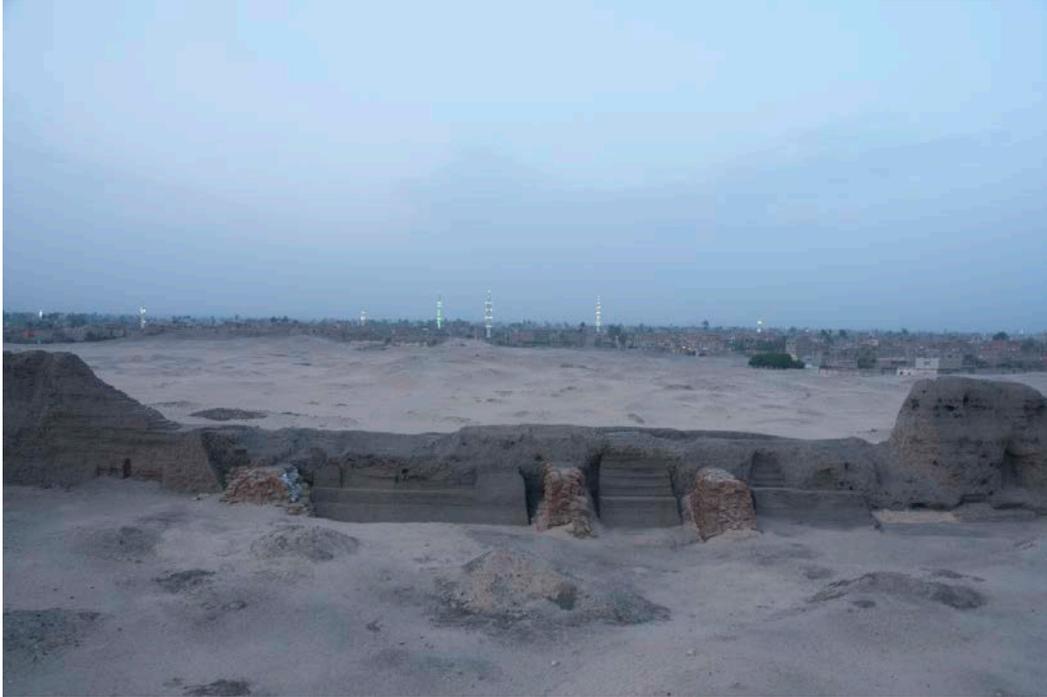
Figure 2 – State of the interior side of the east wall of the main enclosure at the close of the 2010 field season. Photo by Greg Maka for the Institute of Fine Arts, NYU.

As was mentioned above in reference to the individual work areas, the new construction in Operations 15, 21, 35, and 162 was keyed into adjacent sections of new masonry constructed in 2009 and 2010, and the unfinished upper parts of those were completed as part of the 2012 work, resulting in a visually integrated stabilization treatment for the entire low middle part of the east wall of the main enclosure. The condition of the wall in 1999, prior to any conservation interventions (Figure 63), may be compared to its state at the end of the 2010 season (Figure 2) and at the completion of work in 2012 (Figures 64-66).

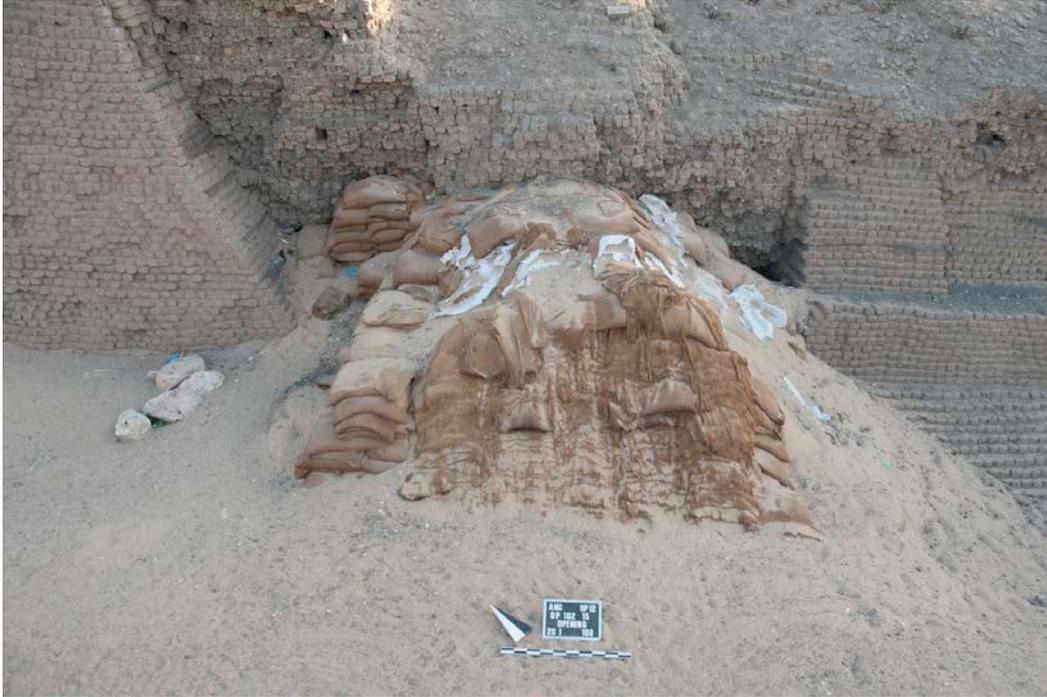
Figure 4 – Remains of the sand bag buttress in Operation 15 constructed in 2001 as a temporary emergency stabilization measure. Photo by Greg Maka for the Institute of Fine Arts, NYU.

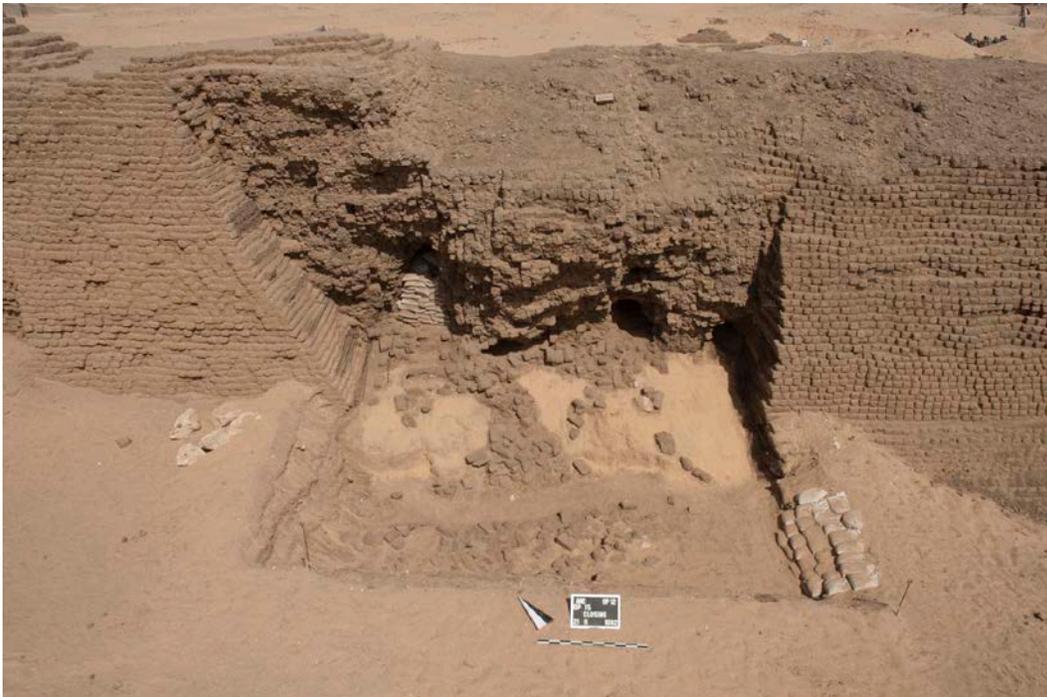
Figure 5 – Brickfall from the collapse of the interior side of the Shuneh east main wall is visible on the side of Mariette's sondage in Operation 15. Photo by Greg Maka for the Institute of Fine Arts, NYU.

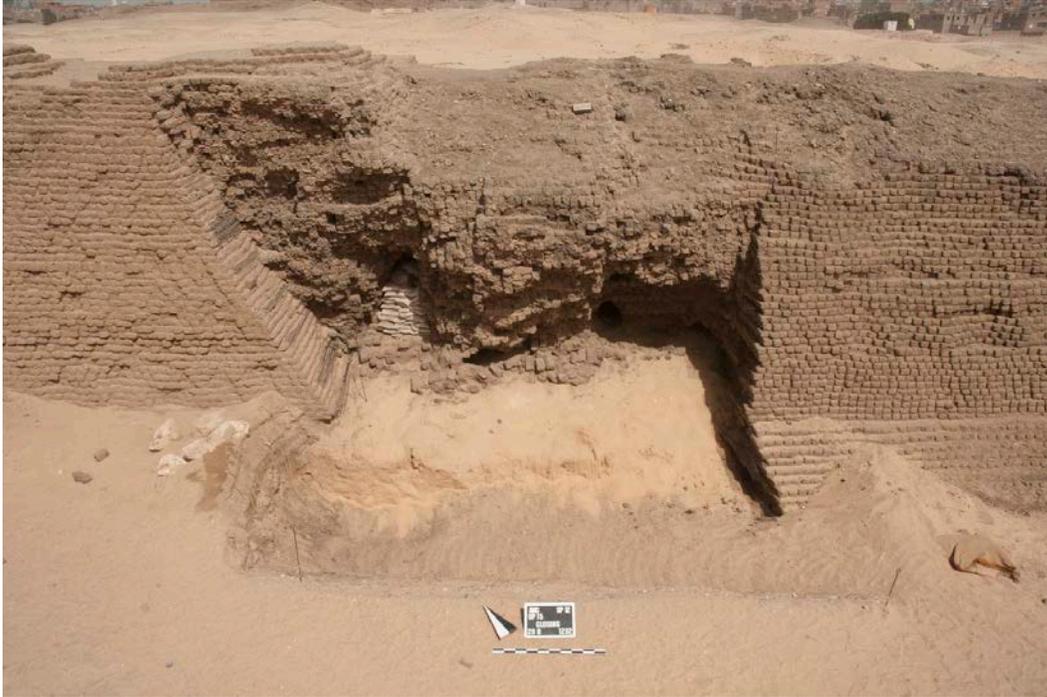
Figure 6 – Operation 15, with collapsed brick removed from the side of Mariette’s sondage. The yellow sand under the wall is the natural sterile *gebel* sand on which the monument was built. Photo by Greg Maka for the Institute of Fine Arts, NYU.

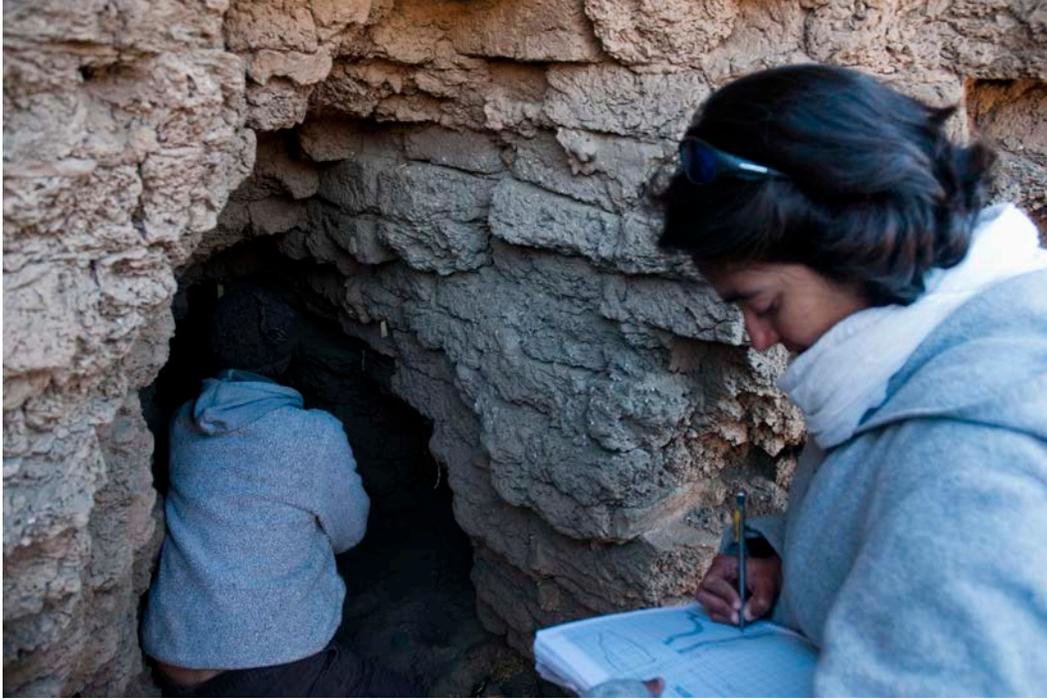
Figure 12 – Preservation architect Shubhra Rajee, right, and conservator Traci Lucero document the large animal burrows in Operation 15. Photo by Greg Maka for the Institute of Fine Arts, NYU.

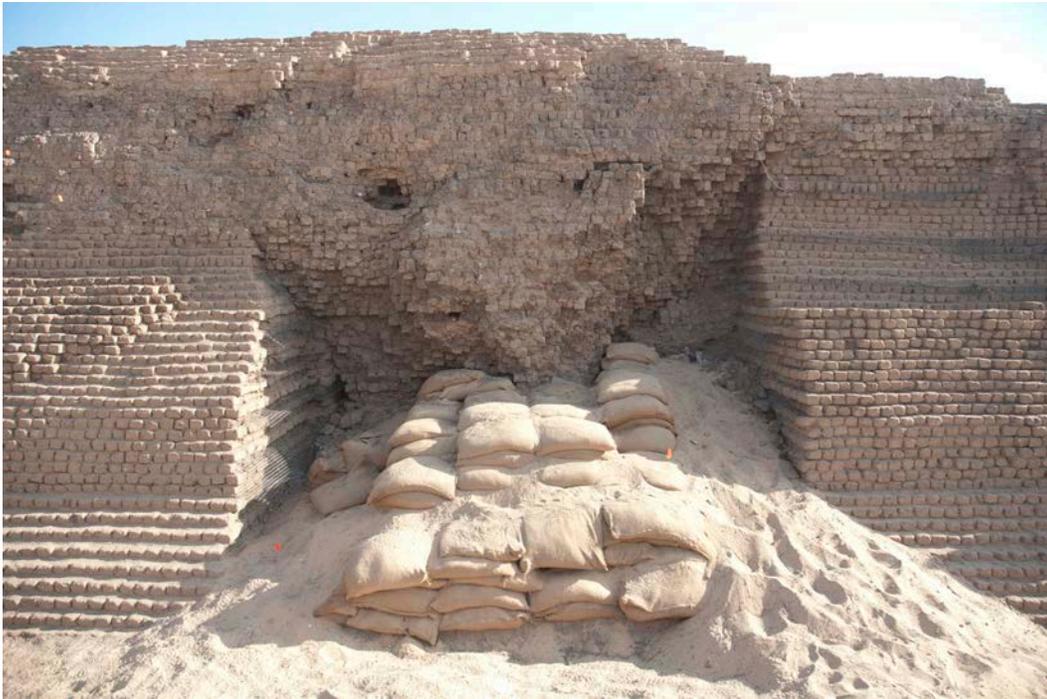
Figure 19 – During removal of the sand bag buttress, significant areas of unstable overhanging masonry were identified. Photo by Greg Maka for the Institute of Fine Arts, NYU.

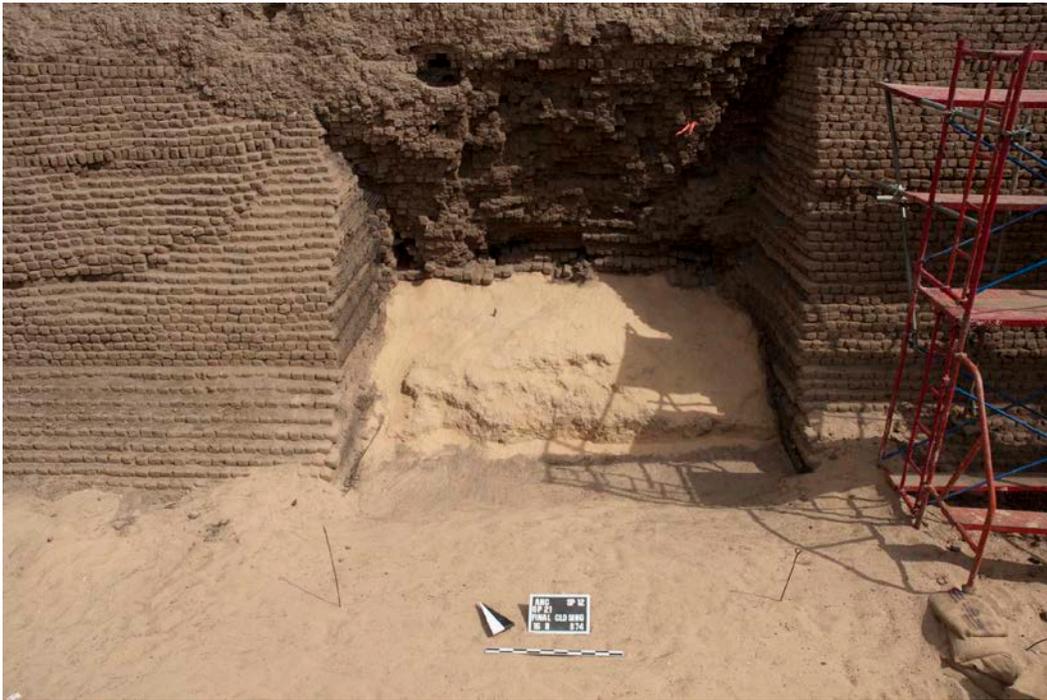
Figure 26 – Natural *gebel* sand under the base of the east wall of the main enclosure, as left by Mariette's sondage. Photo by Greg Maka for the Institute of Fine Arts, NYU.

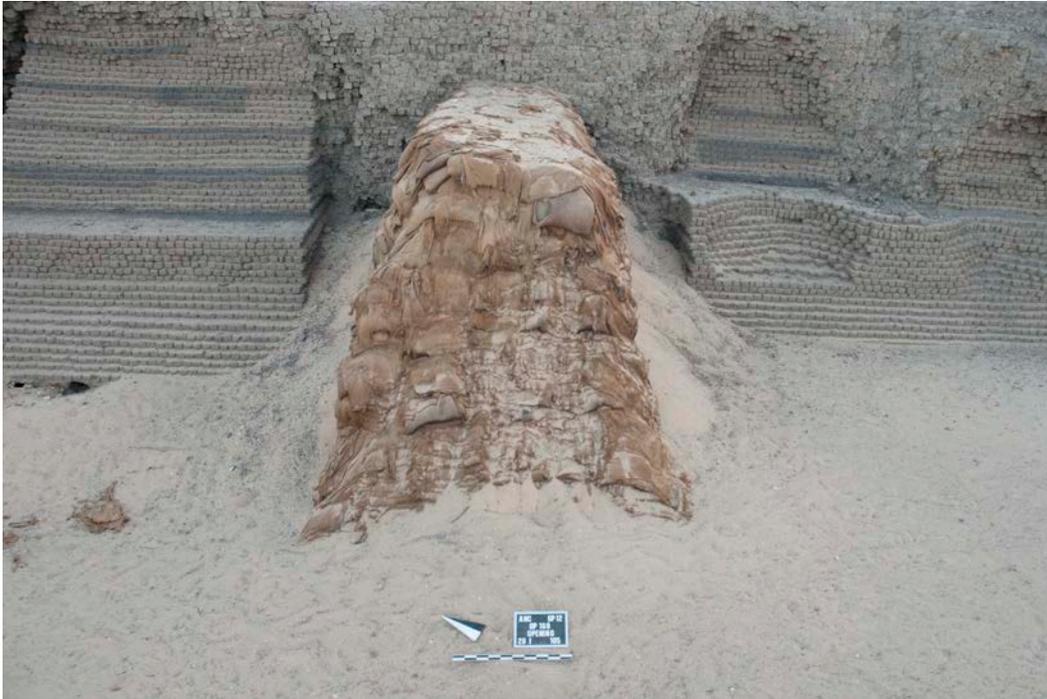
Figure 32 – Operation 35 at the start of work in 2012, showing the remains of the sand bag buttress constructed in 2001. Photo by Greg Maka for the Institute of Fine Arts, NYU.

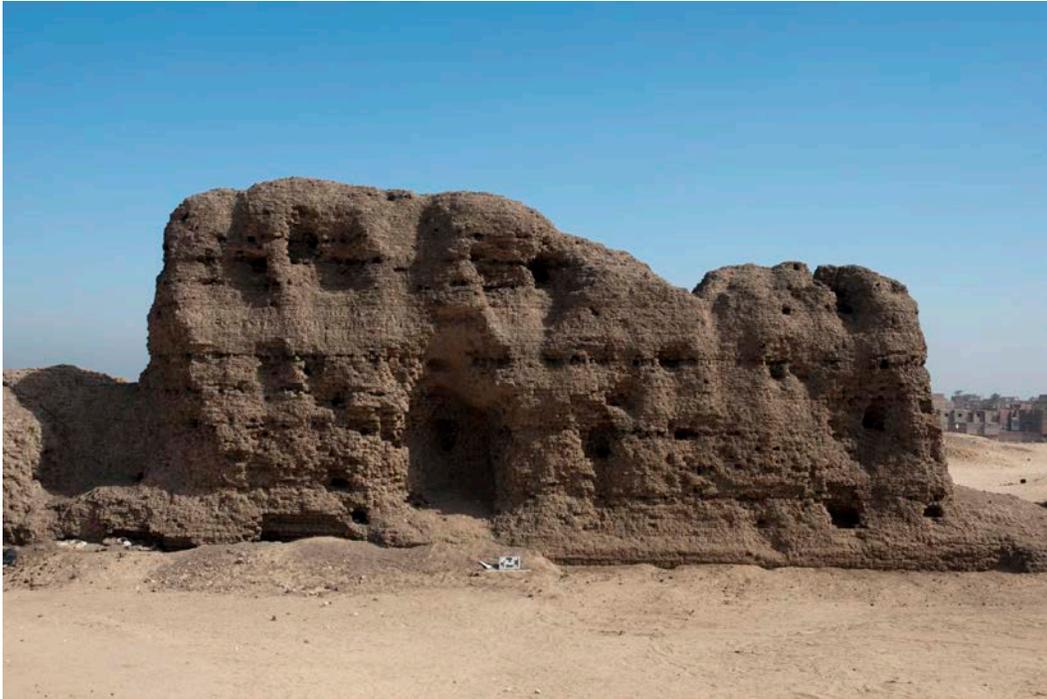
In addition to the stabilization of the wall base in Operation 162, work in 2012 included the infilling of a very large void (Figures 42, 47) that may have been, in origin, the false start for a monastic cell. Once excavation determined no significant cultural features were present in the void, including any traces of finished surfaces such as plasters, it was filled with new masonry as part of the broader stabilization of the wall in Operation 162 (Figure 48).

In addition to the large-scale work on the east wall, additional smaller-scale repairs were made on its tall southern section (Figure 42). A number of holes on the interior side of the wall were filled, most of which were the result of the activity of the burrowing Oriental Hornet (*Vespa orientalis*). The position of each hole was recorded, and each was photographed prior to any modification (Figure 54). After initial documentation, the holes were cleaned of debris that often included the remains of paper hornet nests and then photographed again (Figure 55), after which they were filled with new stabilizing masonry (Figure 56). A deep, heavily eroded crack in the top of the wall was also repaired in 2012 (Figures 57-61). The overall state of the tall southern section of the wall at the close of work in 2012 is shown in Figure 62.

Figure 42 – The interior side of the tall section of the east wall of the main enclosure prior to any conservation intervention. Operation 162 was located along the base of the wall at lower left. Photo by Greg Maka for the Institute of Fine Arts, NYU.

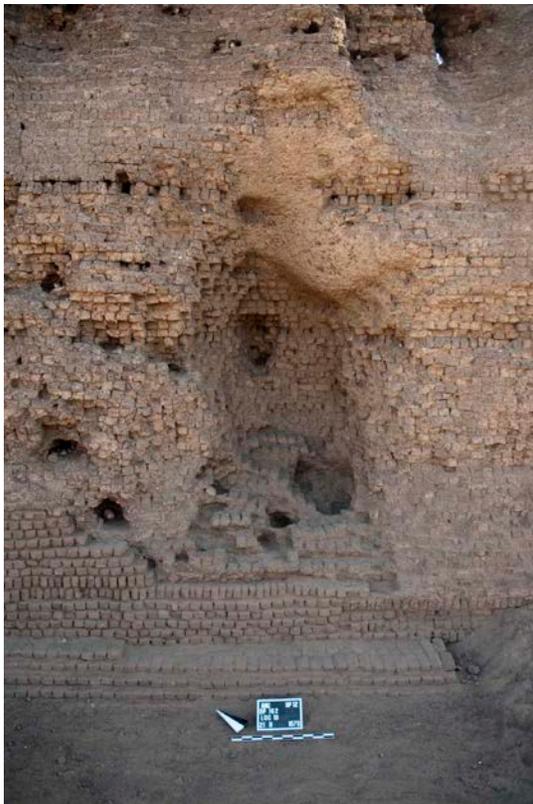
A massive insect nest was attached to the underside of the overhanging masonry at the top of the void (Figure 47). The insect responsible is likely to have been a variety of *Chalicodoma sicula*, a type of bee native to Egypt and north Africa that builds mud nests. Although this bee has not been observed at Abydos during the course of the conservation work at the Shuneh, it has been documented as responsible for similar mud nests at other sites in Upper Egypt.<sup>3</sup> In completing the stabilization infill in the void, how to deal with this nest was an important question. One other even larger such nest had been encountered in a previous season in Operation 120, a monastic cell void in the exterior side of the west wall of the main enclosure. In that case, most of the nest was removed by hammer and chisel, required by the concrete-like hardness of the nest material, when the void was infilled. The earlier experience suggested the time and intense effort necessary to remove the nest are not strictly necessary in the stabilization of the void. In the case of Operation 162, a series of earth anchors were driven into the fabric of the nest and the original masonry to which it was attached (Figures 49, 50). Once secure, the earth anchors were attached to a layer of geotextile embedded in mortar between brick courses in the new masonry, which acts to help secure the new construction to the main mass of the original wall. A small area at the top of the void was left unfilled due to reasons of time at the end of the 2012 season (Figure 51); it will be completed when work resumes in a future season.

Figure 47 – Detail of large void in interior side of the tall section at the southern end of the east wall of the main enclosure, after excavation and cleaning prior to stabilization. A massive mud insect nest is visible at the top of the void. Photo by Greg Maka for the Institute of Fine Arts, NYU.

Because the void in Operation 162 was not a completed monastic cell, even if it represents an abandoned start for one, a somewhat different approach was taken in its stabilization than in features definitely determined to have been cells. With those, the new masonry was given a concave profile, to leave a visual marker of the presence of the cultural feature, the cell, and the void into which it evolved over time. In Operation 162, however, the masonry infill was not concave (Figure 51), following instead the approximate plane of the existing wall, in keeping with the method followed for smaller holes of primarily non-cultural origin and the majority of other interventions at the Shuneh.

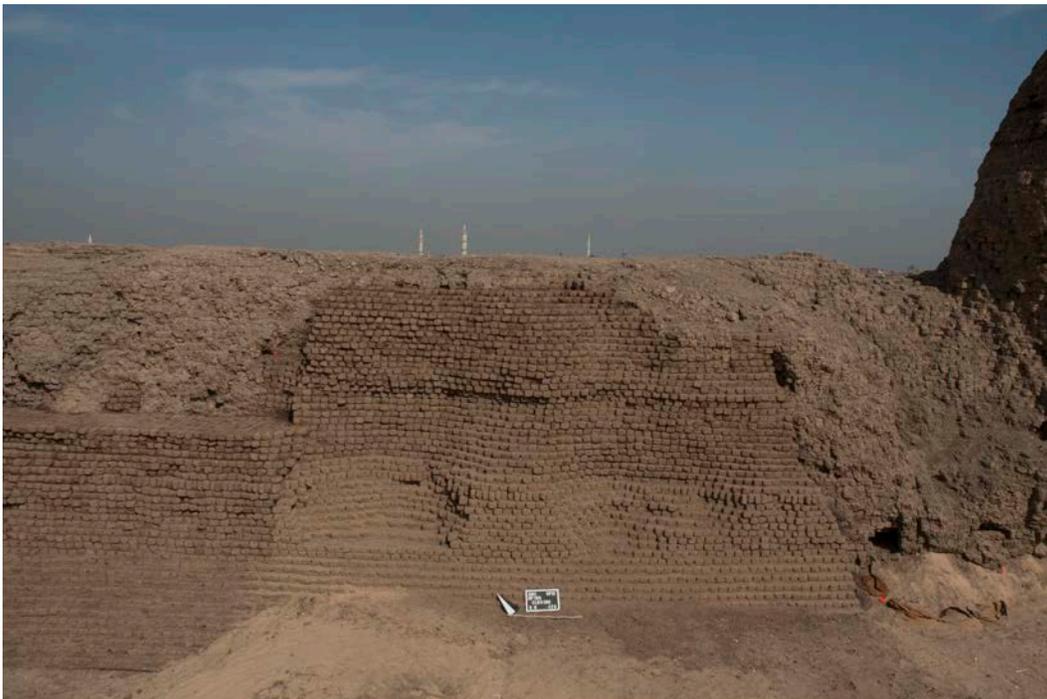
The approach taken in Operation 162 is to be contrasted with the situation in Operation 106, situated just to the local north between Operations 162 and 35 and excavated in 2009. In 106 two large voids in the wall were created by the ancient digging into the wall of a monastic cell and an ancillary chamber in late antiquity and the subsequent collapse of masonry above these spaces. The stabilization of this area was started in 2010, which saw the construction of a below-grade foundation and the first, the infilling of the cell voids proper. Here, the finished exterior of the new construction shows two large concavities that do not affect the stability of the wall but that represent visual indicators of the presence of significant cultural features, the same approach taken with monastic cells elsewhere in the monument. Figure 52 shows the stabilization work at a preliminary stage at the close of the 2010 field season, with the upper part of the filled cell void and the lower part of the concavity in the finished wall face, while Figure 53 illustrates the area in 2012, after the new masonry has reached the surviving wall top but before Operation 106 has been integrated into a broader treatment. The lighter color of the lower courses of brick masonry in Figure 53, the portion constructed in 2010, is due to the moisture content of the new mortar in 2012. The color difference was observed in 2013 to have lessened to the point of negligibility.

Figure 53 – Operation 106 after the completion of basic stabilization in 2012. Photo by Greg Maka for the Institute of Fine Arts, NYU.

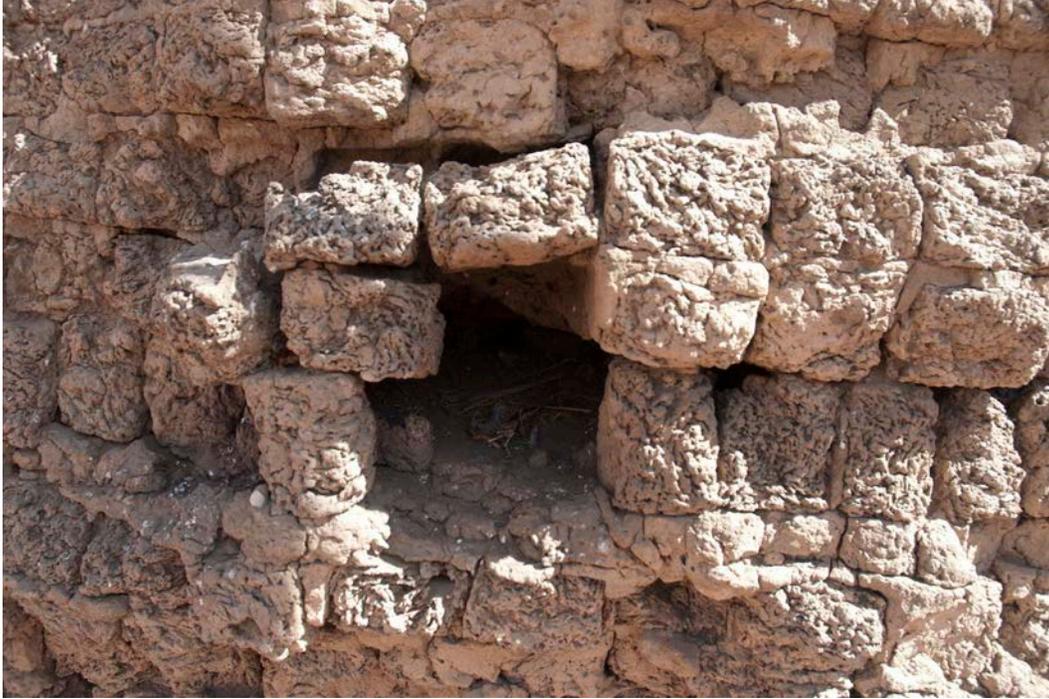
Figure 54 – One of the smaller holes in the tall southern section of the east wall of the main enclosure, before intervention. Photo by Greg Maka for the Institute of Fine Arts, NYU.

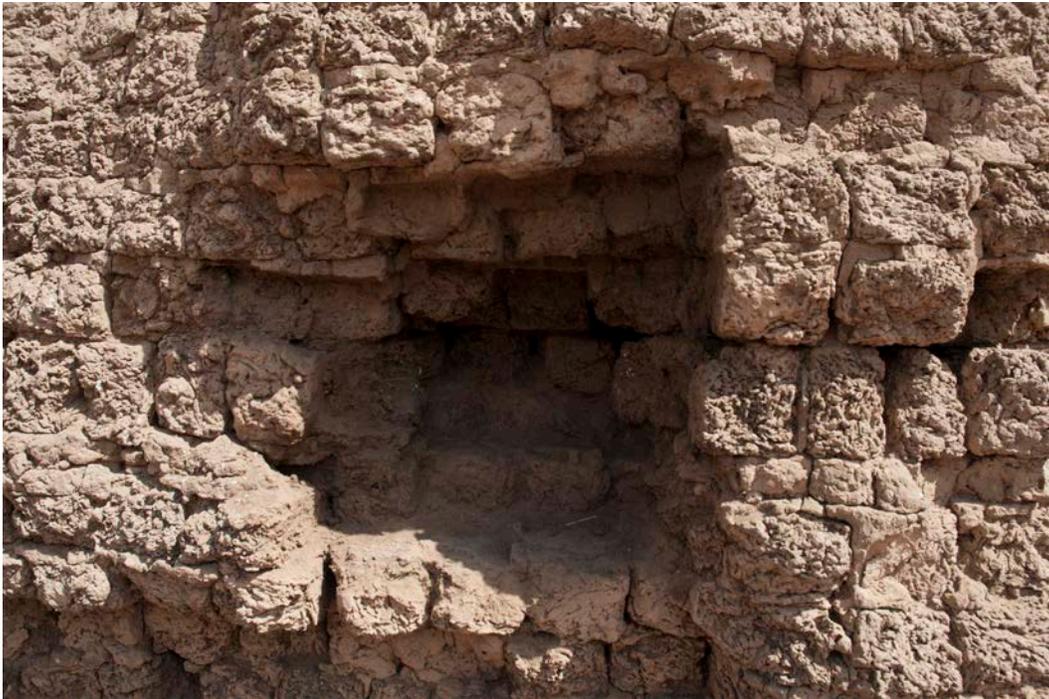
Figure 55 – The same hole as in Figure 54, after cleaning preparatory to infilling. Photo by Greg Maka for the Institute of Fine Arts, NYU.

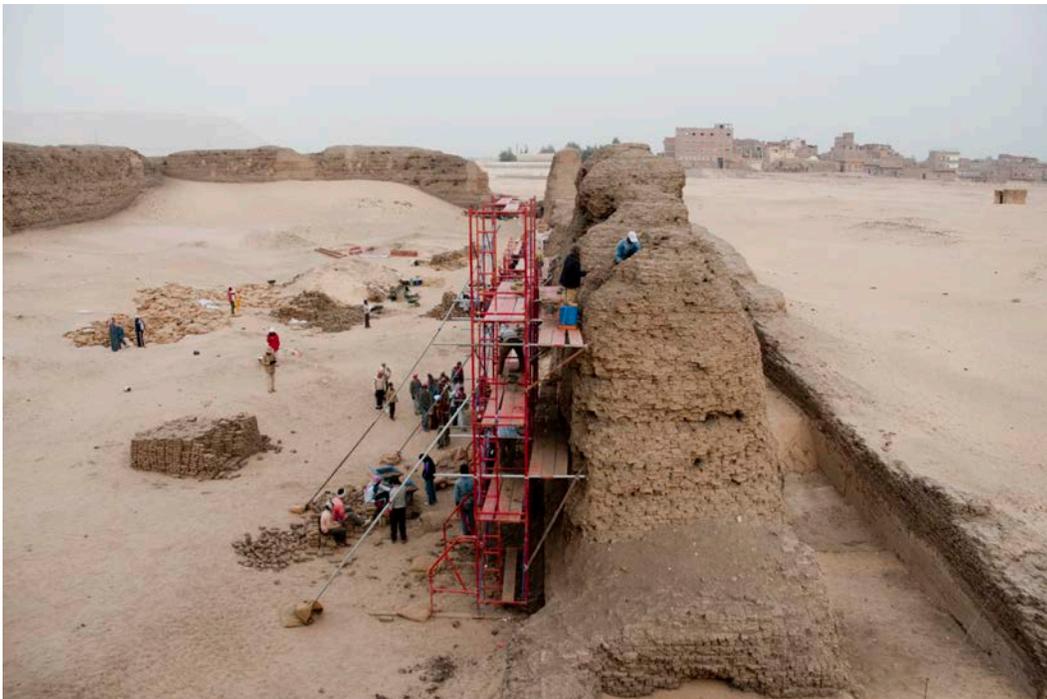
Figure 57 – Scaffolding in place adjacent to the tall southern section of the east wall of the main enclosure. The person in the blue shirt and cap on the wall top is senior mason Nabil Fahmy el-Seman, working on the large crack illustrated below in Figures 58-61. Photo by Greg Maka for the Institute of Fine Arts, NYU.

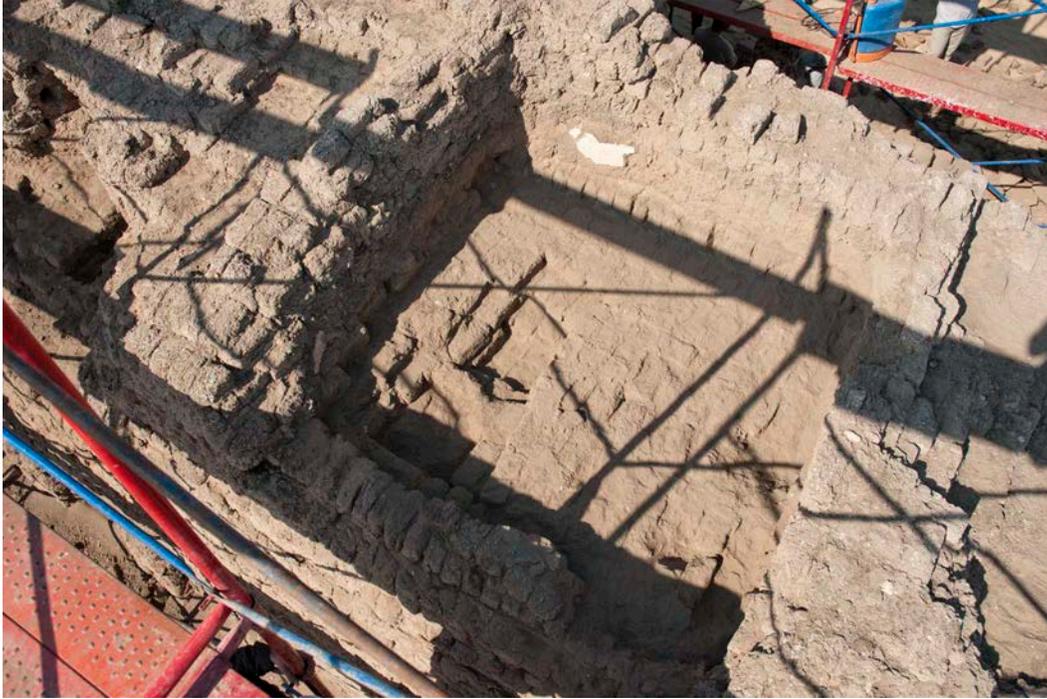
Architectural stabilization was started in 2012 on the south gateway area of the main enclosure. In the 2005-2006 field season, the remains of a small late antique room (Operation 136, Locus 10) in the existing wall top on the local west side of the gateway was excavated and documented (shown in 2012 in Figure 67). The room, created during the occupation of the monument by an early Christian (“Coptic”) monastic community, had originally been cut into the wall when this was preserved to much nearer its original height. The room appears to be the only feature relating to the monastic occupation to have been cut into the south main wall. It had originally been finished in white lime plaster, but almost none of this was preserved in situ. Only a few small patches remained in place on the sides of the room. A few loose fragments of plaster with red line decoration were found during the 2005-2006 excavation of the contents of the room, indicating the room may have been extensively decorated, but no other original features survived. The void created by the room may have contributed to the large-scale collapse of the upper part of the wall on the west side of the south gateway.

Figure 67 – Remains of a late antique room in the top of the south wall of the main enclosure, west of the south gateway. It was excavated and documented in 2005-2006. Photo by Greg Maka for the Institute of Fine Arts, NYU.

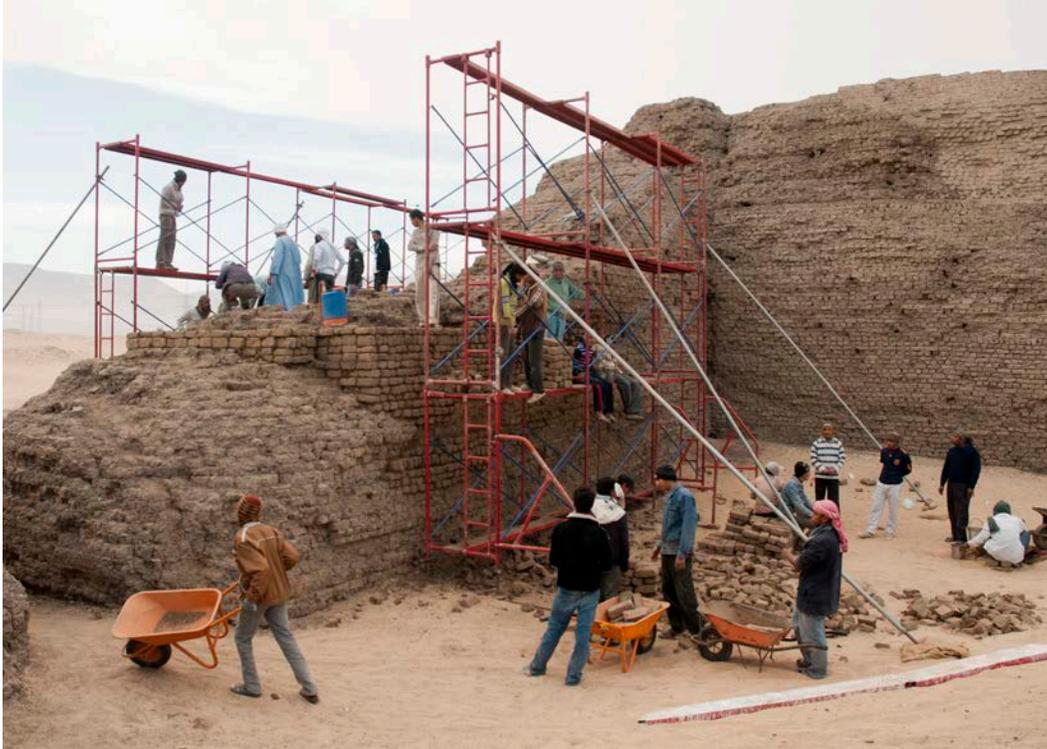
Figure 71 – General view of the stabilization work in progress on the south wall of the main enclosure. The south gateway opening is at left. Photo by Greg Maka for the Institute of Fine Arts, NYU.

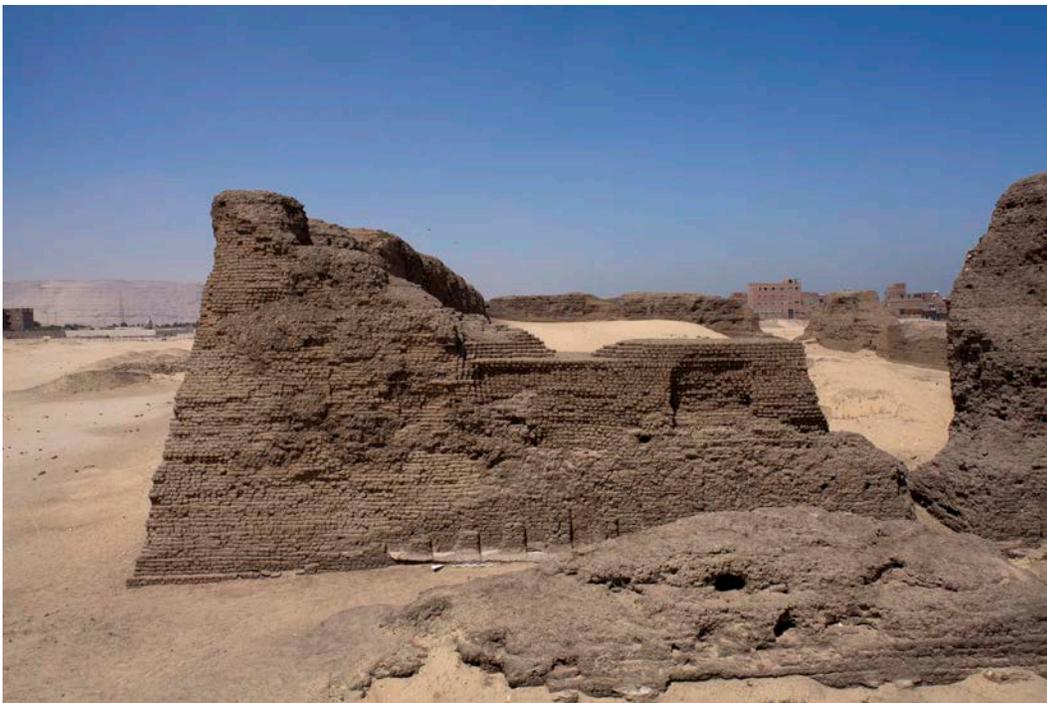
Figure 72 – General view of the exterior side of the south wall of the main enclosure, west of the south gateway, at the close of work in 2012. Note the position of the late antique room, marked by a shallow concavity in the new construction, right of center. Photo by Greg Maka for the Institute of Fine Arts, NYU.

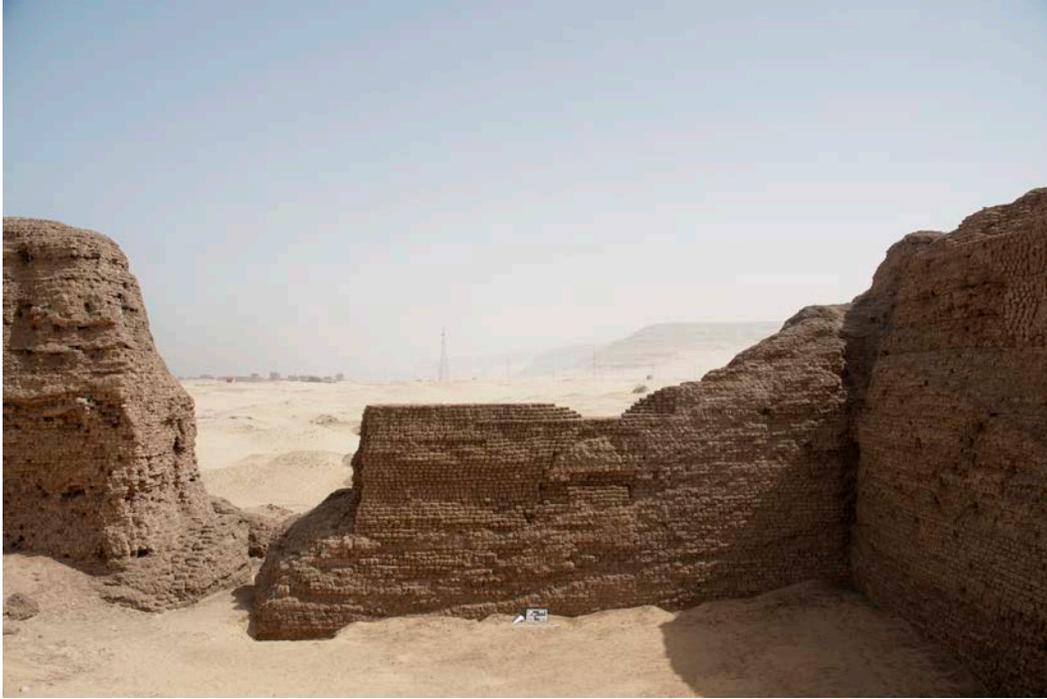
Figure 73 – General view of the interior side of the south wall of the main enclosure, at the close of work in 2012. Photo by Greg Maka for the Institute of Fine Arts, NYU.

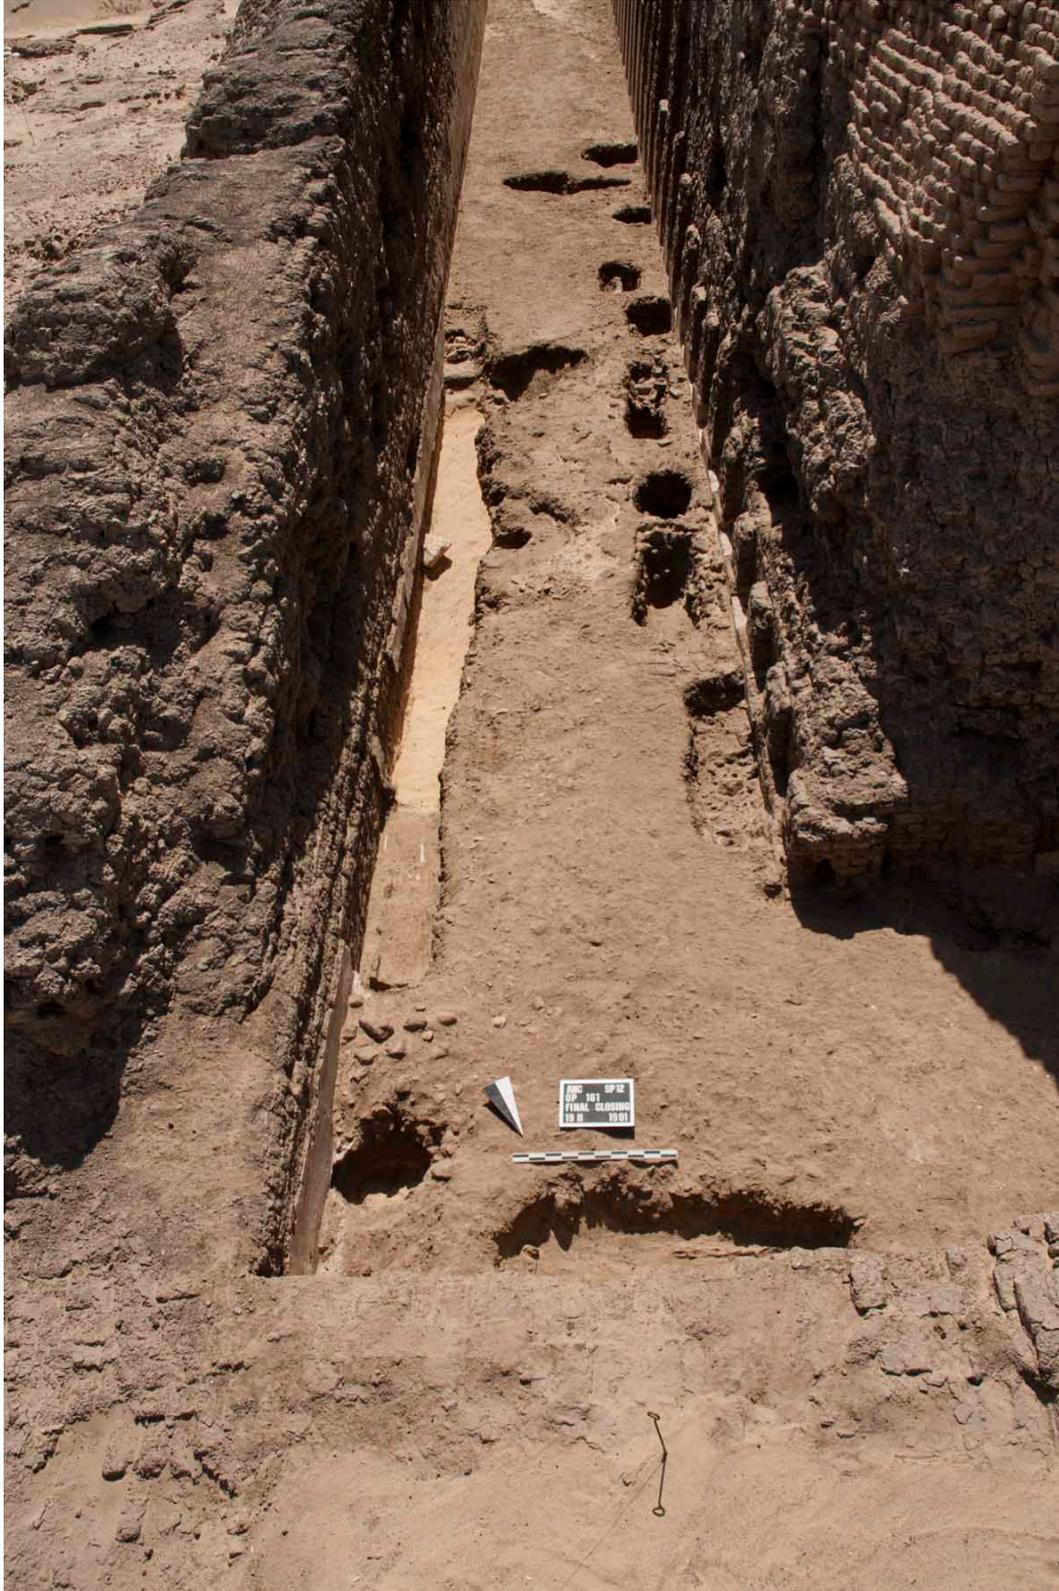
Figure 80 – Dynasty 2 floor of the south perimeter corridor, eastern half, showing later pits cut through the floor. The interior of the southeast corner of the perimeter enclosure wall is at lower left. Photo by Greg Maka for the Institute of Fine Arts, NYU.

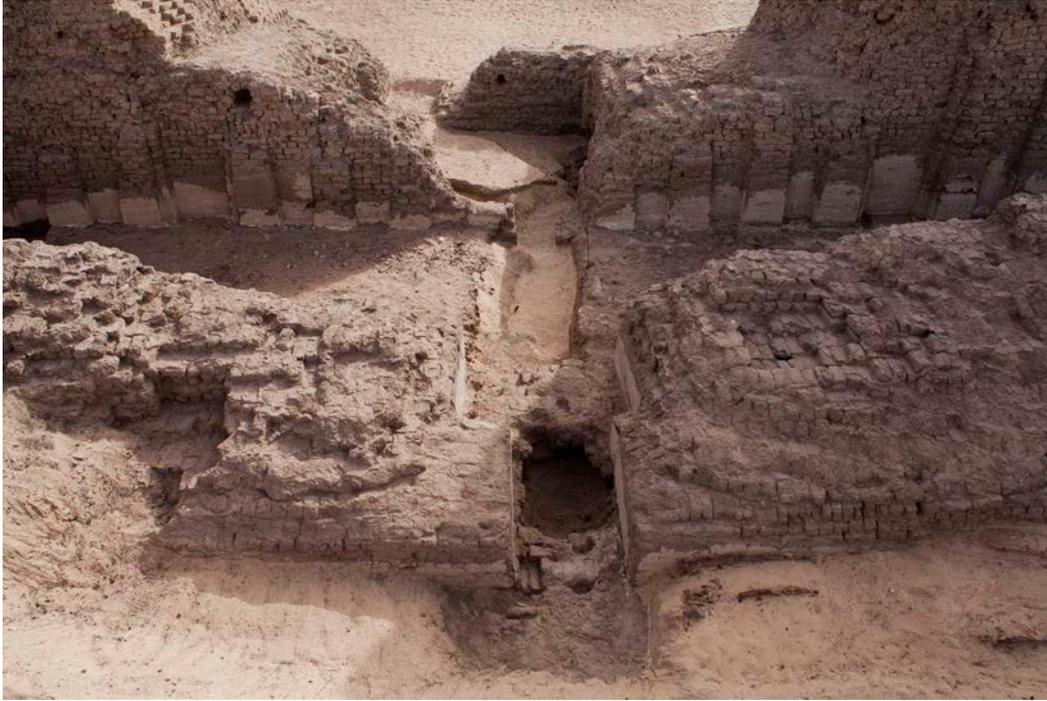
Excavation in both the gateway in the main enclosure and that in the perimeter enclosure (Figure 90) revealed that both had been heavily disturbed at some time in the past. In the gateway in the perimeter wall, a large pit had been cut through several courses of mudbrick masonry that underlay the gateway opening (Figure 91). It appears that in this area the first few courses of the wall were laid continuously, and the opening of the gateway was only defined with the fourth or fifth course. Thereafter, the top of the brick under the opening served as a floor for the gateway. In the perimeter corridor a trench was found to have been, at some point in the past, perhaps by Ayrton, cut down through the Dynasty 2 floor deposits between the perimeter and main walls. The trench provided an informative section through the floor of the corridor.

Figure 90 – General view of the east corner gateway after excavation in 2012, seen from outside the perimeter wall, looking southwest. The opening in the foreground is that in the perimeter wall, with the main enclosure in the background. An old trench cut through the floor of the corridor between the two gateways. Photo by Greg Maka for the Institute of Fine Arts, NYU.

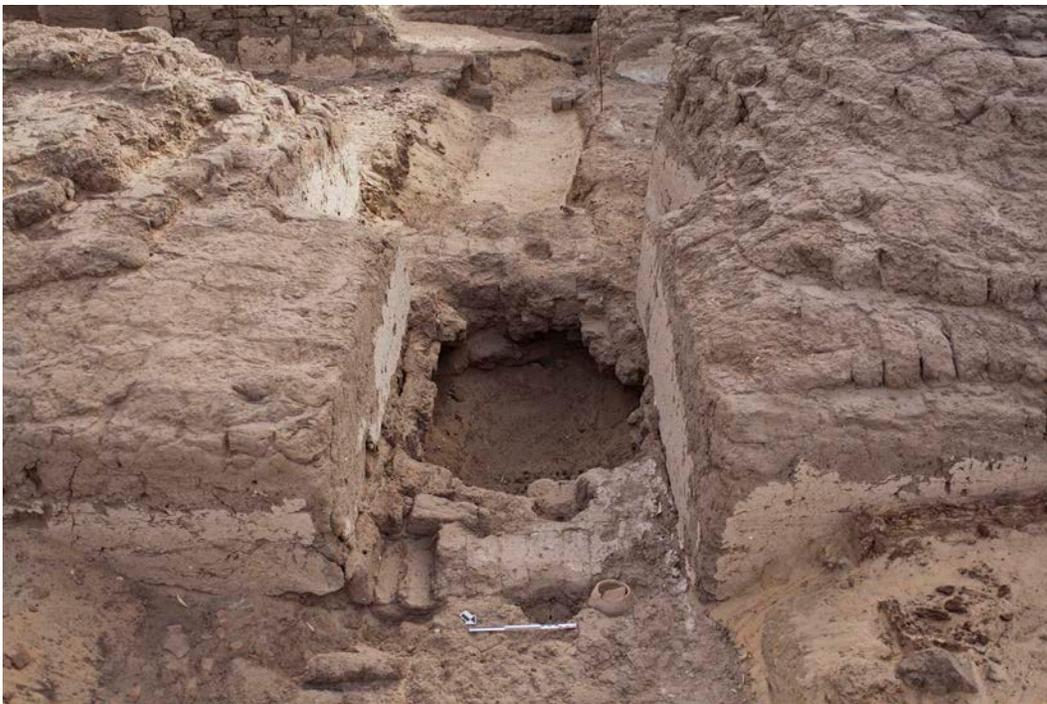
Figure 91 – Detail of the east corner gateway in the perimeter enclosure. A pit has been dug completely through the brick masonry that originally made up the floor of the gateway. Photo by Greg Maka for the Institute of Fine Arts, NYU.

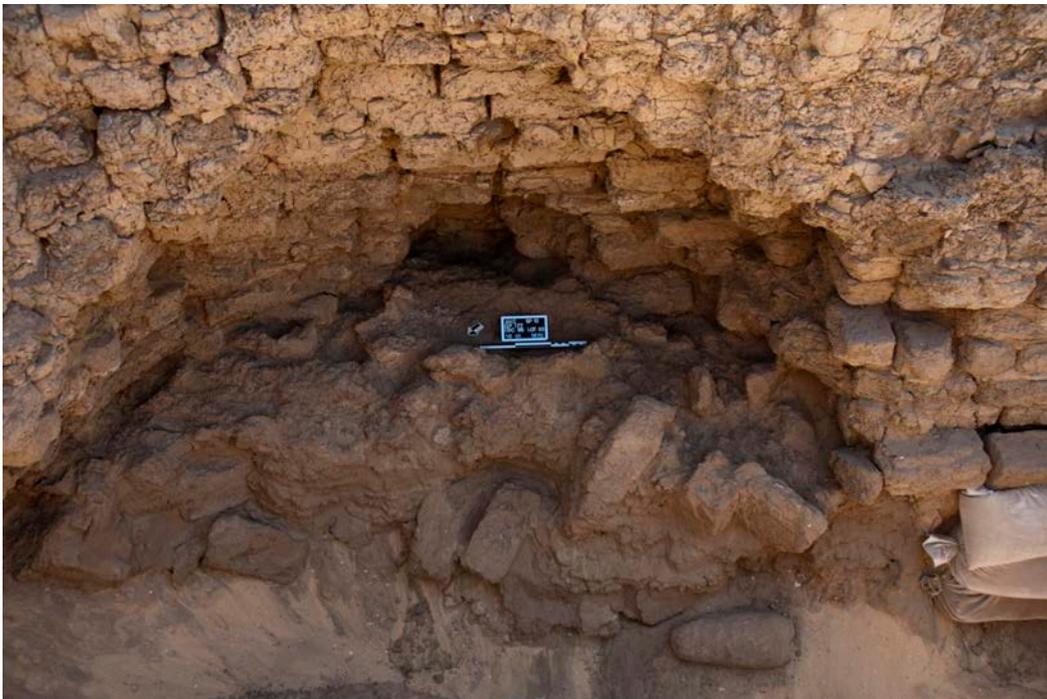
Figure 93 – A large concavity exists in the south side wall of the east corner gateway chamber in the main enclosure. Photo by Greg Maka for the Institute of Fine Arts, NYU.
