Report on present condition of Akhenaten Temple Project 01
'Pennsylvania' magazine
August 2008

Introduction

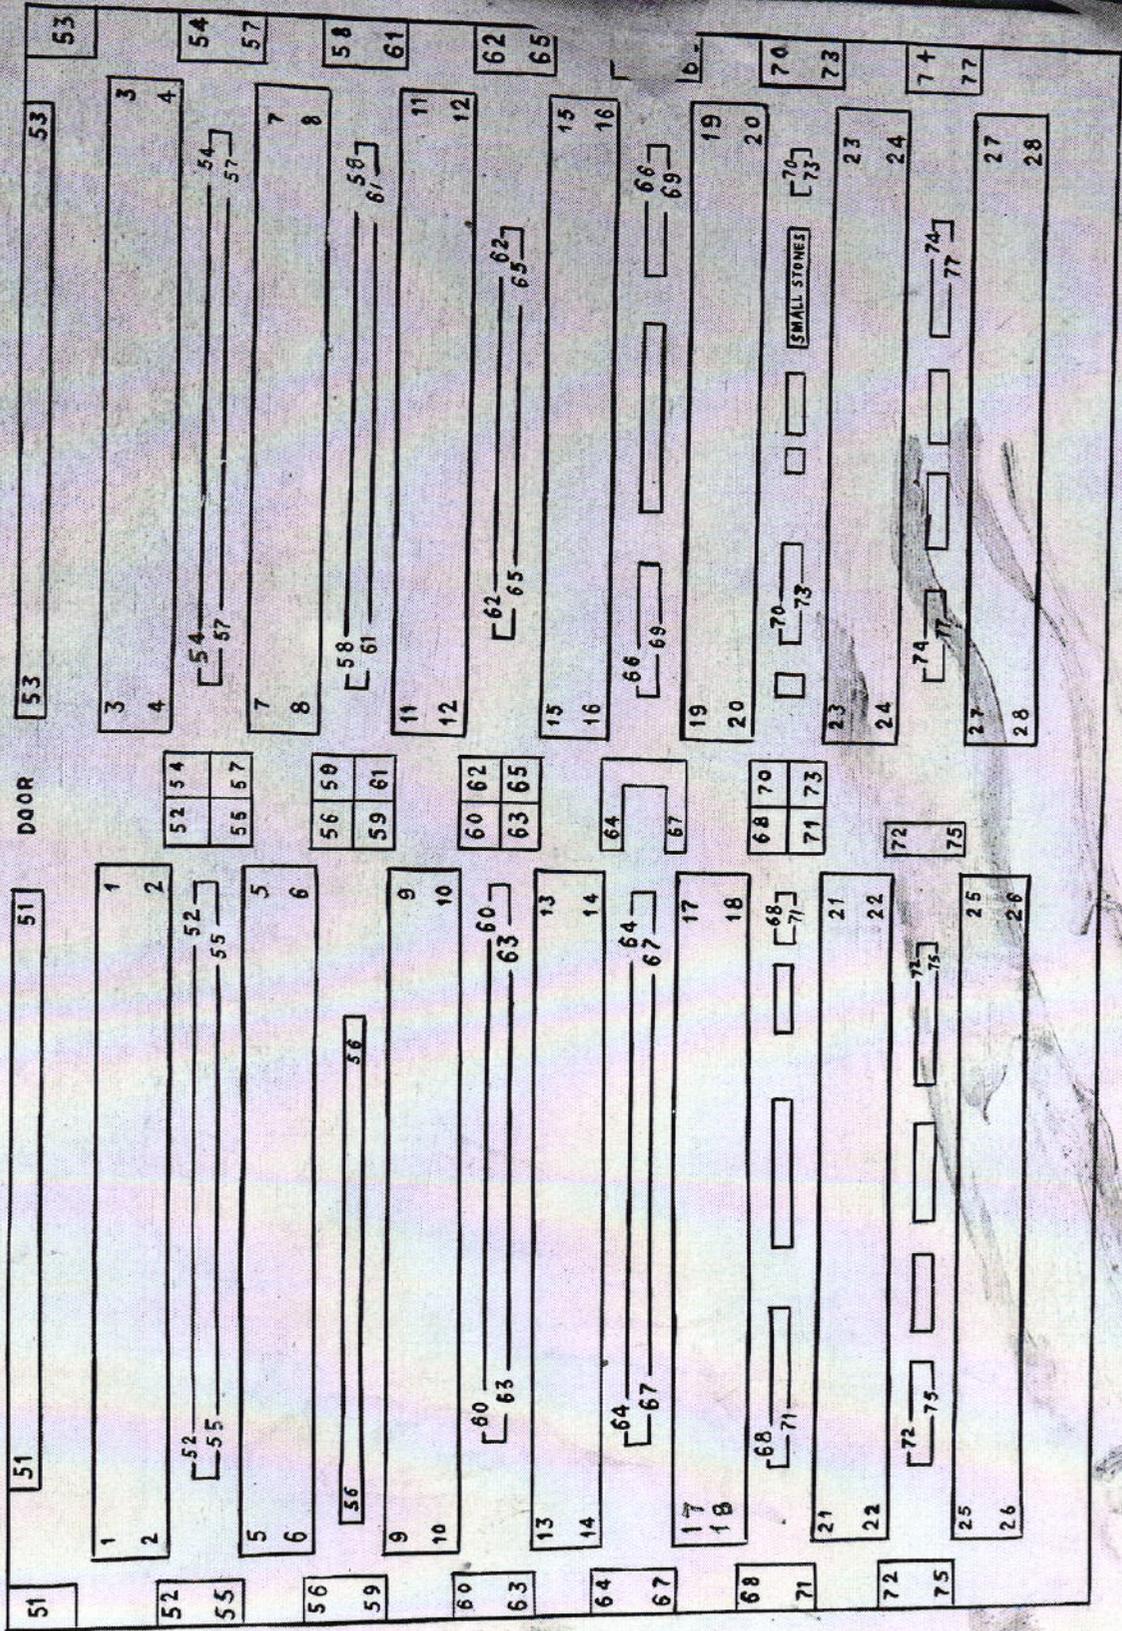
FIRST STORE (01)

The talatat, which are of a uniform size, 52 x 22 x 26 cm, are piled in 14 stacks, each approximately 15–16 metres long and about 2.5 metres high (8–9 courses of blocks), arranged on either side of a central aisle. The stacks are 'double-sided', i.e. the talatat are arranged back to back, so that the decorated surfaces are visible on both sides, and each side of the stack has a separate number, e.g. 1 and 2, 3 and 4, etc. (see attached plan).

For the purpose of this report, the original ATP stack numbers have been used, as in most cases the label with the stack number is still in place at each end of the stacks, and the ATP plan of the magazine is attached to the back of the door.
