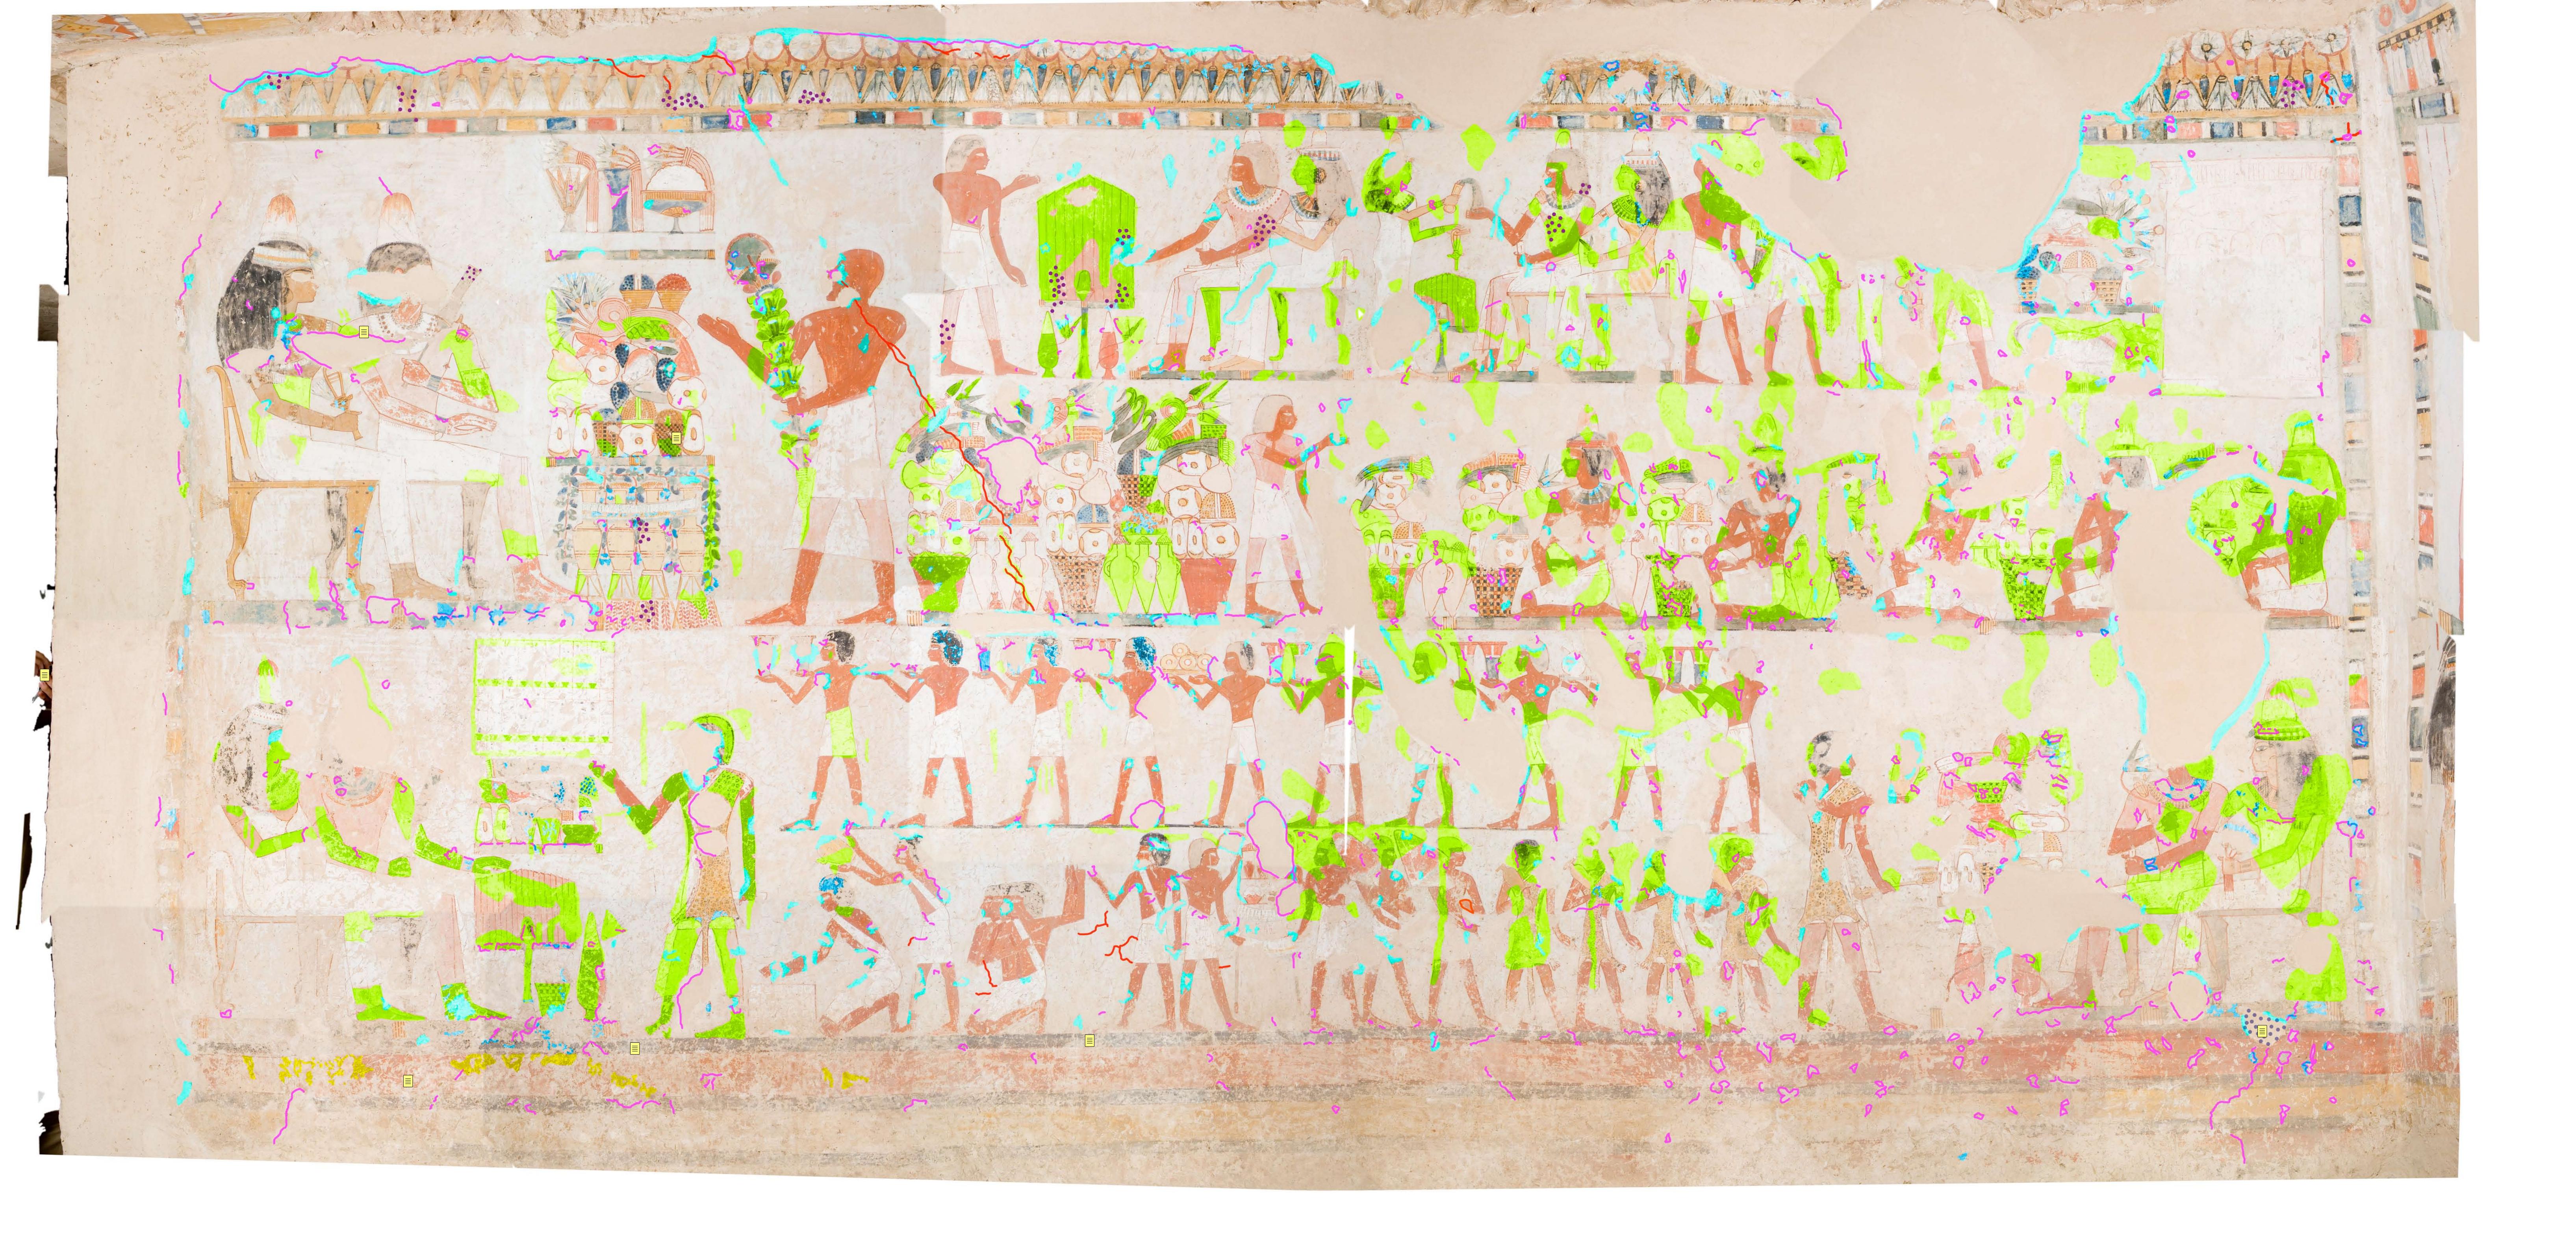
Grouting (Detached Plaster)

**Retouching Over Original**

**Retouching Over Fills**

Water Damage

Wasps Nests

Flaking

Salts

Loosely Bound Paint (Powdering)

Cracks

**B72**

**Smears of Previous Restoration**

Vulnerable Edges (Losses of Original)
