ANNUAL REPORT

December 2006 – December 2007

“Conservation of the Mosque of Aslam al-Silahdar in Darb al Ahmar, Cairo”

**QUARTERLY PROGRESS REPORT
DECEMBER 2006-FEBRUARY 2007**

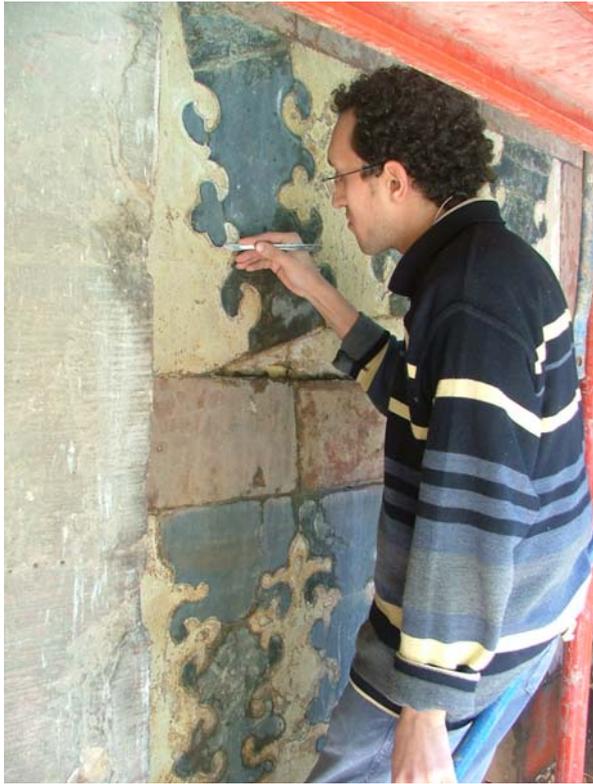
Cleaning of the southern façade by poultices and mechanical techniques

The southern and eastern elevations have been entirely cleaned using humid poultice made of bentonite and paper pulp with a low concentration (3-5%) of Ammonium Bicarbonate. This has revealed the original polychromy of the lime stone made of alternated white and orange horizontal stone courses and has made it possible to identify several stages of construction and restoration.

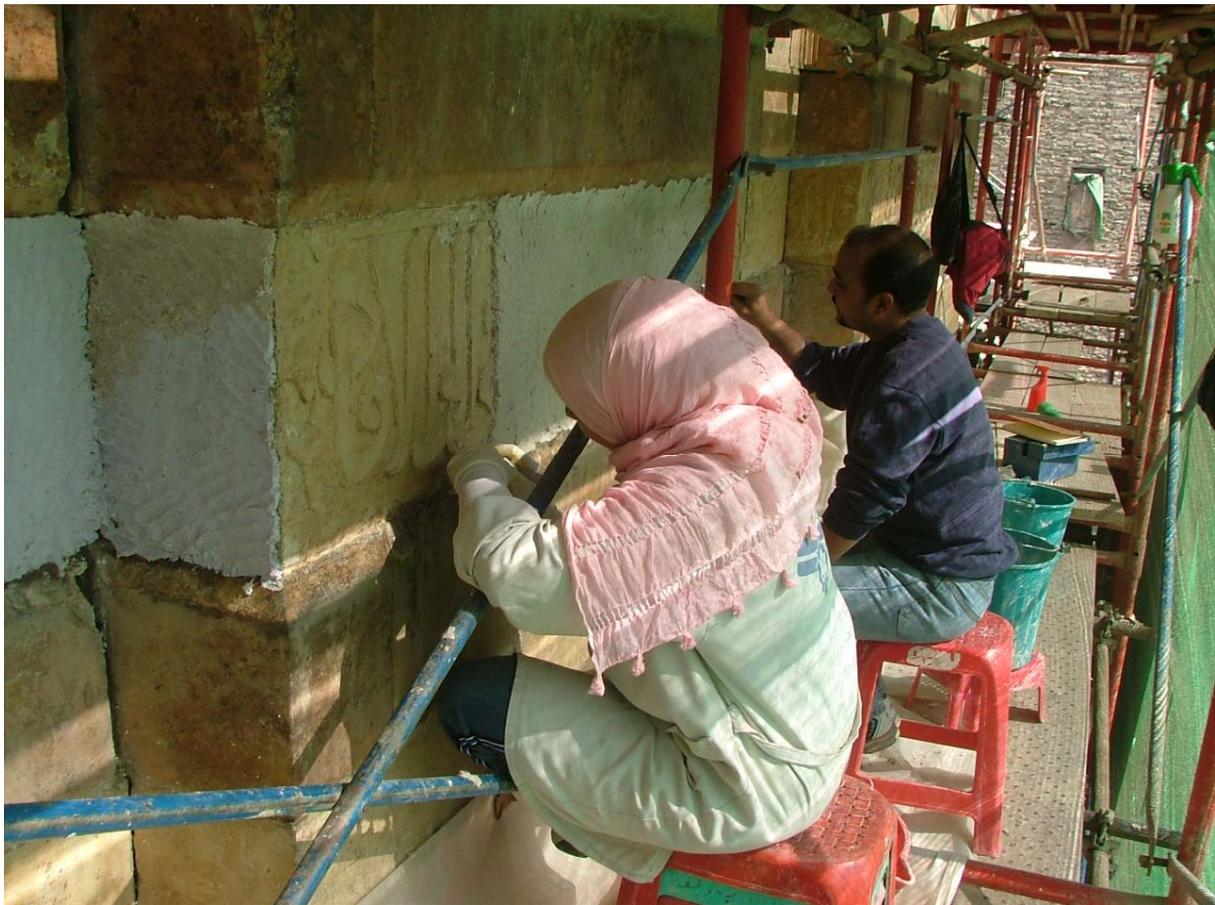
Cleaning of the inscription band on the Eastern façade by poulticing

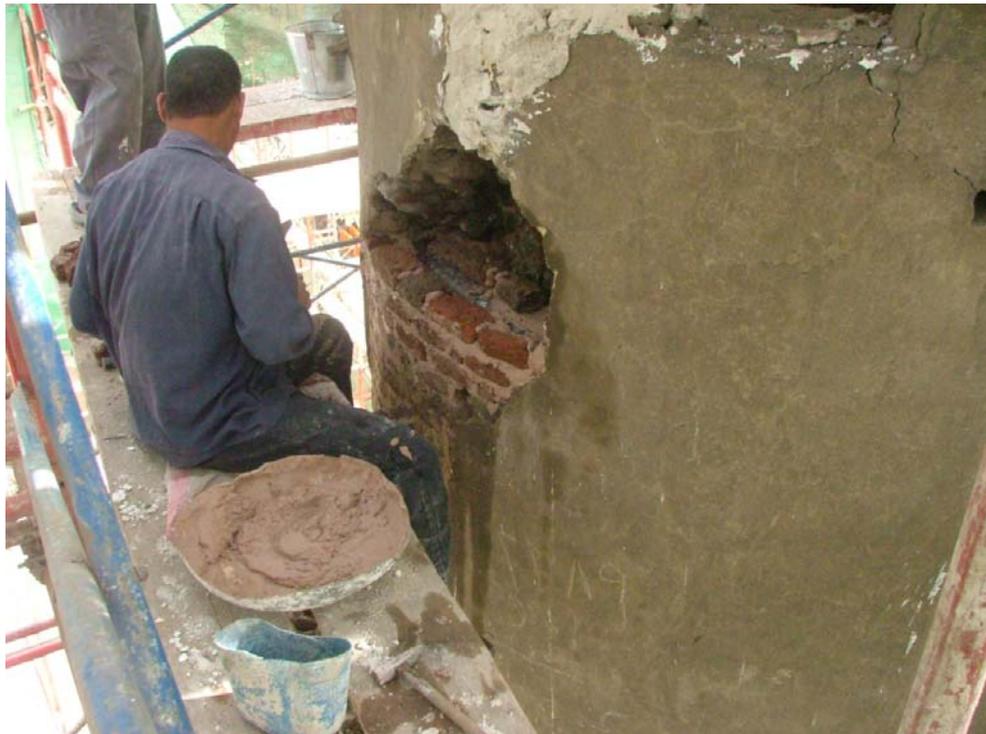
Brick restoration activities taking place on the upper part of the minaret

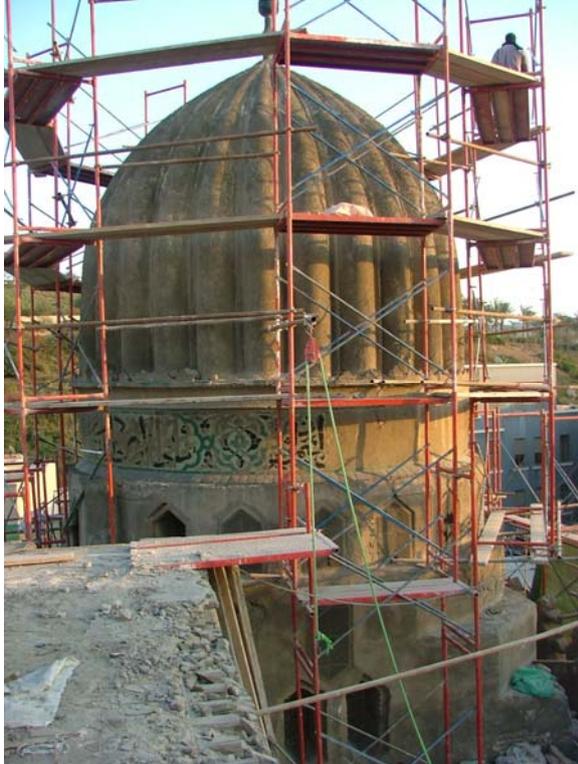
Dome exterior after scaffolding erection

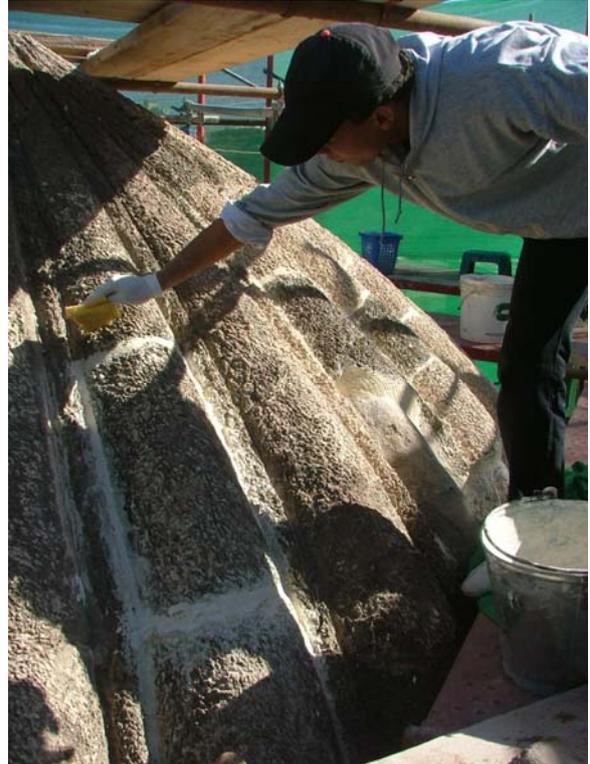
Following the erection of exterior steel scaffolding around the dome, cleaning was initiated by micro-sand blasting and temporary stabilization of the unstable parts was done. The cleaning revealed that the cupola is built with bricks covered by a thick (10-14cm) crust of plaster. Some remains of lime wash are still visible in the recessed angles. Although the cupola is not affected by structural problems, its surfaces and remains of polychrome tiling decoration are in moderately damaged condition.

Stabilization of unstable plaster crusts

The cleaning by micro-sand blasting will be continued and completed. Local injections will re-attach the loose parts of plaster crust. The conservation is currently under testing in order to determine the feasibility of filling the cavities of the upper part of the dome's plaster.

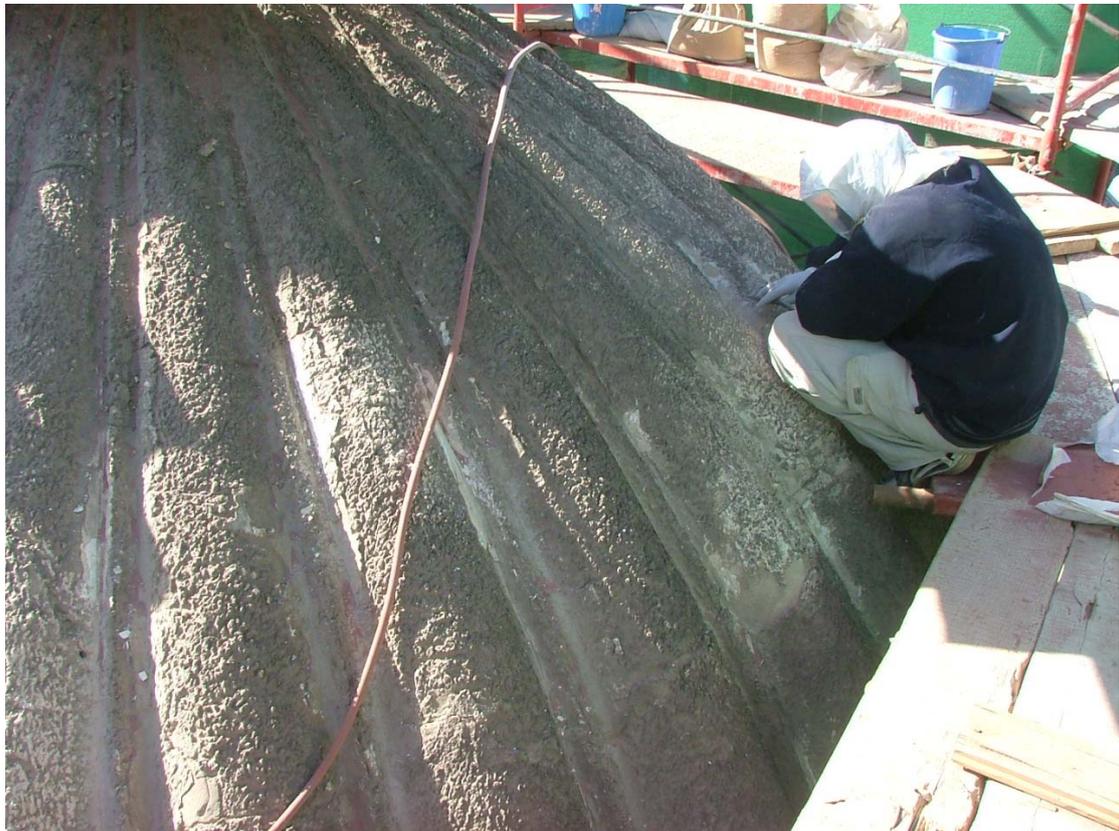
Cleaning of the Cupola by micro-sand blasting

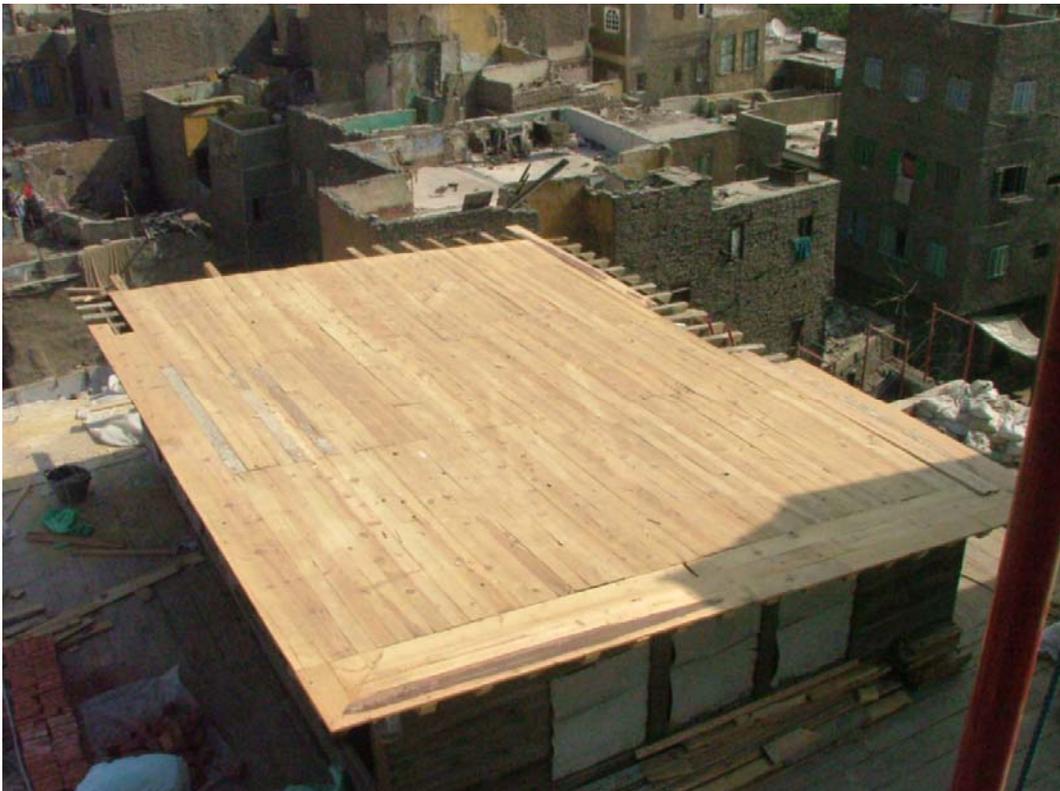
Ceiling after restoration

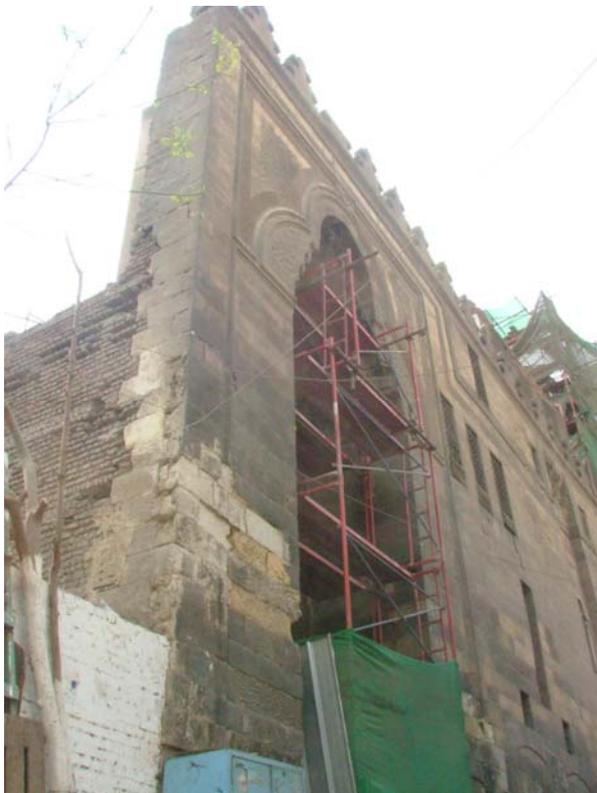
View of the eastern façade during scaffolding erection

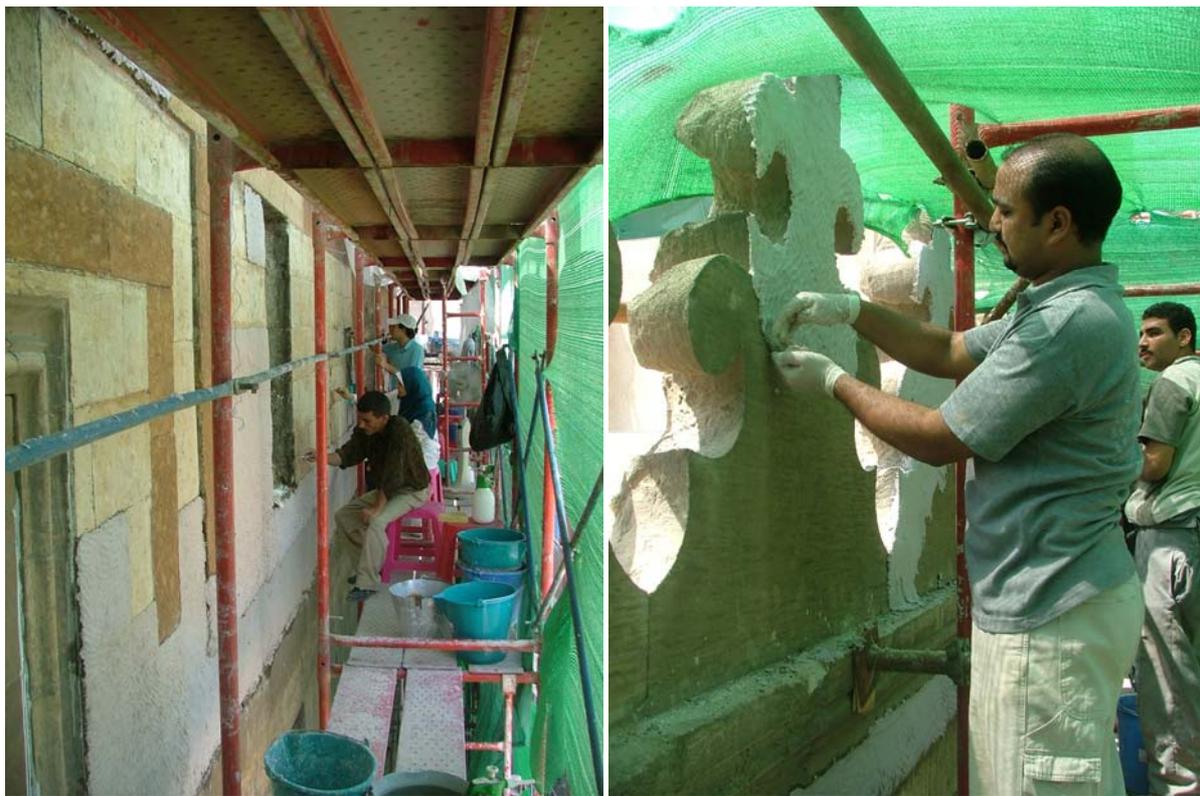
Stone cleaning activities through mechanical and poulticing techniques.

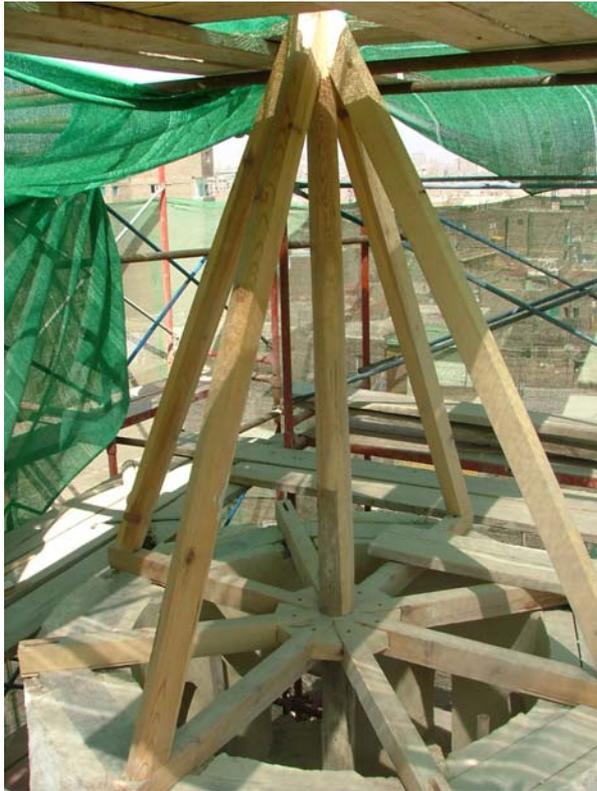
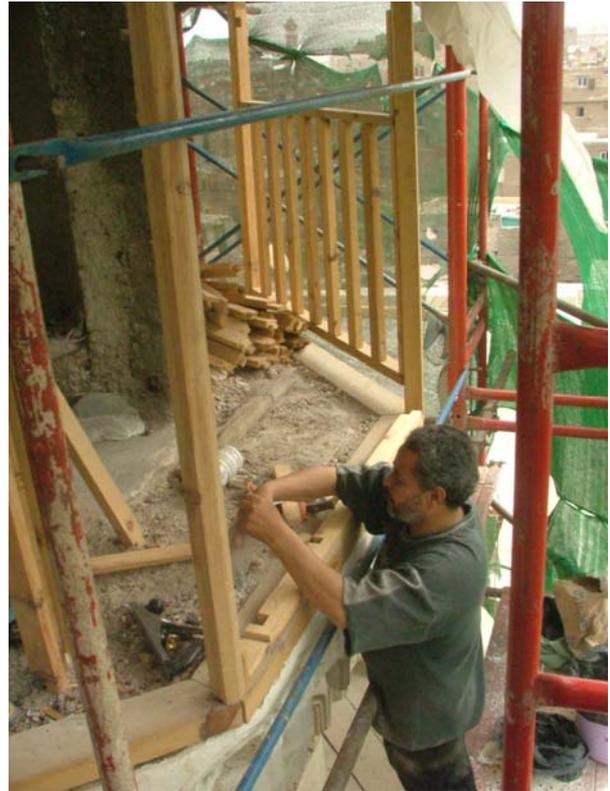
Wood manufacturing of the upper part and the surrounding handrail of the minaret balcony

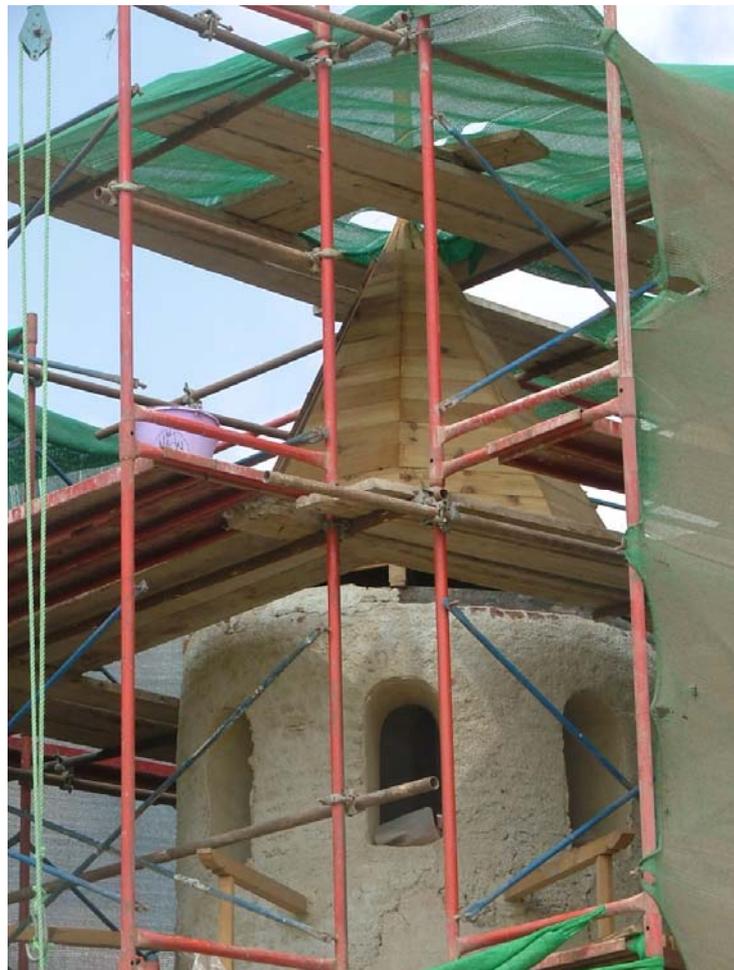
View of the minaret after the completion of the upper pencil part and during plastering activities

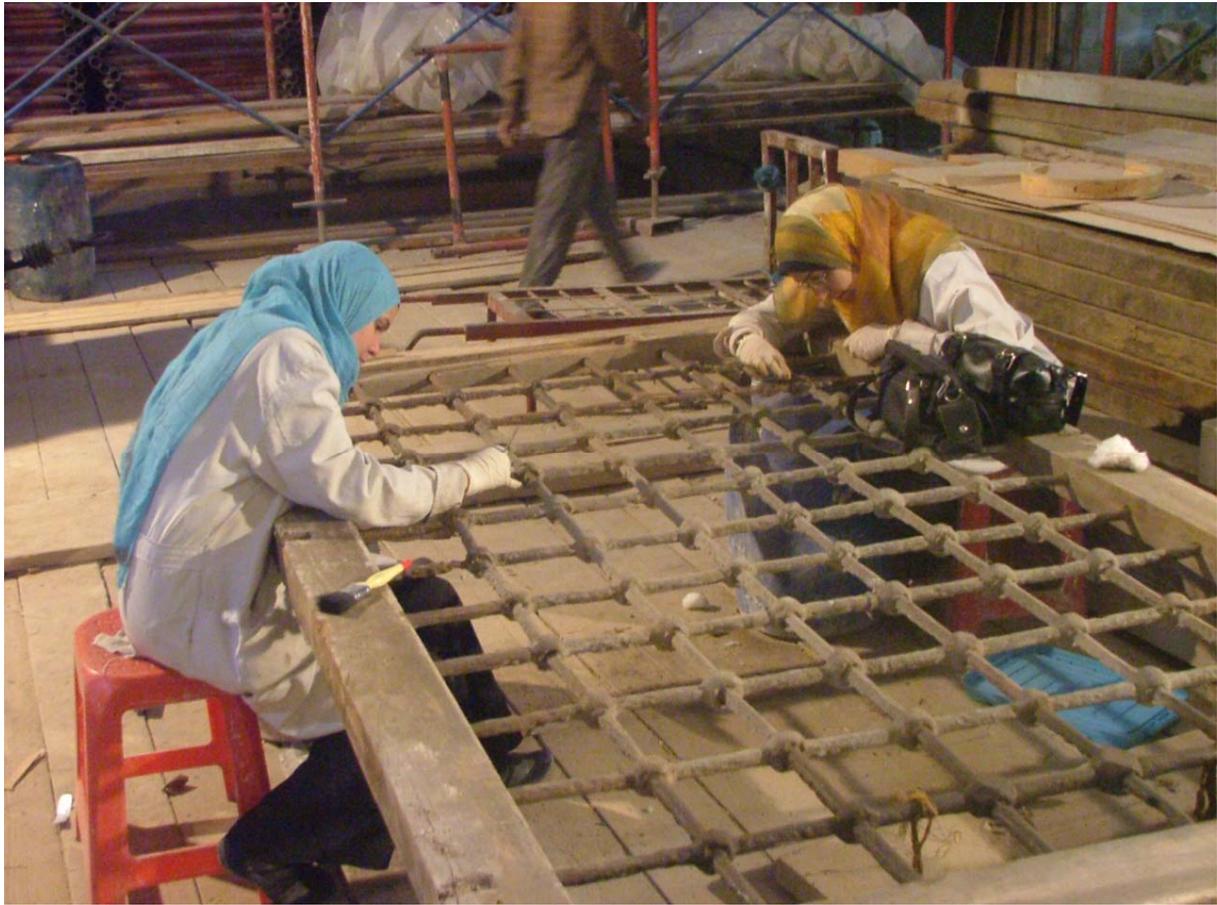
Cleaning activities of the main façade metal grill and wooden frame

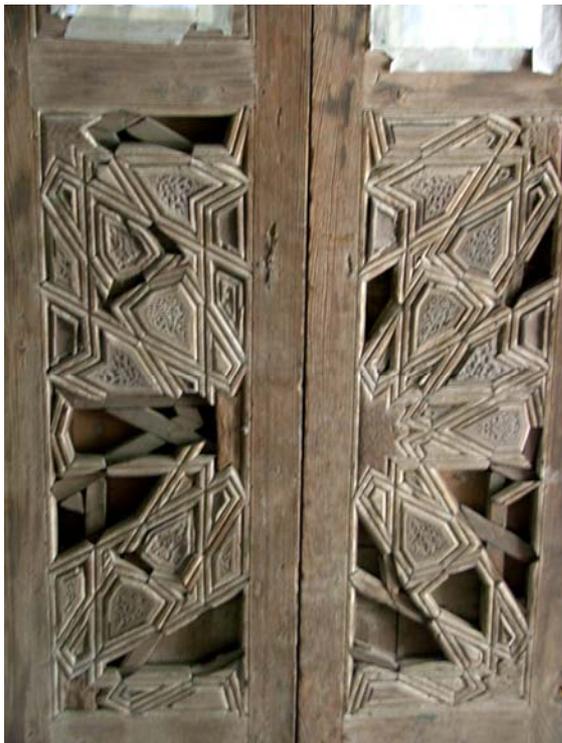
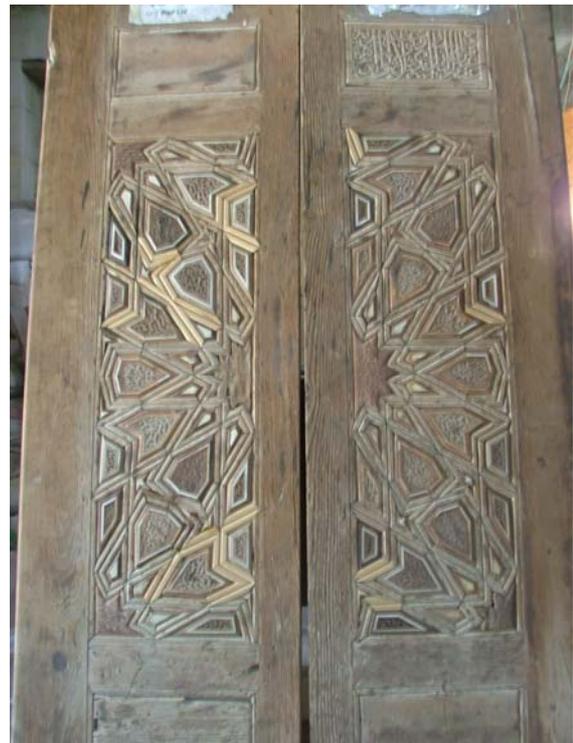
View of the Eastern façade shutters before and after restoration

Woodwork restoration of doors, windows and shutters is currently in progress. Following the state of the items, carpentry restoration takes place followed by fine cleaning and conservation of the wooden elements.

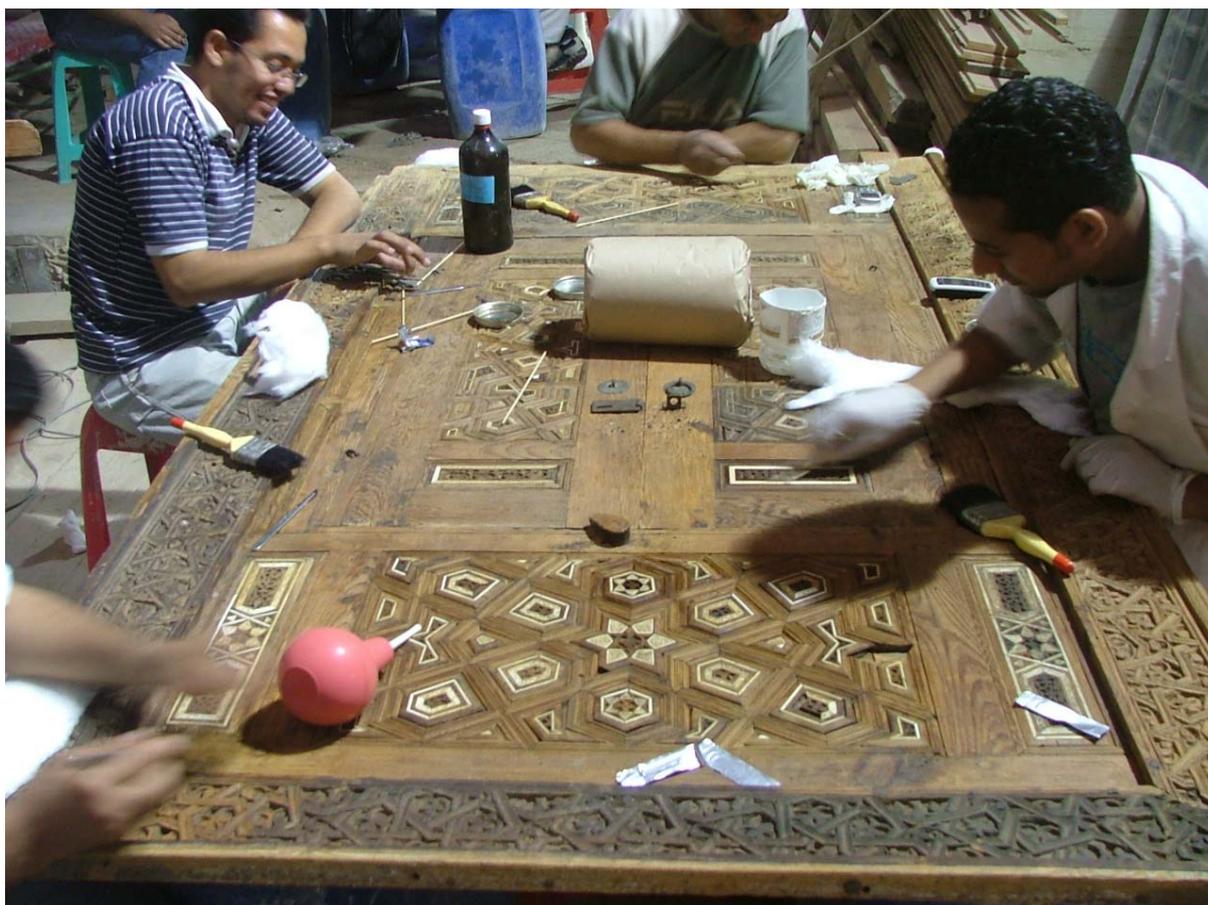
Inlay wooden cupboard during cleaning and consolidation

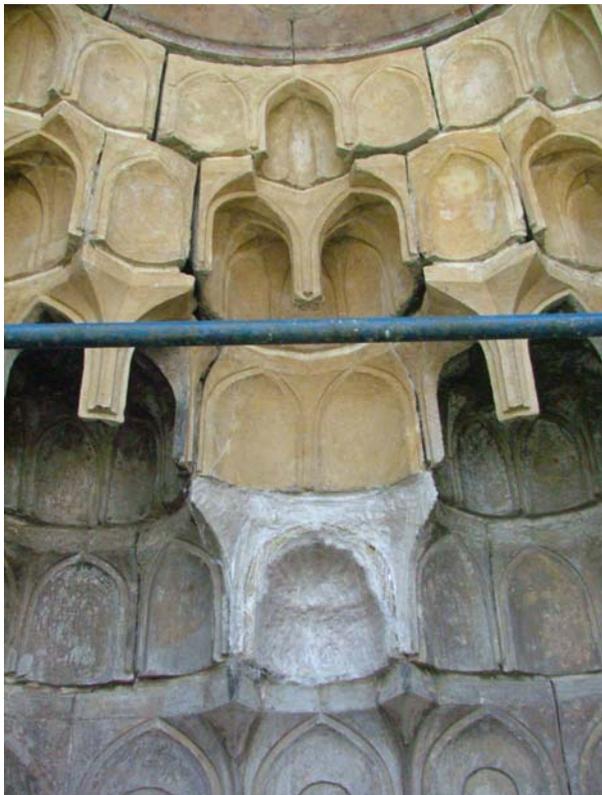
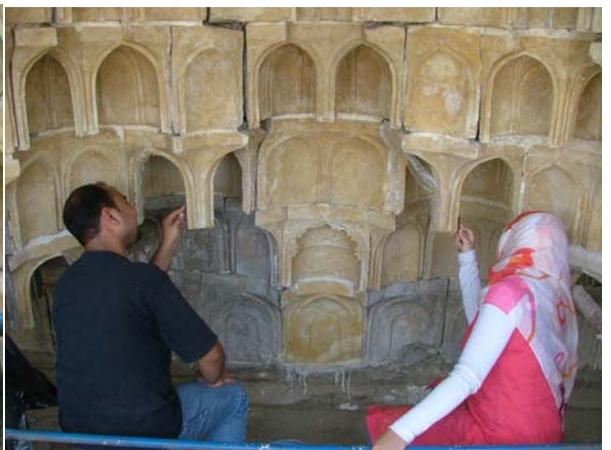
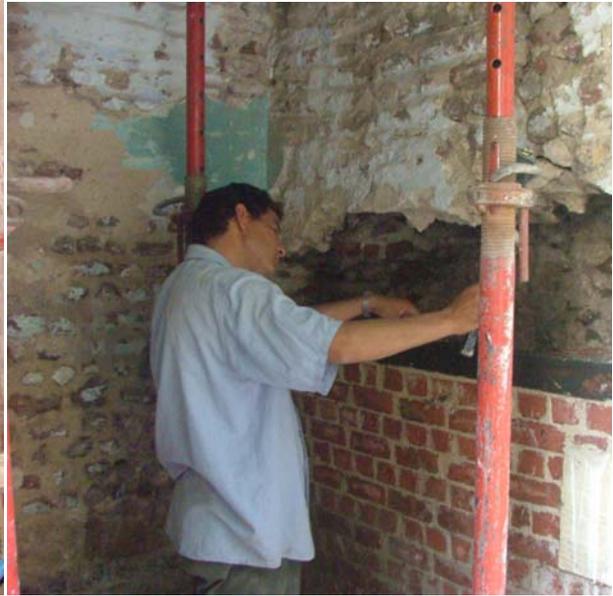
Brick repair and reconstruction activities of damaged and crumbling brick walls in the shops on the western façade

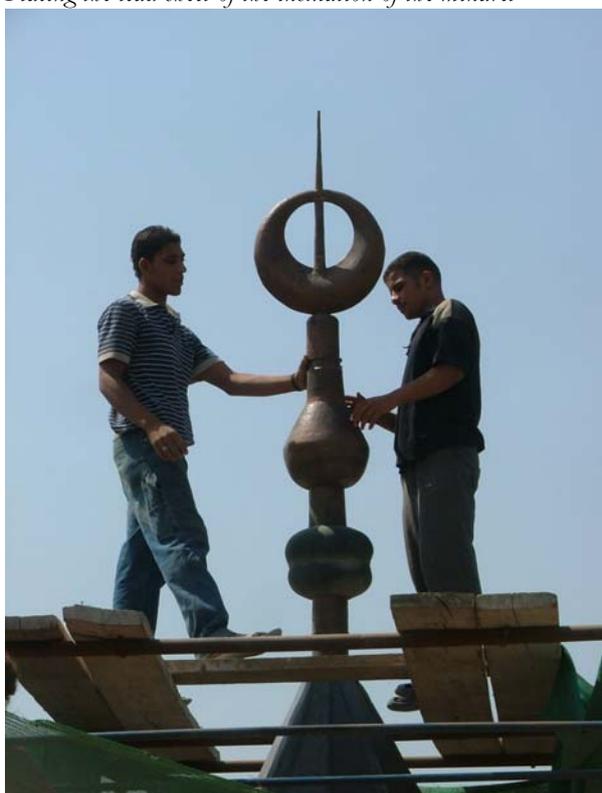
View of the crescent of the minaret

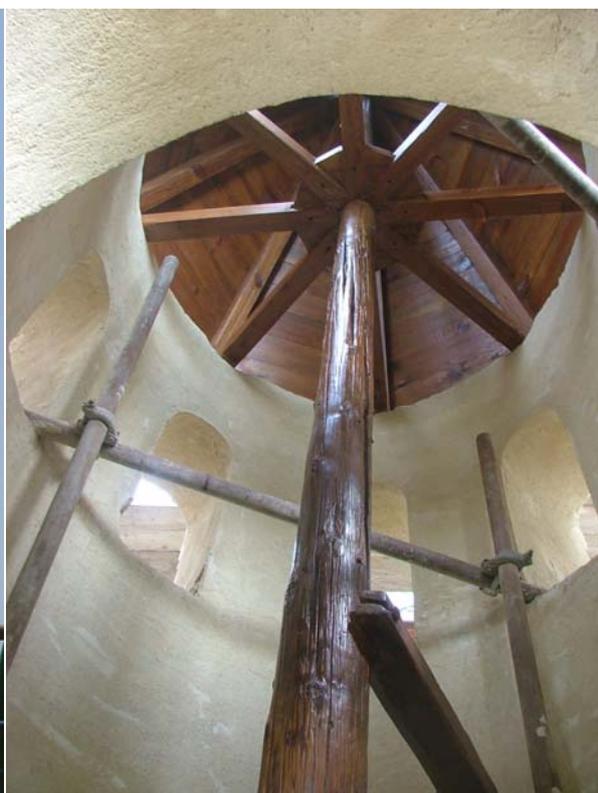
View of the interior of the minaret

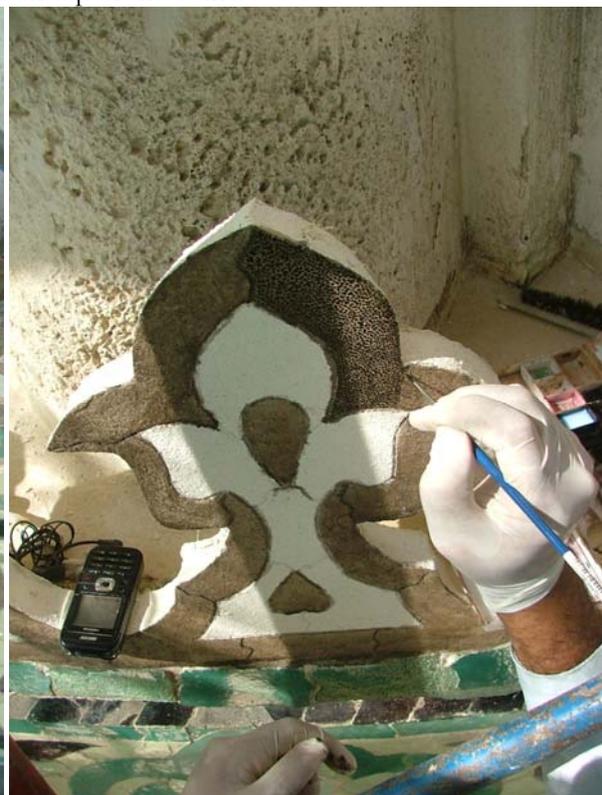
Detail of the sample of the crescent during retouching

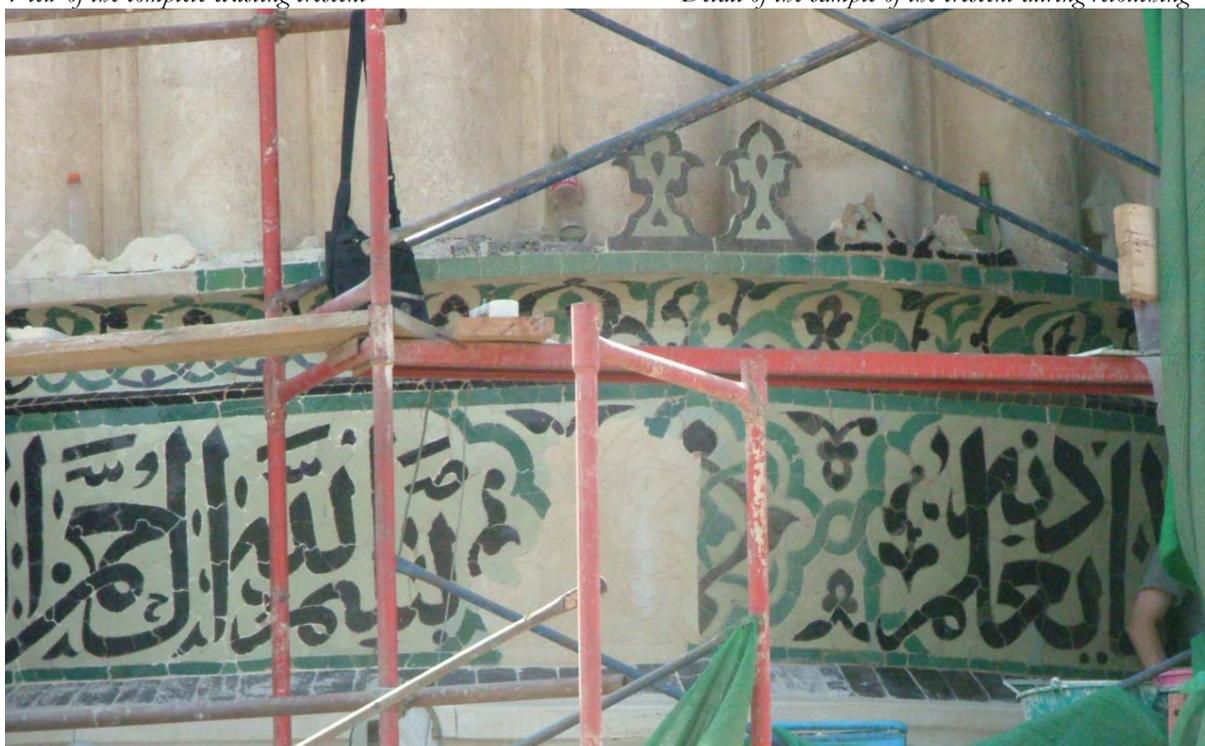
View of the crescents and the retouching tests of the floral pattern

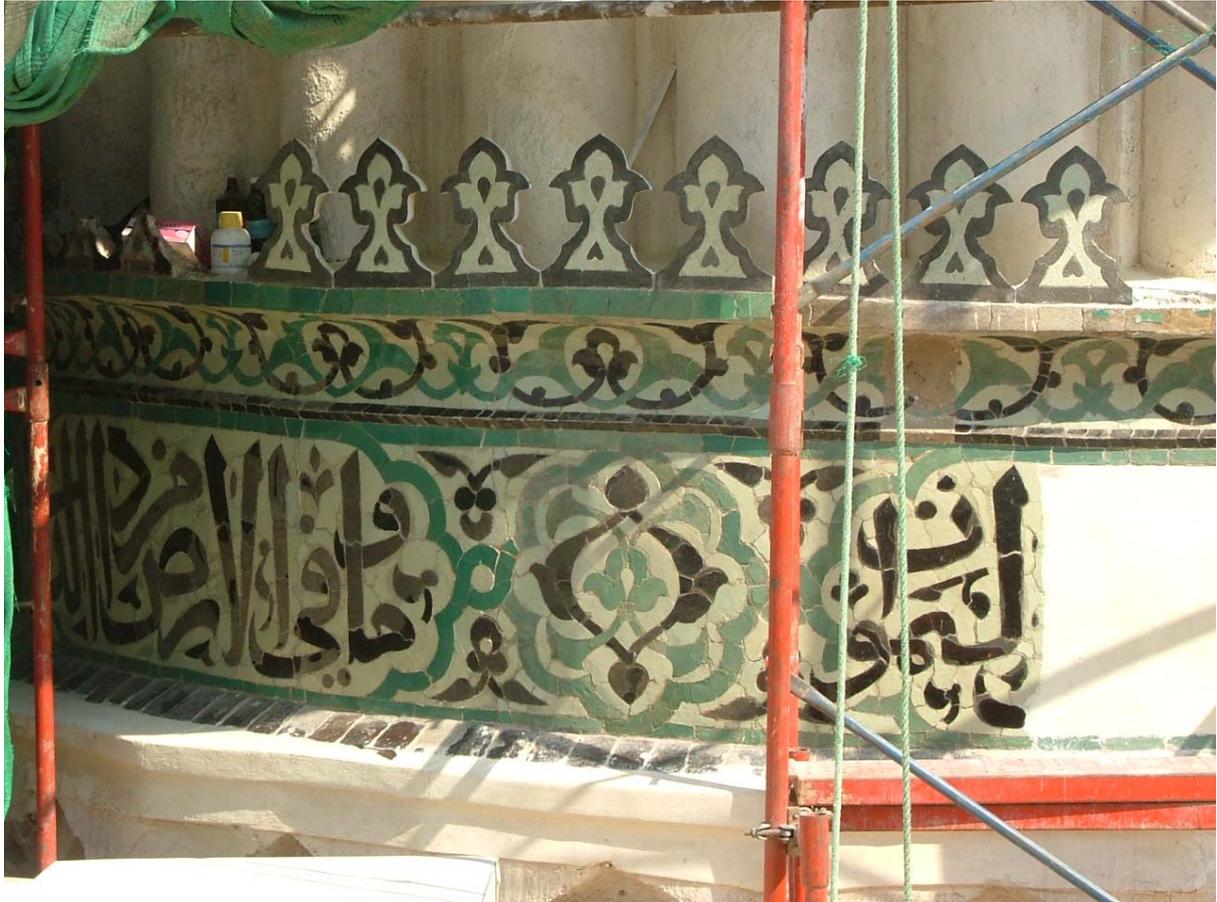
View showing the exterior of the mausoleum with the new crenellations

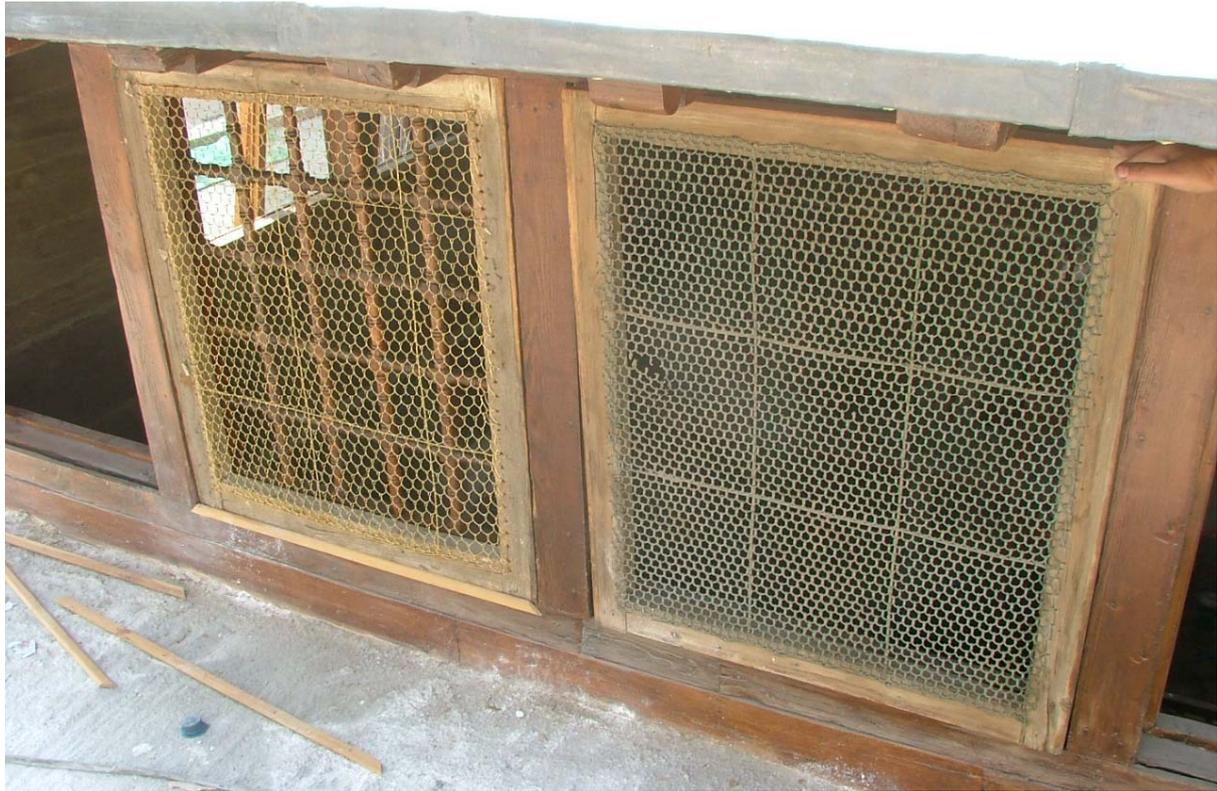
View of the samples of the steel mesh (on the left) and the one of the Comité (on the right)

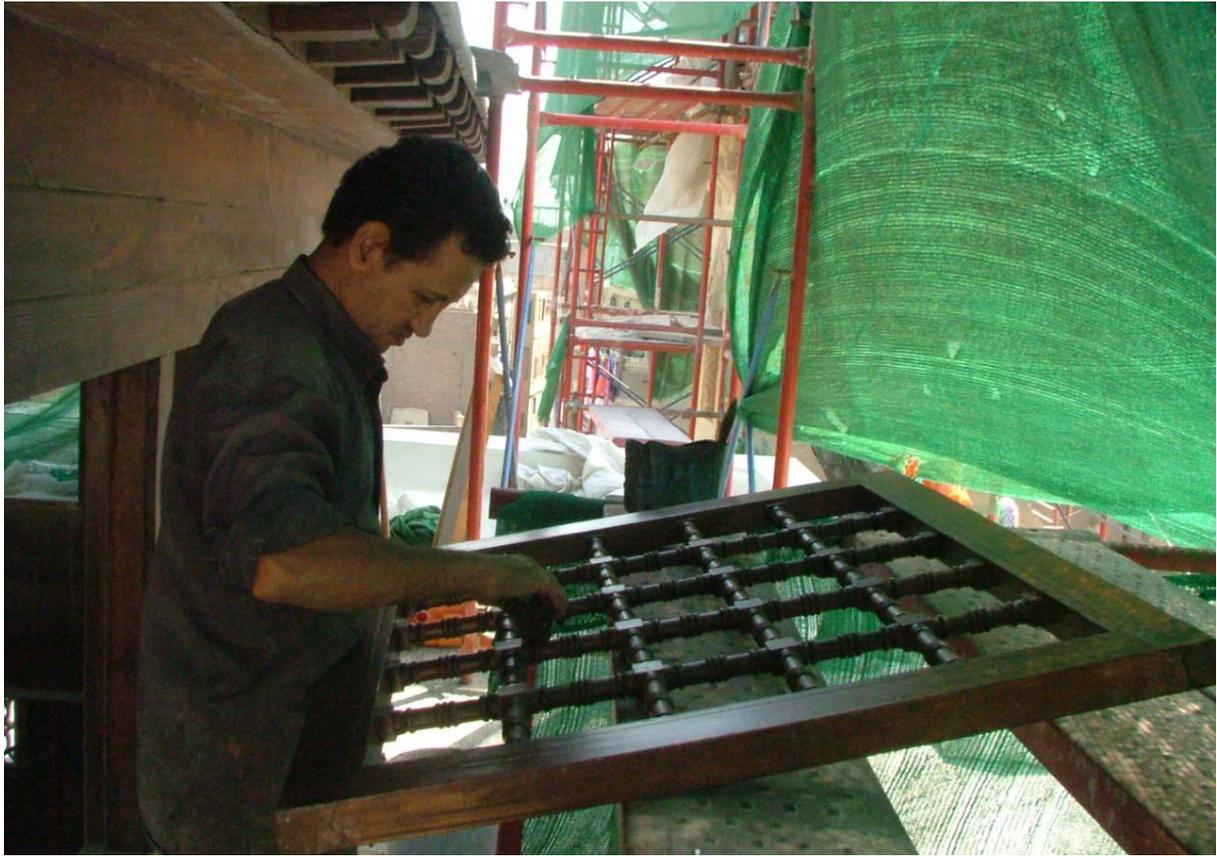
Work of painting the shokhsbaykhaand its wooden screens

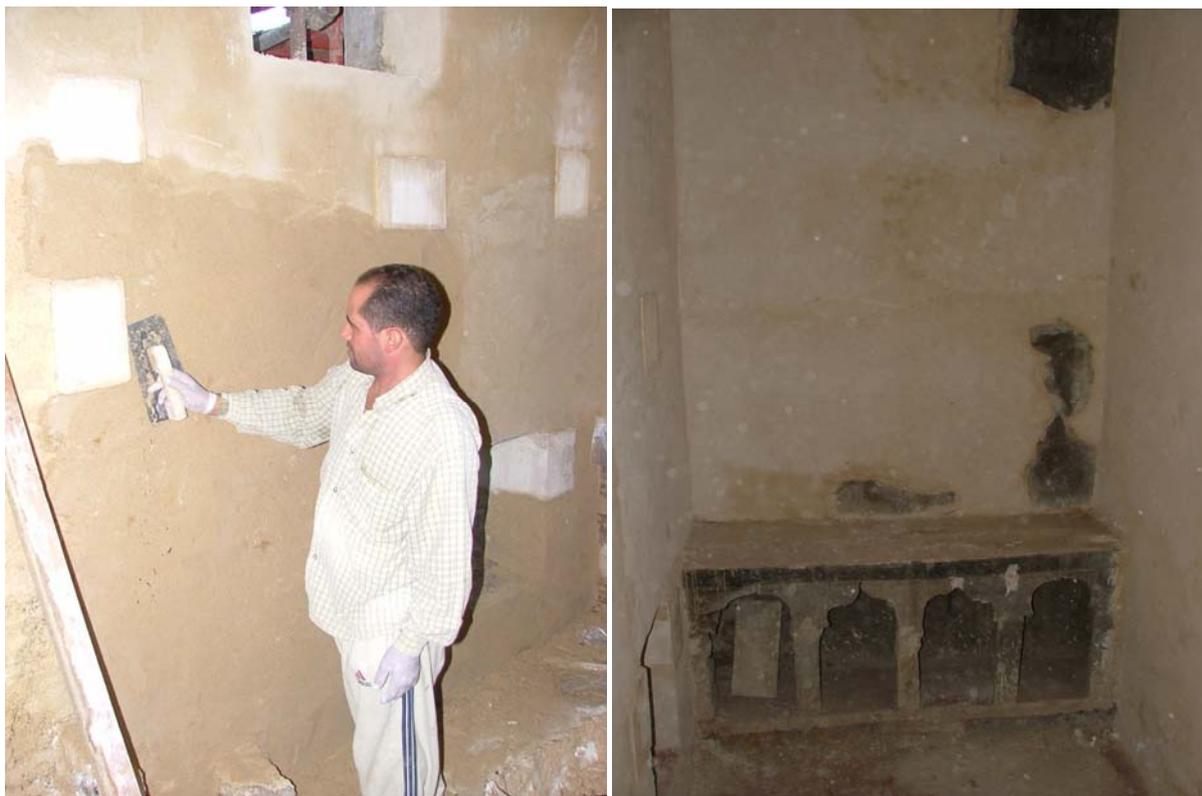
Plastering of room M1

Brick repair activities took place in room M1, also in relation to the western façade to ensure the bonding between the exterior stones of the façade and the brick part in the rooms, as mentioned earlier in the report. The wooden beams and shingles of the ceiling of room M1 (being the flooring of room 1.2) were in a very bad condition and were replaced with new ones. This was followed by brick repair activities in room 1.2 and bonding with the western façade. This activity was completed and currently the room is being plastered.

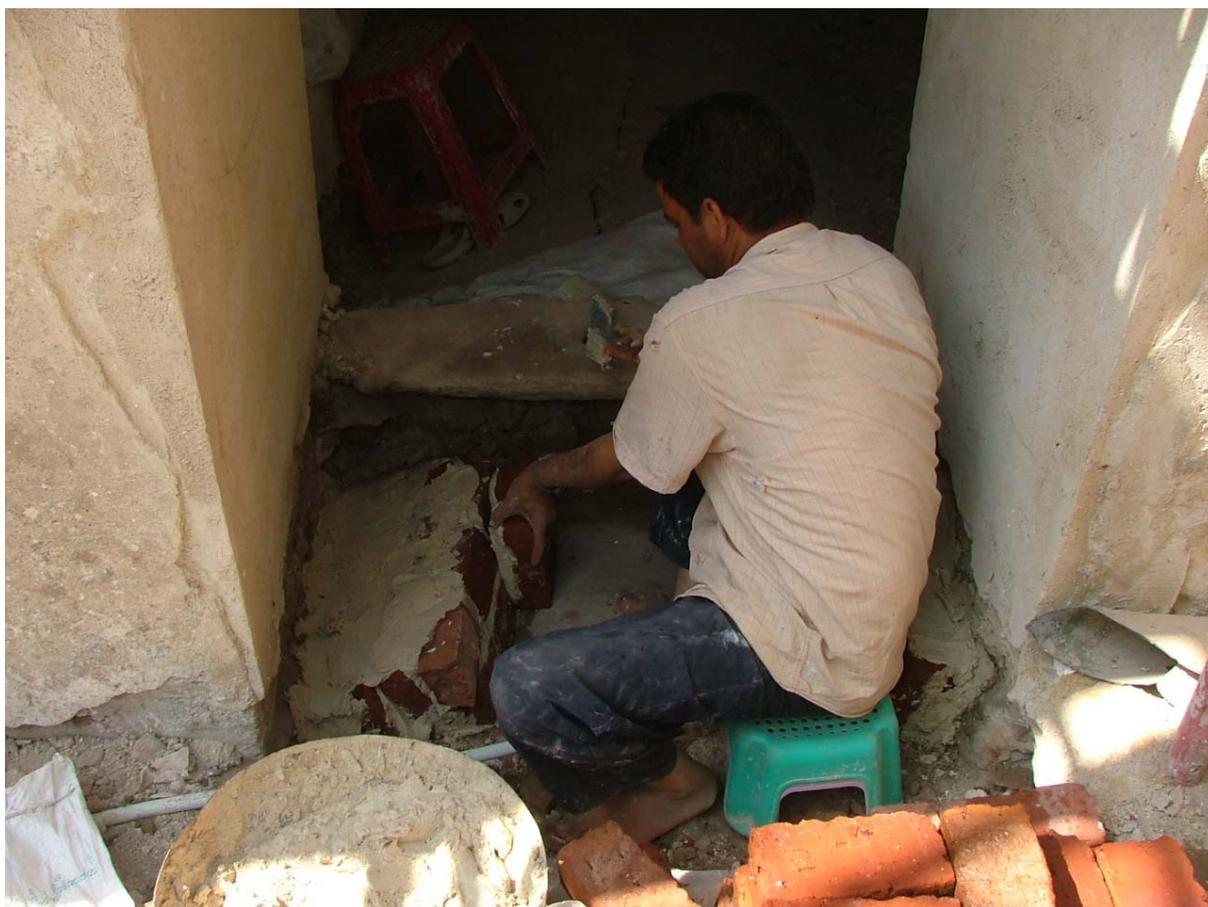
Brick repair activities started in the corridor leading to the ablution area. The vault was seriously cracked and was repaired through the upper room (1.3).

Fixing the vault of the corridor G6 through the upper room 1.3

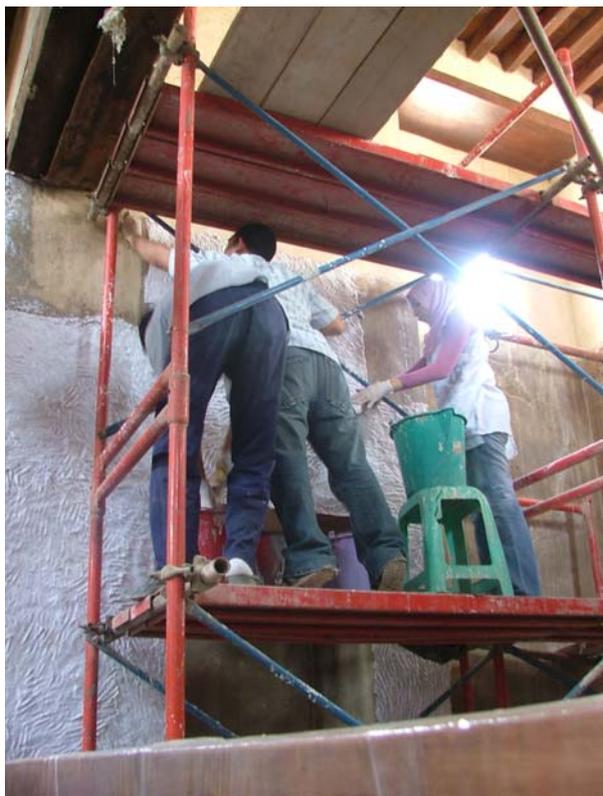
Poulting activities of the walls of room 2.2

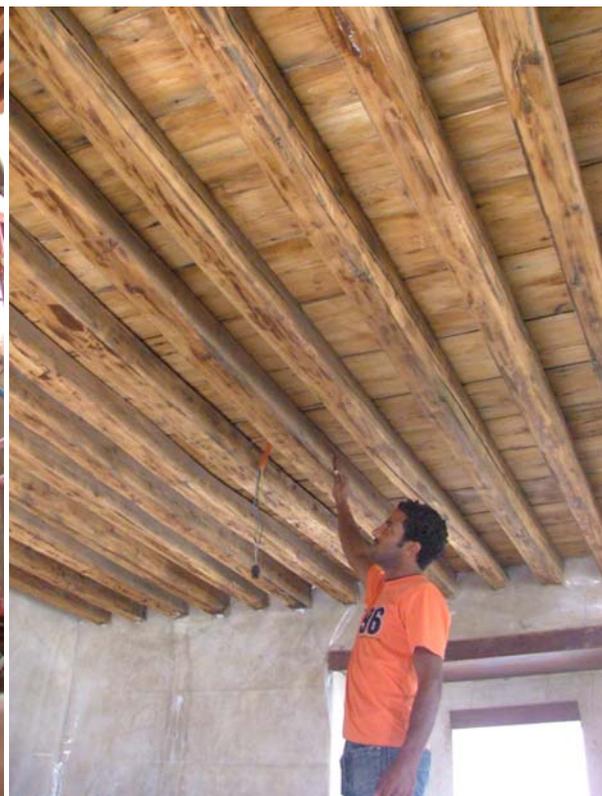
Preparation for painting the ceiling of room 2.2

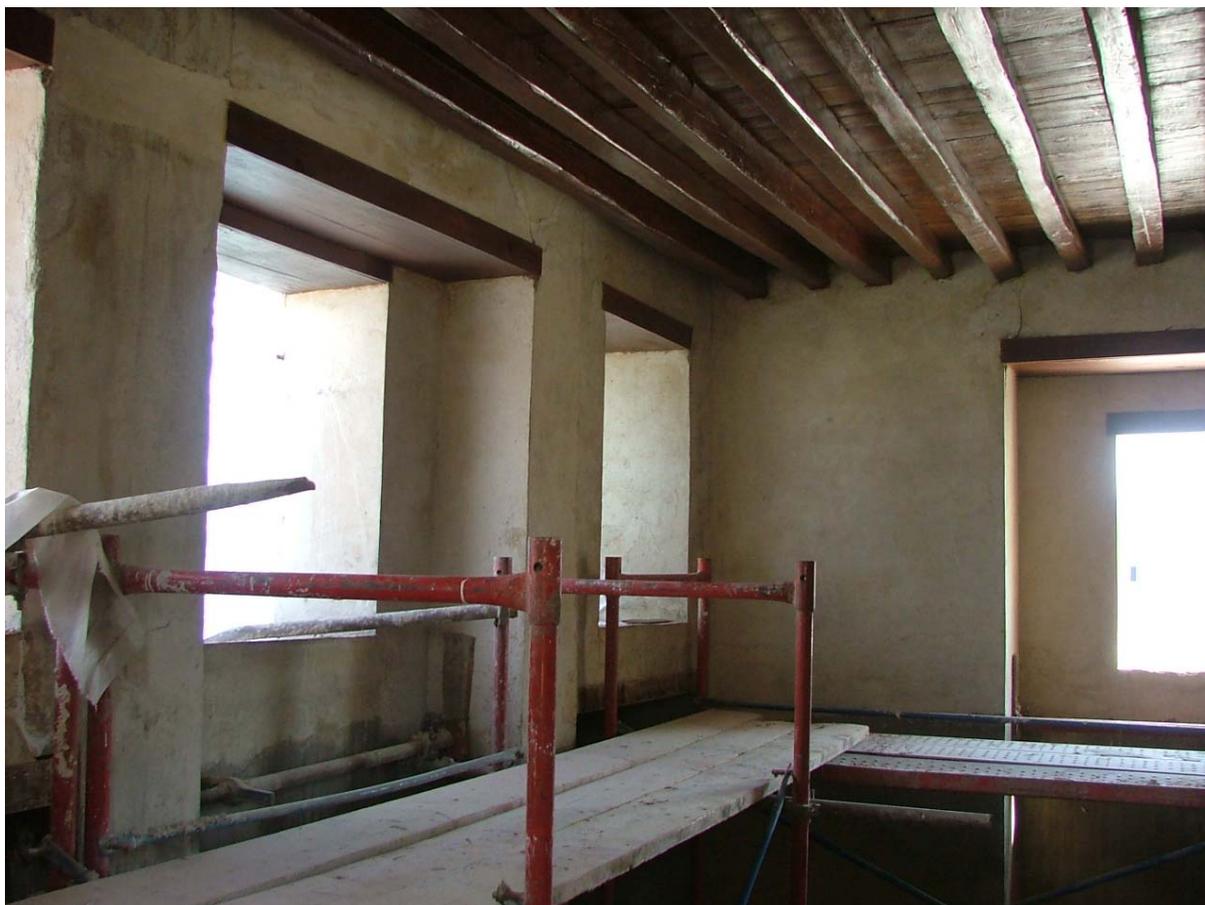
View of the upper part of room 2.2 after painting the ceiling and poulting the walls
