ANNUAL REPORT

December 2006 – December 2007

“Conservation of the Mosque of Aslam al-Silahdar in Darb al Ahmar, Cairo”

**QUARTERLY PROGRESS REPORT
DECEMBER 2006-FEBRUARY 2007**

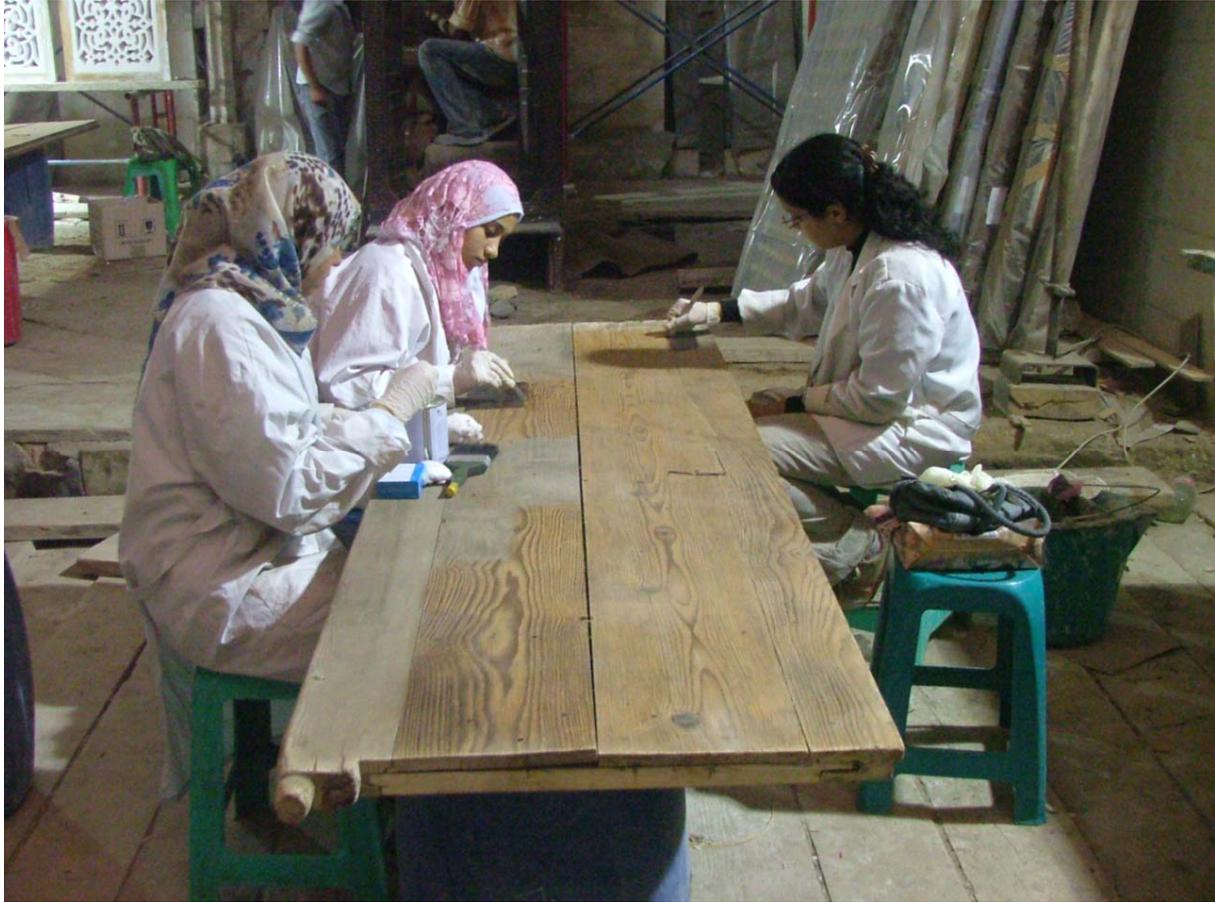
Activities of cleaning the wooden doors

Woodwork restoration of doors, windows and shutters is currently in progress and will be proceeding during the following months. In general, depending on the state of conservation of the item, carpentry restoration takes place followed by fine cleaning and conservation of the wooden elements.

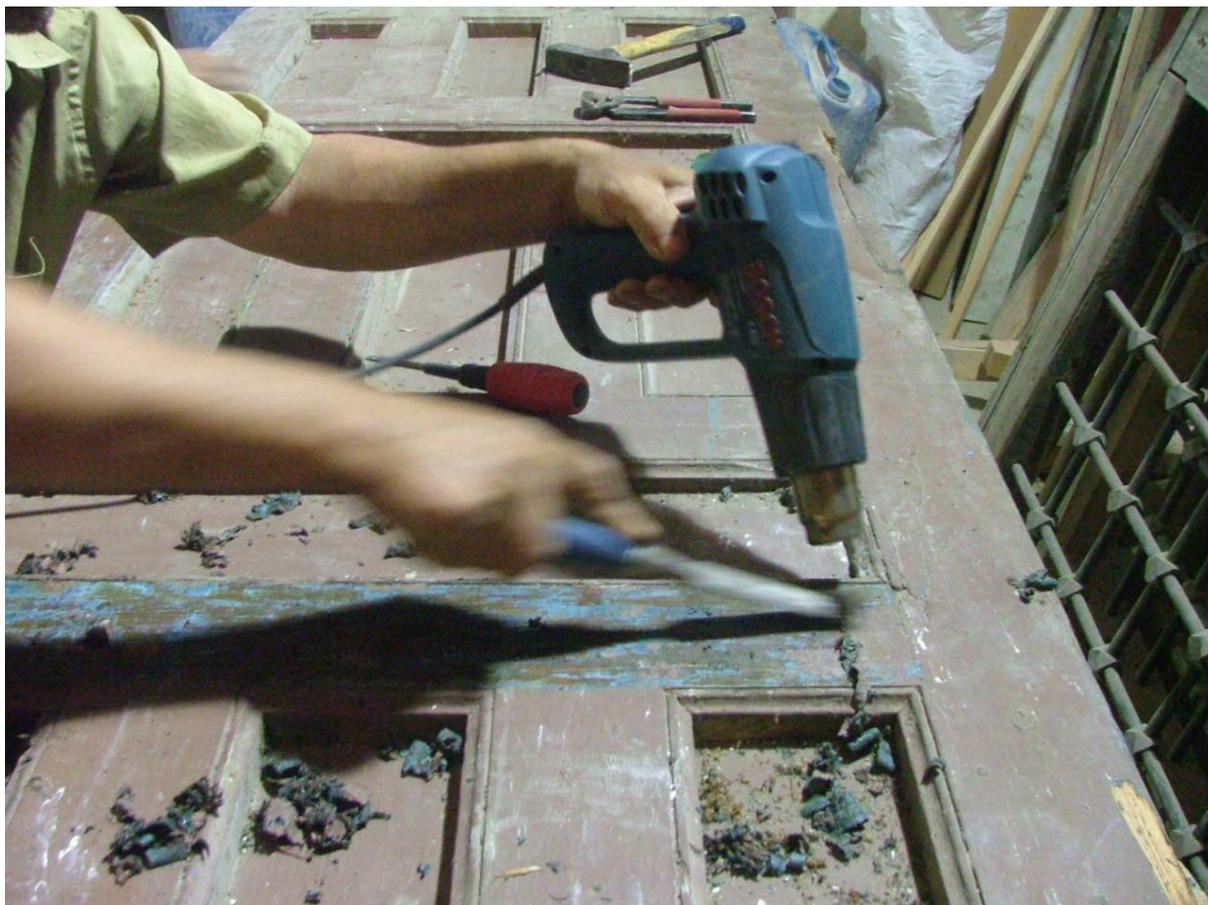
Removal of modern paint using the hot air gun

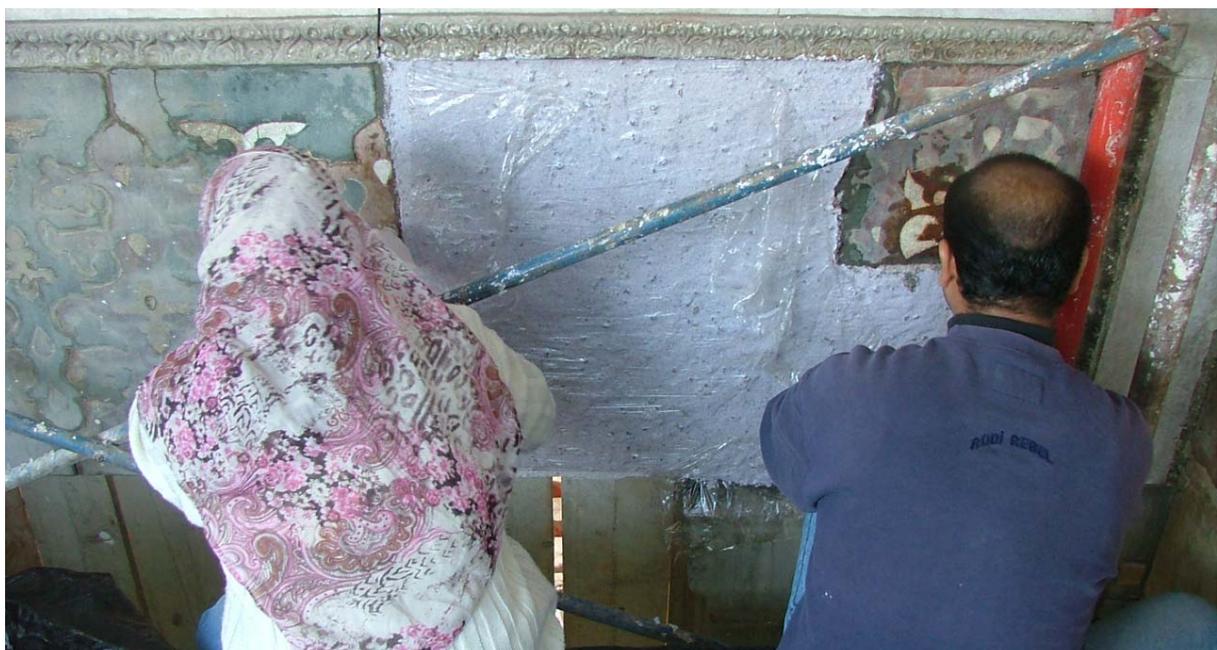
Activities of marble cleaning on the west façade

The fine restoration and cleaning activities were completed on the limestone part of the façade. As for the entrance portal adorned with *muqarnas* and decorated with carved limestone and carved marble, the work is proceeding very well showing nice details and colors of the stones. The cleaning was carried out using different techniques (such as the micro-sand-blaster or poulticing with ammonium carbonate) depending on the type of the stone and the crust on it. The lower part of the entrance portal was in quite a bad condition with a very thick layer of crust; it was cleaned with sand-blasting technique. The remaining activities on the portal will be finalized by mid of January 2008. The wooden elements, repaired and painted, were placed and the scaffolding on the right side of the façade was removed.

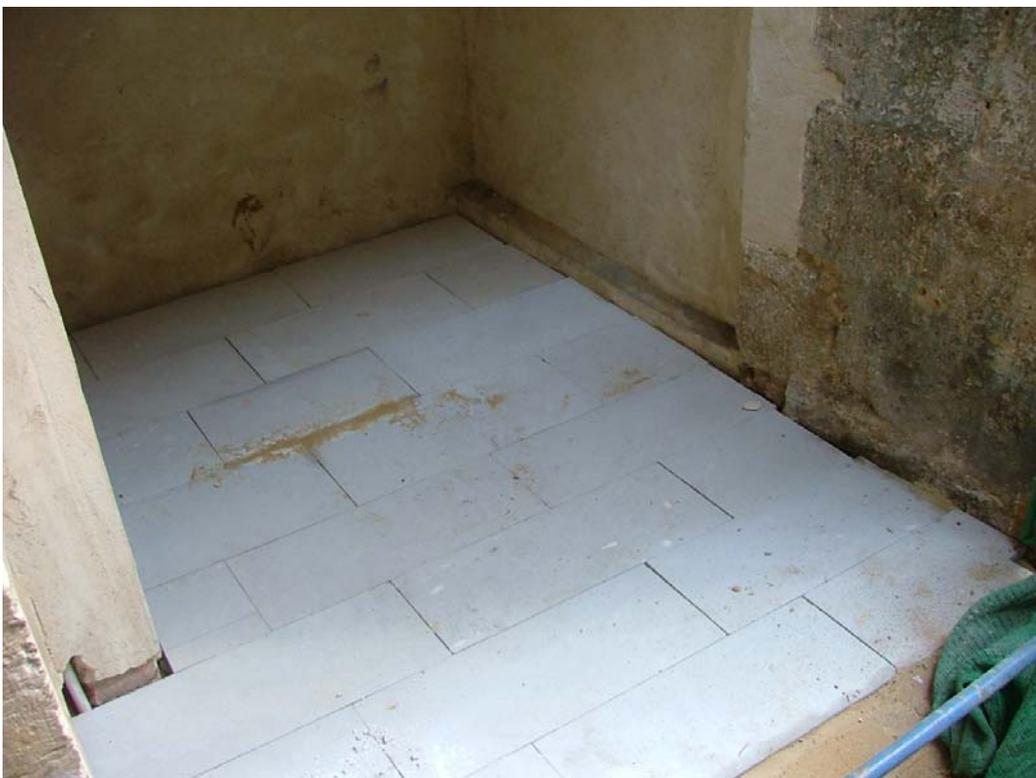
One of the shops after tiling

All remaining activities in the five shops were finalized; the walls were plastered and the floors were tiled. Some remaining activities of stone replacement and stone cleaning were also finalized.

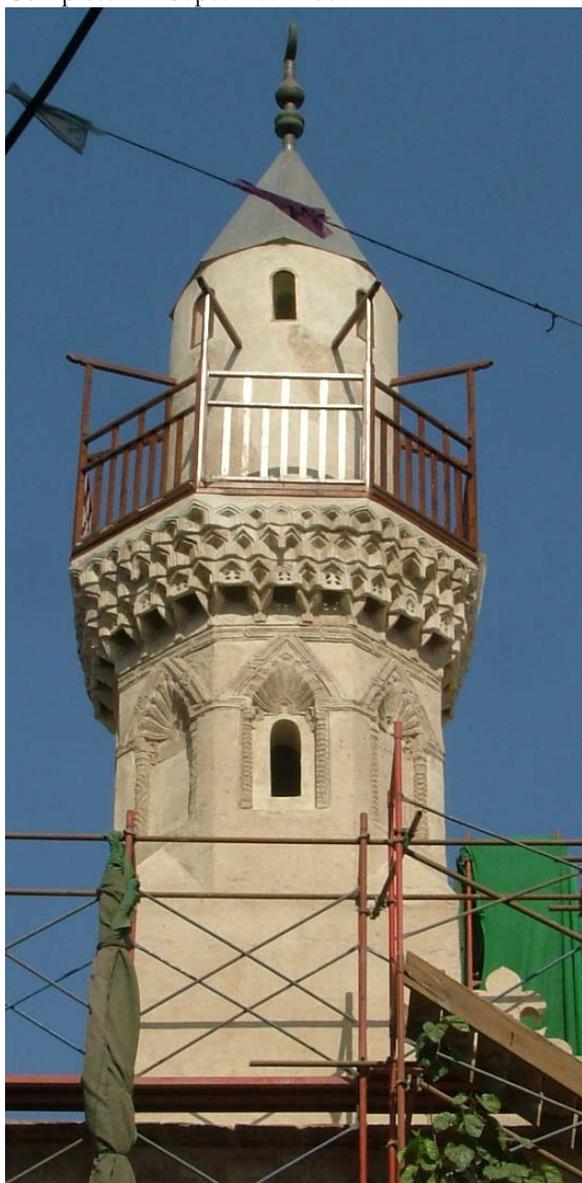
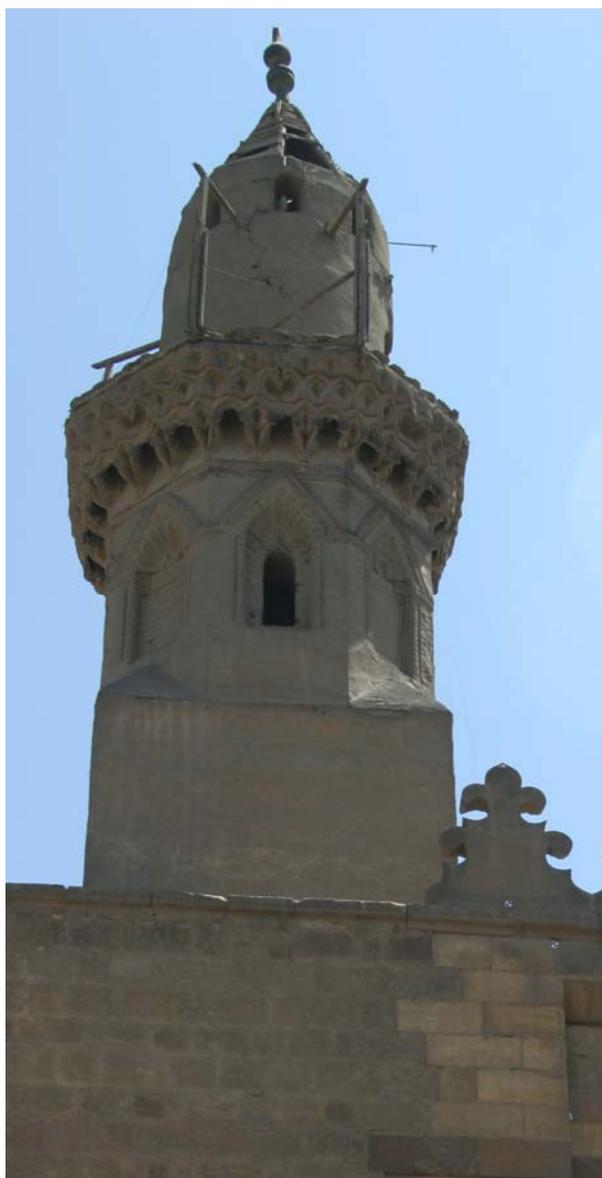
Views of the minaret after restoration and before restoration

All remaining activities on the minaret were finalized: the balcony was tiled, the insulation of the upper wooden part was insulated in lead and the missing part of the crescent was manufactured and put in place. The outer and inner parts were plastered and the interior lights were installed.

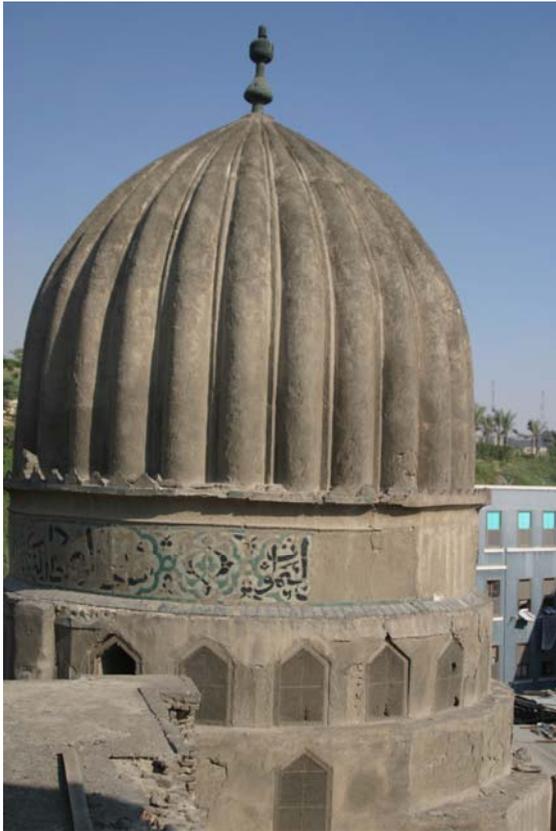
Views of the exterior of the dome before and after intervention

The retouching of the crenellations (made in plaster), the inscription band and its floral decoration was completed. A decision is being studied concerning the completion of the inscription band in the areas where no ceramic tiles are found. The existing gypsum grills with glass on the interior of the mausoleum were cleaned from the outside. As for the exterior gypsum windows (which are missing) designs were proposed to the SCA and discussions are taking place concerning the matter. The scaffolding was dismantled.

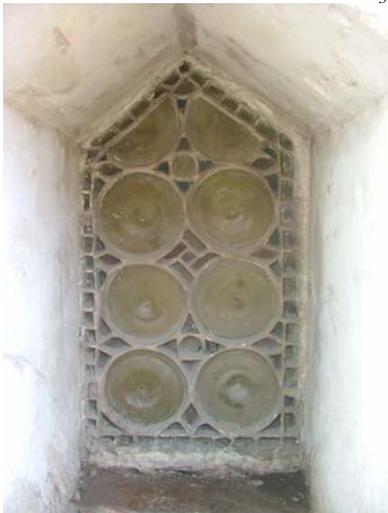
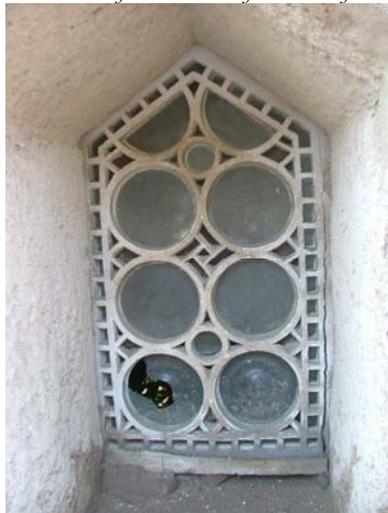
The exterior façade of the interior gypsum windows with glass (the left one is more historic and the only one remaining; the other ones are recent reconstructions by the Comité)

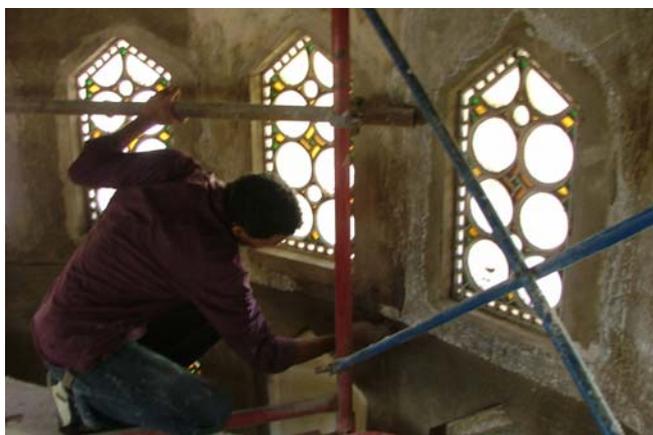
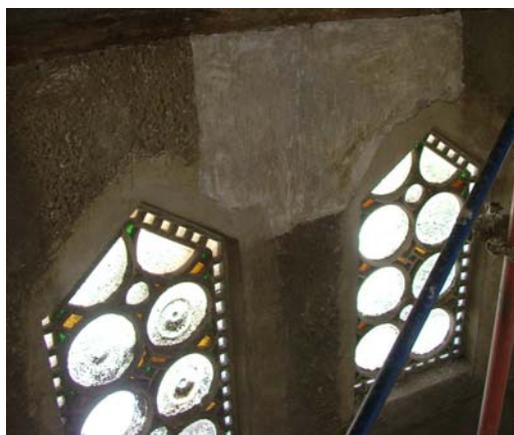
Activities and details of removing the dust and the recent limewash layer around the first level windows of the mausoleum

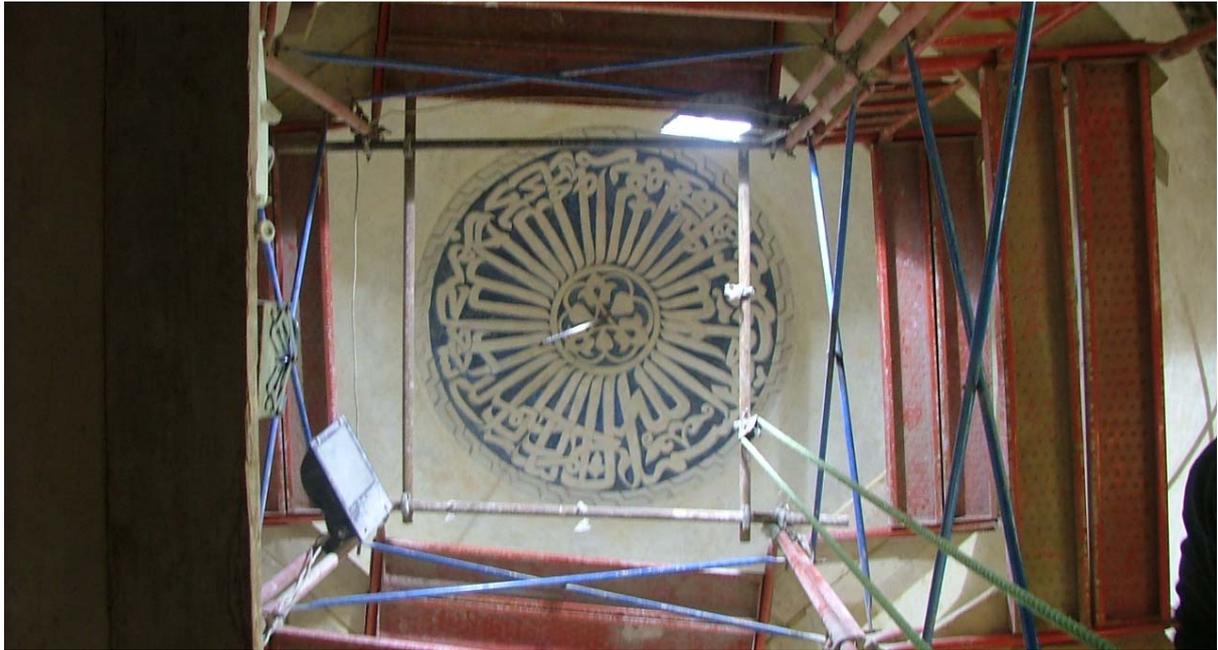
View of the upper roundel after cleaning and retouching the blue background; below: detail of the roundel

The erection of the scaffolding in the interior of the dome was completed and the fine restoration activities started from the top of the dome. The inscription on the roundel was cleaned and the blue background was fixed where it was flaking and retouched where it was lost. The gypsum plaster was cleaned mechanically removing a recent limewash layer; this was followed by further cleaning of the plaster. The highest level gypsum grills were cleaned from the interior.

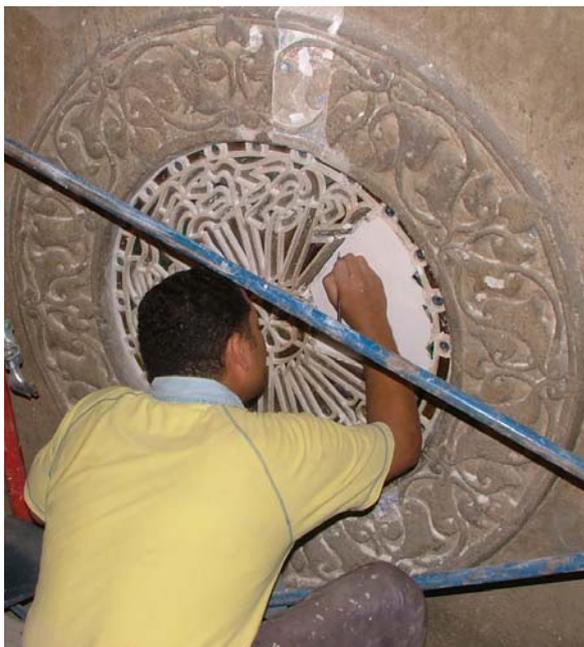
On the lower levels of the mausoleum some gypsum grills and windows were in a very bad condition with numerous missing parts. These are being repaired in-situ. One grill was in a quite bad condition and was dismantled, repaired, cleaned and completed.

Views of repairing and protecting the gypsum decoration in-situ

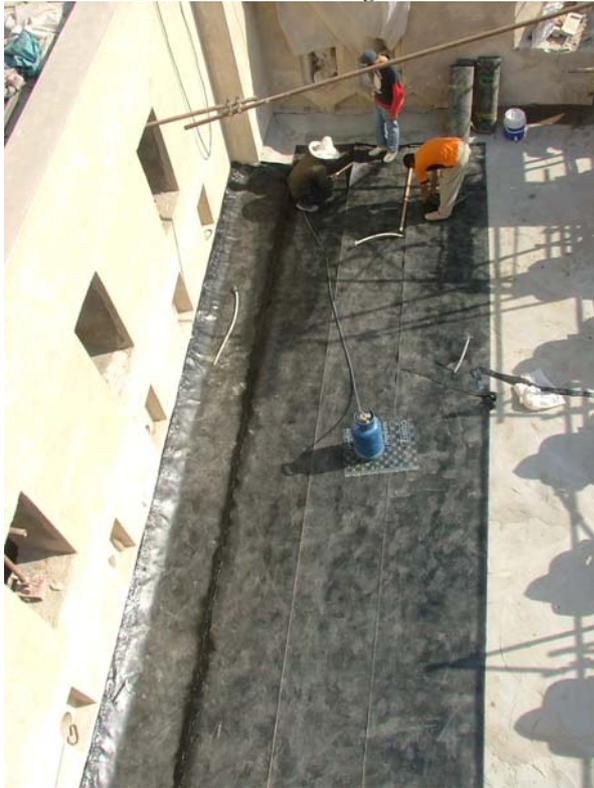
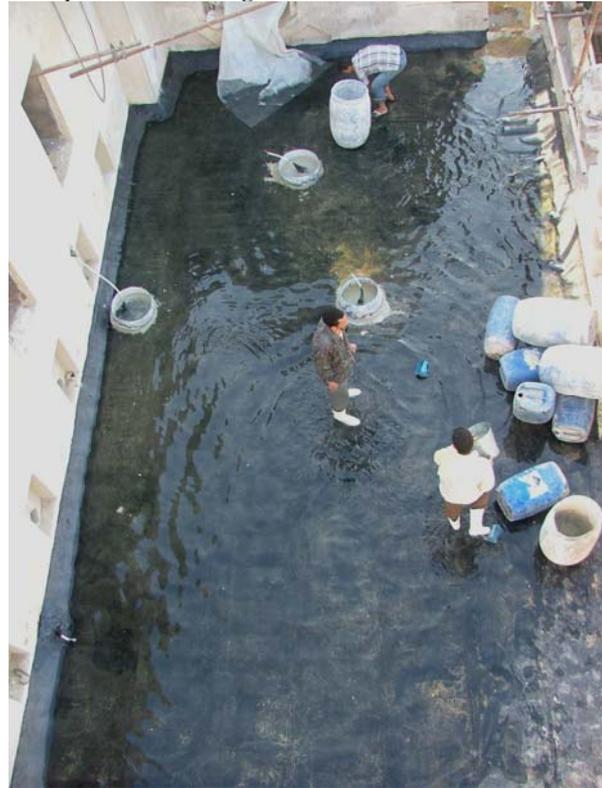
Insulation activities on the south ceiling and water testing the insulation before applying the upper mortar mix layer

The southern and eastern ceilings were insulated; this completes all roofing and insulation activities.

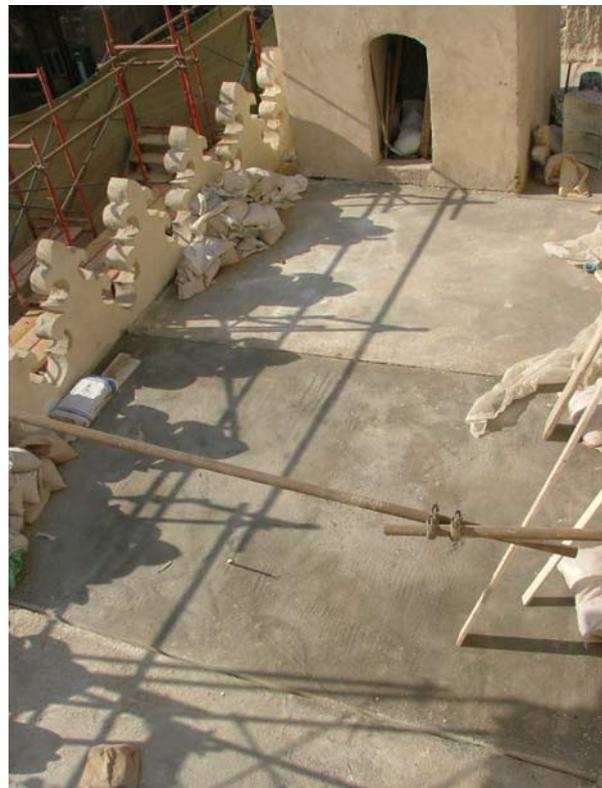
The upper insulation layer during application and after hardening

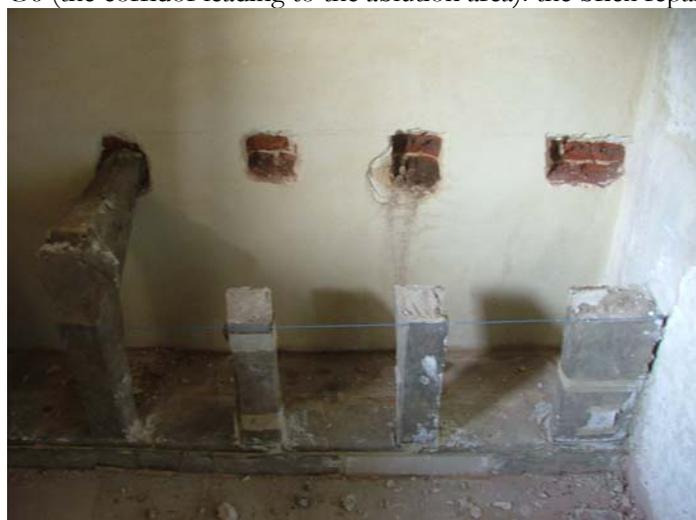
During erection of the niche in room 1.2

The stone niches in the rooms, (the one in room 1.2 was dismantled earlier to repair the ceilings and the walls), were repaired restored, replacing the damaged or lost ones and cleaning the existing ones.

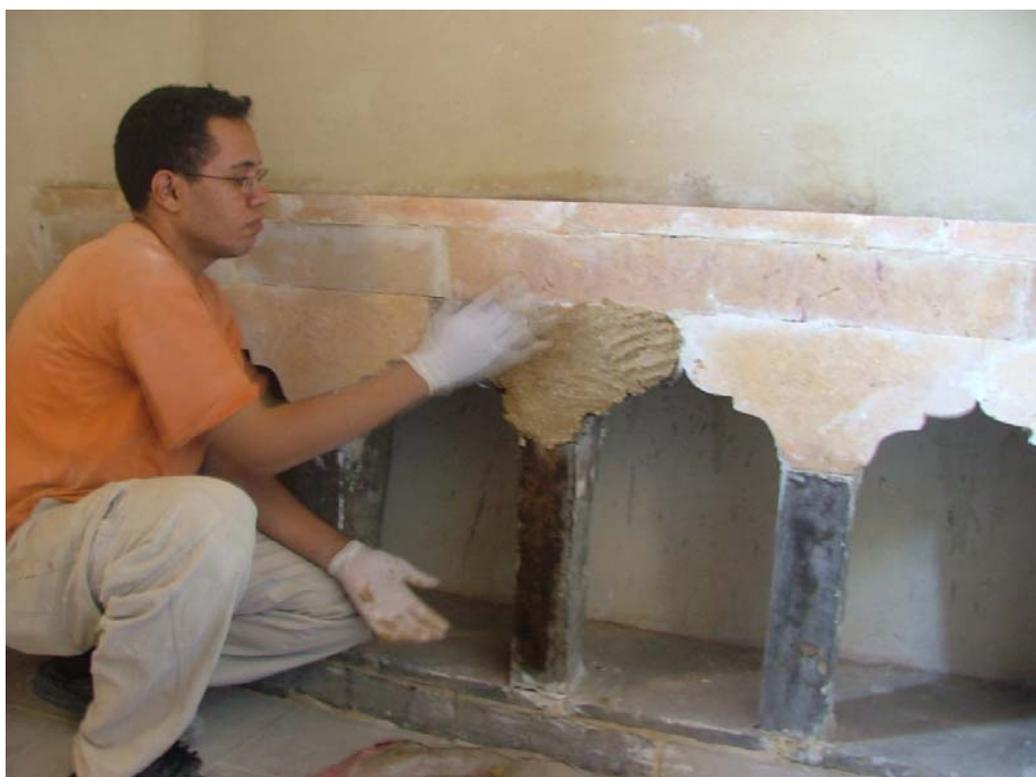
Room 1.2 after the niche was installed and during cleaning

Rooms 1.2 and M1: The rooms around the staircase (rooms 1.2 and M1) were completely restored; after the brick repair activities were finalized and the ceilings restored and repaired, plastering and tiling activities started and were completed, as well as the stone cleaning and plaster cleaning.

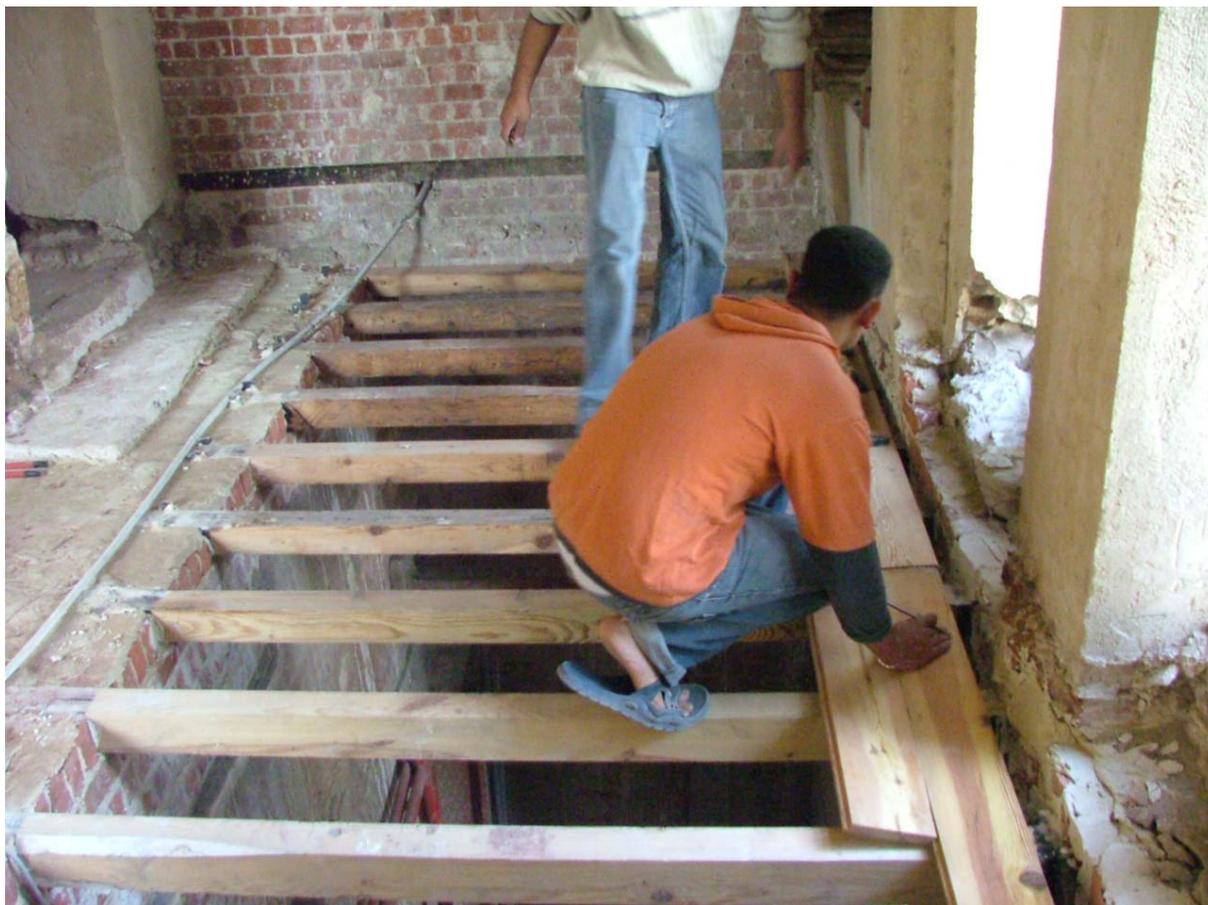
Room M2: the brick repair activities in room M2 was finalized, as well as stitching it to the exterior west wall. The ceiling of the room (also the floor of room 1.3) was in quite a bad condition; the damaged beams and shingles were replaced with new ones.

Wooden ceiling of room M2 (the floor of room 1.3)

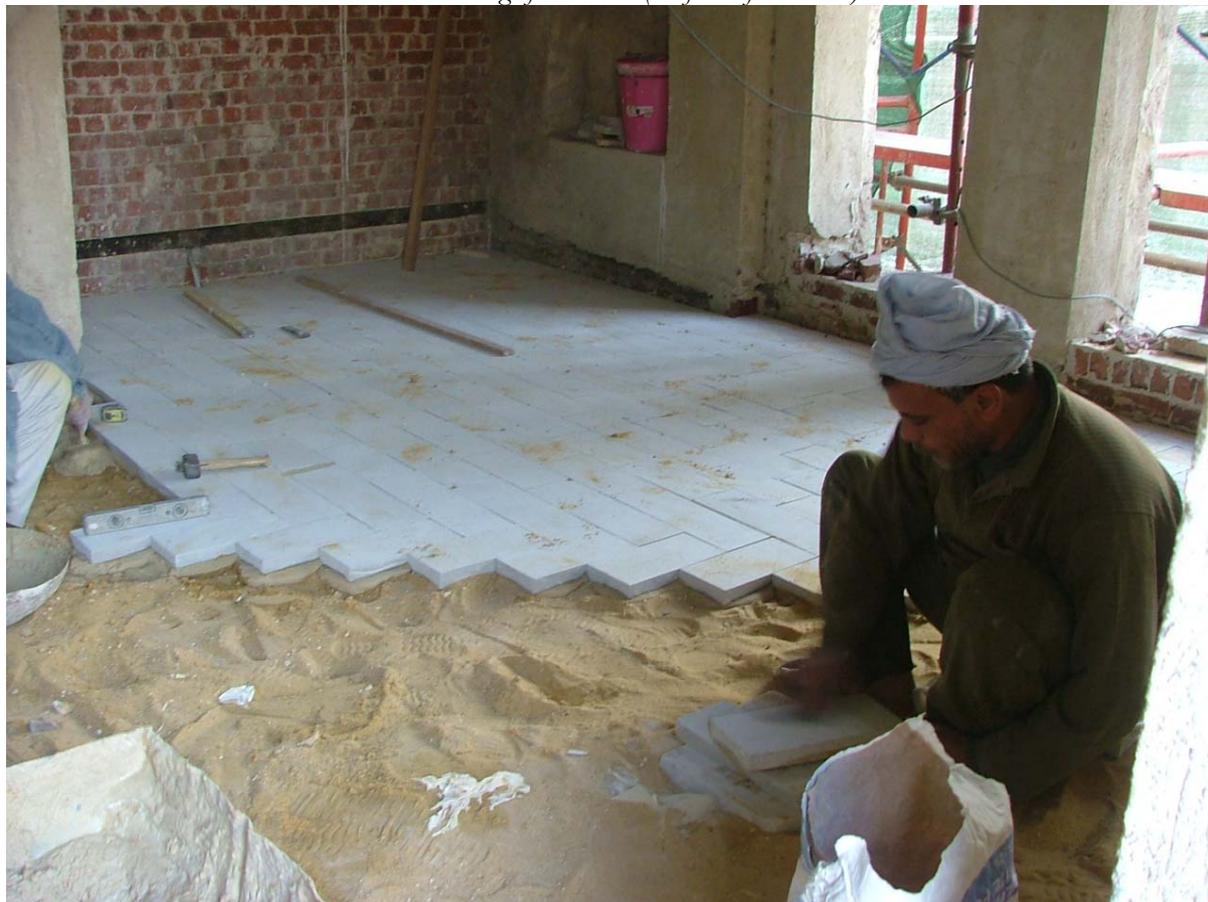
Room 1.3: the brick repair in the room was completed as there was a serious crack between the room and the west iwan. The floor of the room (the ceiling of room M2) was also completed.

Tiling of room 1.3

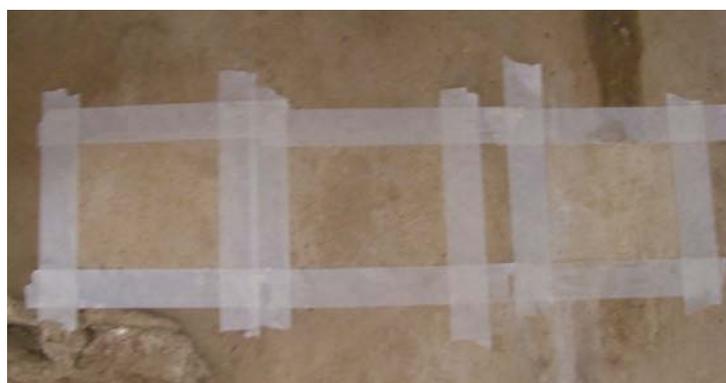
The gypsum plaster was carefully studied and the problems identified. In several areas the plaster is detached from the background brick wall and this needs injection. Also, serious cracks existed and had to be filled. Before the injection activities started, the fine dust covering all the walls was removed with fine brushes. Cleaning tests were also applied to see what kind of method to be applied for cleaning the gypsum. It was decided to use a 2 % ammonium carbonate poultice.

Samples of cleaning the gypsum mortar with poultice and with mechanical cleaning

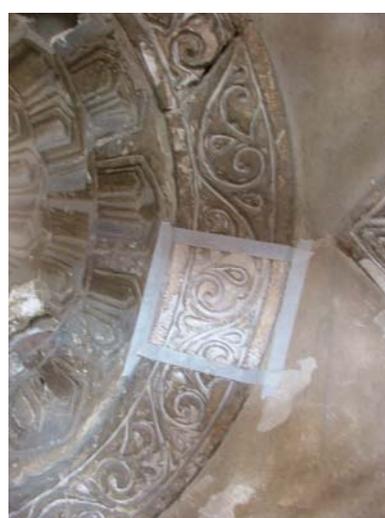
Example of the condition of the gypsum plaster in the courtyard showing serious cracks and detachment

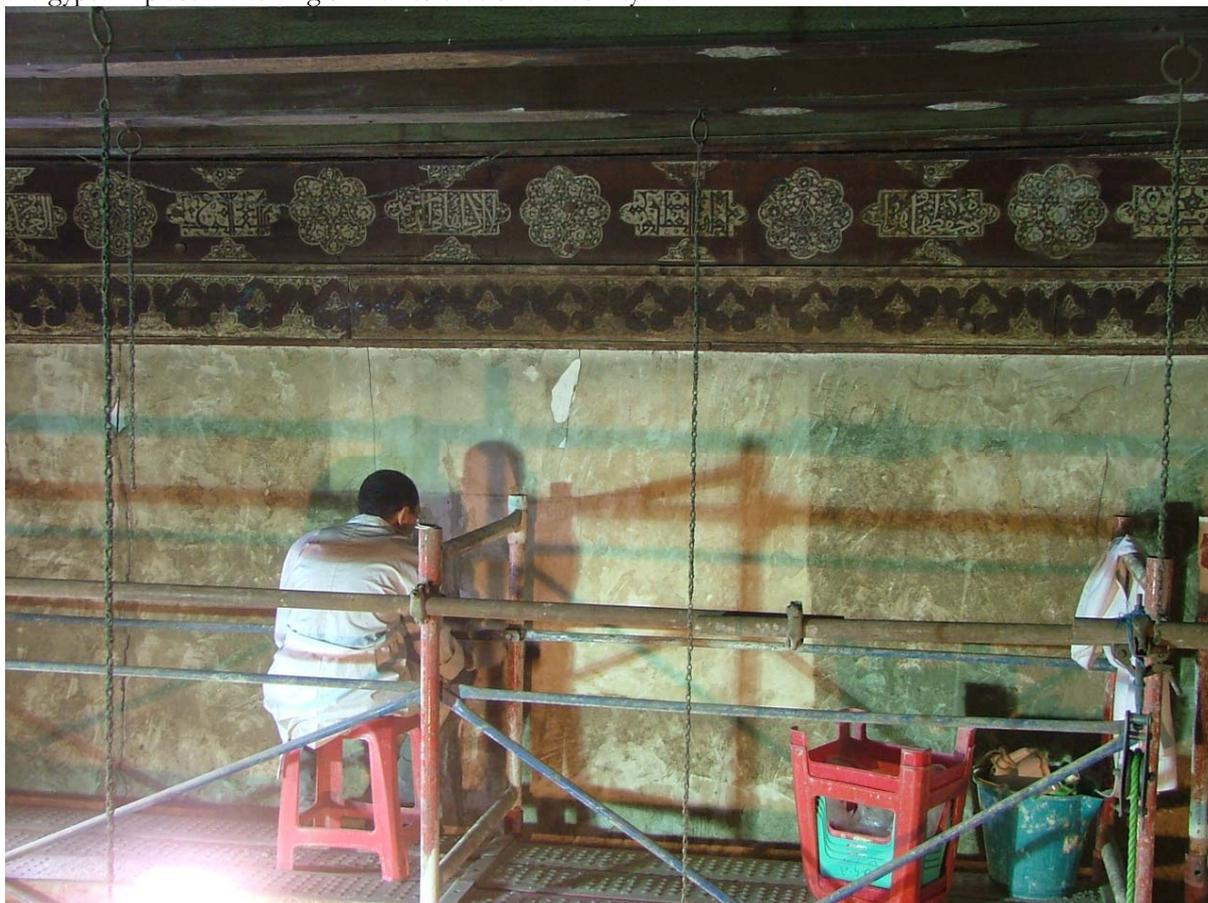
Restoration and conservation activities started also in the East (qibla) iwan. The activities started also with the gypsum plaster cleaning similar to that of the courtyard.

Activities of removing the fine dust from the walls (middle part cleaned; left and right still with fine dust)

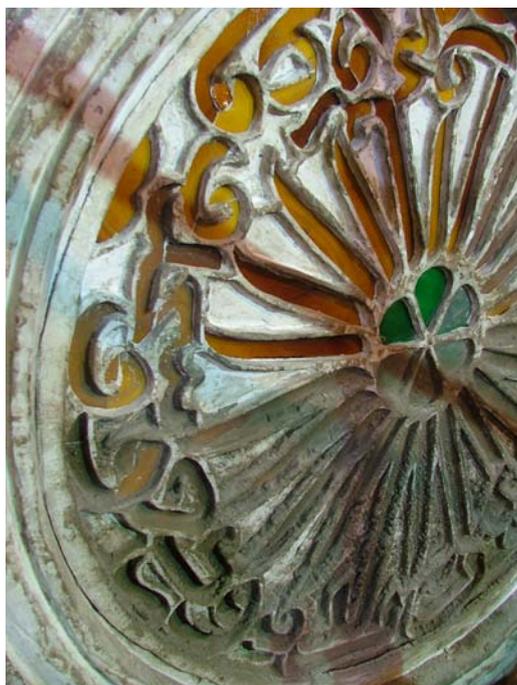
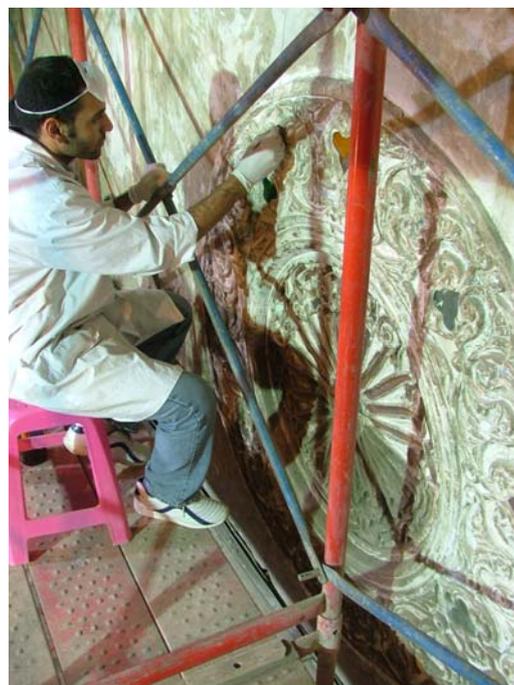
Activities of removing the fine dust from the decorated gypsum roundel in the qibla iwan

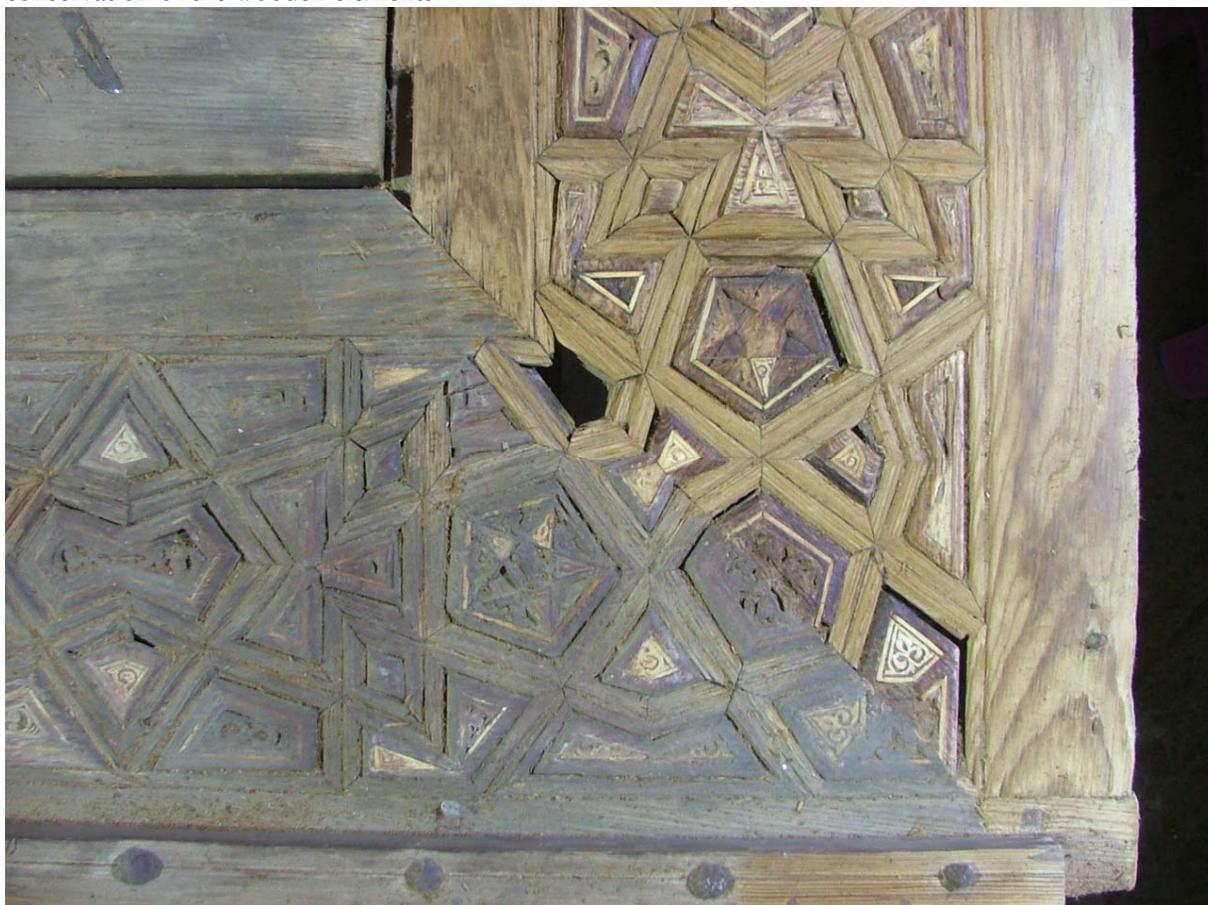
As mentioned in the previous report, the woodwork restoration of doors, windows and shutters is currently in progress and will be proceeding during the following months. In general, depending on the state of conservation of the item, carpentry restoration takes place followed by fine cleaning and conservation of the wooden elements.

Sample of cleaning the wooden shutters of the niches of the qibla ivan
