CONSERVATION PROJECT OF THE
ASLAM AL-SILAH DAR MOSQUE

QUARTERLY PROGRESS REPORT

January-March 2009

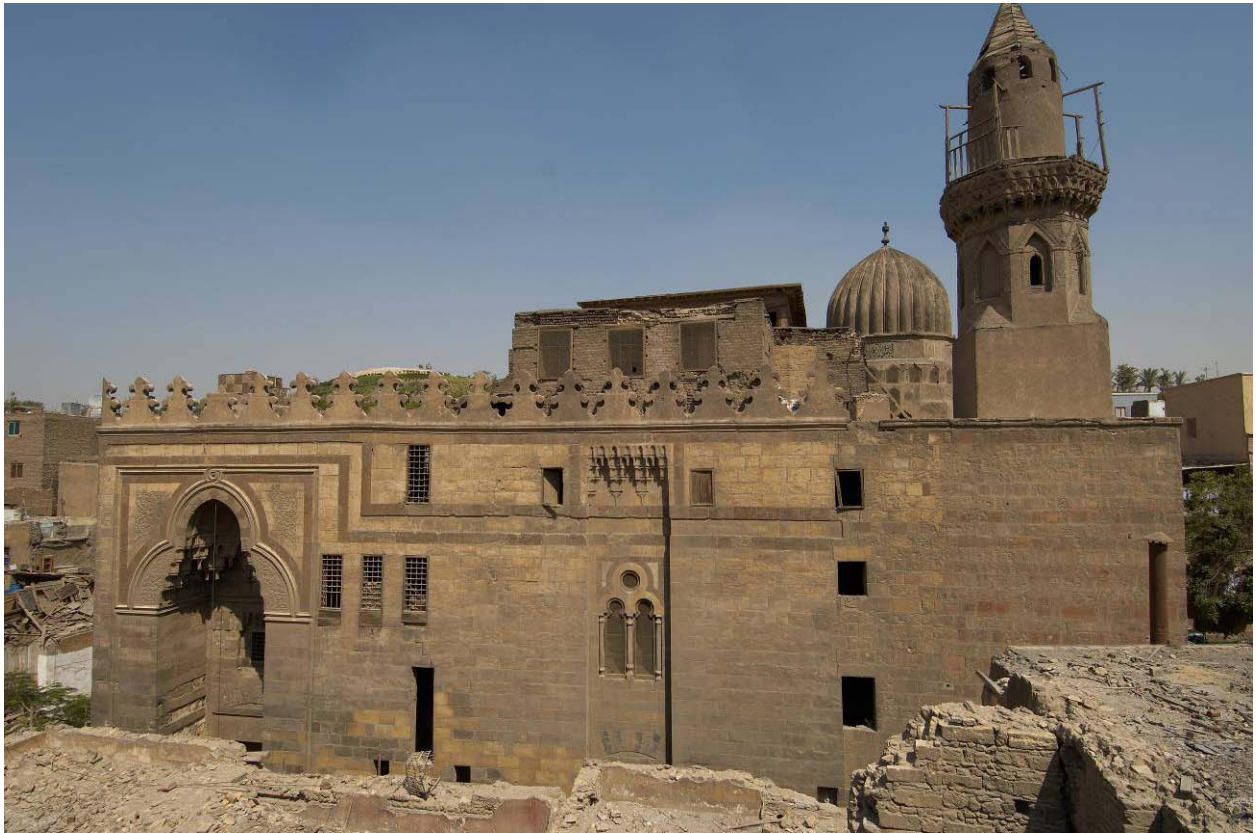
View of the western façade before and after conservation

- Northern, Southern, Western and Eastern facades
 - The remaining cleaning and restoration activities on the western façade portal were completed. The installation of a new *Maqsala* stone on the right side of the portal enabled the finishing the stone replacement needed below that level. The construction of the entrance staircase was also finalized.
 - Concerning the facades openings, it was decided to install copper mesh windows on all exterior openings of the three main facades. Some of the old mesh windows which were found in place were cleaned, restored and re-used, while new ones were fabricated for the missing openings.

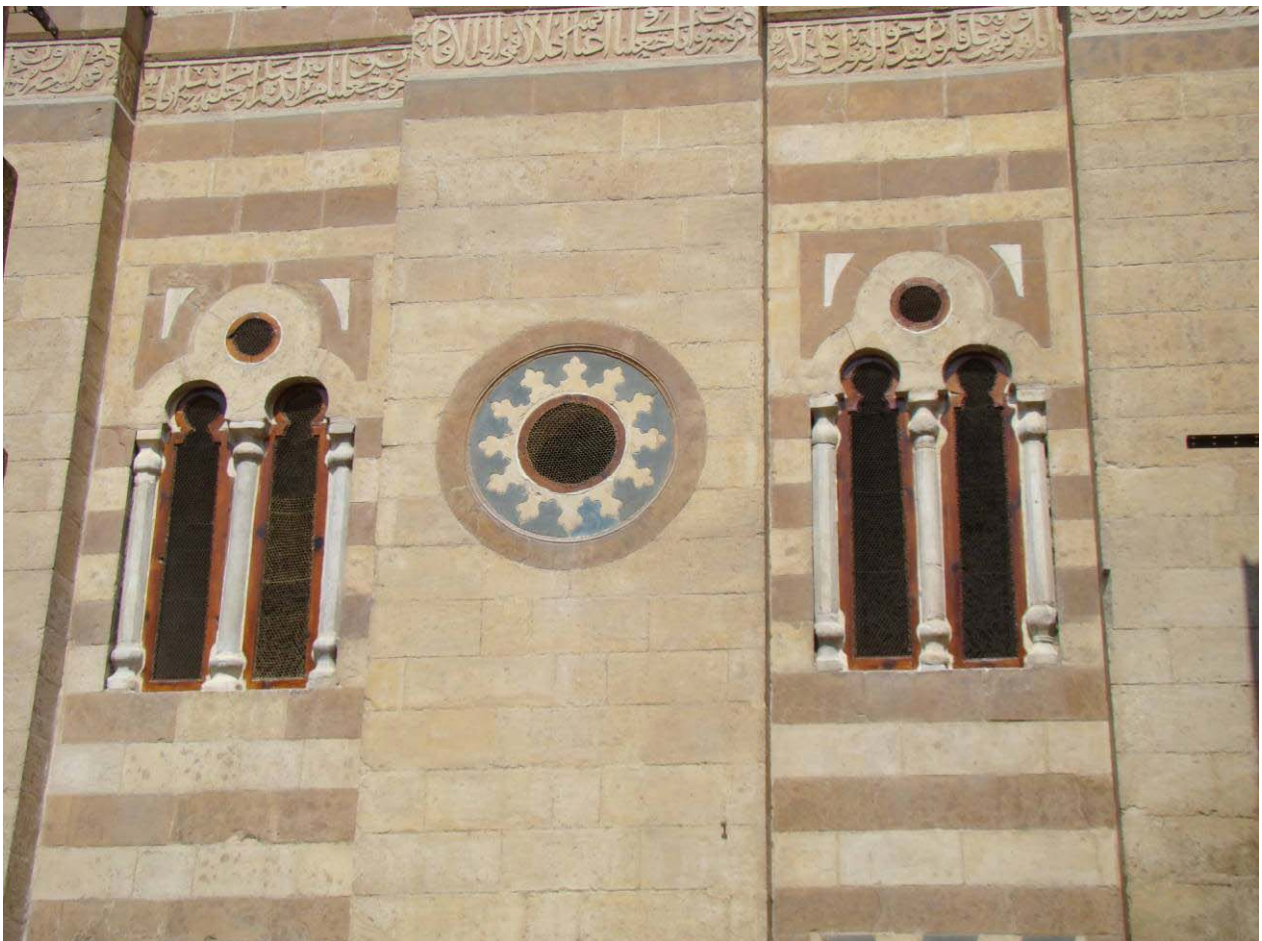
View of the eastern façade after the installation of mesh grills

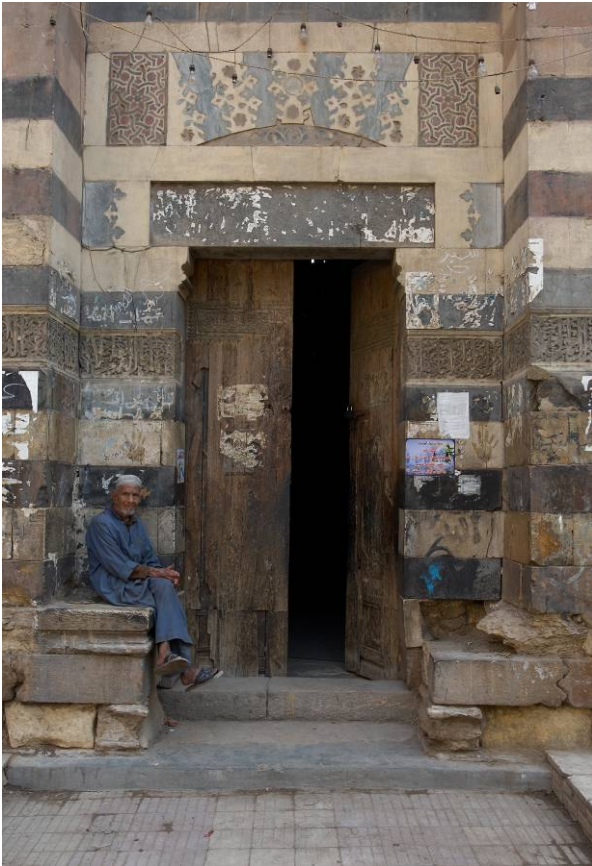
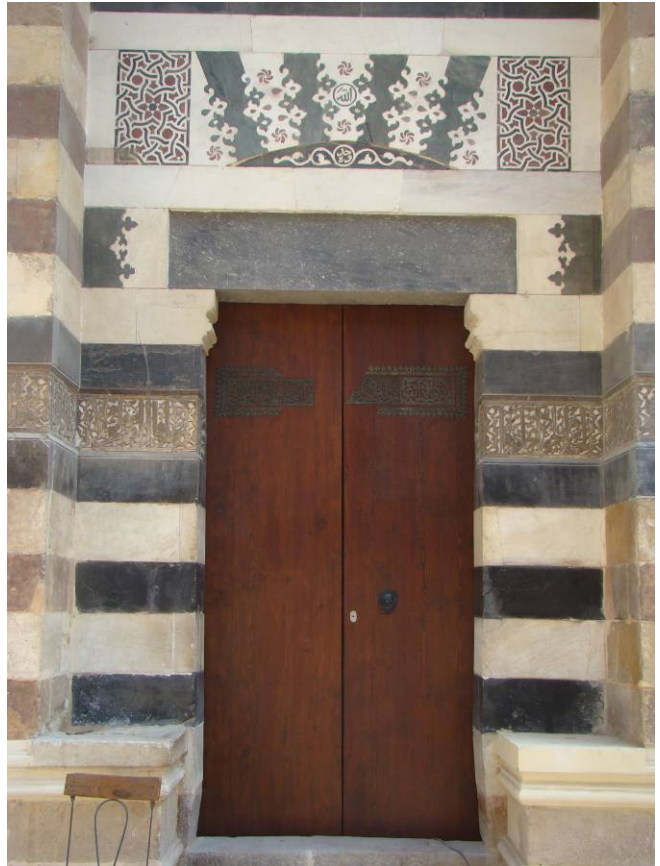
Main mosque entrance before and after restoration

- The installation of all wooden doors, shutters and windows of the facades has also been completed and both main doors, that of the southern and western façade have been installed in place and are in function.

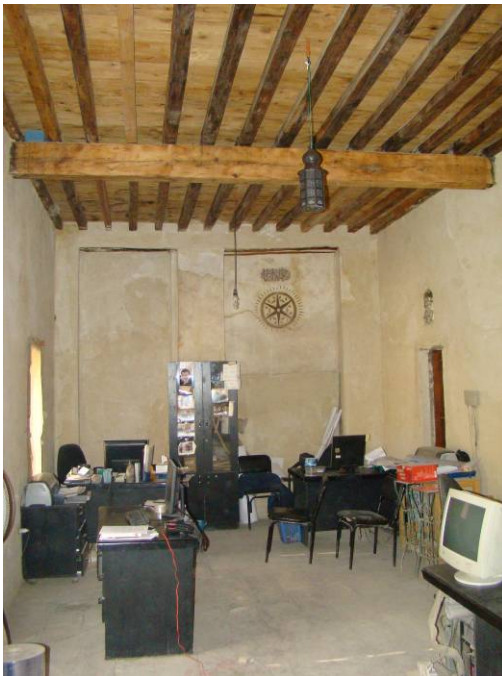
Room M1.4 as a site office

- Mezzanine, first floor and second floor rooms
 - Work in room 1.4 which was previously been used as a temporary site office was completed; this included painting of the wooden ceiling, plastering of the walls and installation of wooden elements such as doors and windows.
 - Tiling replacement activities took place in room M2 on the mezzanine level.
 - Plastering work and finishes were completed in G6, the corridor linking the ablution area to the mosque interior.
 - The installation of the lighting units and fixtures was also completed in all the mosque rooms and interior spaces.
 - Tiling and plastering finishes in the entrance of the secondary staircase leading to the first floor rooms was completed and the main electric panel was installed.

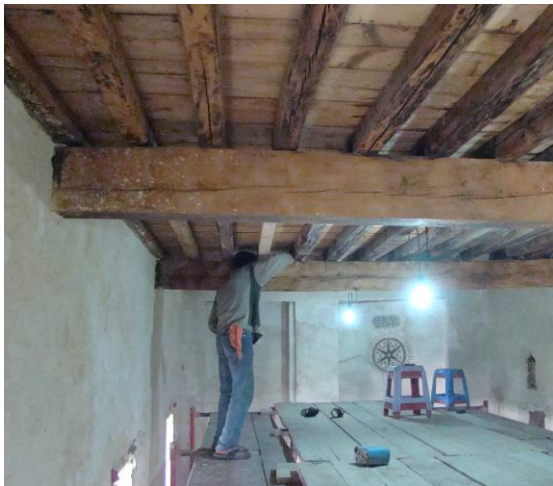
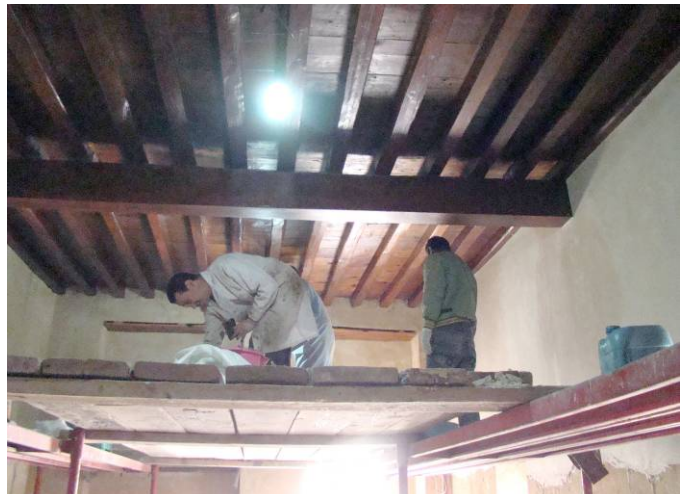
Painting of the wooden ceiling of room 1.4

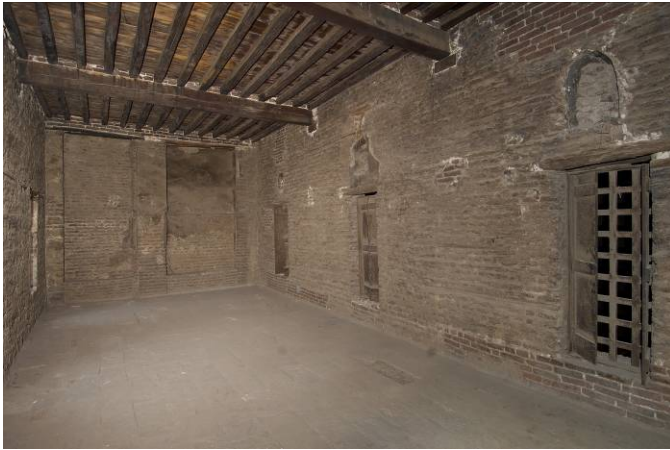
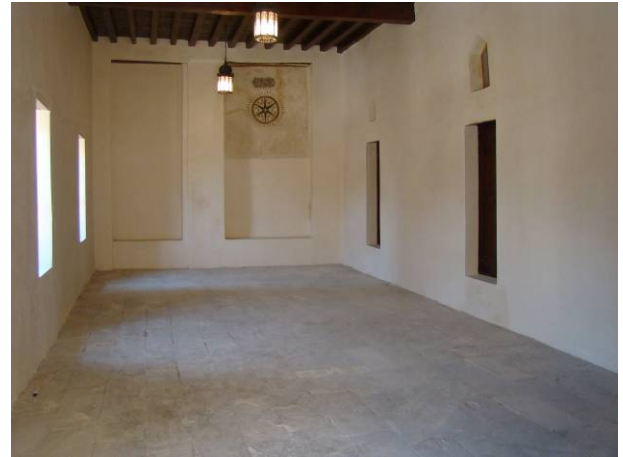
View of room 1.4 before and after restoration

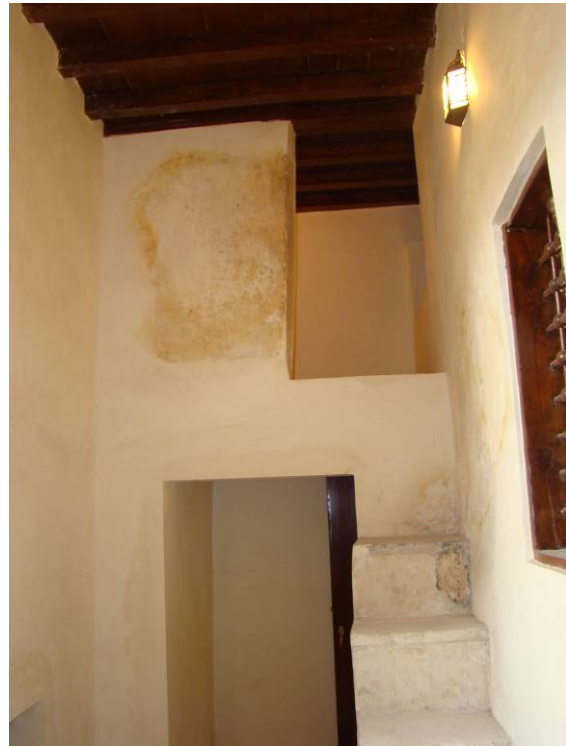
View of the M2 after completion

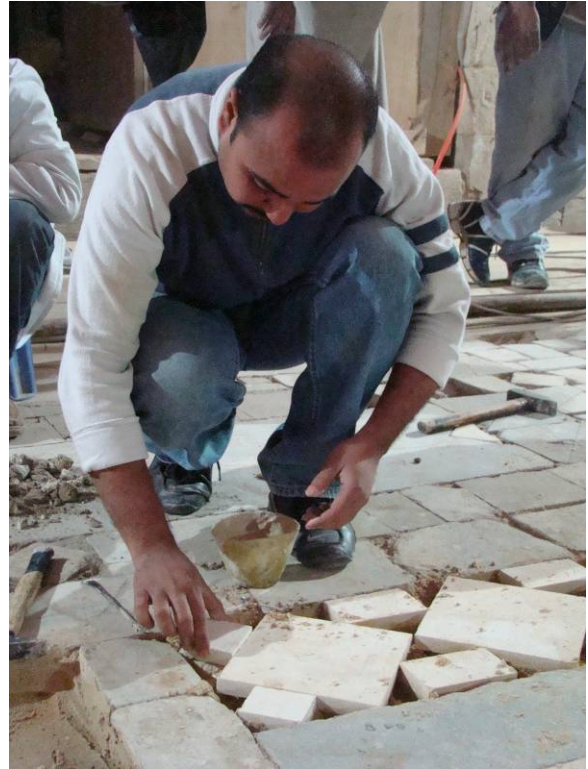
General view of the marble tiling in the courtyard during conservation

- The replacement and cleaning of stone tiles in the courtyard was completed.
- Conservation and cleaning of the marble tiling was completed. Damaged and missing parts of the marble were replaced following the original pattern.
- The conservation of the wooden *dikka* was finalized. After cleaning, the consolidation of the weak parts of the wooden took place following which the *dikka* was painted with a layer of micro-crystalline wax acting as a protection layer.

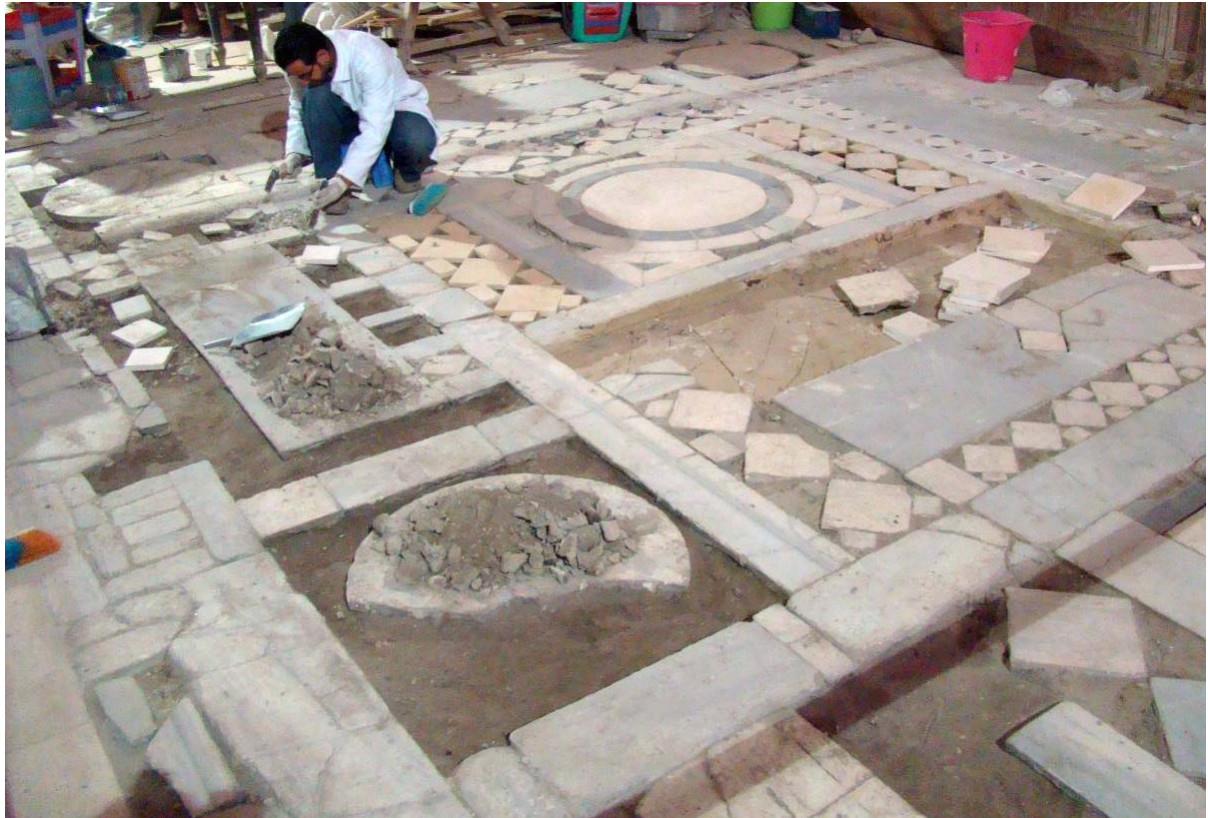
Mosque courtyard after completion of tiling conservation

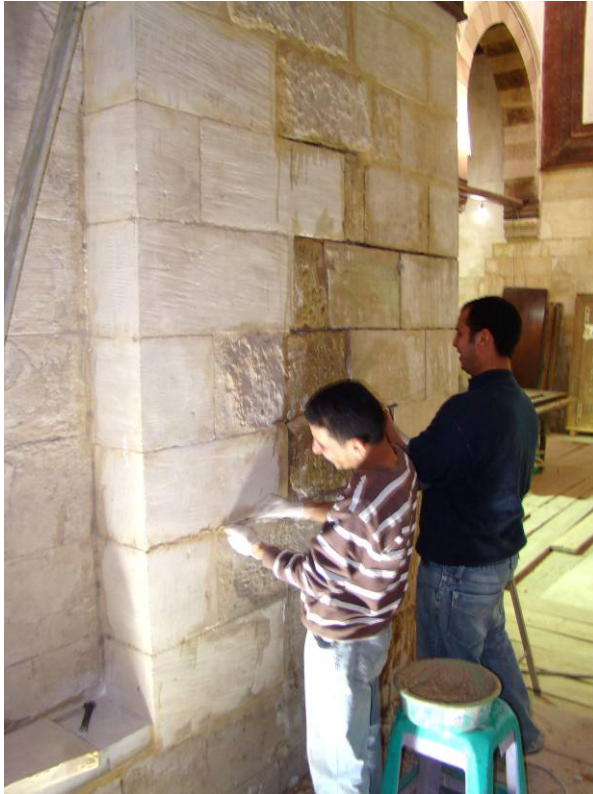
Re-pointing of joints in the western iwan

- During the past three month, the western iwan which was been used as a temporary site store was cleared.
- The replacement of few stone tiles took place, followed by the cleaning and re-pointing of the tiles.
- Re-pointing of the stone joints was completed.
- The lighting units for the illumination of the ceiling were installed.

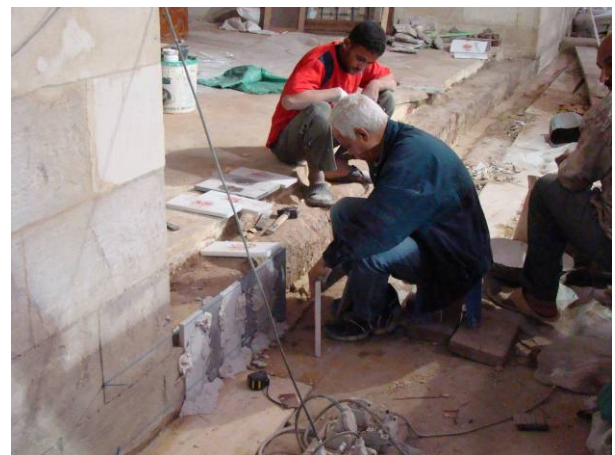
- The tiling of the qibla iwan was in a very bad condition; the surface of the stone tiles was eroded, the levels were uneven due to a certain settlement which was in return filled with cement patches. It was found necessary to dismantle the whole *iwan* tiling in order to re-adjust the levels and install the electric wiring for the lighting and sound system. During the process, damaged stones were replaced when necessary and others were cleaned mechanically and re-used.
- The alternating, black and white tiles on the *qibla* step were cleaned and the missing ones were replaced.

Installation of the marble panels on the Qibla step

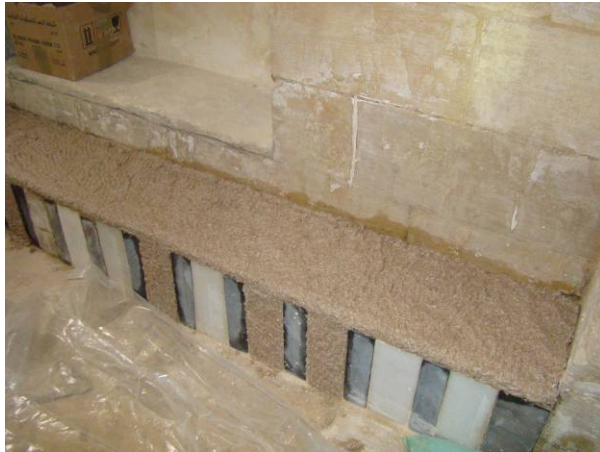
Cleaning of the marble tiles by poultices

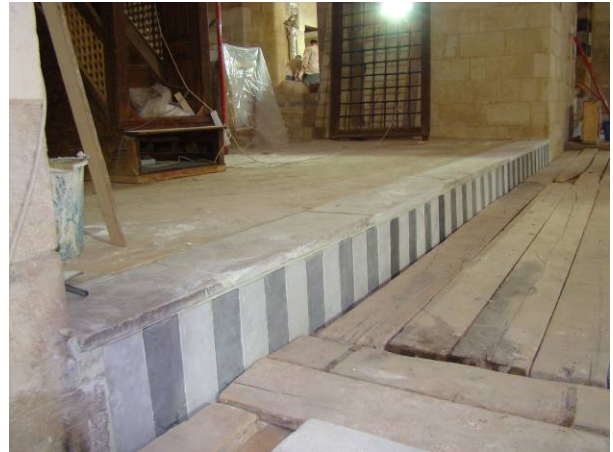
View of the tiles after completion

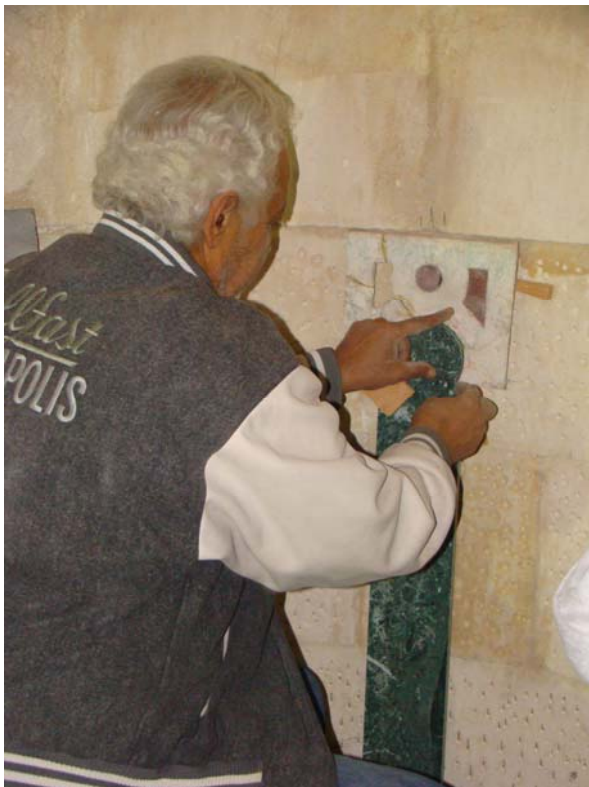
Installing the old marble panels in the mihrab

- After research and negotiations with the SCA, it was agreed to complete the missing marble panels in the *mihrab* given that it is the main prayer area. The design followed the old pattern of the marble which was deducted from the remaining pieces, while the new type of marble used was the closest resembling the old pieces.

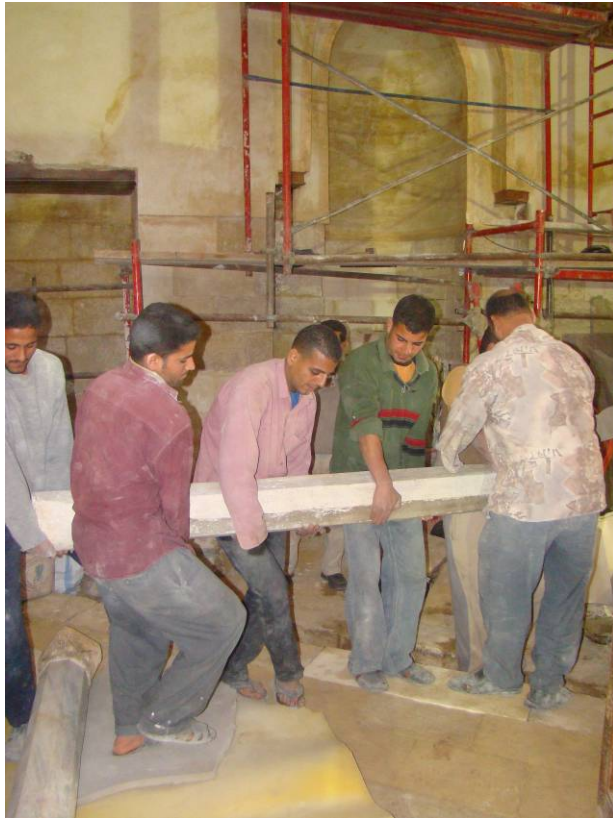
- The cleaning and conservation of the two marble columns was also finalized. The left column was damaged and badly deteriorated; however, it was decided not to change it given the difficulty of finding a similar type of marble and as a matter of conserving the original column. Therefore, both columns were dismantled in order to change the base and complete the eroded parts.
Completing the eroded octagonal marble column was done on several stages; first, a wooden cast was made surrounding the column to enable completing the column. Following that, each side of the column was filled with epoxy mixed with marble powder which gives the blend a similar color to that of the marble. This was repeated several times giving the mixture time to settle and dry.

Dismantling the Mihrab marble columns

- The two marble bases of the marble columns in the *mihrab* façade were badly damaged and had to be replaced. The design was done following the shape of the old base.

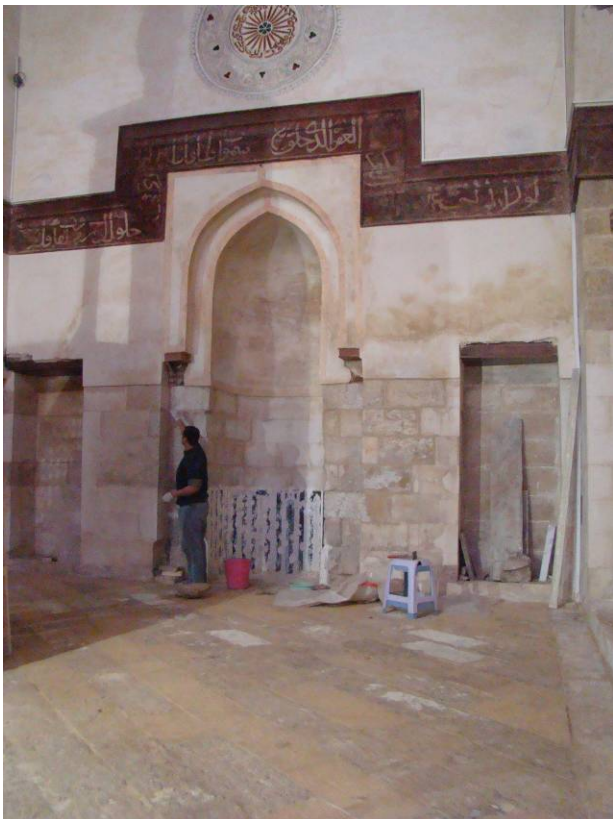
Stone conservation and re-pointing of joints

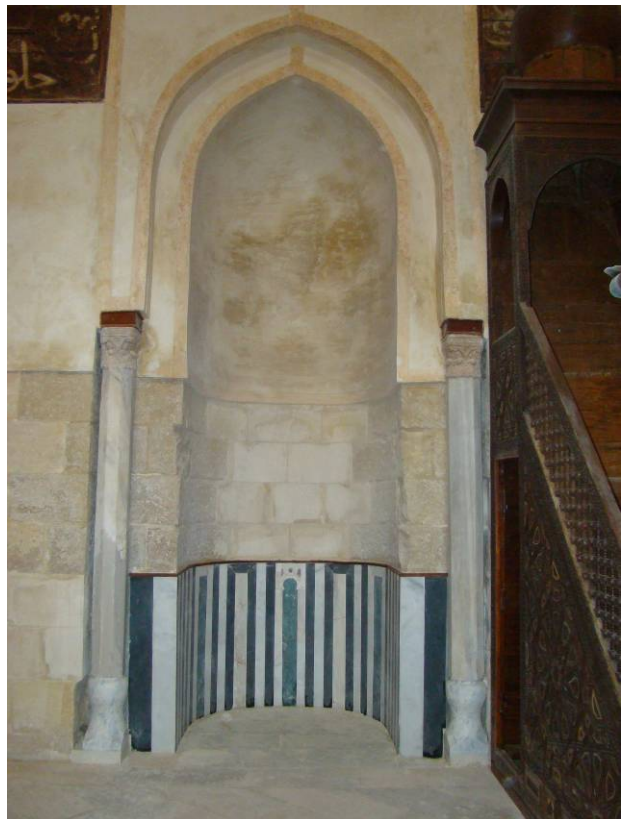
View of the Mibrab after restoration

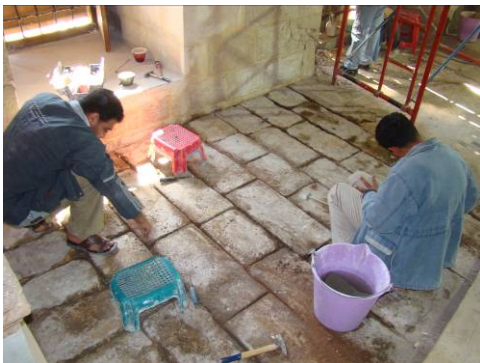
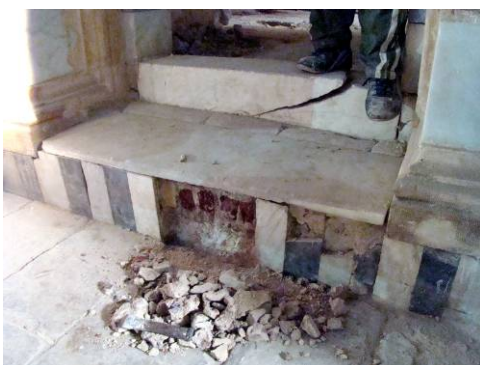
- Fine restoration activities were finalized in this iwan.
- Plastering of the cracked and missing parts of the plaster were completed.
- The stone tiles were cleaned and few damaged ones replaced. The alternating black and white marble tiles missing on the step of the entrance to the mausoleum were also replaced.
- Two up lighters illuminating the decorated ceiling were installed as were the glass lamps (*mishkawat*)

Cleaning of the stone and marble tiles

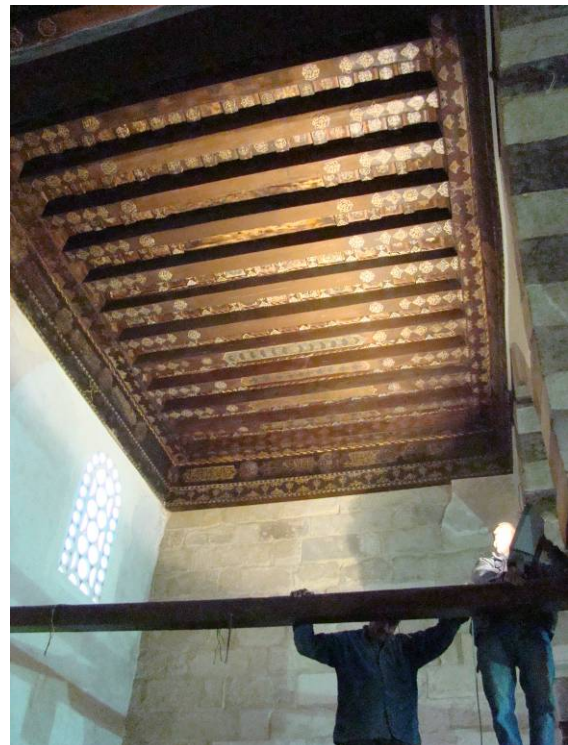
Installation of ceiling up-lighters

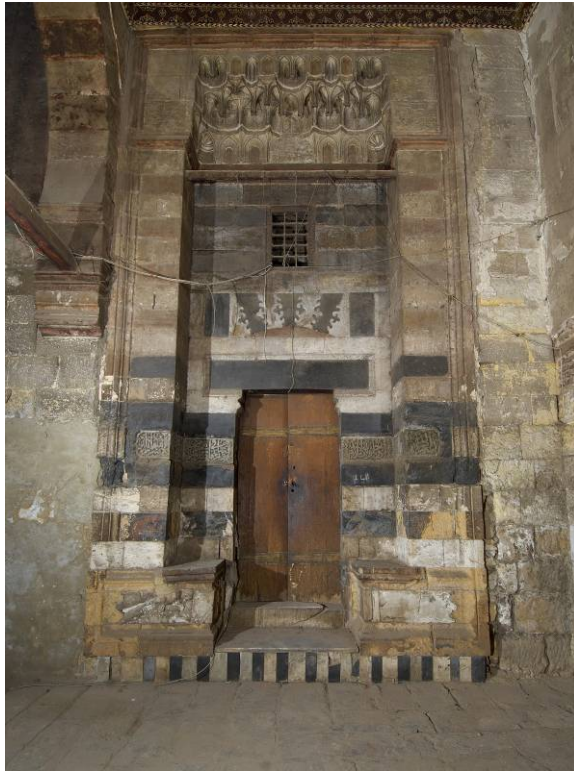
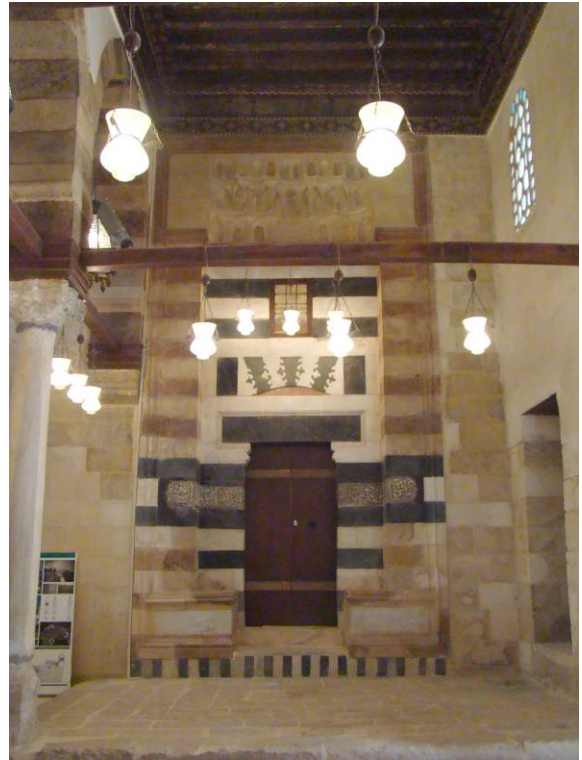
View of the South iwan (mausoleum entrance) before and after restoration

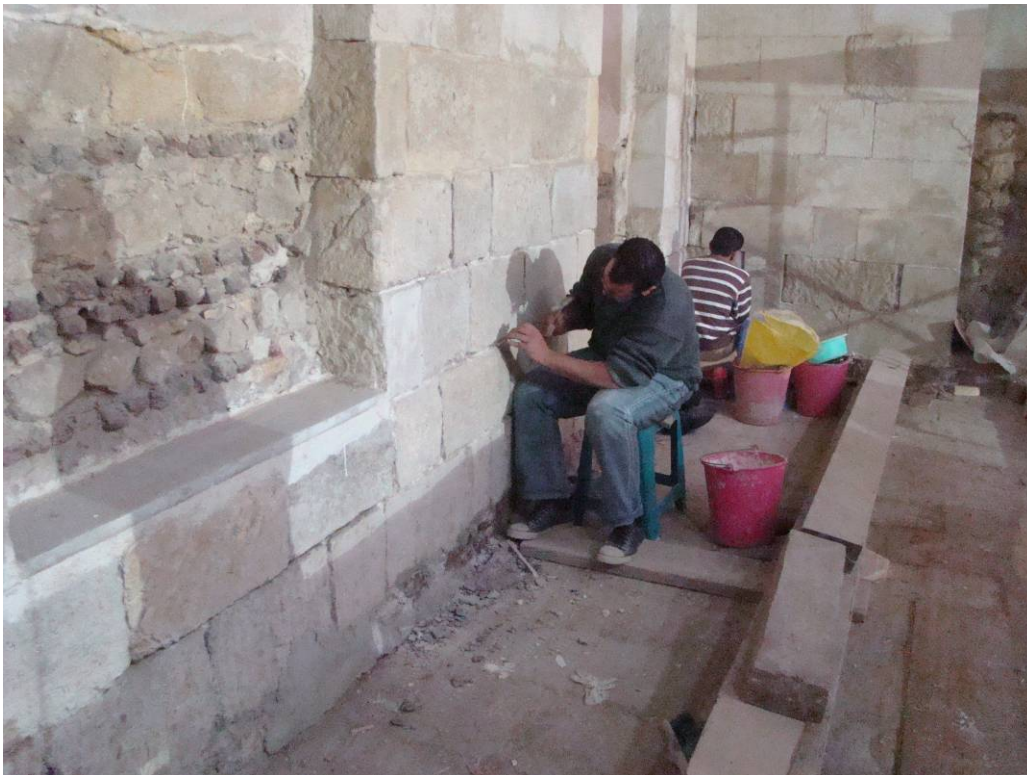
- Cleaning and conservation of the wooden decorated ceiling was finalized.
- Plastering of the cracked and missing parts of the plaster were completed.
- The stone tiles were cleaned and the damaged ones replaced. Two up lighters illuminating the decorated ceiling were installed as were the glass lamps (*mishkawat*)

Cleaning of stone courses and re-pointing of joints

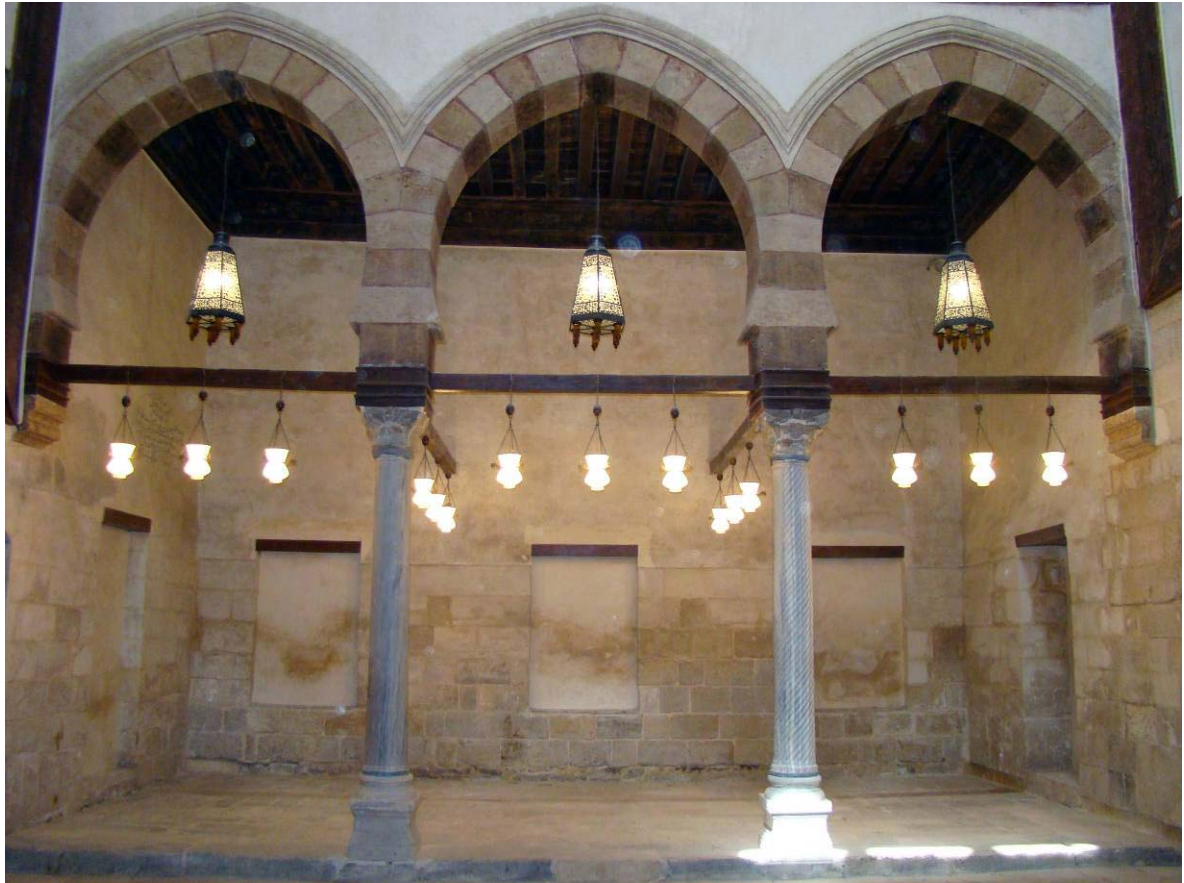
North Iwan after restoration

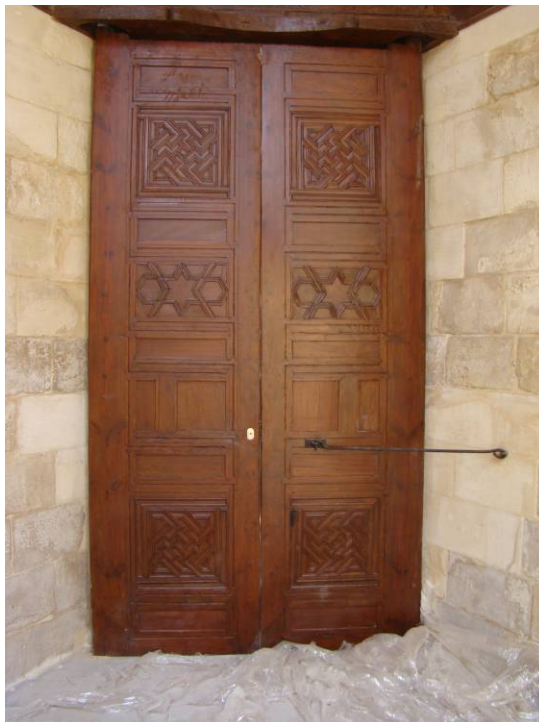
- Cleaning and architectural restoration of the two main wooden doors that of the southern entrance and the ablution entrance have been finalized.
- All wooden elements (doors, windows, cupboards and shutters) have been restored, painted and installed.

Ablution door after restoration

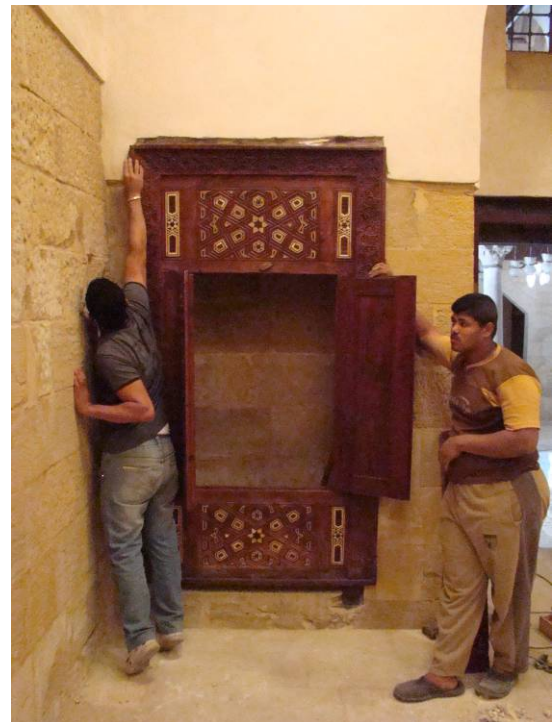
Installation of inlaid cupboards

- The restoration of the ivory inlaid wooden cupboards has also been completed. Missing decorated ivory parts were replaced by carved camel bone.
- All inlaid wooden elements were painted with micro crystalline wax having a function of a protection coat.
- The cleaning and wooden architectural restoration of the *minbar* was finalized.

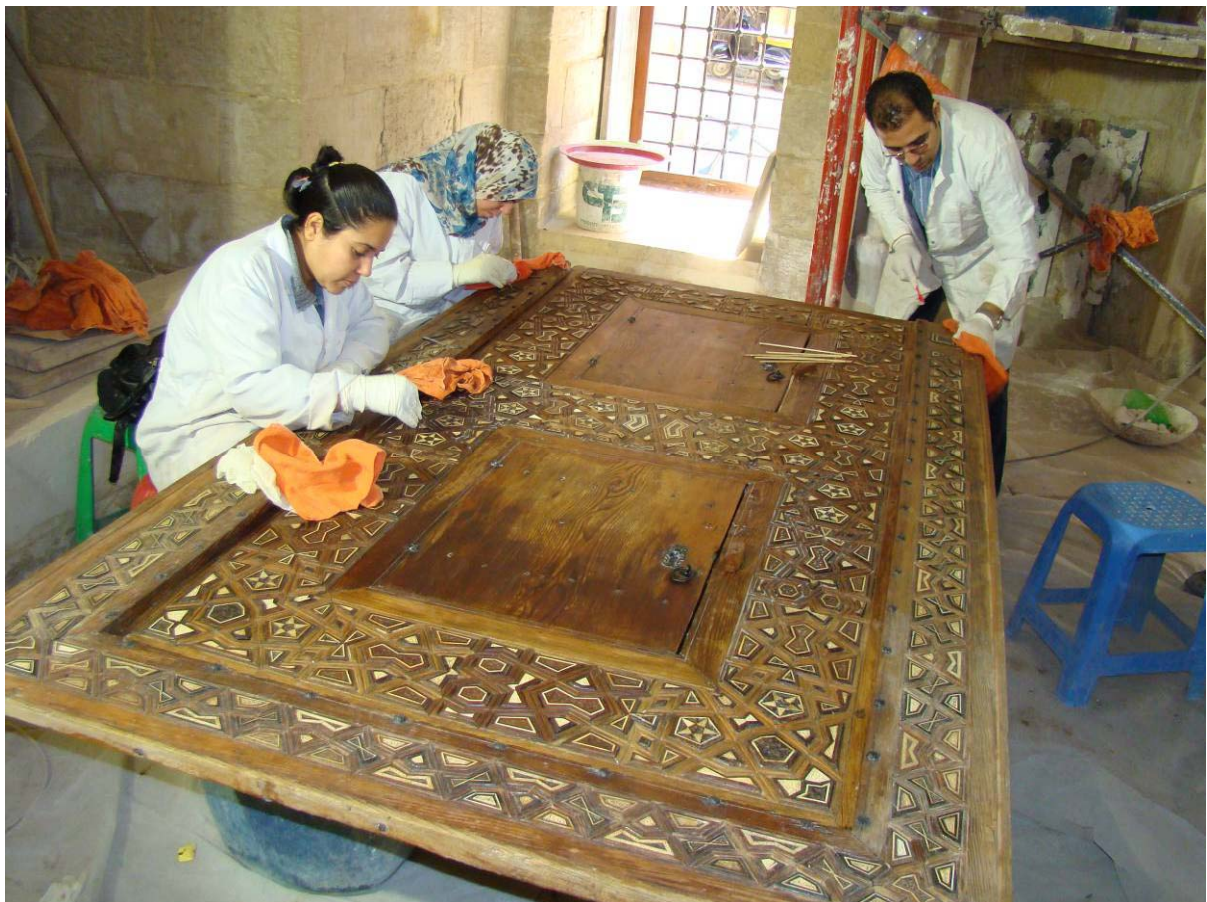
Applying micro-crystalline wax protection

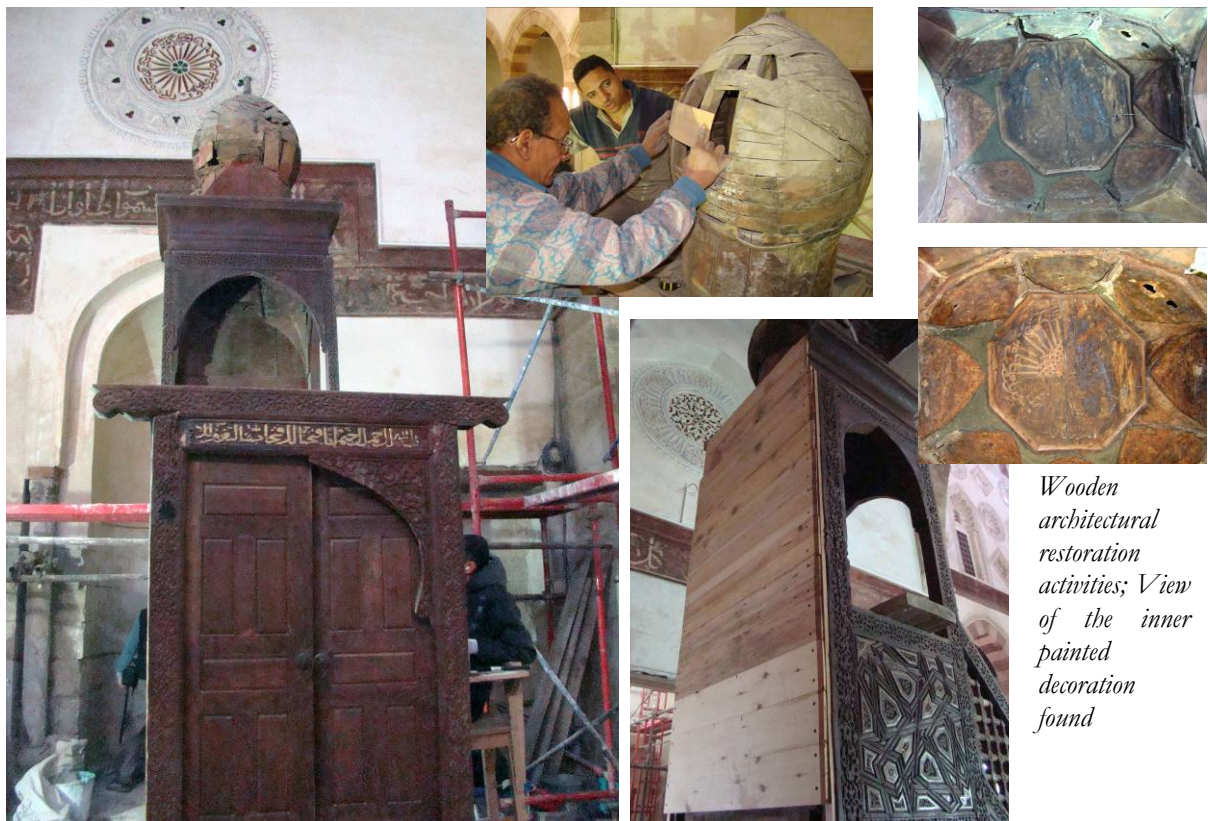
Traces of decorative paintings were found in the inner upper dome. Cleaning and consolidation of the paintings took place. Wooden shingles were manufactured and installed on the rear of the *minbar* as the original parts were missing. On the other hand, a wooden frame was installed on the bottom part of the *minbar*, slightly elevating it from the ground level, in order to protect the lower inlaid parts from future deterioration.

Wooden architectural restoration activities; View of the inner painted decoration found

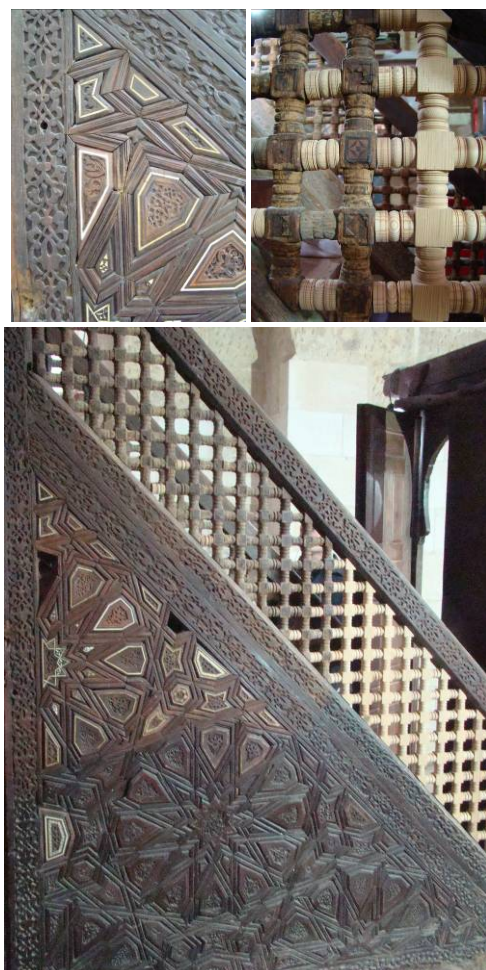
New turned wood replacing missing parts

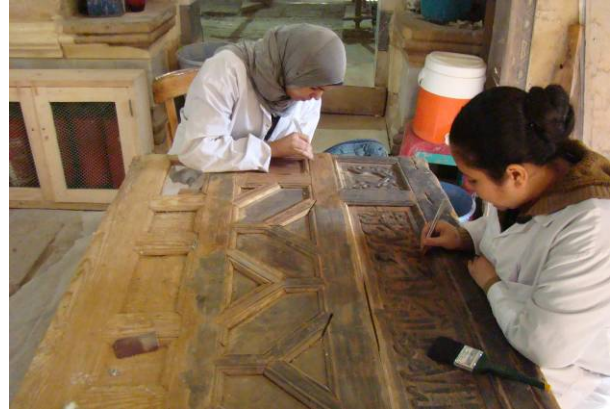
- The cleaning of the mausoleum wooden *shabed* was completed.
The structure was found in several pieces which were in a relatively deteriorated condition. Mechanical cleaning was done first; following architectural wooden restoration took place. Several parts of the *Shabed* and few carved wooden panels were missing. Those were replaced by new ones. The structure was painted, assembled and put in its place in the mausoleum.

Mechanical cleaning activities

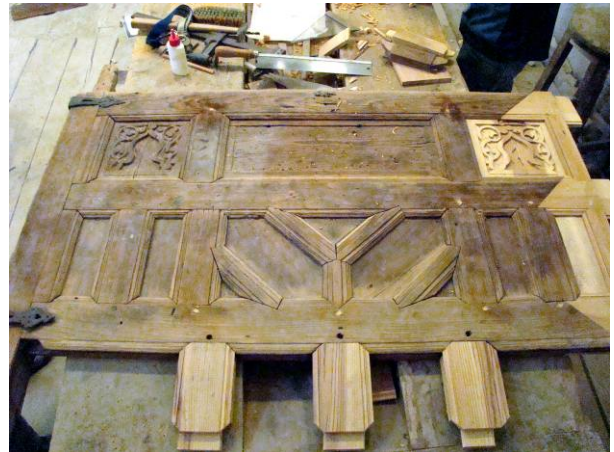
Architectural restoration activities

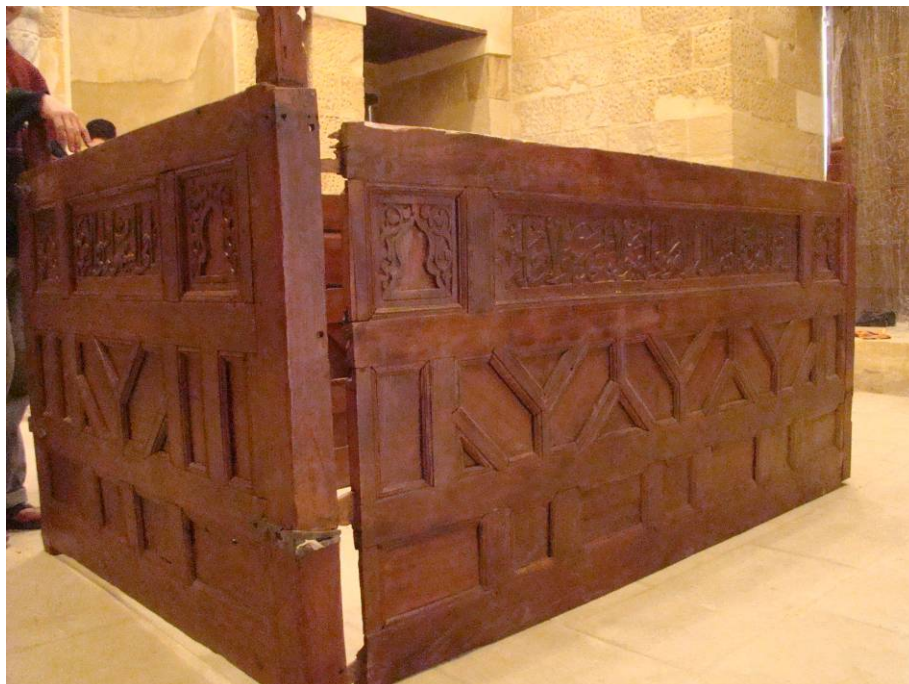
Assembling the wooden shabed

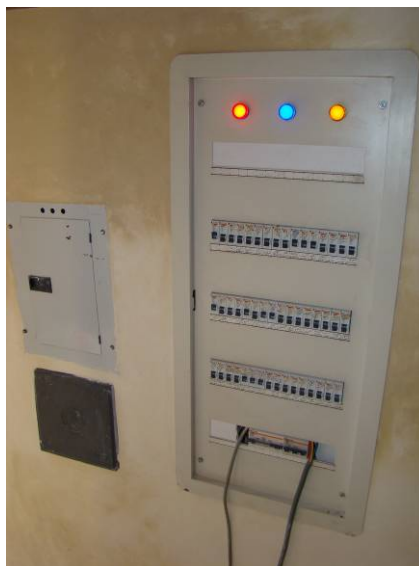
Main electric panel installed in the staircase entrance

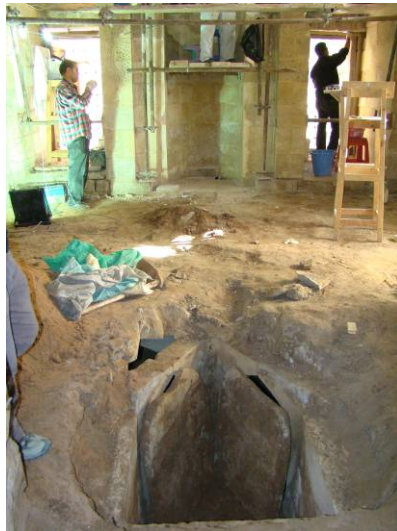
- The tiling of the mausoleum was in a very bad condition due to the thin thickness of the original tiles and to an obvious settlement that had occurred previously. Therefore, it was decided to remove the damaged tiles in order to excavate and check the structural condition of the tombs below. The tomb opening was filled with rubble and dust. After the cleaning, the entrances to two chambers were revealed, having quite a distinguished angular design, each blocked by a large stone (door).

Entrance to chambers

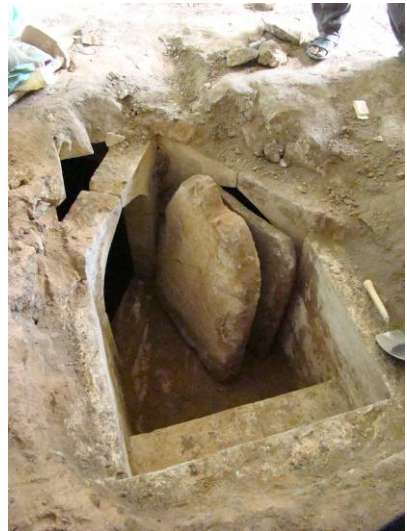
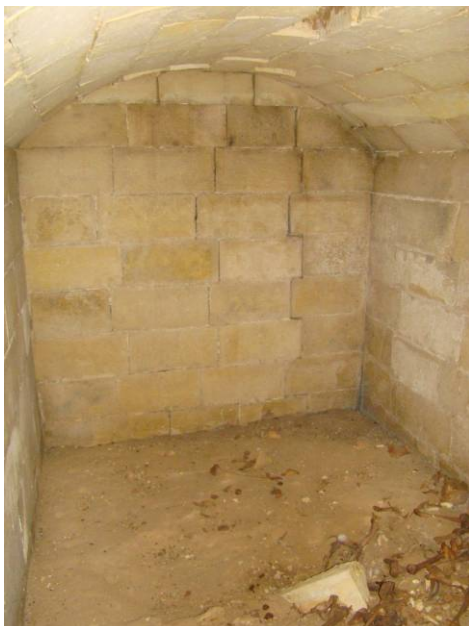
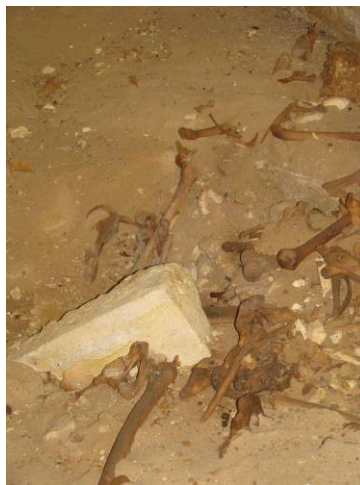
The right chamber was the men's burial tomb; several skeletons were found inside. However, one stone from the vault had fallen on the skeletons and damaged a few of them. Apart from the fallen stone, few other stone from the vault were displaced. This entailed removing the remains in order to restore the structure of the vault as a necessary safety major regarding the stability of the whole dome structure. The stone were put back into place and the joints were filled with mortar to ensure bonding.

View of the right side tomb (men) with the fallen stone

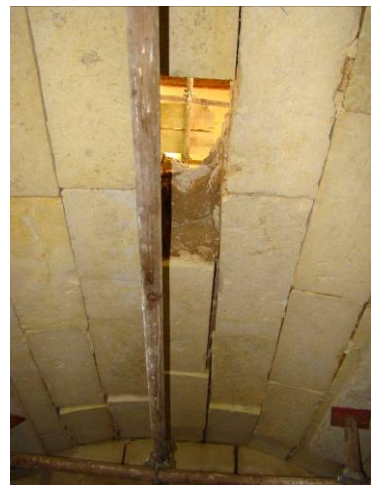
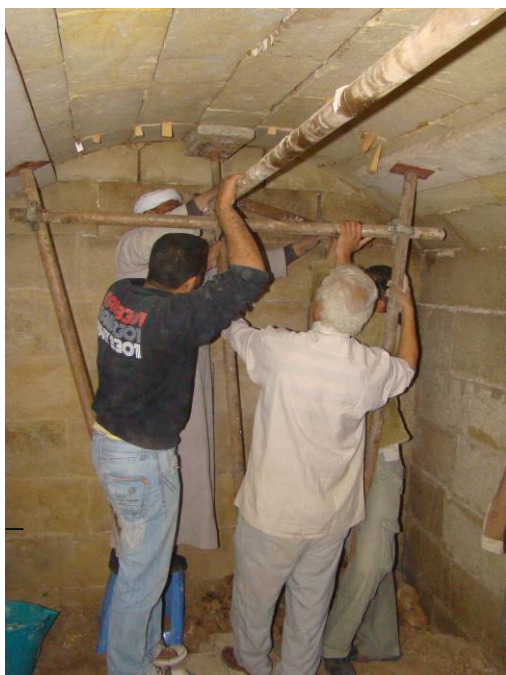
Structural consolidation of the vault

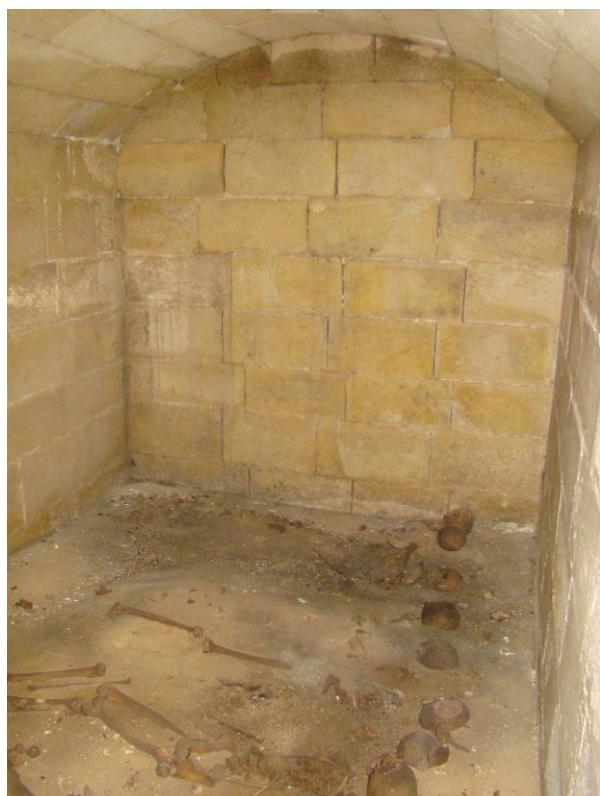
The left chamber which was the burial tomb of the women was in a much better shape. The skeletons found were also very well conserved (almost ten were found). The structural condition of the stones and vault was stable. No major intervention was needed apart from the filling of joints and re-pointing which was successfully done without disturbing the order of the skeletons.

View of the left tomb (women)
