CONSERVATION PROJECT OF THE
ASLAM AL-SILAH DAR MOSQUE

QUARTERLY PROGRESS REPORT

January-March 2009

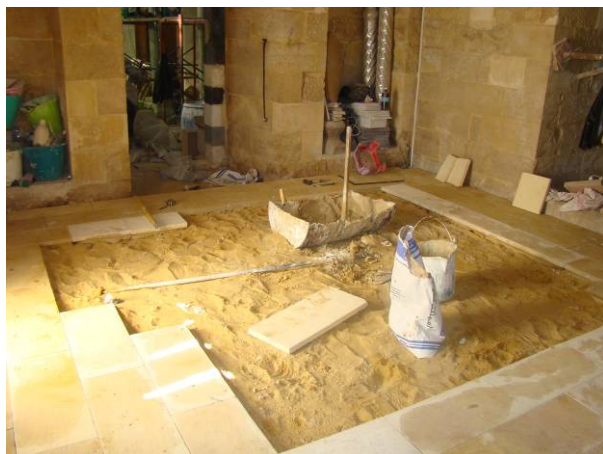
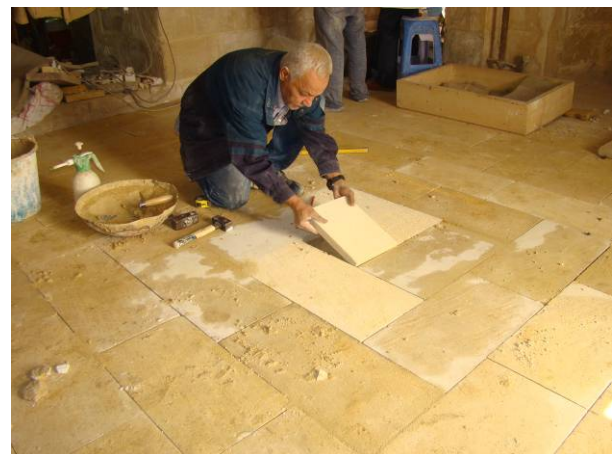
- Following, the tiling of the mausoleum proceeded. The tiles above the entrance of the tombs were distinguished from the remaining as an indication to its location in the case of a future need to open it.

Stone tiling activities in the mausoleum

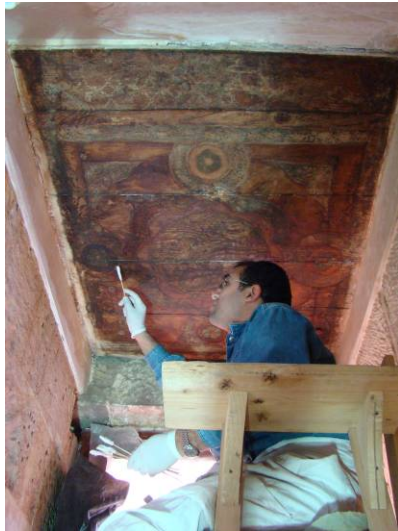
Conservation of painted ceiling

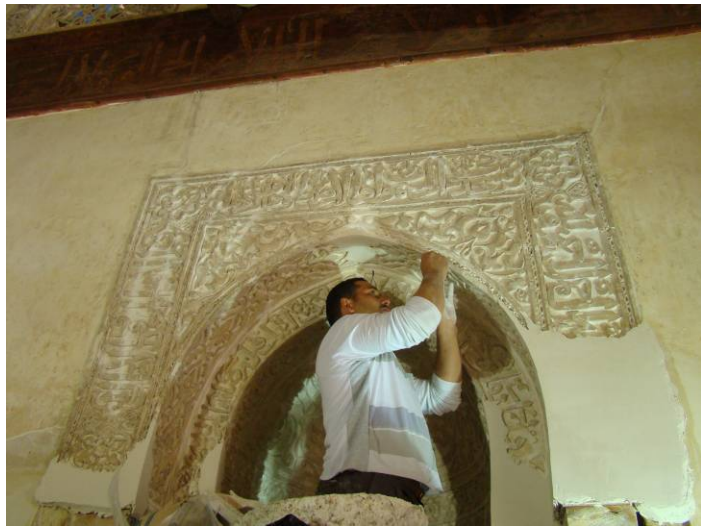
- The cleaning and consolidation of the *mihrab* stucco decoration panel was completed. Missing and cracked areas were completed.
- The marble found in the *mihrab* area was cleaned and re-installed. It was agreed not to complete the marble panels since the pattern was not clear from the remains. The mihrab was plastered till the level of the marble given the traces of old plaster

Completing the stucco decoration of the mihrab

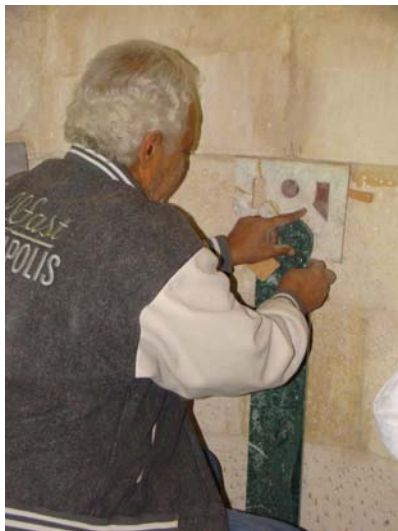
Installing the marble panels

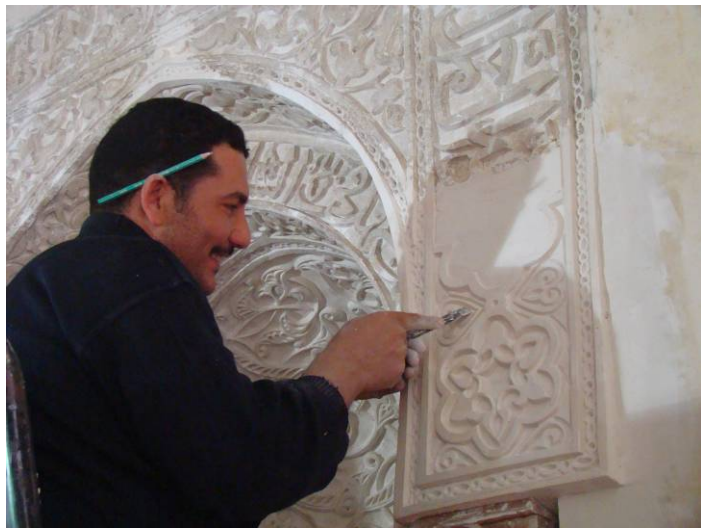
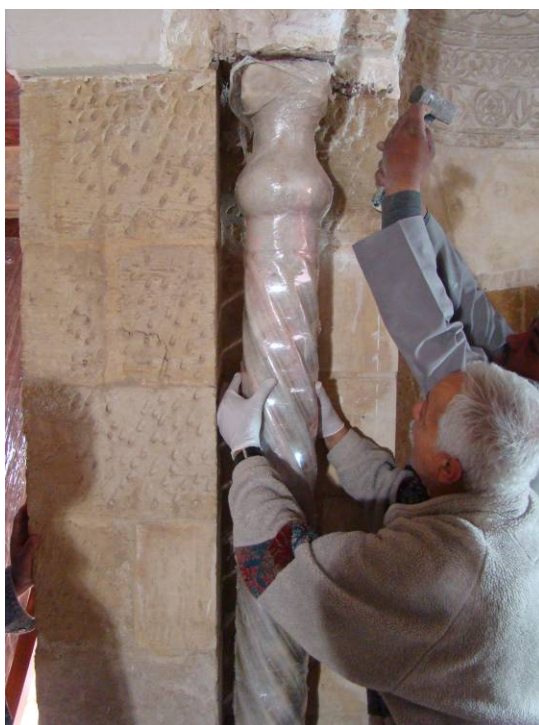
- The condition of the columns base were badly deteriorated, hence they were replaced based on the shape of the original ones. The marble columns were then fixed in place.

Fixing the marble columns

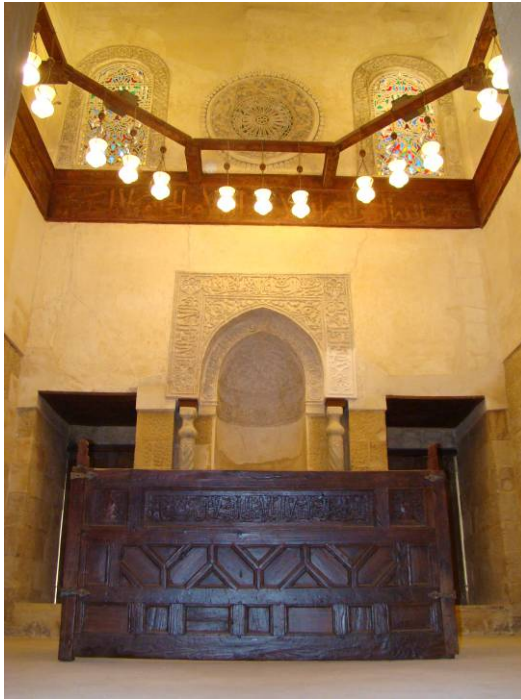
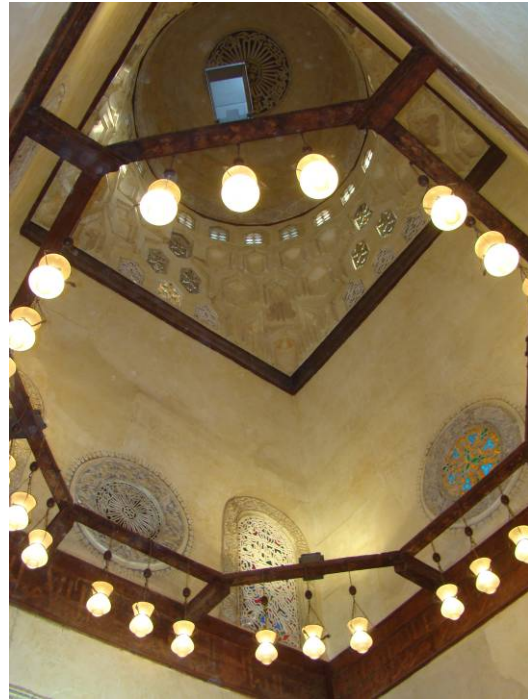
View of the mausoleum interior after conservation

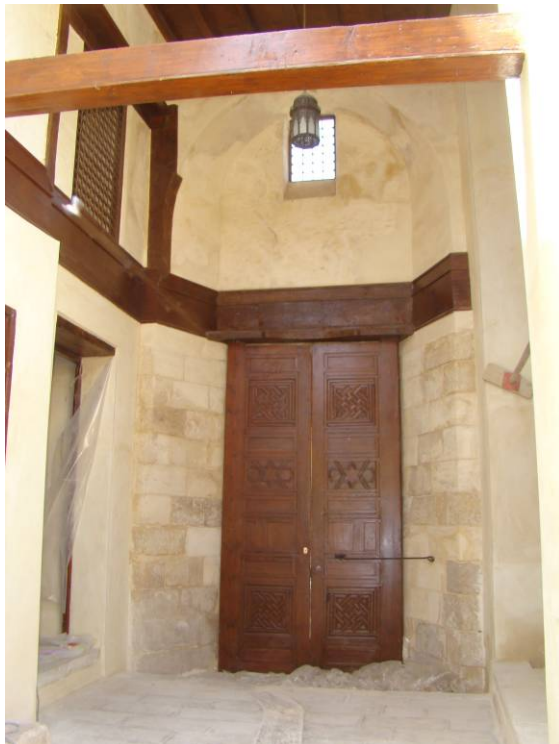
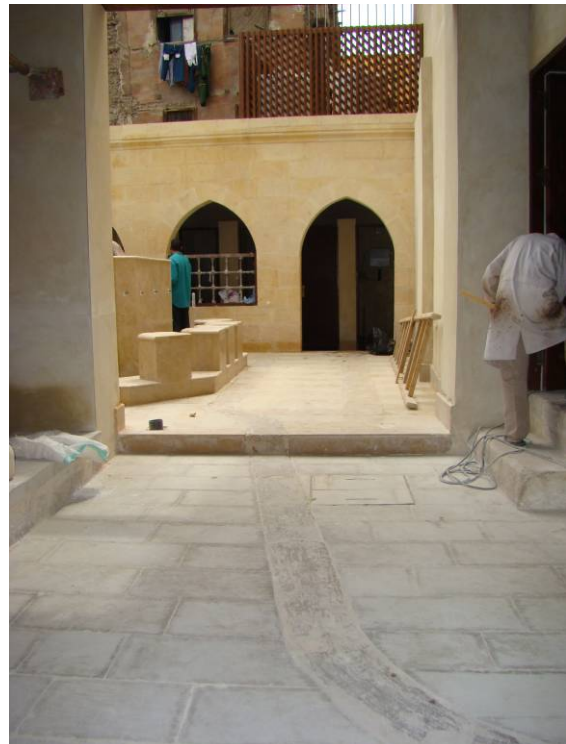
Ablution area entrance

- Construction of the ablution area and installation of all electro-mechanical/ sanitary wears and fittings were completed in December 2008.
- A water pump was purchased and installed in place.
- The activities which took place during the past three month were mainly tiling and plastering finishes in the entrance and vestibule area.
- All lighting units were installed.

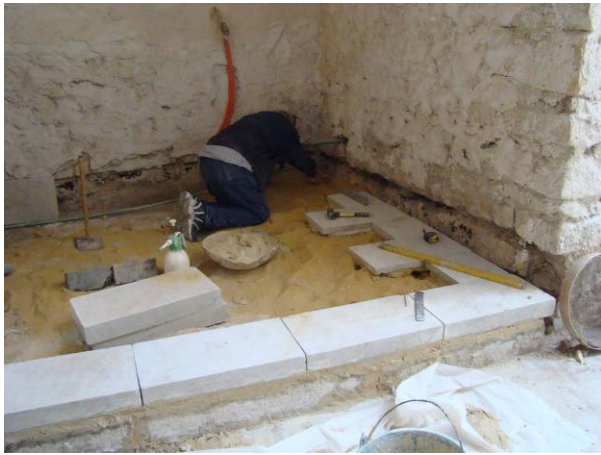
Tiling of the vestibule area

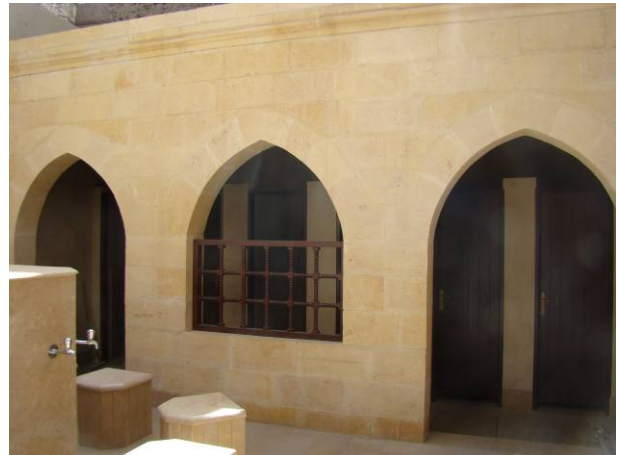
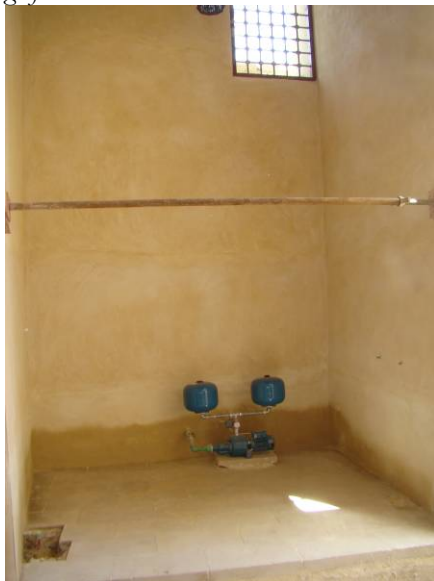
The Vestibule

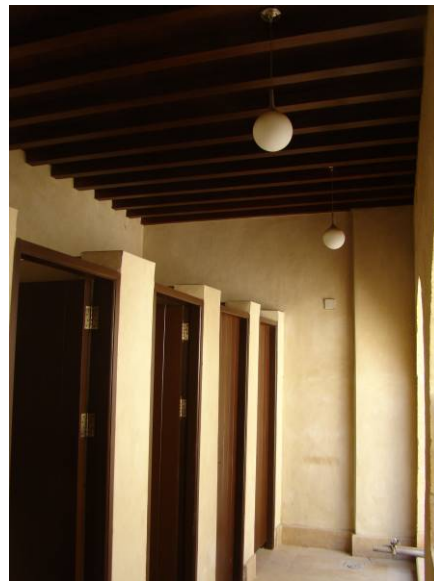
The toilettes corridor

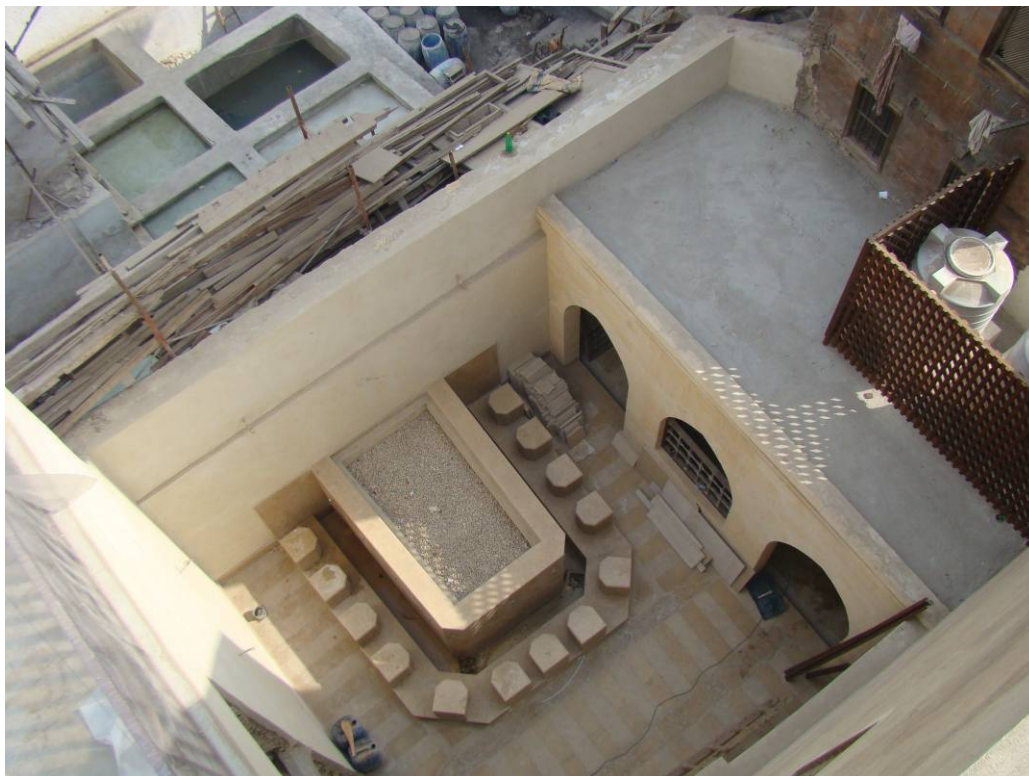
View of the ablution area
